# Abbreviated Noise Monitoring Report

Monitoring Period: 05 January 2026 to 01 February 2026

**Project:** Grenfell Tower

**Document Ref:** EEMC-NMR-201/105 – Grenfell Tower Rev 02

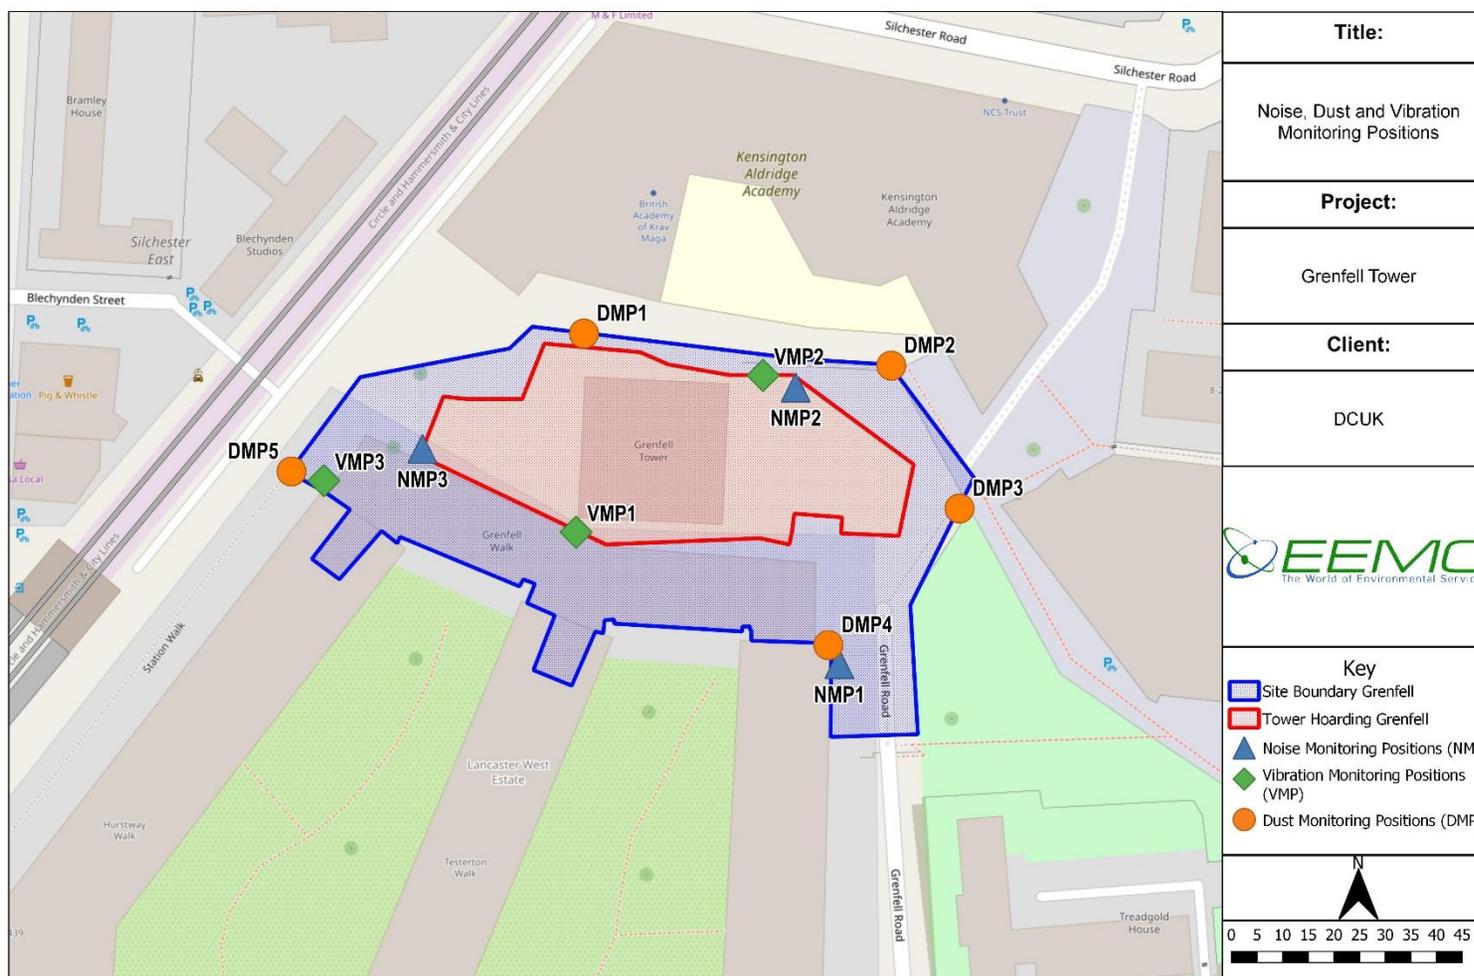
Figure 1- Map of Noise, Dust & Vibration Monitoring Locations

The site boundary and hoarding line of this project is shown in Figure 1. The project is located at Grenfell Tower, Grenfell Road, W11 1TQ. The entire site is located within Royal Borough of Kensington & Chelsea (RBKC) and is bordered by residential blocks to the south, and a school and football pitches to the north and a leisure centre to the east. The London Underground viaduct is 70m to the west and Latimer Road Tube station is 200m from the project

Three (3) Class 1 compliant noise monitors have been deployed to undertake noise monitoring on the site. A map indicating the location of the noise monitors is provided as Figure 1 and photographs of the installed noise monitors are provided as Image 1-3.

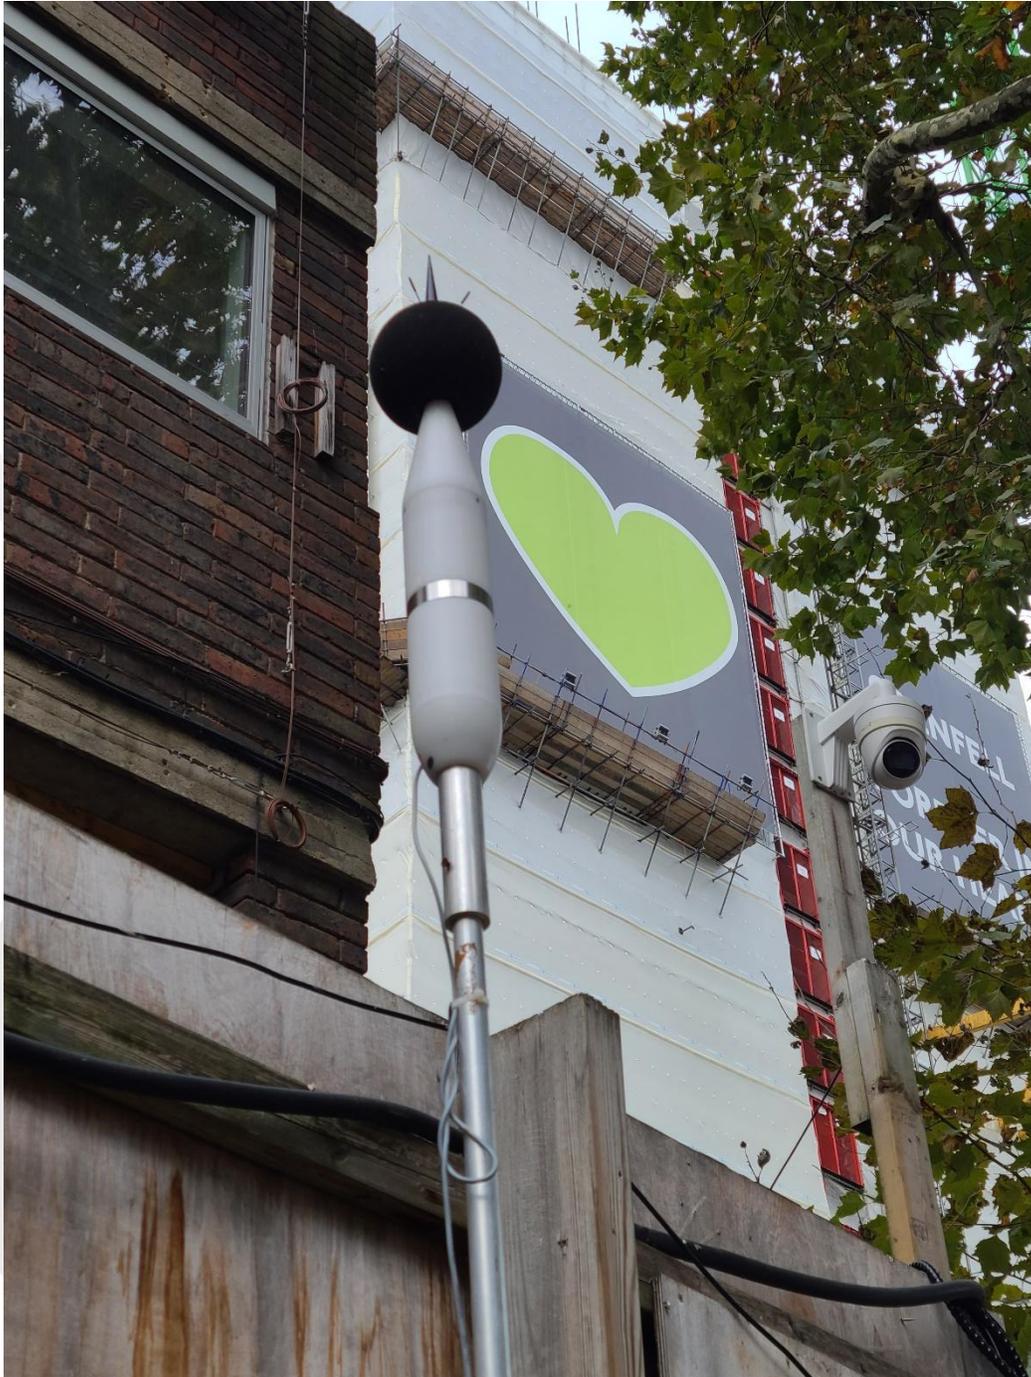
**Image 1 –NMP1 Monitoring Location (19<sup>th</sup> May 2025)**

ID Reference	Location
NMP1	South-East of site on the hoarding
NMP2	North-East of site on the hoarding
NMP3	South-West of site on the hoarding

The noise monitors are installed with an all-weather protective system fitted to the remote microphone, at elevations and locations previously agreed with RBKC. Each system is fitted with a modem to allow remote access to the measurement data via the internet. The modem also enables the provision of automatic email alerts.

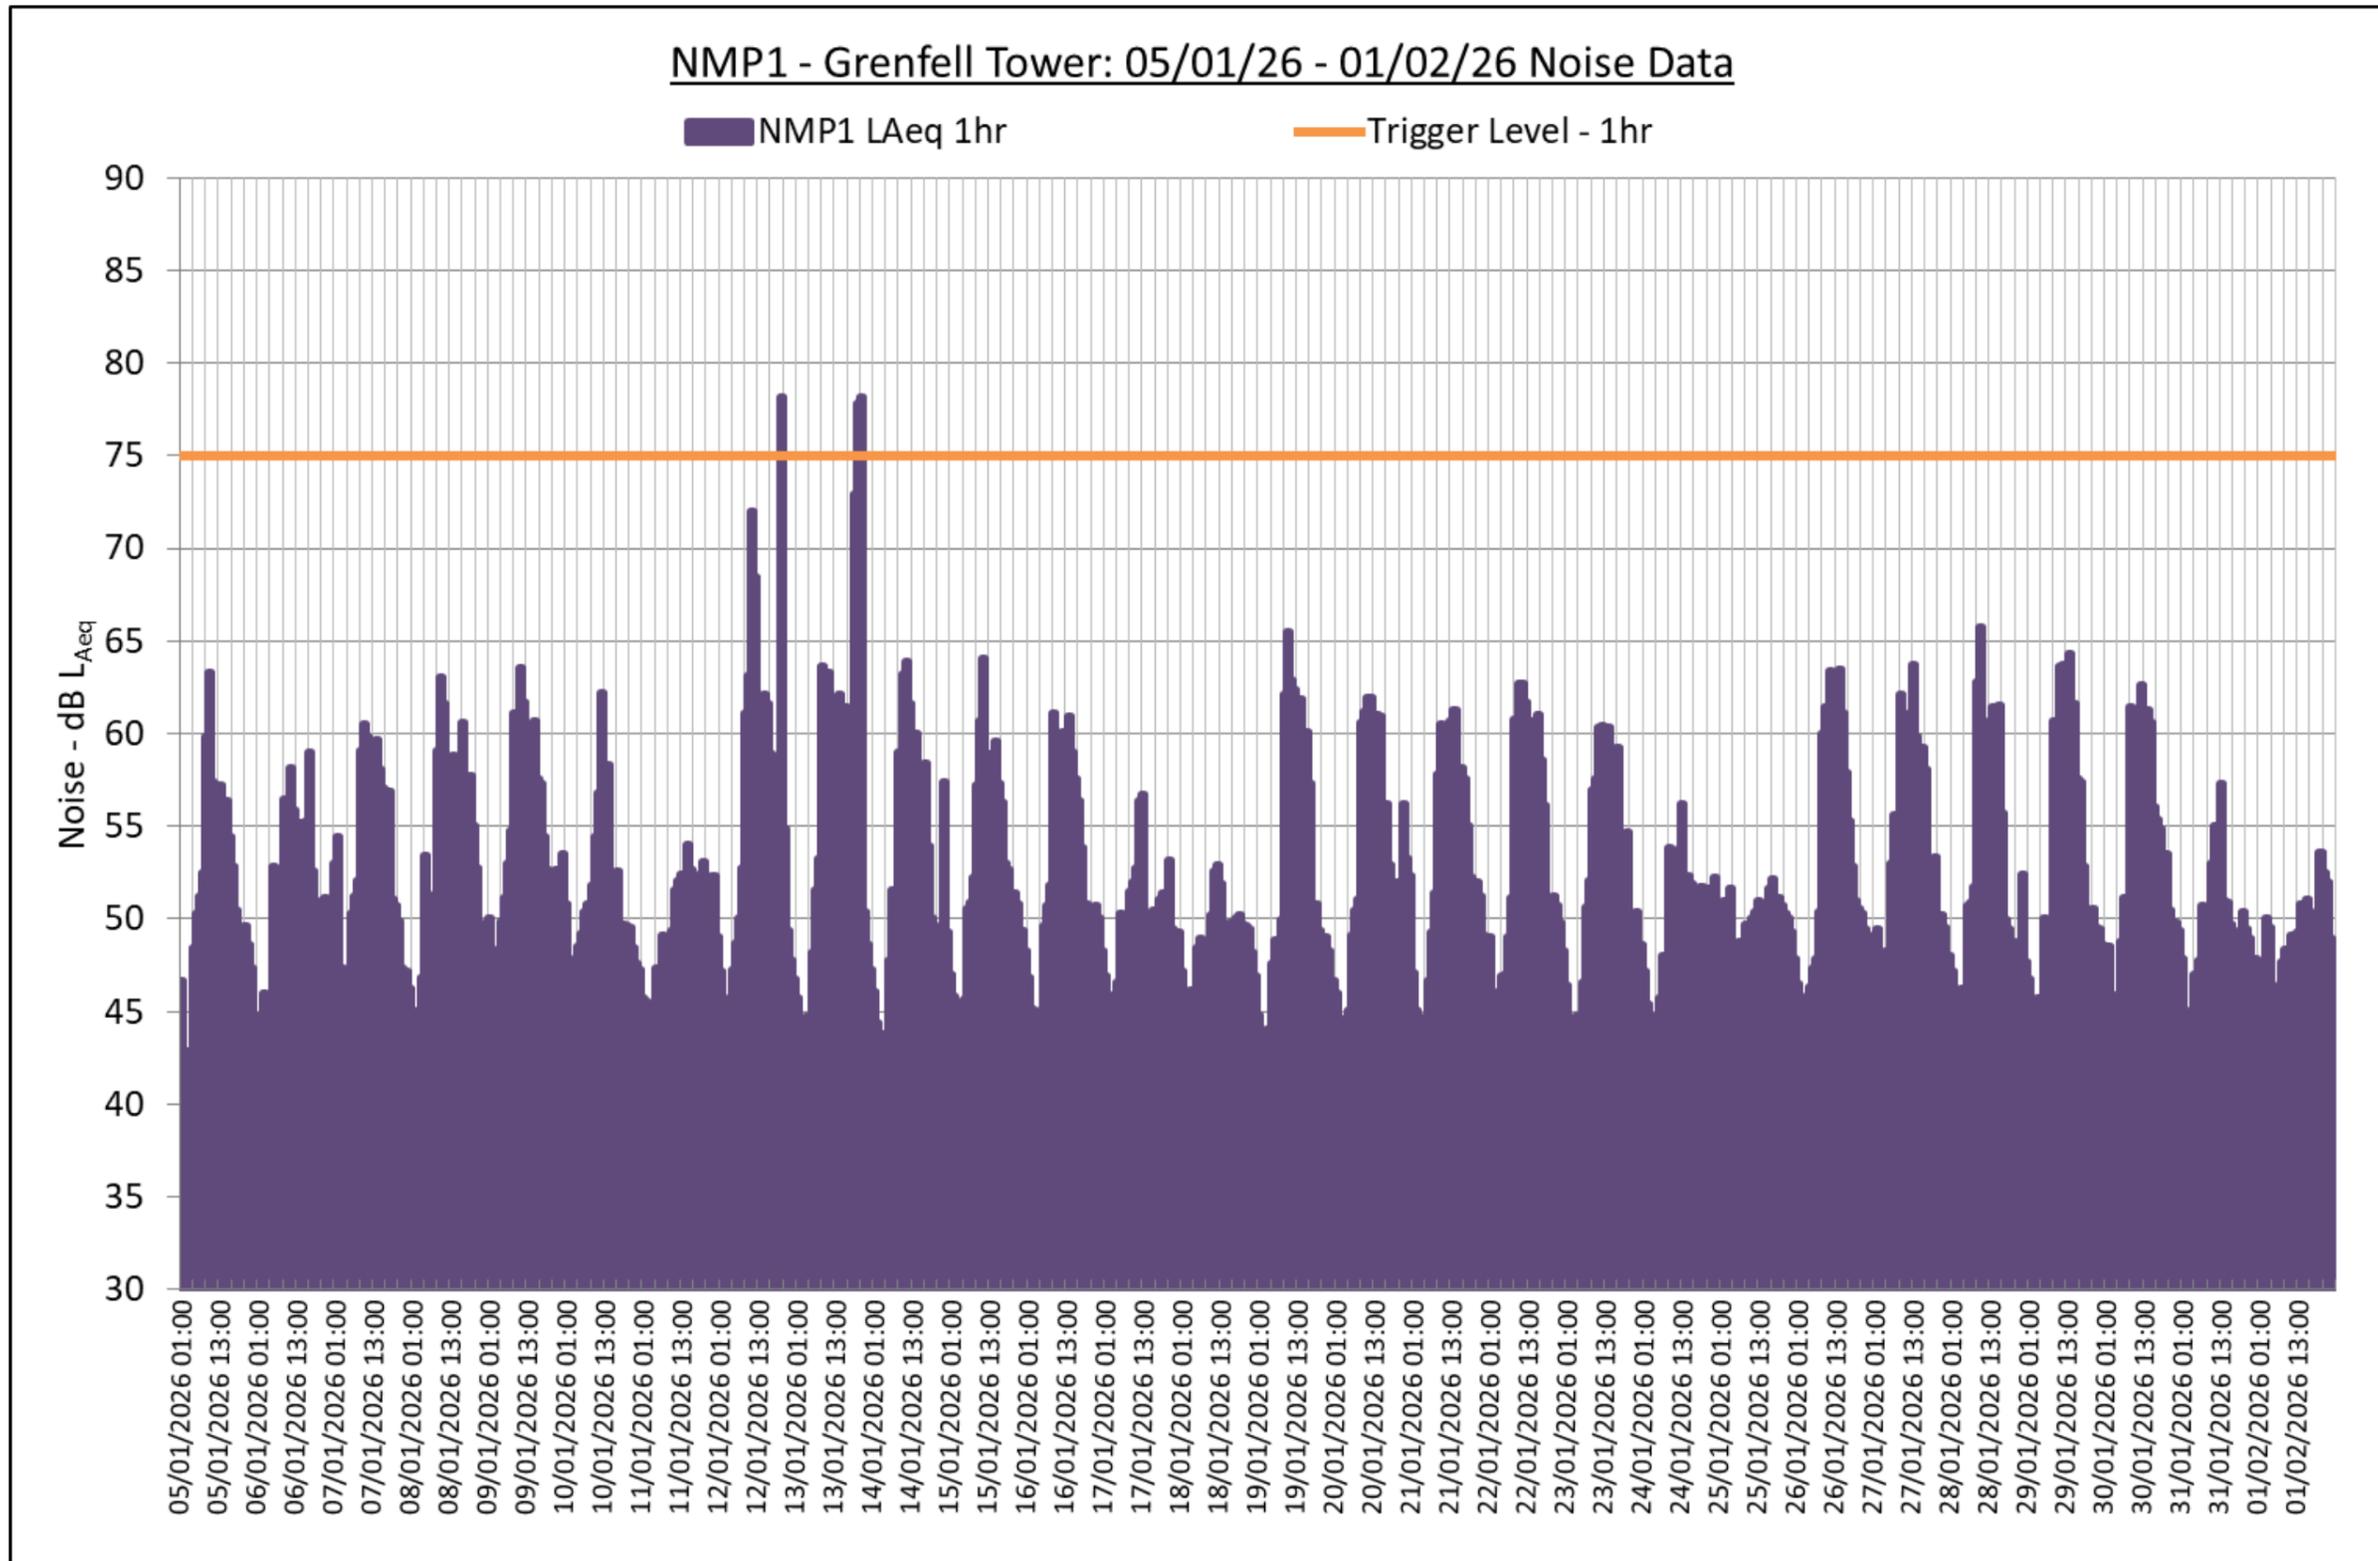
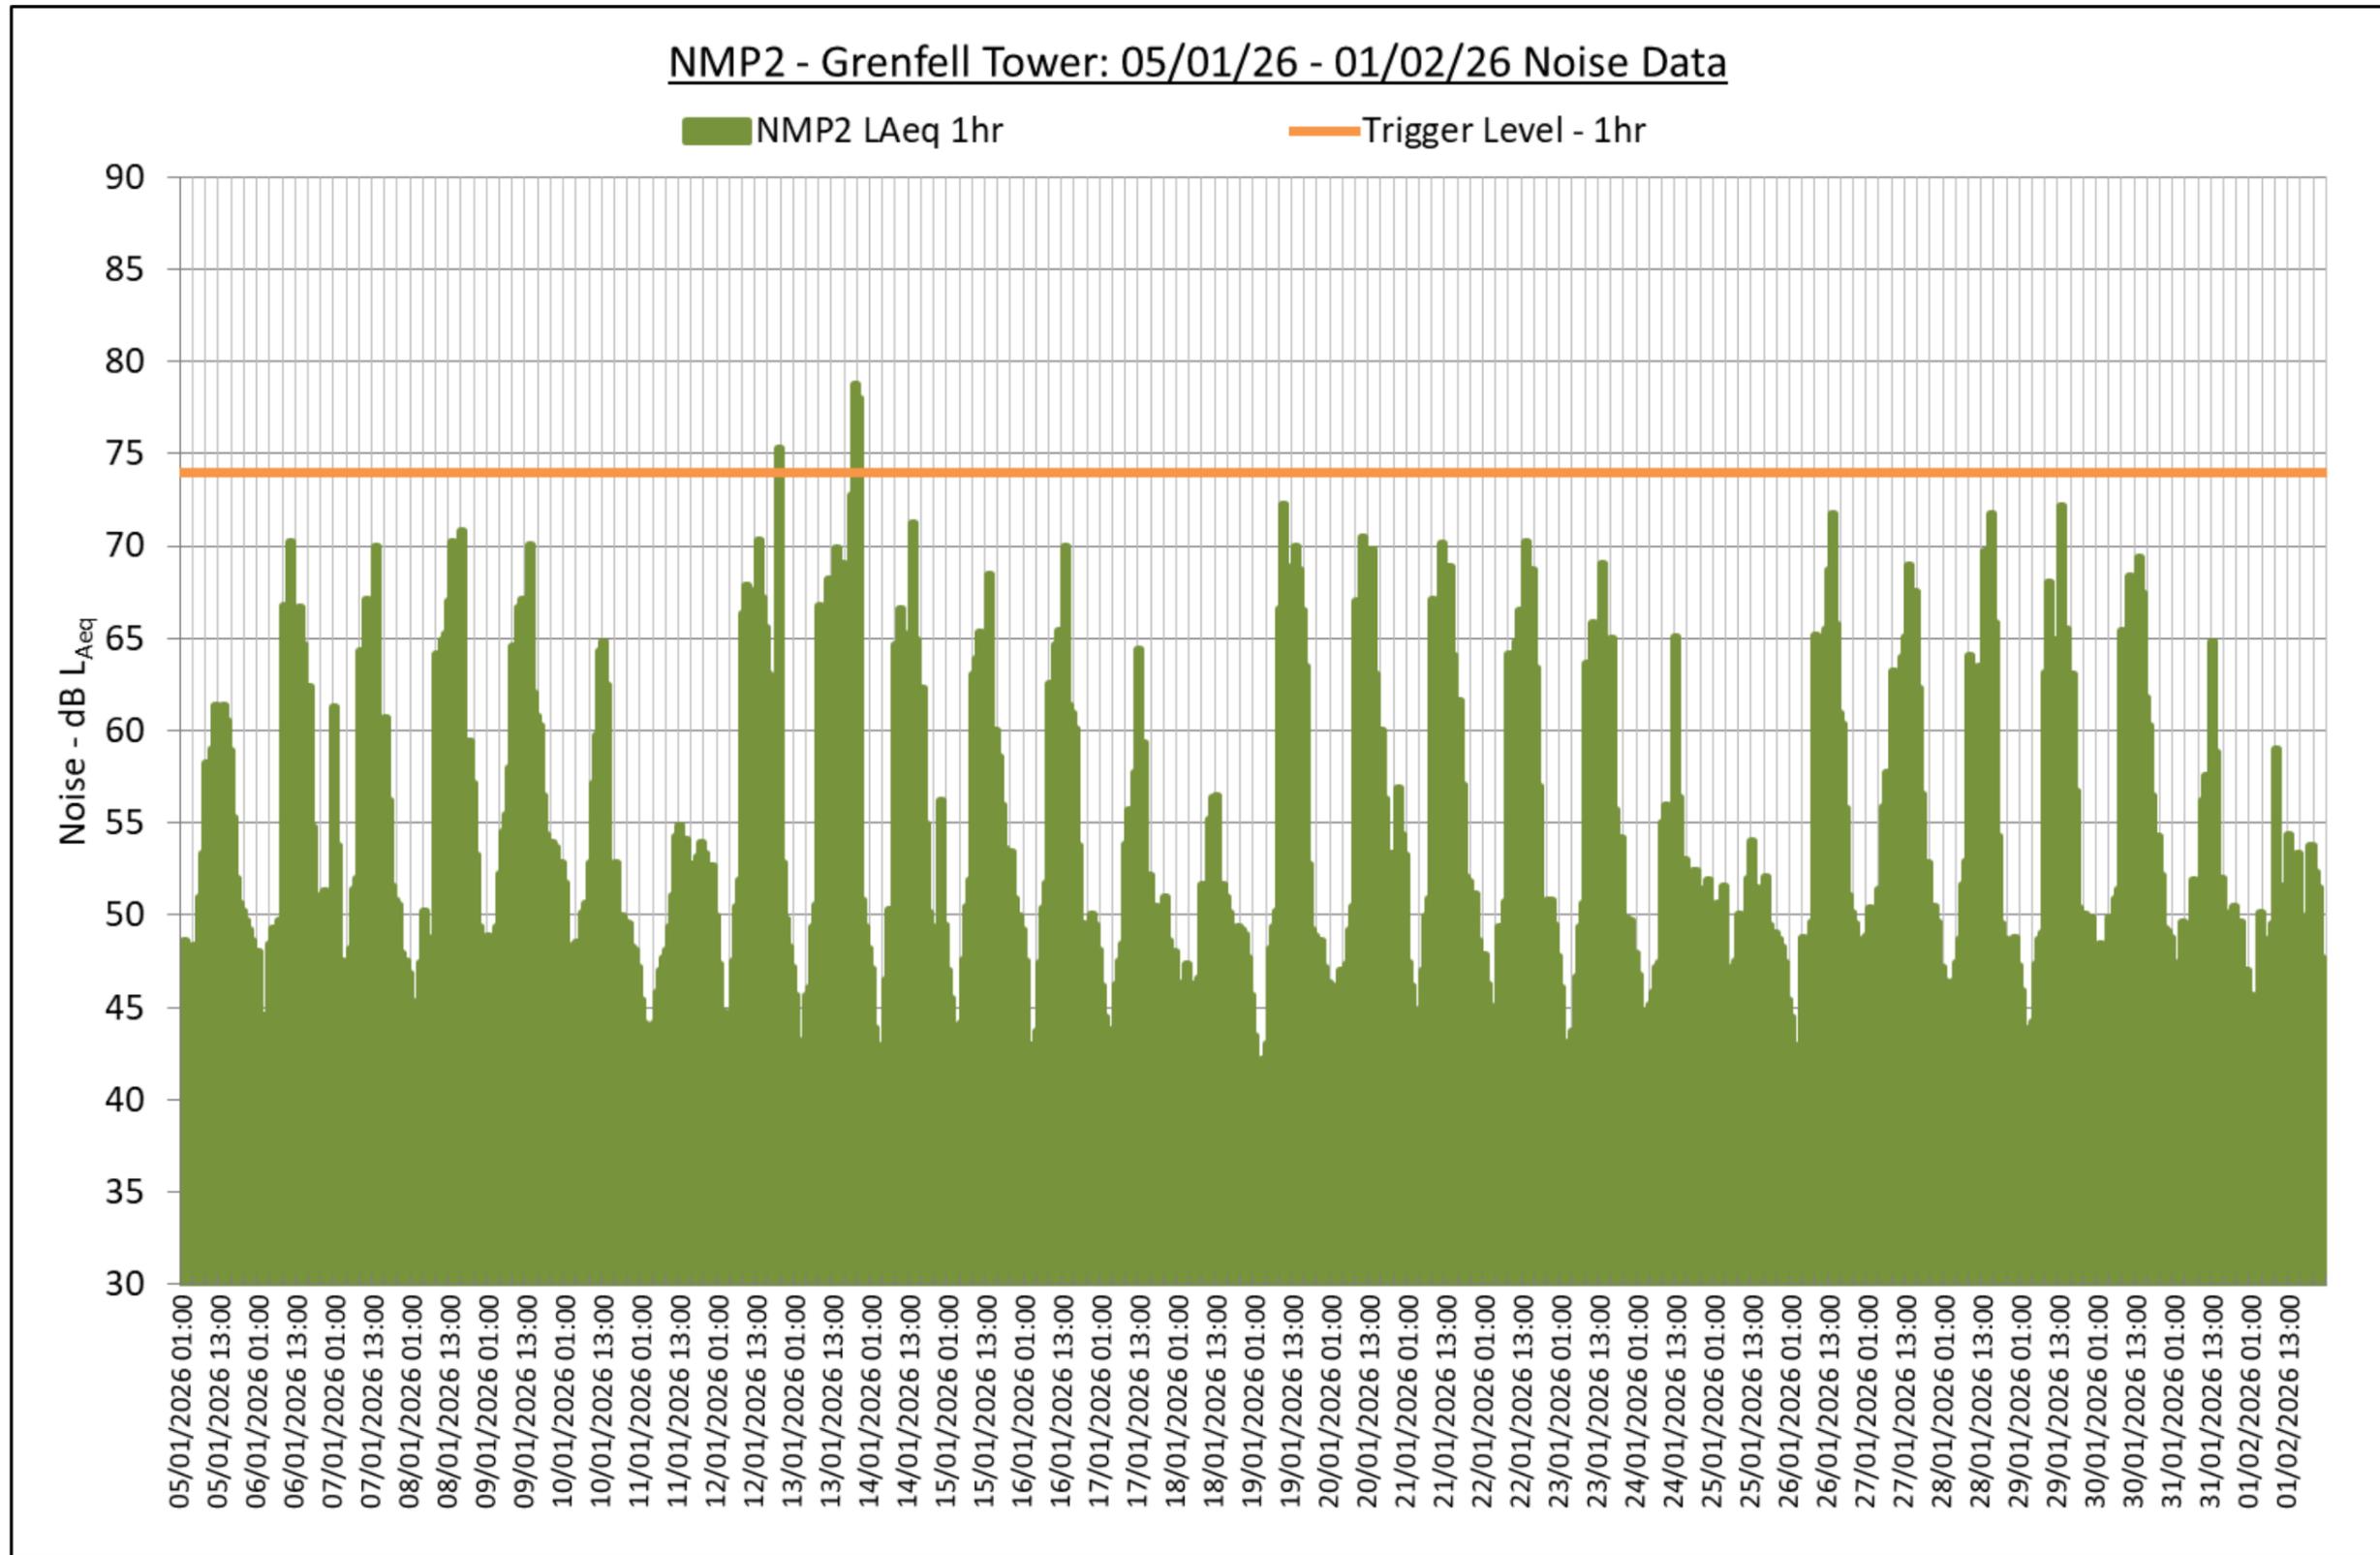
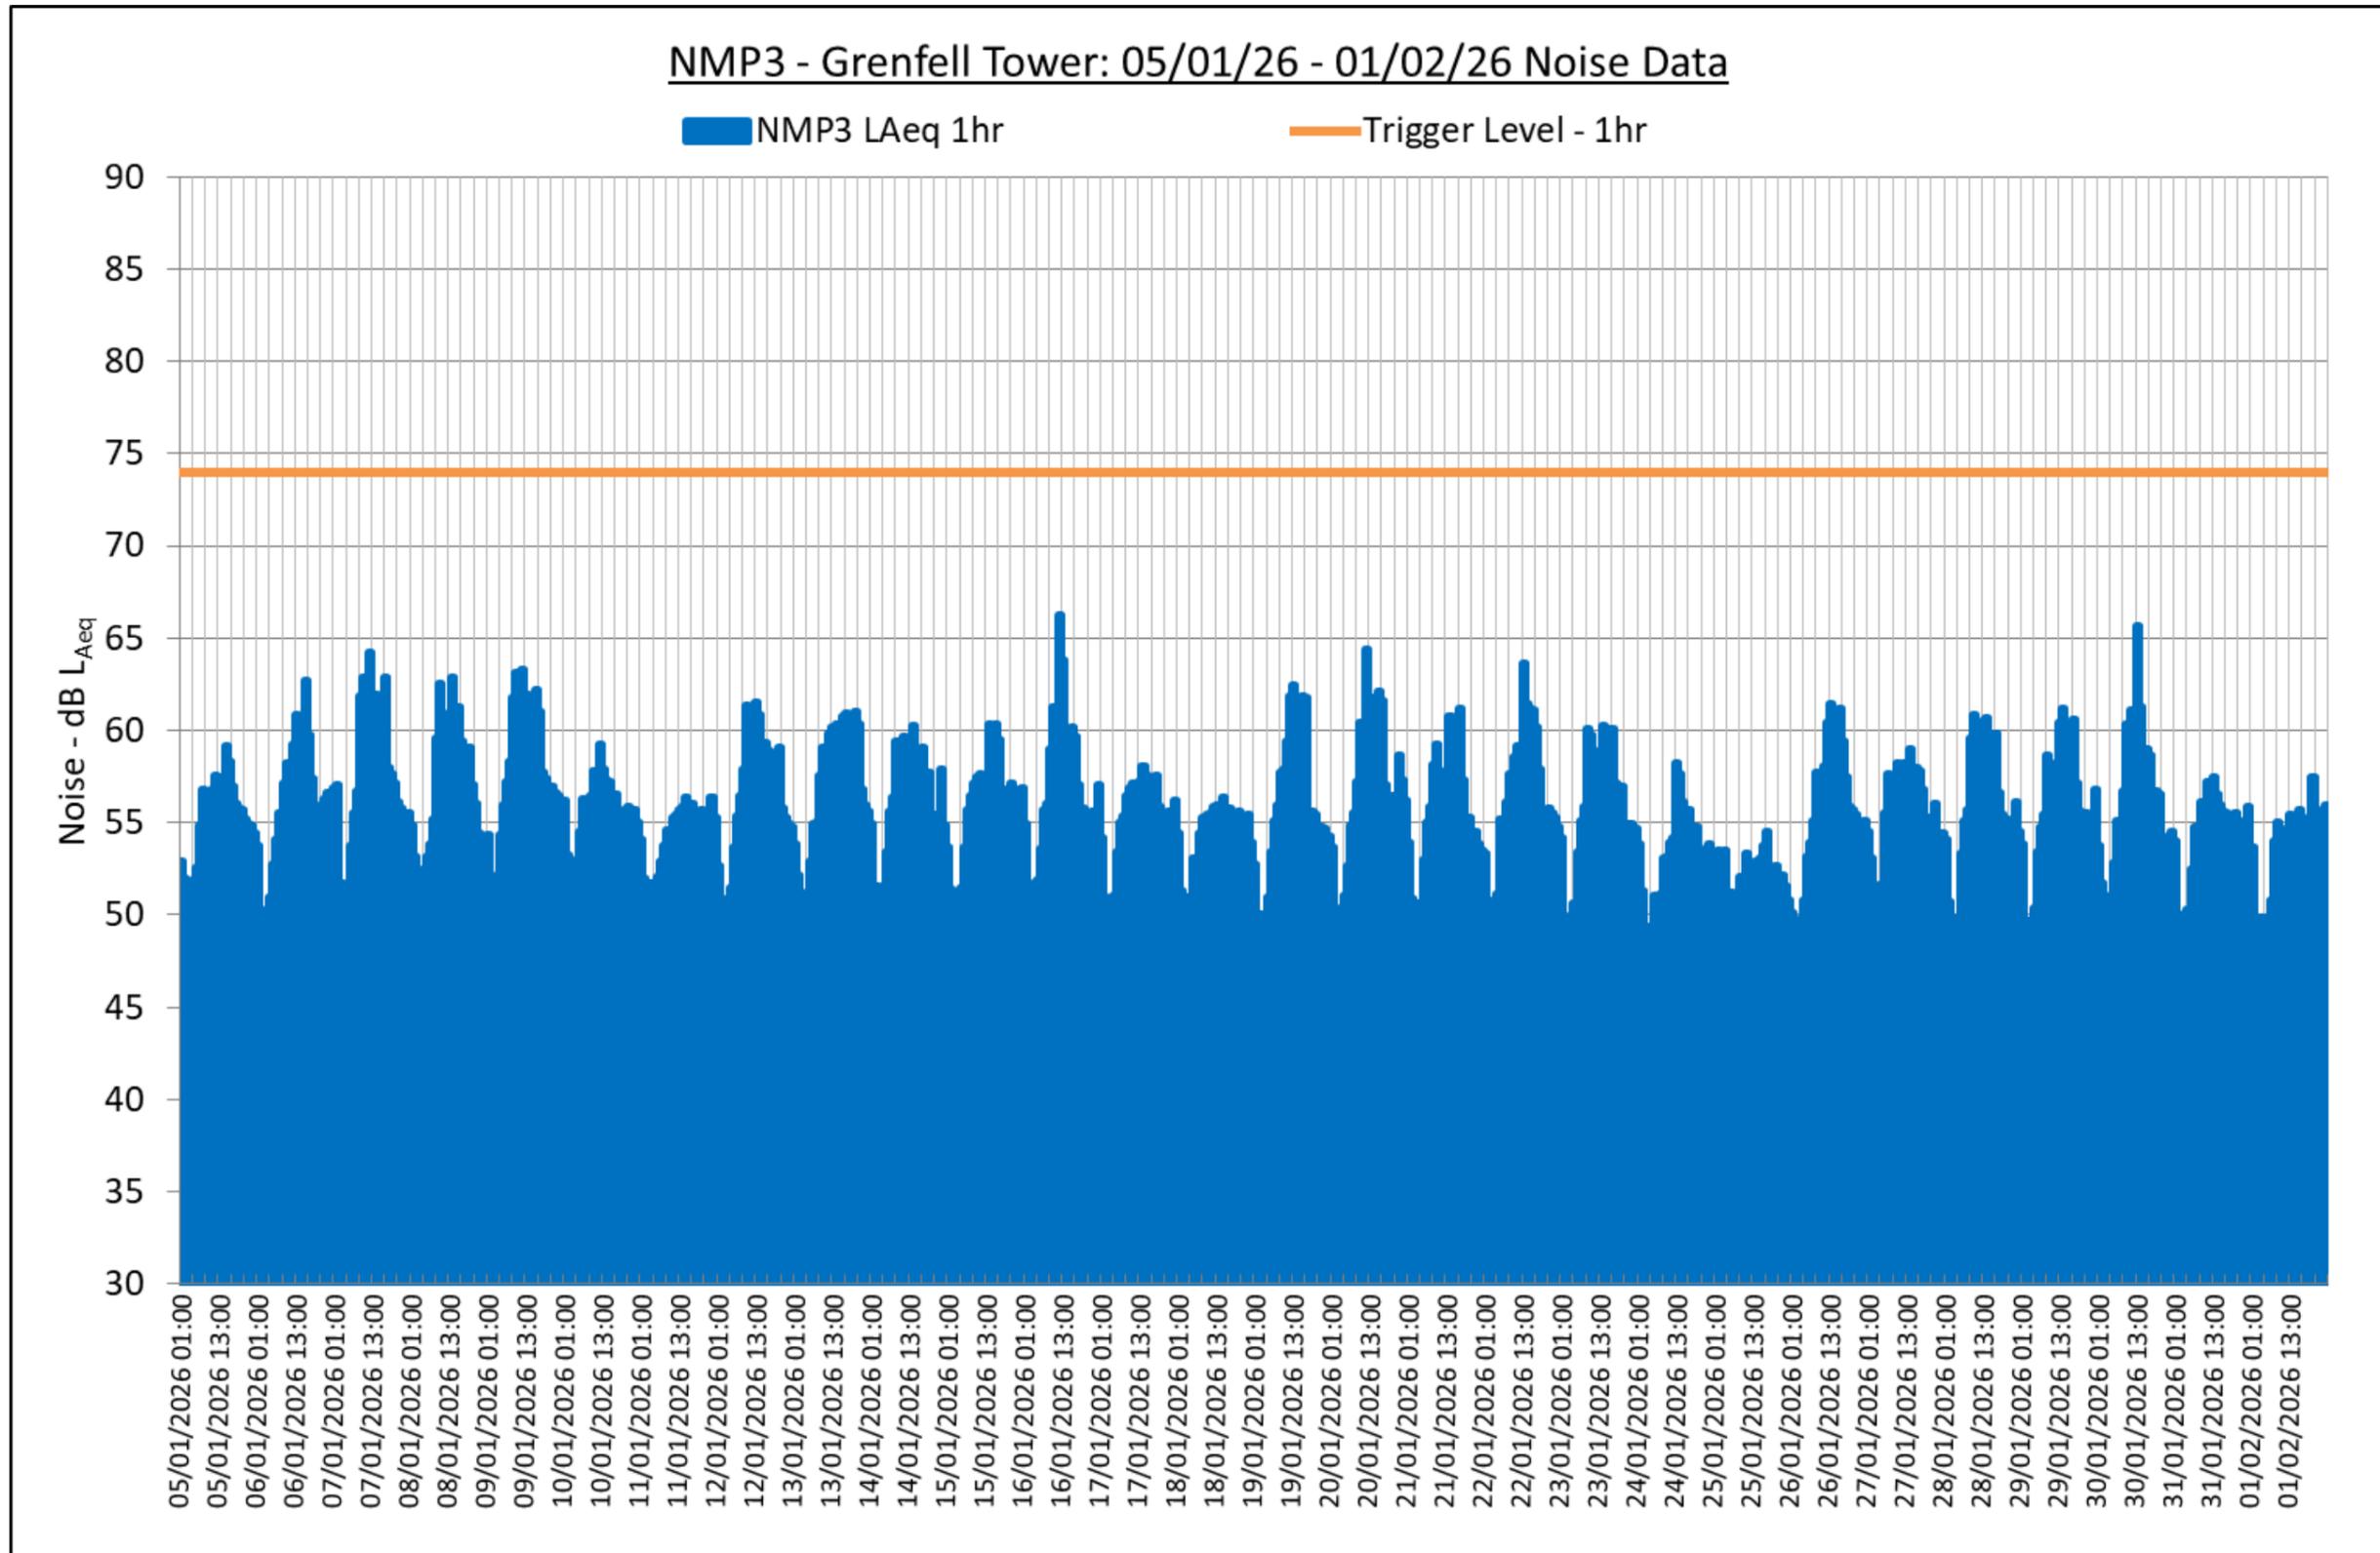
6. 1-hour Noise Monitoring Graphs

During site working hours there were **no exceedances** of the 75dB  $L_{Aeq, 1hr}$  Amber or the 72dB  $L_{Aeq, 10hr}$  Red Alert level.

Outside of site working hours there were **three (3) exceedances** of the 75dB  $L_{Aeq, 1hr}$  level and due to the occurrence of the noise generated and activity outside of permitted working hours these are classified as Red Alerts to ensure site were acting proactively and protecting nearby residents.

During site working hours there were **no exceedances** of the 74dB  $L_{Aeq, 1hr}$  Amber or the 71dB  $L_{Aeq, 10hr}$  Red Alert level.

Outside of site working hours there were **three (3) exceedances** of the 74dB  $L_{Aeq, 1hr}$  level and due to the occurrence of the noise generated and activity outside of permitted working hours these are classified as Red Alerts to ensure site were acting proactively and protecting nearby residents.

There were **no exceedances** any of the alert levels during site working hours during this reporting period.

Monitoring Location	Time and Date of Exceedance	Measured Level of Exceedance ( $dB L_{Aeq,1hr}$ )	Amber Trigger Alert Level ( $dB L_{Aeq,1hr}$ )	Cause of Exceedance	Mitigation
NMP1	12/01/2026 20:00	78.1	75	Faulty alarm on a delivery truck	Reported technical fault to company and the trucks were taken to be repaired.
	13/01/2026 20:00	77.8			
	13/01/2026 21:00	78.2			
NMP2	12/01/2026 20:00	75.3	74		Site have received a repairs report from the manufacturers
	13/01/2026 20:00	78.8			
	13/01/2026 21:00	78.0			
NMP3	-	-	74	-

The results of the Noise measurements in this period are presented graphically and tabulated in Sections 6 and 7 respectively of this report.
