Abbreviated Vibration Monitoring Report

Project: Grenfell Tower

Document Ref: EEMC-VMR-201/104 – Grenfell Tower Rev 01

Period: 05 January 2026 to 01 February 2026

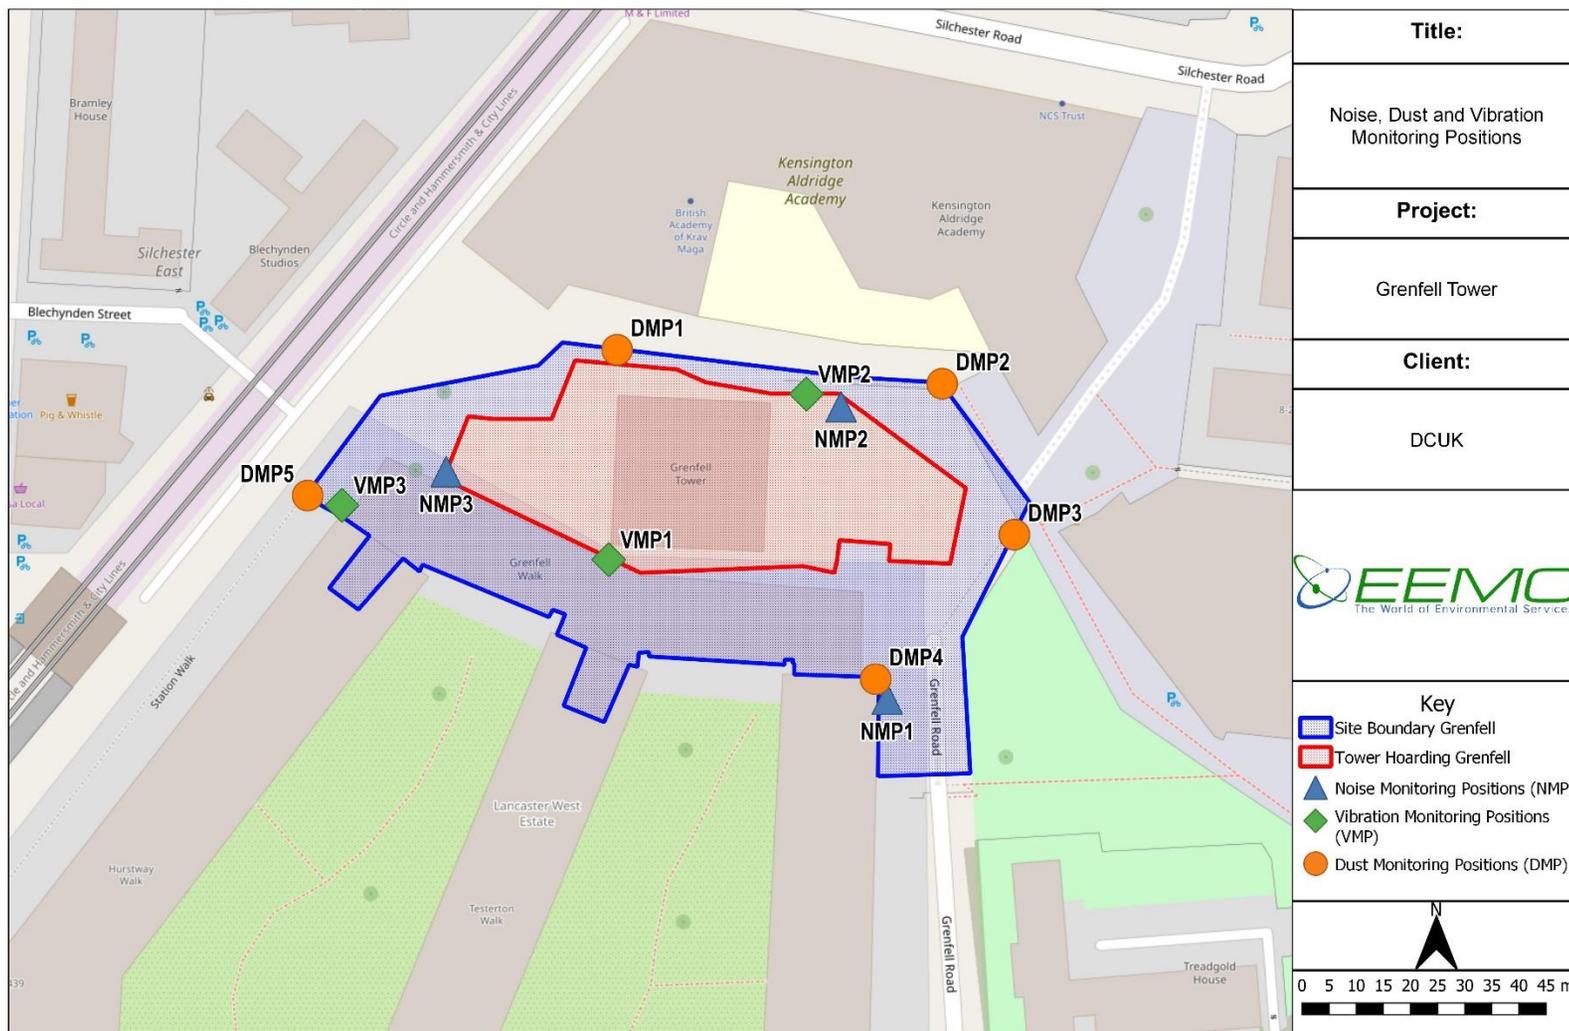
Figure 1- Map of Vibration, Dust & Vibration Monitoring Locations

The site boundary and hoarding line of this project is shown in Figure 1. The project is located at Grenfell Tower, Grenfell Road, W11 1TQ. The entire site is located within Royal Borough of Kensington & Chelsea (RBKC) and is bordered by residential blocks to the south, and a school and football pitches to the north and a leisure centre to the east. The London Underground viaduct is 70m to the west and Latimer Road Tube station is 200m from the project

The Swarm monitors record Peak Particle Velocity (PPV) in orthogonal (x, y and z) directions in mm/s continuously over 1-minute periods. A map showing the locations of the monitors is in Figure 1. A photograph showing the monitoring location is shown in Image 1.

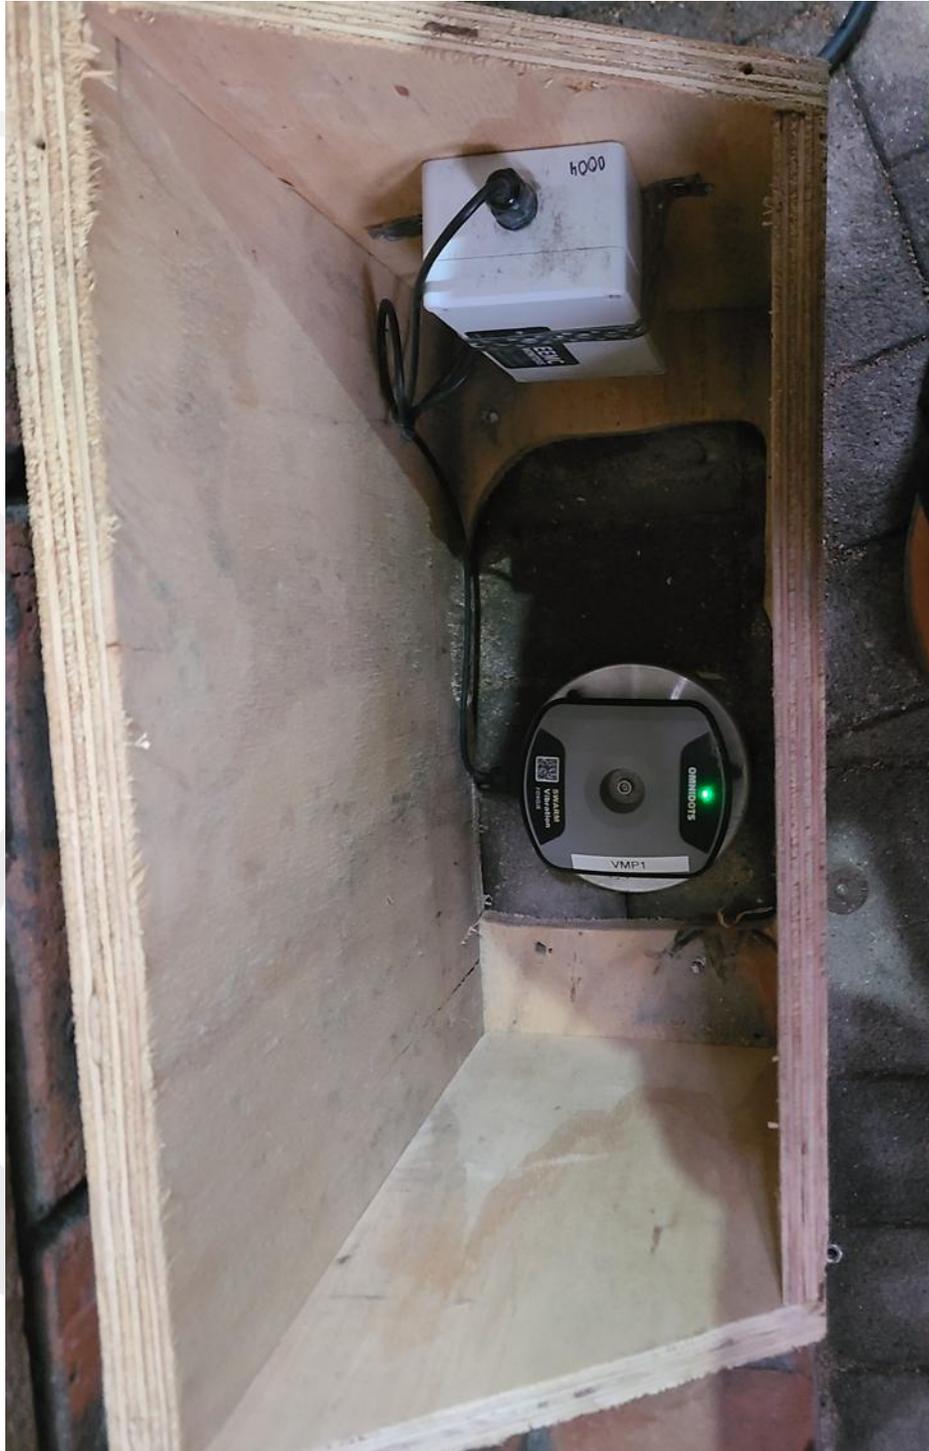
Image 1 – VMP1 Monitoring Location

ID Reference	Location
VMP1	Opposite Southeast corner of tower between two (2) concrete blocks
VMP2	Base of North hoarding co located with NMP2
VMP3	Mobile unit- Located base of NW hoarding with DMP5 and NMP3

Due to this monitoring location having experienced a few accidental disturbances site have installed a physical barrier in front of VMP1 to help prevent these.

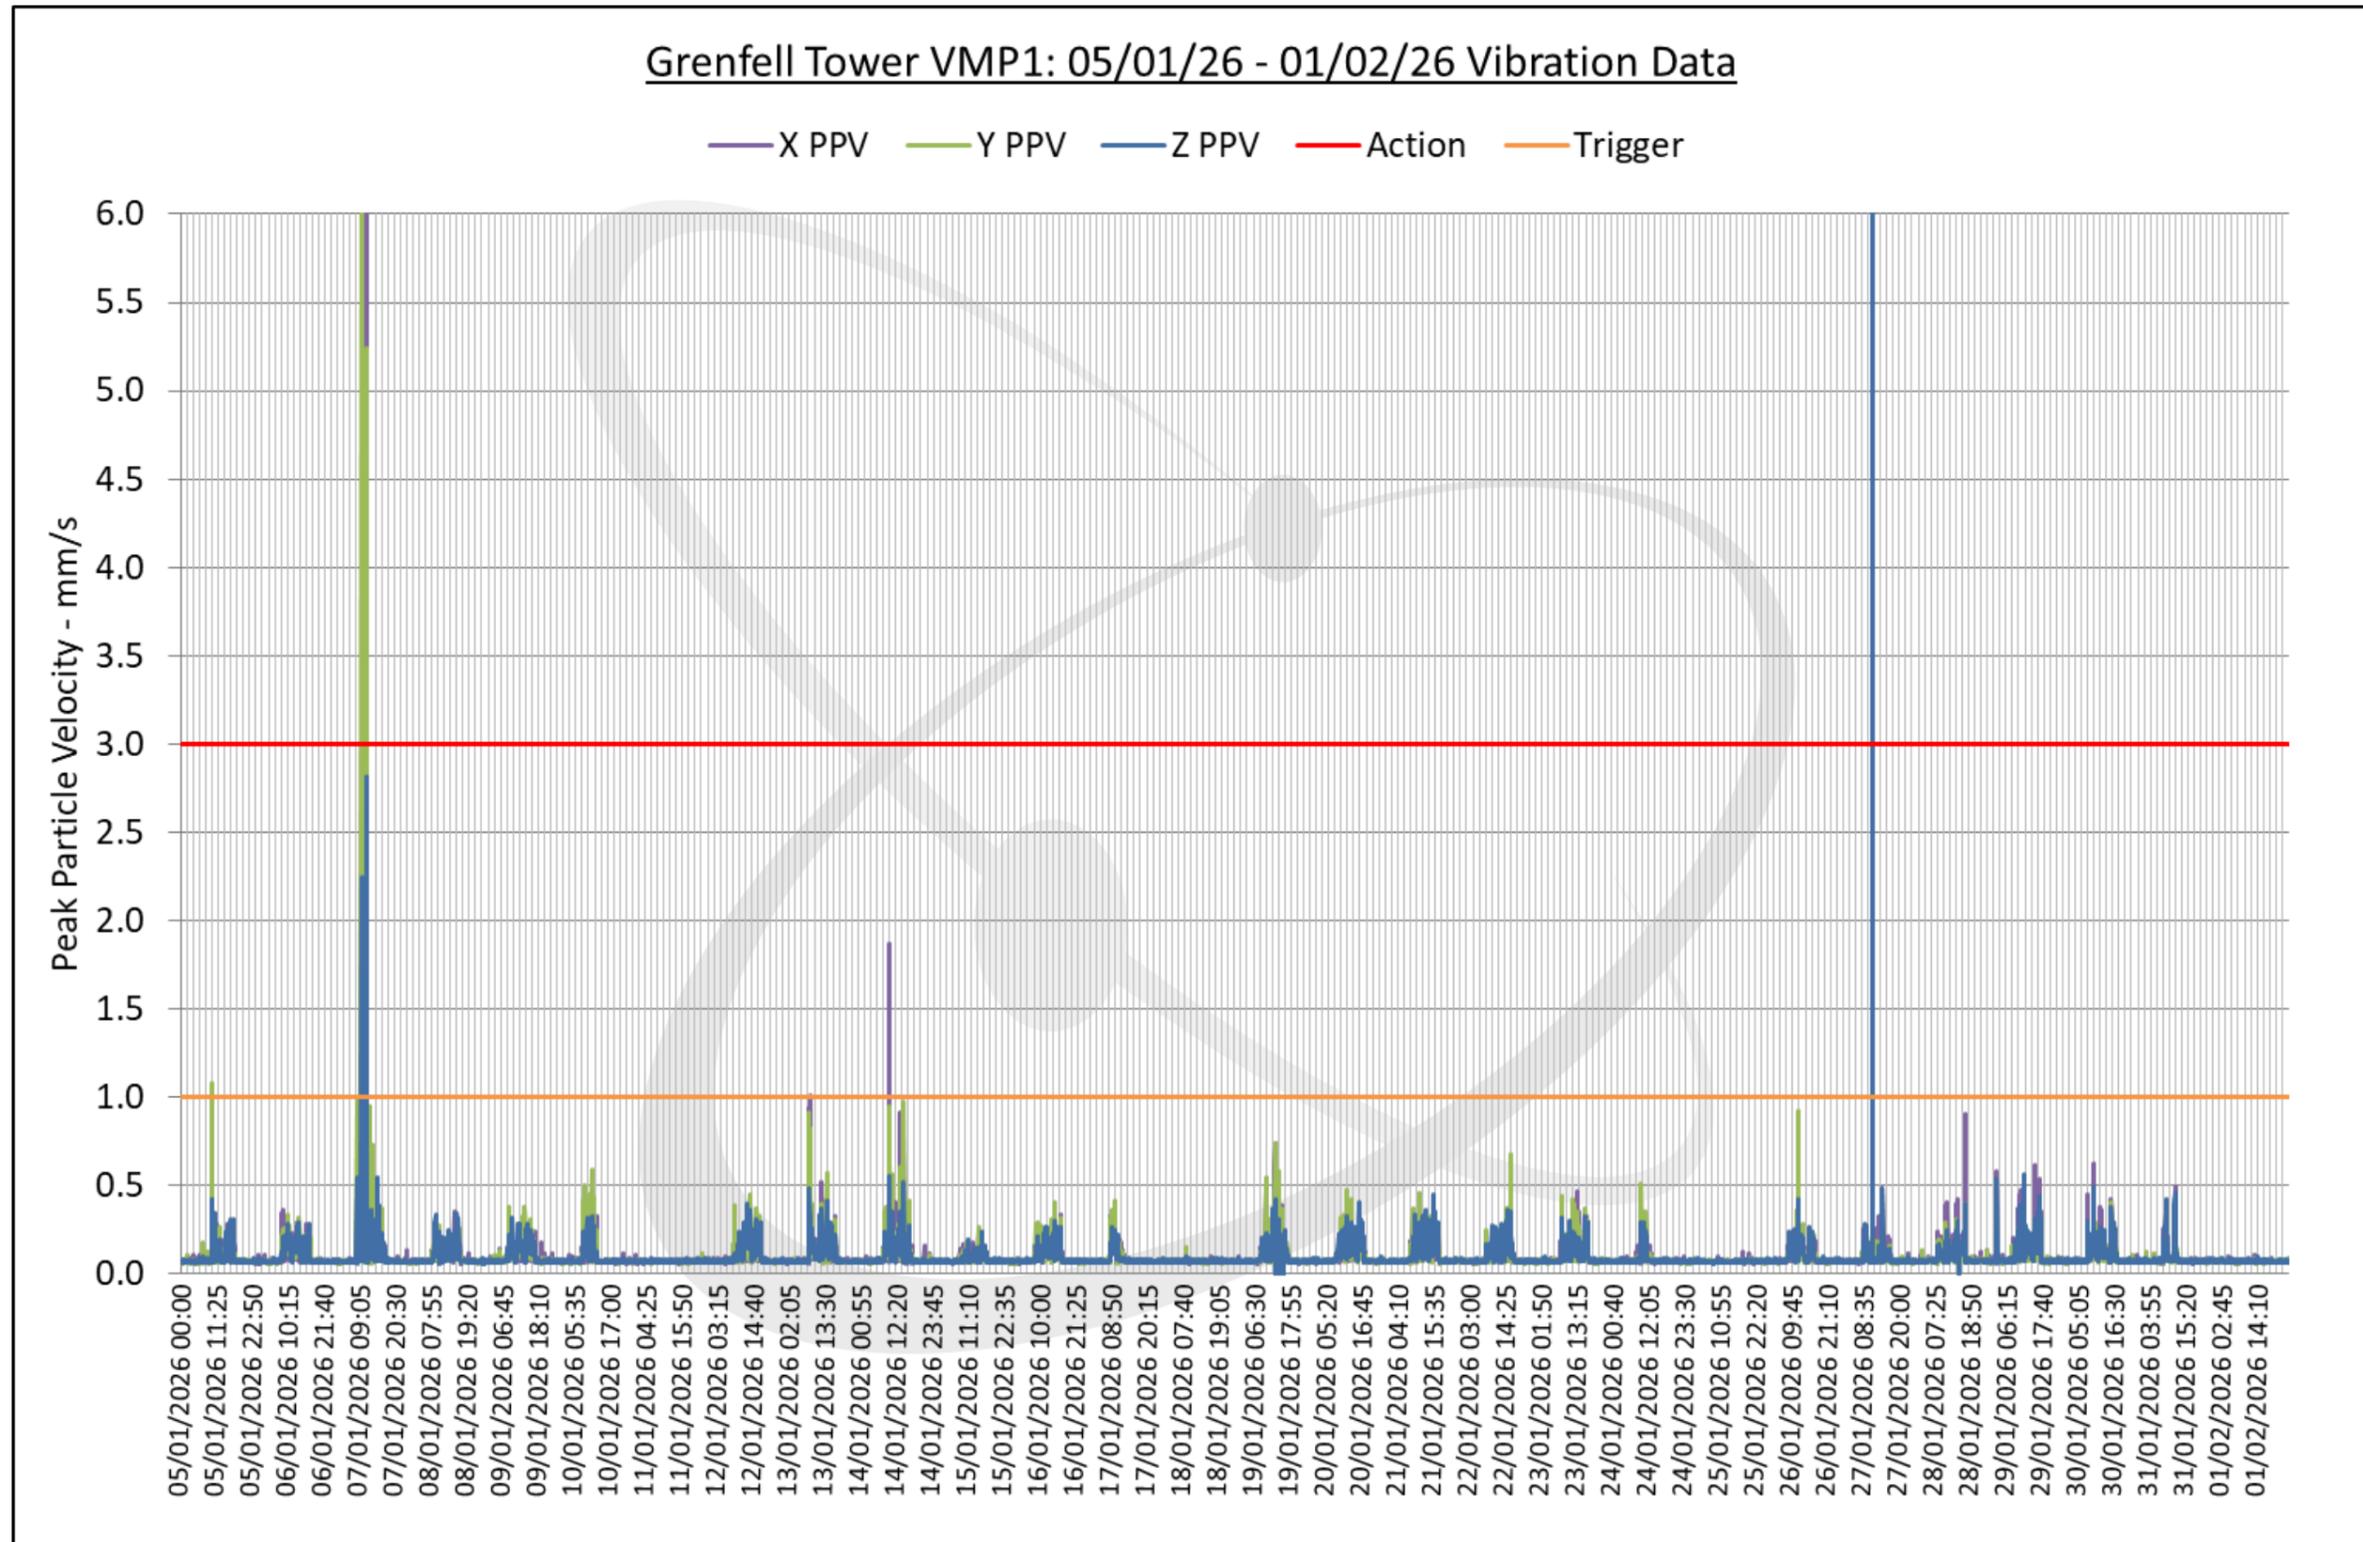
At VMP1:

There were **five (5) exceedances** of the red action level 3.0mm/s and **four (4) exceedance** of the amber trigger level 1.0mm/s during working hours in this reporting period.

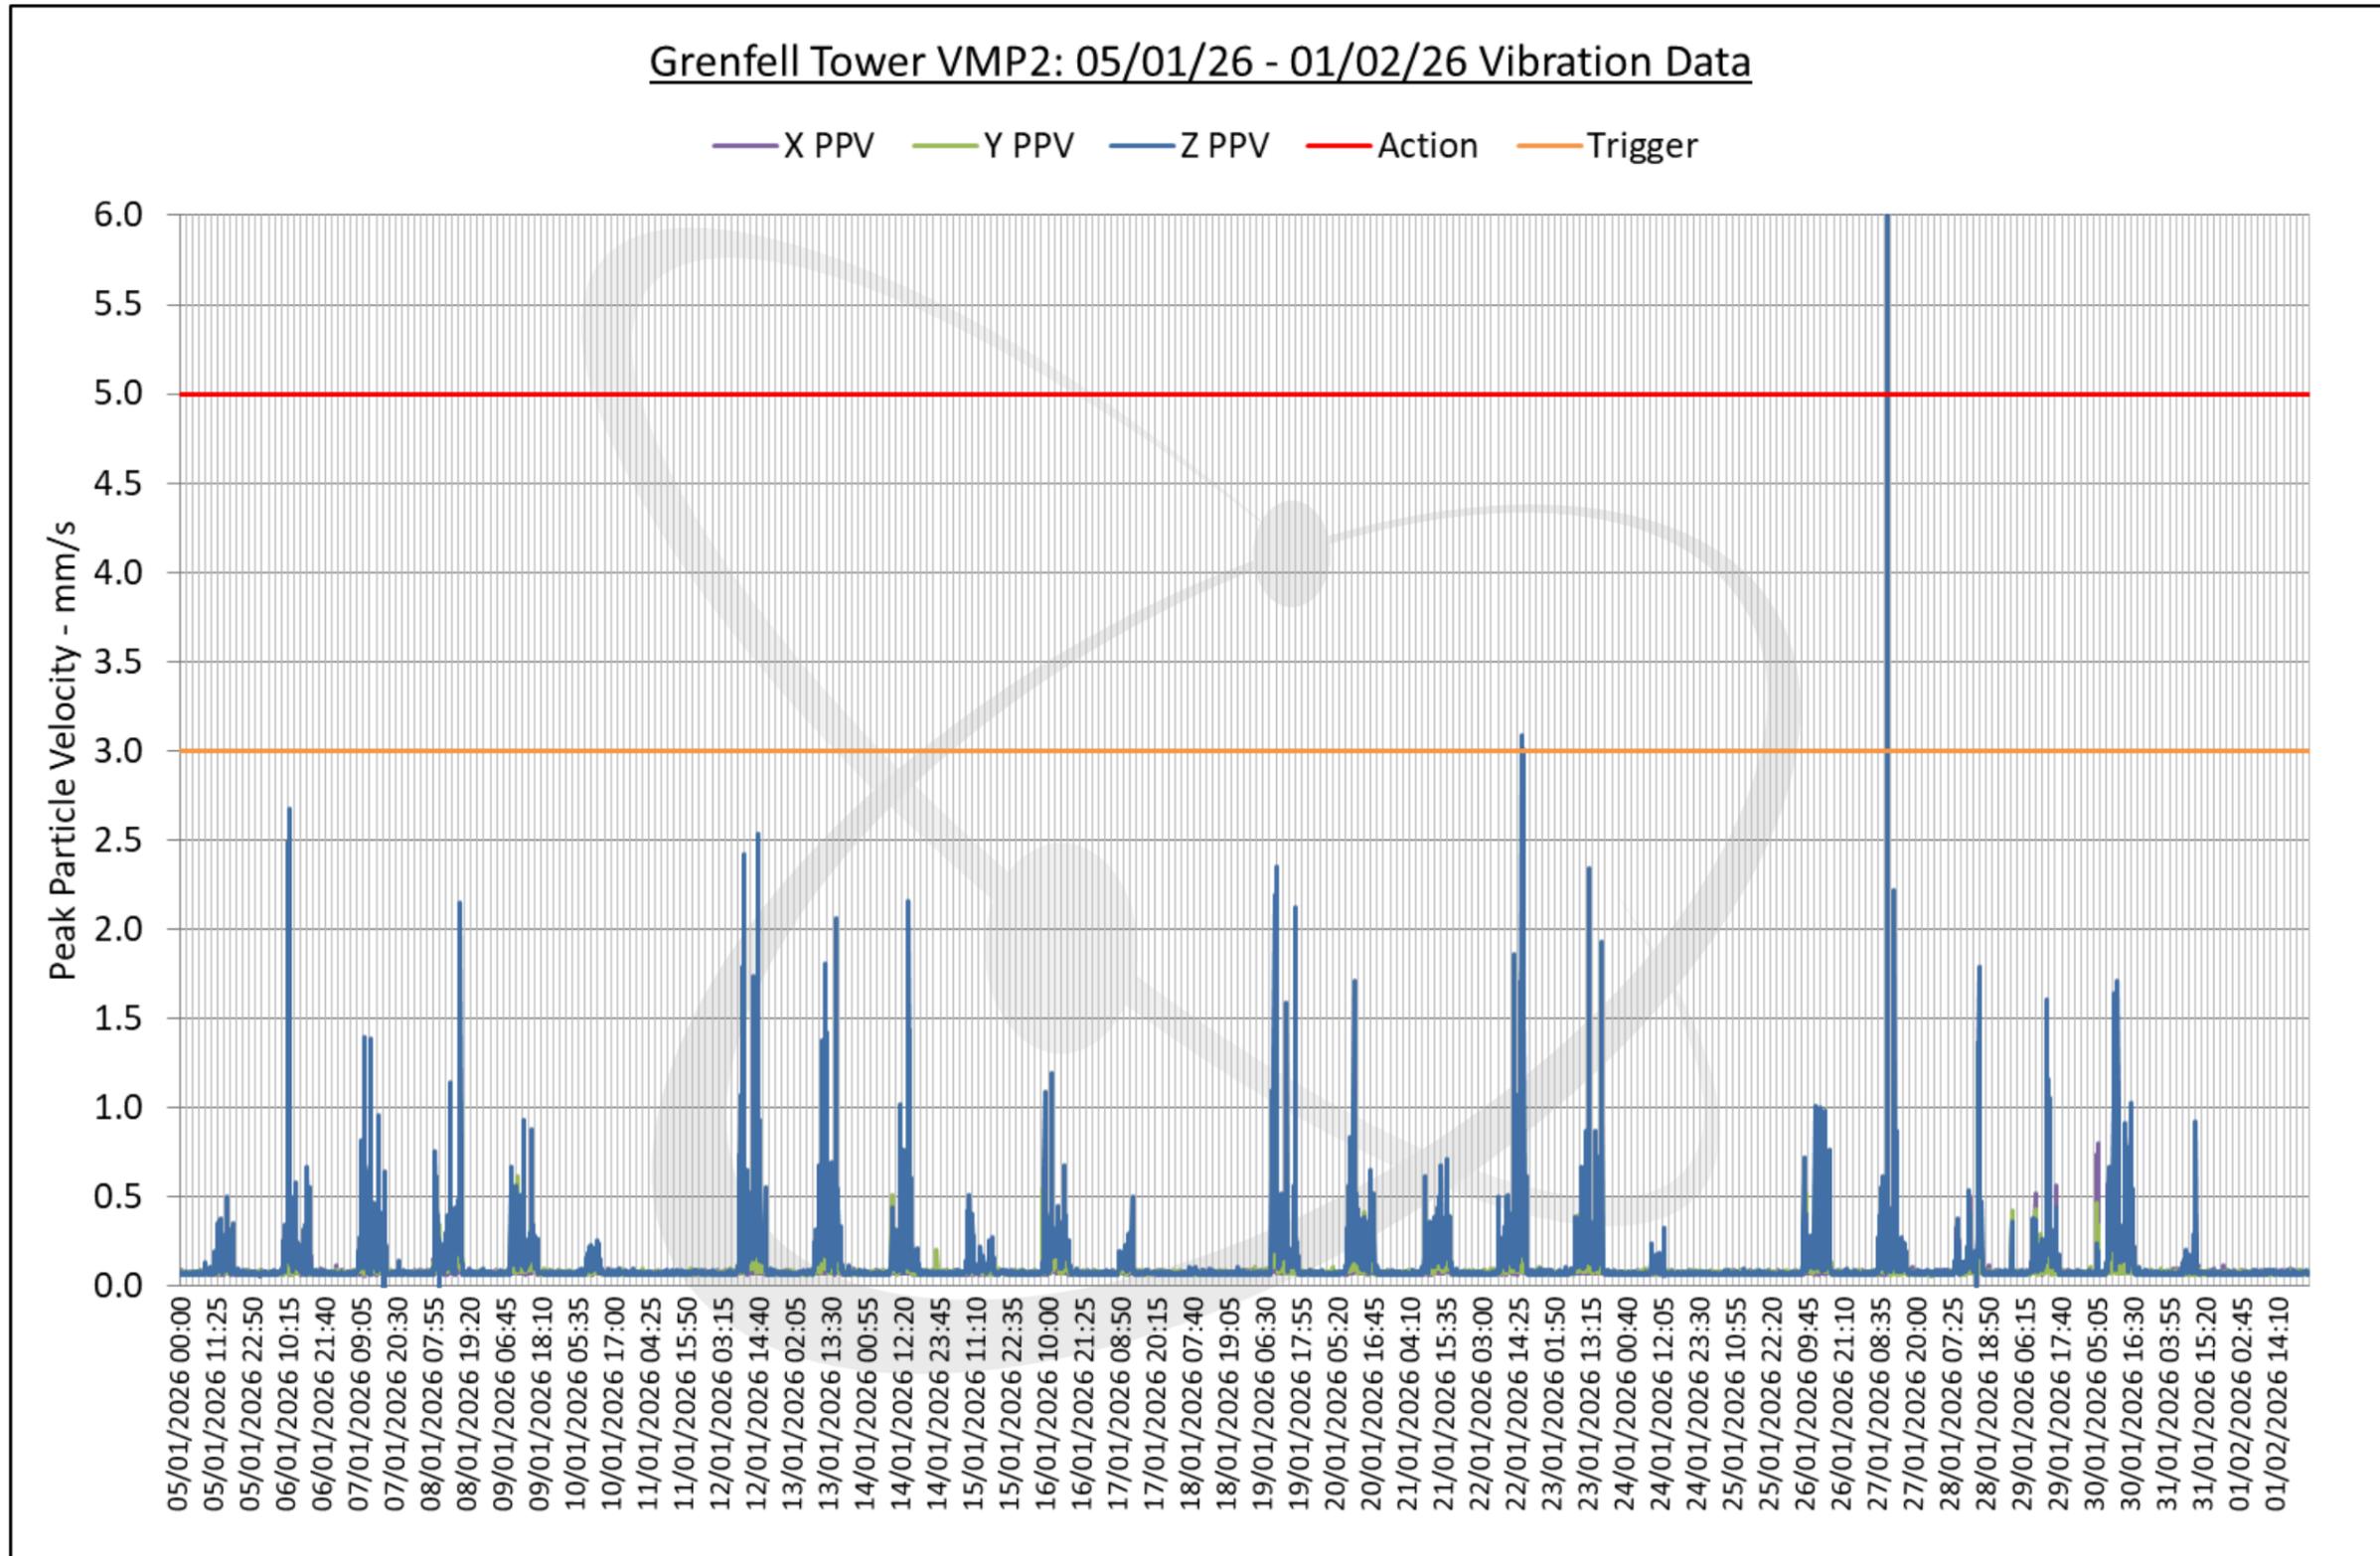
At VMP2:

- There was **one (1) exceedance** of the Red Action level 5.0mm/s and **two (2) exceedances** of the Amber Trigger level 3.0mm/s during working hours in this reporting period.

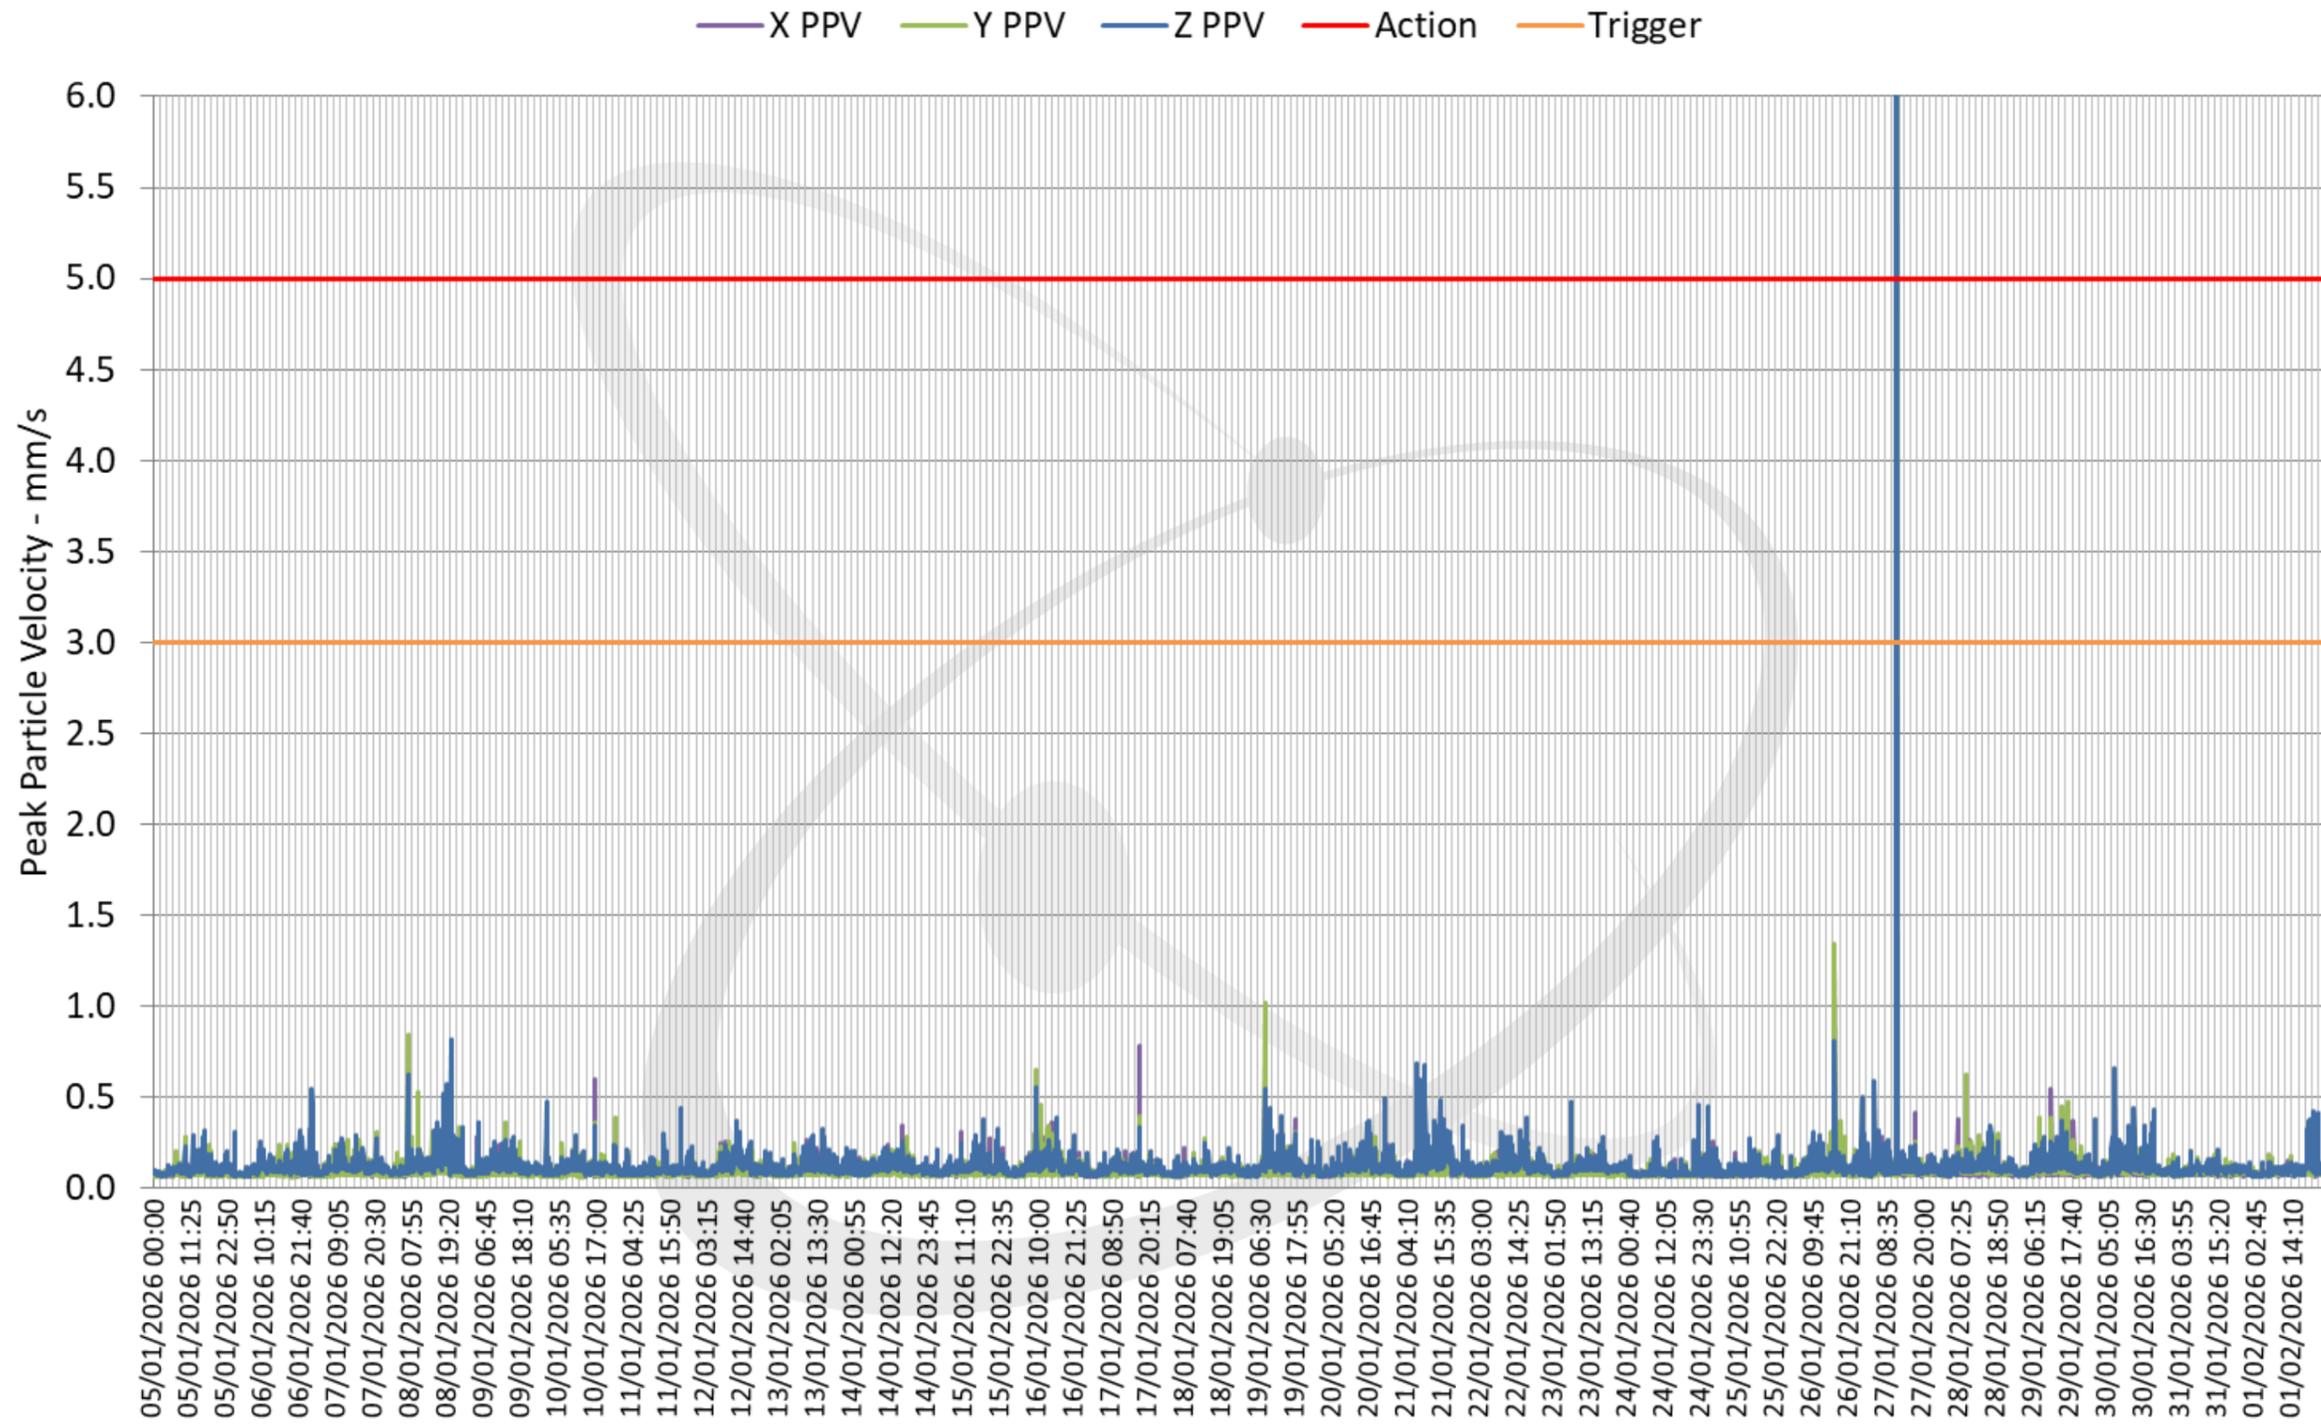
Grenfell Tower VMP3: 05/01/26 - 01/02/26 Vibration Data

At VMP3:

- There were **two (2) exceedances** of the Red Action Level 5.0mm/s, and **no exceedances** of the Amber Trigger level in this reporting period during working hours.
