Abbreviated Dust Monitoring Report

Monitoring Period: 05 January 2026 to 01 February 2026

Project:	Grenfell Tower
Document Ref:	EEMC-DMR-201/105 – Grenfell Tower Rev 01
Period:	05 January 2026 to 01 February 2026

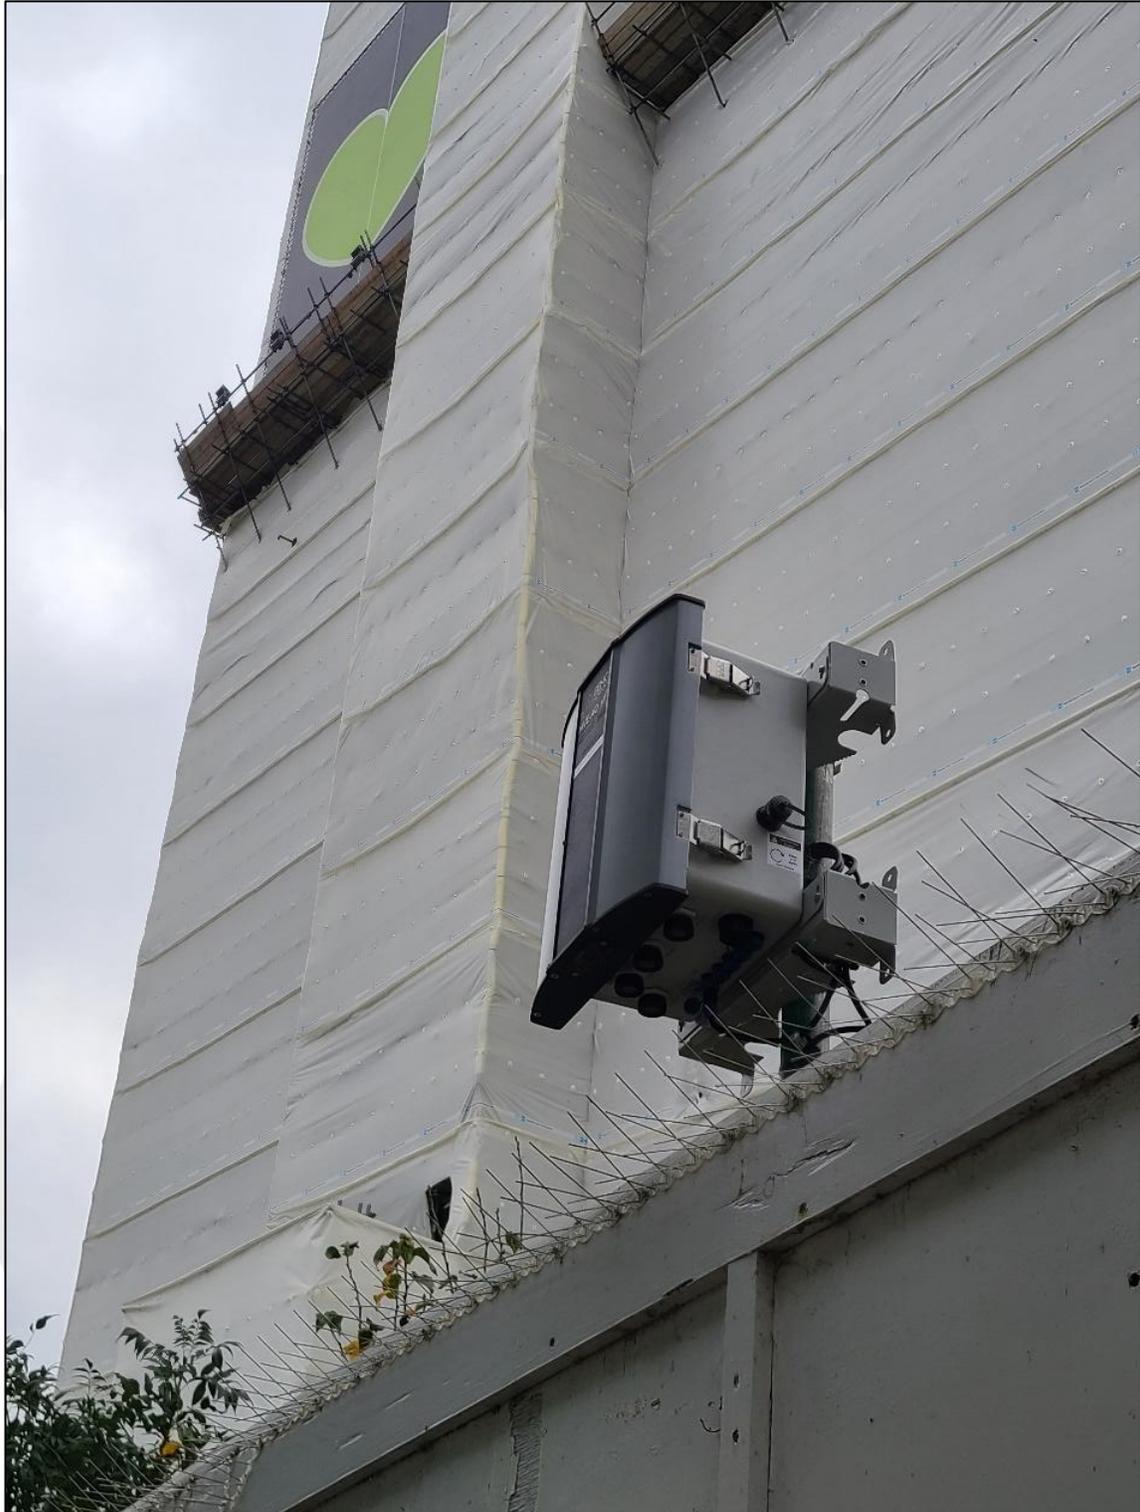
Images 1 – DMP1 Monitoring Location (*photo taken on site on 19/5/2025*).

Five (5) MCerts approved HIVE-AQ DUSTROID™ monitors are deployed to carry out the continuous monitoring on site. A map showing the monitoring locations is shown in Figure 1. Photographs showing the equipment installed at locations DMP1- DMP5 are shown in Images 1-5.

The monitors are housed in a weather-resistant environmental enclosure and were installed at locations previously agreed between the site developers and Kensington and Chelsea council. The systems are each fitted with a modem to allow remote access to measurement data on the internet and provision of email alerts. The monitors continuously measure particulate matter (in $\mu\text{g}/\text{m}^3$) and data is recorded as 1 hour and 15 minute average periods.

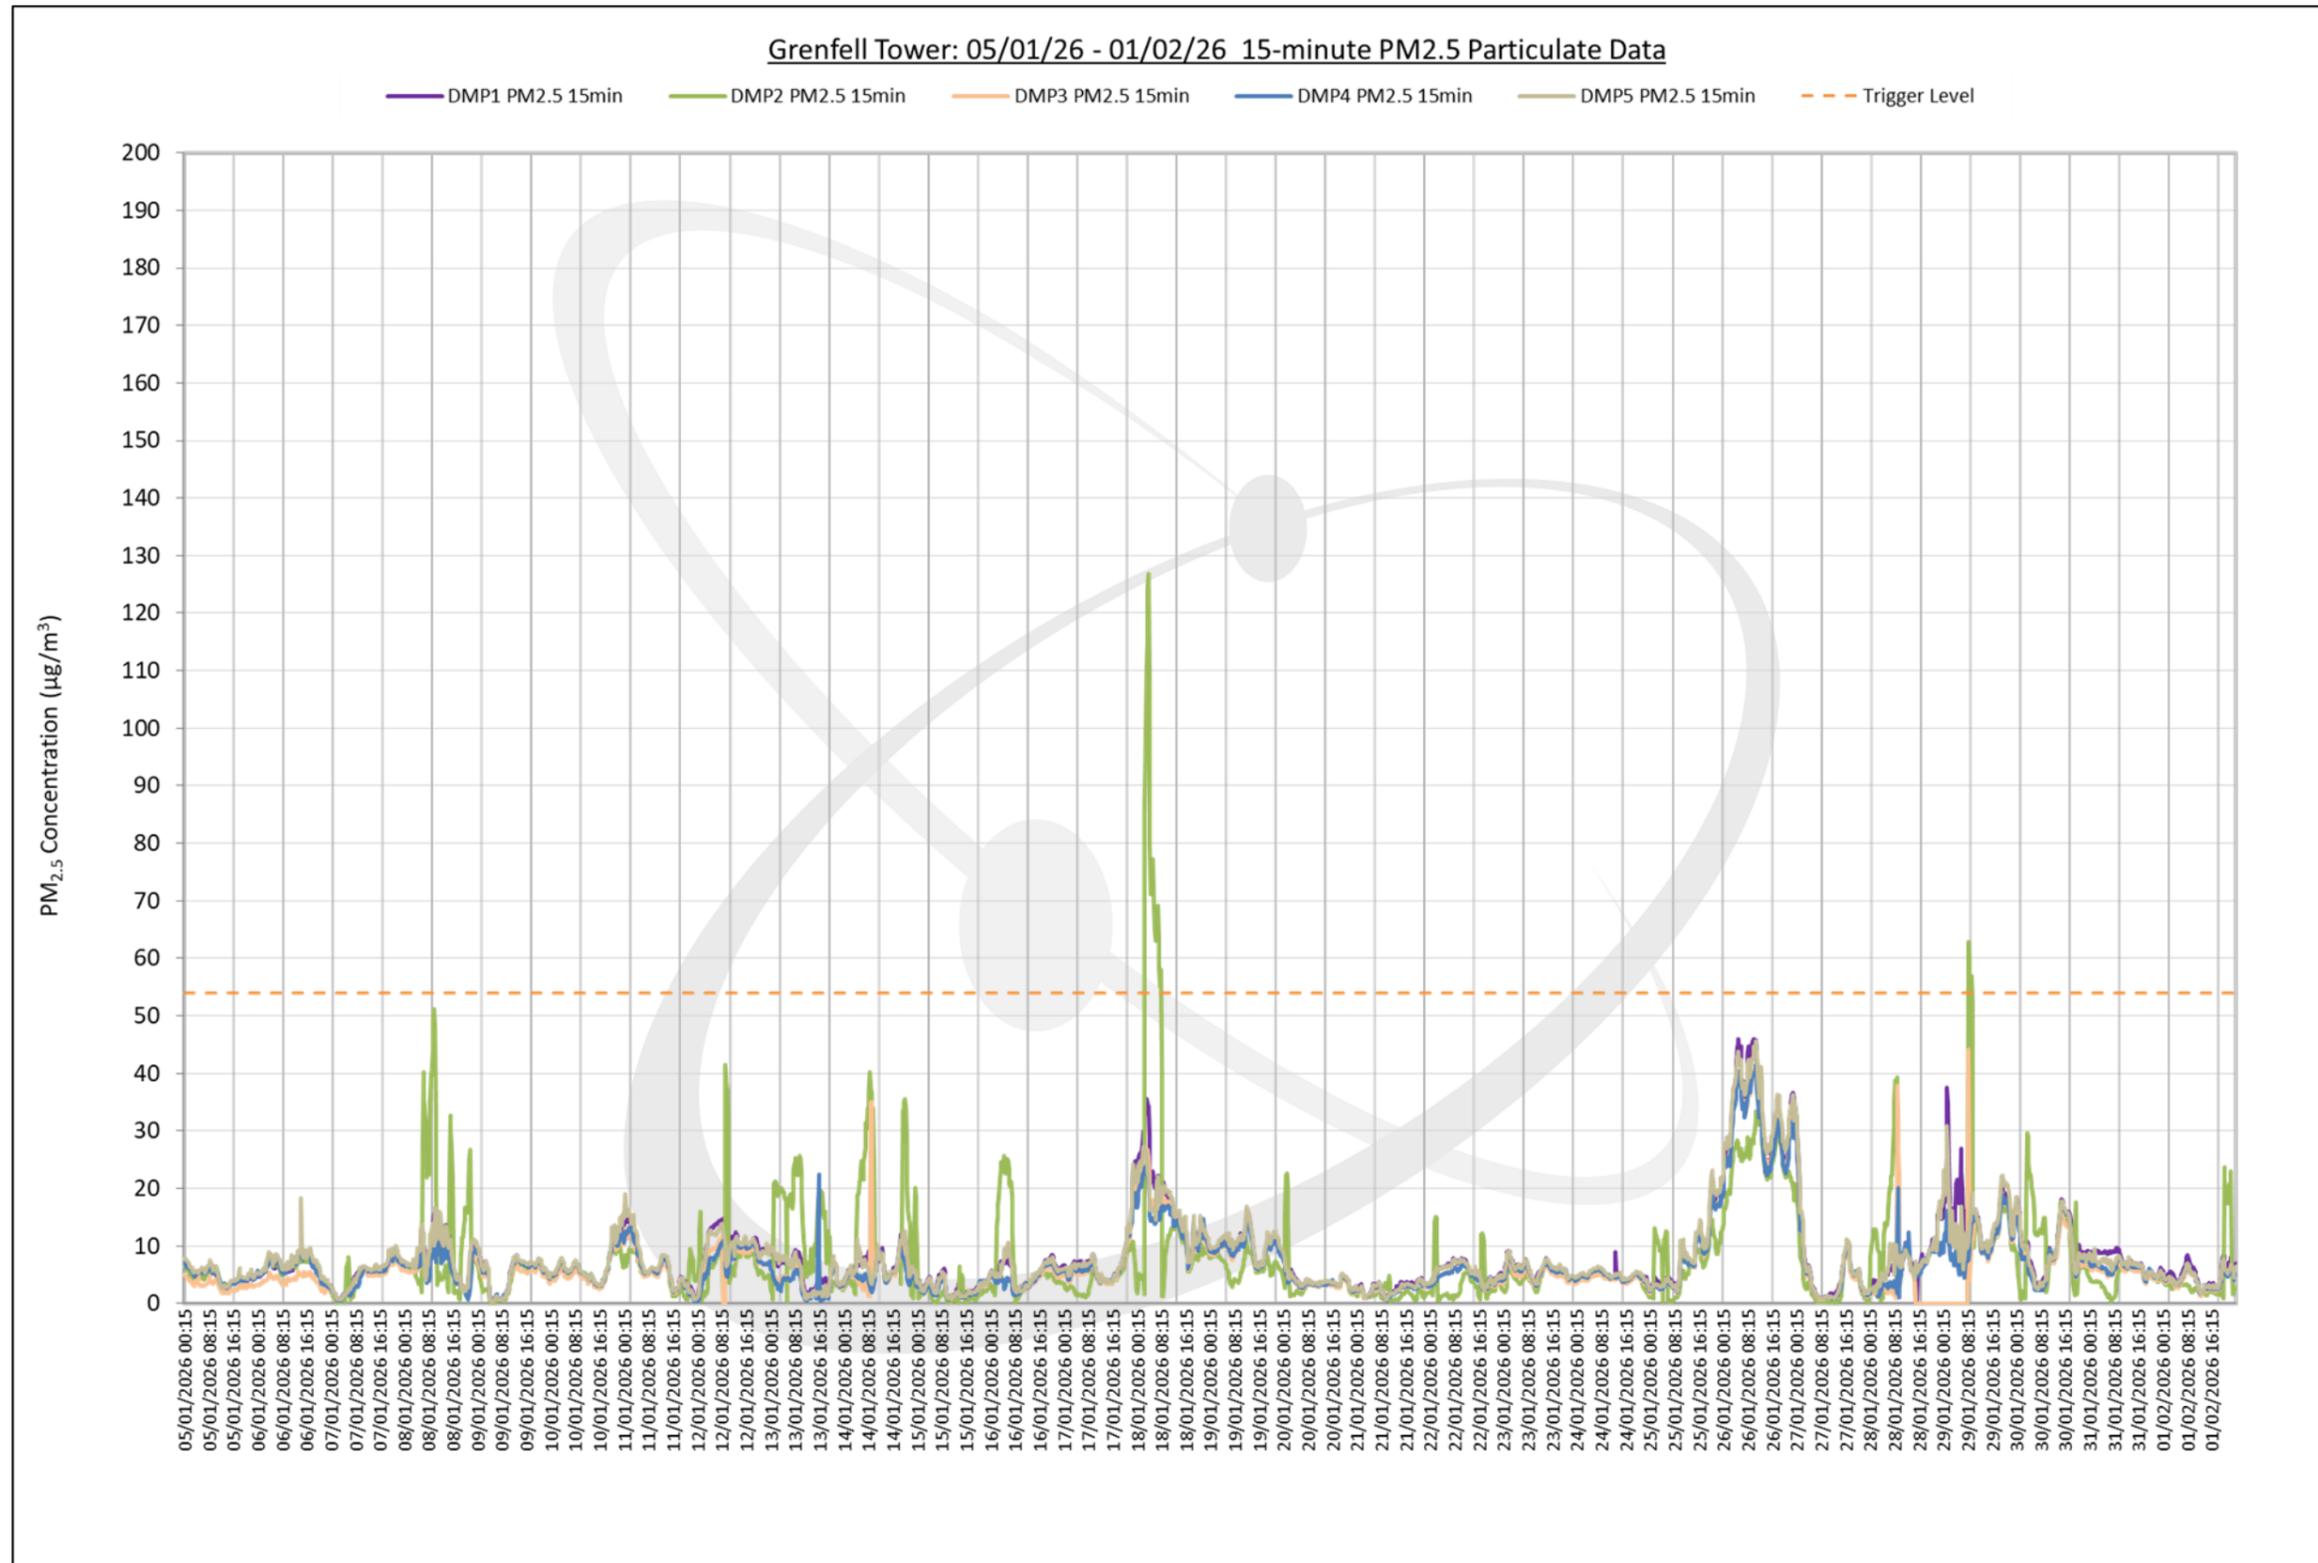
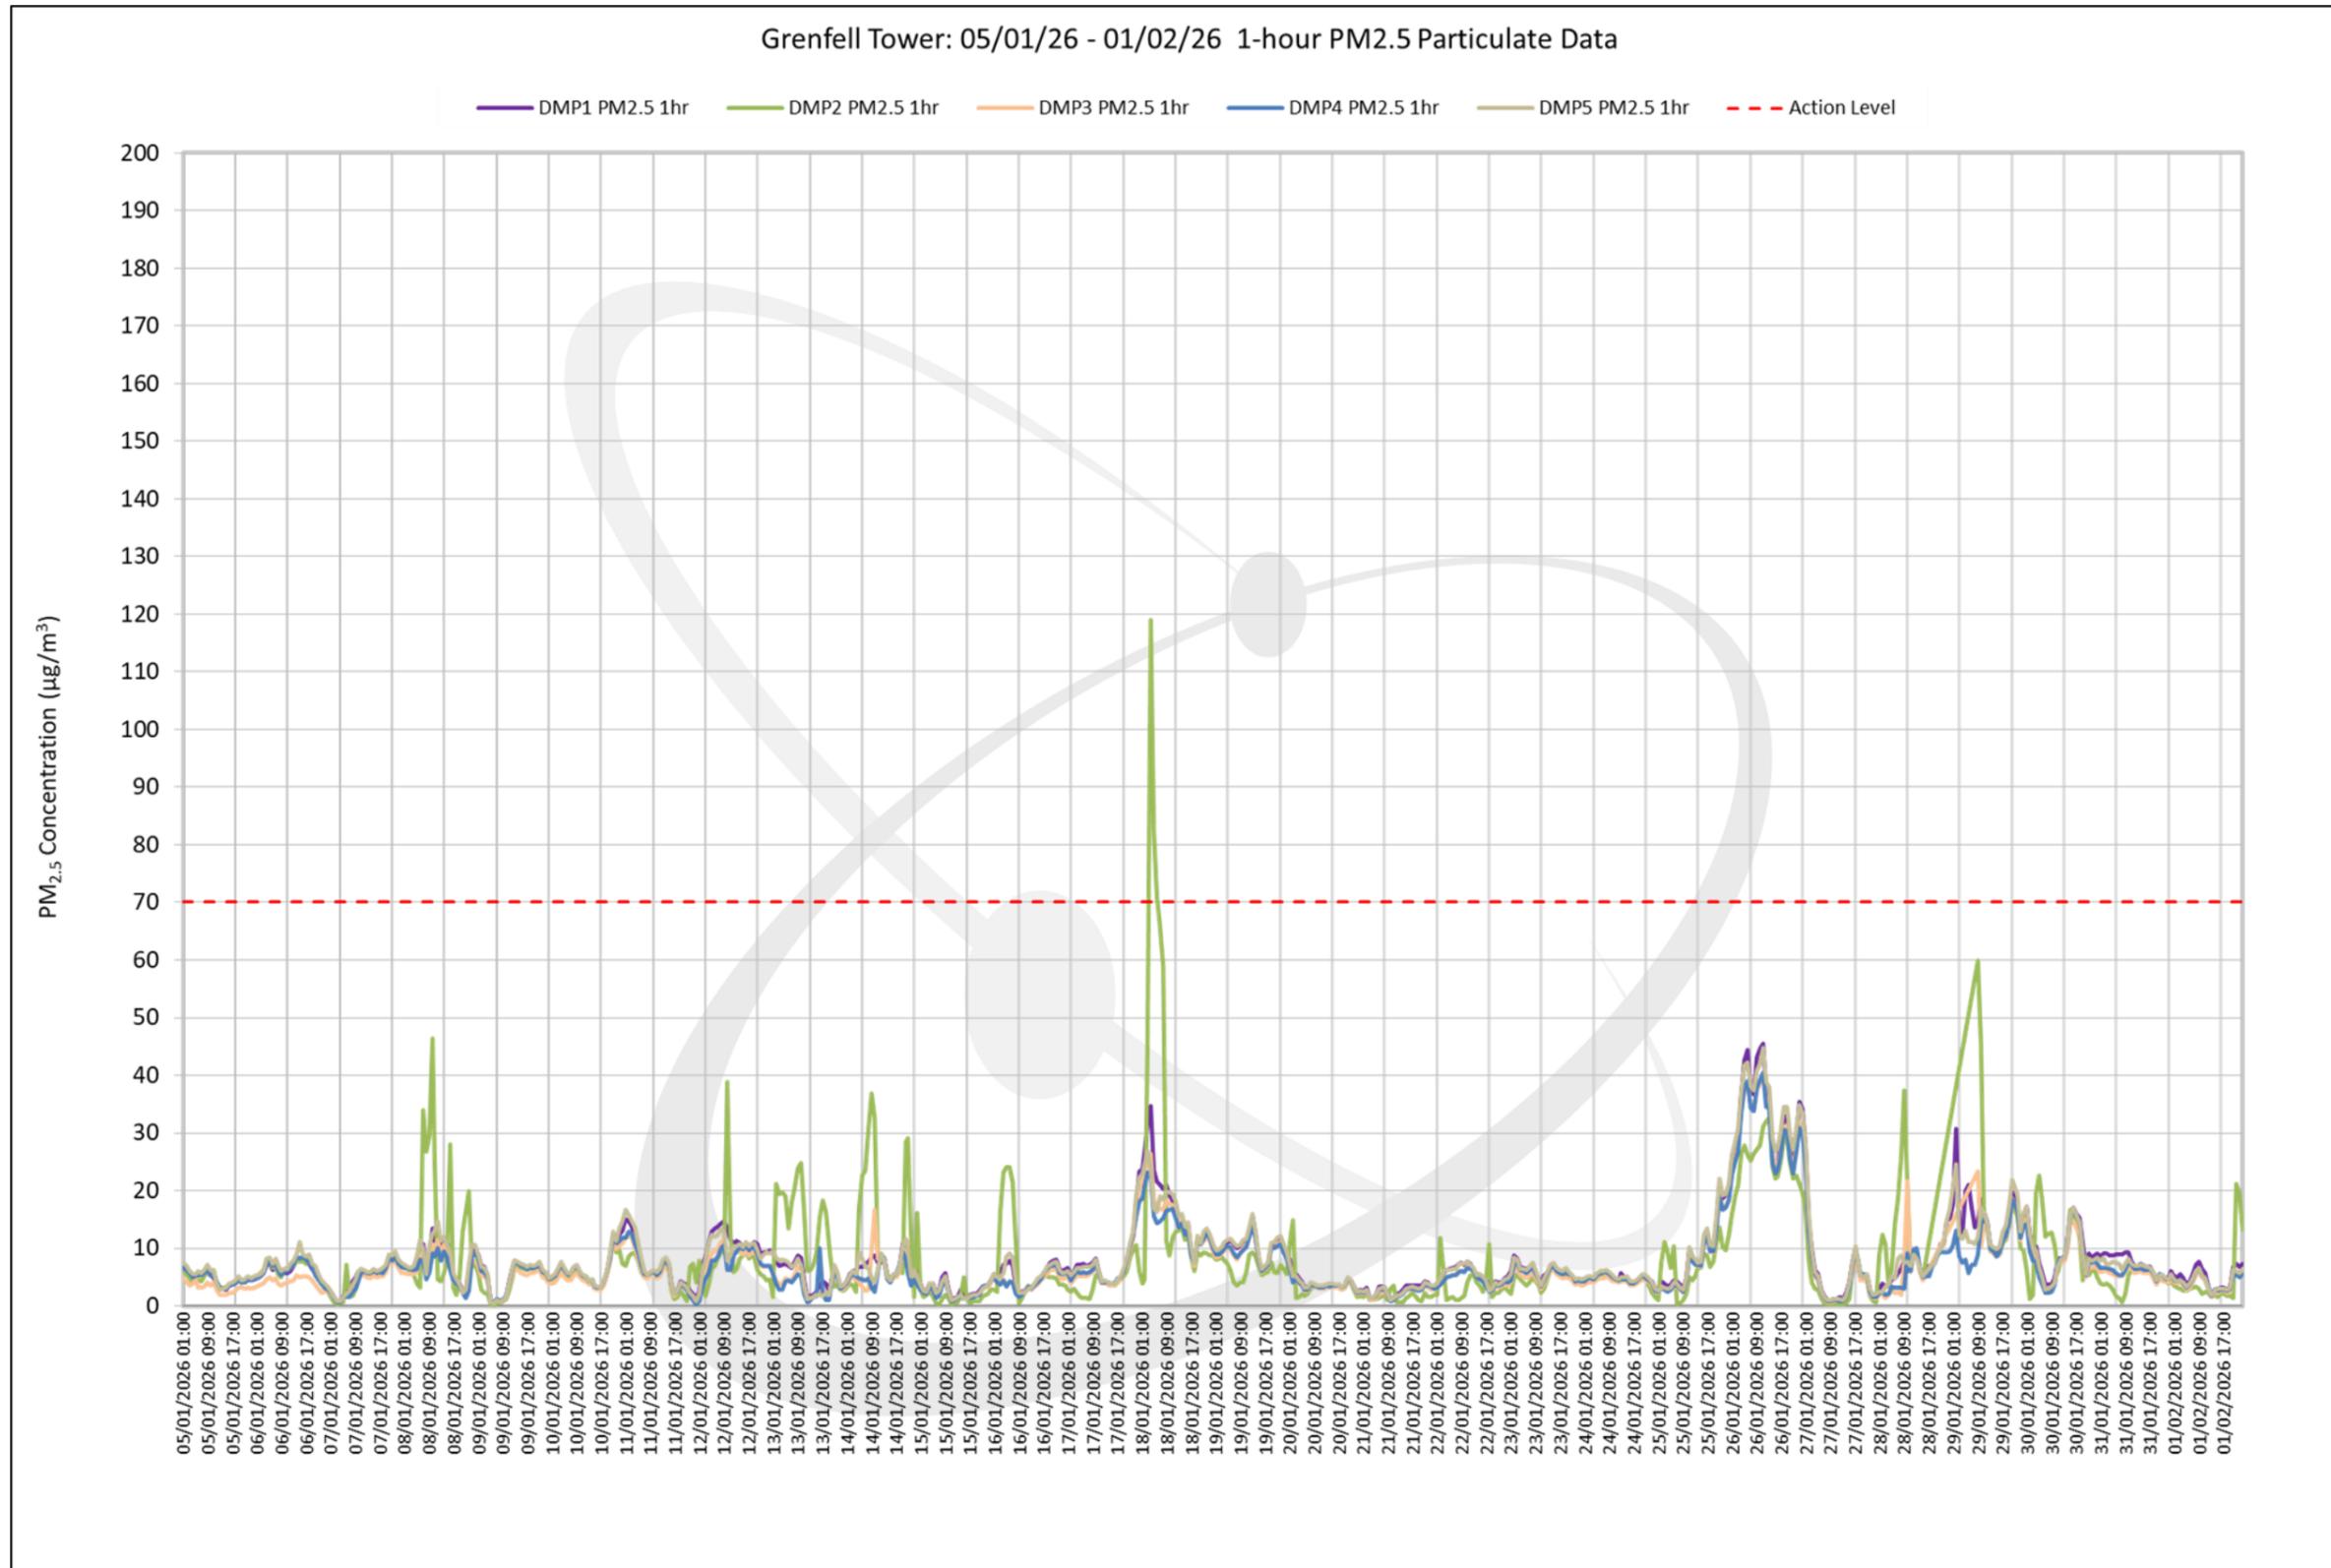
8. PM_{2.5} Dust Monitoring Graphs

There were **twenty-seven (27) exceedances** of the 15-minute PM_{2.5} 54 (µg/m³) and **seven (7) exceedances** of the 15-minute PM₁₀ 150 (µg/m³) Amber Trigger levels at **DMP2**.

There were **three (3) exceedances** of the 1-hour PM_{2.5} 70 (µg/m³) and Red Action Alert levels **one (1) exceedance** of the 1-hour PM₁₀ 190 (µg/m³) at **DMP2**.

**Foggy weather can affect PM_{2.5} due to a combination of; stagnant air, low wind and an increase in humidity. It can also be explained due to a phenomena known as- pollutant fog. This is due to an increased humidity, causing a false reading of water droplet molecules on the light scattering sensor. Increased humidity can cause aerosols to absorb water and therefore grow in size. This is known as ‘hygroscopic growth’.*

The results of the Dust measurements in this period are presented graphically for PM₁₀ and PM_{2.5} in Sections 7 and 8 respectively of this report.
