Construction Noise and Vibration Monthly Report – December 2025

Warwick District Council

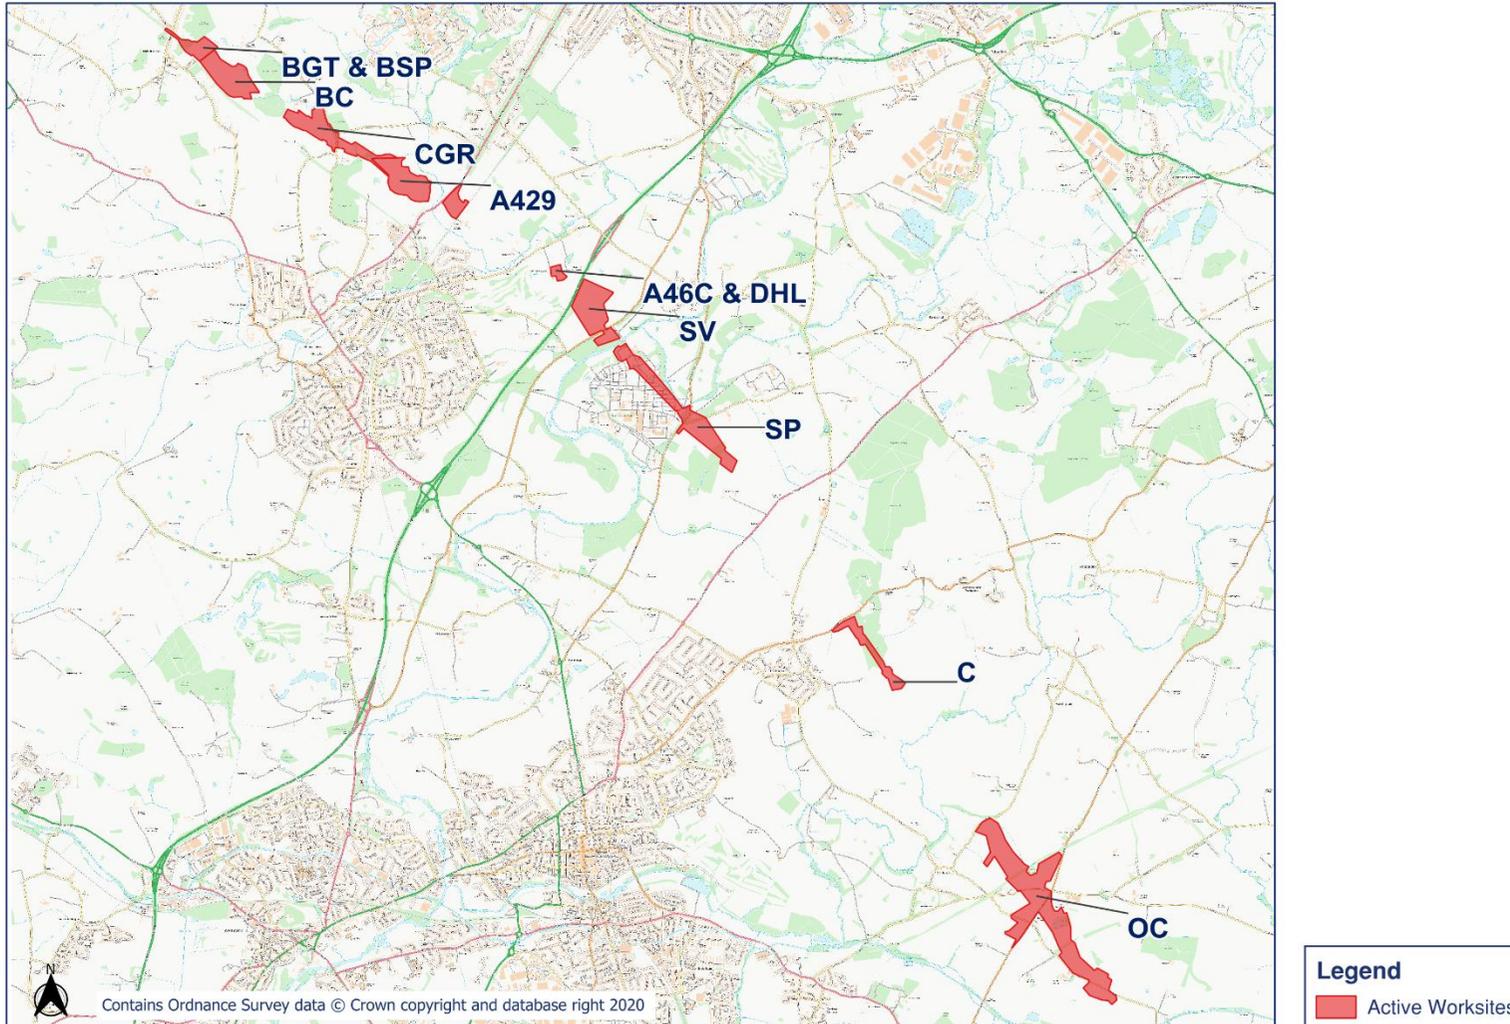
Worksite Identification Plan - 1

- Burton Green Tunnel worksite (ref.: BGT, see plan 1 in Appendix A) where work activities included:
 - Tunnel works.
- Burton Green Tunnel Southern Portal worksite (ref.: BSP, see plan 1 in Appendix A) where work activities included:
 - Structural works.
 - Track and drainage works.
- Bockenden Cutting worksite (ref.: BC, see plan 1 in Appendix A), where work activities included:
 - Site maintenance.
 - Fire tank structure works.
 - Dewatering and backfilling.

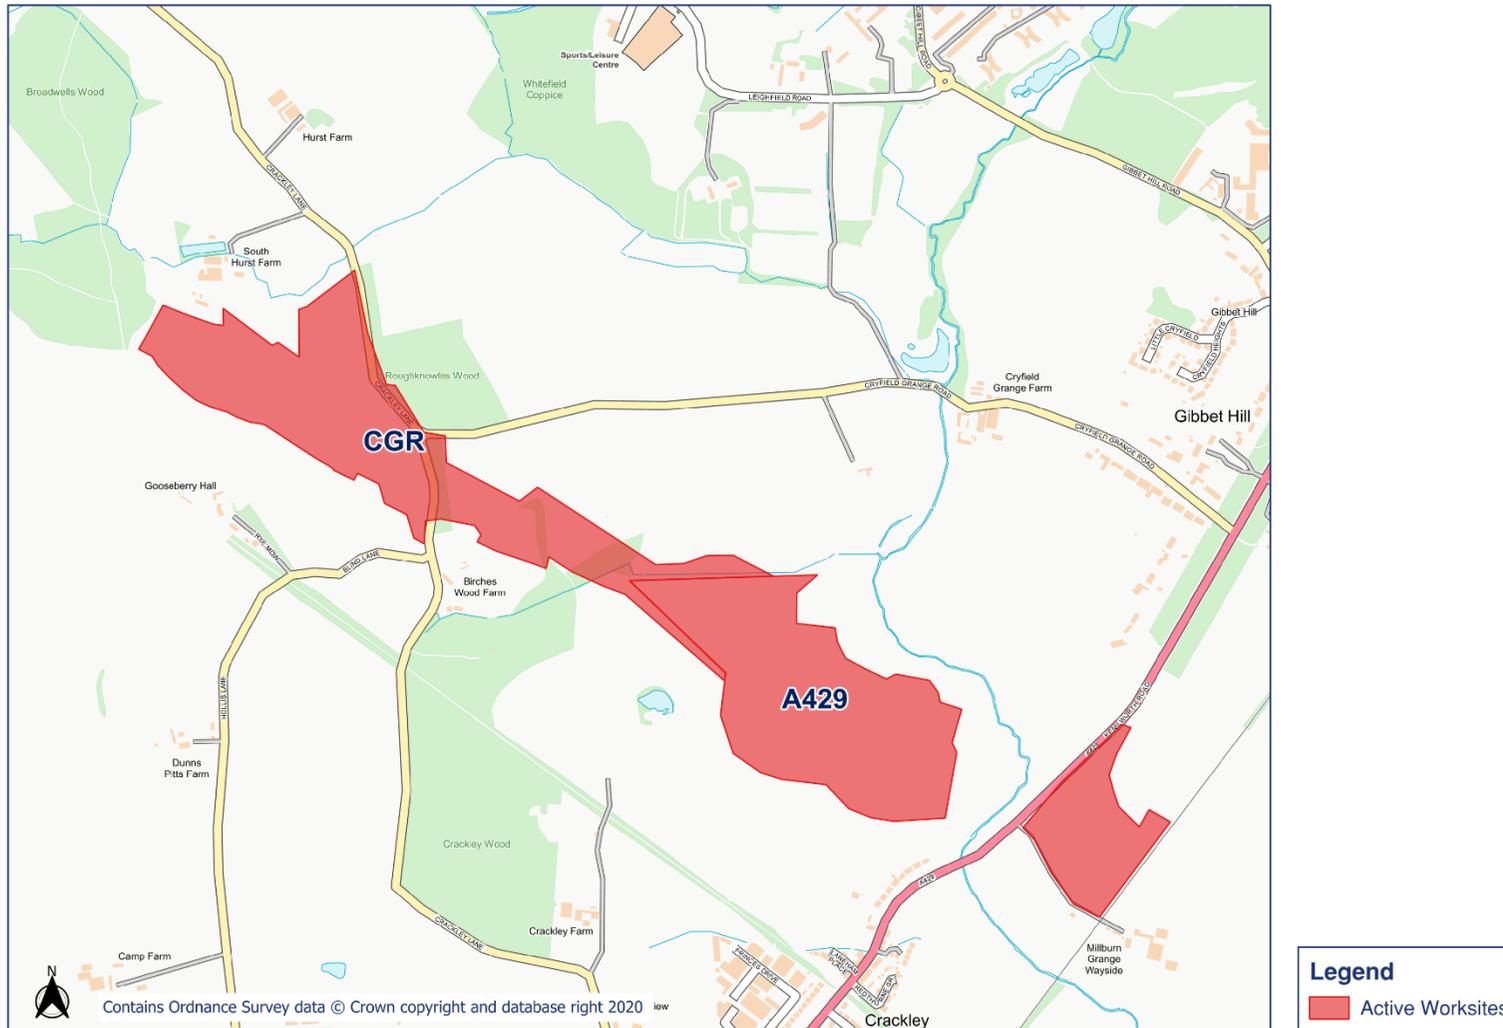
Worksite Identification Plan - 3

- Dig and replace.
 - Excavation.
 - Mainline cutting and crushing.
- A46 Compound and Dalehouse Lane worksite (ref.: A46C & DHL, see plan 3 in Appendix A), where work activities included:

- Earthworks.
 - Construction of glass house cutting.
 - Haul road maintenance.
 - Hydro demolition.
 - Road sweeping.
- Stoneleigh Village worksite (ref.: SV, see plan 3 in Appendix A), where work activities included:

- Monitor maintenance.
- Stoneleigh Park worksite (ref.: SP, see plan 3 in Appendix A), where work activities included:
 - Road realignment works.
 - Platform construction.

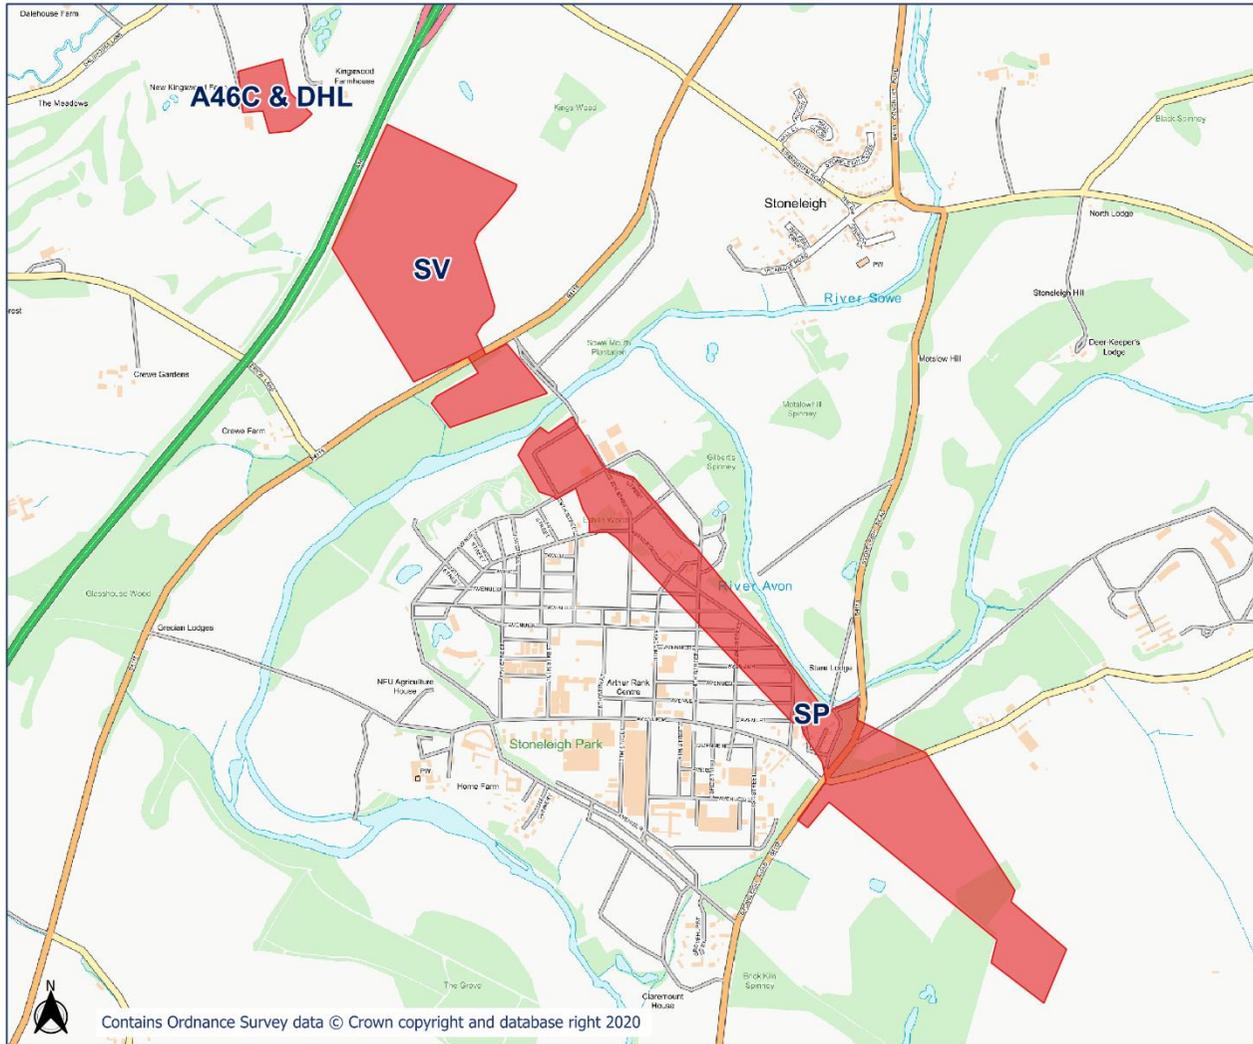
Worksite Identification Plan - 4

- Overbridge construction including concrete pours.
 - Wingwall reinforcement.
 - Shutter removal.
 - Haul road operation and vehicle movements.
- Cubbington Road worksite (ref.: C, see plan 4 in Appendix A), where work activities included:

- Overbridge works.
 - Deck reinforcement.
 - De-vegetation.
 - Wingwalls works including steel fixing and shutter installation and striking.
 - Repair works.

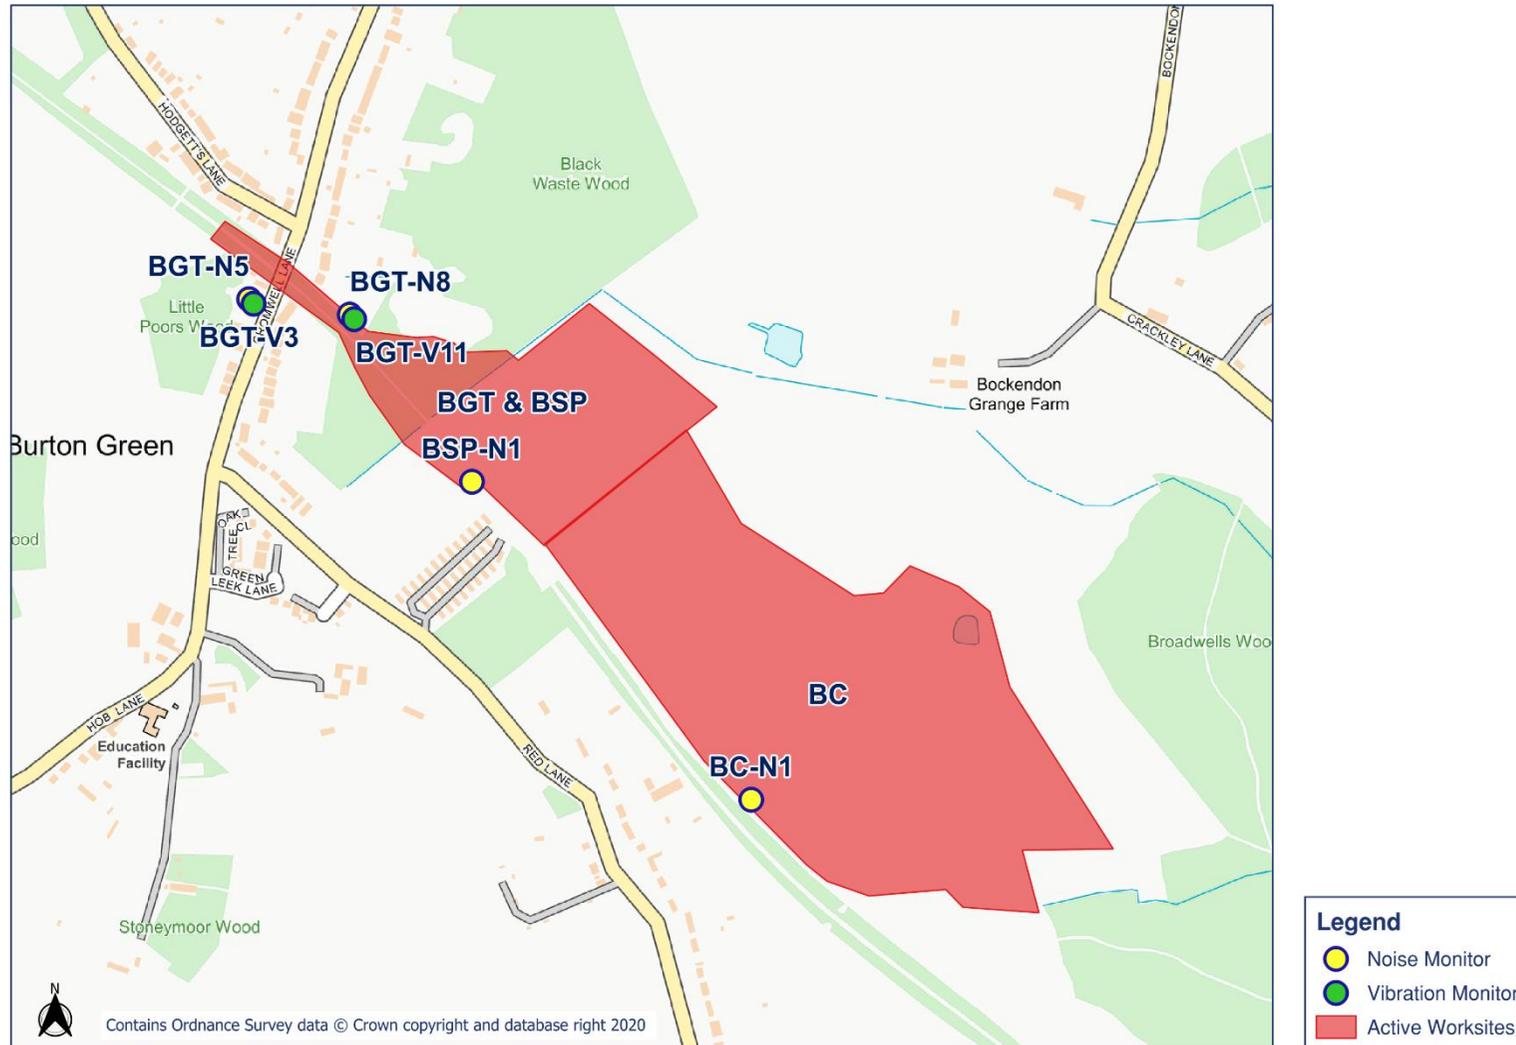
Noise and Vibration Monitoring Plan - 1

1.2.3 Maps showing the position of the noise and vibration monitoring installations are presented in Appendix B.

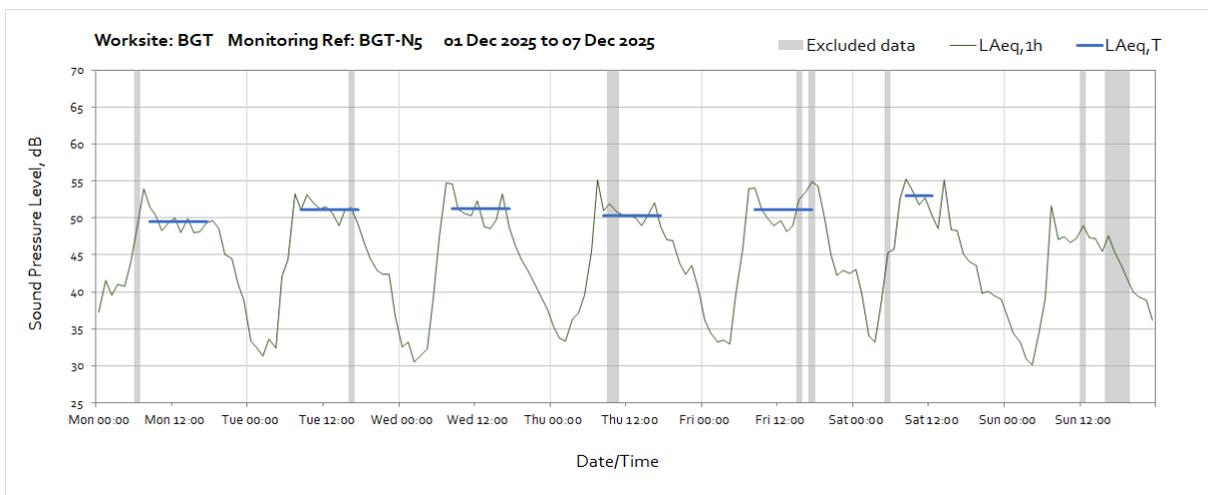
Worksite: BGT – Monitoring Ref: BGT-N5

The following graphs show the hourly measured ambient noise level $L_{Aeq,1h}$ and, where relevant, the averaged noise level $L_{Aeq,T}$ values, where the time period T is as specified in Table 1 of HS2 Information Paper E23. Periods where noise levels are adversely affected by weather or only measured for part of the period, which are not representative of HS2 construction works, have been greyed out and excluded from the calculation of the $L_{Aeq,T}$ values in in Table 3 of the main report.

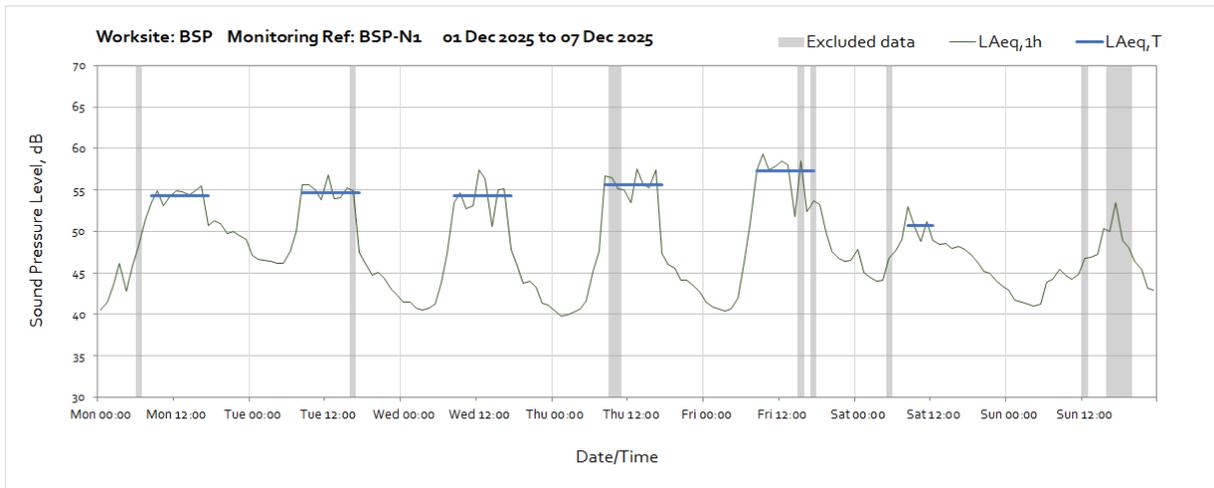
Worksite: BSP – Monitoring Ref: BSP-N1

Note: Missing data between 02:00 and 10:00 on Friday 19th December and between 20:00 on Sunday 21st December and 11:00 on Monday 22nd December was due to loss of power to the monitoring station caused by poor weather conditions preventing sufficient light to reach the solar panel.

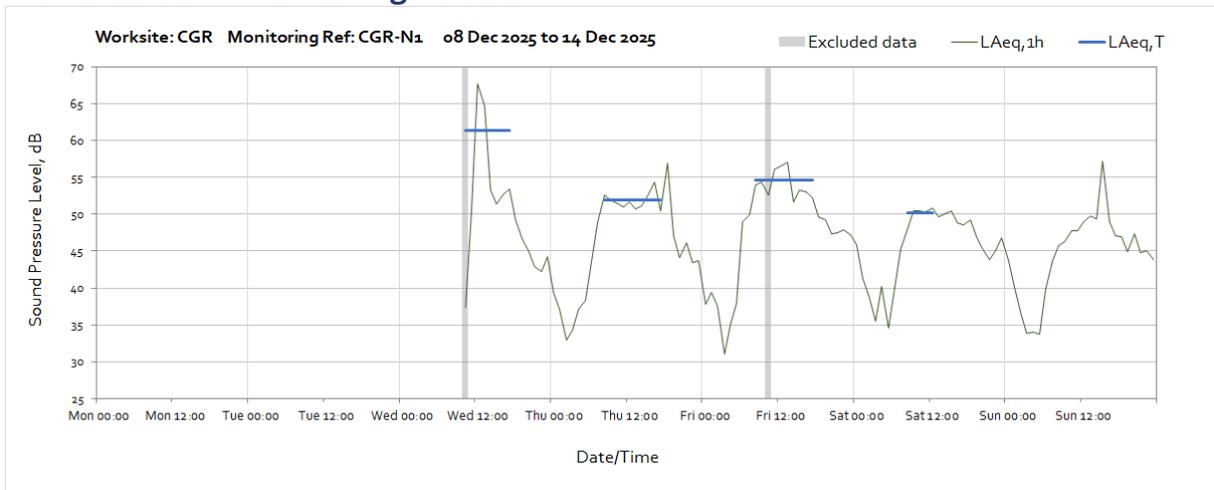
Worksite: CGR – Monitoring Ref: CGR-N1

Note: The monitor was installed on Wednesday 10th December.

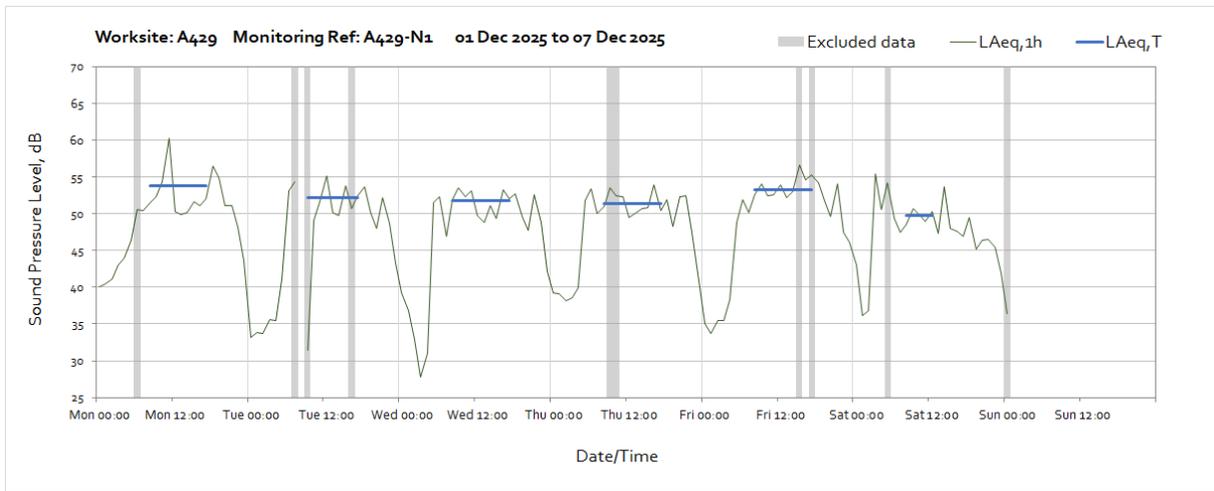
Worksite: A429 – Monitoring Ref: A429-N1

Note: Missing data throughout the week was due to loss of power to the monitoring station caused by poor weather conditions preventing sufficient light to reach the solar panel.

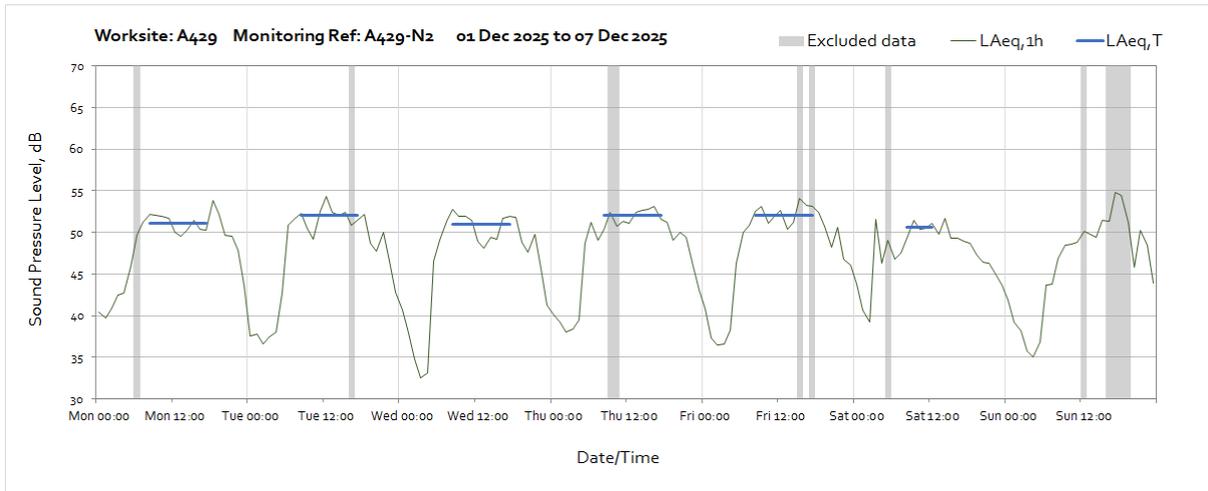
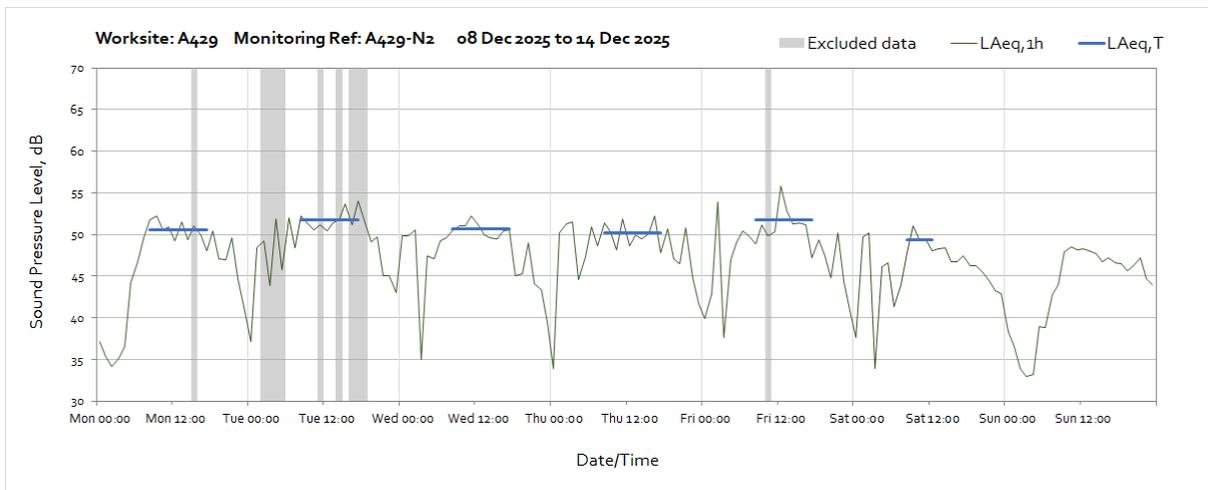
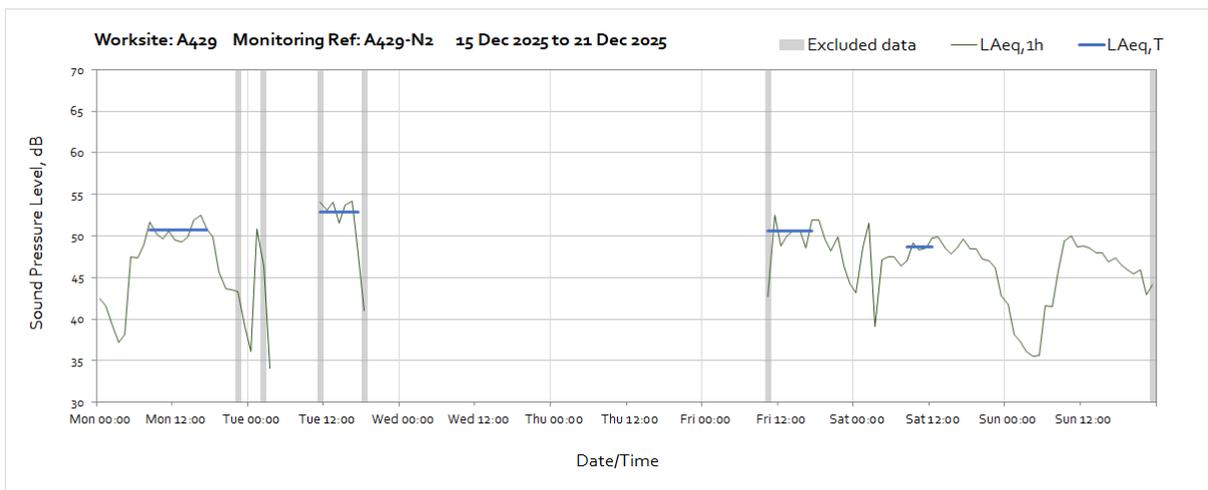
Worksite: A429 – Monitoring Ref: A429-N2

Note: Missing data throughout the week was due to loss of power to the monitoring station caused by poor weather conditions preventing sufficient light to reach the solar panel.

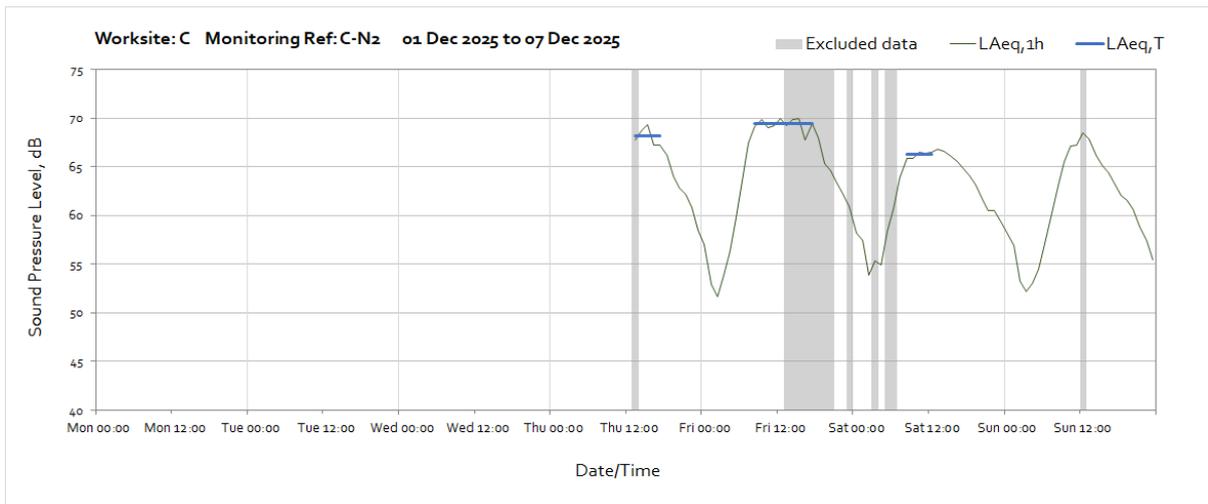
Worksite: C – Monitoring Ref: C-N2

Note: Missing data between start of the month and 13:00 on Thursday 4th December was due to faulty system at the monitoring station.

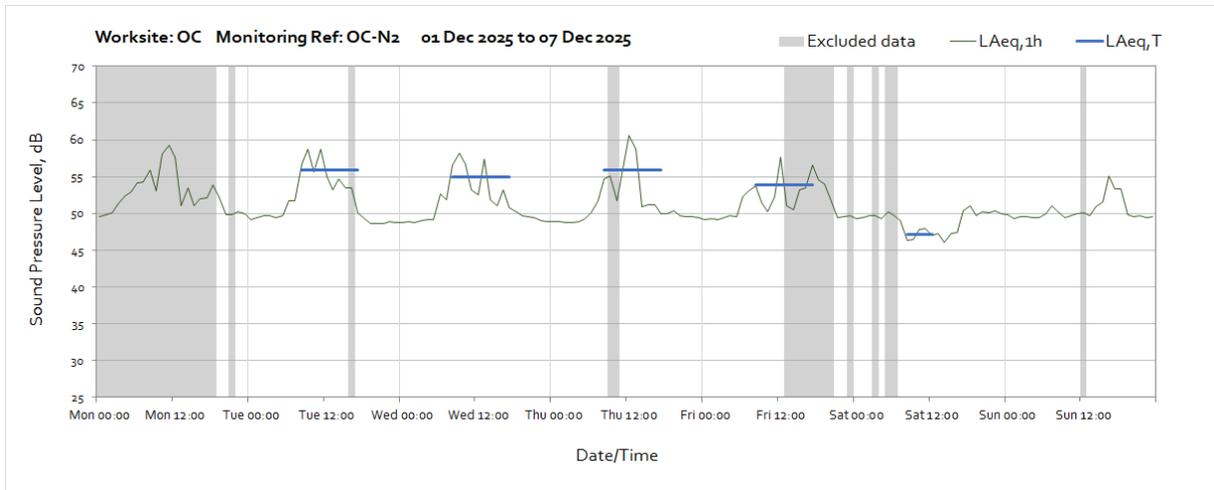
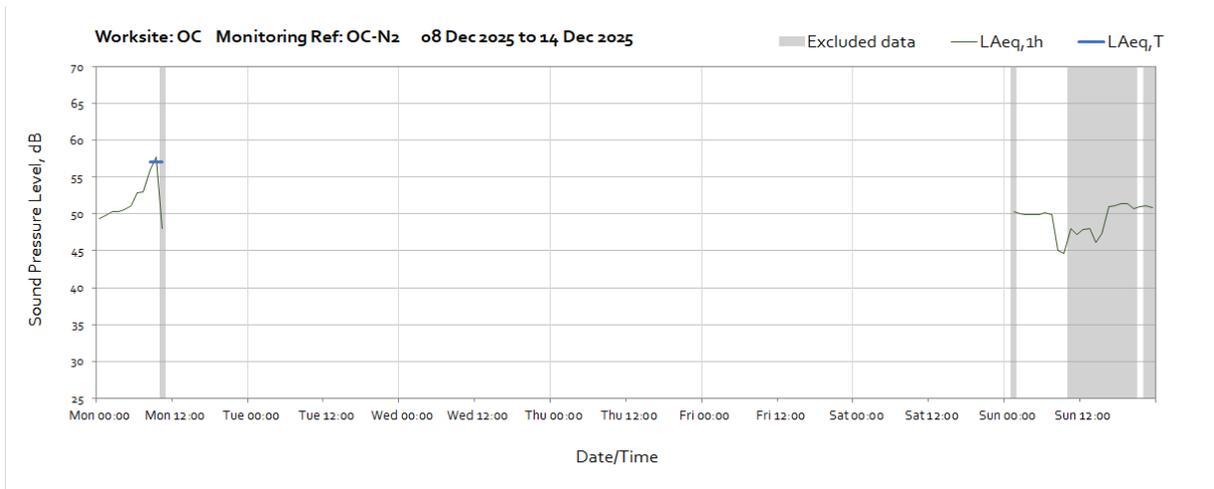
Worksite: OC – Monitoring Ref: OC-N2

Note: Missing data throughout the week was due to system reset issues at the monitoring station.

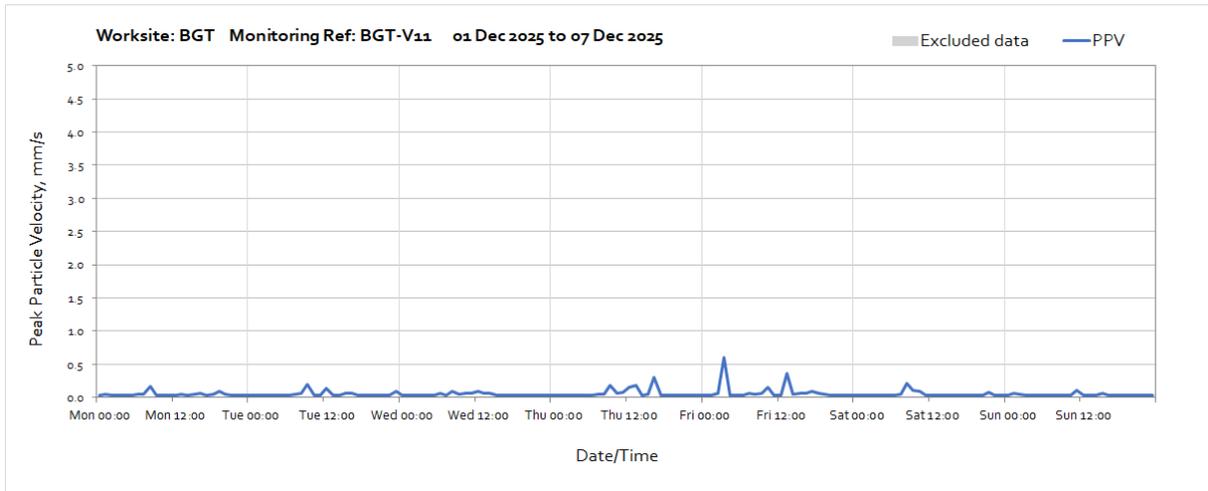
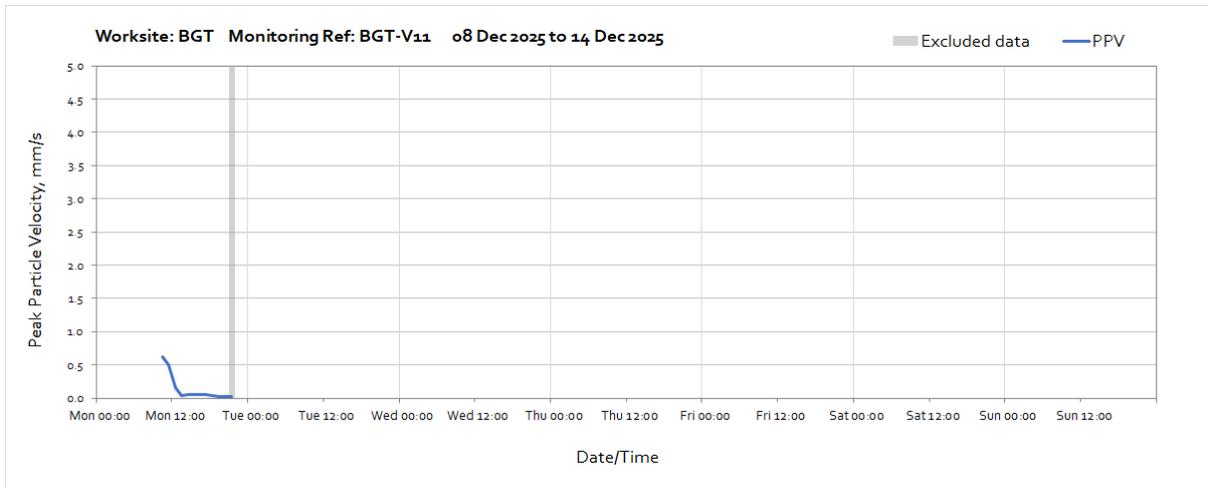
Worksite: BGT - Monitoring Ref: BGT-V11

Note: Missing data throughout the week was due to loss of power to the monitoring station caused by poor weather conditions preventing sufficient light to reach the solar panel
