Abbreviated Dust Monitoring Report

Project: Grenfell Tower

Document Ref: EEMC-DMR-201/106 – Grenfell Tower Rev 00

Period: 02 February 2026 to 01 March 2026

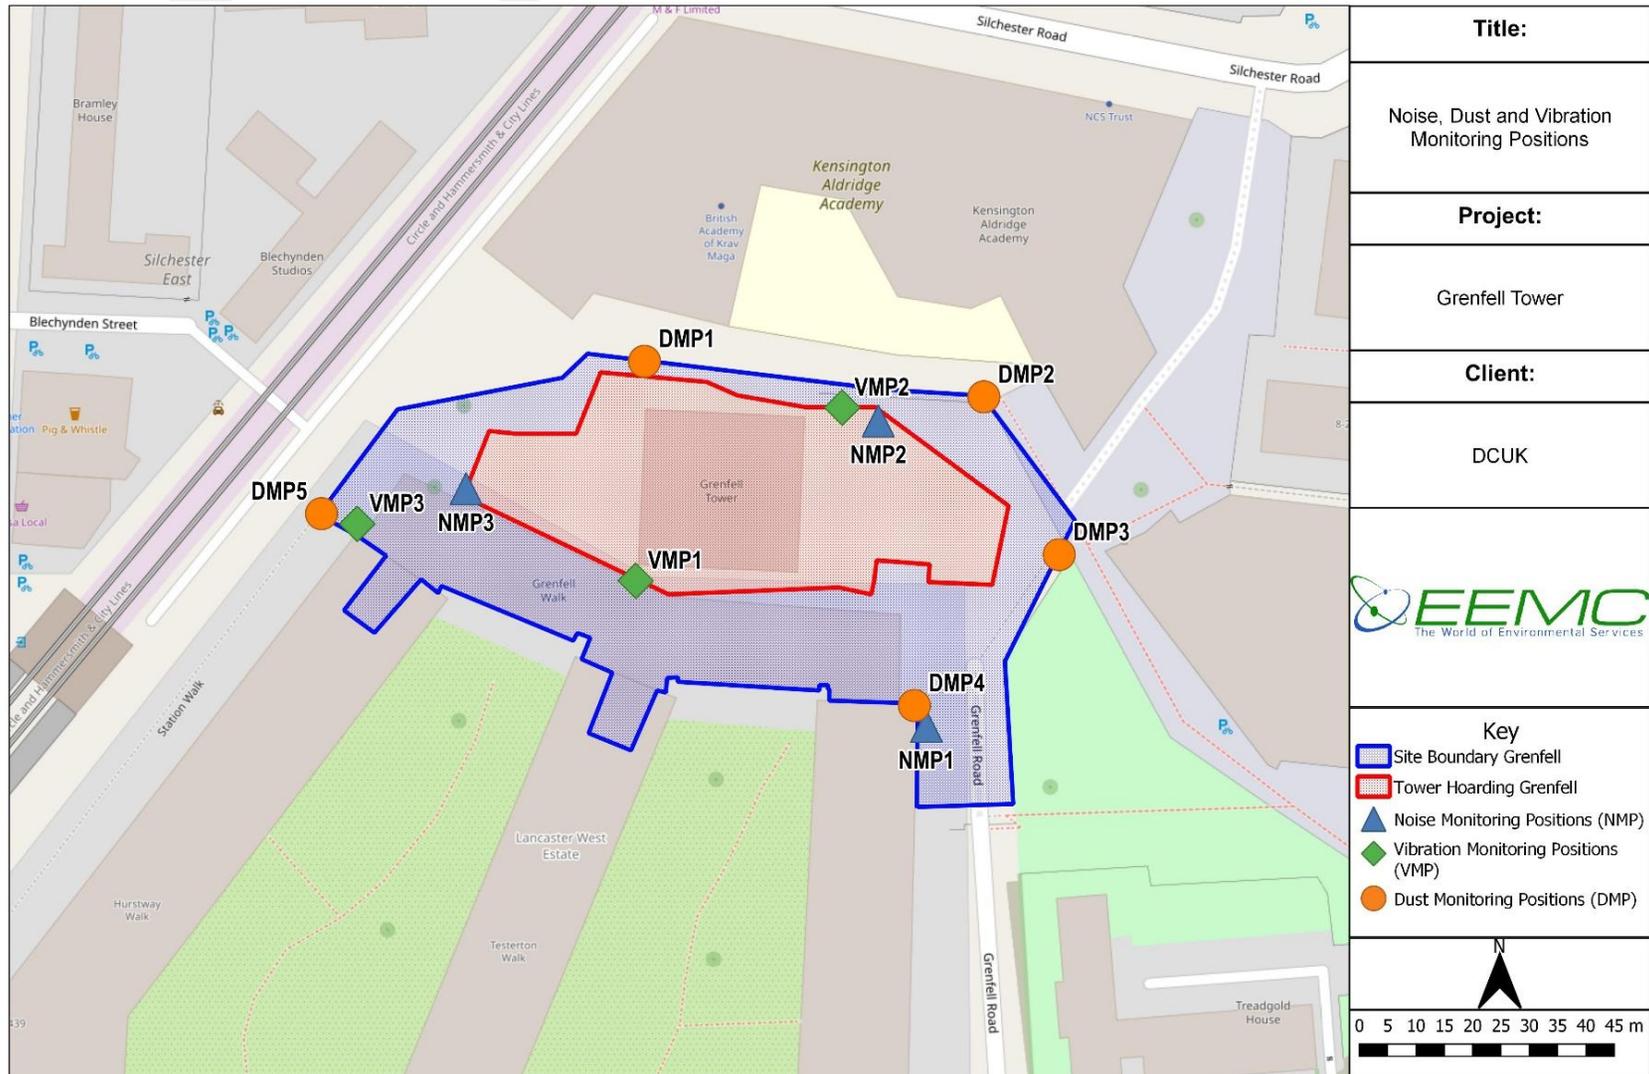
Figure 1- Map of Noise, Dust & Vibration Monitoring Locations

The site boundary and hoarding line of this project is shown in Figure 1. The project is located at Grenfell Tower, Grenfell Road, W11 1TQ. The entire site is located within Royal Borough of Kensington & Chelsea (RBKC) and is bordered by residential blocks to the south, and a school and football pitches to the north and a leisure centre to the east. The London Underground viaduct is 70m to the west and Latimer Road Tube station is 200m from the project

Five (5) MCerts approved HIVE-AQ DUSTROID™ monitors are deployed to carry out the continuous monitoring on site. A map showing the monitoring locations is shown in Figure 1. Photographs showing the equipment installed at locations DMP1- DMP5 are shown in Images 1-5.

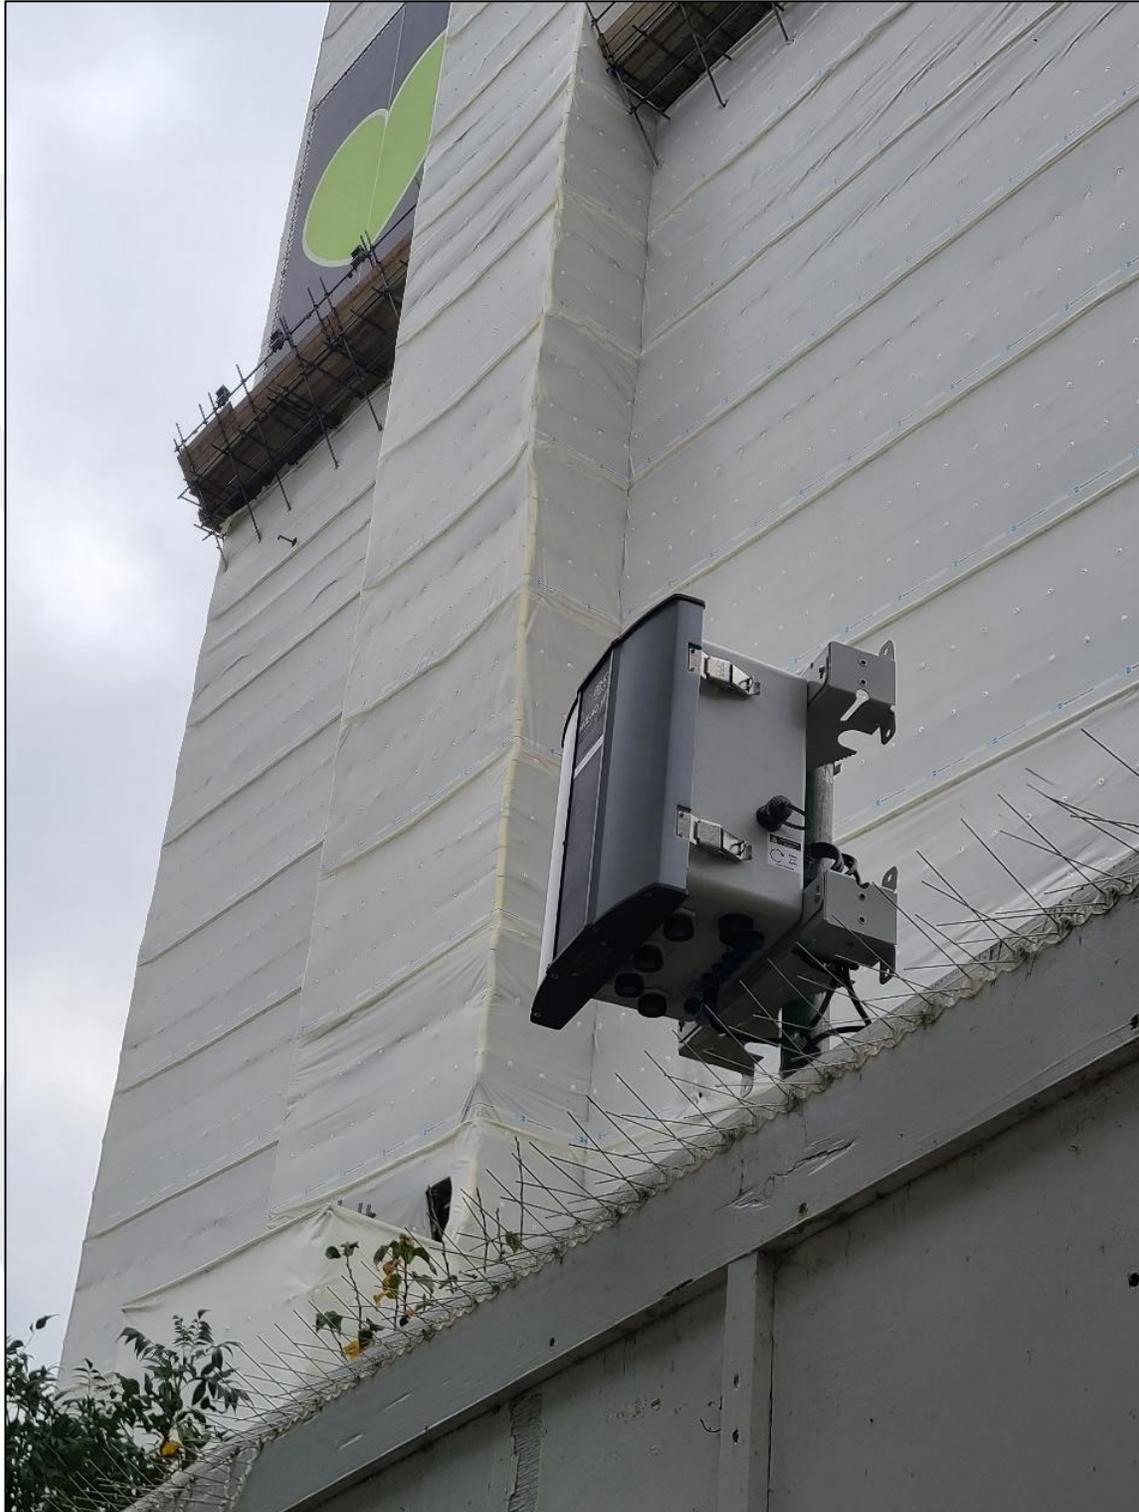
Images 1 – DMP1 Monitoring Location (photo taken on site on 19/5/2025).

ID Reference	Location
DMP1	North west hoarding, opposite Krav Maga centre
DMP2	North east Hoarding, opposite school academy
DMP3	East Hoarding
DMP4	South East Hoarding, on Grenfell Road
DMP5	West Hoarding, near Station Walk, opposite the under pass

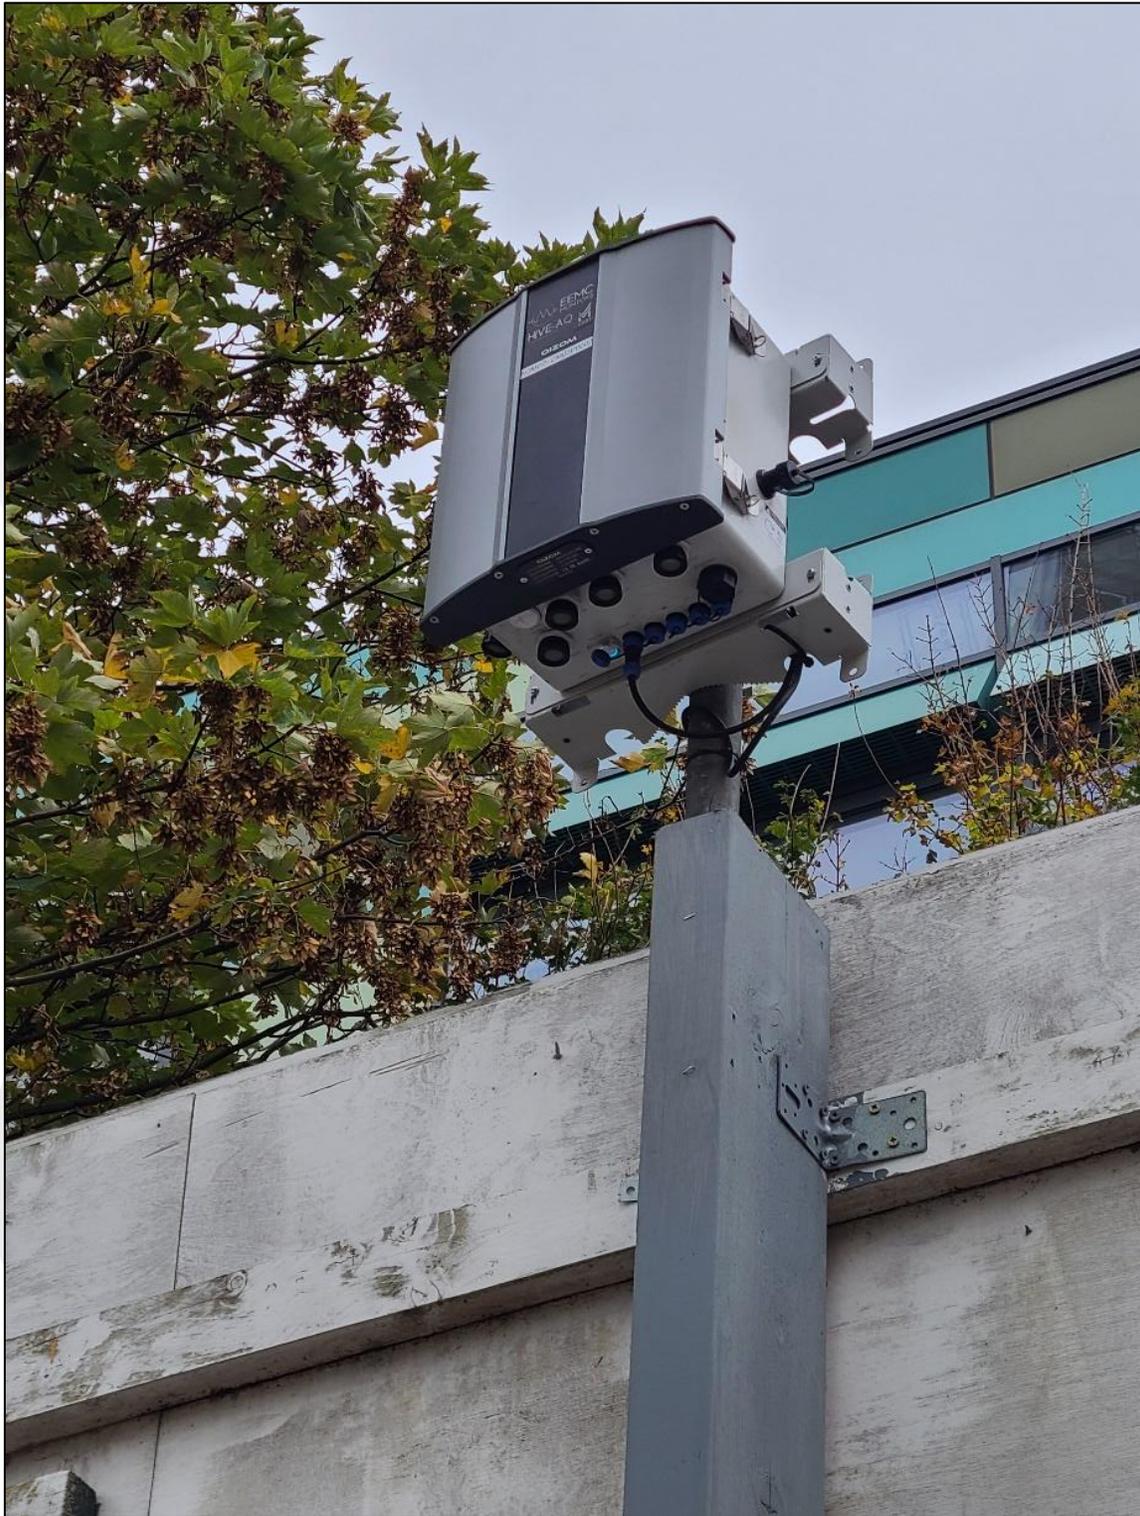
Images 3 – DMP2 Monitoring Location (photo taken on site on 19/5/2025).

There were **twelve (12) consecutive exceedances** of the 15-minute PM_{2.5} 54 (µg/m³) Amber Trigger level and **one (1) exceedance** of the 1-hour PM_{2.5} 70 (µg/m³) Red Action Alert level. All exceedances occurred between 01:15 and 04:00 on 04 February 2026 and are likely due to the foggy weather at **DMP2**.

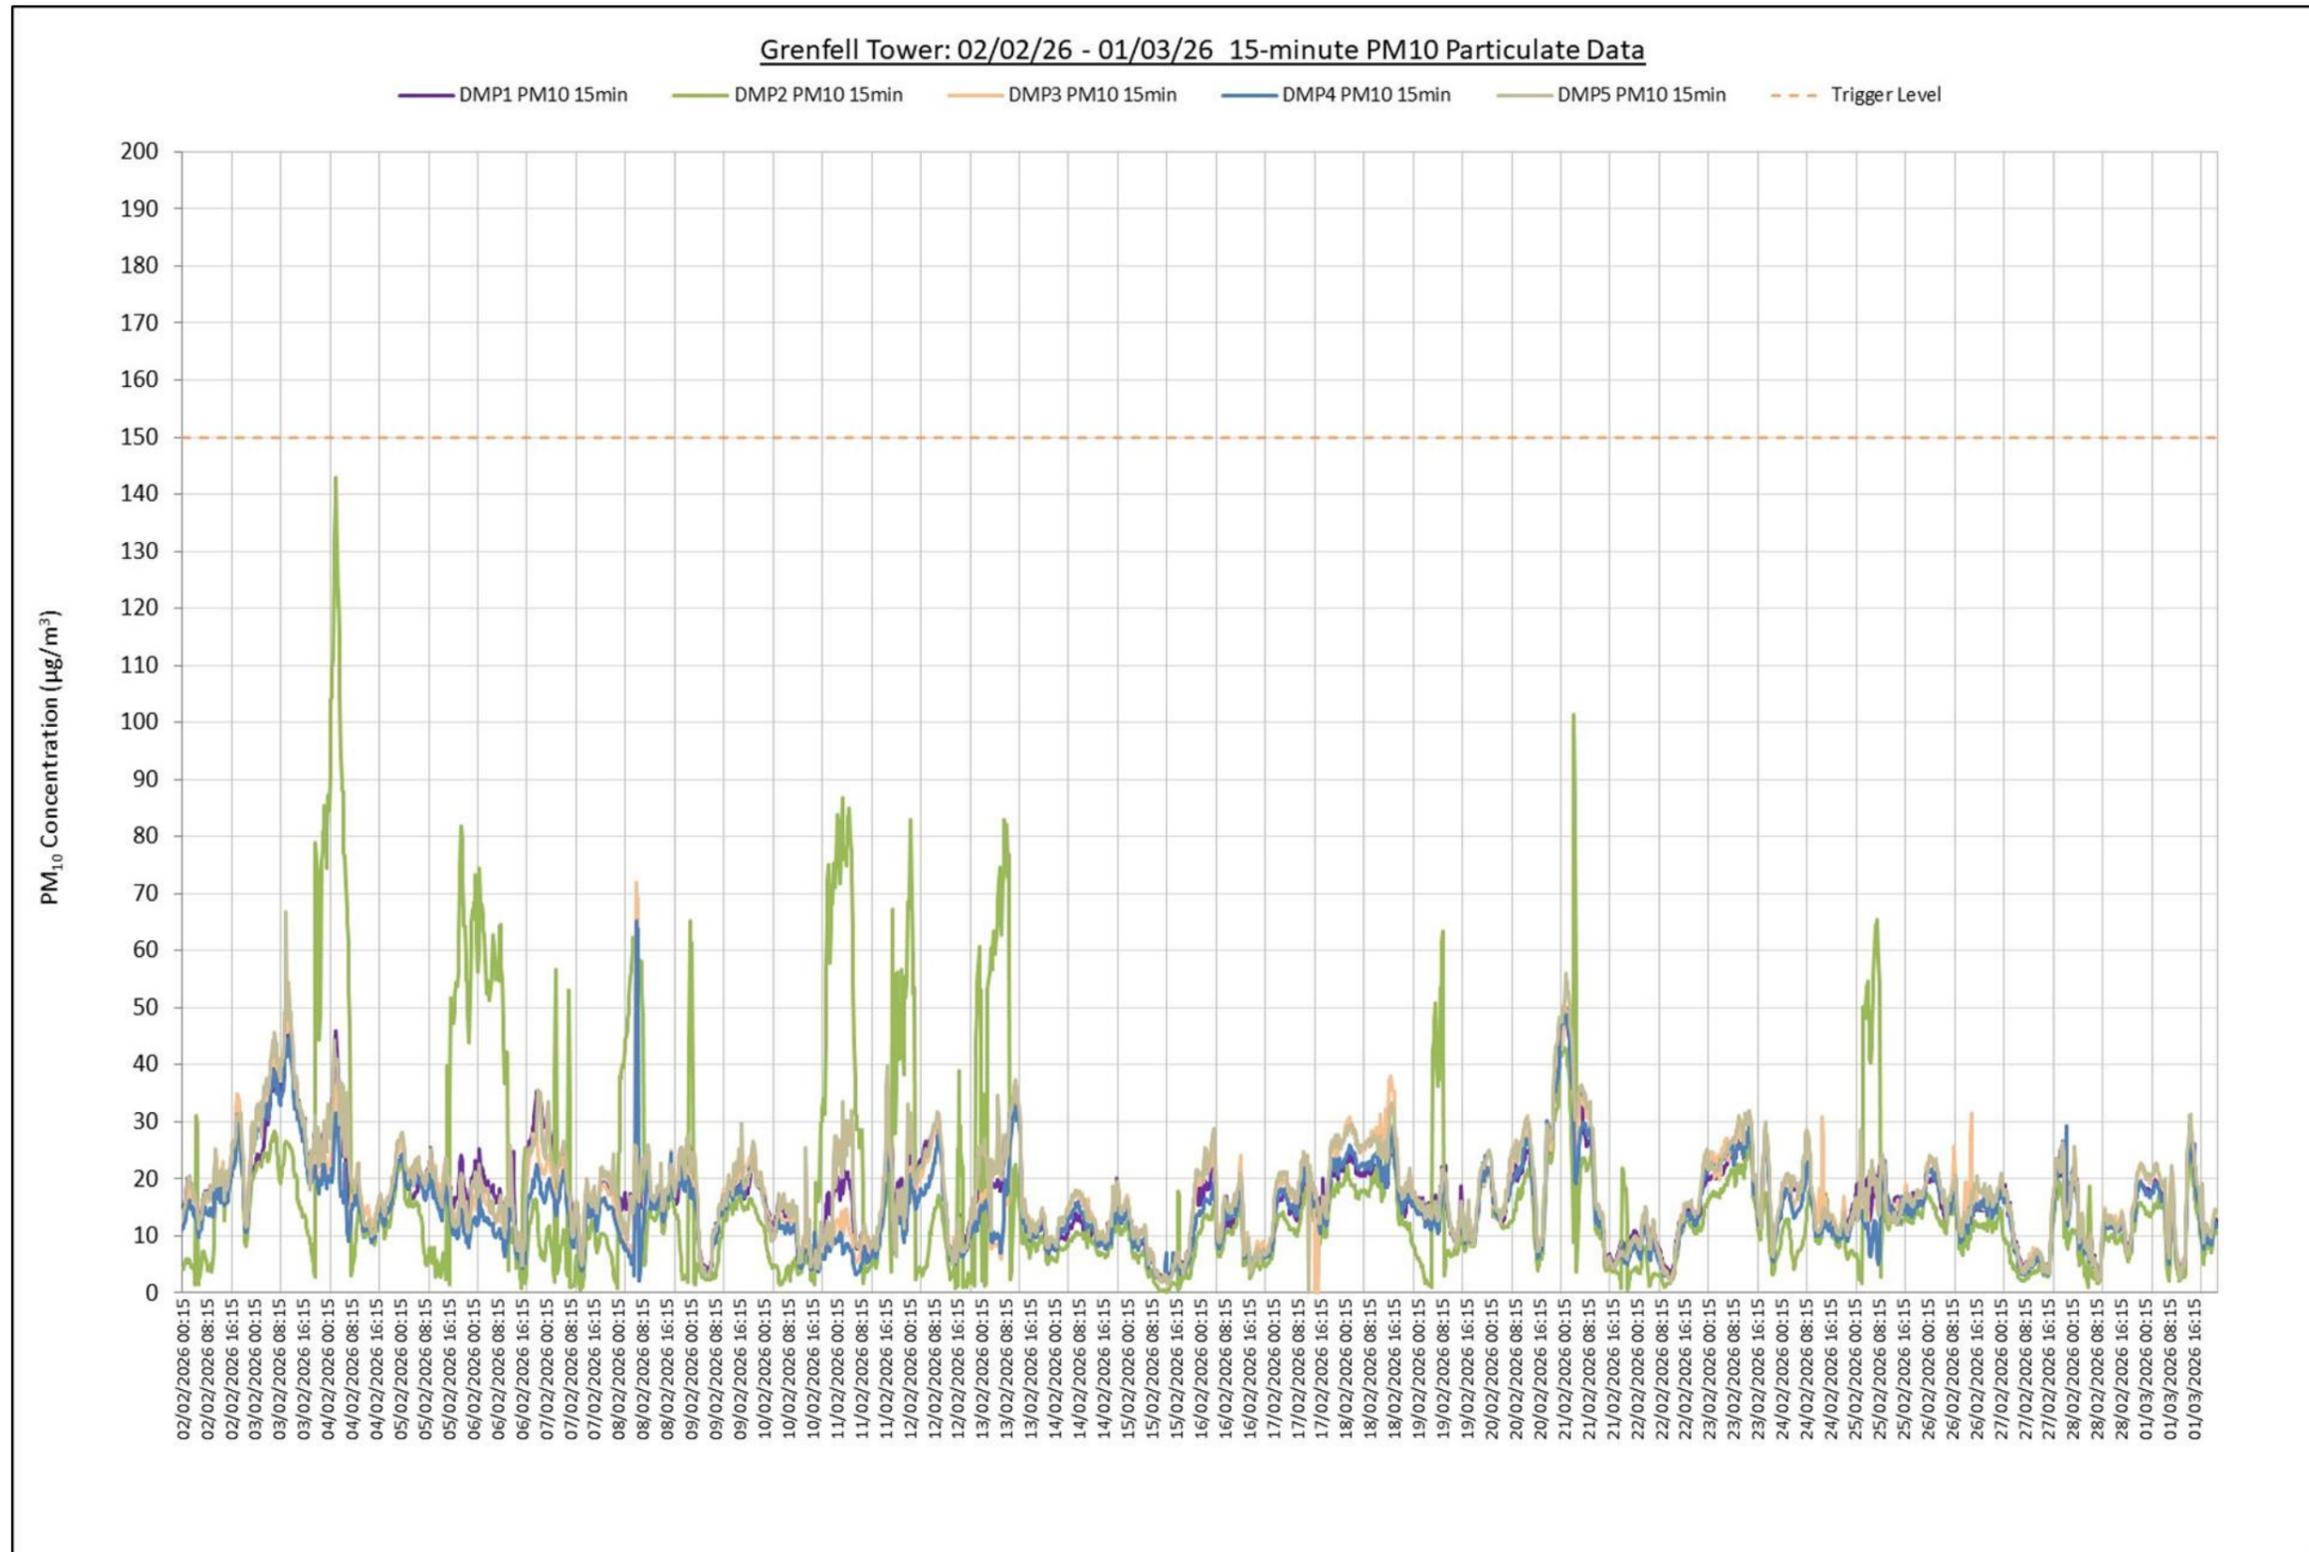
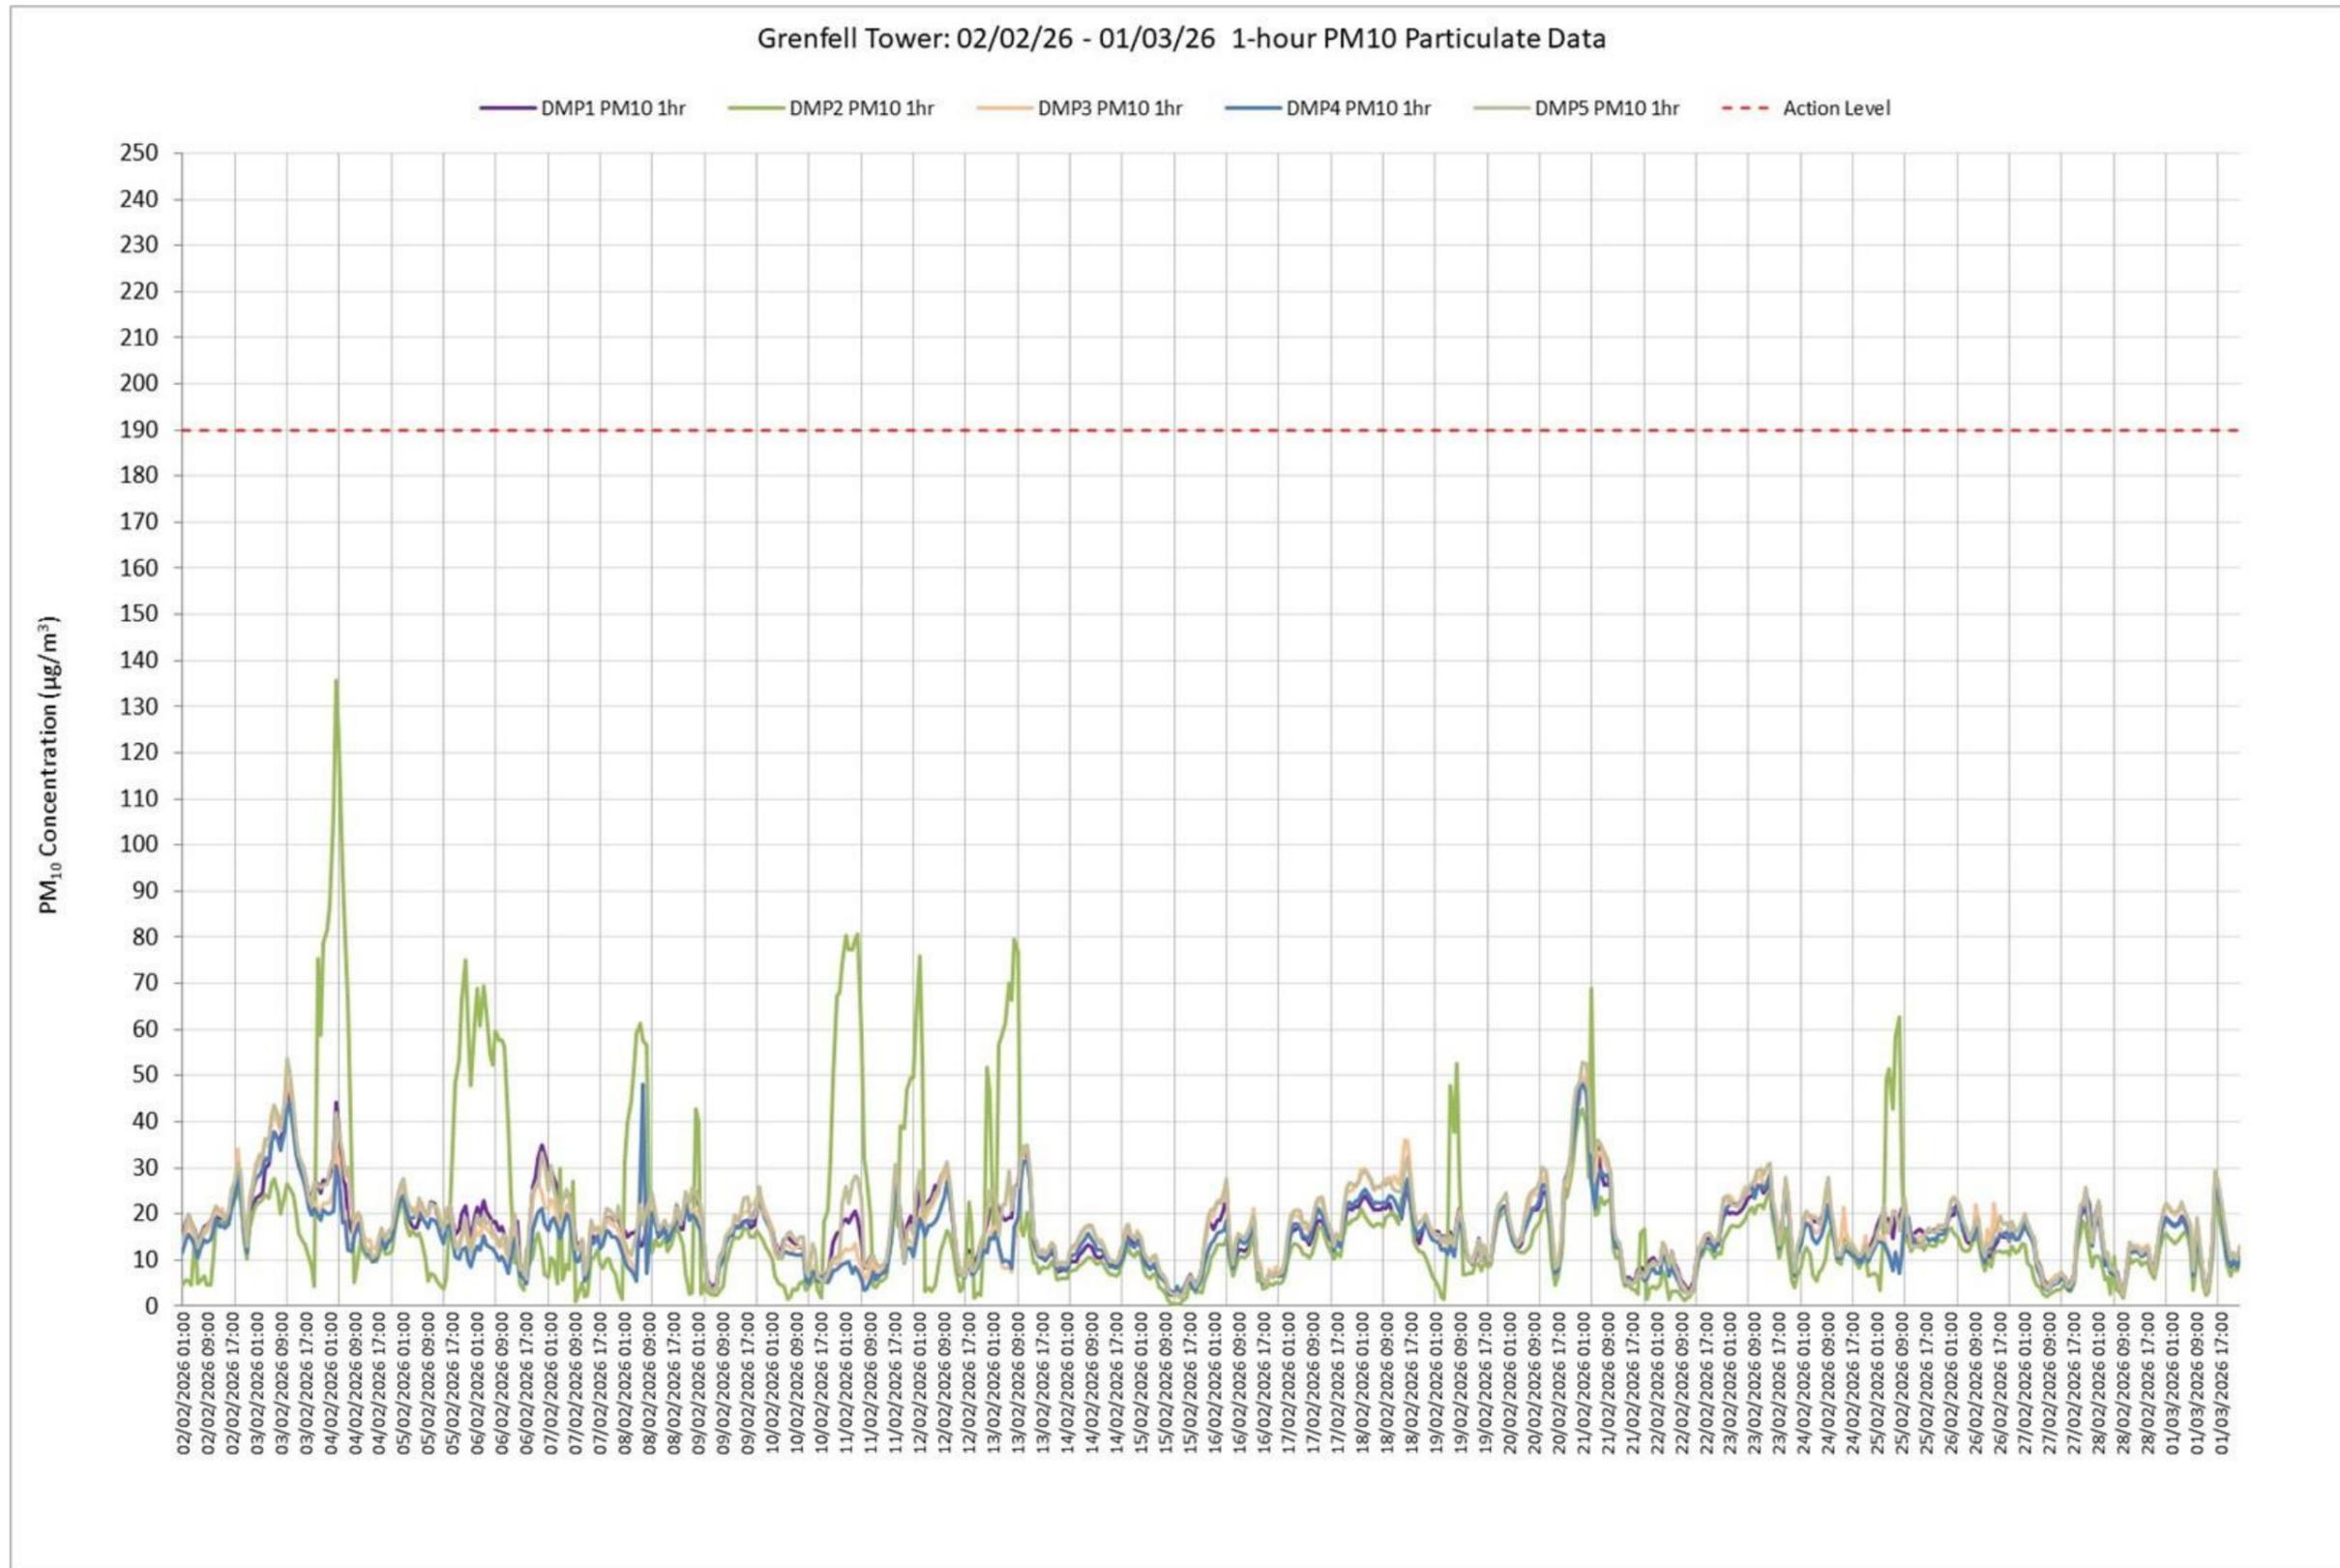
7. PM₁₀ Dust Monitoring Graphs

There were **no exceedances** of either the 15-minute PM₁₀ 150 (µg/m³) or the 15-minute PM_{2.5} 54 (µg/m³) Amber Trigger levels at any other monitoring locations.

The results of the Dust measurements in this period are presented graphically for PM₁₀ and PM_{2.5} in Sections 7 and 8 respectively of this report.

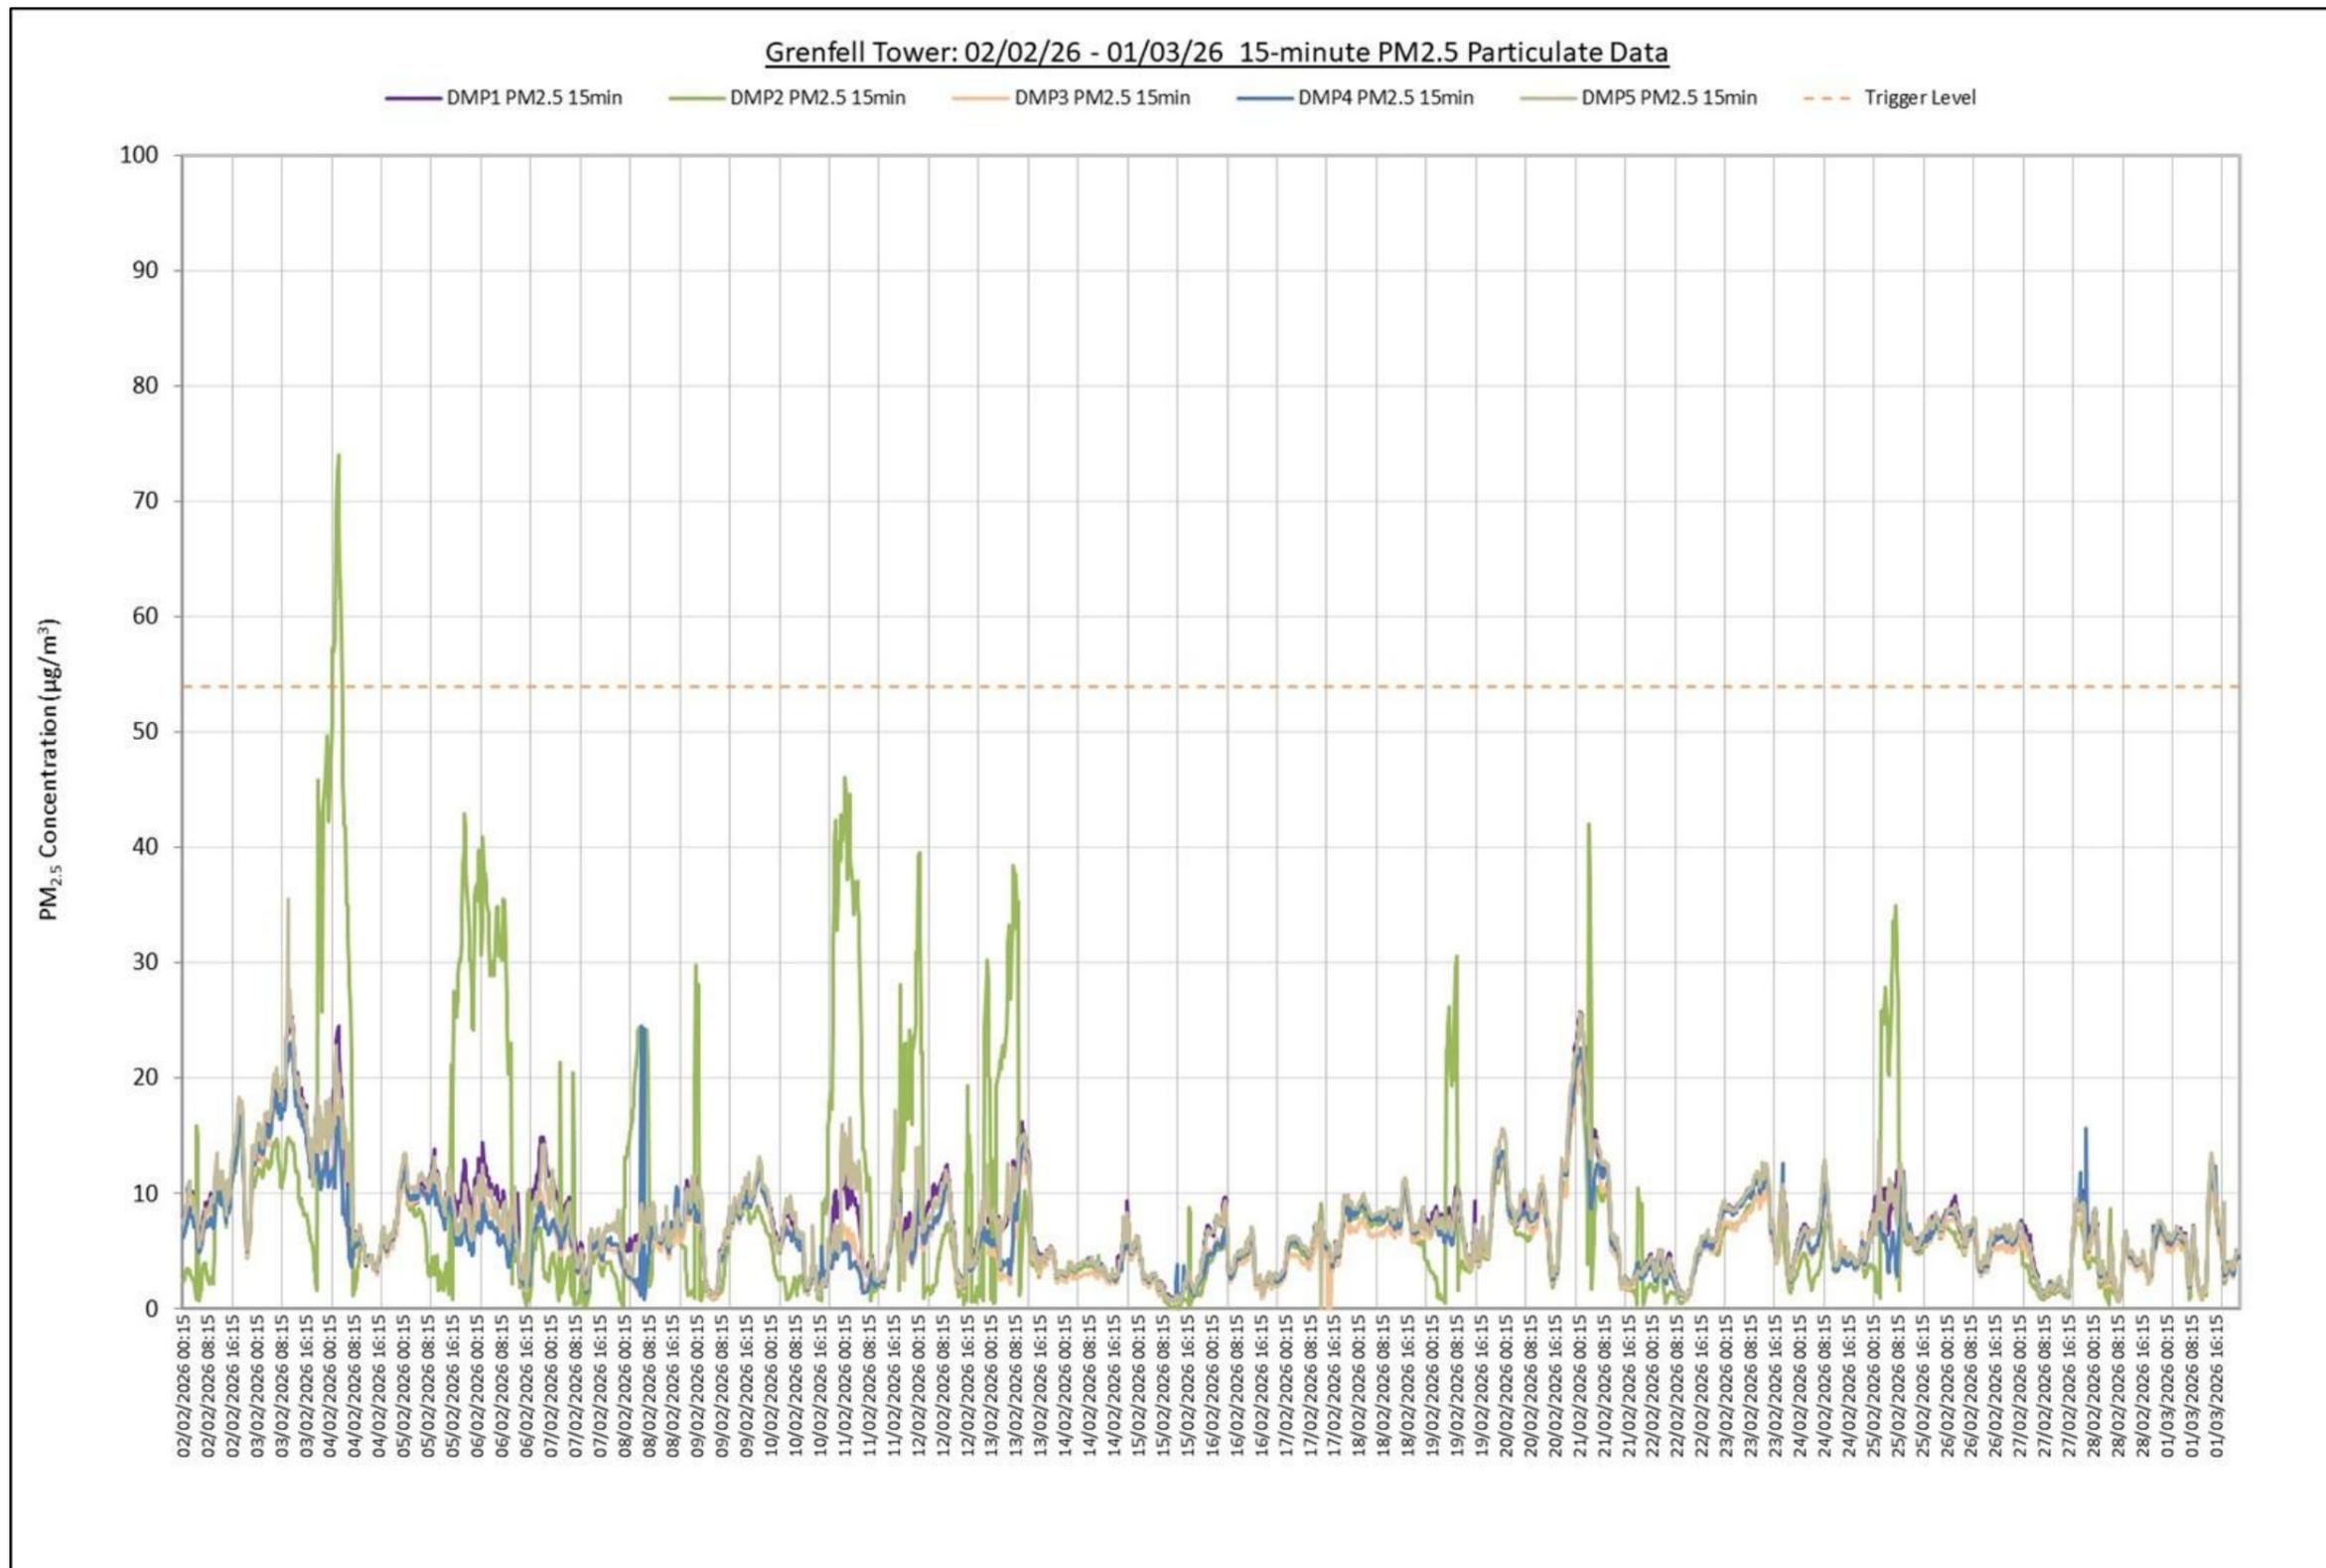
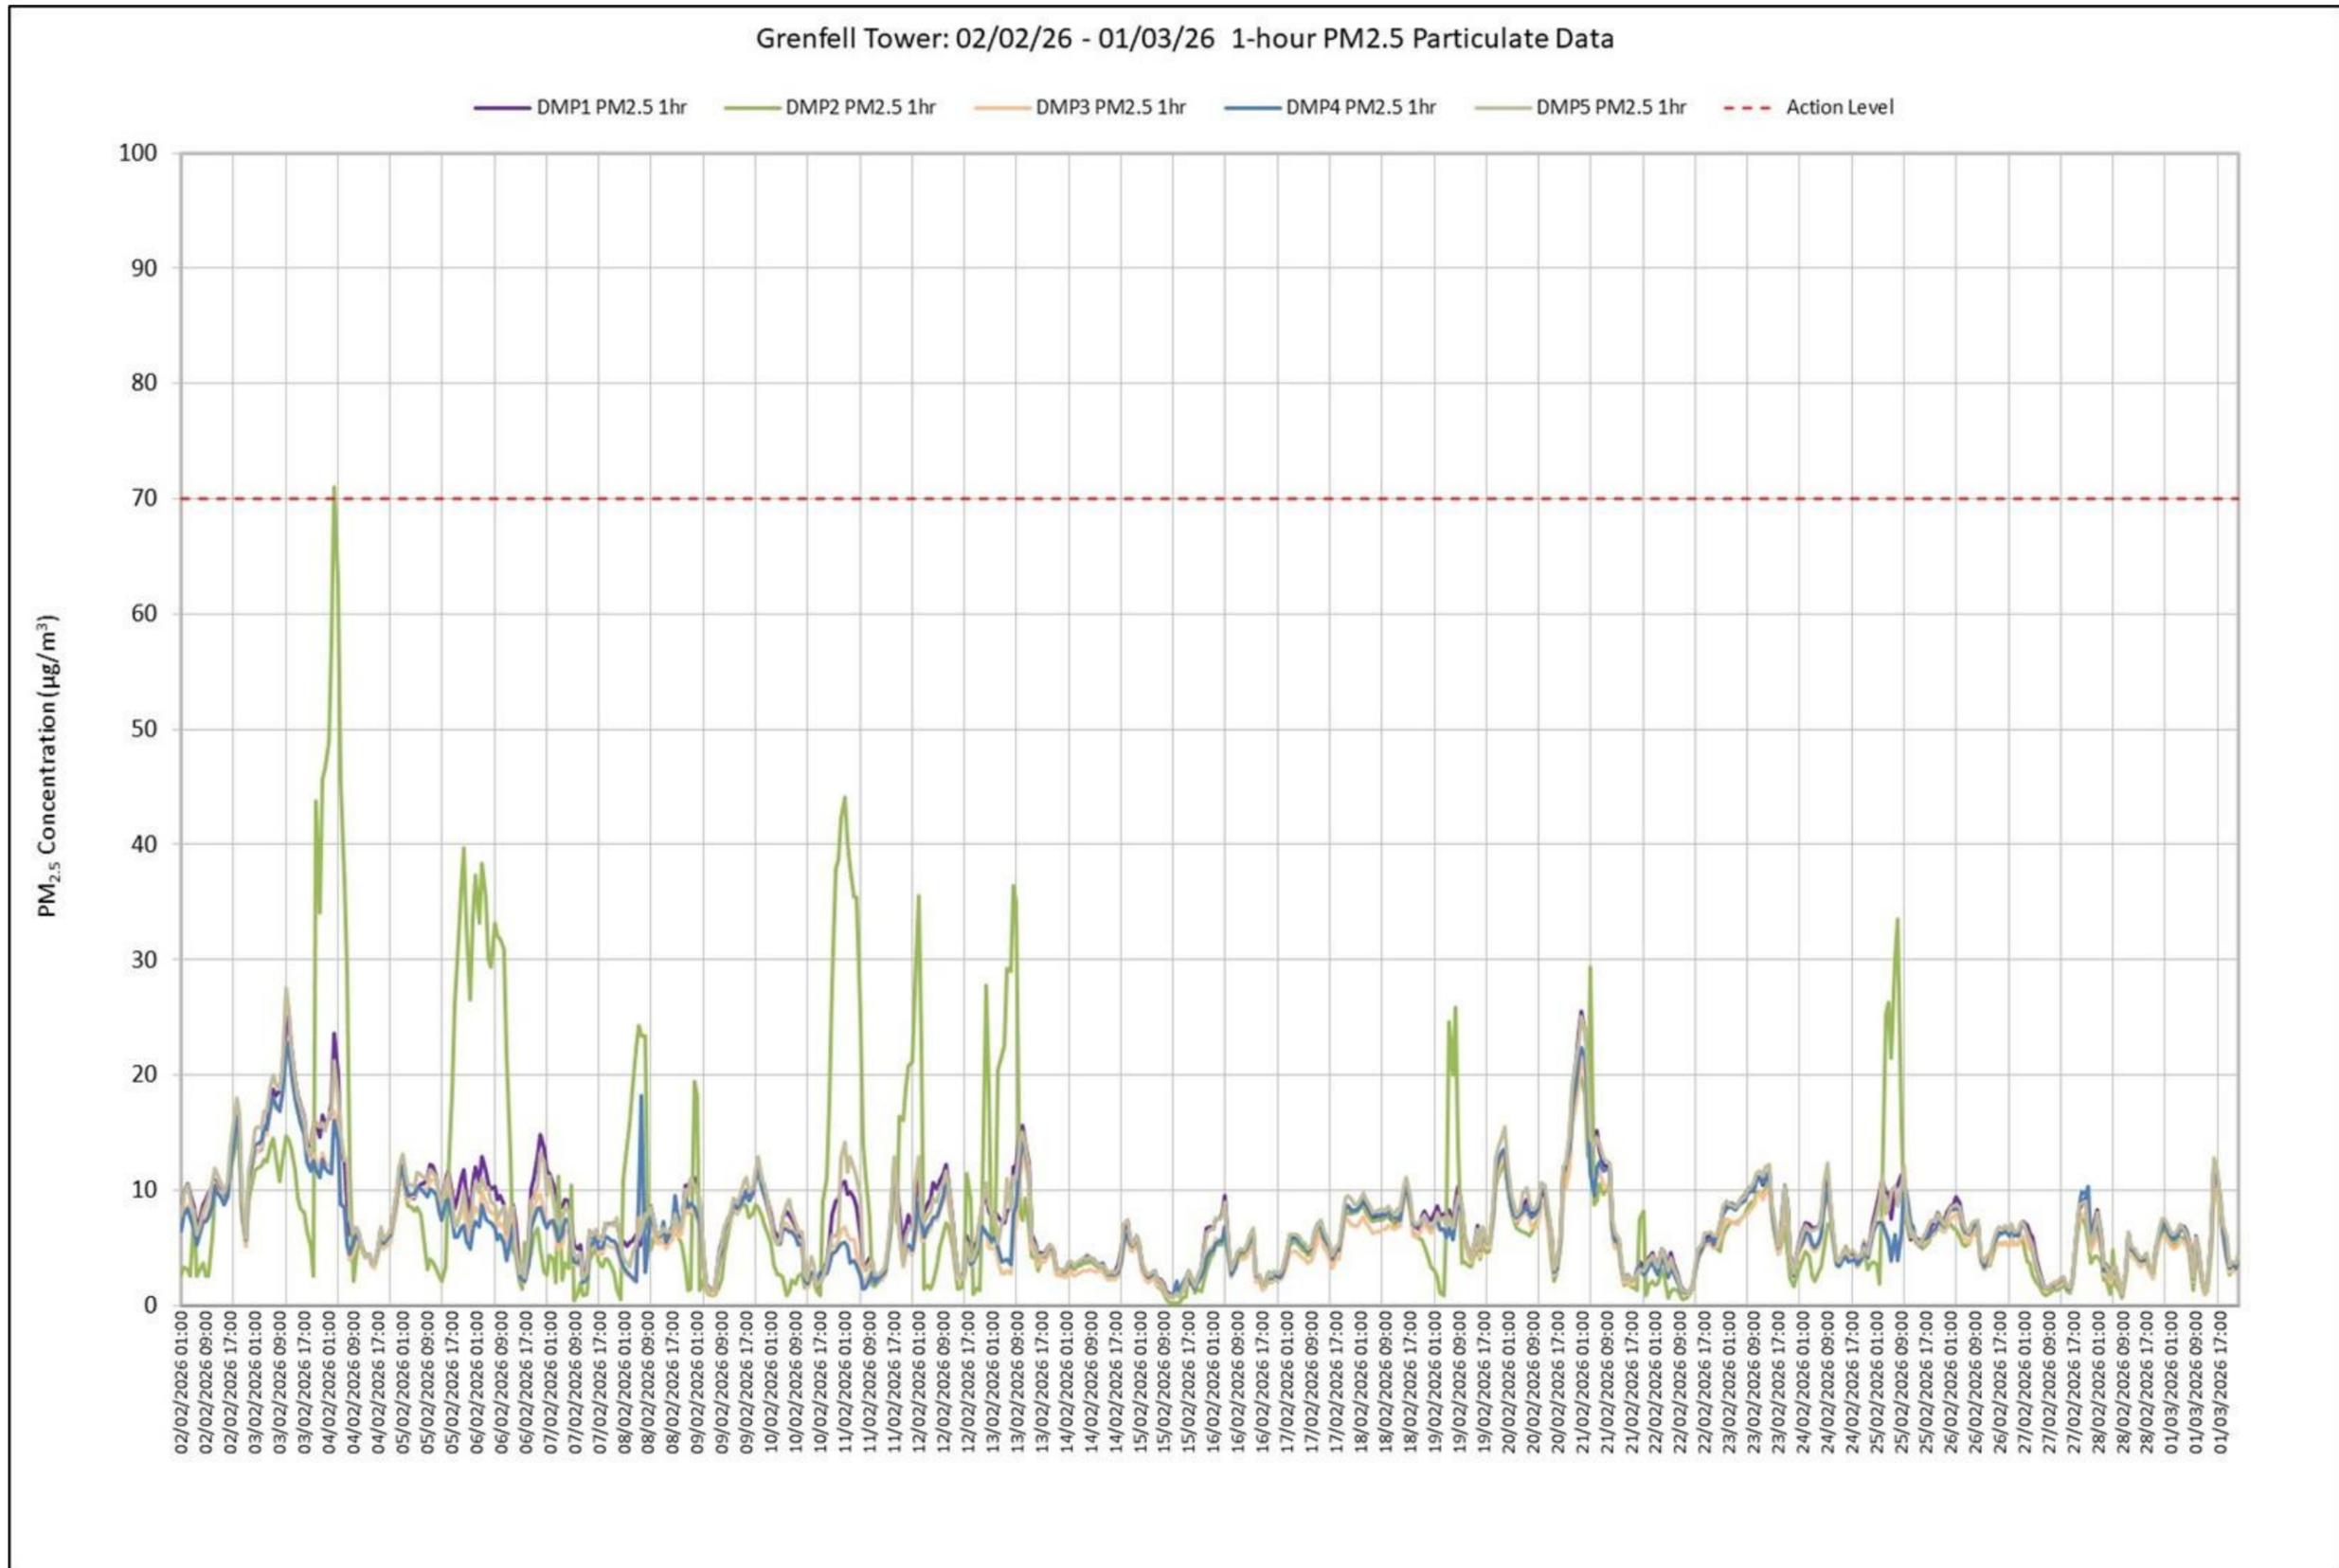
8. PM_{2.5} Dust Monitoring Graphs

**Foggy weather can affect PM_{2.5} due to a combination of; stagnant air, low wind and an increase in humidity. It can also be explained due to a phenomena known as- pollutant fog. This is due to an increased humidity, causing a false reading of water droplet molecules on the light scattering sensor. Increased humidity can cause aerosols to absorb water and therefore grow in size. This is known as 'hygroscopic growth'.*
