Characterisation and monitoring of oil-well cements under simulated CCS well conditions

Report for WP5 of the CEMENTEGRITY Project

UK ACT ERA-NET EC PROJECT NUMBER 691712

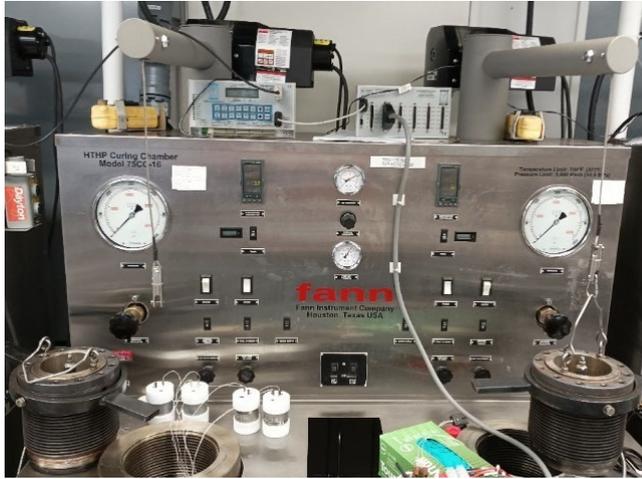
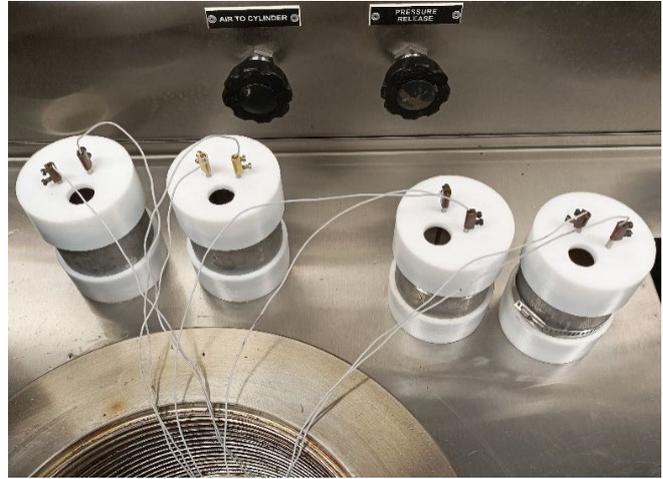
Figure 5. Logging system placed above the two-chamber autoclave (left) and 2-pin electrode samples ready for testing (right)

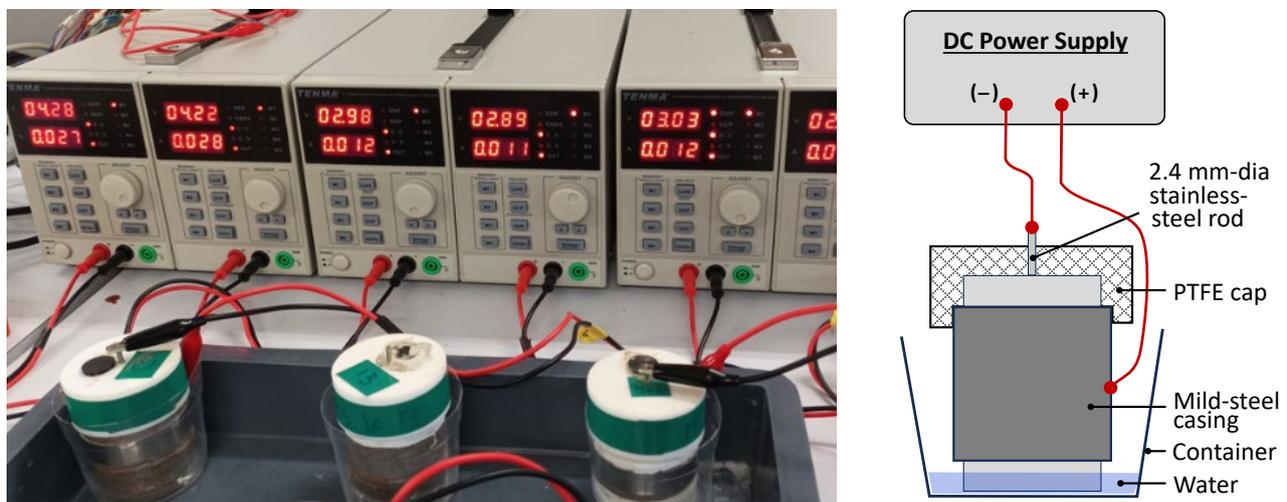
Figure 7. Photo and schematic diagram of accelerated corrosion exposure test

A schematic diagram of the accelerated corrosion tests and the corresponding samples is presented in **Figure 7**. Each sample contained 2.4 mm diameter stainless-steel rod embedded along the longitudinal axis of the sample at the time of casting. These samples were stored under water for 25 days. As illustrated in the schematic diagram, the lower part of the samples was immersed in water in a small plastic container. On the same day (Day 26), four of the

samples were connected to a DC power supply to artificially induce corrosion. This was done by connecting the stainless-steel central rod to the positive terminal of the power supply (acting as a cathode) and the metal casing to the negative terminal (acting as an anode). Two of the samples were exposed to a constant current of 15mA and the other two to 30 mA, corresponding to an average current density of 0.21 and 0.42 mA/cm², respectively. They were connected to the power supply for 6 days, followed by 1 day rest to allow for various measurements to be undertaken. This continued on a weekly basis until required for bond testing at 90 days. The remaining three samples were left unconnected and used as a benchmark. During the testing period, half-cell potential measurements were taken (between the stainless-steel rod and the mild-steel casing) to evaluate the likelihood and presence of corrosion.

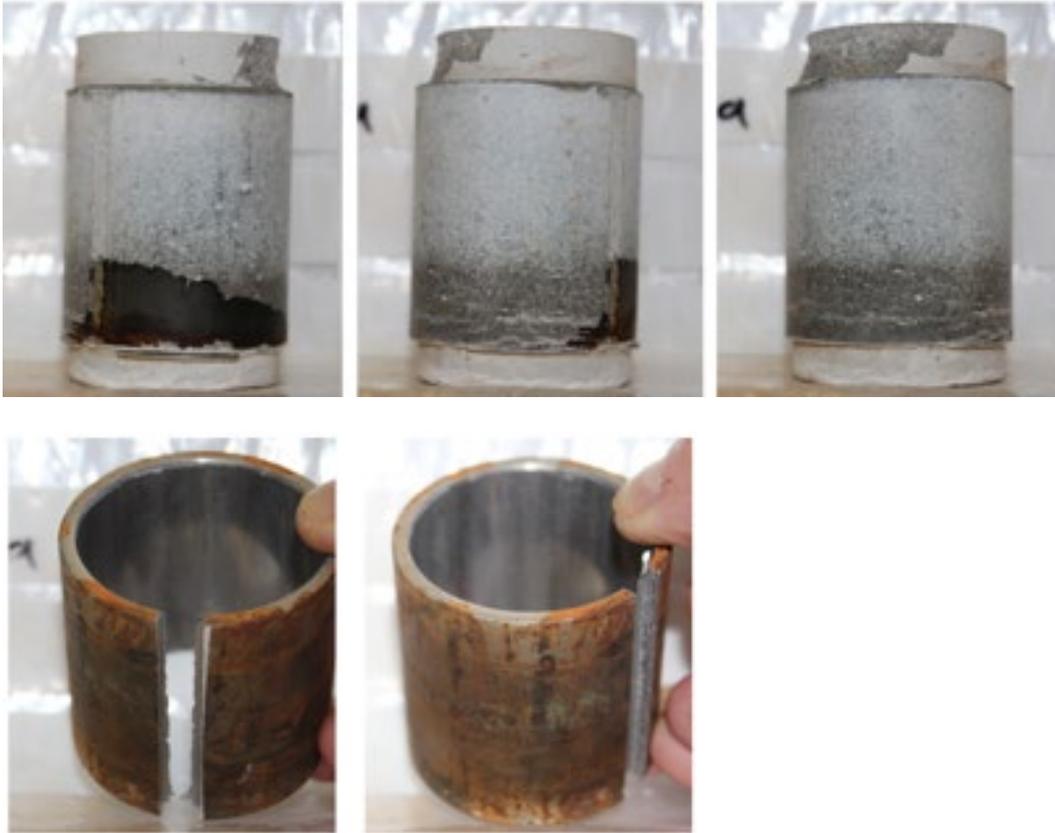
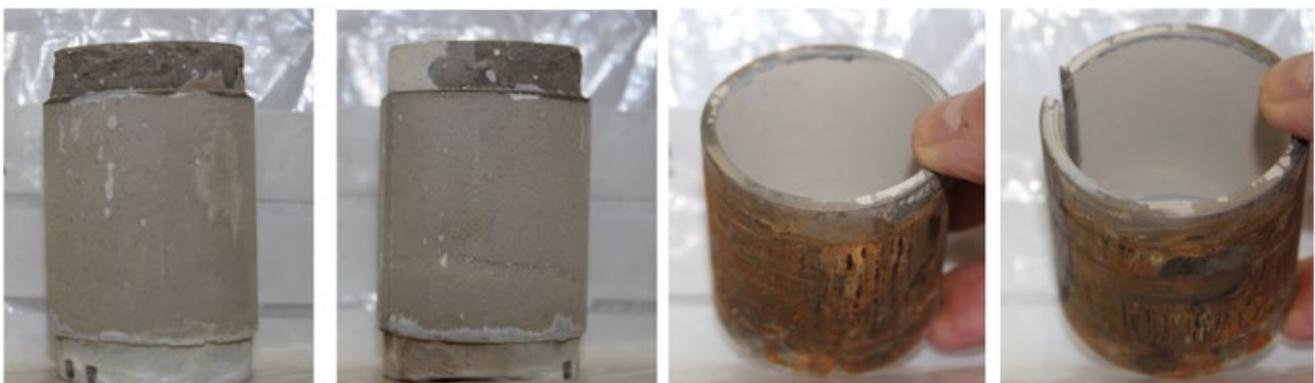
Figure 19. Conditions of the sealant's outer surface of and the pipe's inner surface following bond testing: (a) Sealants S5 and (b) S1RF.

Figure 19 (a) displays the surface conditions of the Sealant S5 samples, illustrating both the outer surface of the sealant and the inner surface of the steel casing. Notably, this particular sealant demonstrates an exceptionally smooth interface with the steel casing, showing minimal and largely no visible signs of corrosion apart from a small, localised area highlighted in the figure. Among all the sealants tested in this study, Sealant S5 exhibits the smoothest surface, closely replicating the texture of the internal surface of the steel casing. From the photos, a discernible layering effect is visible, which suggests a degree of segregation occurred during the fabrication of the samples. This is likely due to the lower viscosity of Sealant S5 compared to the other sealants tested. The upper sections of the samples are lighter in colour and covered with numerous white spots, while the lower sections are darker but similarly exhibit several white spots.

For comparative purposes, **Figure 19(b)** presents the surface conditions of the Sealant S1RF samples, showing both the external surface of the sealant and the inner surface of the steel casing. Interestingly, no visible signs of corrosion are evident in these samples, a finding that contrasts with the results of the three previous batches. In this batch, the material near the surface appears to have sheared off, leaving white zones adhered to the steel surface. This suggests that this layer detached under the application of shear load. This observation indicates that the bond failure in the Sealant S1RF samples was governed by material failure below the steel/sealant interface rather than debonding. Although the exact cause of this behaviour could not be conclusively identified, the absence of corrosion in this batch could be attributed to enhanced volumetric stability compared to the original S1 sealant from earlier batches.
