## Abbreviated Vibration Monitoring Reports

Monitoring Period: 02 March 2026 to 29 March 2026

<b>Project:</b>	Grenfell Tower
<b>Document Ref:</b>	EEMC-VMR-201/107 – Grenfell Tower Rev 02
<b>Period:</b>	02 March 2026 to 29 March 2026

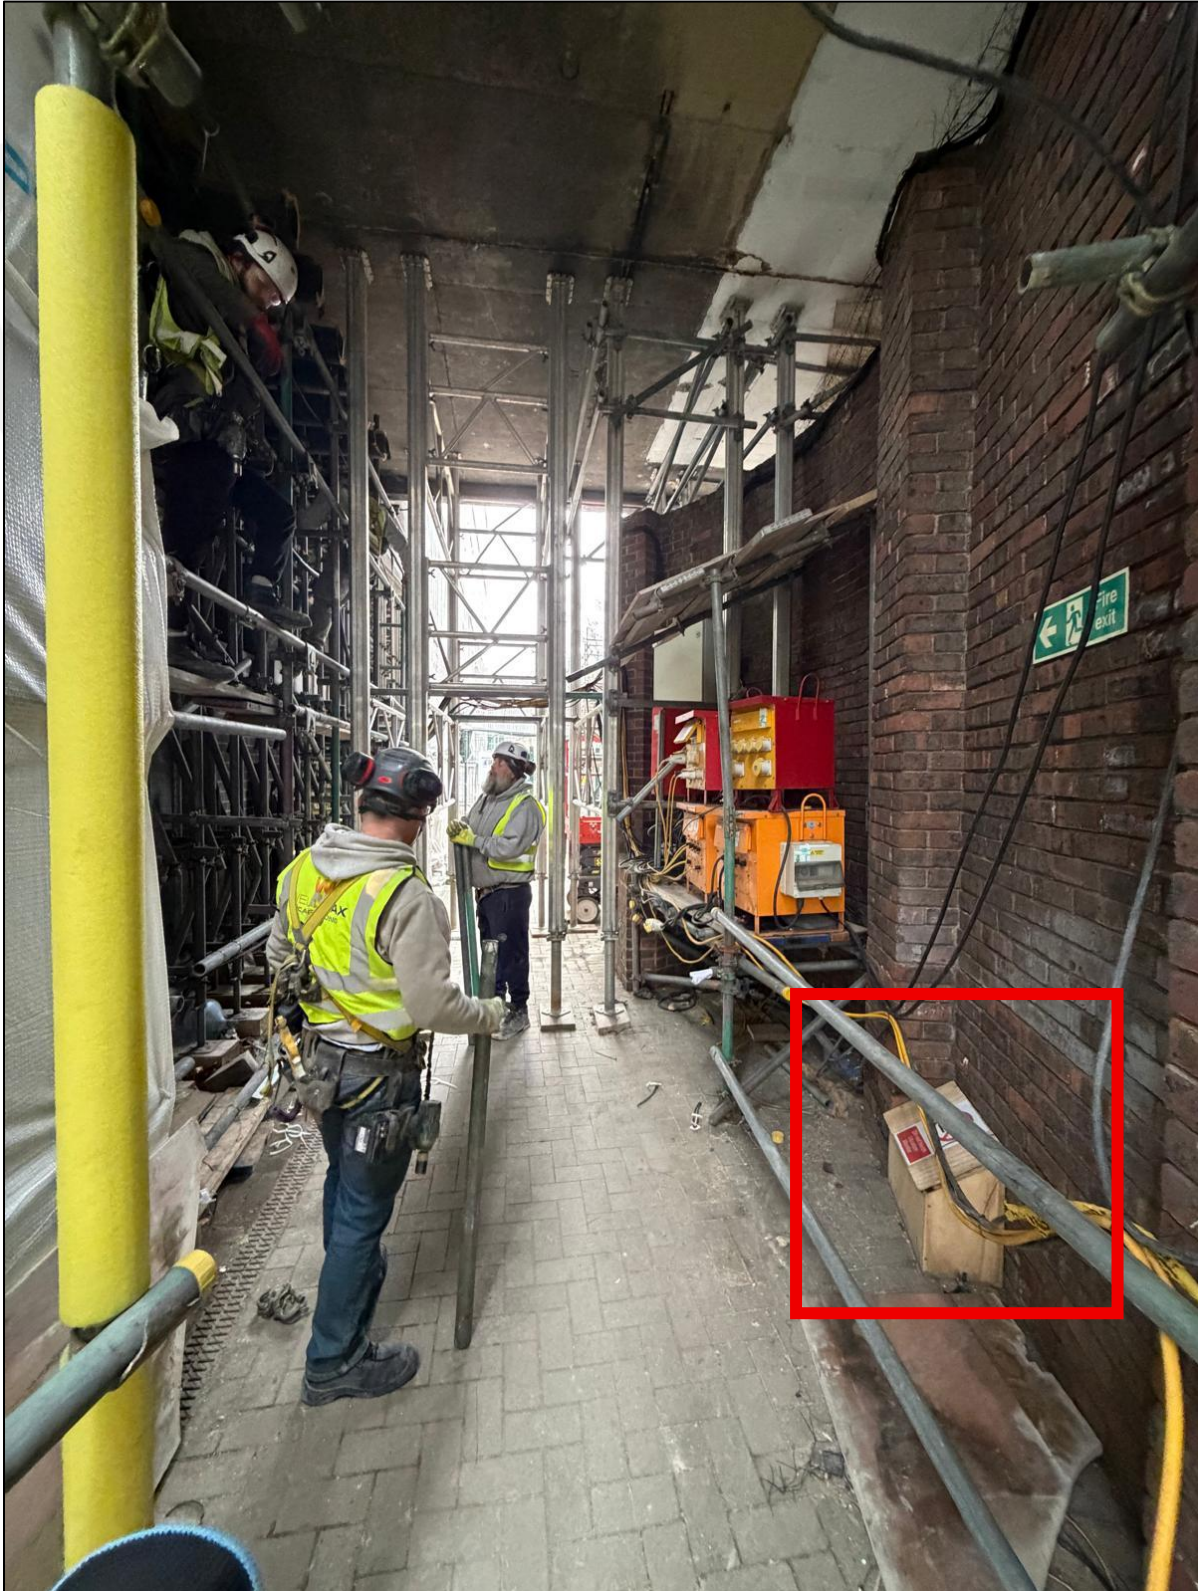
**Image 1 – Works Location throughout the monitoring period, adjacent to VMP1**

There were works adjacent to VMP1 throughout this monitoring period as outlined in Tables 0.1 and 0.2, and the location of works and the monitor are shown in Image 1.

*Wooden box on the right hand side houses the vibration monitor – highlighted with a red box*

Monitoring Location	Date and Time of Exceedance	Measured Level of Exceedance (mm/s)	Red Action Level (mm/s)	Cause of Exceedance	Mitigation
VMP1	02/03/2026 16:15	3.02	3.0mm/s	Scaffolding works to enable temporary propping and temporary propping.	Soft stripping methodology reviewed with operatives; works briefed to minimise direct impact adjacent to monitor. Reduced use of percussive tools within exclusion zone and increased supervision during close-proximity activities.
	02/03/2026 16:25	7.99			
	02/03/2026 17:00	3.77			
	06/03/2026 08:30	4.30			
	06/03/2026 08:40	3.54			
	06/03/2026 09:15	16.63			
	06/03/2026 09:25	33.04			
	06/03/2026 09:35	3.14			
	06/03/2026 12:35	11.29			
	06/03/2026 12:40	3.31			
	06/03/2026 12:45	5.92			
	06/03/2026 12:55	19.00			
	06/03/2026 13:00	3.85			
	06/03/2026 13:15	6.12			
	06/03/2026 13:20	17.43			
	06/03/2026 13:45	4.18			
	06/03/2026 13:50	3.92			
	06/03/2026 14:50	16.88

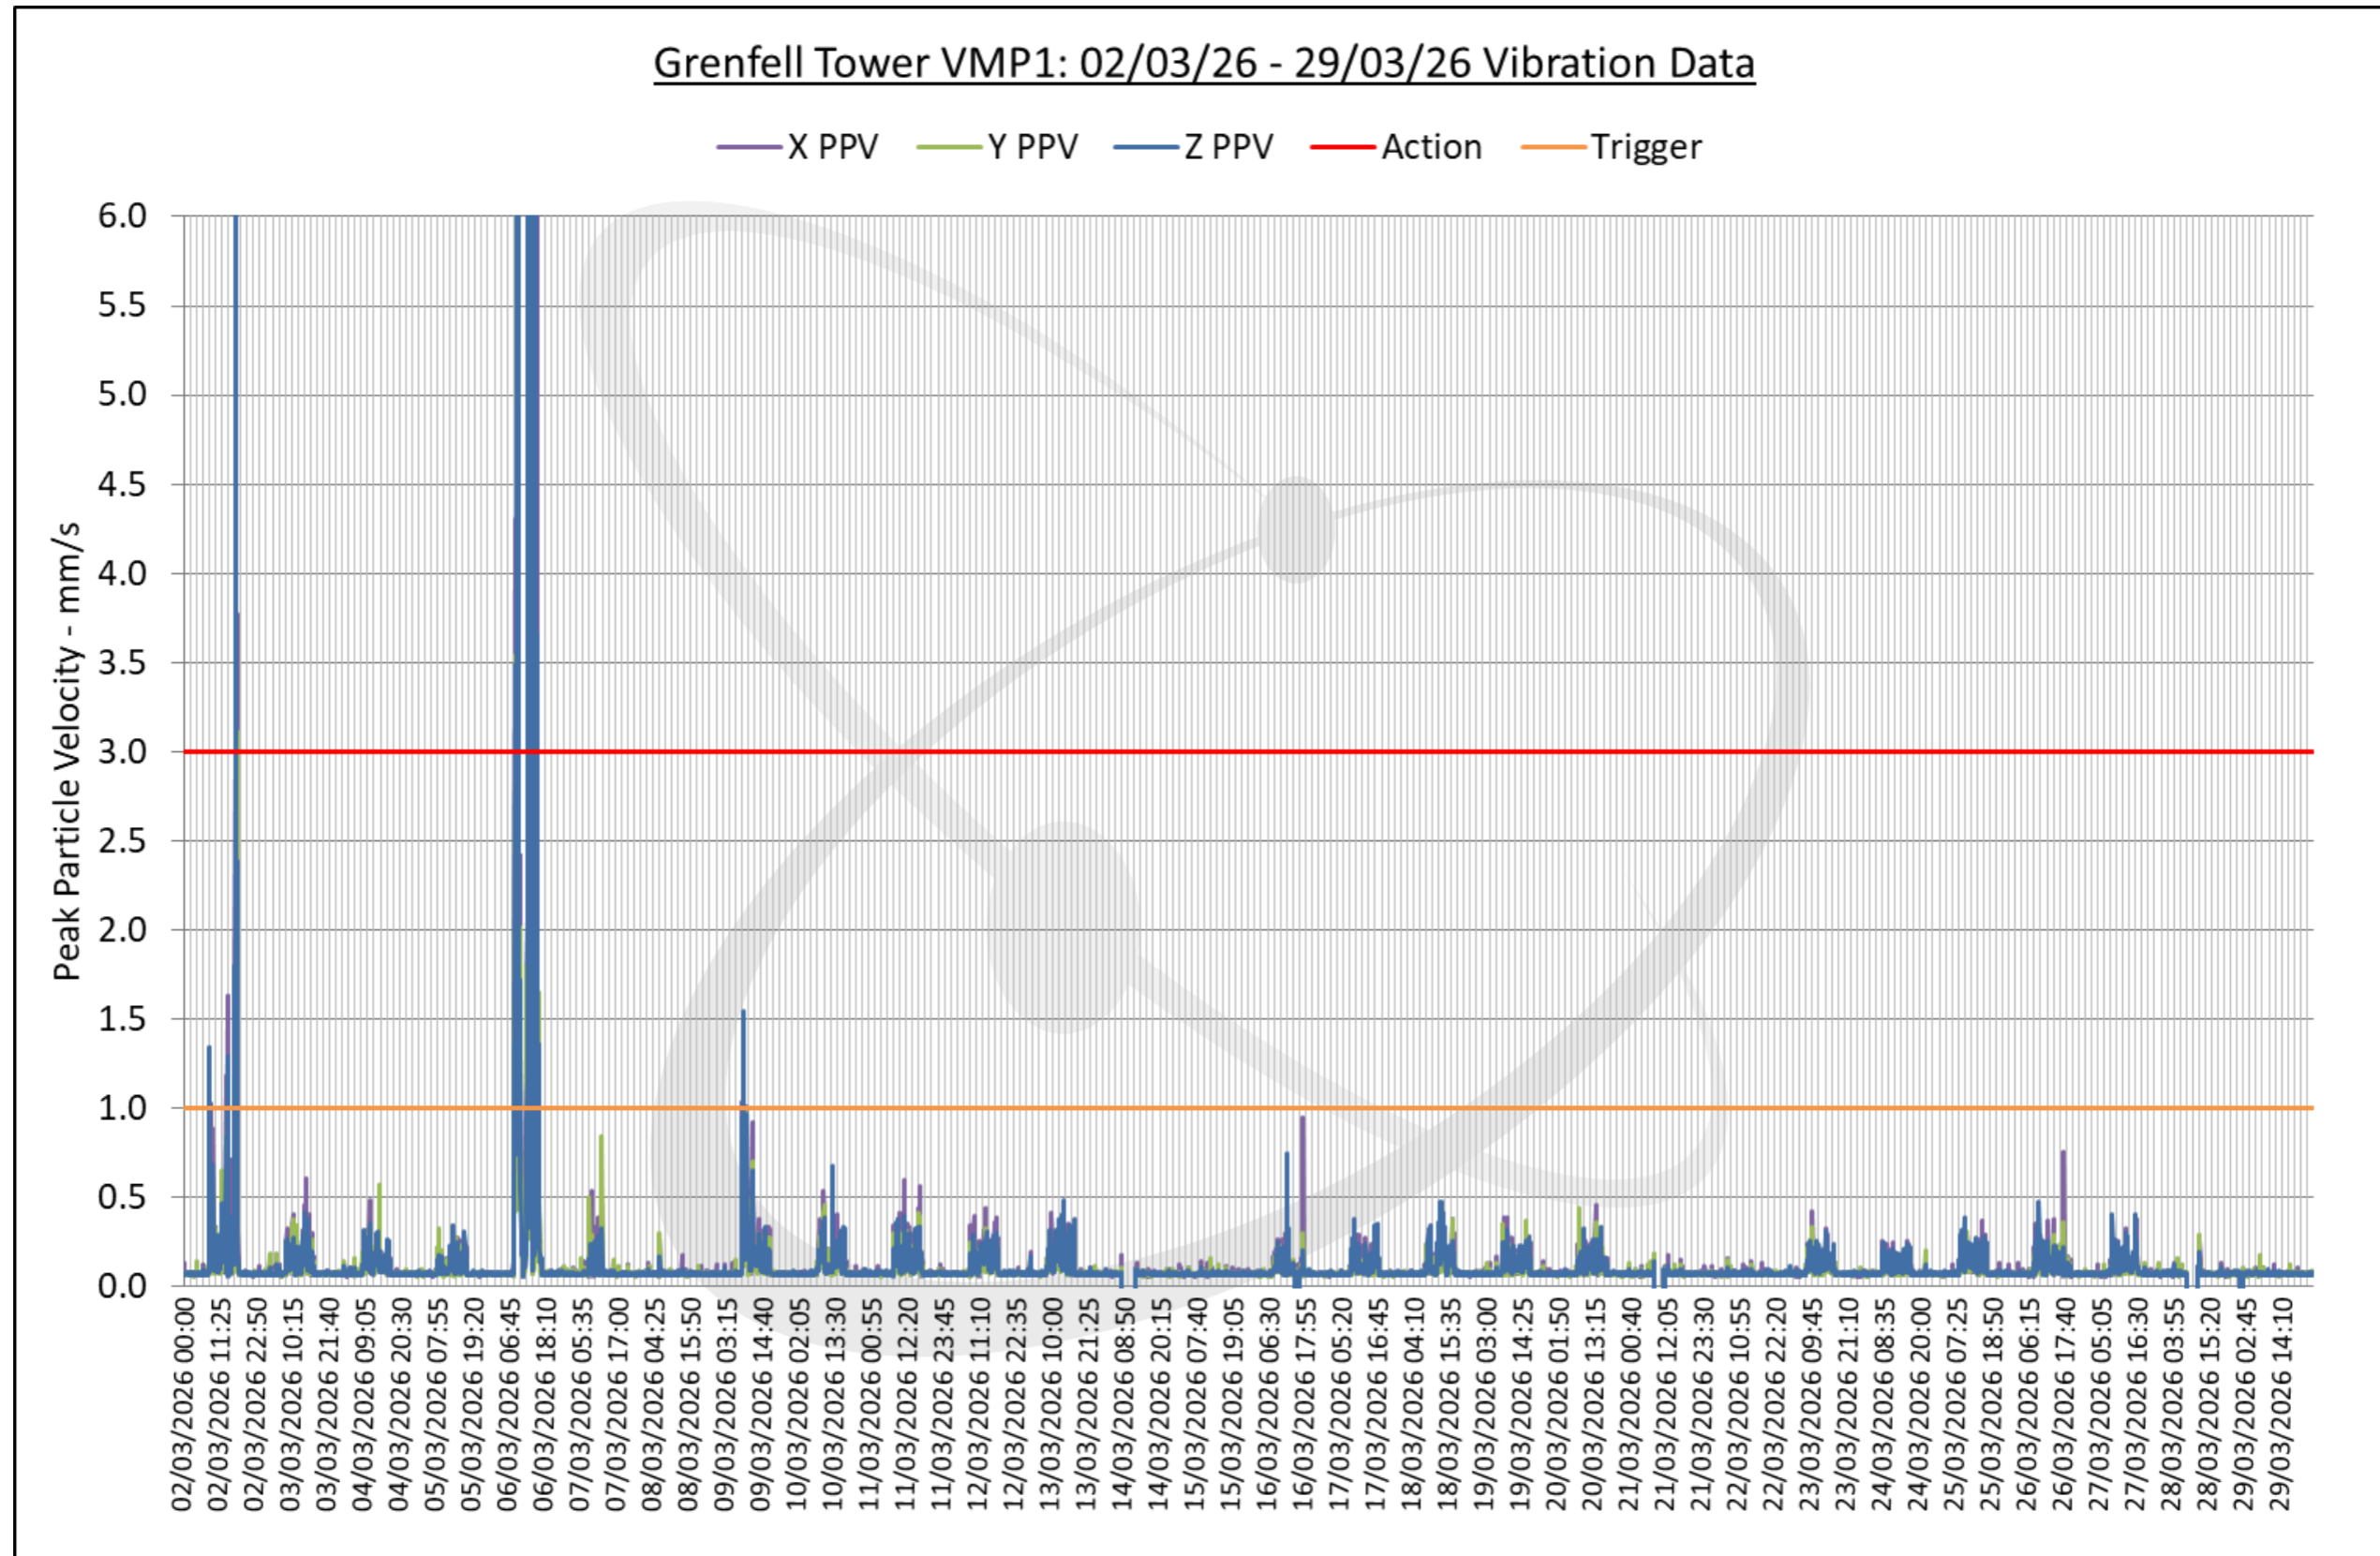
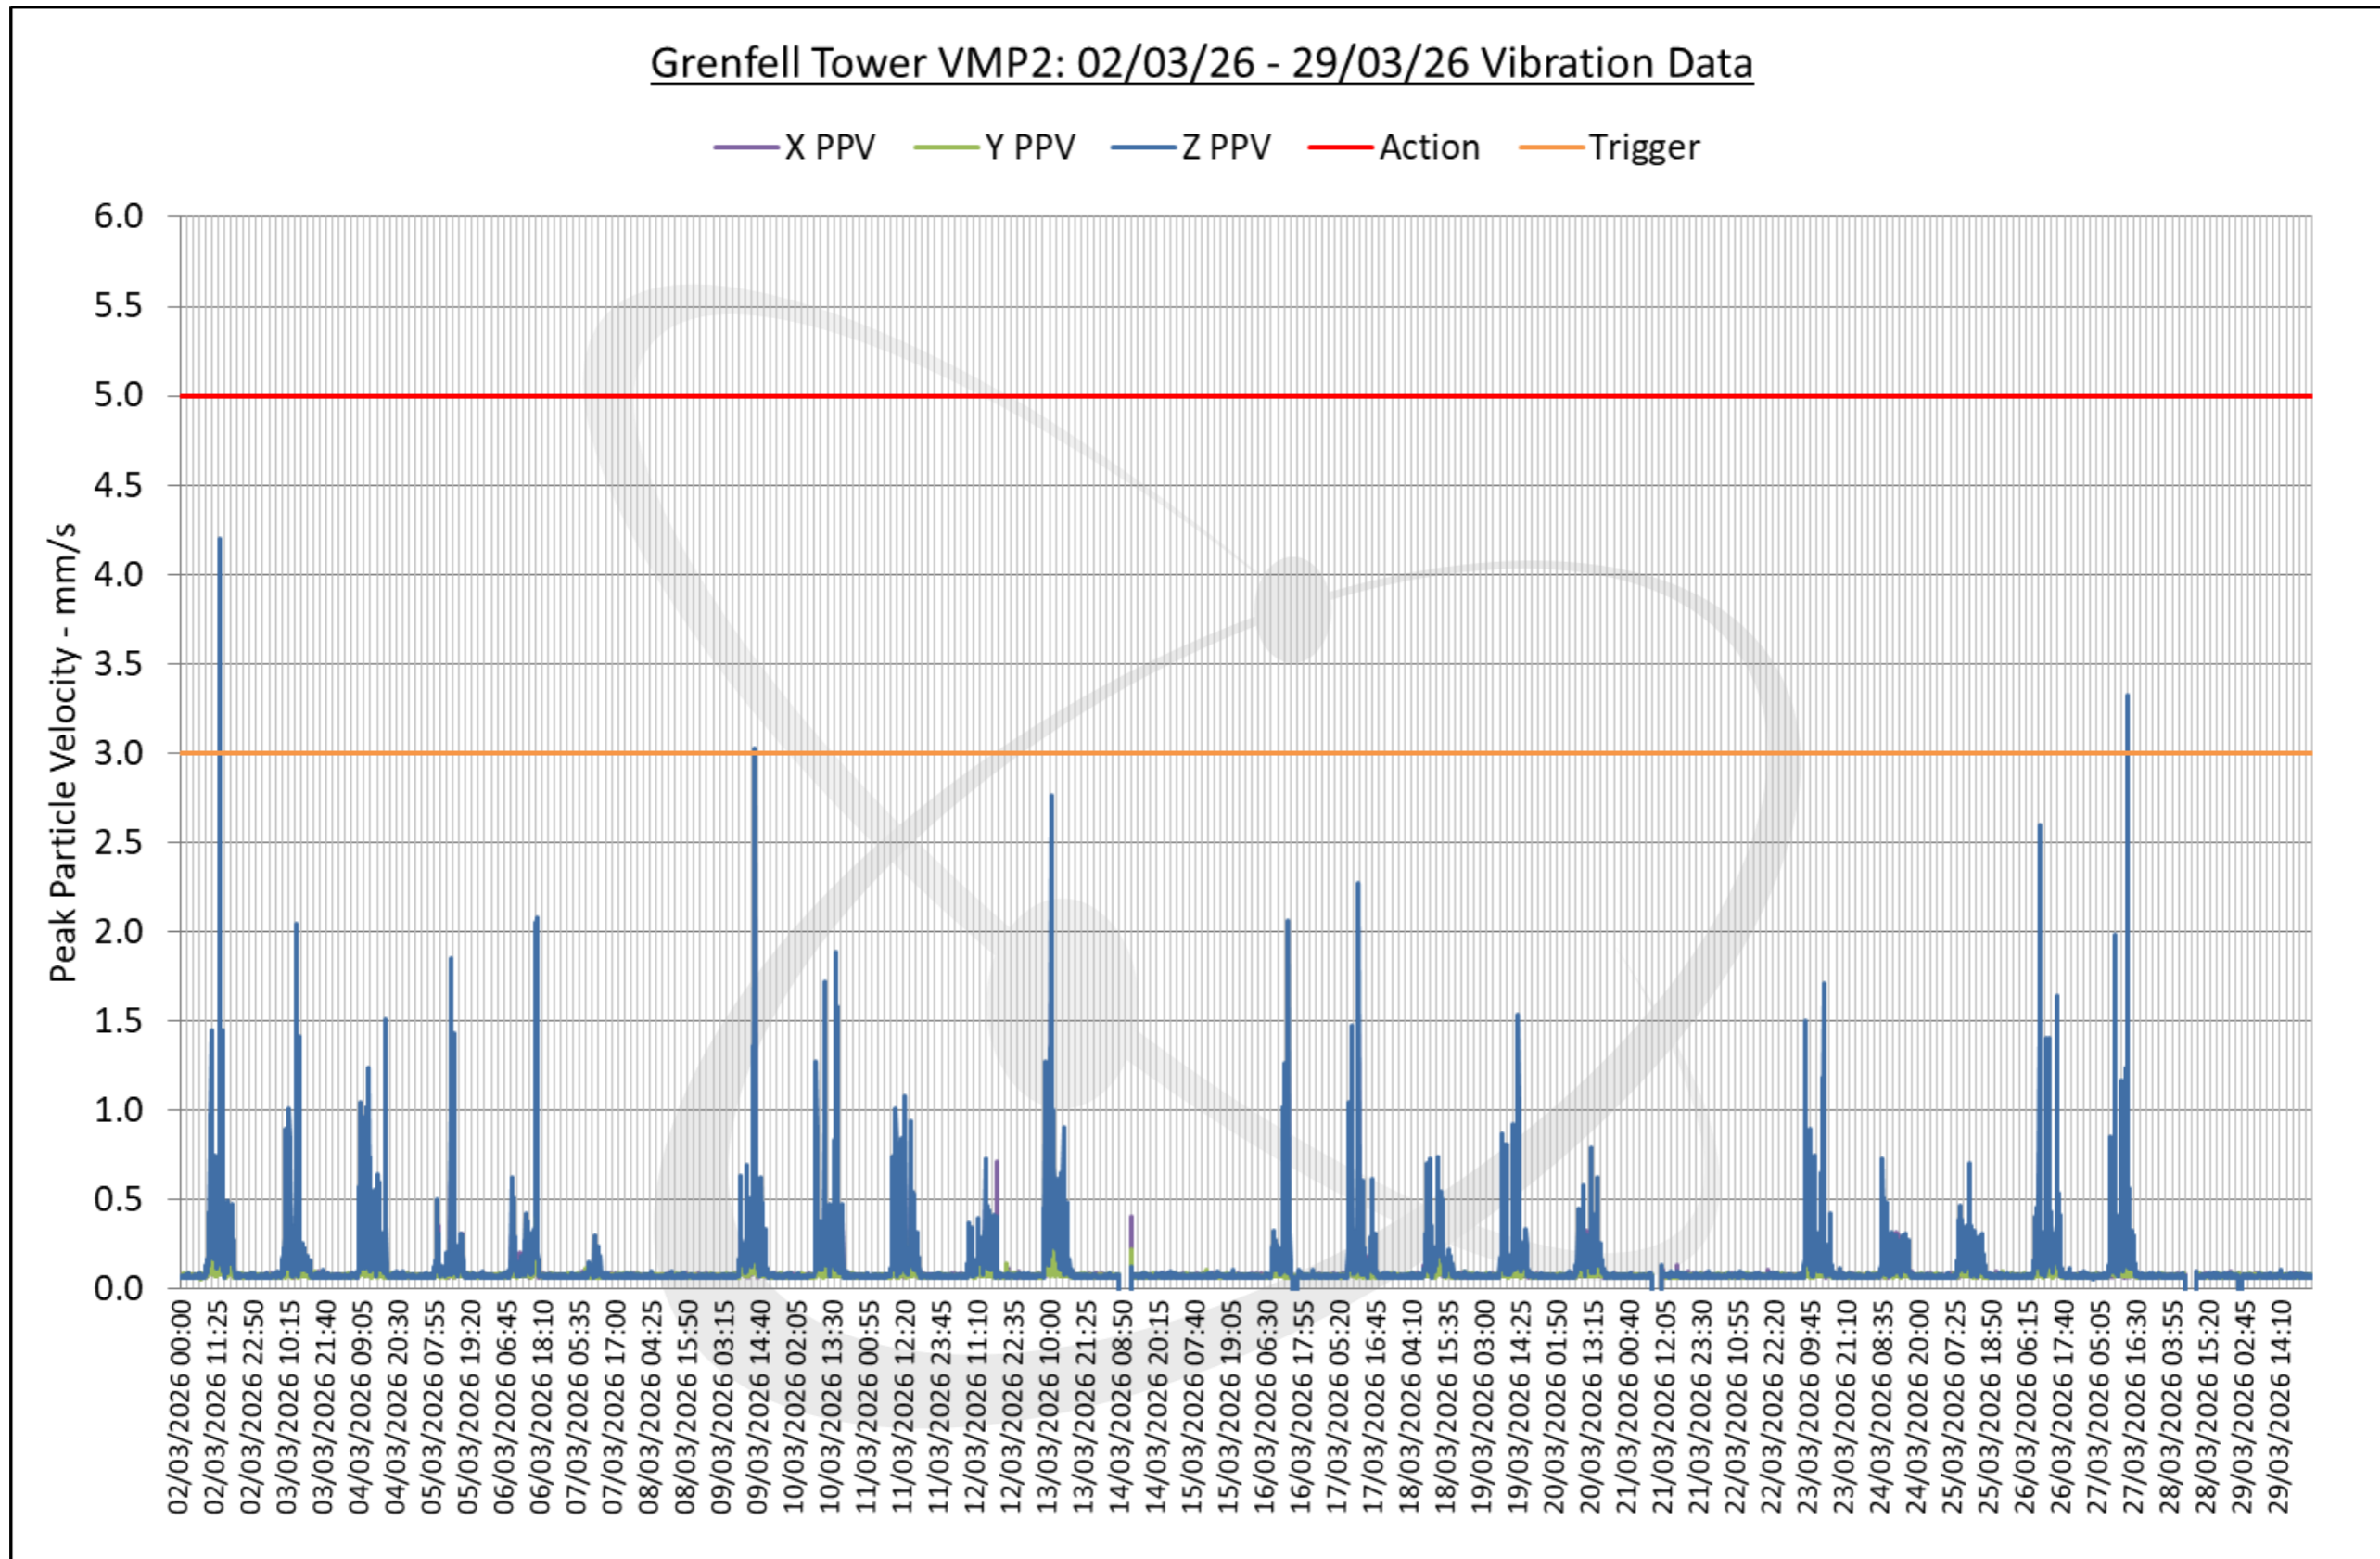
6. Vibration Monitoring Graphs

There were **twenty-two (22) exceedances** of the Red Action Level 3.0mm/s and **fifty-one (51) exceedances** of the Amber Trigger level 1.0mm/s during working hours in this reporting period.

There were **no exceedances** of the Red Action level 5.0mm/s, **three (3) exceedances** of the Amber Trigger level 3.0mm/s during working hours in this reporting period.

The results of the Vibration measurements in this period are presented graphically in Section 6 of this report.

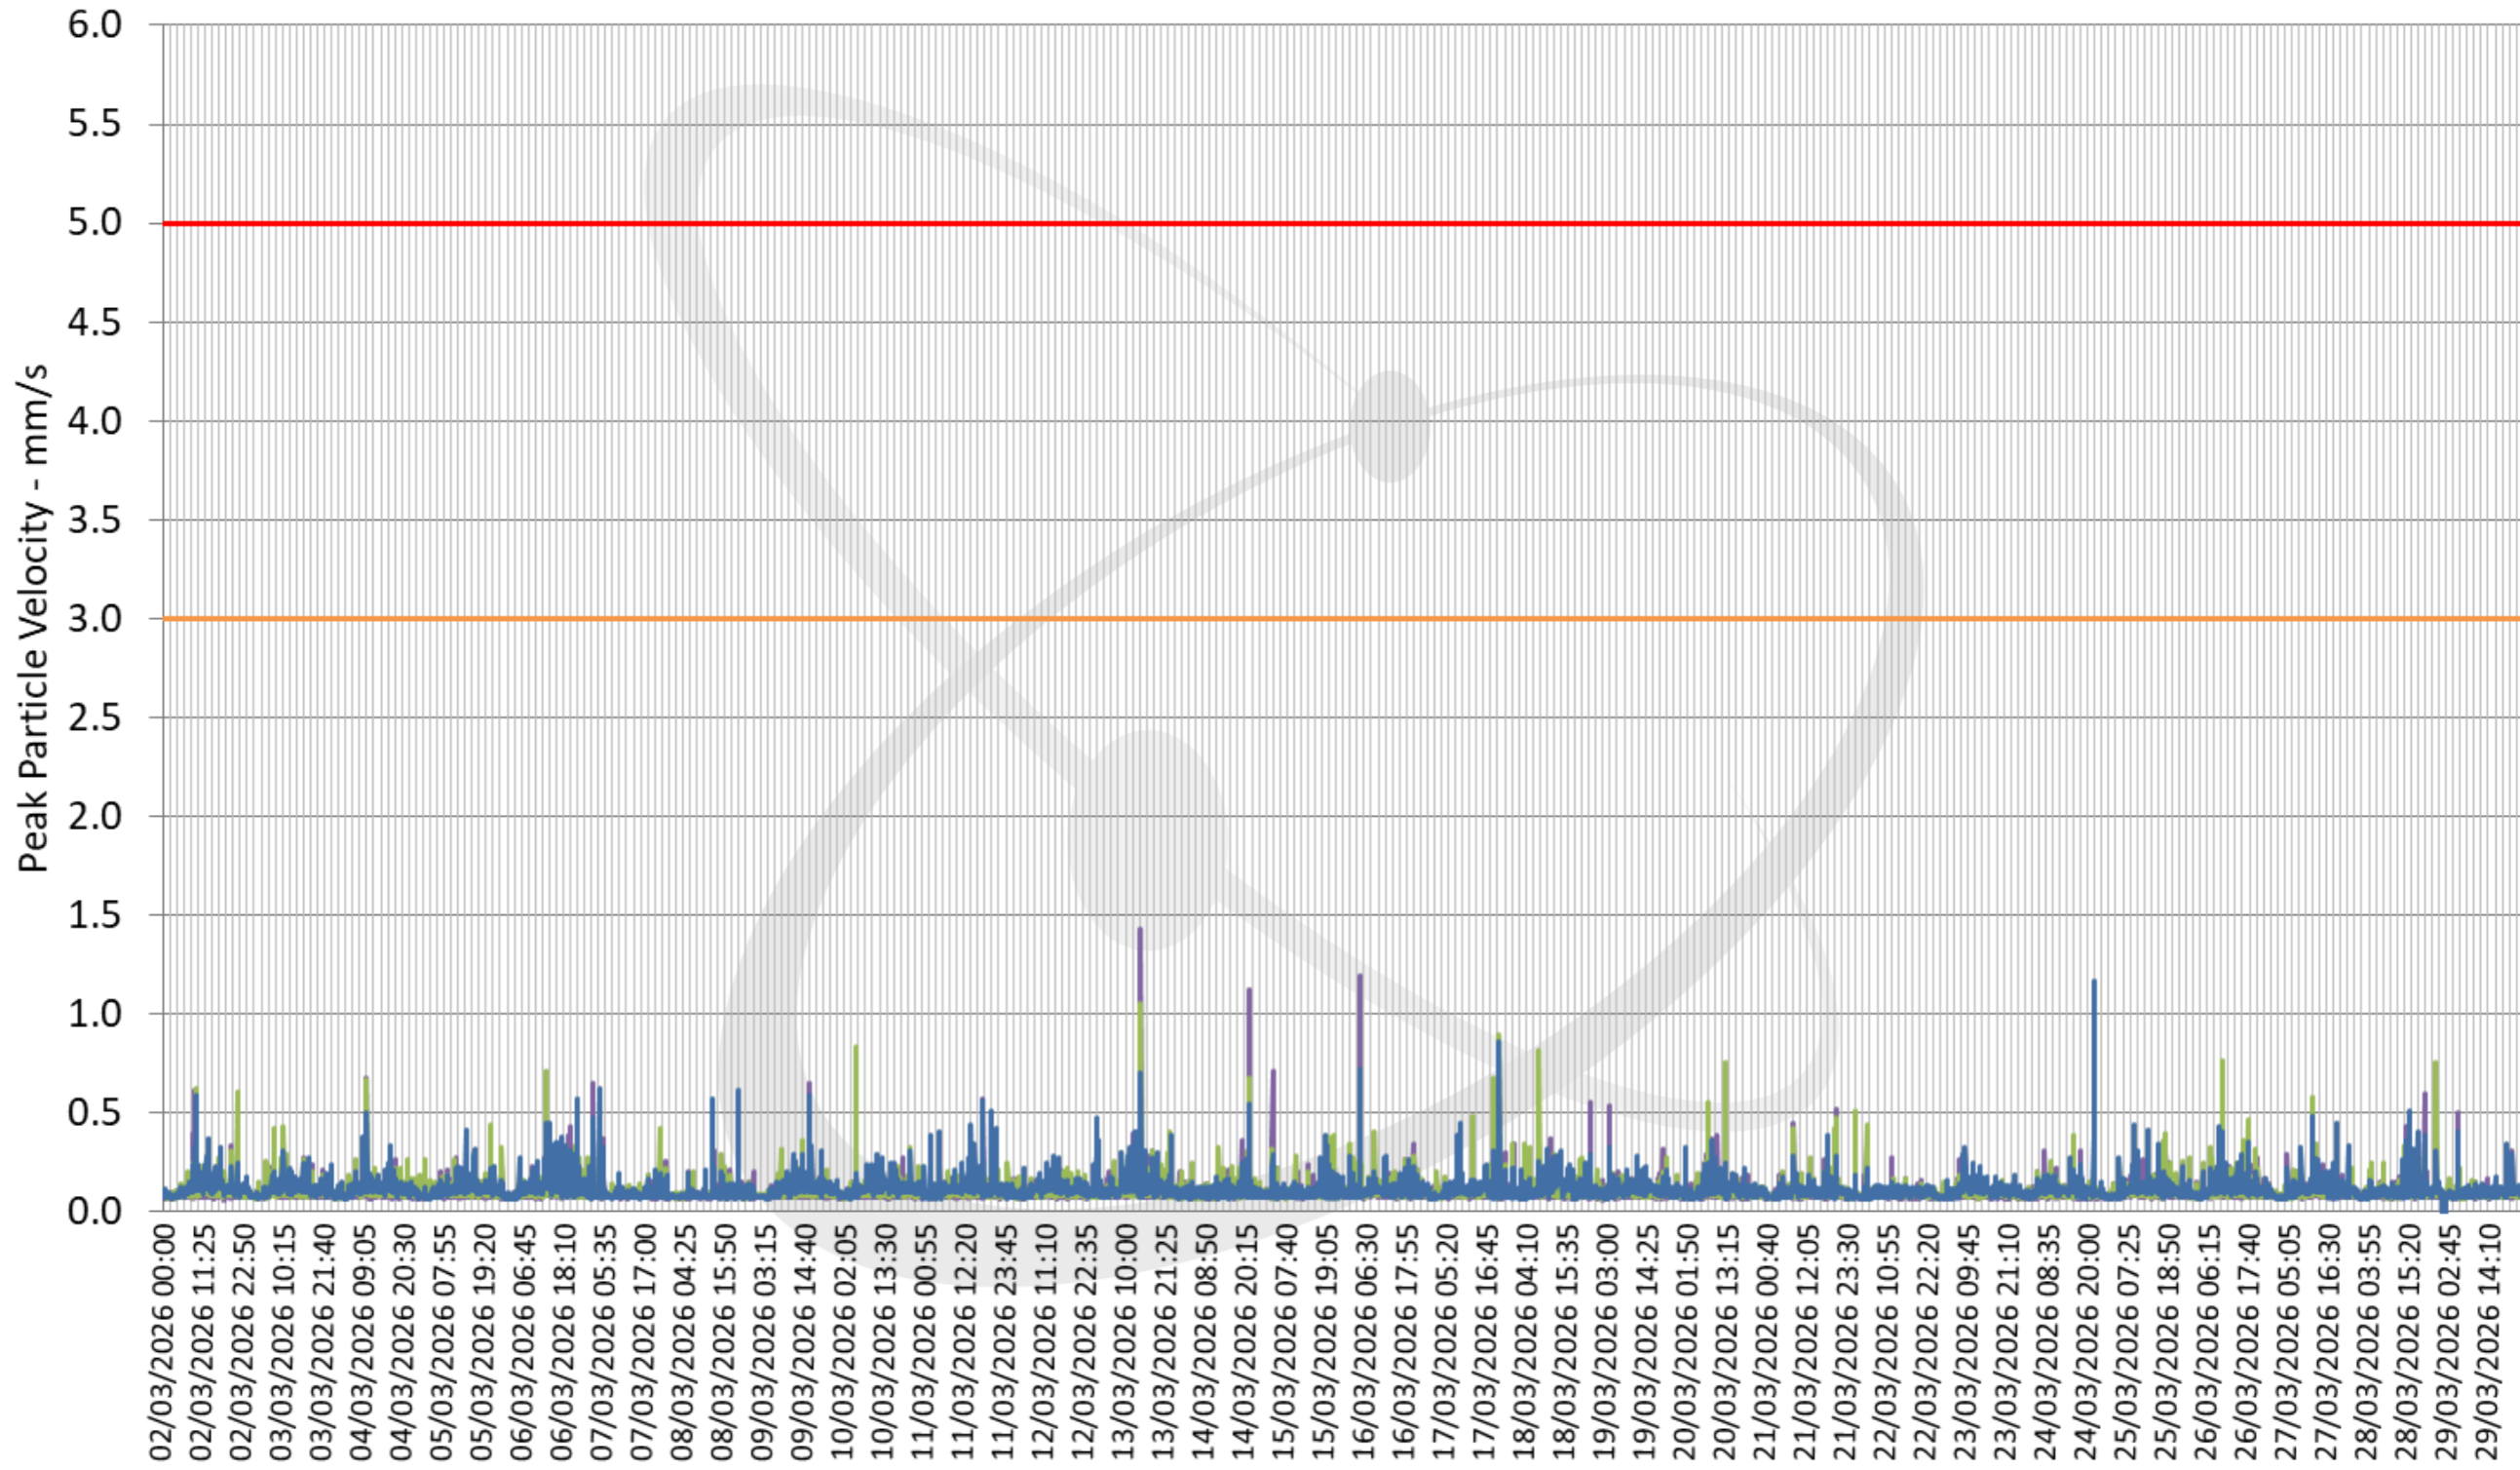
### Grenfell Tower VMP3: 02/03/26 - 29/03/26 Vibration Data

There were **no exceedances** of the Red Action level 5.0mm/s, or of the Amber Trigger level 3.0mm/s in this reporting period.

— X PPV — Y PPV — Z PPV — Action — Trigger
