## **Construction Noise and Vibration Monthly Report – January 2026**

**London Borough of Ealing**

# Non-Technical Summary

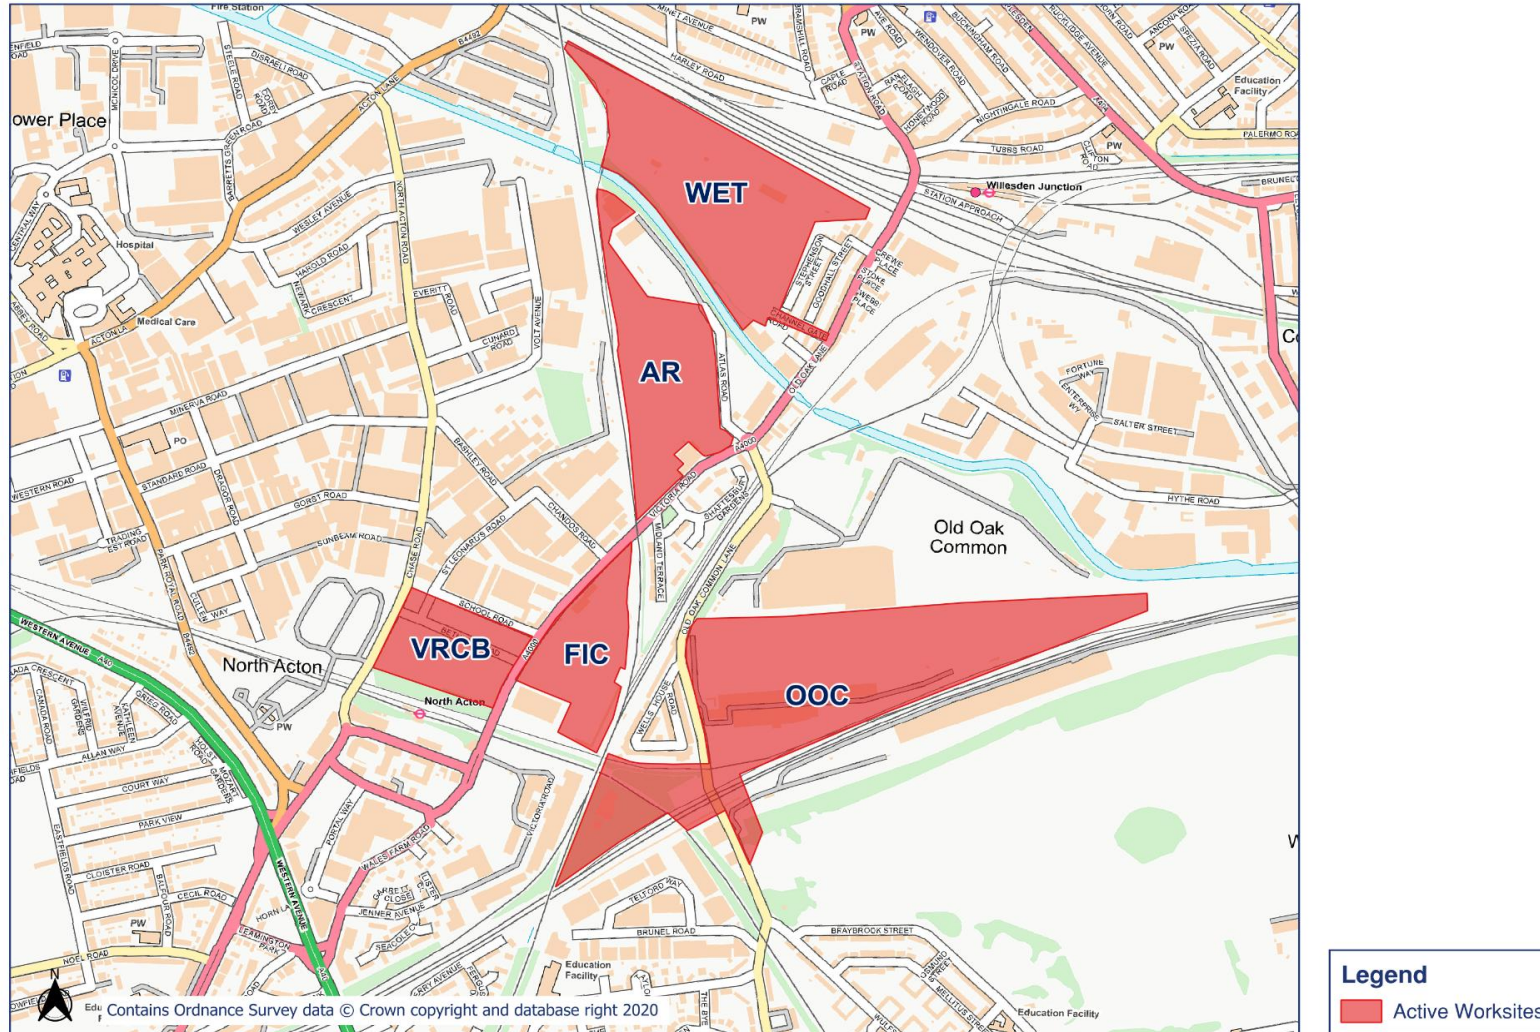
## Worksite Identification Plan - 4

- Stockpile management.
- Victoria Road Crossover Box worksite, ref. VRCB (see plan 4 in Appendix A), where work activities included:
  - Support works for tunnelling, including segment repairs and cleaning.

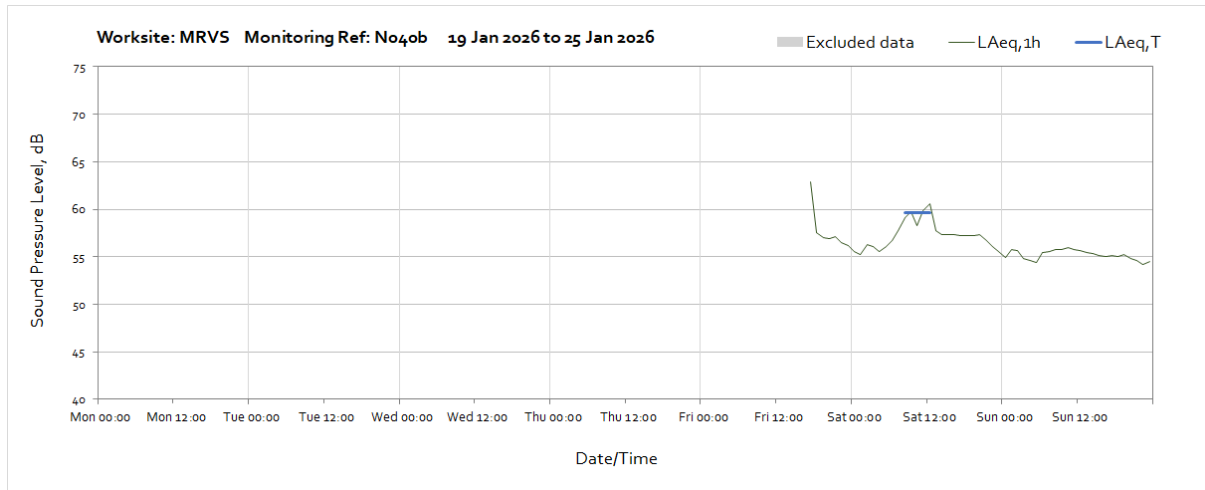
### Worksite: MRVS – Monitoring Ref: N040b

Note: Monitor was installed at 17:00 on Friday 23<sup>rd</sup> January.

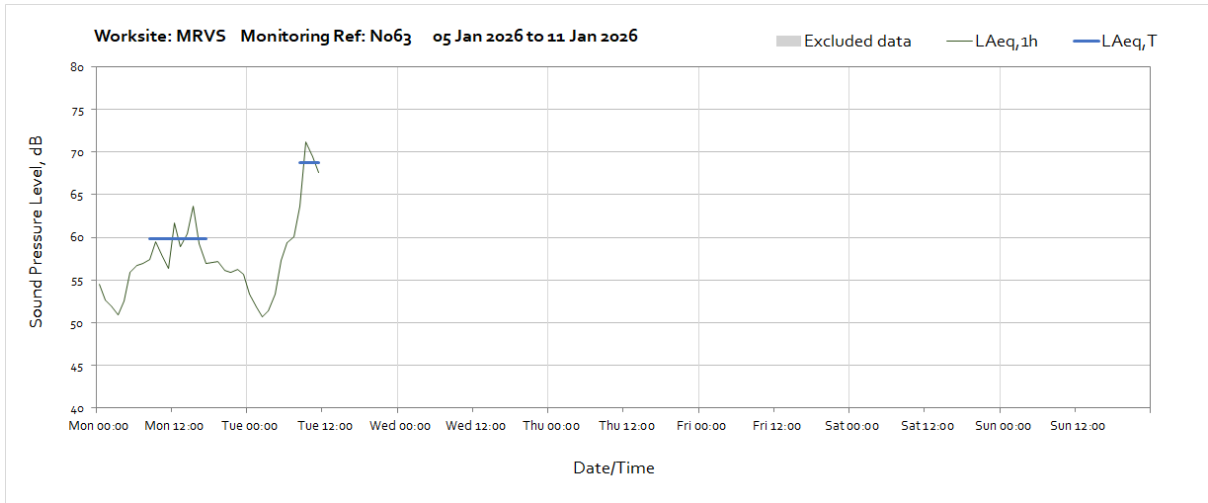
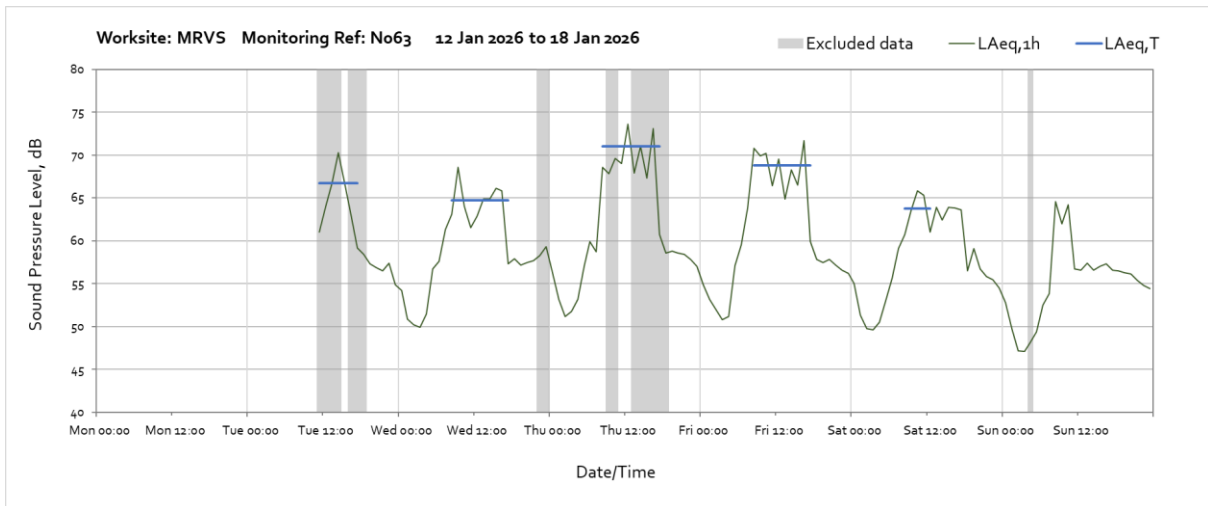
**Worksite: MRVS - Monitoring Ref: N063**

Note: Missing data between 12:00 on Tuesday 6<sup>th</sup> and 11:00 on Tuesday 13<sup>th</sup> January was due to a loss of power to the monitoring station.

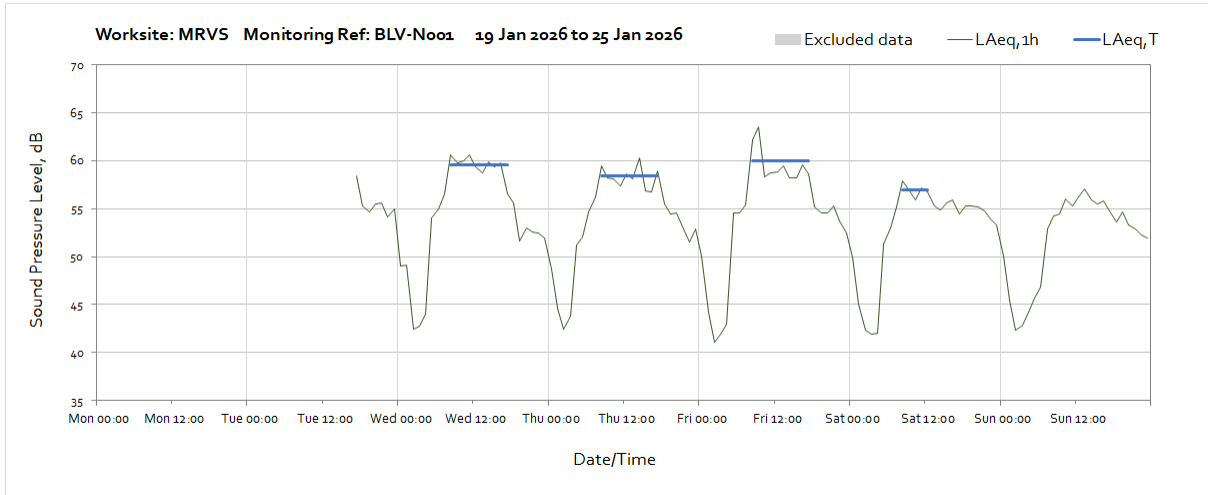
**Worksite: MRVS – Monitoring Ref: BLV-N001**

Note: Missing data from the beginning of the month until 17:00 on Tuesday 20<sup>th</sup> January was due to a depleted battery at the monitoring station.

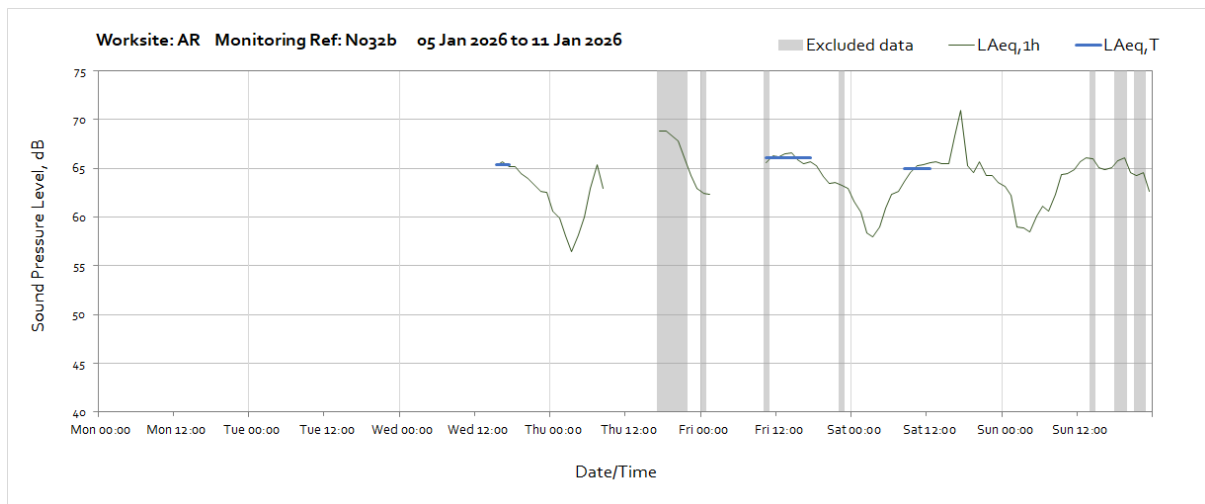
## Worksite: AR – Monitoring Ref: N032b

Note: Missing data from the beginning of the month until 15:00 on Wednesday 7<sup>th</sup> January was due to loss of lighting column power at the monitoring station. Missing data between 09:00 and 17:00 on Thursday 8<sup>th</sup> and between 02:00 and 10:00 on Thursday was due to a fault at the monitoring station.

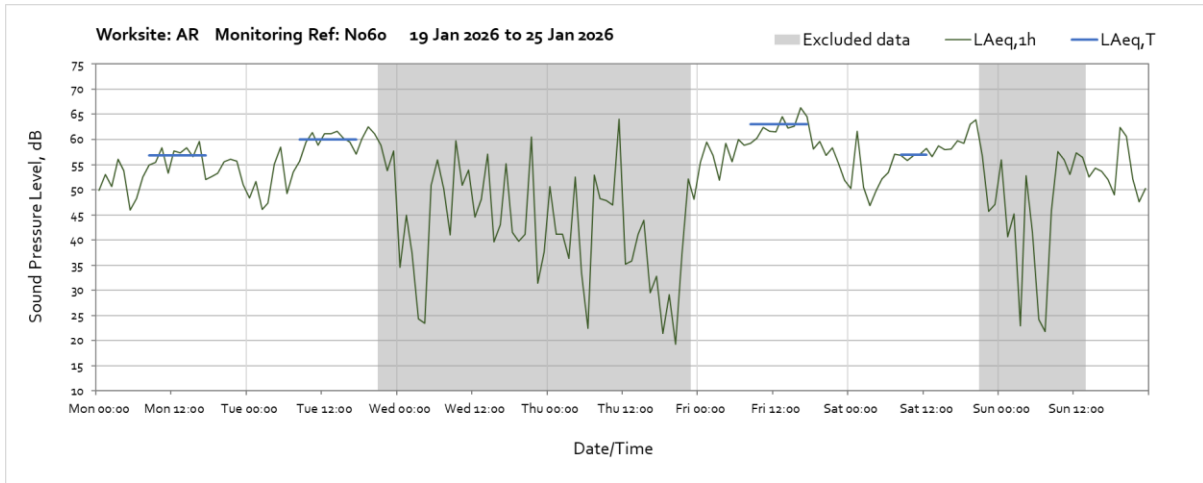
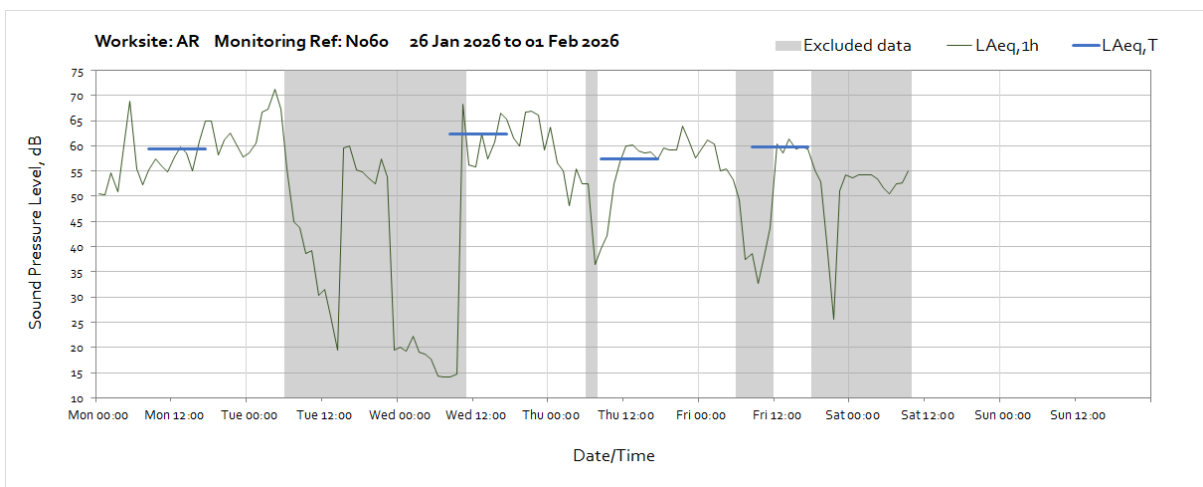
## Worksite: AR – Monitoring Ref: N060

Note: Missing data from 10:00 on Saturday 31<sup>st</sup> January until the end of the month was due to loss of continuous site power.

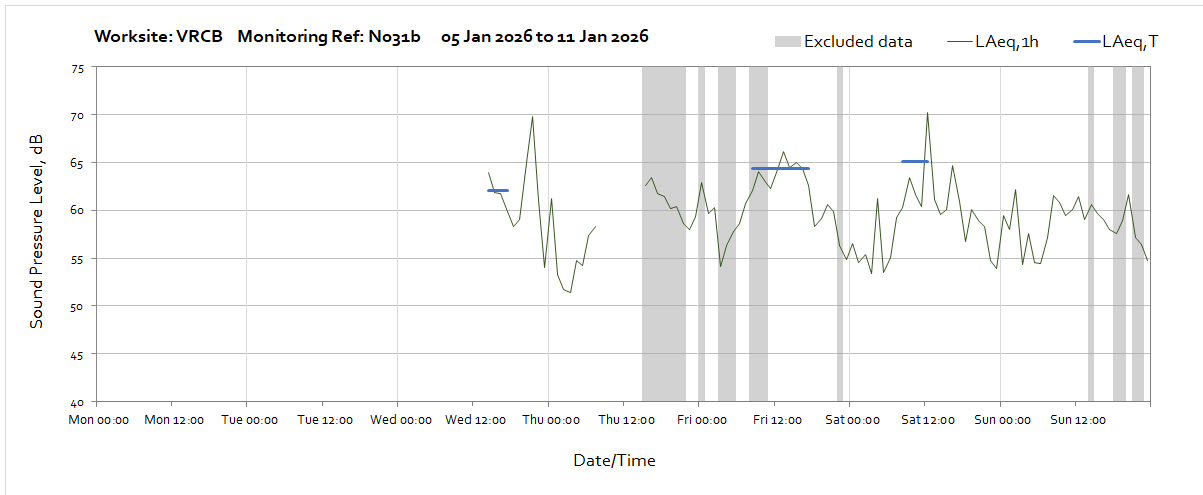
## Worksite: VRCB – Monitoring Ref: N031b

Note: Missing data from the beginning of the month until 14:00 on Wednesday 7<sup>th</sup> January was due to a power supply issue. Missing data between 08:00 and 15:00 on Thursday 8<sup>th</sup> January was due to a fault at the monitoring station.

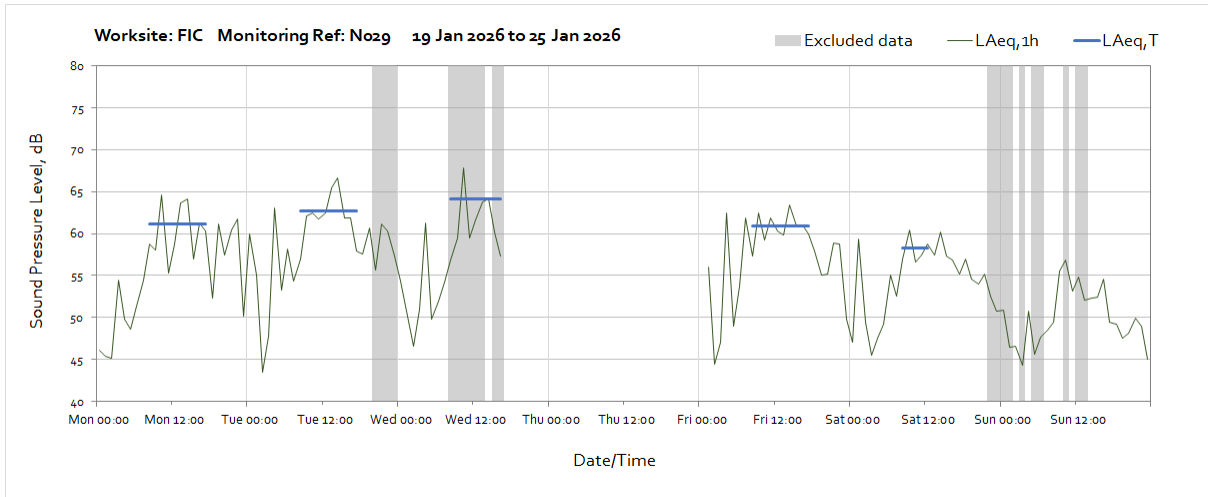
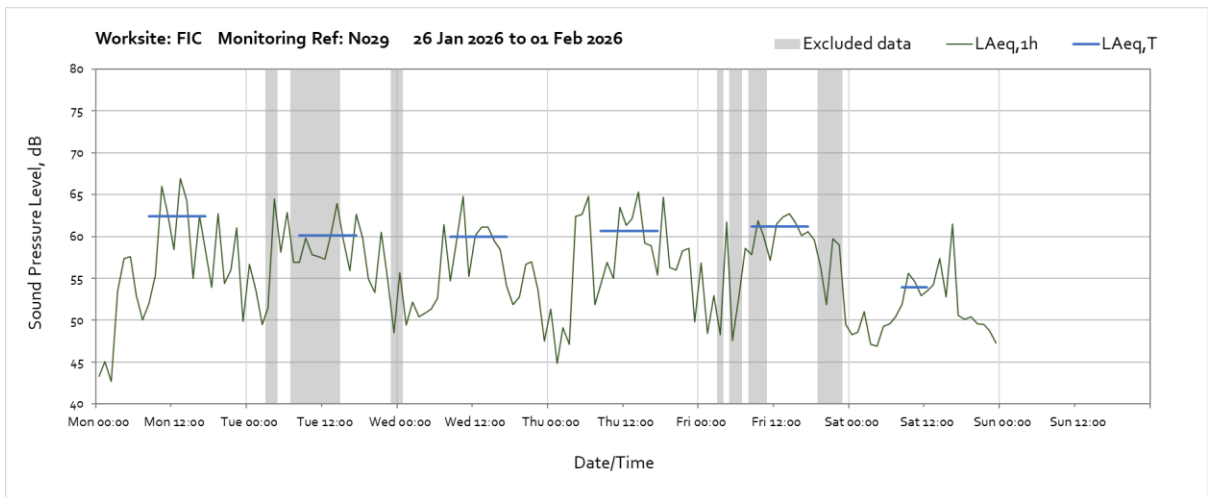
## Worksite: FIC – Monitoring Ref: N029

Note: Missing data between 17:00 on Wednesday 21<sup>st</sup> and 01:00 on Friday 23<sup>rd</sup> January was due to loss of lighting column power at the monitoring station.

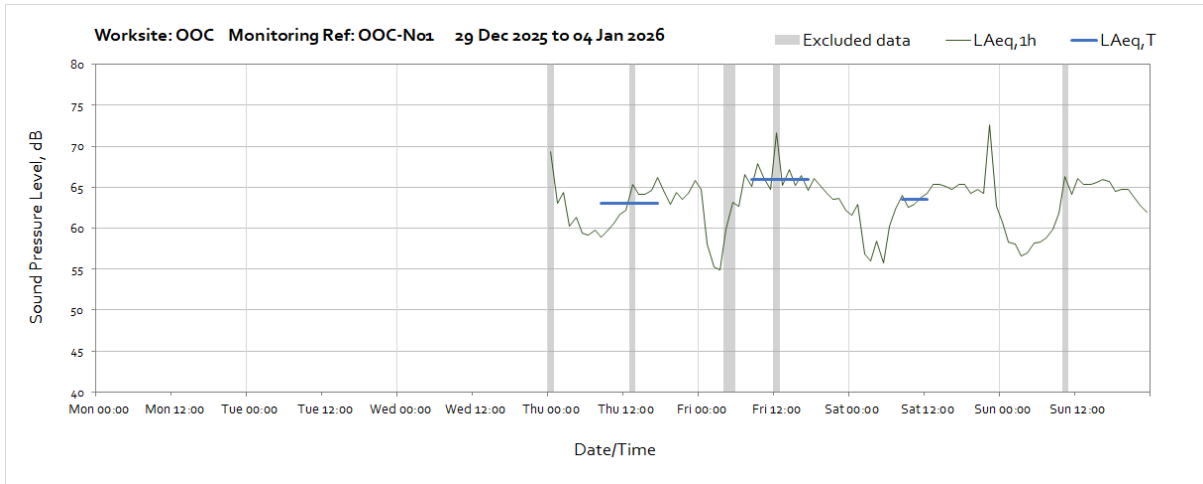
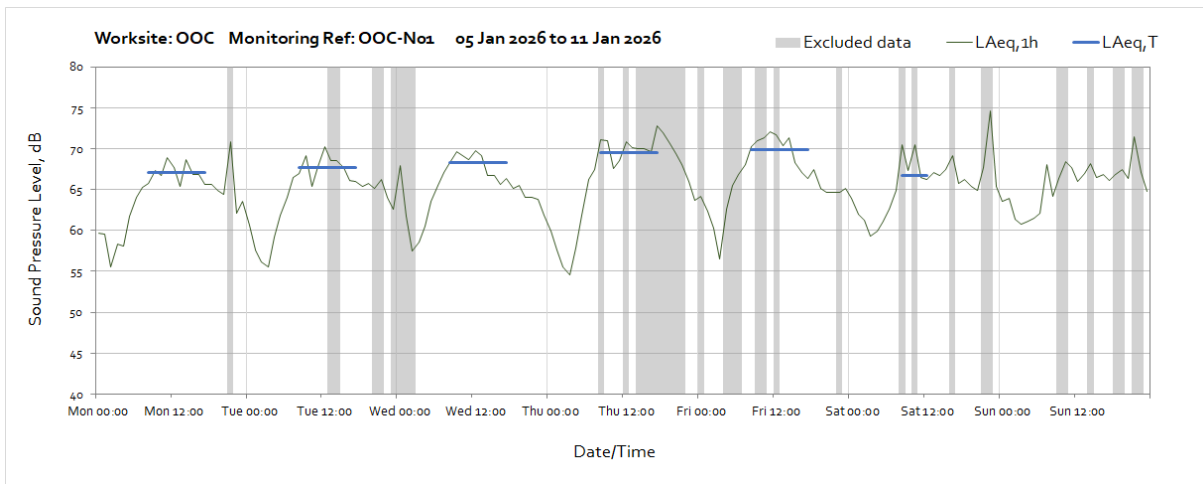
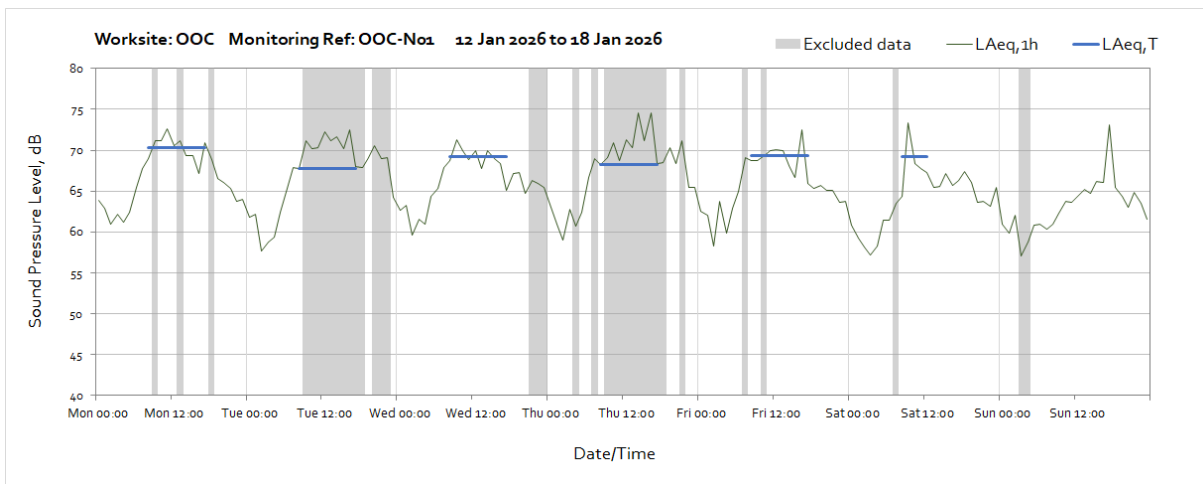
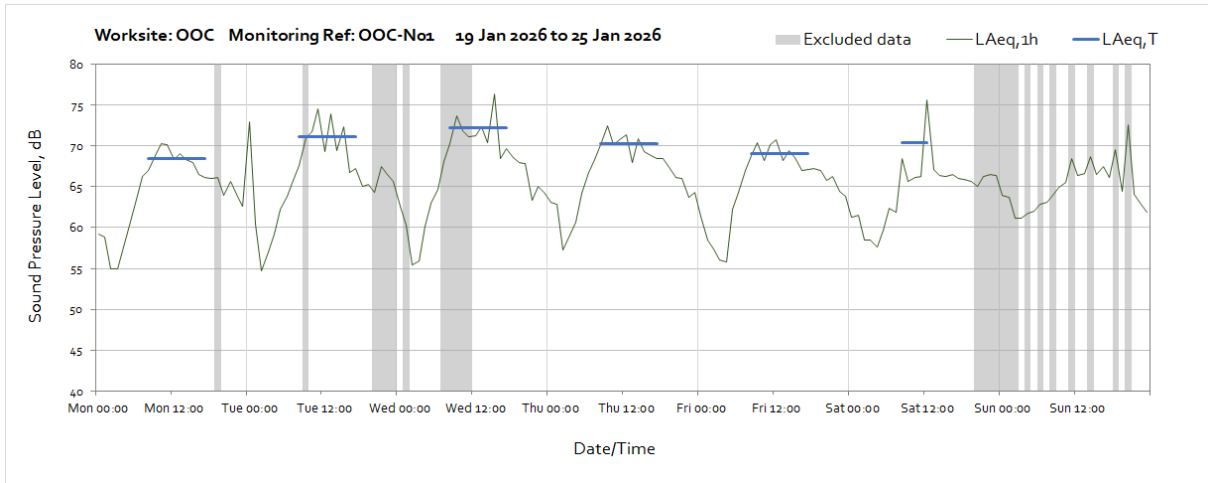
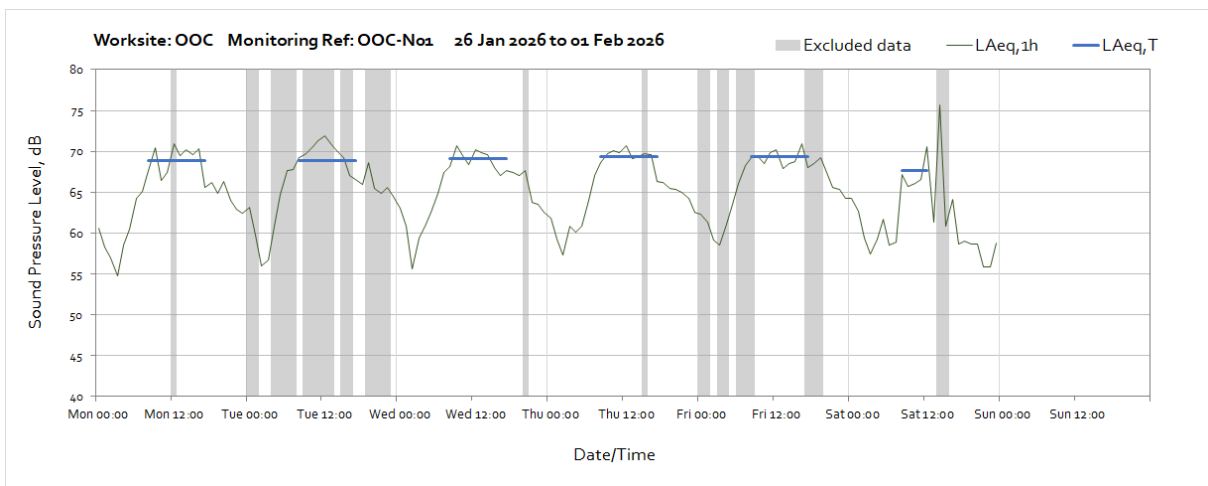
## Worksite: OOC – Monitoring Ref: OOC-N01

2.1.3 Appendix C presents graphs of the noise and vibration monitoring data over the month for each of the measurement locations. Noise data presented consists of the hourly  $L_{Aeq}$  values and, where relevant, the  $L_{Aeq,T}$  values (where the time period T has been taken to be the averaging period as specified in Table 1 of HS2 Information Paper E23). Vibration data presented consist of hourly PPV values. The full data set for the monitoring equipment can be found at the following location:  
<https://data.gov.uk/dataset/24542ae7-dd44-444f-b259-871c4cc43b5e/environmental-monitoring-data>.

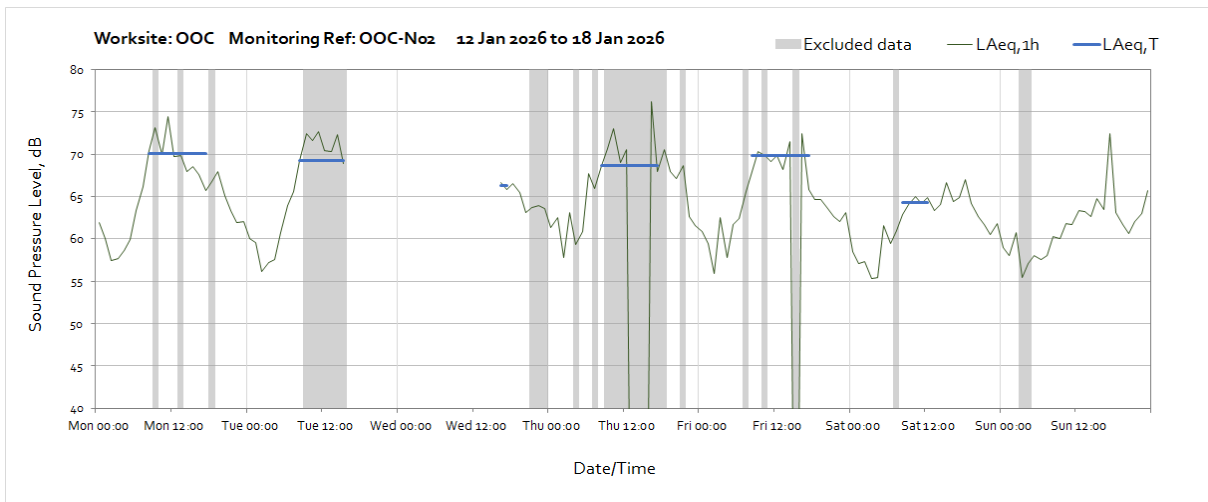
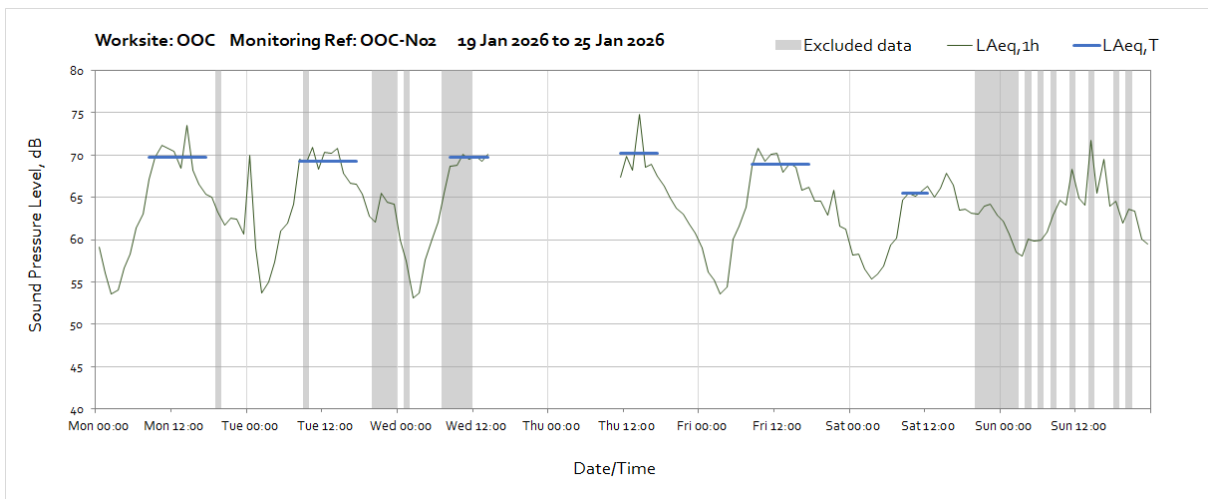
### Worksite: OOC – Monitoring Ref: OOC-N02

Note missing data between 16:00 on Tuesday 13<sup>th</sup> and 16:00 on Wednesday 14<sup>th</sup> January was due to monitor replacement.

Note missing data between 15:00 on Wednesday 21<sup>st</sup> and 11:00 on Thursday 22<sup>nd</sup> January was due to monitor replacement

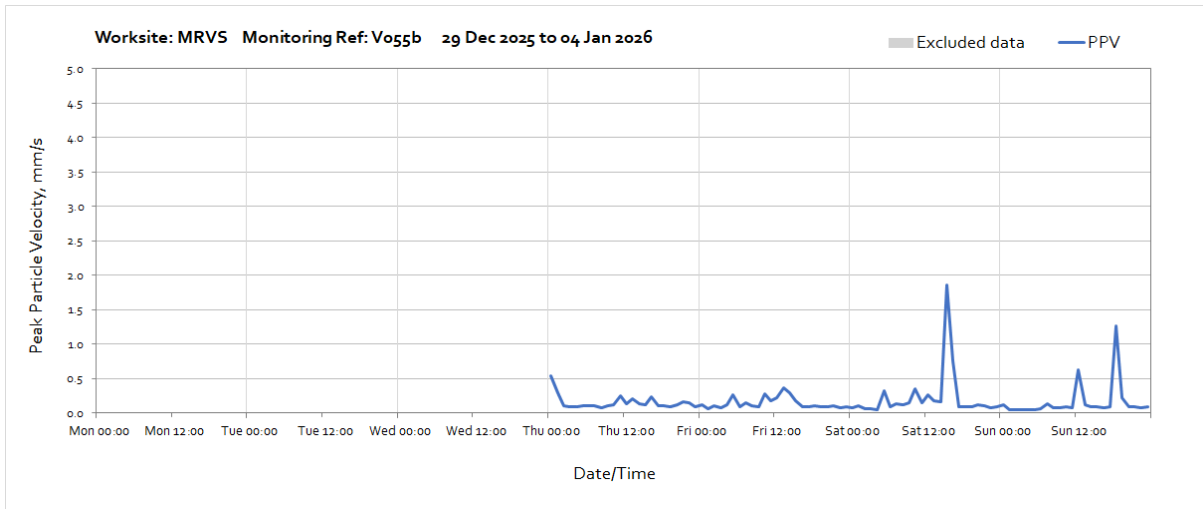
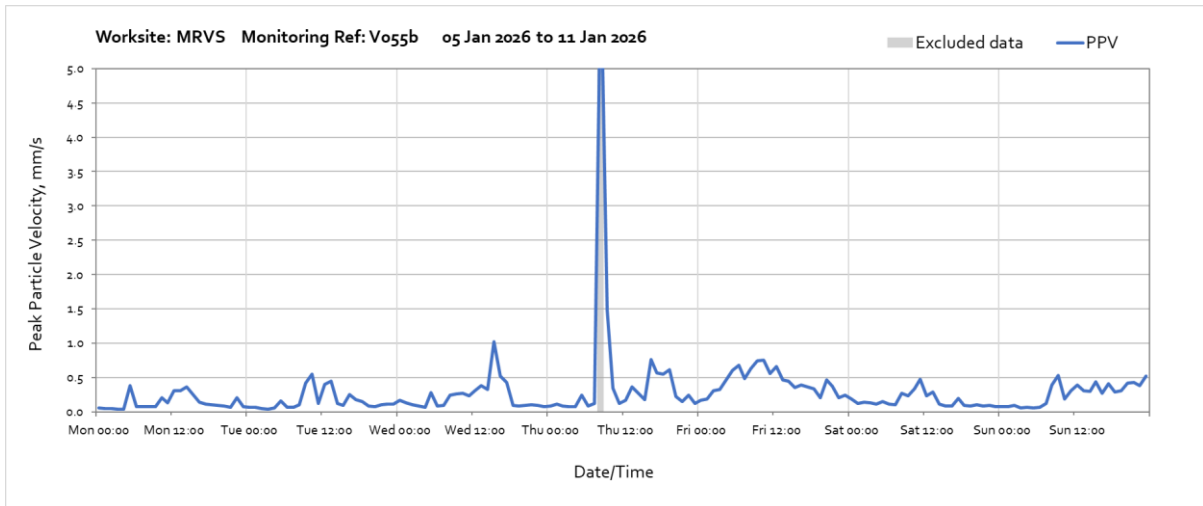
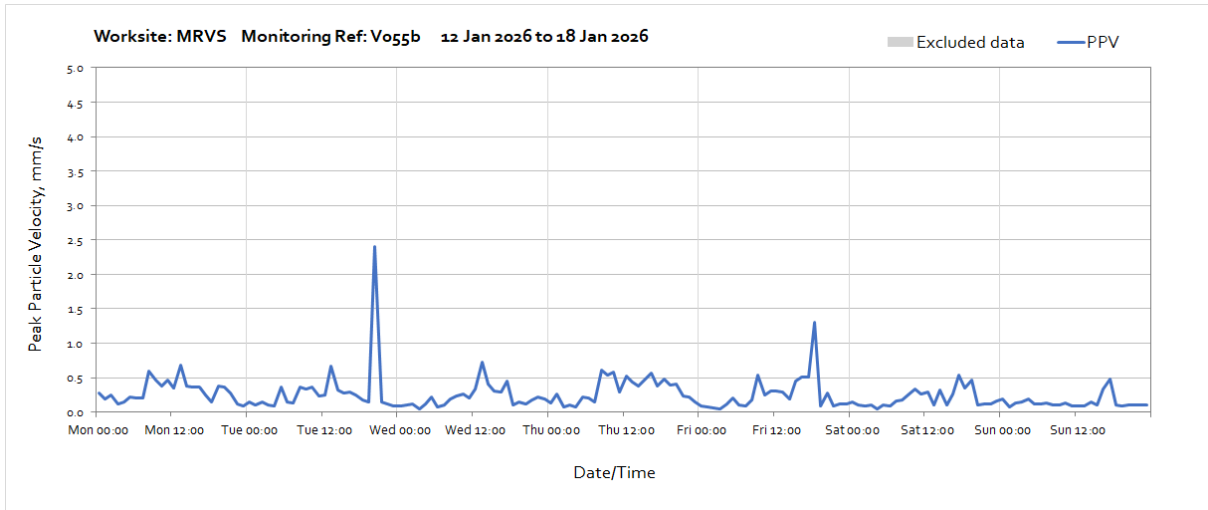
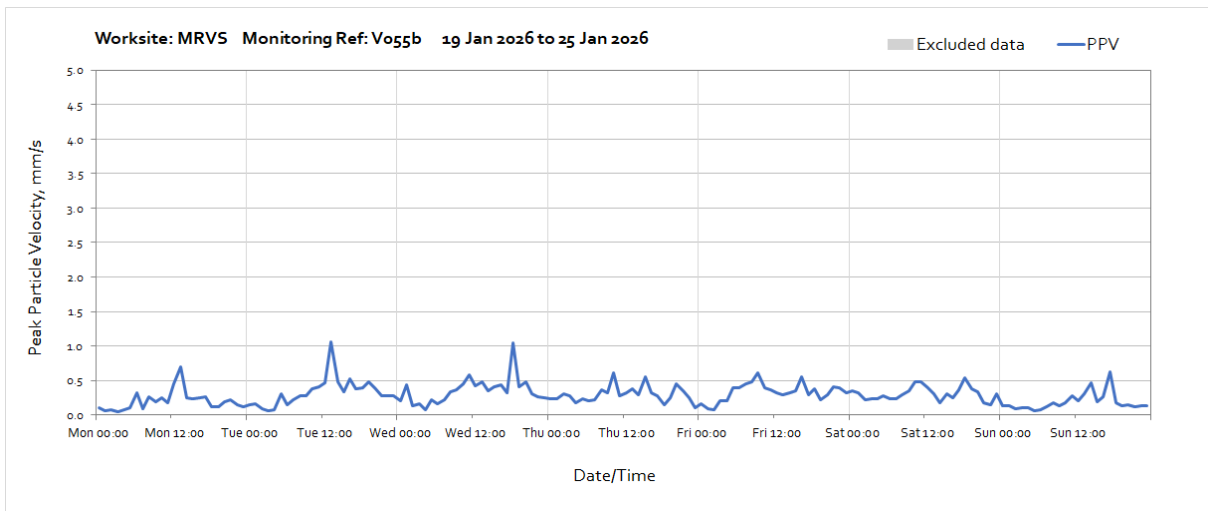
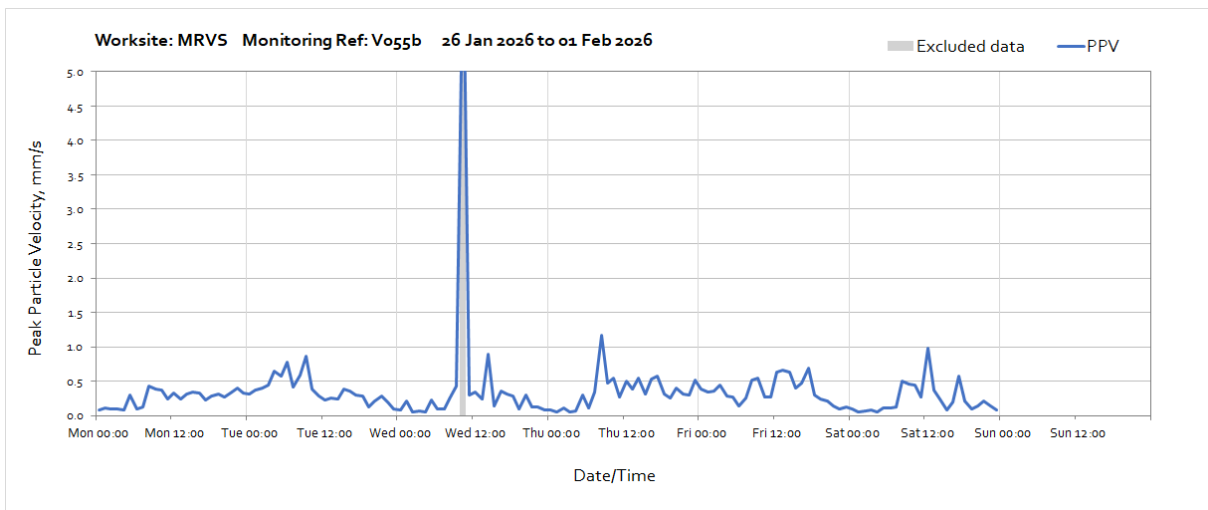
### Worksite: MRVS – Monitoring Ref: V055b

The following graphs show the hourly measured peak particle velocity PPV recorded during the monitoring period. The graphs show the highest PPV of the three orthogonal axis x, y and z. Periods where PPV values have been affected by local interference with the vibration monitor or only measured for part of the period, which are not representative of HS2 construction works, have been greyed out and excluded when calculating values in Table 4 of the main report.

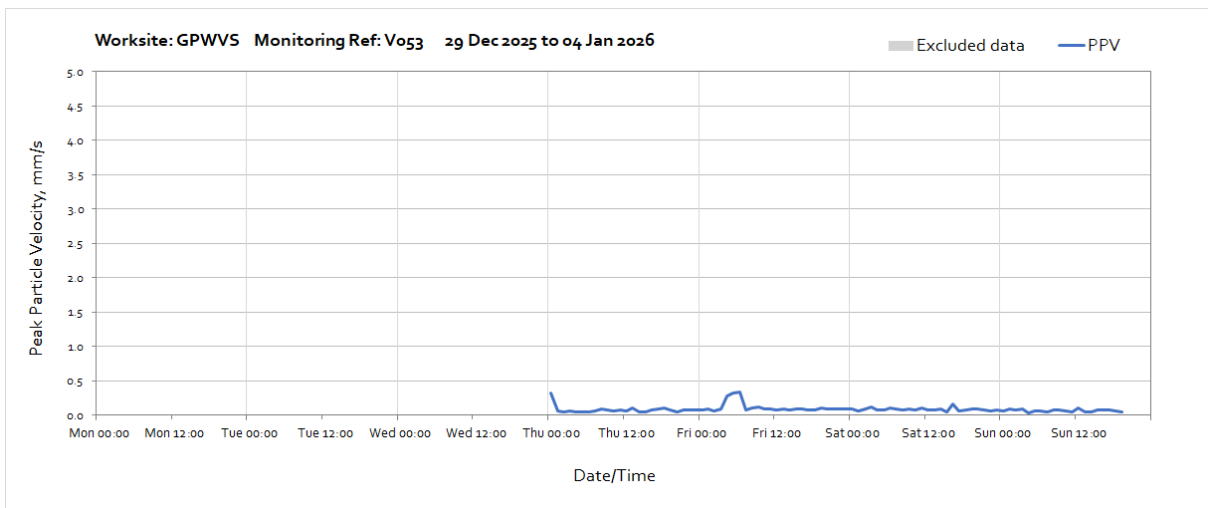
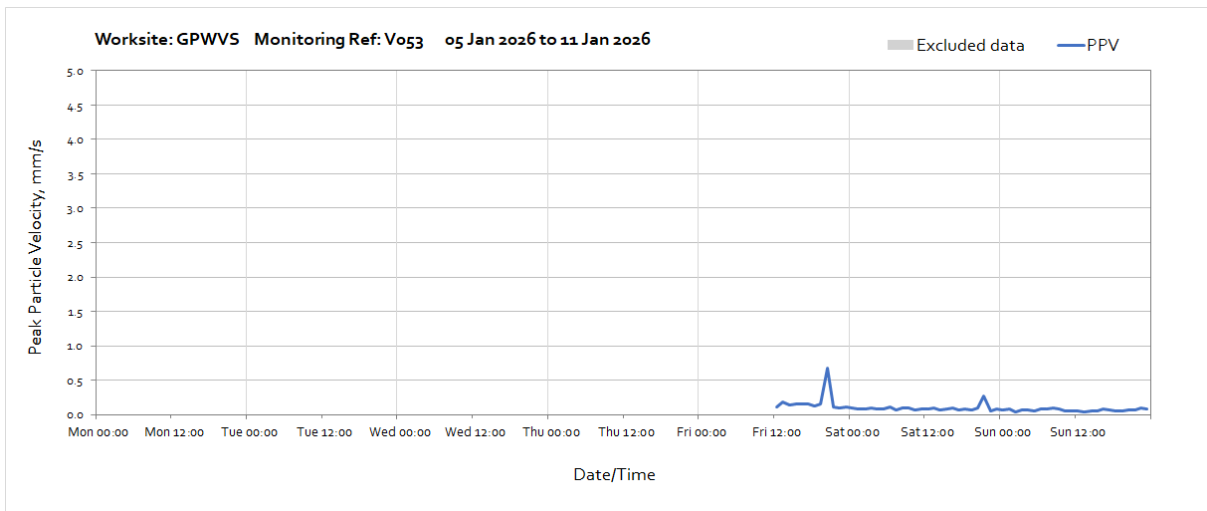
**Worksite: GPWVS – Monitoring Ref: V053**

Note: Missing data between 20:00 on Sunday 4<sup>th</sup> and 12:00 on Friday 9<sup>th</sup> January was due to a depleted battery at the monitoring station.

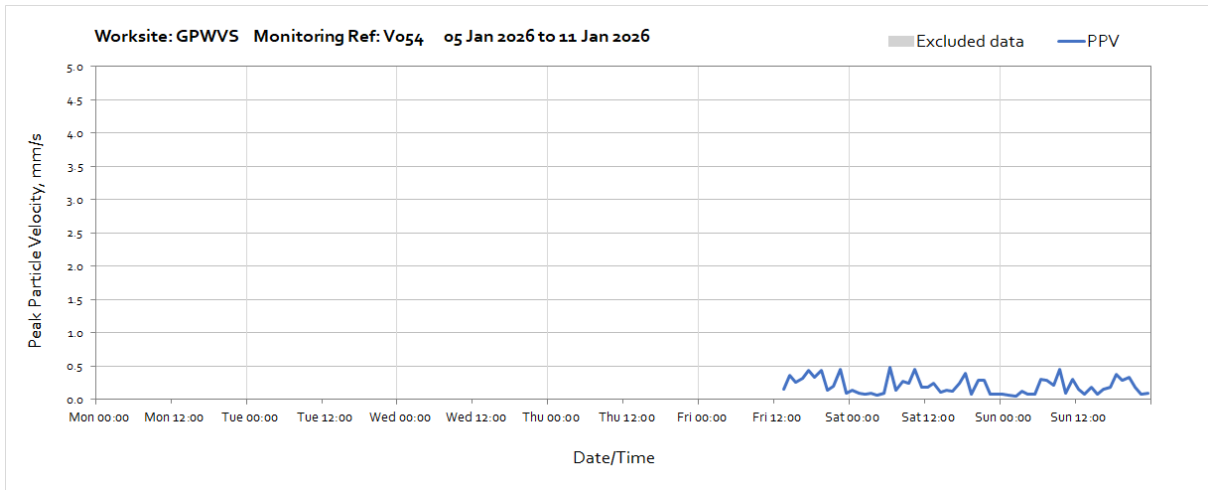
### Worksite: GPWVS – Monitoring Ref: V054

Note: Missing data from the beginning of the month until 13:00 on Friday 9<sup>th</sup> January was due to a depleted battery at the monitoring station.

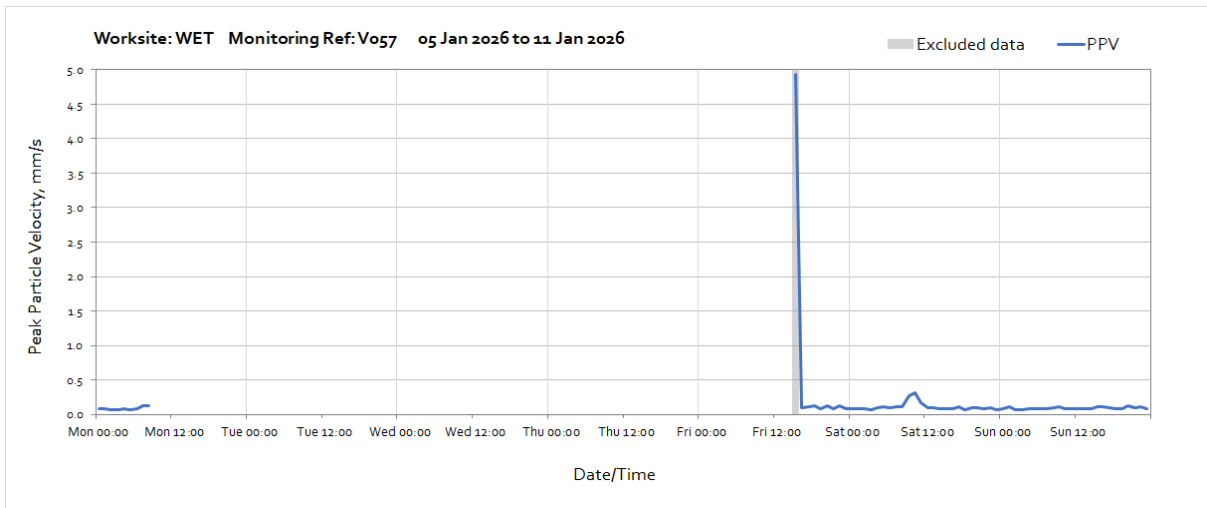
### Worksite: WET – Monitoring Ref: V057

Note: Missing data between 09:00 on Monday 5<sup>th</sup> and 15:00 on Friday 9<sup>th</sup> January was due to a depleted battery at the monitoring station.
