HS2

March 2026

Construction Noise and Vibration Monthly Report – January 2026

Lichfield District Council

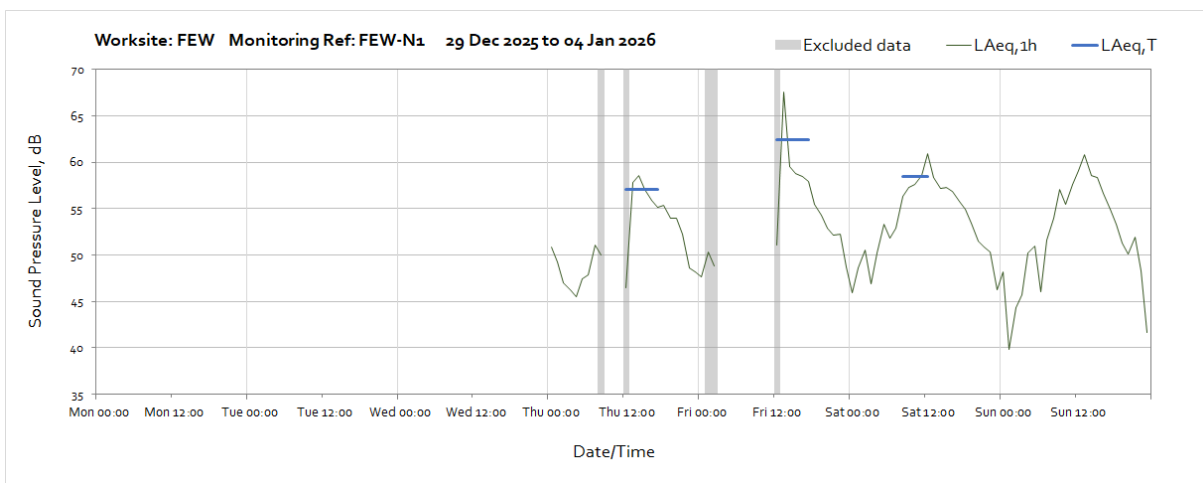
Worksite: FEW – Monitoring Ref: FEW-N1

Note: Missing data throughout the month was due to a loss of power to the monitoring station caused by poor weather conditions preventing sufficient light reaching the solar panel.

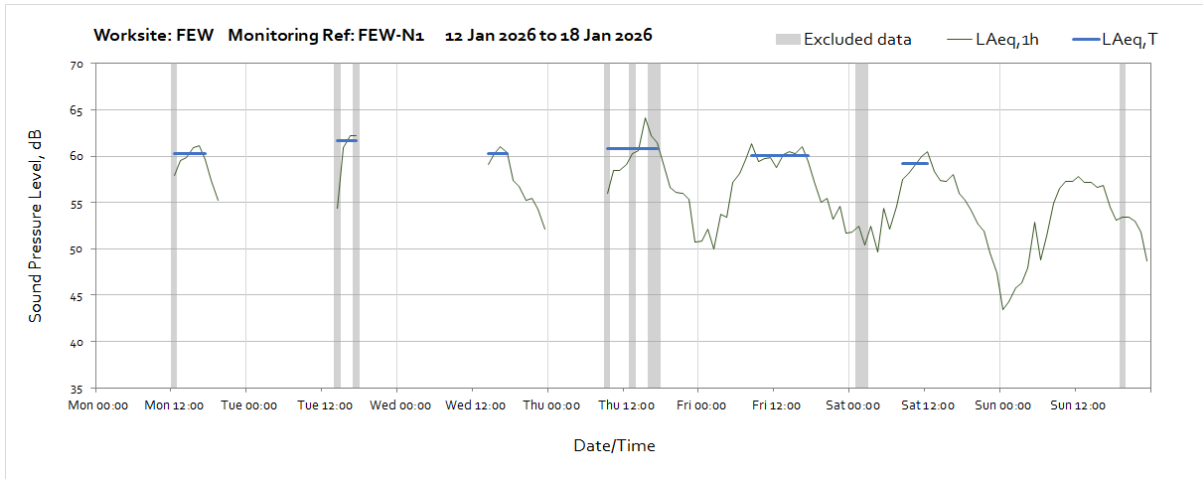
Note: Missing data throughout the month was due to a loss of power to the monitoring station caused by poor weather conditions preventing sufficient light reaching the solar panel.

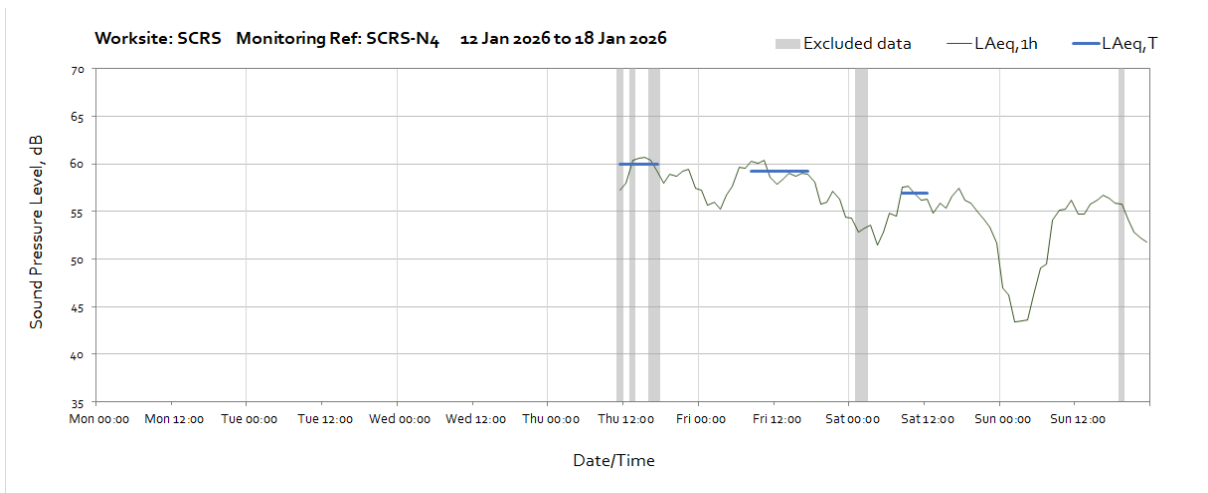
Worksite: SCRS – Monitoring Ref: SCRS-N4

Note: Missing data between the start of the month and 10:00 on Thursday 15th January was due to a loss of power to the monitoring station caused by poor weather conditions preventing sufficient light reaching the solar panel.
