Construction Noise and Vibration Monthly Report – January 2026

North Warwickshire Borough Council

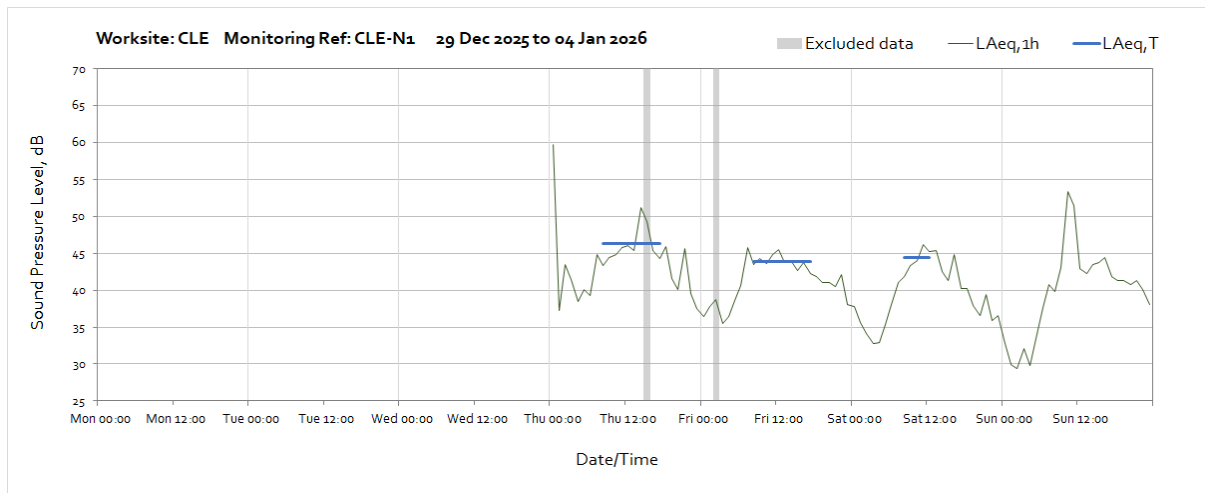
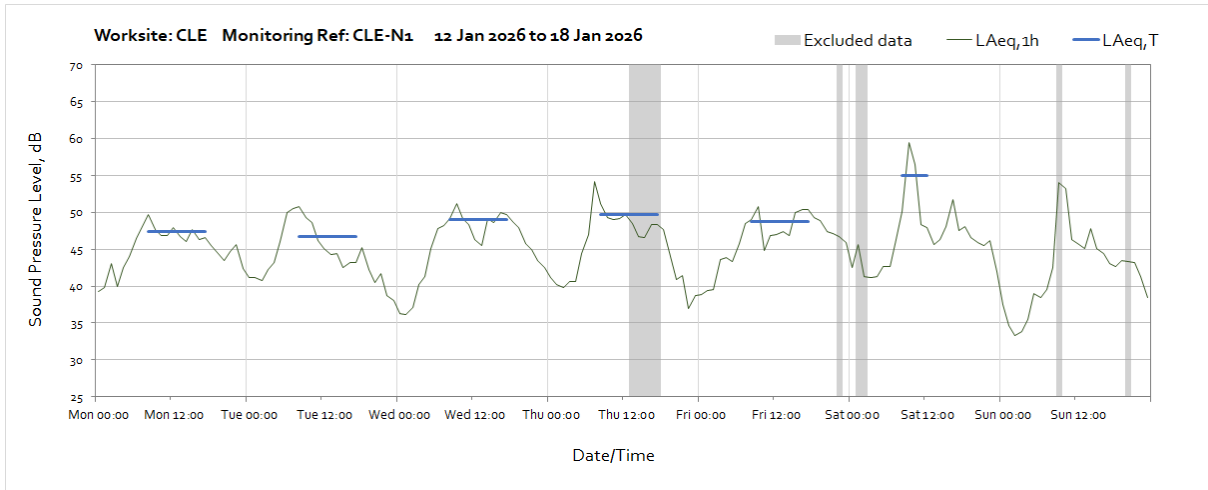
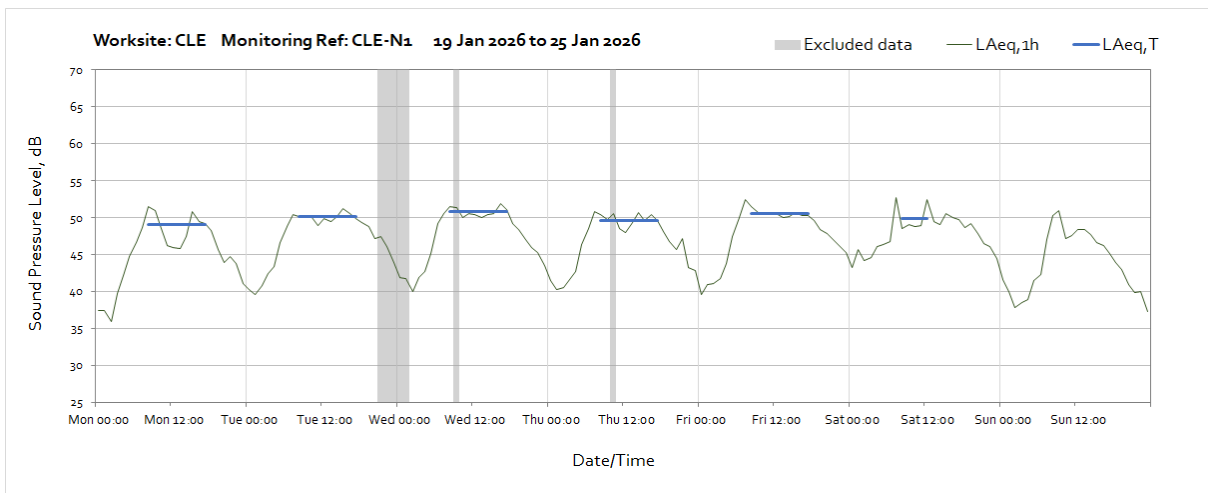
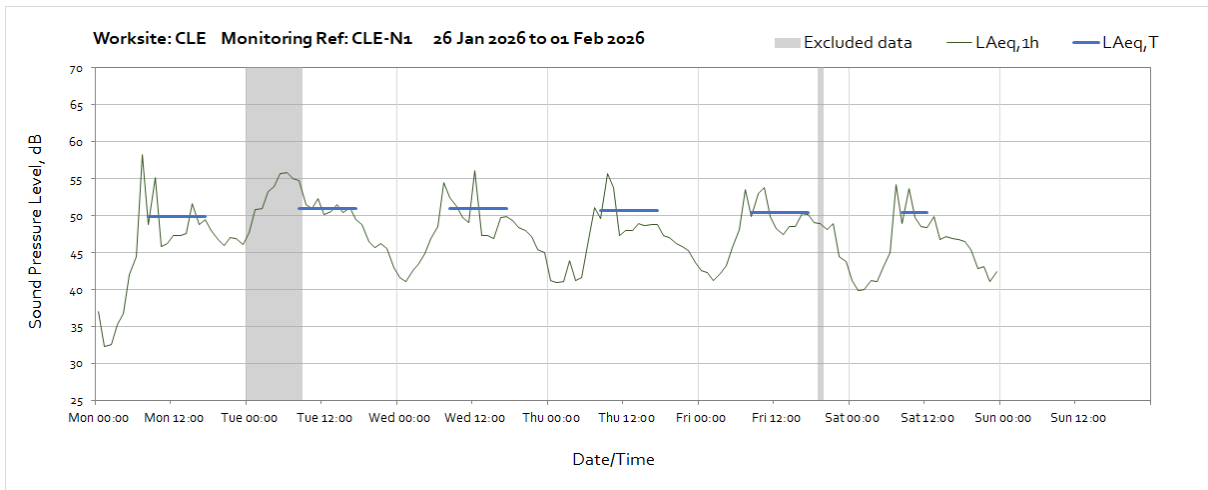
Worksite: CLE – Monitoring Ref: CLE-N1

The following graphs show the hourly measured ambient noise level $L_{Aeq,1h}$ and, where relevant, the averaged noise level $L_{Aeq,T}$ values, where the time period T is as specified in Table 1 of HS2 Information Paper E23. Periods with adversely weather affected noise levels are greyed out and have been excluded from the calculation of the $L_{Aeq,T}$ values in Table 3 of the main report.:

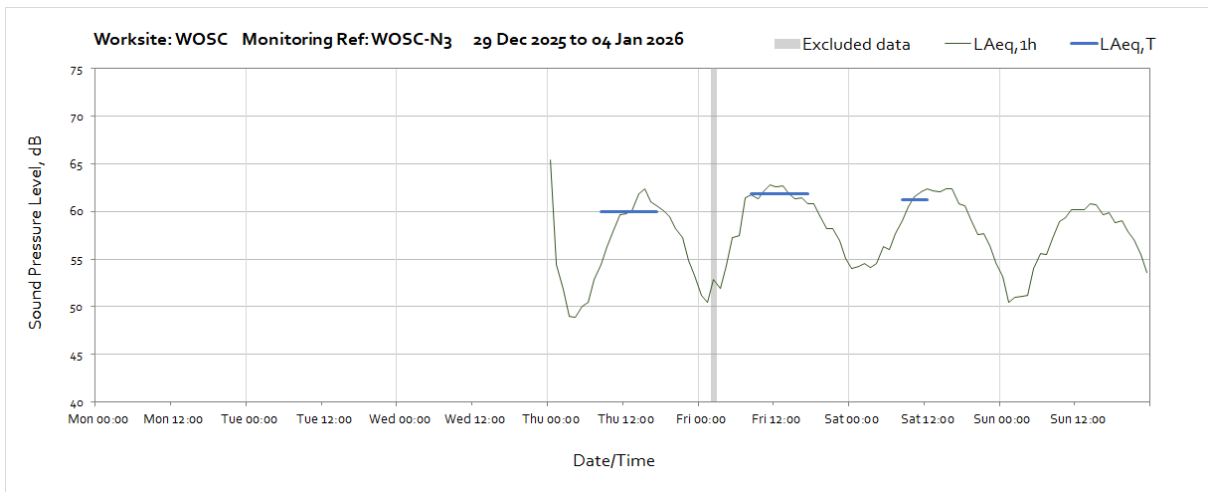
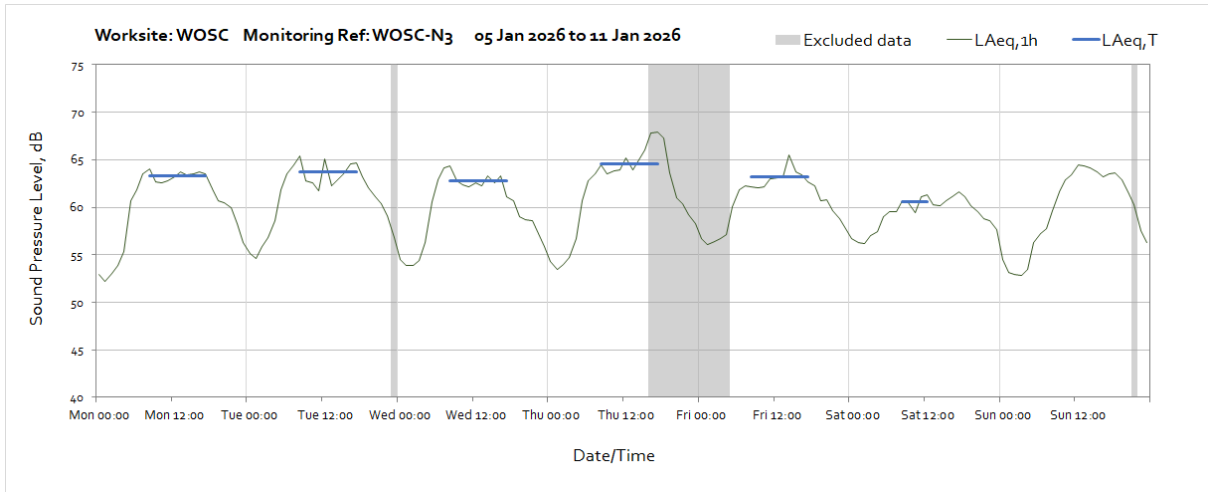
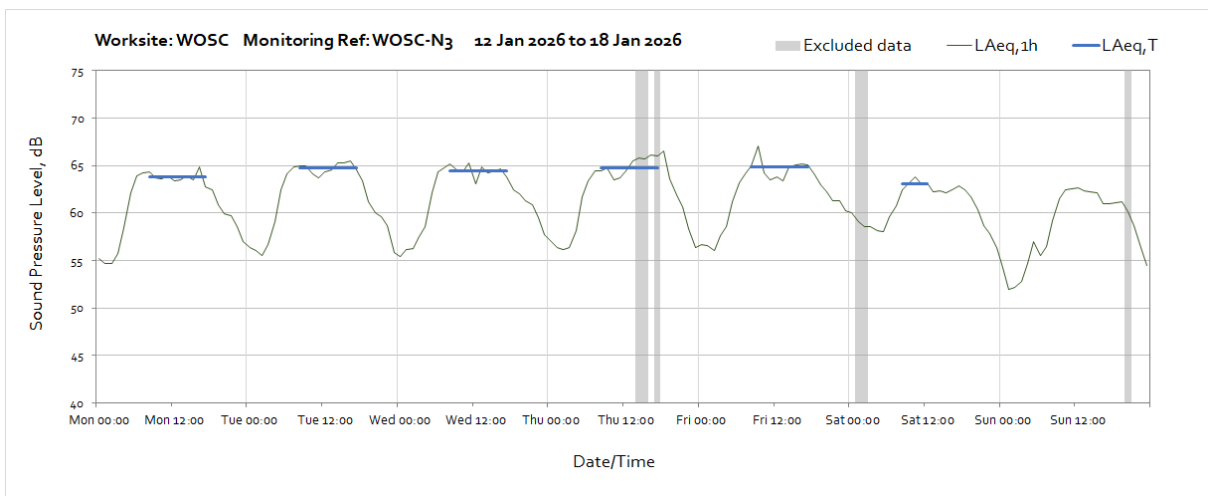
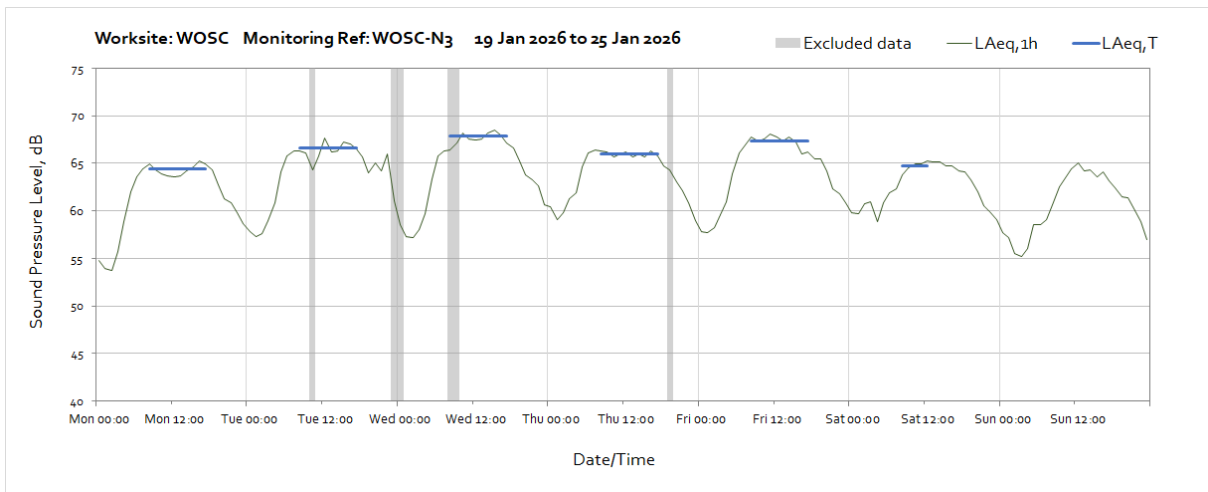
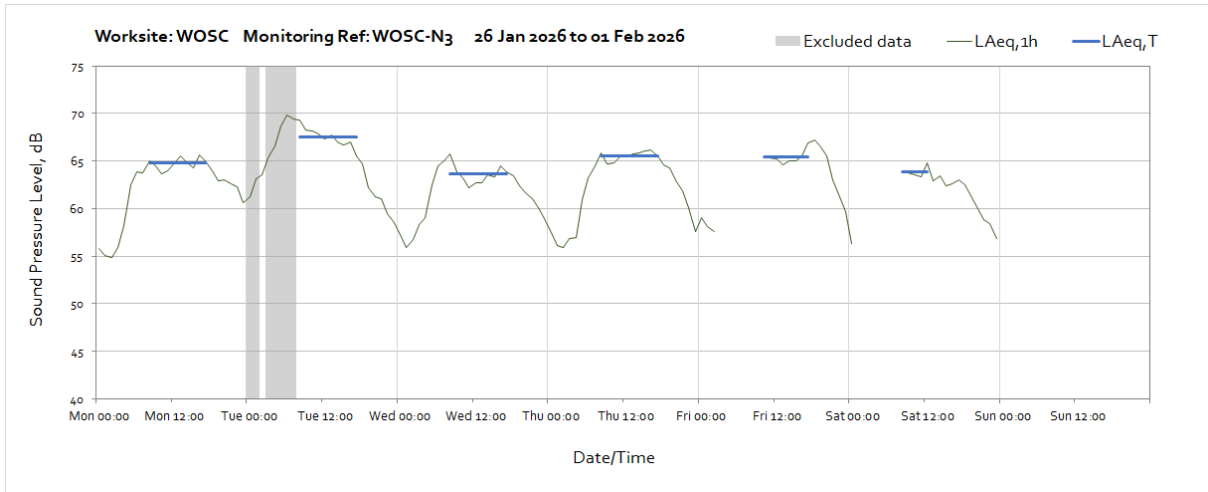
Worksite: WOSC – Monitoring Ref: WOSC-N3

Note: Missing data throughout the week was due to a loss of power at the monitoring station.

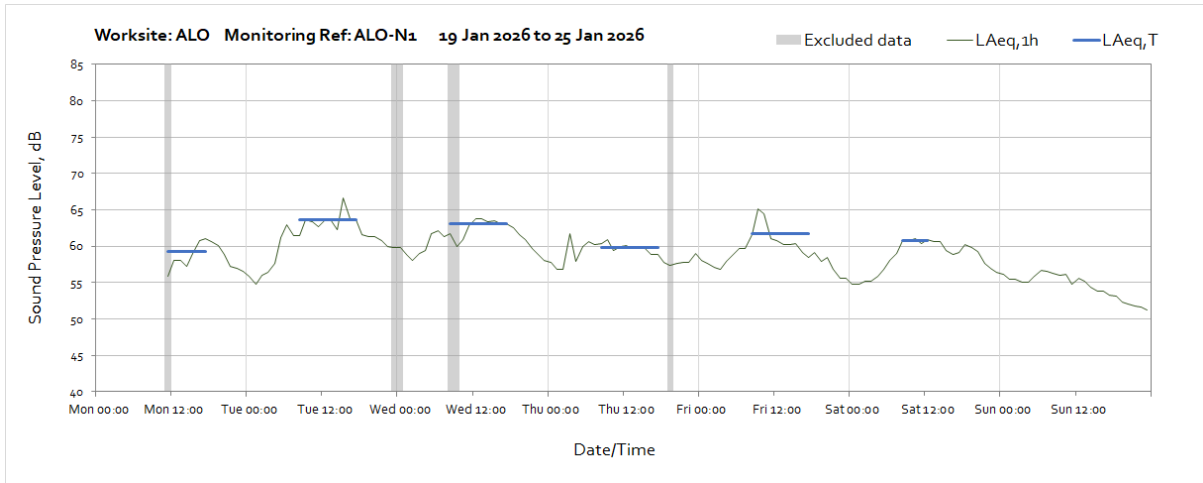
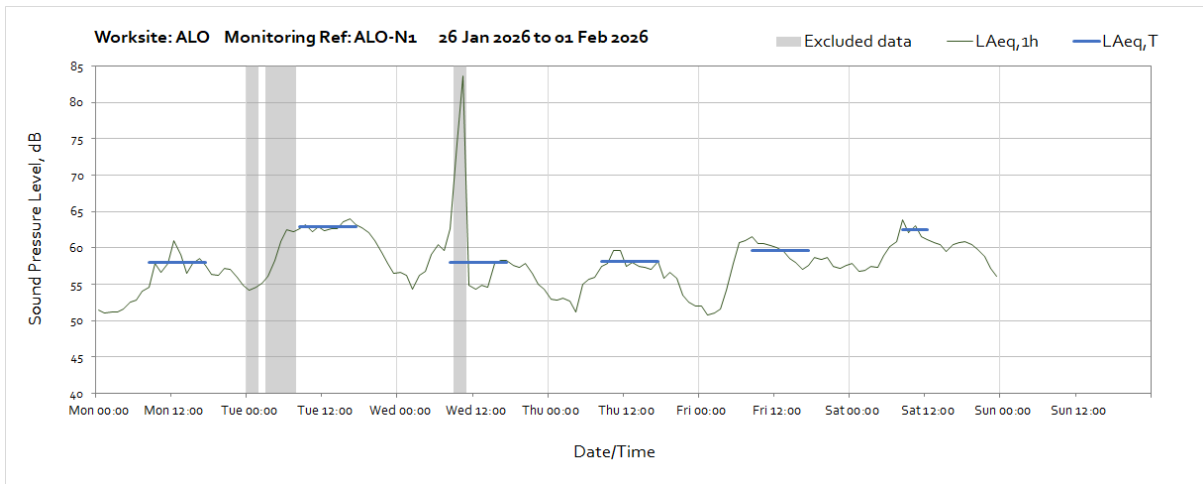
Worksite: ALO – Monitoring Ref: ALO-N1

Note: Missing data between the start of the month and 11:00 on Monday 19th January was due to a monitoring station battery issue.

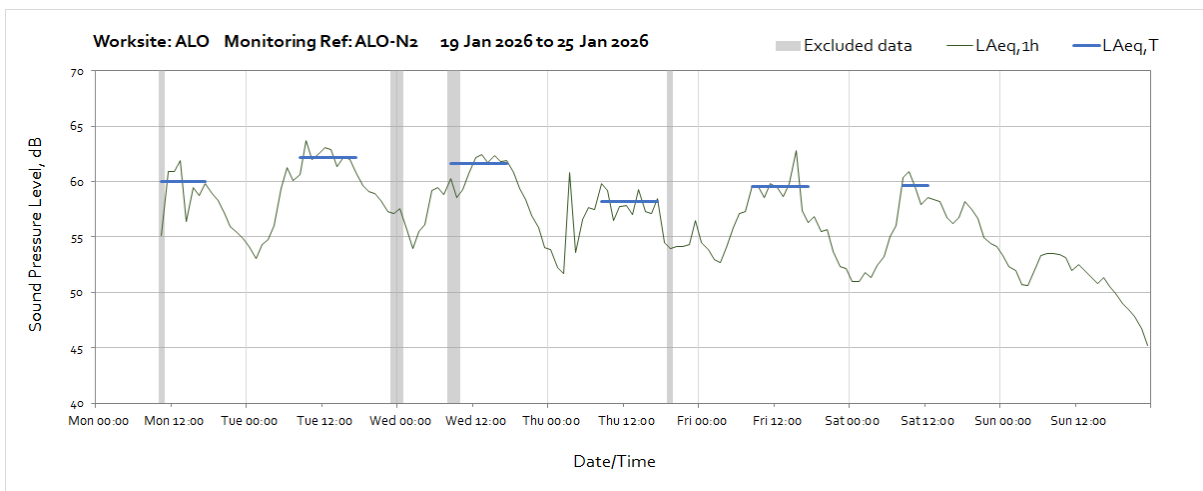
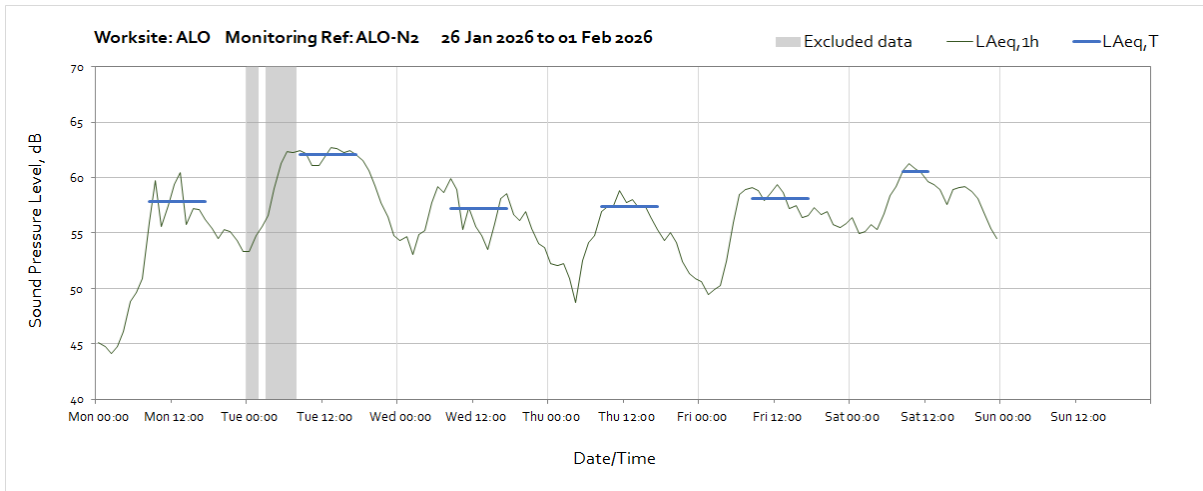
Worksite: ALO – Monitoring Ref: ALO-N2

Note: Missing data between the start of the month and 11:00 on Monday 19th January was due to a monitoring station battery issue.

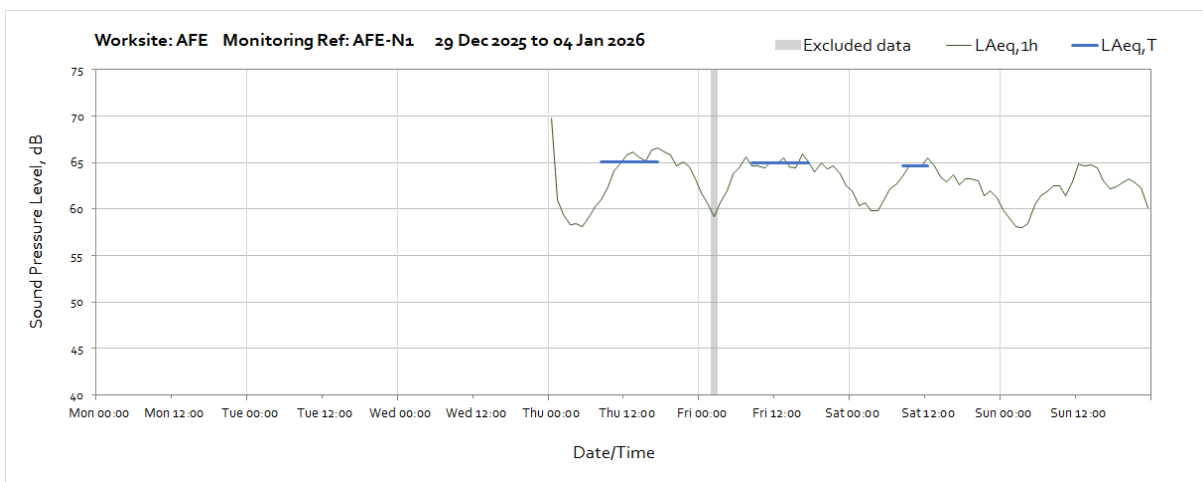
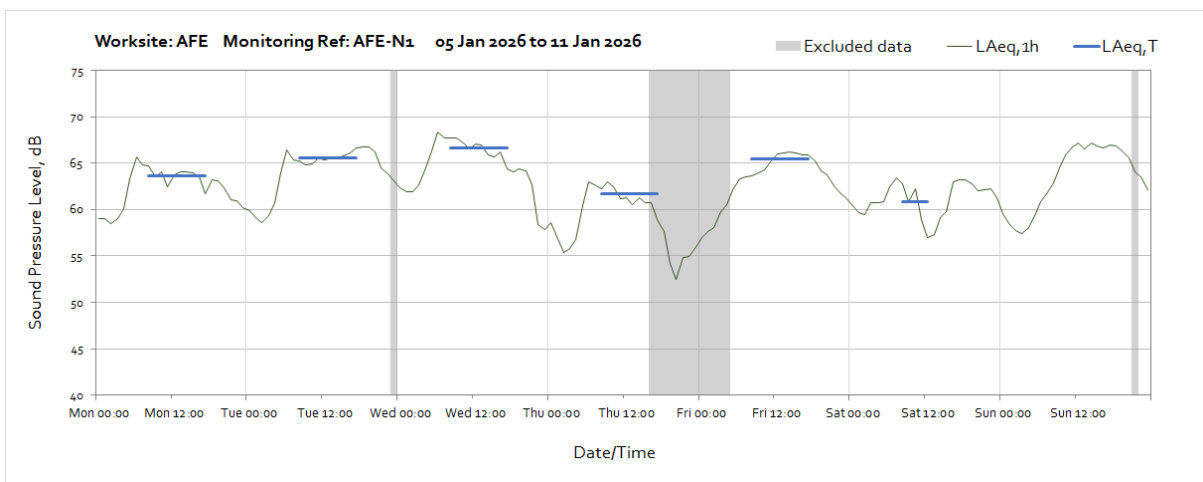
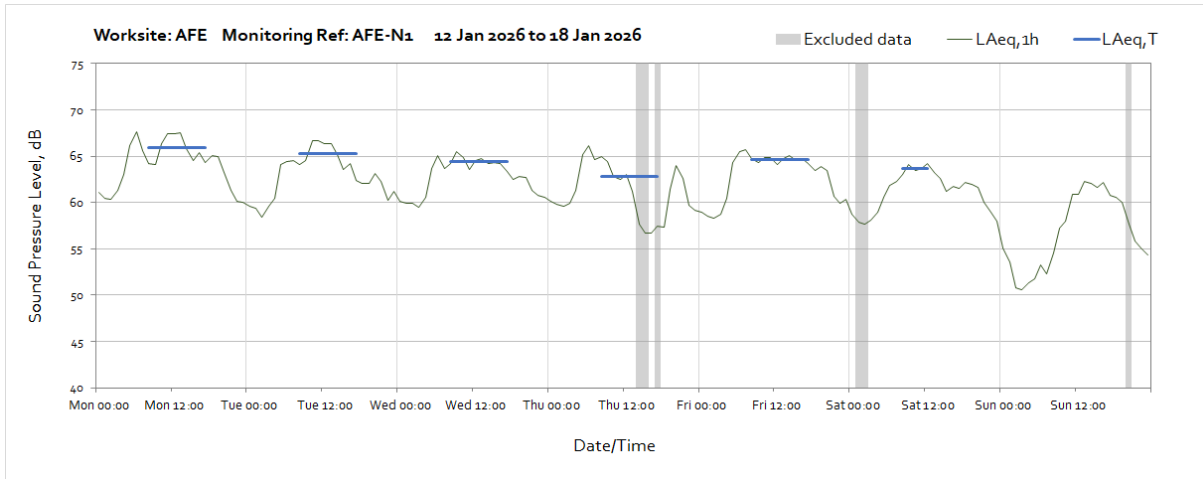
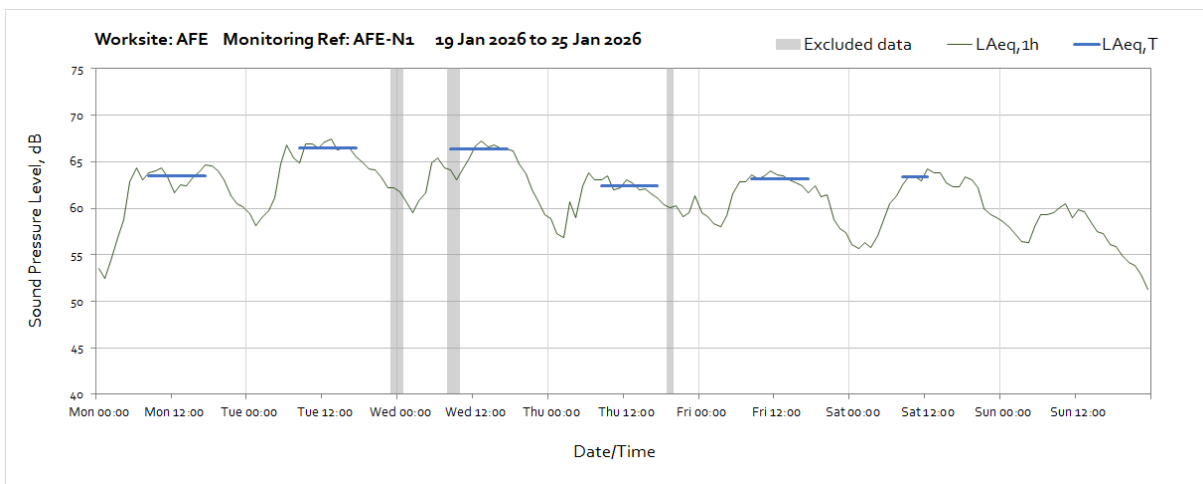
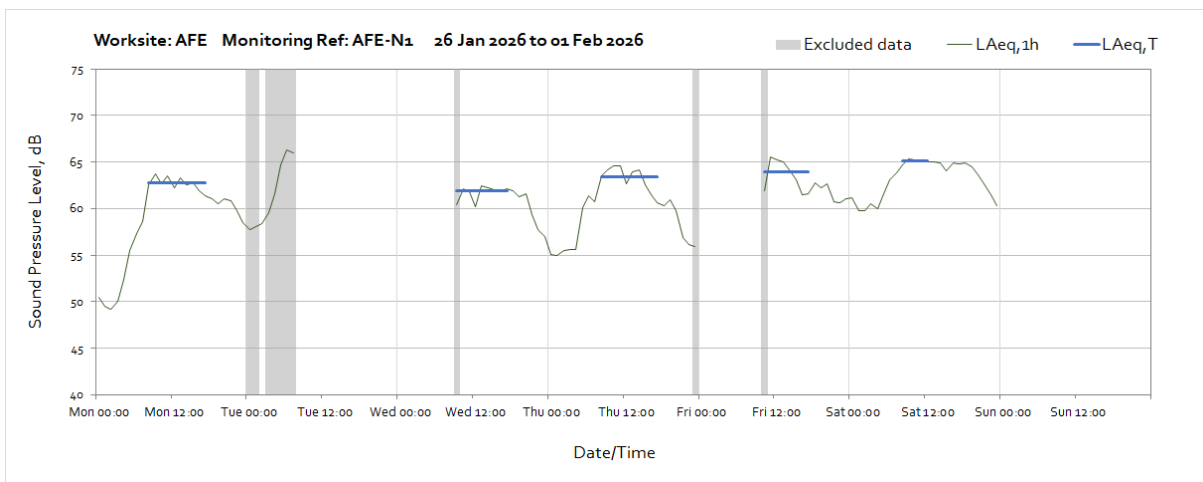
Worksite: ALO – Monitoring Ref: AFE-N1

Note: Missing data throughout the week was due to a monitoring station battery issue.

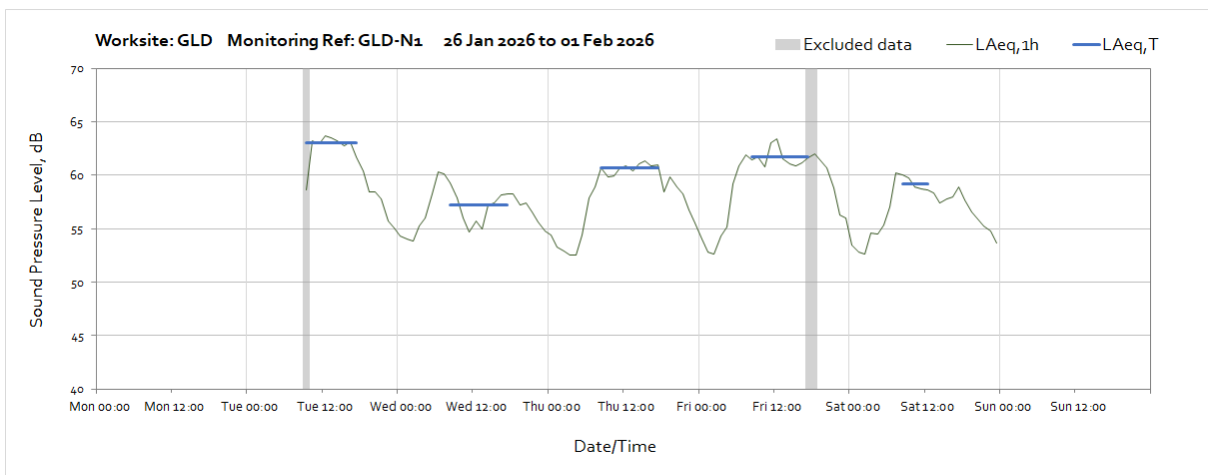
Worksite: GLD - Monitoring Ref: GLD-N1

Note: Missing data between the start of the month and 09:00 on Tuesday 27th January was due to a loss of power at the monitoring station.

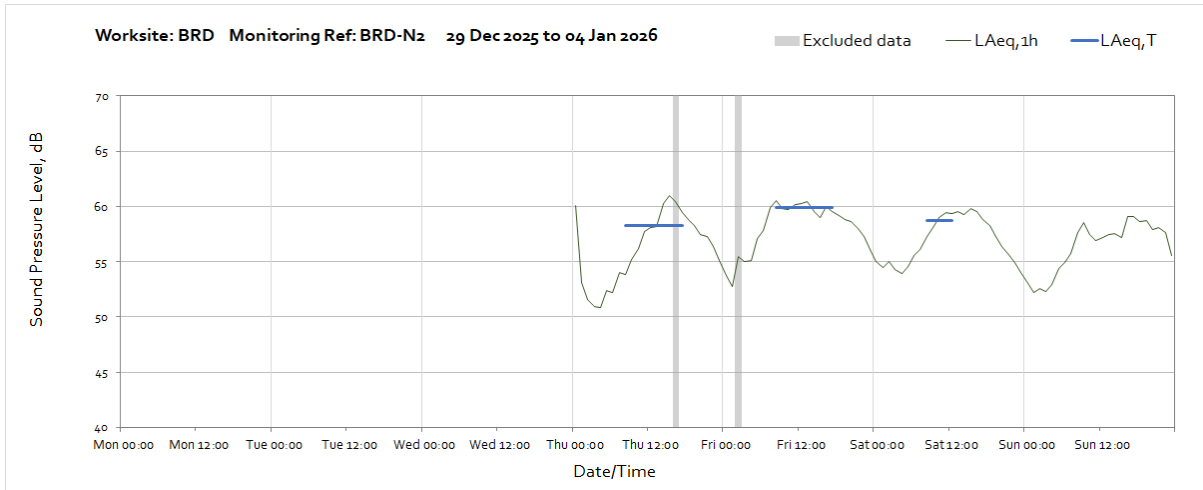
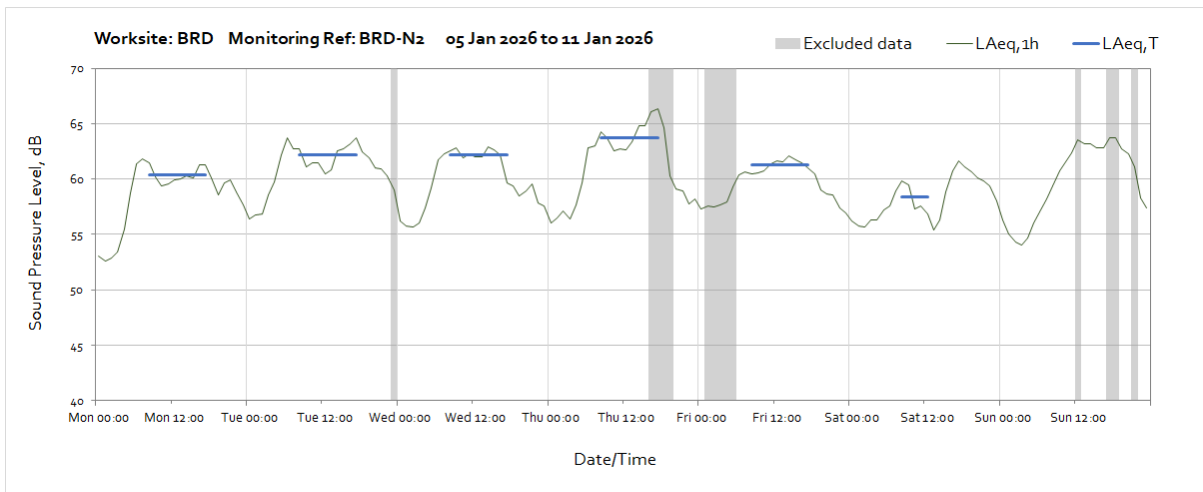
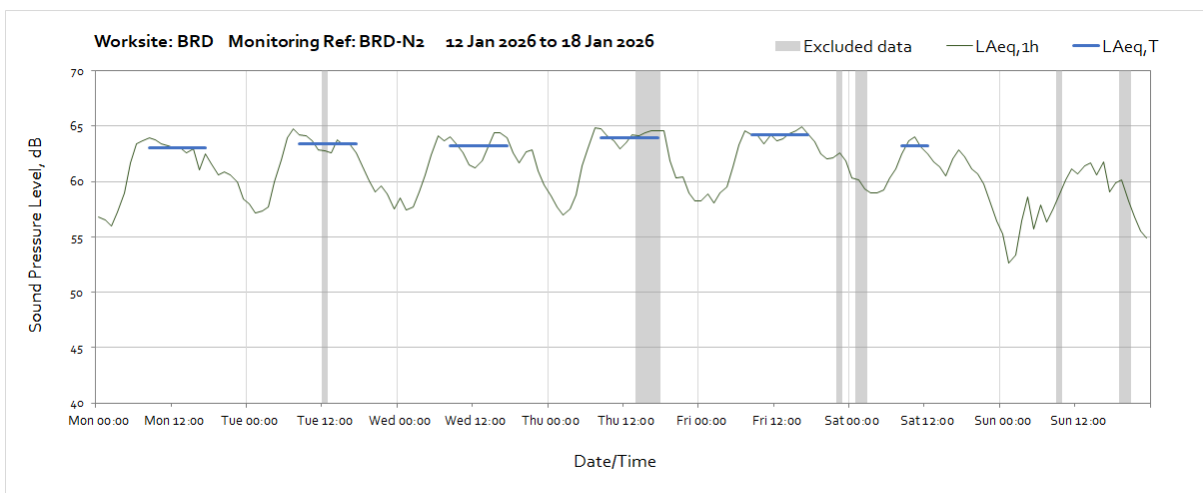
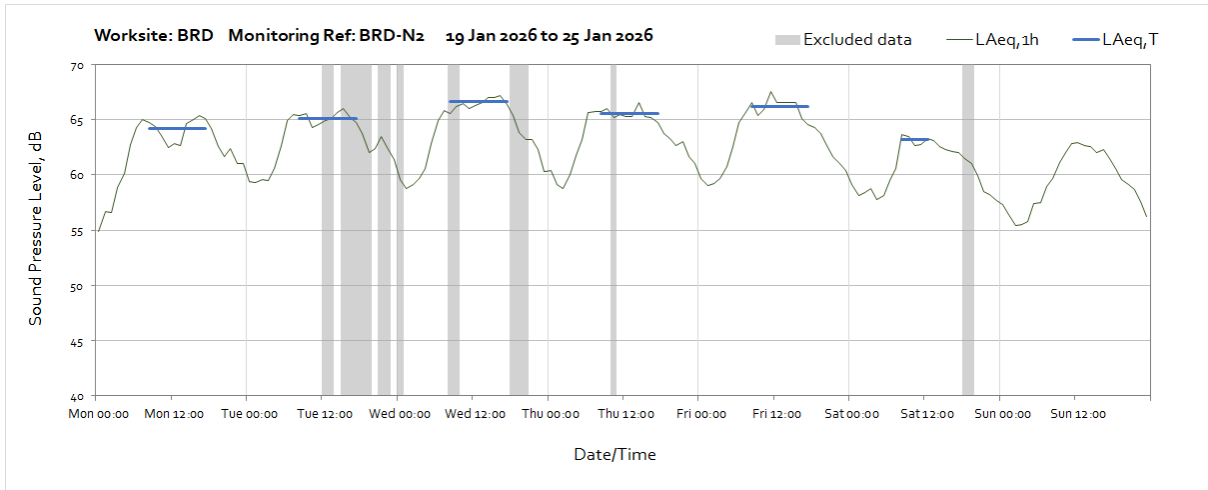
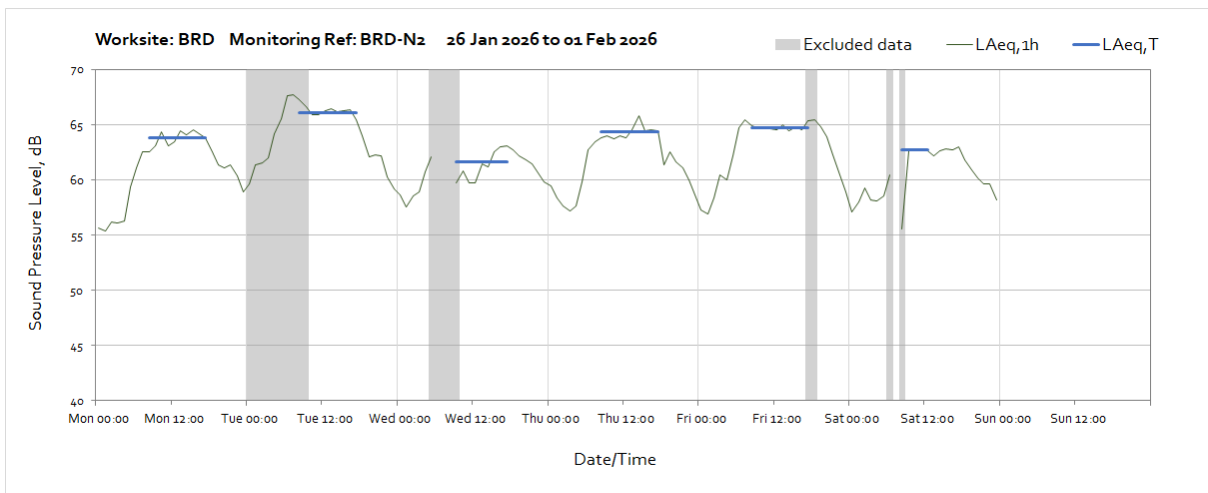
Worksite: BRD - Monitoring Ref: BRD-N2

Note: Missing data between 07:00 and 08:00 on Saturday 31st January was due to a loss of power to the monitoring station caused by poor weather conditions preventing sufficient light reaching the solar panel.

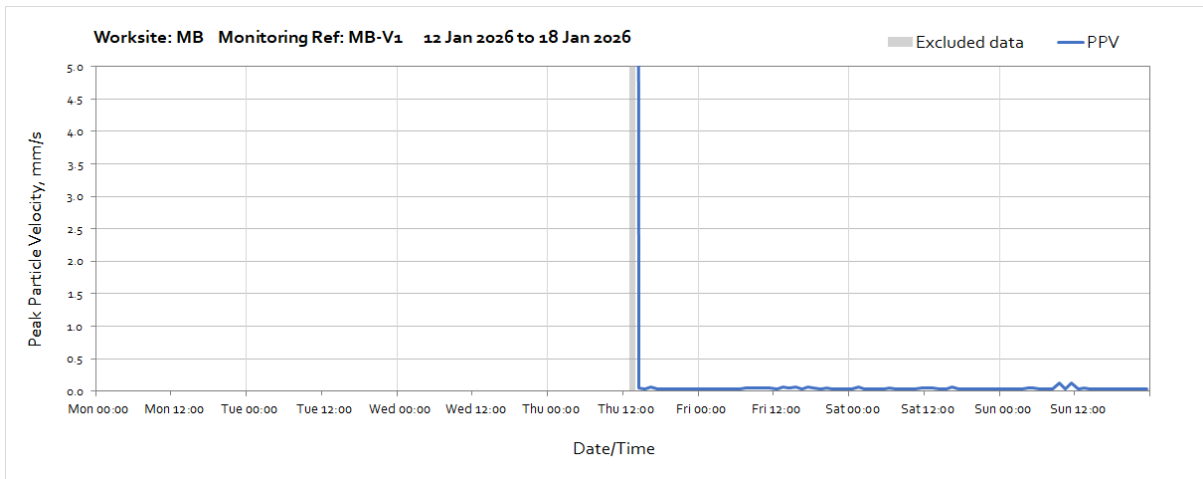
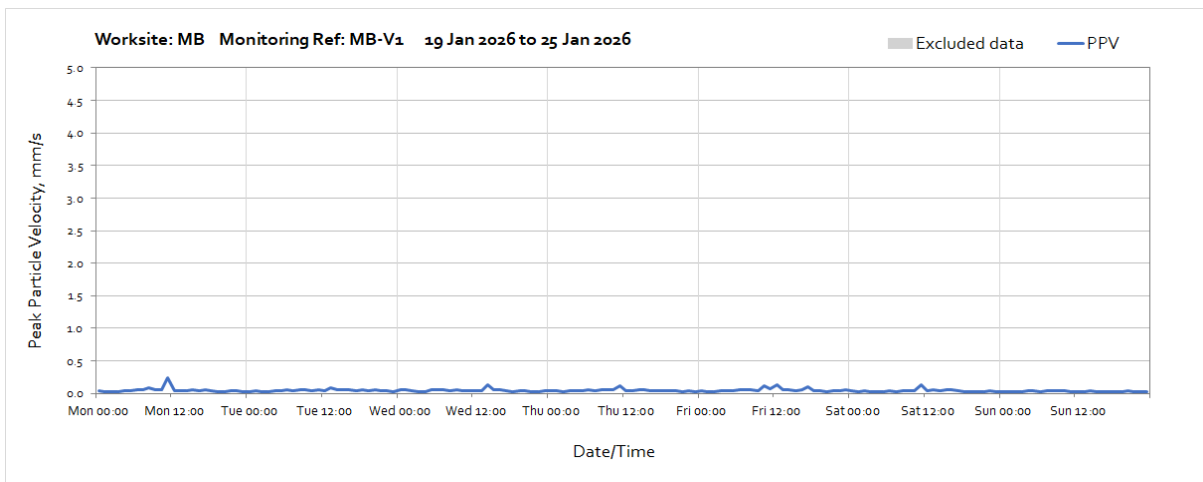
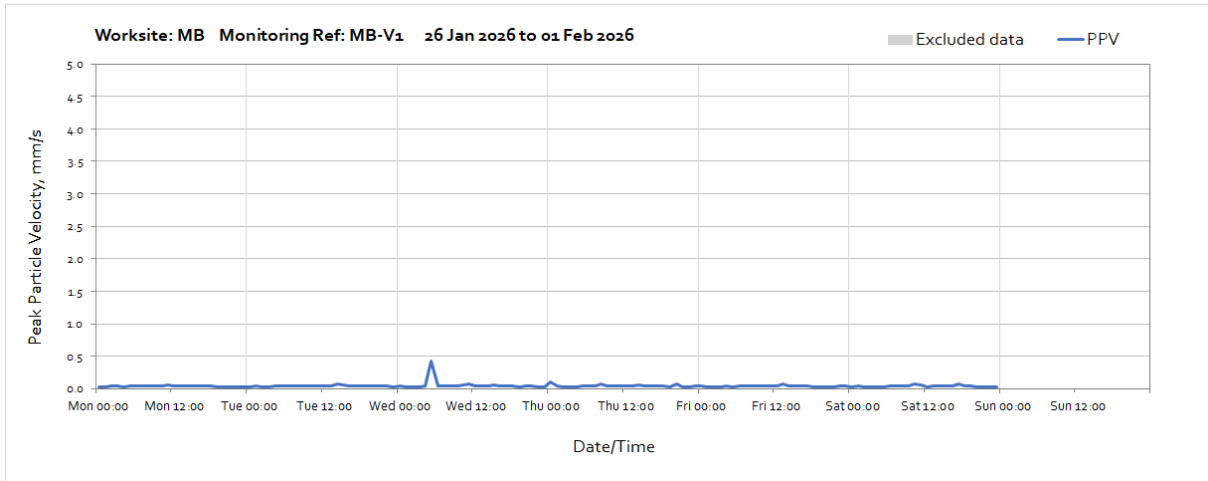
Worksite: MB – Monitoring Ref: MB-V1

The following graphs show the hourly measured peak particle velocity PPV recorded during the monitoring period. The graphs show the highest PPV of the three orthogonal axes x, y and z. Where high values of PPV were caused by local interference with the vibration monitor, which are not representative of HS2 construction works, these values have been greyed out in the following charts and have been excluded to calculate values in Table 4 of the main report.

Note: Missing data between the start of the month and 13:00 on Thursday 15th January was due to a monitoring station battery issue.

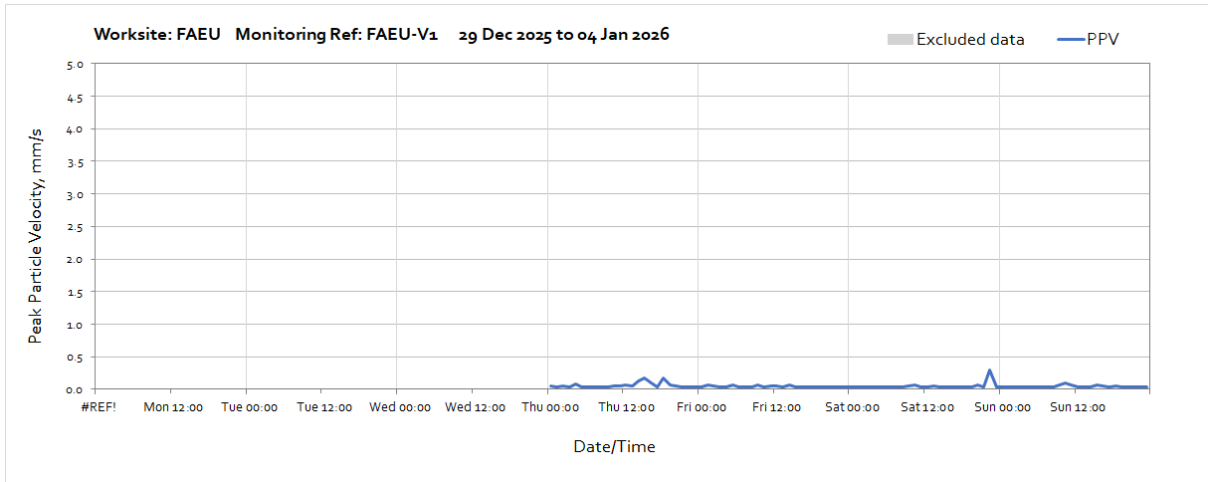
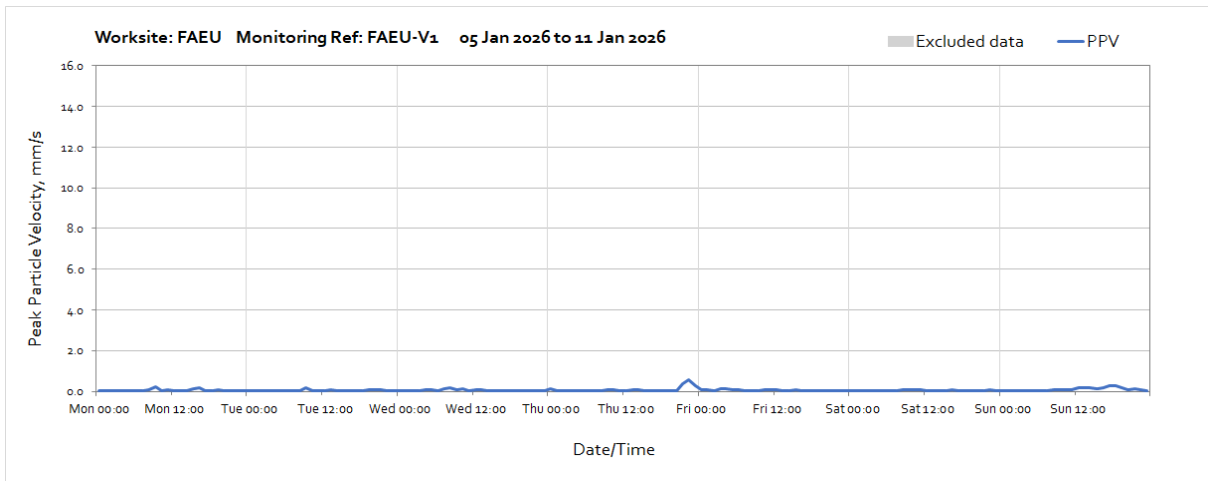
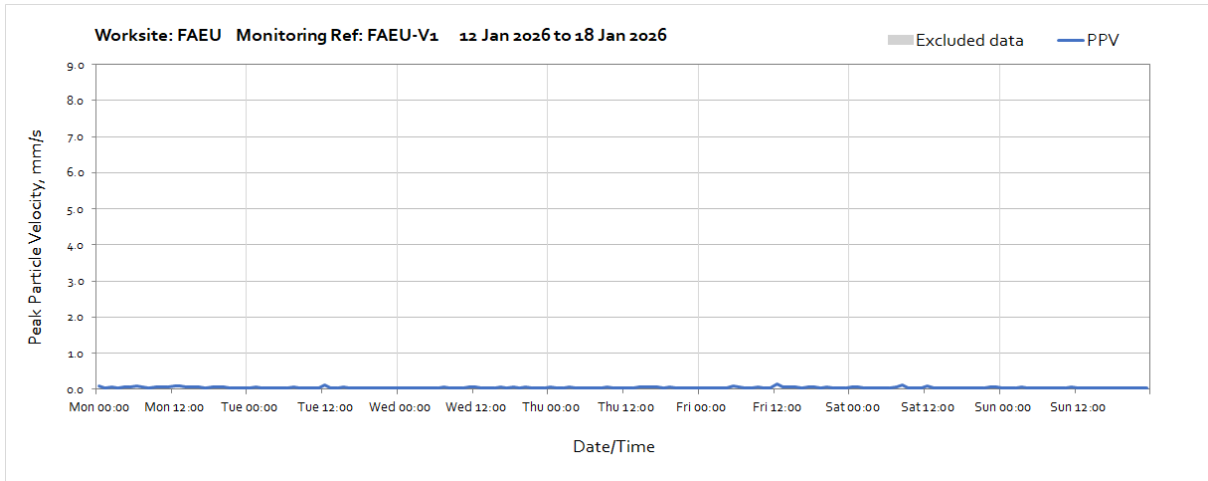
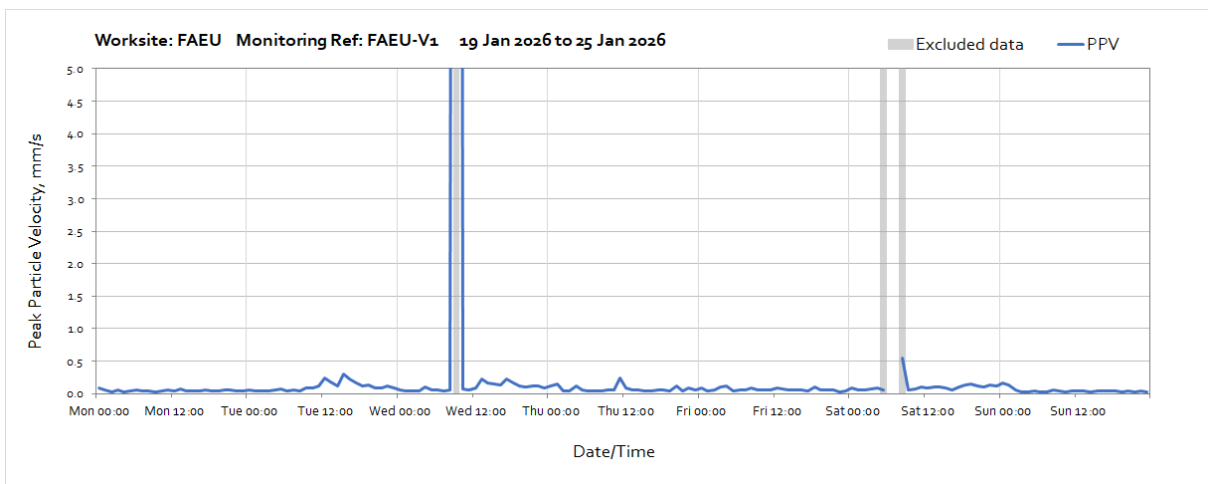
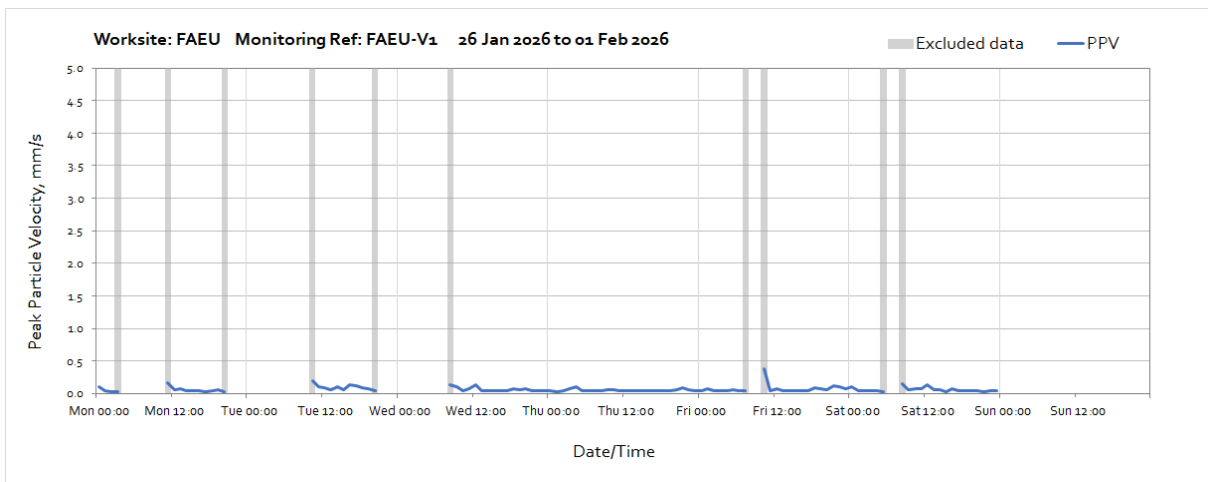
Worksite: FAEU – Monitoring Ref: FAEU-V1

Note: Missing data throughout the month was due to a loss of power at the monitoring station.

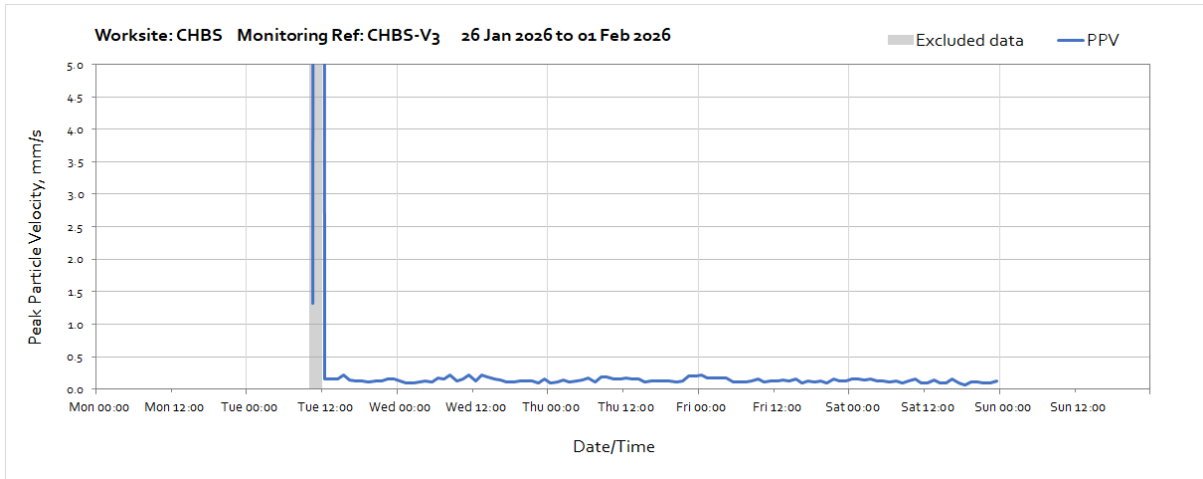
Worksite: CHBS – Monitoring Ref: CHBS-V3

Note: Monitoring station installed at 10:00 on Tuesday 27th January.

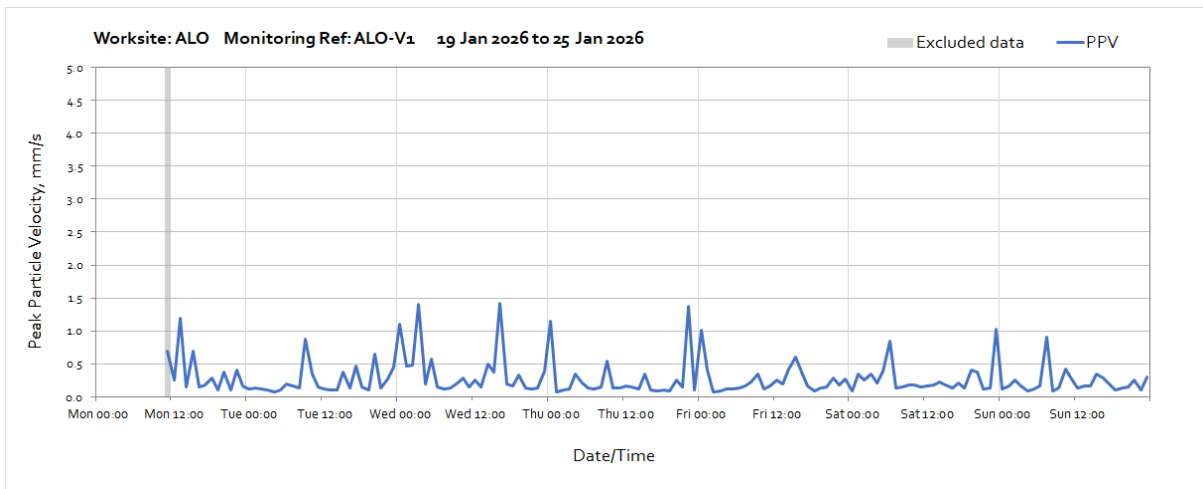
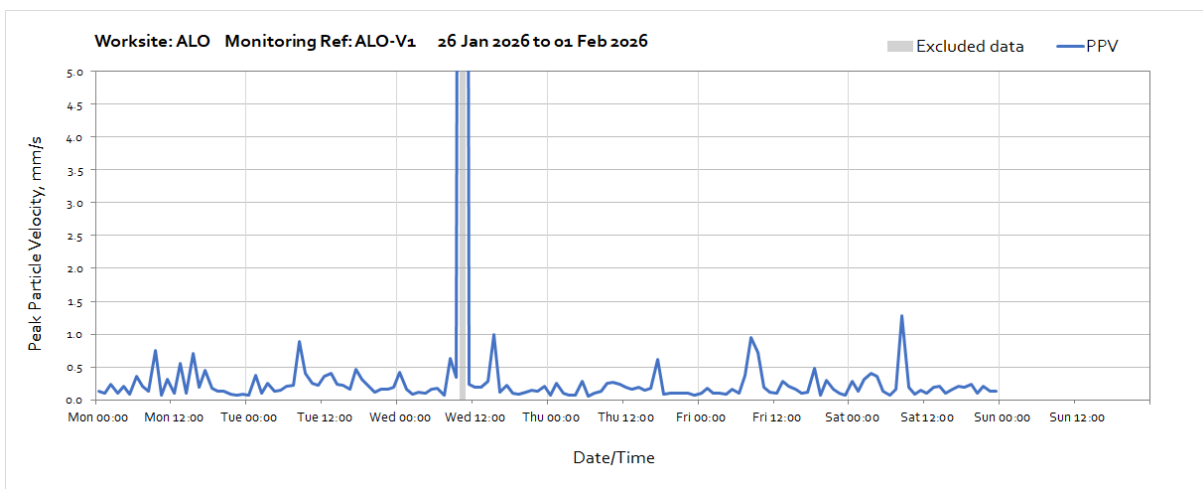
Worksite: ALO – Monitoring Ref: ALO-V1

Note: Missing data between the start of the month and 11:00 on Monday 19th January was due to a monitoring station battery issue.

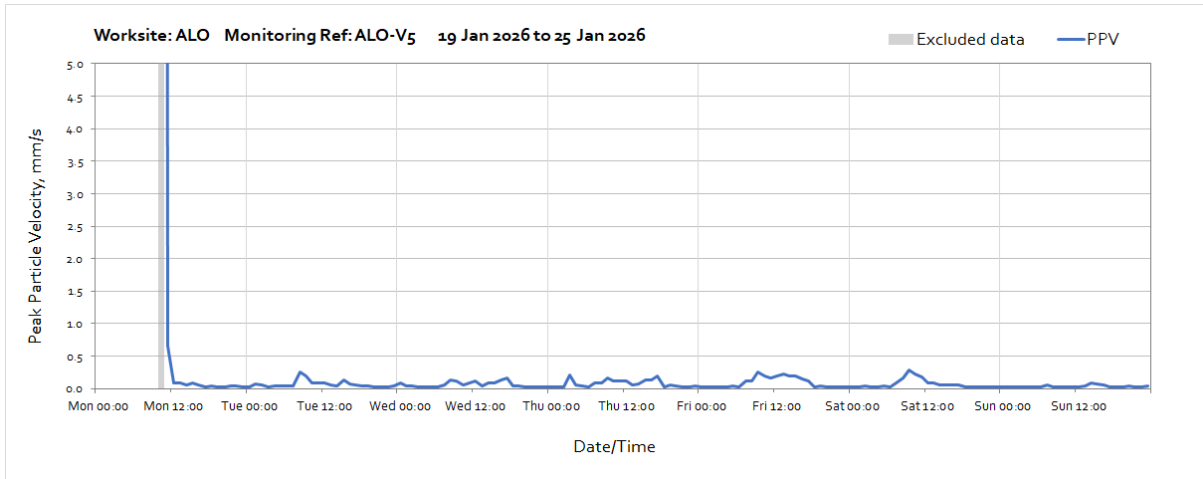
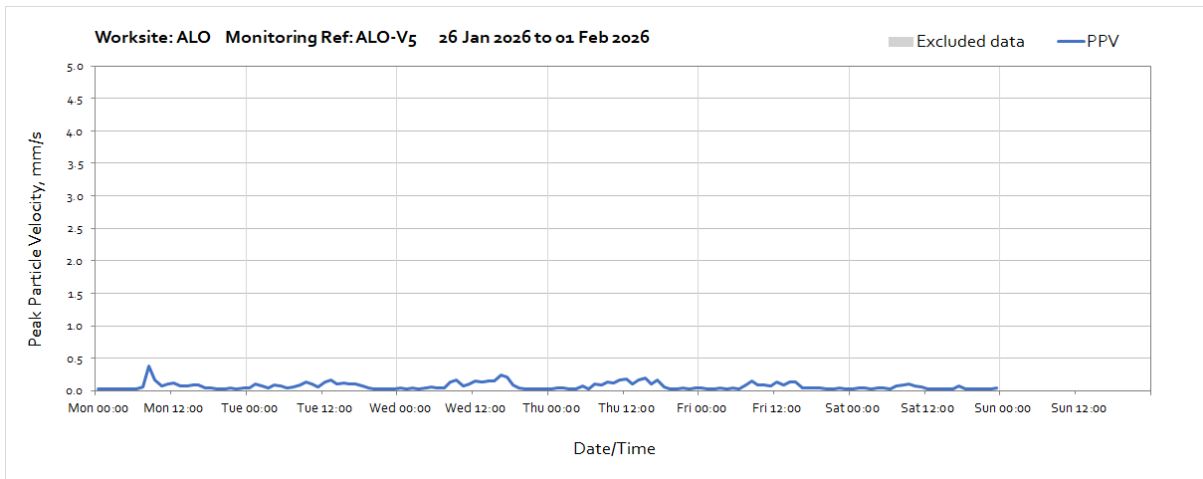
Worksite: ALO – Monitoring Ref: ALO-V5

Note: Missing data between the start of the month and 11:00 on Monday 19th January was due to a monitoring station battery issue.
