Construction Noise and Vibration Monthly Report – January 2026

North Warwickshire Borough Council

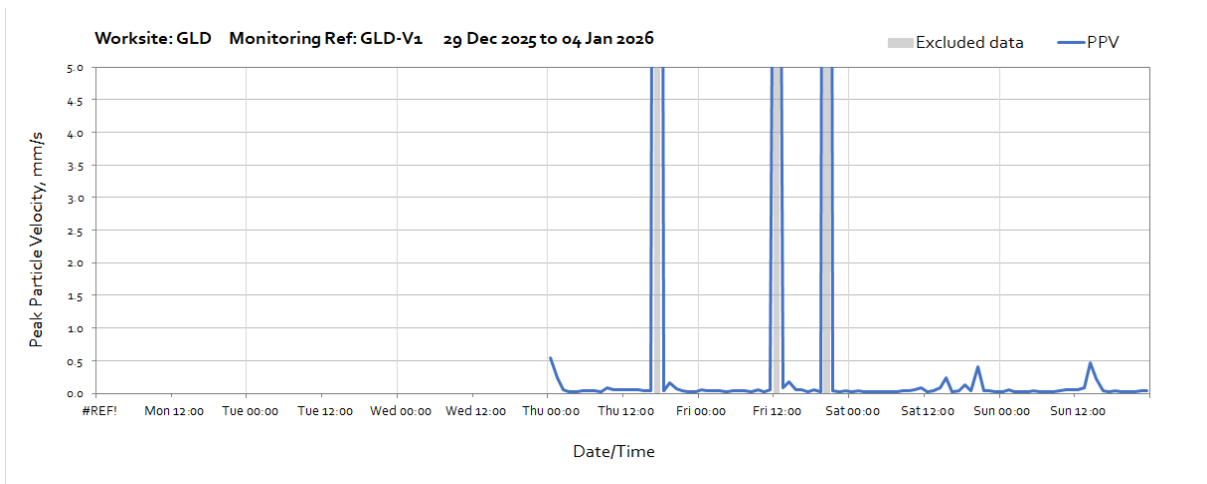
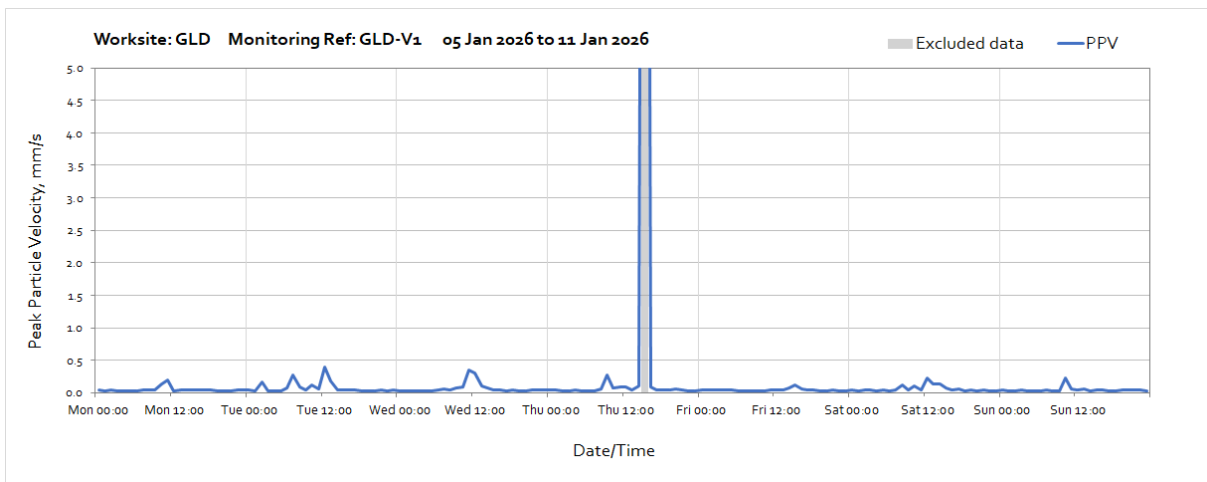
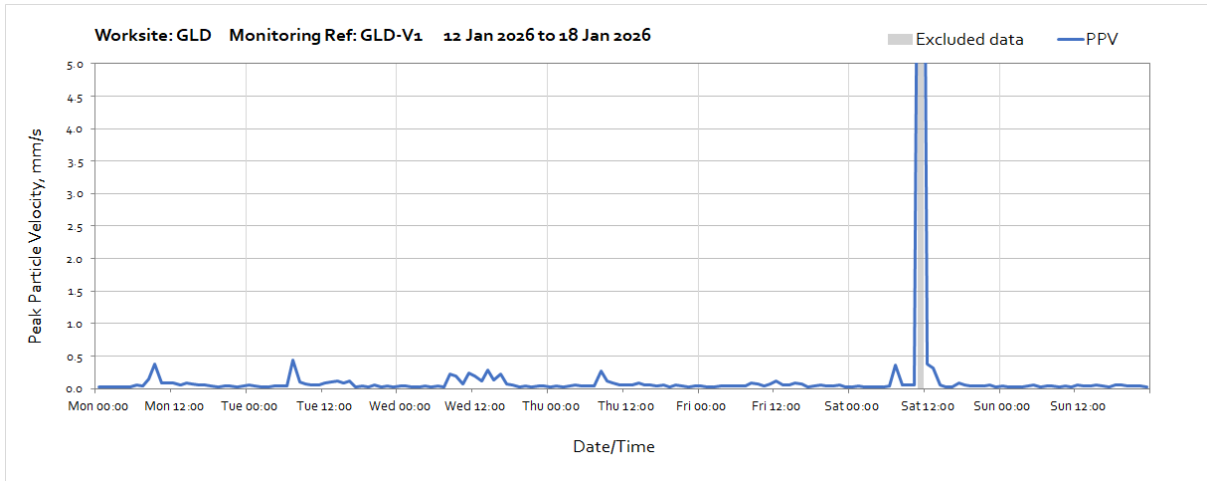
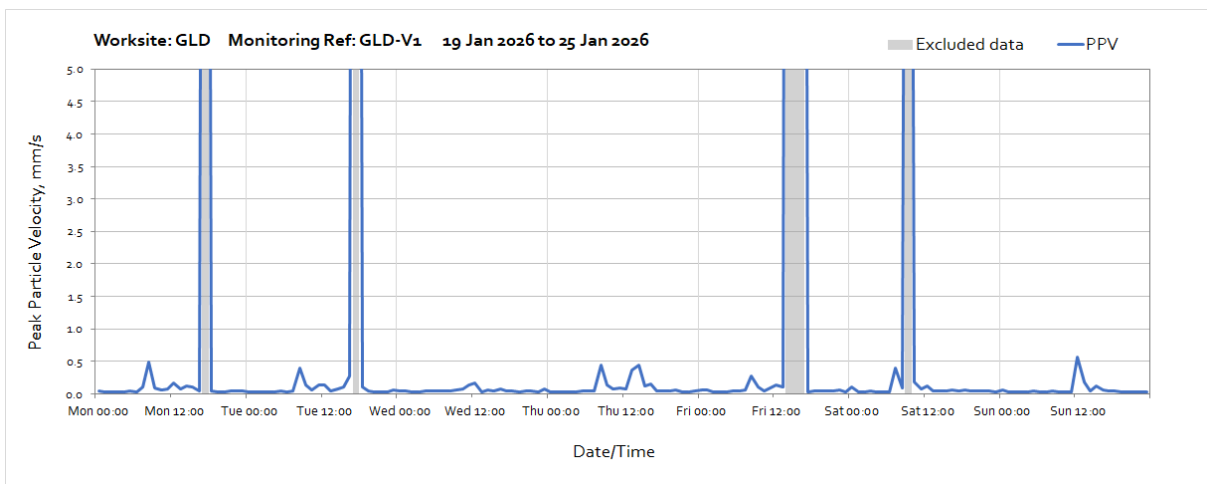
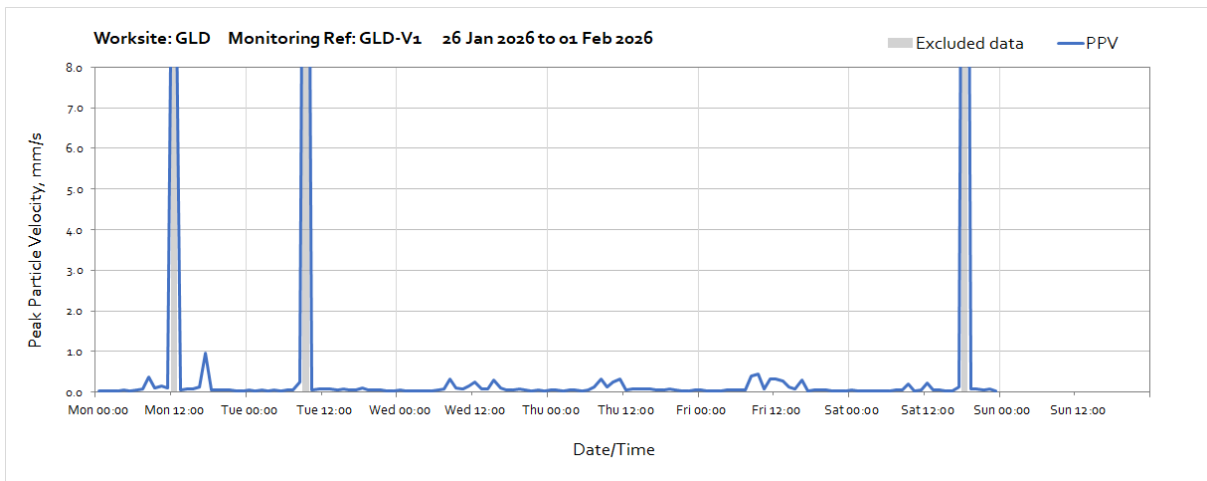
Worksite: GLD – Monitoring Ref: GLD-V1

The following graphs show the hourly measured peak particle velocity PPV recorded during the monitoring period. The graphs show the highest PPV of the three orthogonal axes x, y and z. Where high values of PPV were caused by local interference with the vibration monitor, which are not representative of HS2 construction works, these values have been greyed out in the following charts and have been excluded to calculate values in Table 4 of the main report.
