Construction Noise and Vibration Monthly Report – January 2026

Solihull Metropolitan Borough Council

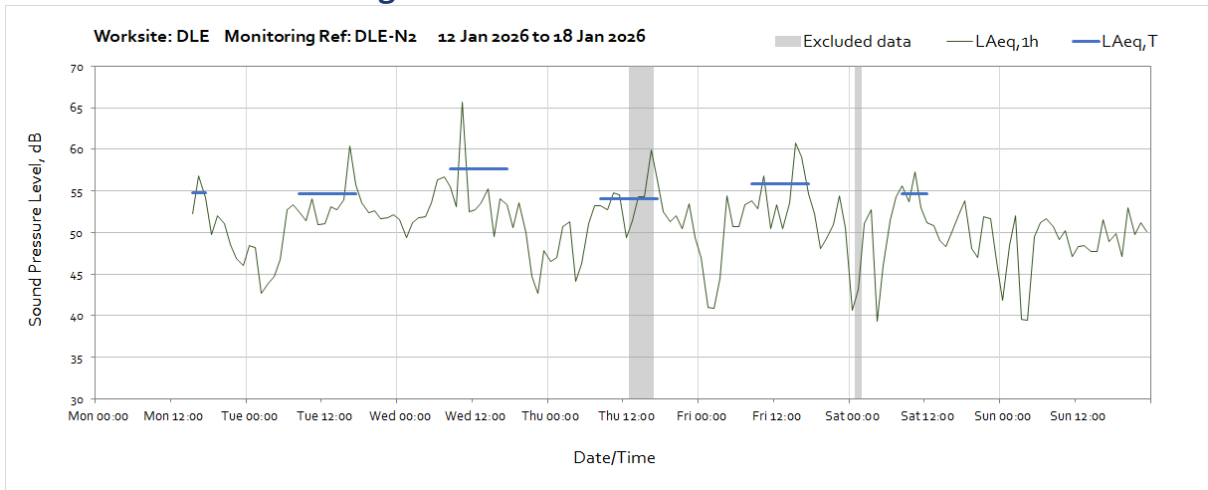
Worksite: DLE - Monitoring Ref: DLE-2

Note: Missing data from the beginning of the month until 15:00 on Monday 12th January was due to a loss of power to the monitoring station caused by poor weather conditions preventing sufficient light reaching the solar panel.

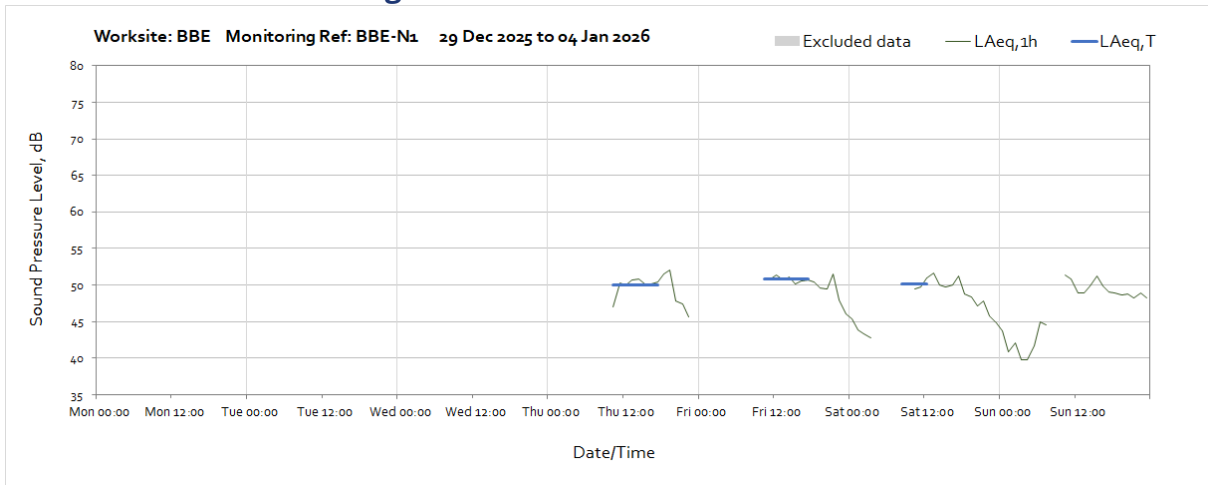
Worksite: BBE – Monitoring Ref: BBE-1

Note: Missing data throughout the month was due to a loss of power to the monitoring station caused by poor weather conditions preventing sufficient light reaching the solar panel.

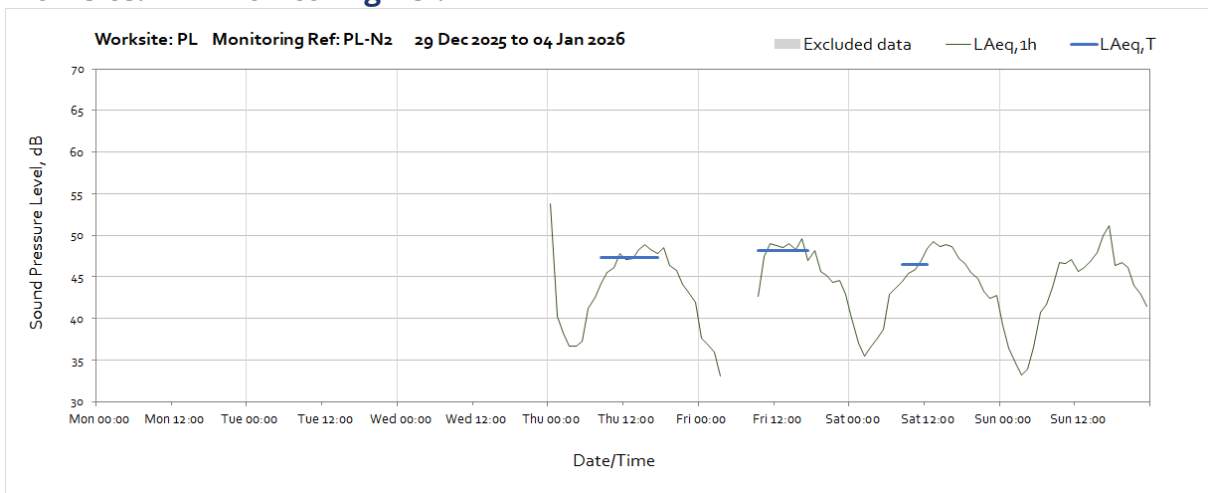
Worksite: PL - Monitoring Ref: PL-2

Note: Missing data from 04:00 until 09:00 on Wednesday 2nd January was due to a loss of power to the monitoring station caused by poor weather conditions preventing sufficient light reaching the solar panel.

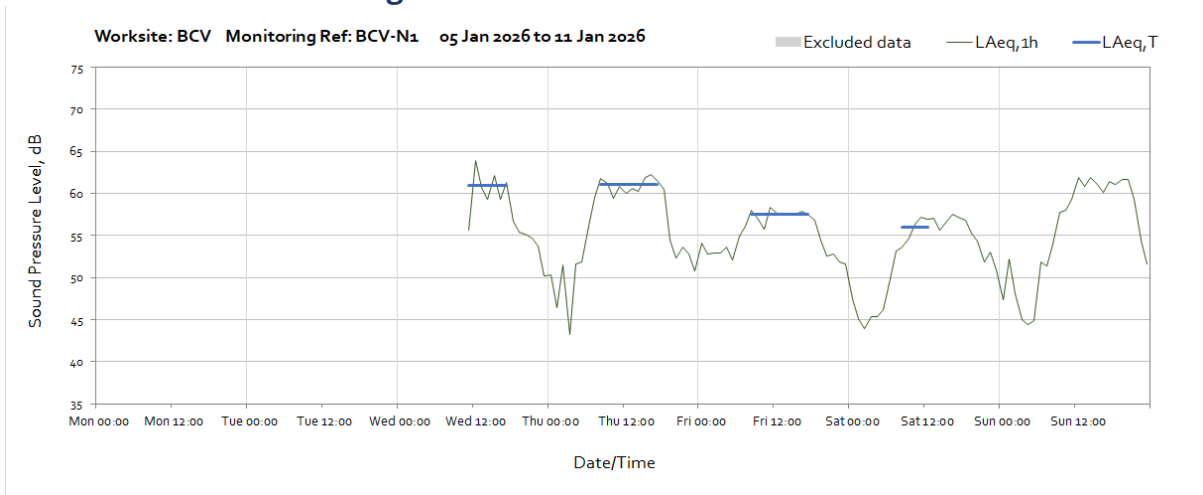
Worksite: BCV – Monitoring Ref: BCV-1

Note: Missing data from the beginning of the month until 11:00 on Wednesday 7th January was due to a loss of power to the monitoring station caused by poor weather conditions preventing sufficient light reaching the solar panel.

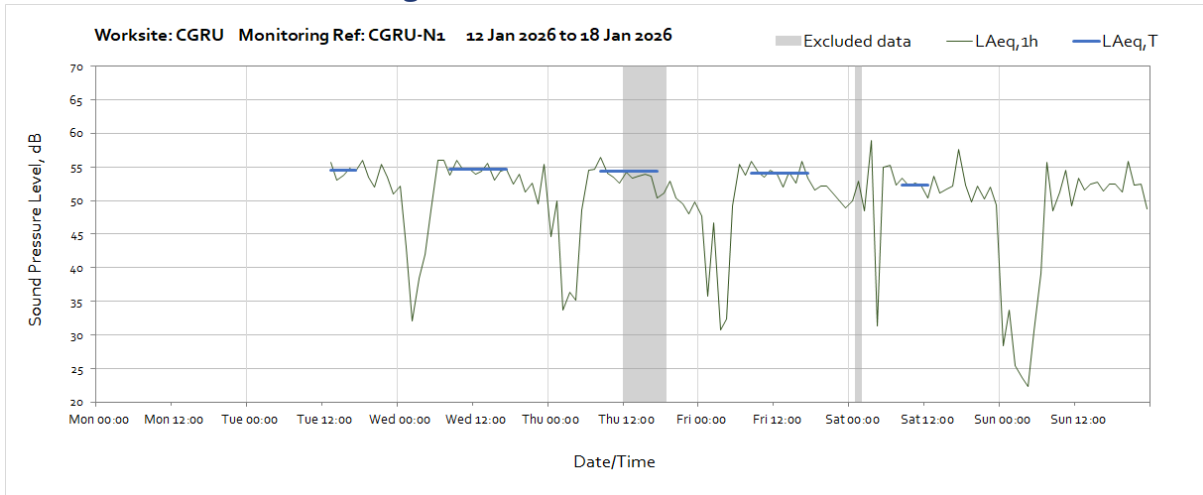
Worksite: CGRU- Monitoring Ref: CGRU-1

Note: Missing data from the beginning of the month until 13:00 on Tuesday 13th January was due to a loss of power to the monitoring station caused by poor weather conditions preventing sufficient light reaching the solar panel.

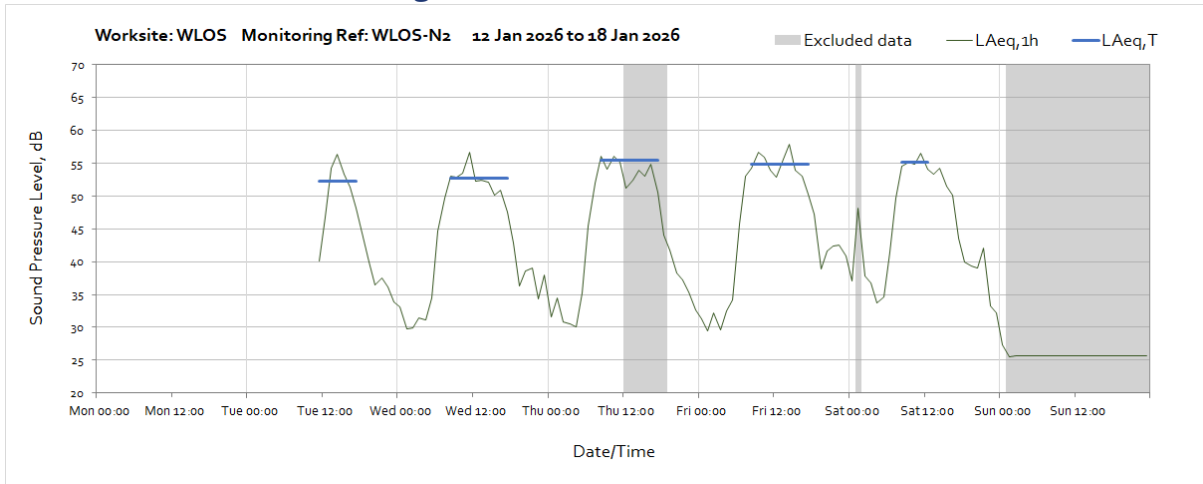
Worksite: WLOS - Monitoring Ref: WLOS-2

Note: Missing data from the beginning of the month until 11:00 on Tuesday 13th January was due to a loss of power to the monitoring station caused by poor weather conditions preventing sufficient light reaching the solar panel.

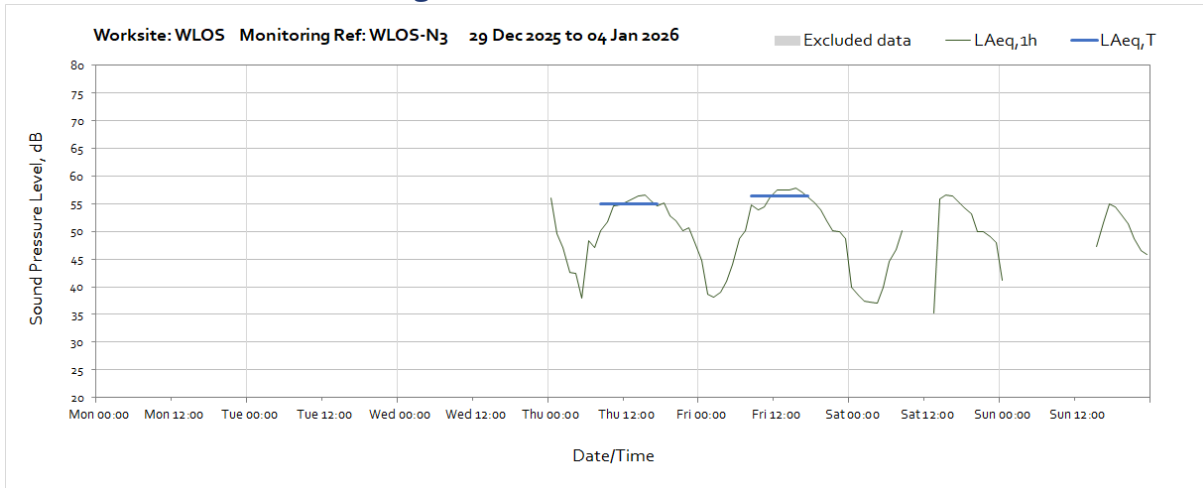
Worksite: WLOS – Monitoring Ref: WLOS-3

Note: Missing data between 09:00 and 13:00 on Saturday 3rd January and between 01:00 and 15:00 on Sunday 4th January was due to a signalling issue at the monitoring station.

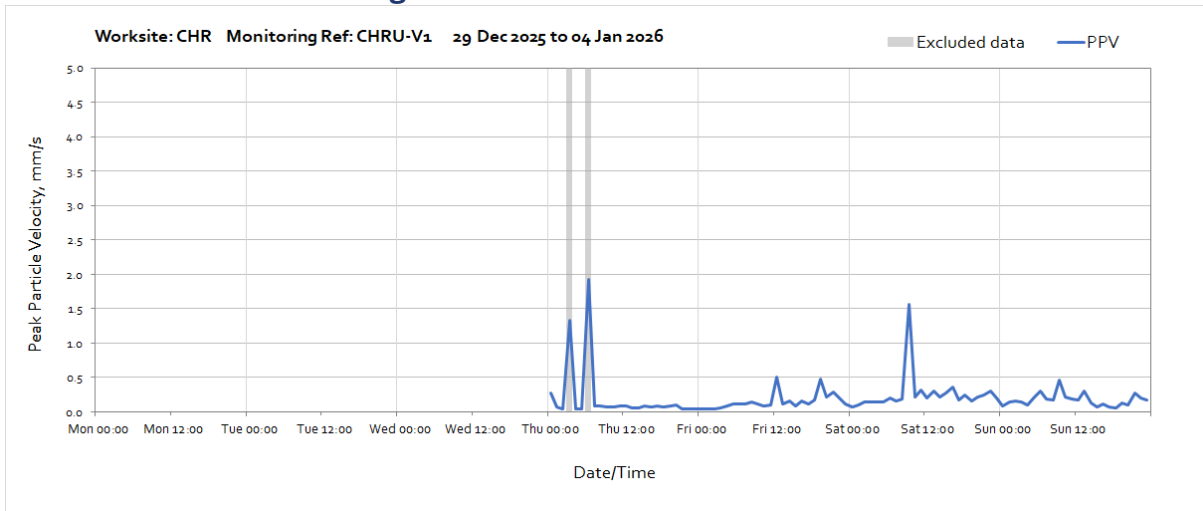
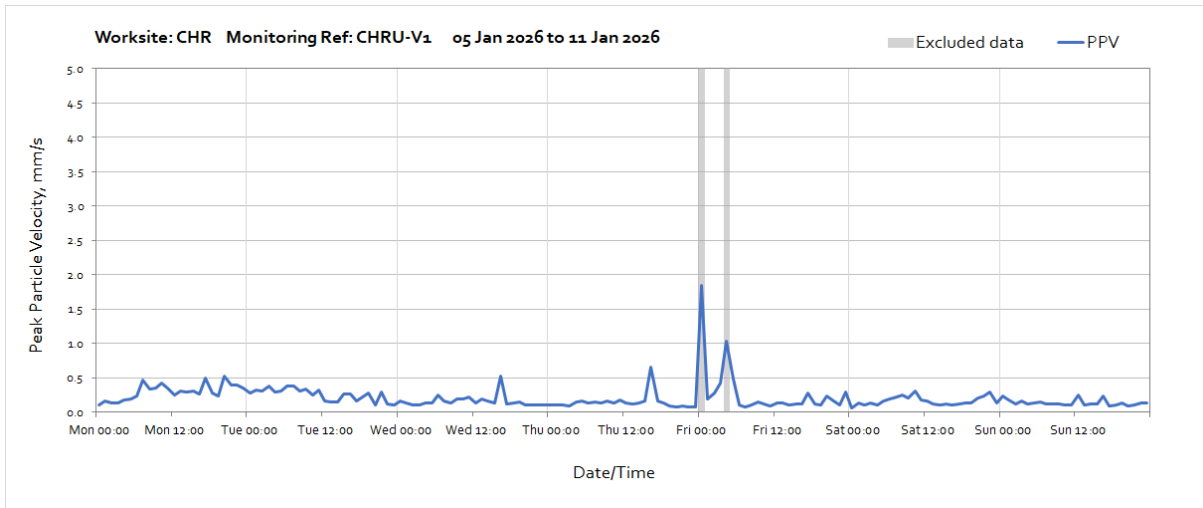
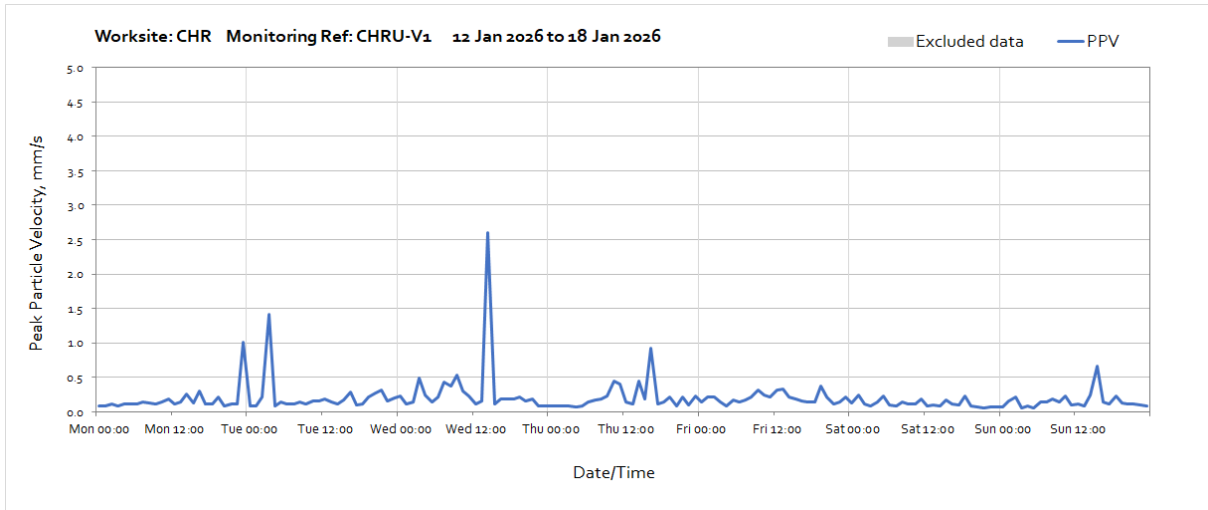
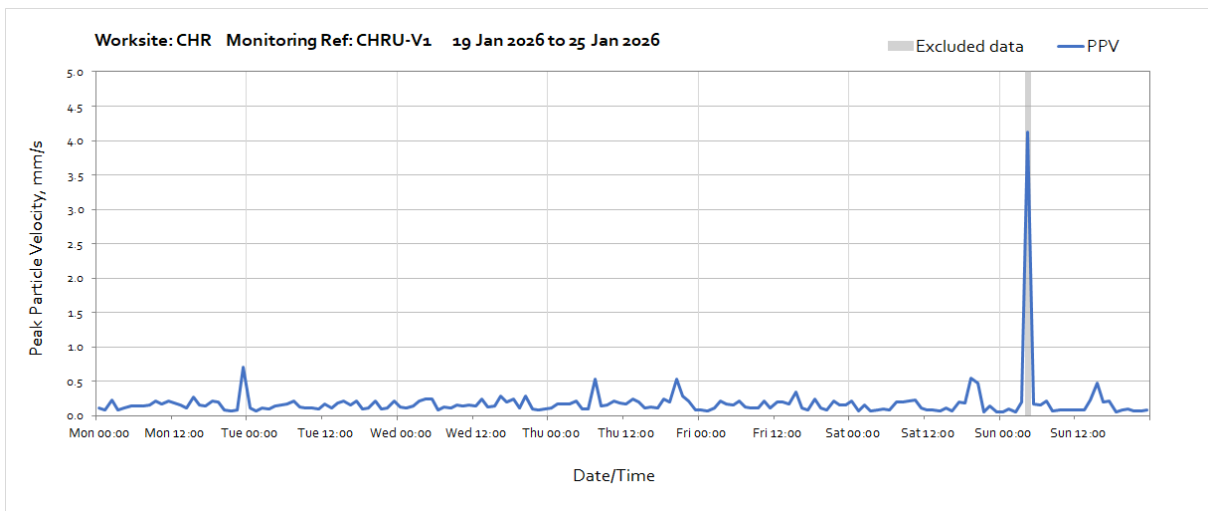
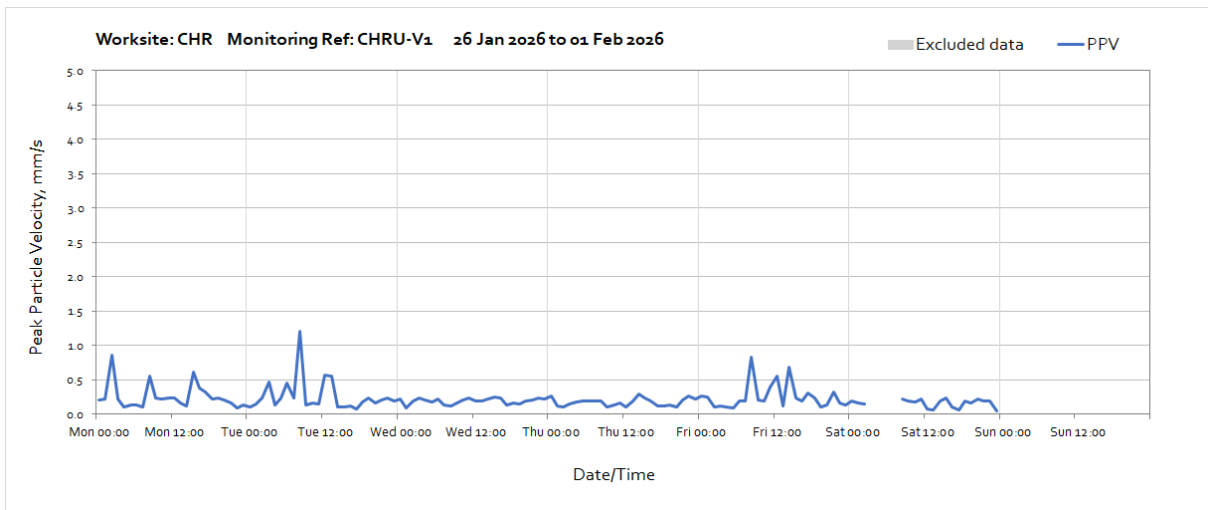
Worksite: CHR – Monitoring Ref: CHRU-V1

The following graphs show the hourly measured peak particle velocity PPV recorded during the monitoring period. The graphs show the highest PPV of the three orthogonal axes x, y and z. Periods where PPV values have been affected by local interference with the vibration monitor or only measured for part of the period, which are not representative of HS2 construction works, have been greyed out and excluded when calculating values in of the main report.

Note: Missing data between 03:00 and 08:00 on Saturday 31st January was due to an issue on monitor restart.

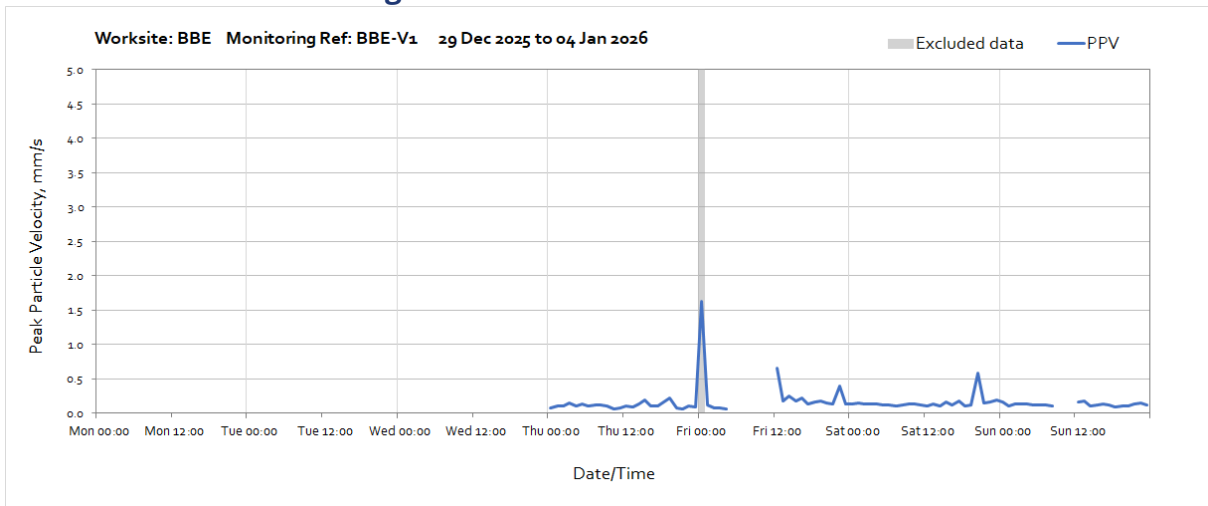
Worksite: BBE – Monitoring Ref: BBE-V1

Note: Missing data throughout the month was due to a loss of power to the monitoring station caused by poor weather conditions preventing sufficient light reaching the solar panel.

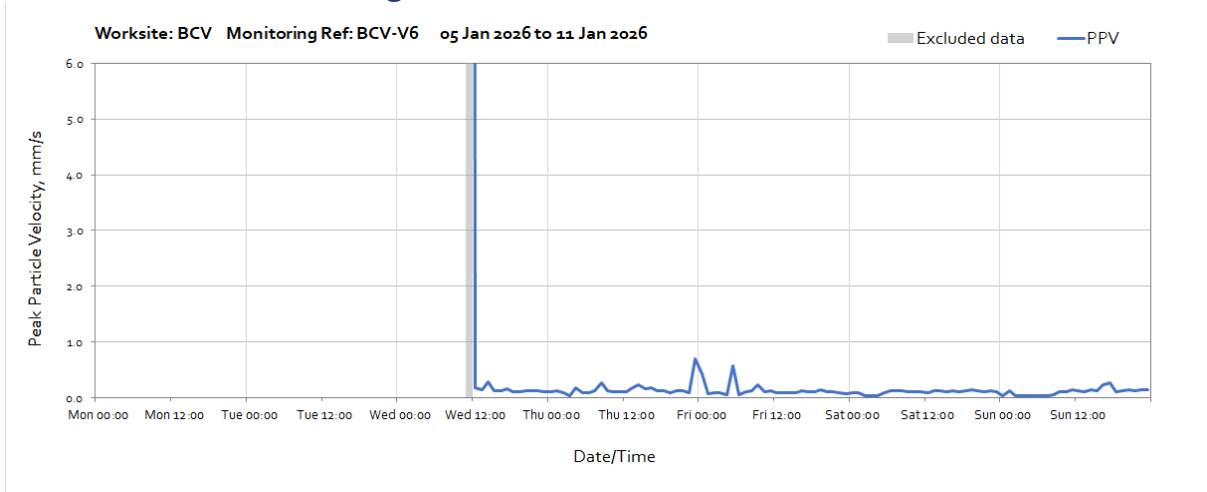
Worksite: BCV – Monitoring Ref: BCV-V6

Note: Missing data from the beginning of the month until 11:00 on Wednesday 7th of January was due to a loss of power to the monitoring station caused by poor weather conditions preventing sufficient light reaching the solar panel.

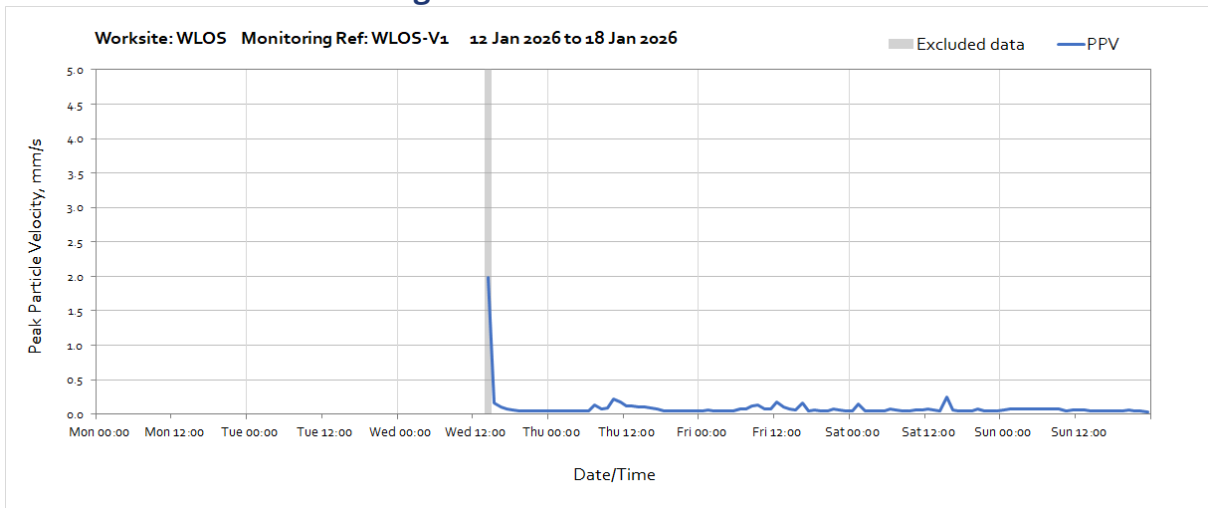
Worksite: WLOS - Monitoring Ref: WLOS-V1

Note: Missing data from the beginning of the month until 14:00 on Wednesday 14th January was due to a loss of power to the monitoring station caused by poor weather conditions preventing sufficient light reaching the solar panel.
