Trees Protection Cages (Birch, Larch and Sycamore) Close Out Report

This document is the close out report for the Decommissioning Programmes for the Trees Protection Cages.

The Trees development is located in UK Central North Sea block 16/12a (Licence P.212), comprising of Birch, Larch, Sycamore Central and Sycamore South – in water depths around 125m. The field is owned and operated by Spirit Energy and is approximately 215km North East of Peterhead. In order to facilitate well decommissioning activity, the protection cages were required to be recovered with the Xmas Trees (XTs), as these are integrated structures. There was no requirement for cutting subsea as the cages are an integral part of the XT.

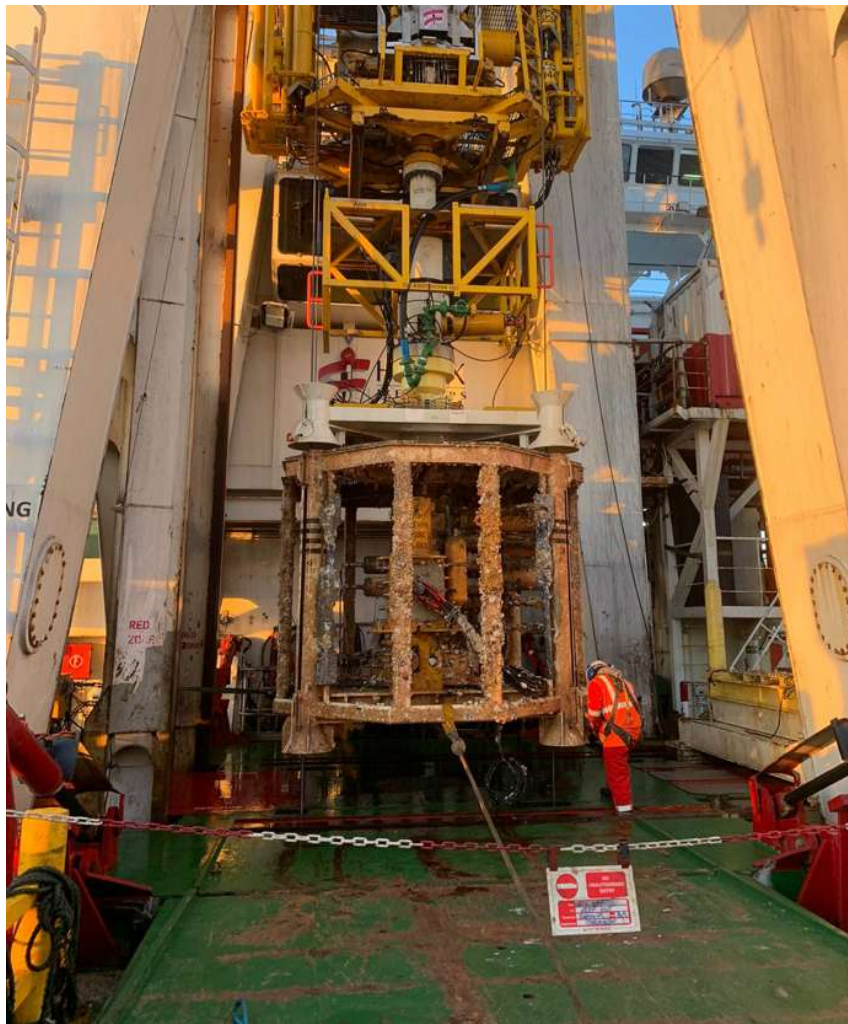
Figure 8.1.1: Protection cage recovery using WellSafe Defender

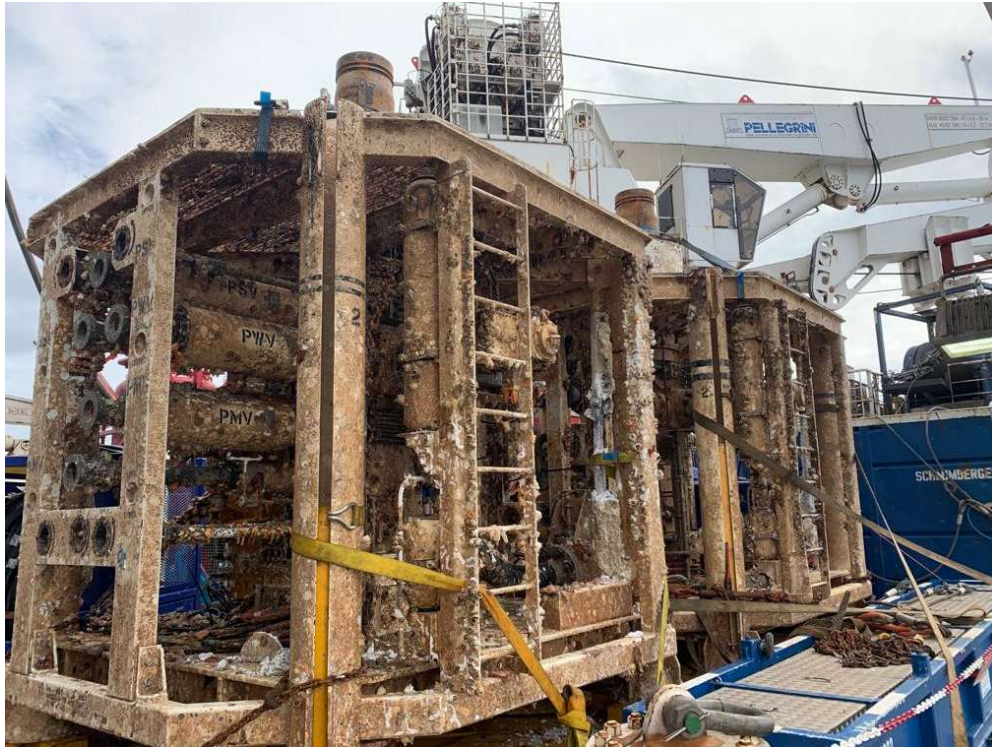
Figure 8.1.2: Protection cages recovered to back deck of vessel

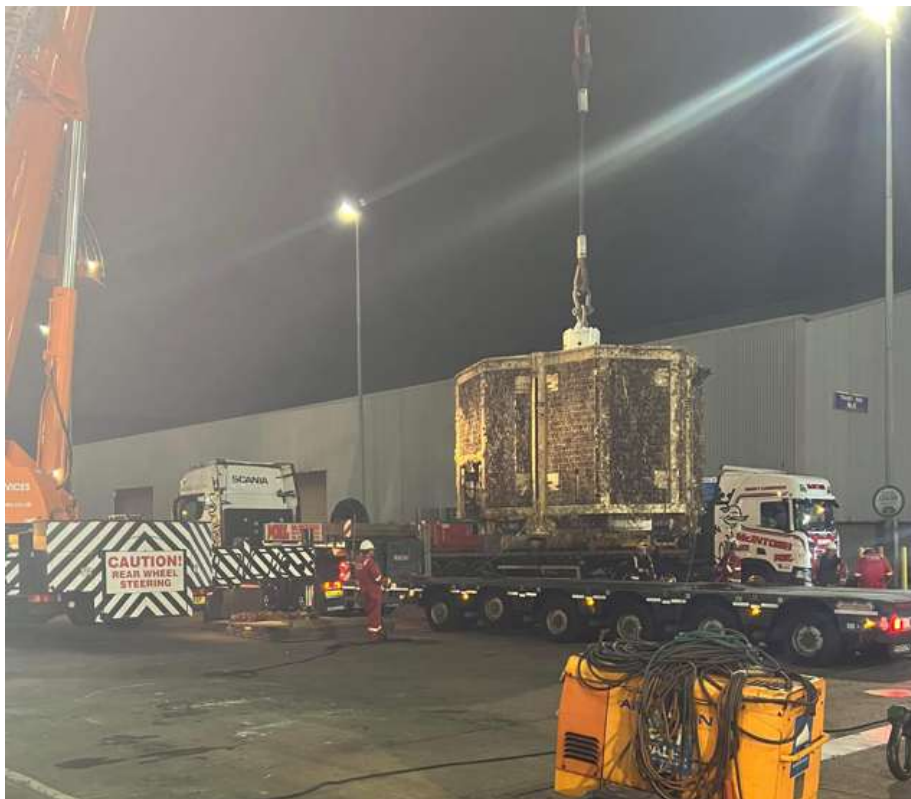
Figure 8.1.3: Protection cage recovered to quayside
