TEMPORARY BULKY WASTE RECYCLING FACILITY (TBWRF), EDMONTON ECOPARK

Environmental Permit, Surrender Site Condition
Report

OUR REF. NO. UK0040909.4846 – 62282829 NLHPP – TBWRF SSCR_I1

DATE: JANUARY 2026

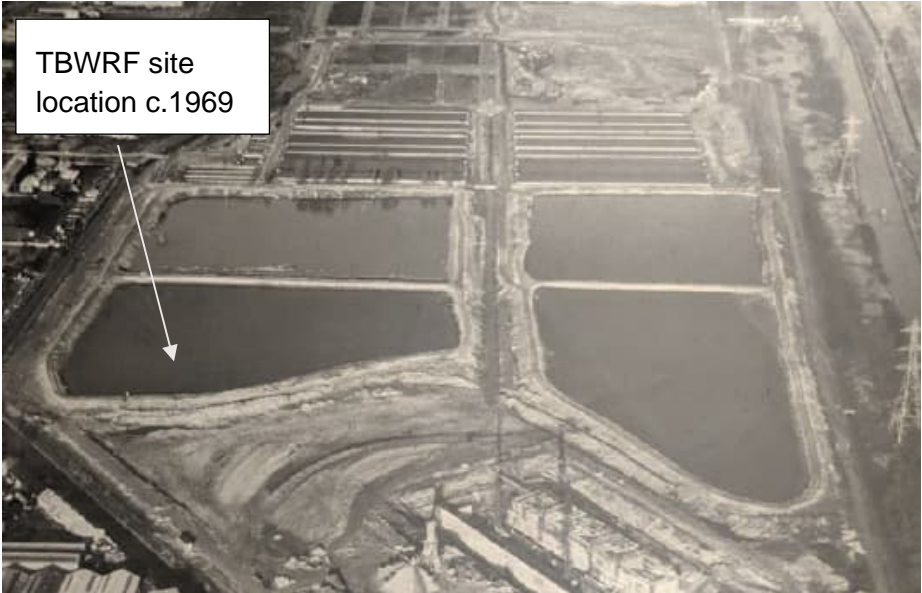
Item	Details		
		site prior to construction of the IVC	
	Made ground perched groundwater	Perched groundwater found in the made ground in the north of the EcoPark has been identified to contain detectable concentrations of potentially polluting substances	Ammonium, dissolved metals, and potential PAH, total petroleum hydrocarbons (TPH), localised phenol and pesticides
	Kempton Park Gravel aquifer	Water in the Kempton Park Gravel aquifer in the north of the EcoPark has been identified to contain detectable concentrations of potentially polluting substances	Ammonium, dissolved metals, phenols, localised pesticides, PAH and TPH.
	<p>Figure 2.1 Historical aerial photograph showing sludge lagoons (c. 1969)</p>

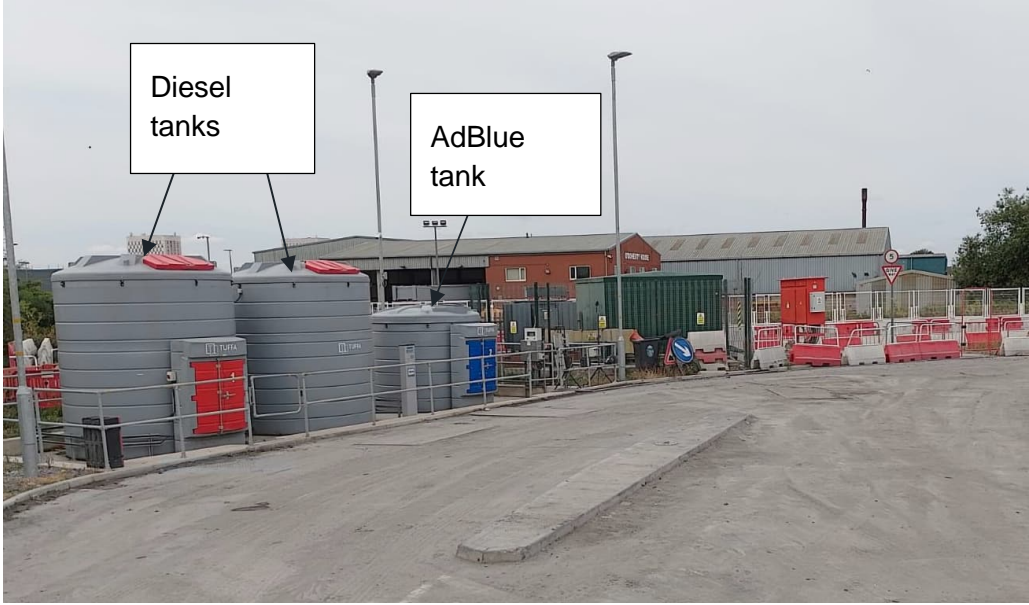
<p>Fuels and oils</p>	<p>Fuel Storage/ Handling Two above ground integrally bunded (to 110% of the tank capacity) and interlinked 15,000 litre diesel storage tanks and one integrally bunded (to 110% of the tank capacity) 6,000 litre AdBlue tank were located within a concrete kerbed area in the south of the TBWRF. These were used for refuelling of waste vehicles and site vehicles (see photograph below). The kerbed area was protected by heavy duty crash bollards and drained to an oil interceptor. All pipework was above ground and located within the bund. The filling hoses for the diesel and AdBlue tanks were located within the cabinets attached to the tanks and, therefore, kept within the tank bunds' lockable cabinets when not in use. Refuelling pumps had a valve in the feed line to prevent the tank contents emptying accidentally. Spill kits were held at the refilling area.</p> <p>The refuelling area was surfaced with impermeable hardstanding, with local surface drainage to a Kingspan Forecourt oil interceptor before reaching the attenuation tank.</p>

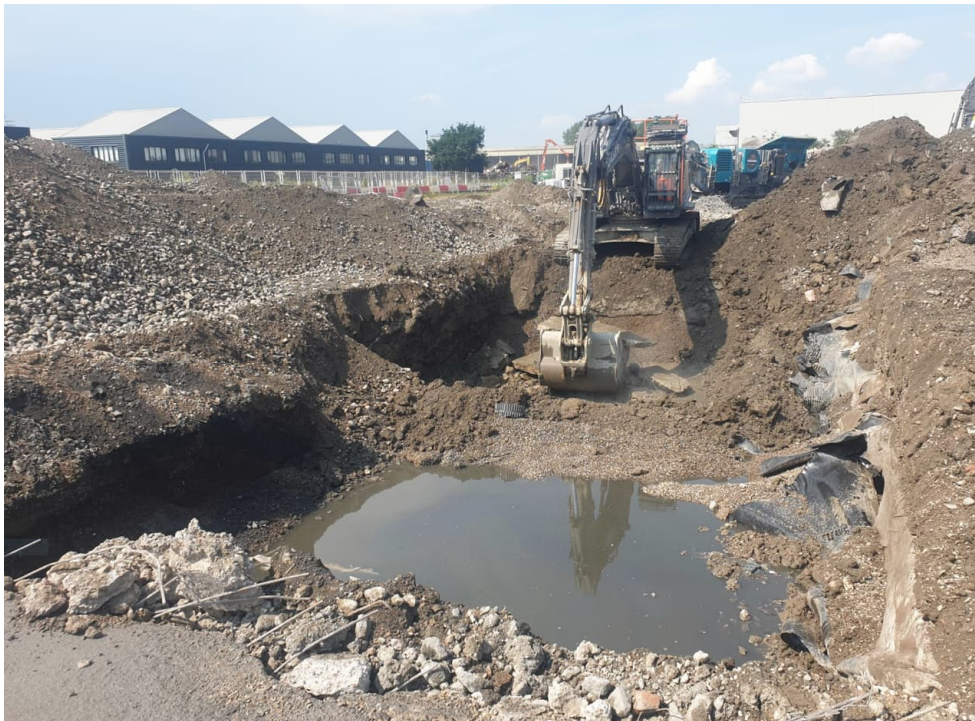
Photograph 1: Photograph taken during removal of the TBWRF attenuation tank by DSM, June 2023.

Photographs of the completed demolition works are included in DSM's reports (see **Appendix E**). Photographs of the TBWRF attenuation tank being removed by DSM are presented below.

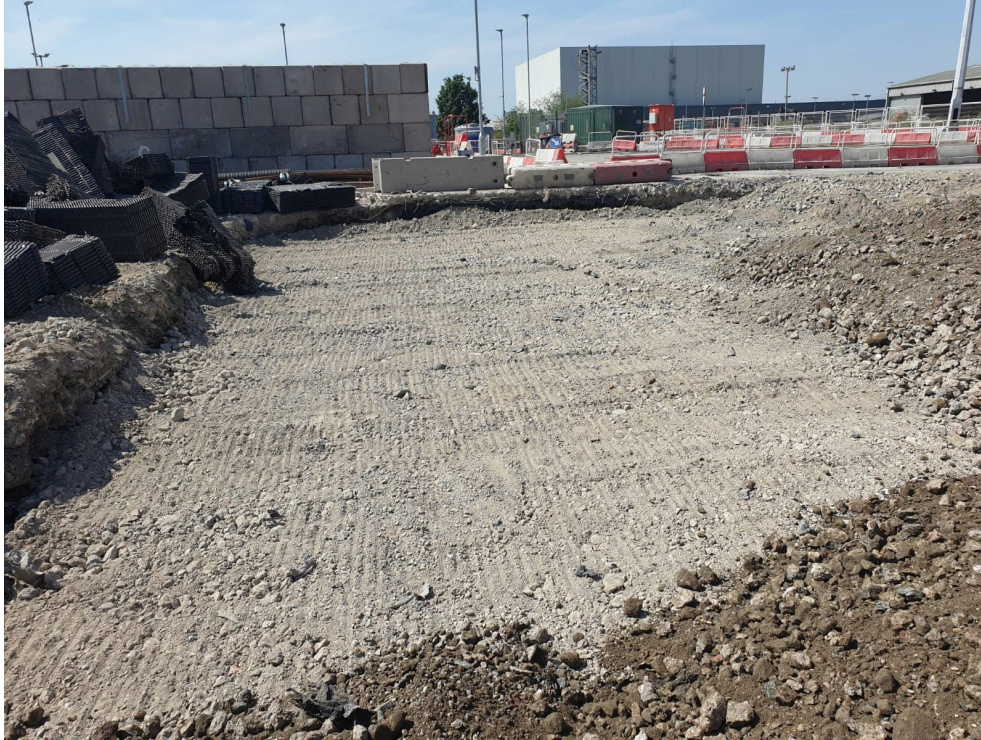
Photograph 2: The reinstated area following backfilling of the void left by attenuation tank removal, June 2023.

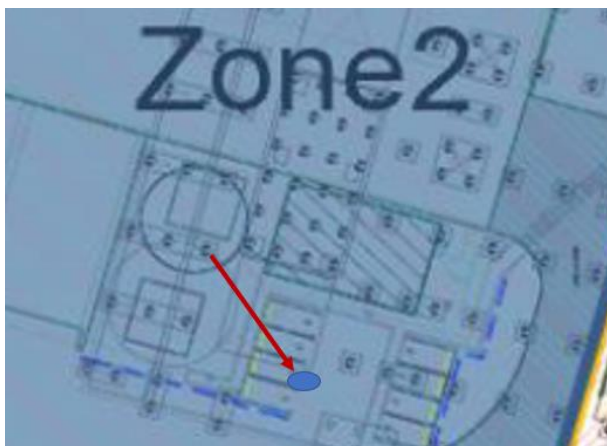
DSM have installed a metered standpipe on an existing hydrant on the boarder or Zones 2 / Zone 1a.

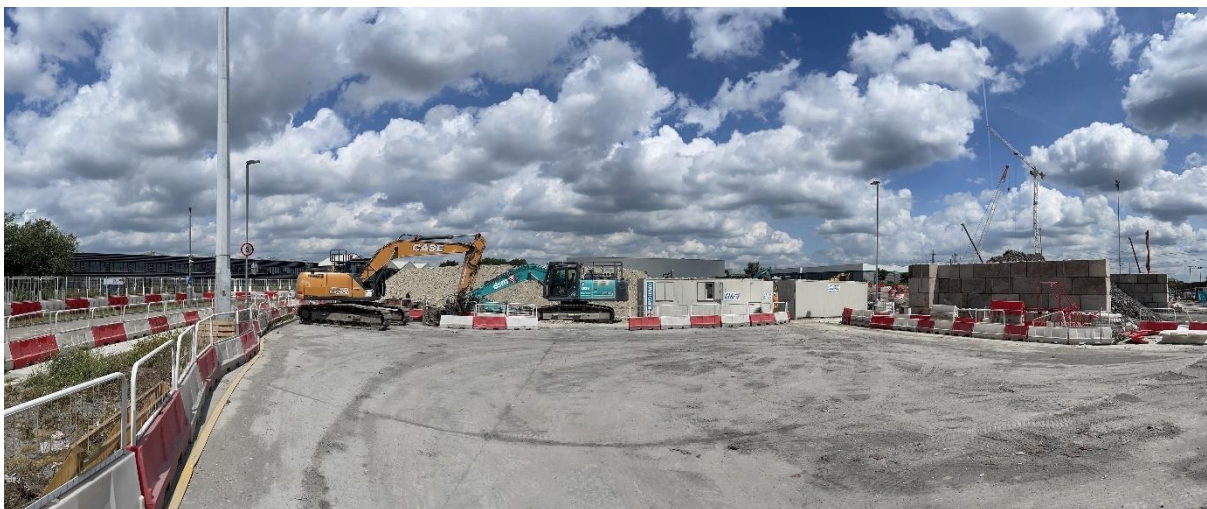
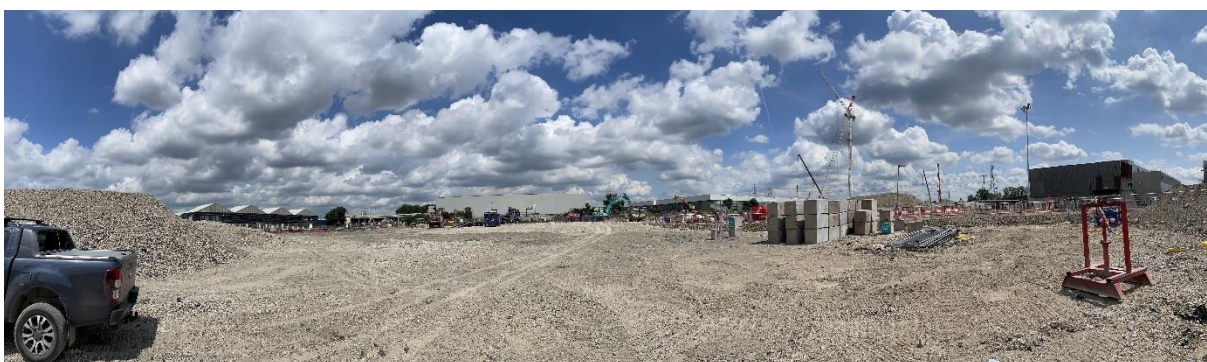
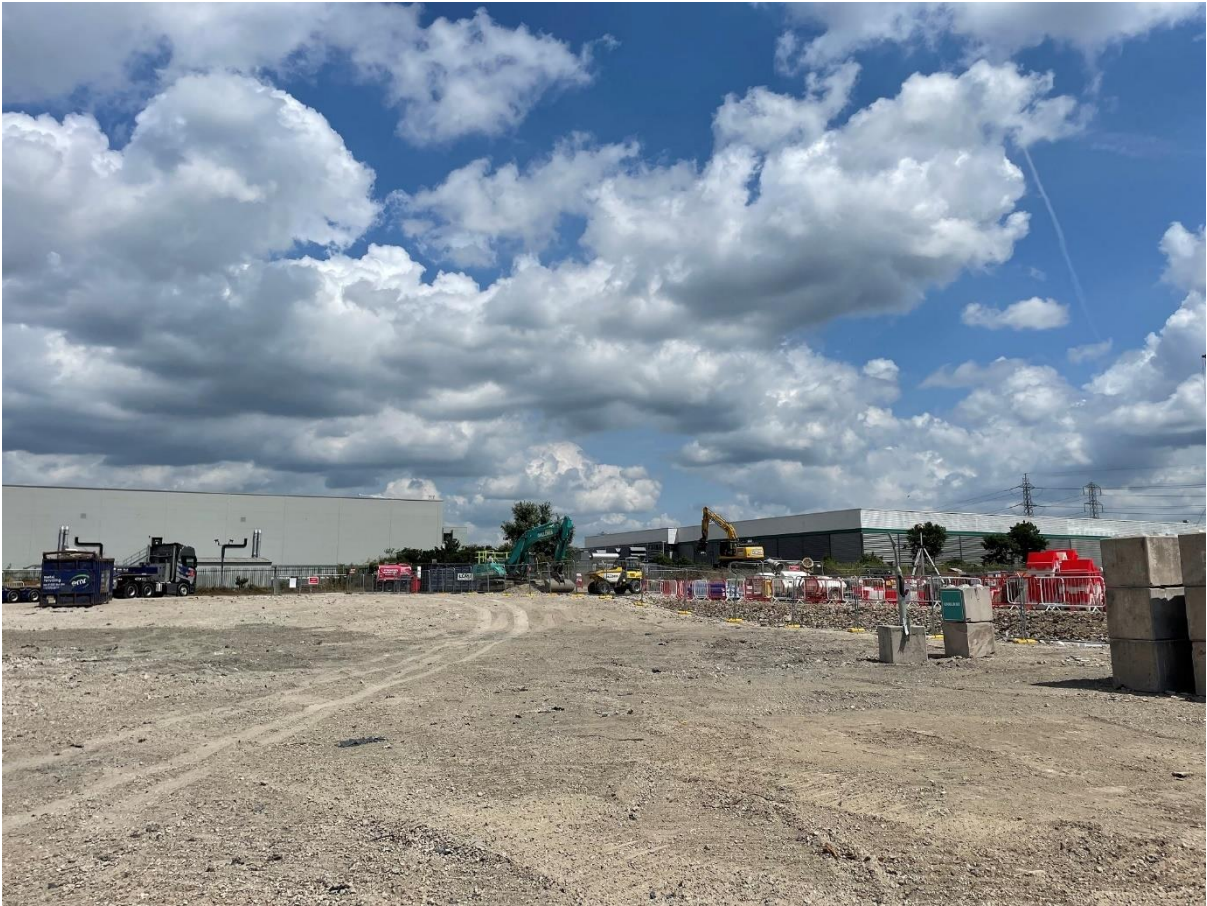
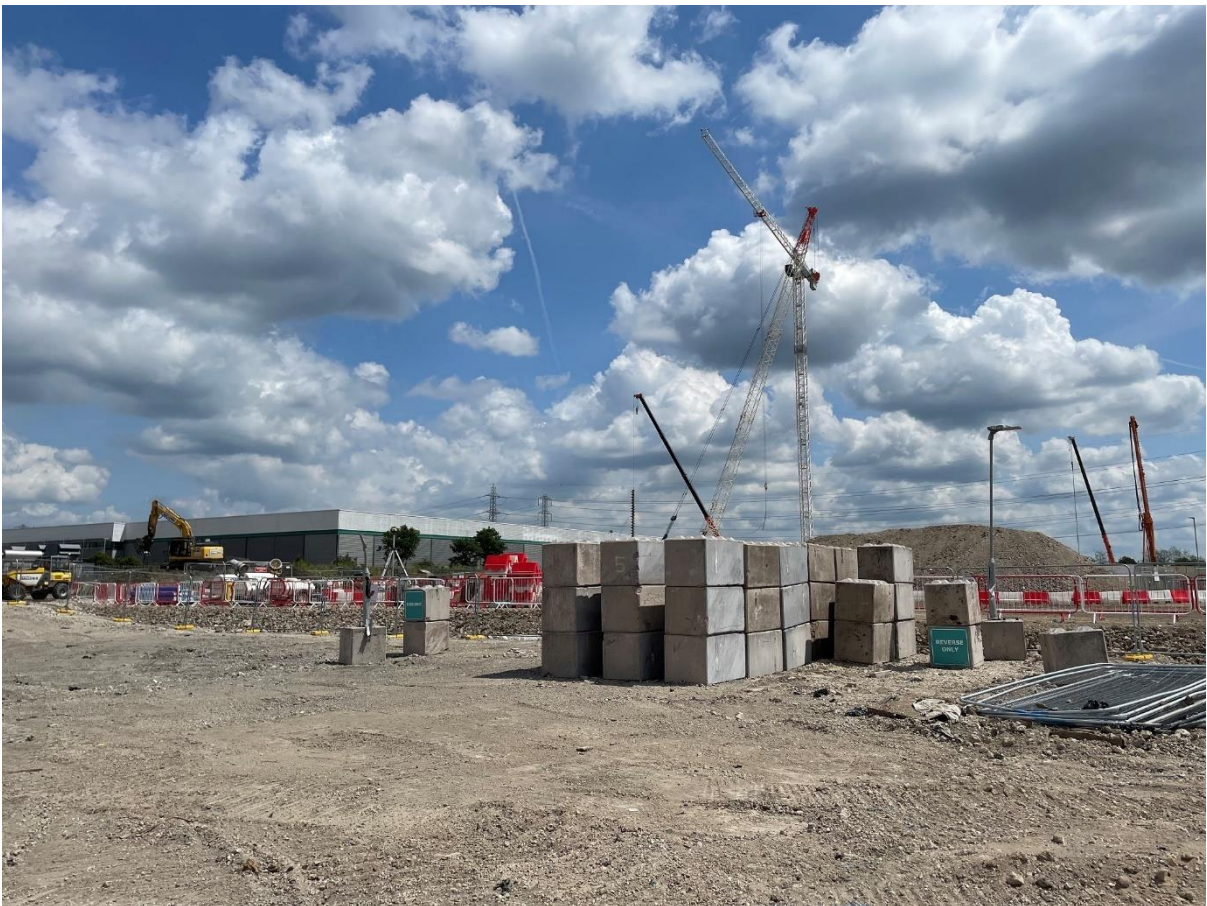
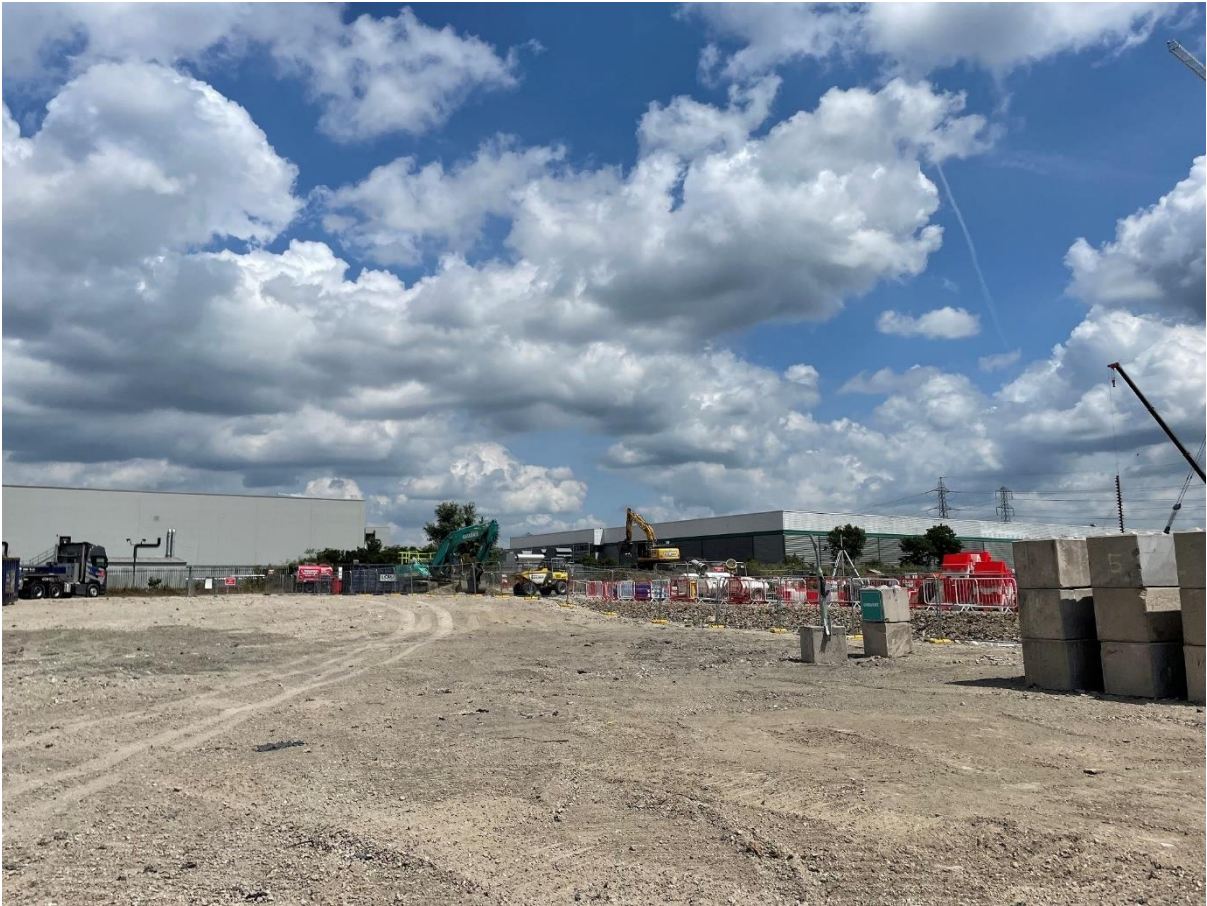
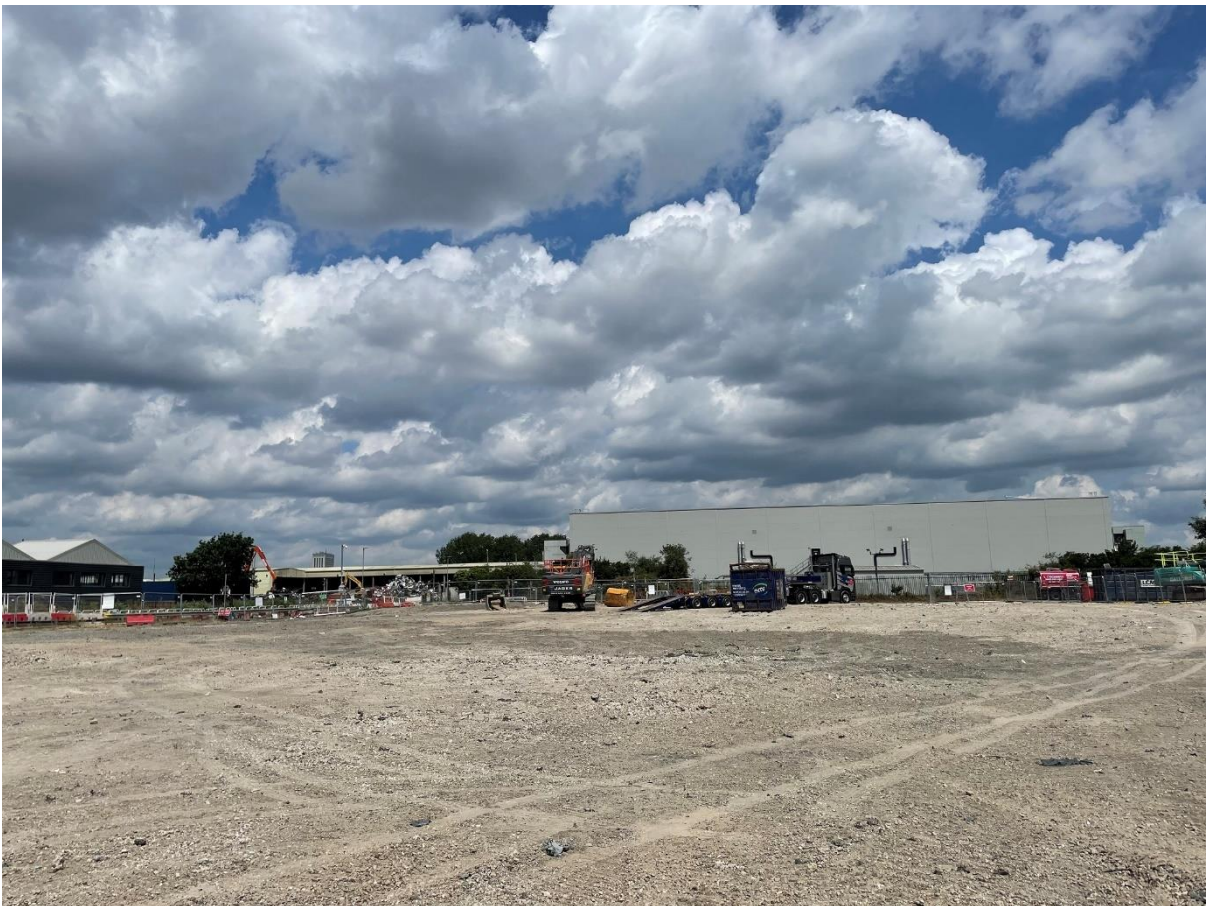
9. Site conditions upon handover to the client

Photos showing the condition of the site upon handover to the client on 16th June 2023. will be appended once the handover is complete.
