## Abbreviated Vibration Monitoring Reports

Monitoring Period: 30 March 2026 to 03 May 2026

**Project:** Grenfell Tower

**Document Ref:** EEMC-VMR-201/108 – Grenfell Tower Rev 00

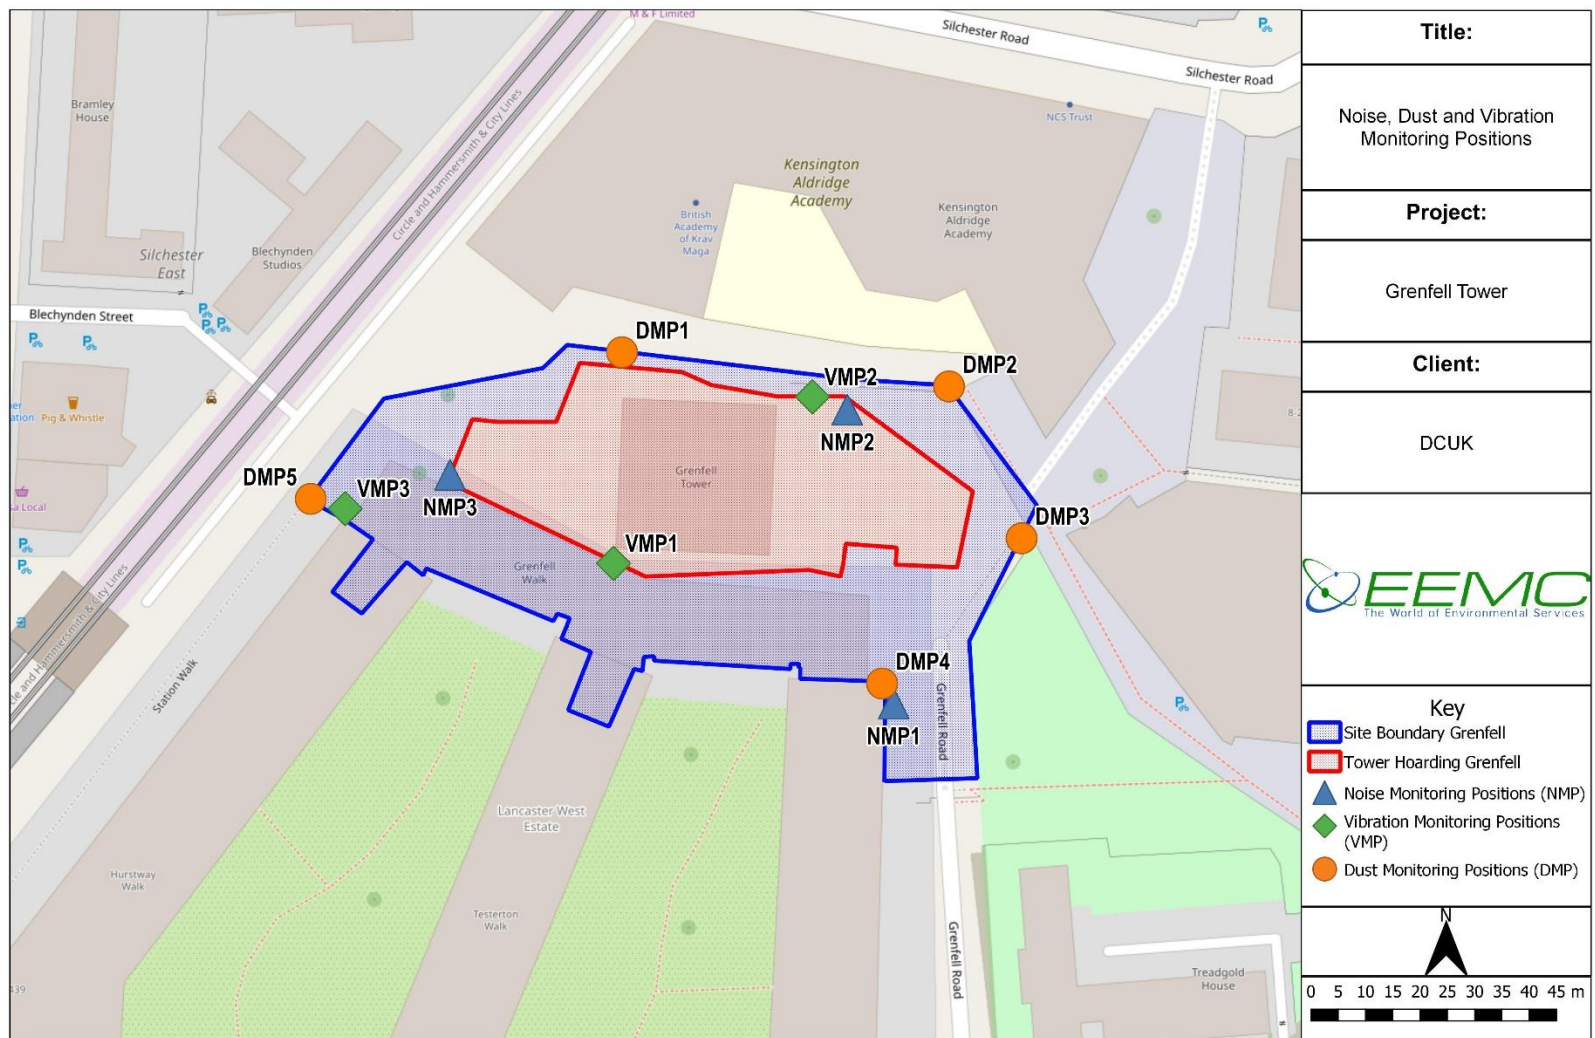
Figure 1- Map of Vibration, Dust & Vibration Monitoring Locations

The site boundary and hoarding line of this project is shown in Figure 1. The project is located at Grenfell Tower, Grenfell Road, W11 1TQ. The entire site is located within Royal Borough of Kensington & Chelsea (RBKC) and is bordered by residential blocks to the south, and a school and football pitches to the north and a leisure centre to the east. The London Underground viaduct is 70m to the west and Latimer Road Tube station is 200m from the project

The Swarm monitors record Peak Particle Velocity (PPV) in orthogonal (x, y and z) directions in mm/s continuously over 1-minute periods. A map showing the locations of the monitors is in Figure 1. A photograph showing the monitoring location is shown in Image 1.

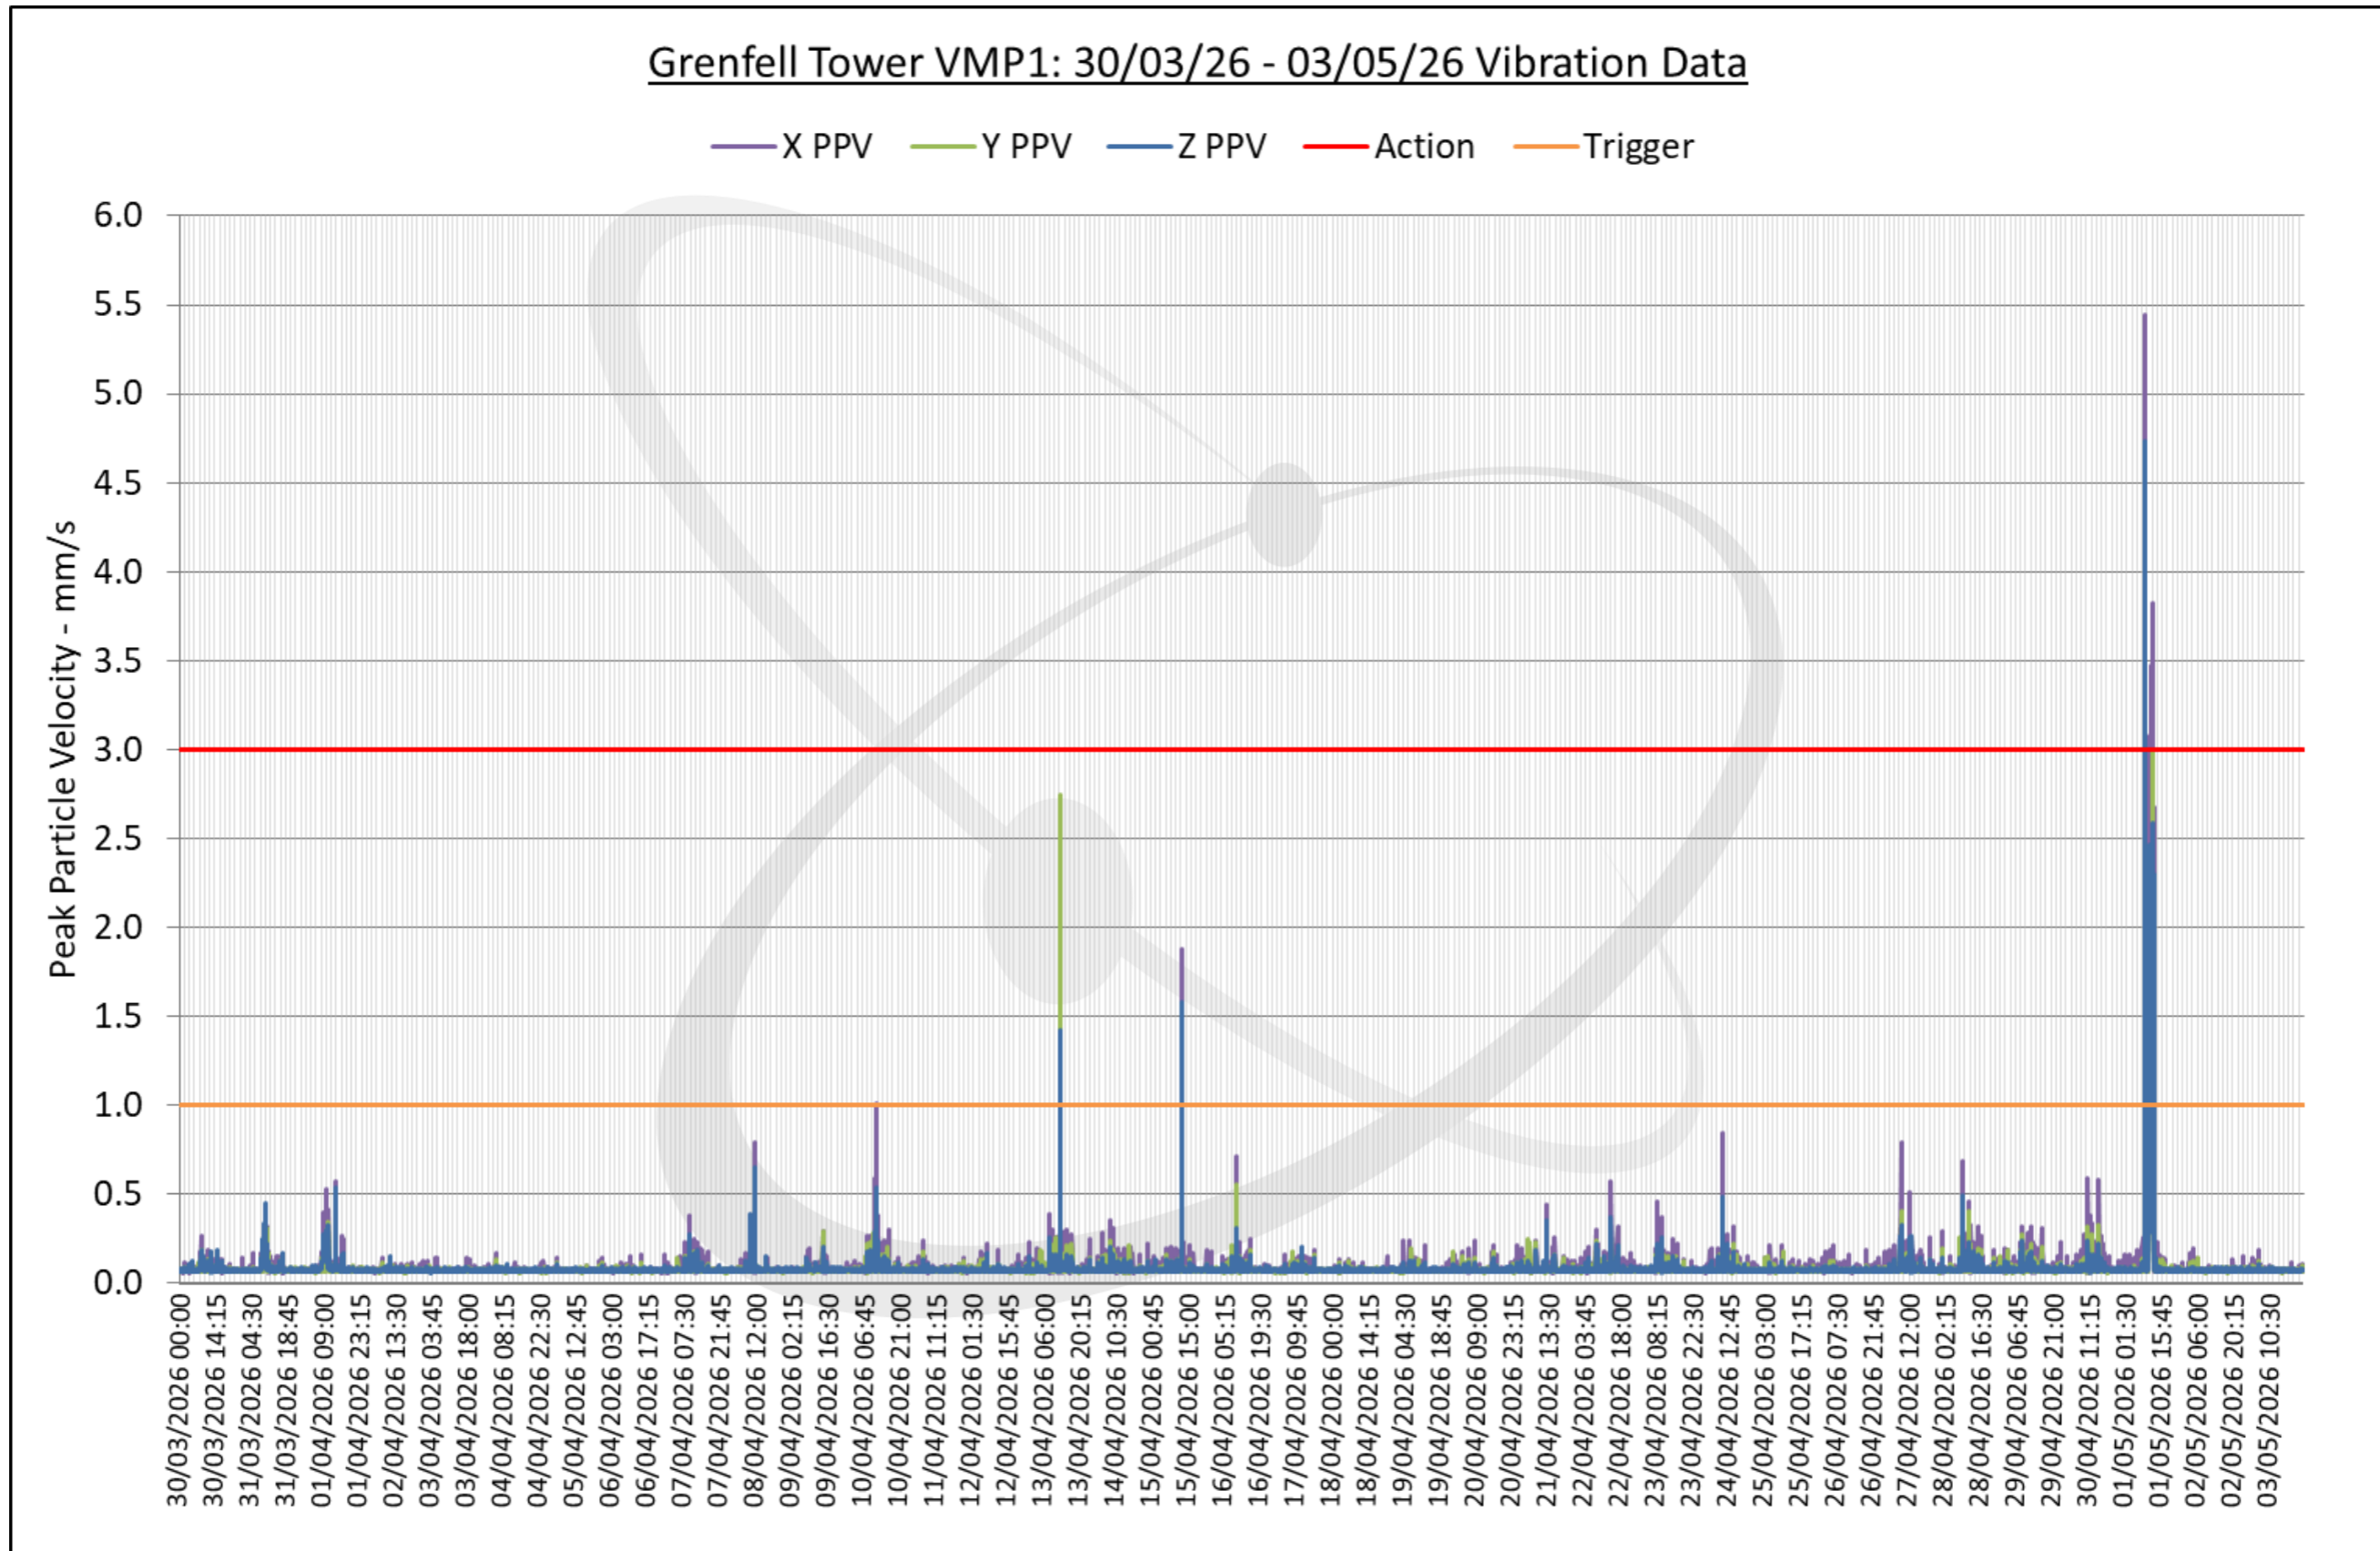
6. Vibration Monitoring Graphs

There were **five (5) exceedances** of the 3.0mm/s Red Action level, occurring mostly on 01 May 2026 and **twenty-four (24) exceedances** of the 1.0mm/s Amber Trigger level during working hours in this reporting period.

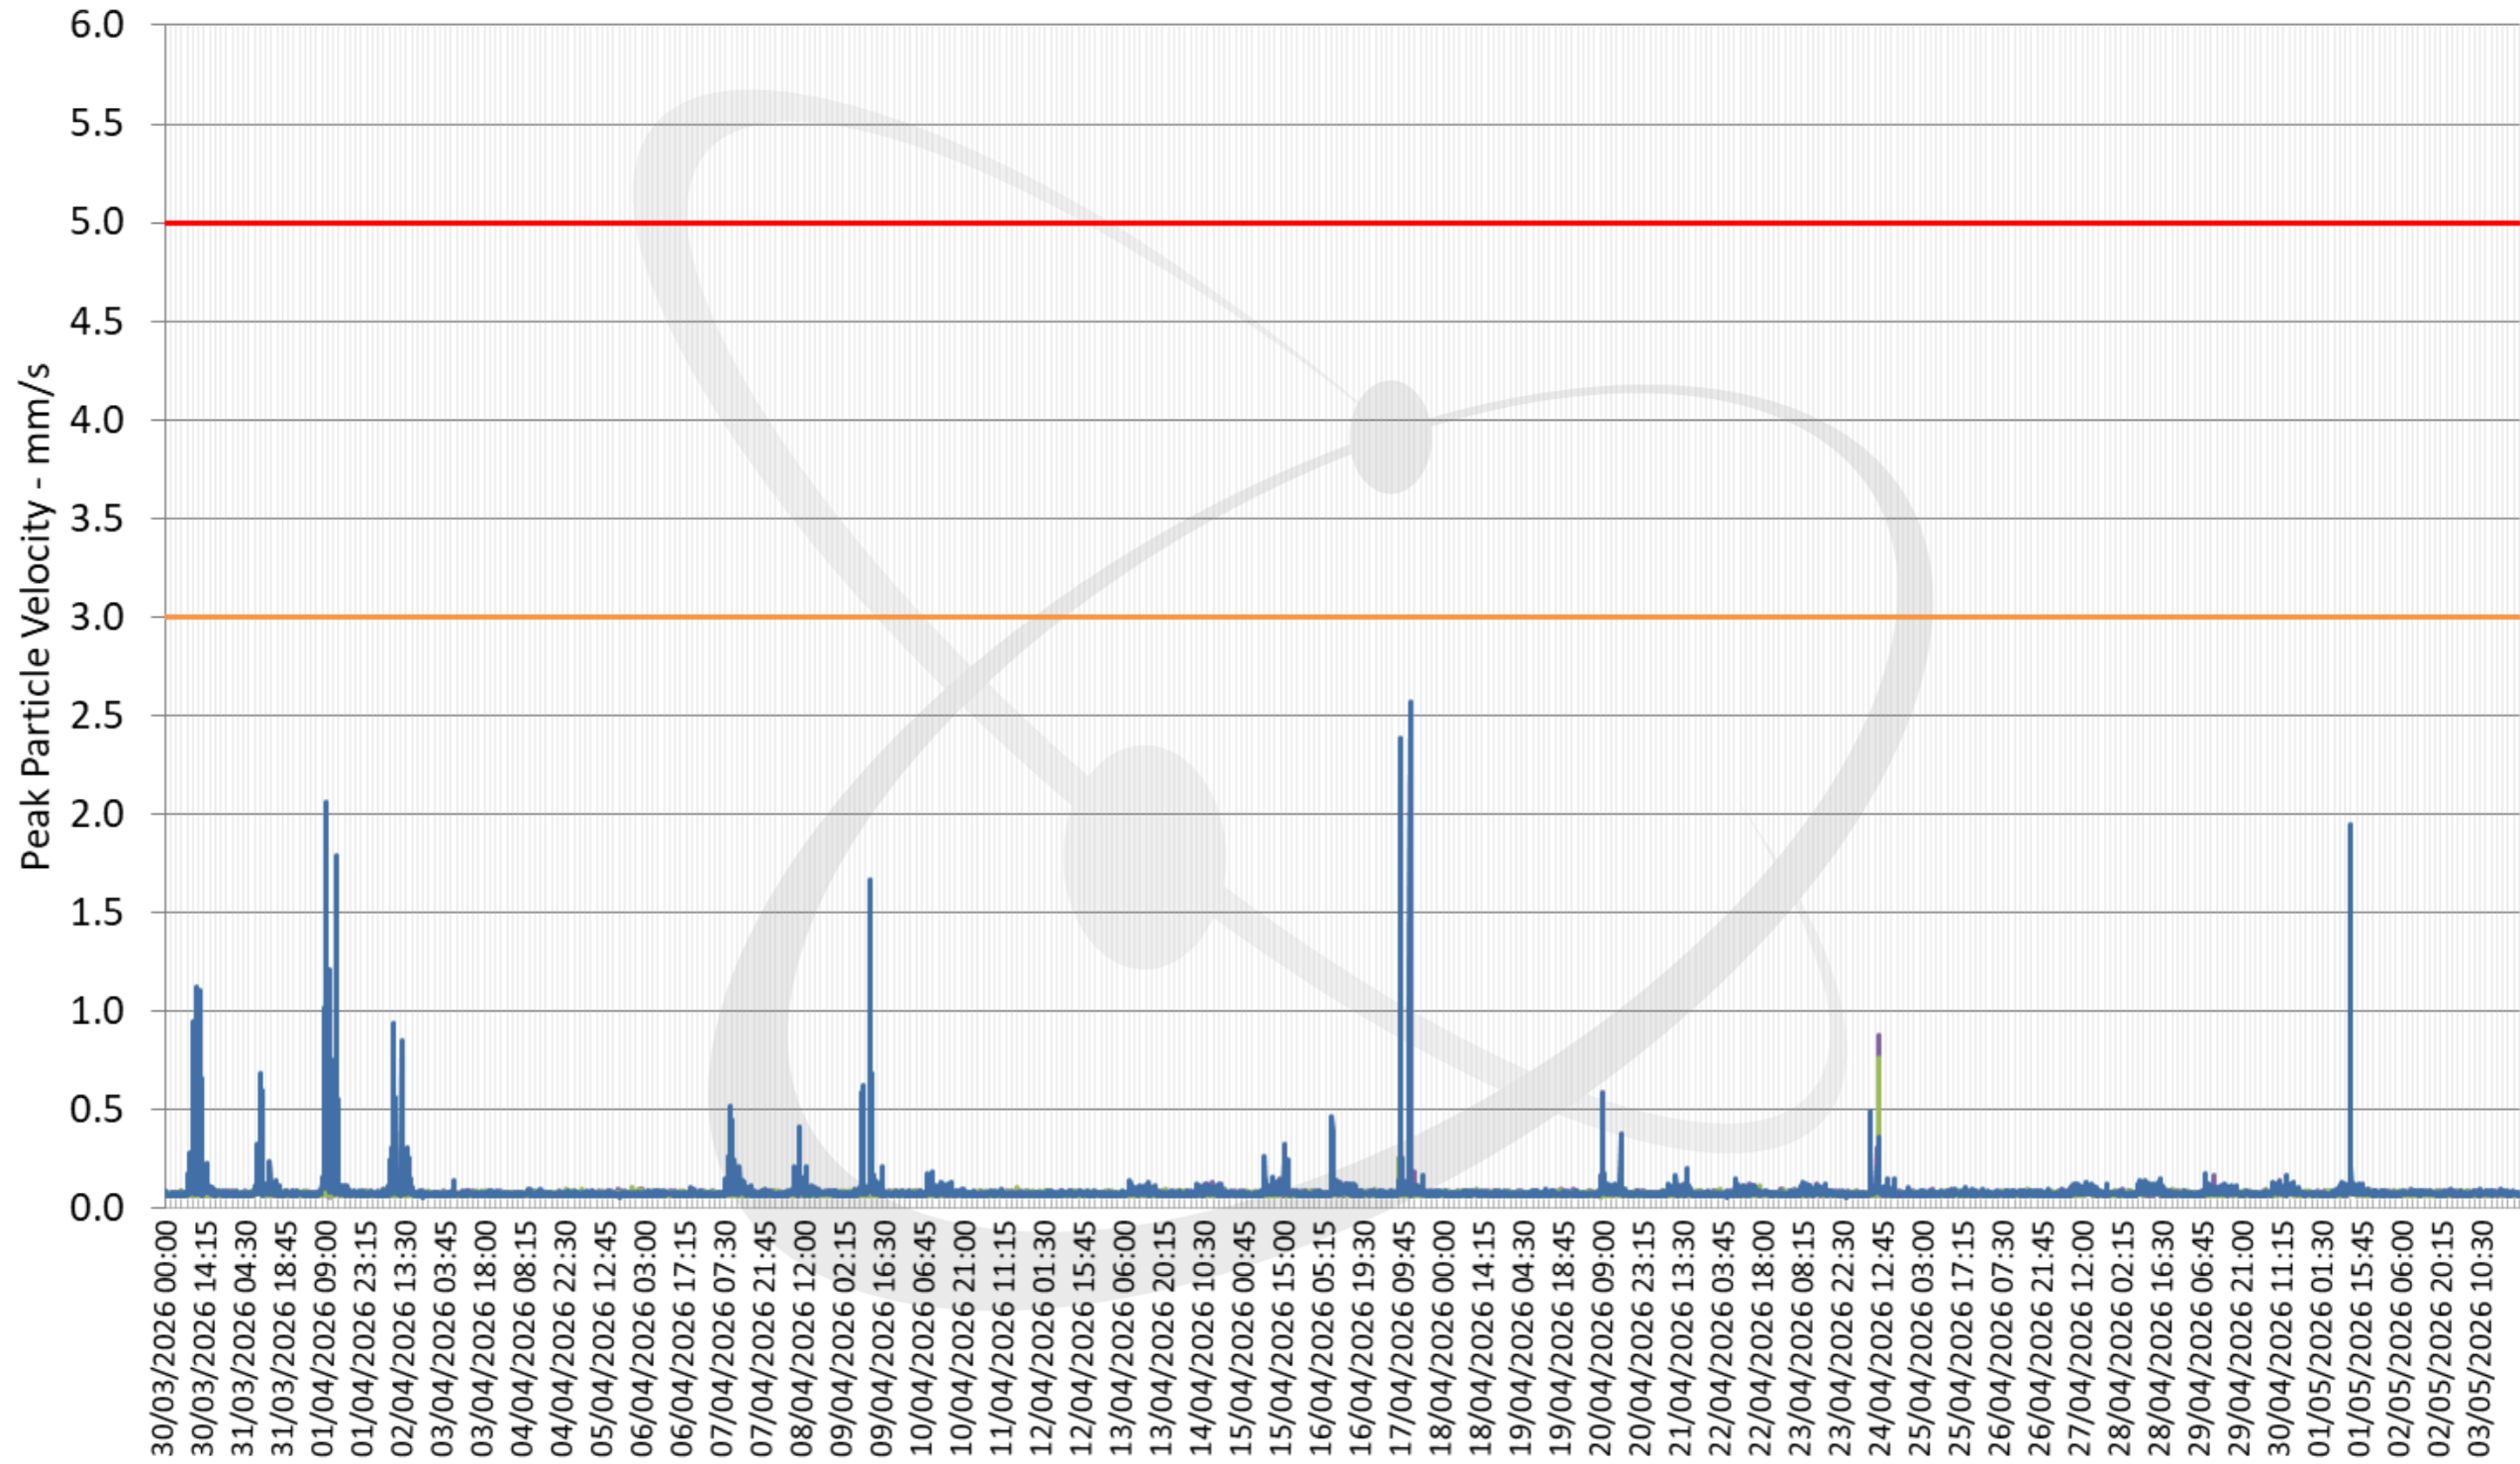
### Grenfell Tower VMP2: 30/03/26 - 03/05/26 Vibration Data

There were **no exceedances** of the Red Action level 5.0mm/s, or of the Amber Trigger level 3.0mm/s during working hours in this reporting period.

— X PPV — Y PPV — Z PPV — Action — Trigger

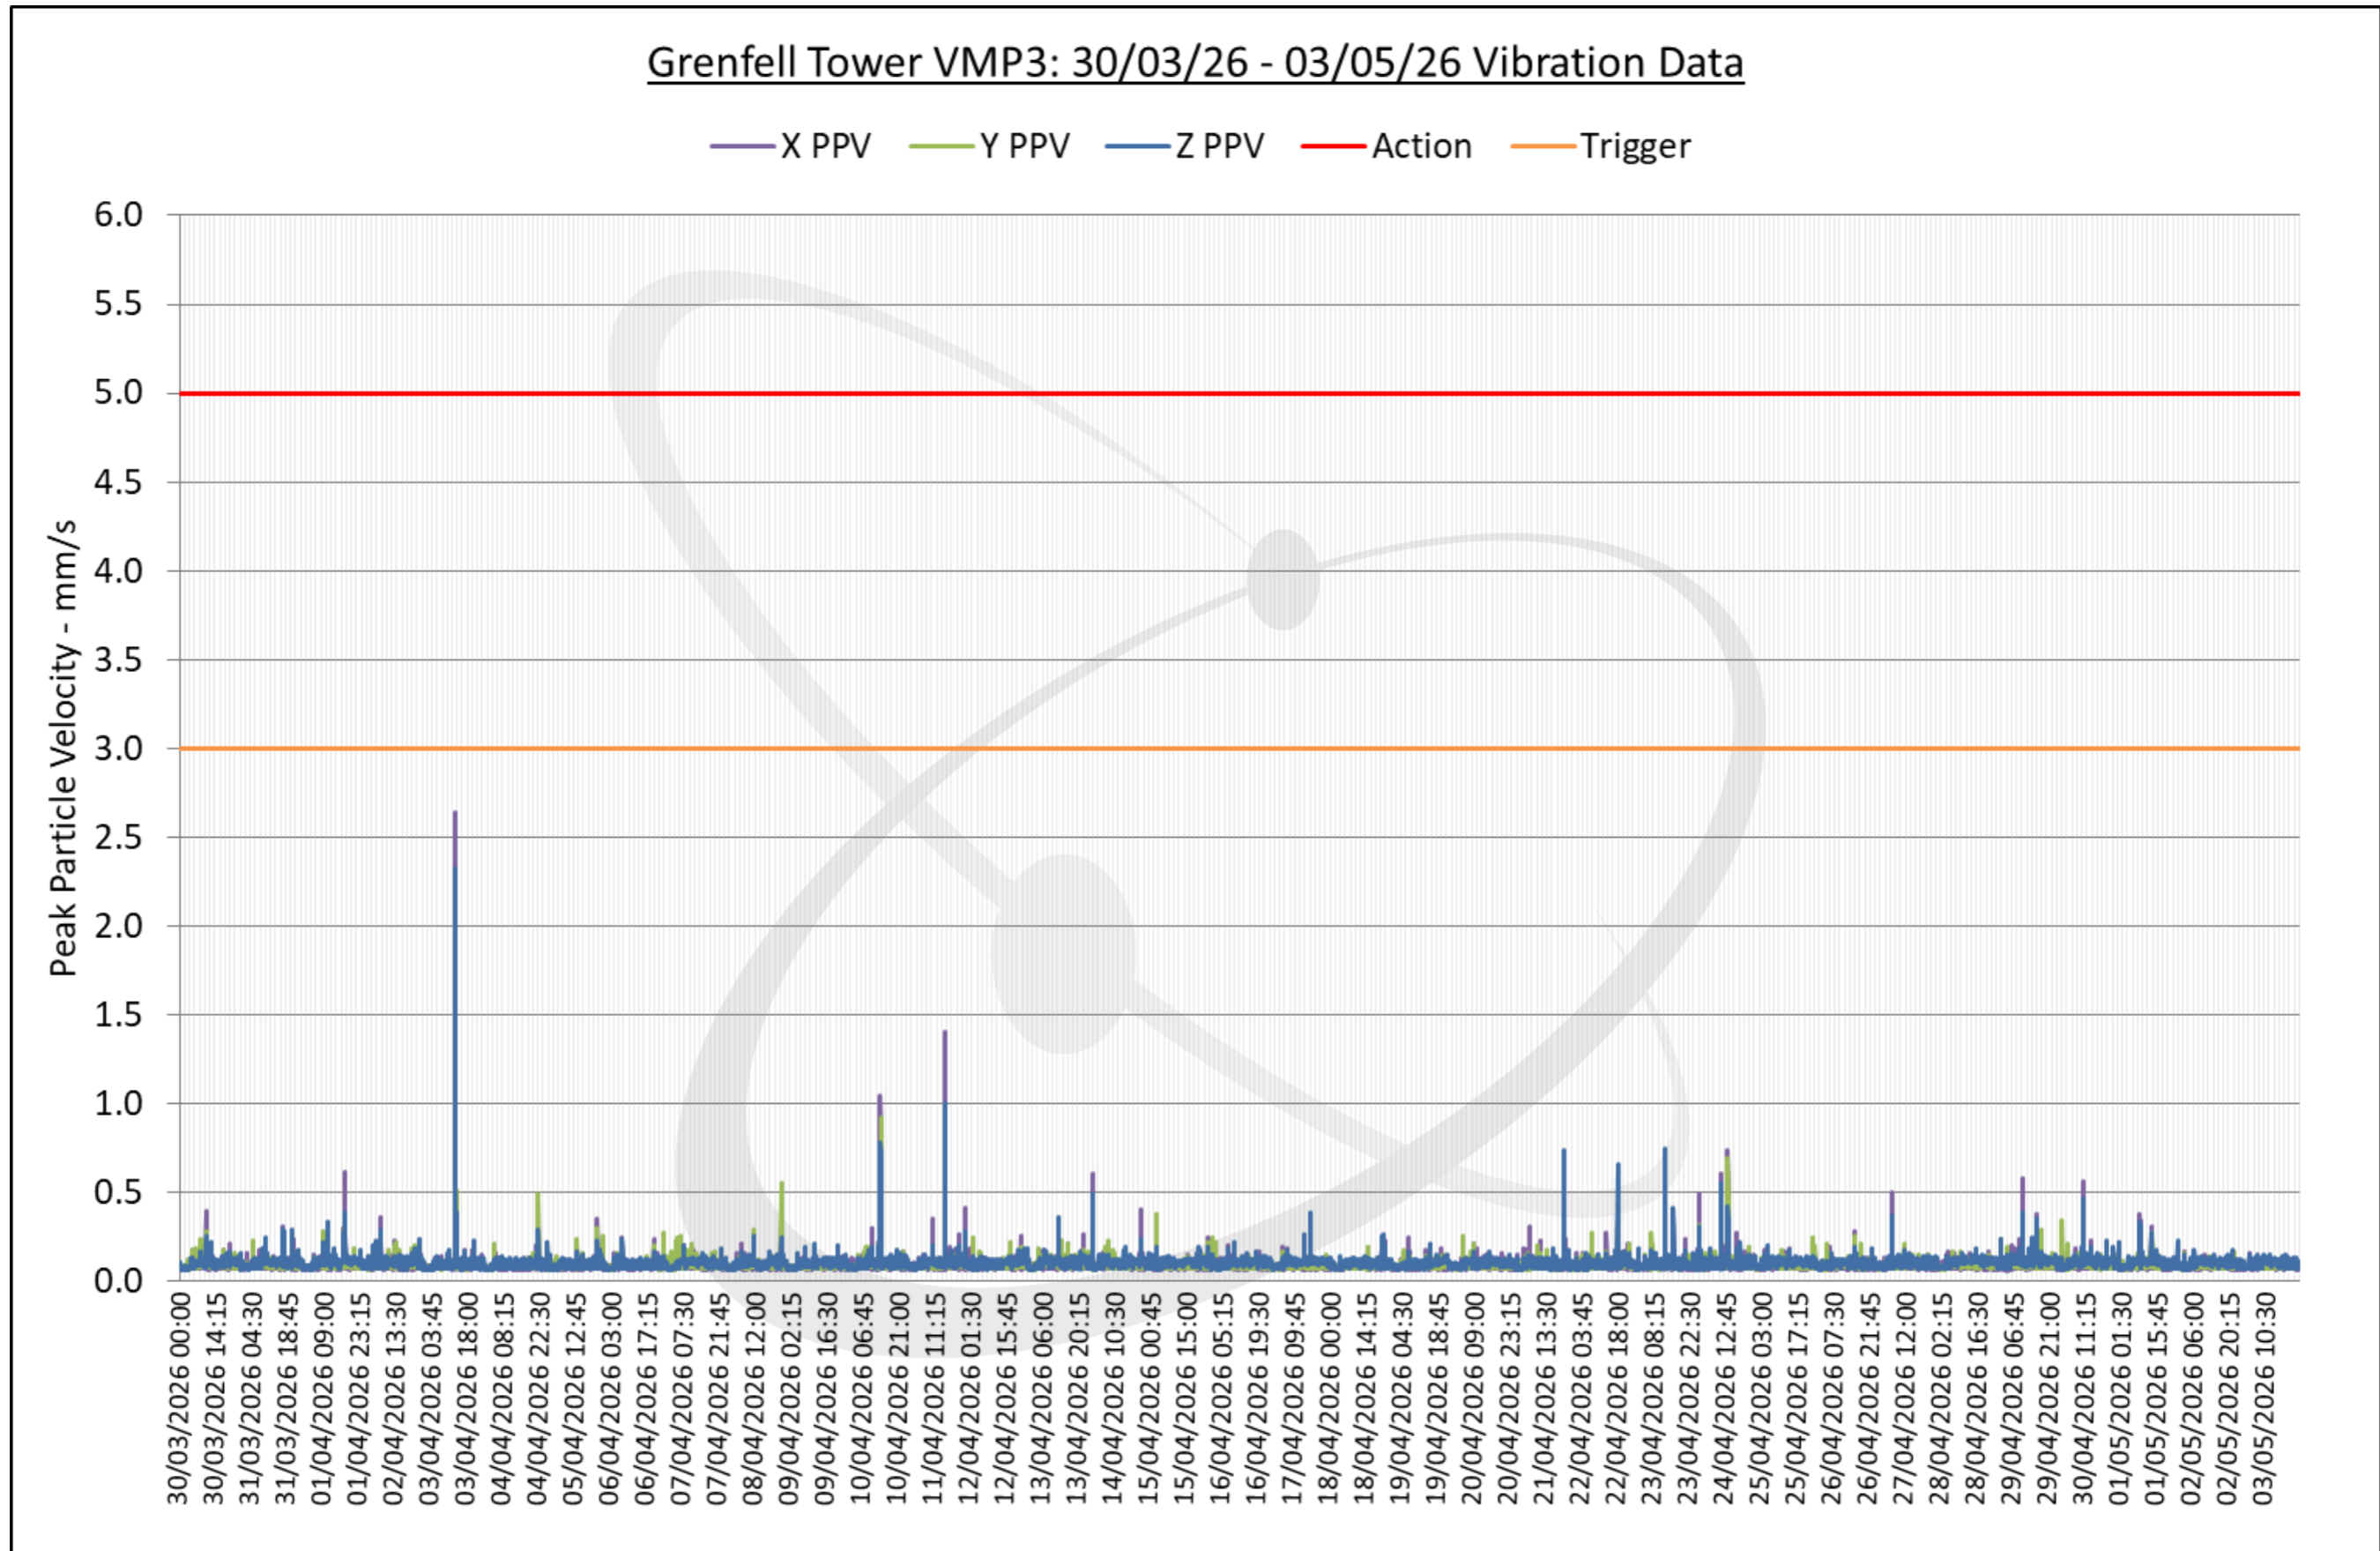
There were **no exceedances** of the Red Action level 5.0mm/s, or of the Amber Trigger level 3.0mm/s in this reporting period.
