## Housing Health and Safety Rating System (HHSRS)

## Case Studies

Hazard A1  
Falls on the Level

Example A1.3  
1946–1979  
Second-storey Flat  
(Non-HMO)

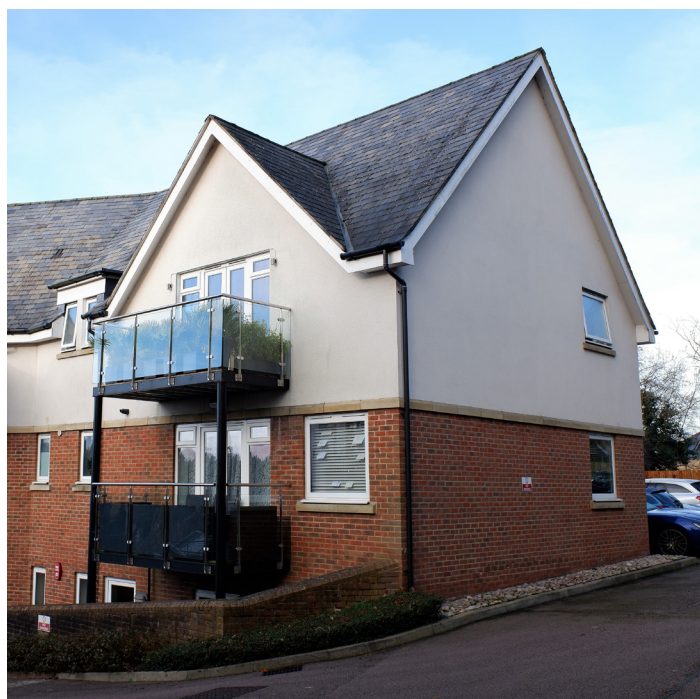
1

Front view of flat,  
the top right property

Externally there are two kerbs to cross to reach the wheeled bin store cupboards (visible at the right-hand side of the photo of the front of the flats). The external areas are well lit and well drained.

Provision of suitably positioned grab rails in the shower room and levelling the threshold to the balcony would be necessary to reduce the score to the national average. Provision of lowered kerbs/a ramp to the bin store access would reduce the risk further to a lower likelihood than average.

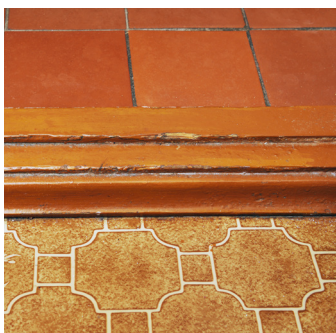
In the living room there is a 100mm step up and down to get through the patio door to the balcony.

2  
Raised threshold between living room and balcony
