Housing Health and Safety Rating System (HHSRS)

Hazard A1
Falls on the Level

Example A1.4
Post-1979
Mid-terraced
House

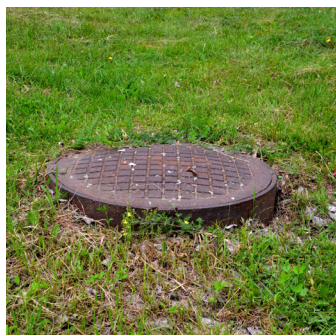
The enclosed rear garden, mainly laid to lawn, slopes steeply over the rear quarter of the overall garden depth, dropping some 920mm vertically over a horizontal distance of around 1.85 metres. In addition, there is a raised inspection chamber cover, projecting around 70mm above the level of the lawn, some 600mm beyond the edge of the patio at the rear of the house.

2
Raised inspection
chamber in lawn

The protruding inspection chamber cover in the lawn poses a clear trip risk. Occupants are likely to encounter this on a regular basis when gardening, hanging out washing or socialising. They are likely to be distracted by the activity they are involved in, and potentially carrying something (e.g. washing basket) that obstructs their view of the ground. Notably, a member of the vulnerable group is more likely to spend more time in the garden if retired. There is an external light (but only one), which is unlikely to light the rear garden adequately.

The protruding inspection chamber means that over a 12-month period there is an above-average risk of the vulnerable group tripping and falling.

The baseline indicators address the deficiencies present: BI 2.5 requires the inspection chamber cover to be flush with the surrounding surfaces, and BI 11.1 requires adequate external lighting to be provided. Complying with these indicators would return the likelihood to the national average.
