Housing Health and Safety Rating System (HHSRS)

Case Studies

Hazard A2
Falling on
Stairs etc.

Example A2.1
1920–45
Semi-detached House

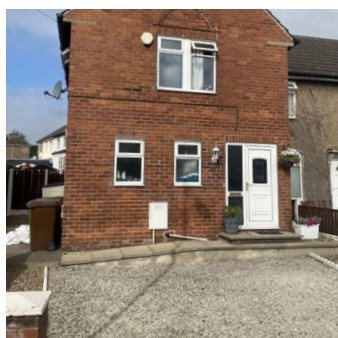
1
Front view of house with front entrance door and slope/step access

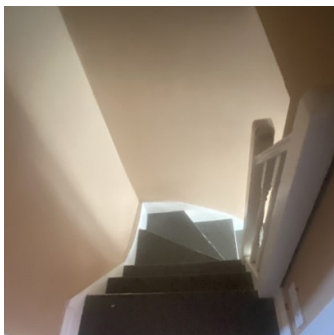
There is no natural light on the first-floor landing, making the edge of the top step difficult to see when going down the stairs. The light switches for the stairs light are inconveniently located, i.e. more than arm's length from the top or bottom step, meaning the occupant would be unlikely to use either switch.

The stairs from ground to first floor have three angled steps providing a 90 degree turn at the mid-point, and there is a handrail on one side of the stairs only. The handrail on the inside of the turn of the stairs does not run the full length of the stairs, and the newel post at the turn of the stairs is difficult to hold. The electrical socket at the top of the stairs increases risk of trips.

3
Staircase looking down
from first floor landing

The internal staircase would benefit from the implementation of baseline indicators 12.4 and 14.2 and it is anticipated that 'controllable and accessible' lighting would require the light switches to be moved to more useful locations. Other baseline indicators would ensure that the slope and steps to the front are in good repair and provided with a greater level of frictional quality, with appropriate lighting. As the slope and step do not amount to 'four or more risers' as described by 12.4, the requirement for a continuous handrail is not applicable. As such, the likelihood score will still be higher than average.

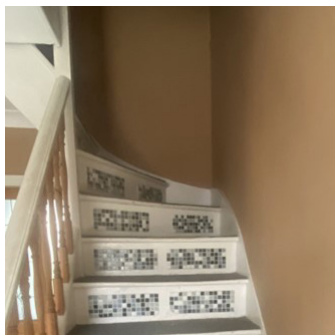
4
Staircase looking up from
ground floor hallway

The staircase between the ground and first floors has an interrupted handrail. The missing section of handrail is where it is needed most, namely at the winder. Stairs with winders command concentration, and as such there is usually a reduced likelihood of falls in comparison with straight staircases. There is a lack of natural lighting at the top of the stairs, making it difficult to judge the first step, and due to the proximity of the electrical socket to this unlit area, there is a potential for equipment or trailing wires (or even the fear of them) to break the concentration of the vulnerable age group when commencing their descent. The staircase will be used frequently to access the sanitary provisions and bedrooms, including during in the evening when the house will be naturally darker. The inconvenient positioning of the light switches may lead to attempts to navigate the staircase in dark conditions, increasing the likelihood of a harmful occurrence to a member of the vulnerable age group.

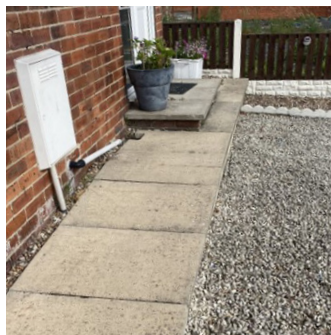
The sloped pathway and step to the entrance has no guarding or handrail.

5
Sloped pathway leading to
front door steps

In order to access the front entrance, an occupier (or visitor) in the vulnerable age group of 60 years and over must negotiate the sloped pathway and step up to the front entrance door. This sloped pathway and step has no guarding or handrail, which, as suggested in the Inspection and Assessment Manual, will double the likelihood of a fall. This is the main entrance to the property and will be used daily irrespective of weather conditions, increasing the likelihood of a fall due to slips in wet or freezing conditions. This is compounded by reduced coordination and balance of those in the vulnerable age group in cold conditions.

A well-anchored, structurally secure handrail should be provided to the right-hand side (ascending) of the slope and steps to reduce risk of falls. The hand grip should be designed to facilitate safe use, bearing in mind that it is in an external environment. Along the ramp, it should be 900–1100mm high, measured vertically from the floor; and to the right of the steps should be 900–1000mm high from the pitch line to the top of the handrail. An additional continuous handrail that is structurally sound should be provided to the internal staircase right-hand side wall (looking upwards to the staircase), including to the stair winder, fitted 900–1100mm high when measured from the pitch line to the top of the handrail. The handrail shall be fastened firmly to the wall, capable of supporting a load of 140kg and in good condition.
