Housing Health and Safety Rating System (HHSRS)

Hazard A4
Fire and Explosions

Example A4.2
Pre-1920
Mid-terrace Maisonette
(FMO)

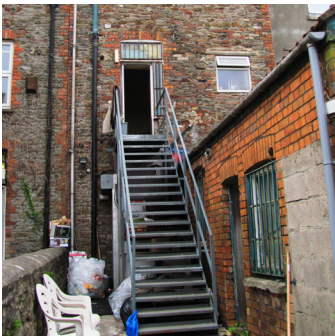
2
Entrance to the
maisonette via the rear

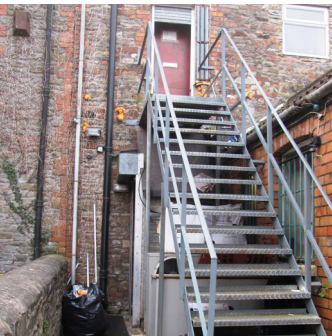
3
Close-up of rear entrance

There is a key-operated lock on the kitchen entrance door, as opposed to a preferred thumb-turn lock. None of the windows conform to escape standard so the only means of escape is via the lounge/kitchen, containing a gas hob and gas-fired boiler. There is no Gas Safe certificate for the gas installations.

There is no external lighting to the metal stairs or the rear yard, nor is there any emergency lighting within the maisonette. The only natural light to the internal stairs is from the front dormer window in the attic, though PIR-triggered artificial light is available.

Compliance with the BIs would ensure the provision of external and emergency lighting, a thumb-turn lock for the final exit-door, and the testing and certifying of the electrics and gas appliances as safe. They would also address the condition of the fire alarm system, specifying a control panel for the fire alarm located within the residential premises.

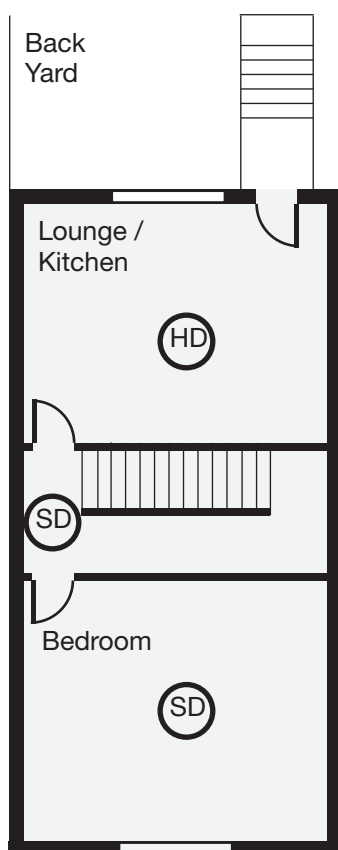
5
First Floor

The mains-wired fire alarm system interlinked to the ground-floor commercial premises is not working. The system incorporates call points at all levels and battery back-up, with detectors used throughout. The control panel is contained in the commercial premises and inaccessible to the residential element. The internal walls and floors, including the floor separating the commercial premises from the maisonette, provide 30 minutes of fire protection.

Works carried out to comply with BI 19.6 should also result in a re-orientation of rooms in the property and specifically the removal of the shared kitchen from its current location to one where it can be compartmentalised and not form part of the means of escape.

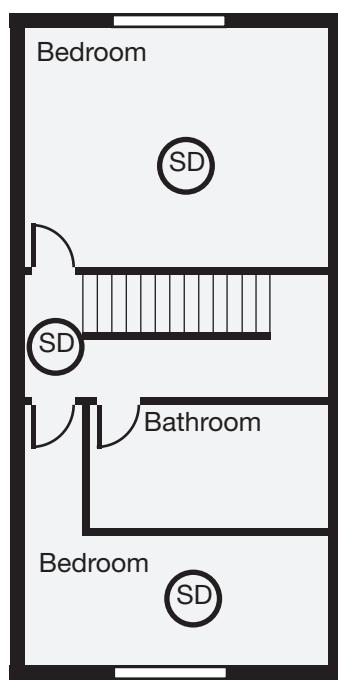
6
Second Floor

All the internal doors are well-fitting wood-panel doors, not fire doors. Each door has a door closer and is fitted with a thumb-turn lock. The walls to the common halls/landings are lined with painted woodchip wallpaper. The bottom of the external stairs is next to the rear entrance door and window to the baker's shop, both of which are rated as 30-minute fire resistant.
