## Housing Health and Safety Rating System (HHSRS)

## Case Studies

Hazard A4  
Fire and Explosions

Example A4.3  
1946–79  
Shared house  
HMO

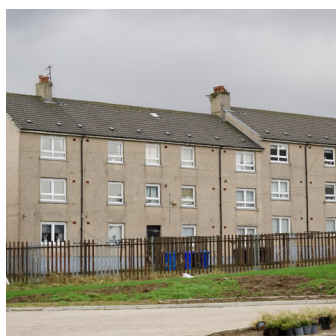
1  
Front exterior

This is a three-storey, mid-terrace HMO with six bedsits, one on the ground floor, two on the first floor and three on the top floor. The two first-floor bedrooms can accommodate up to two persons each, but the other four bedsits are for one person.

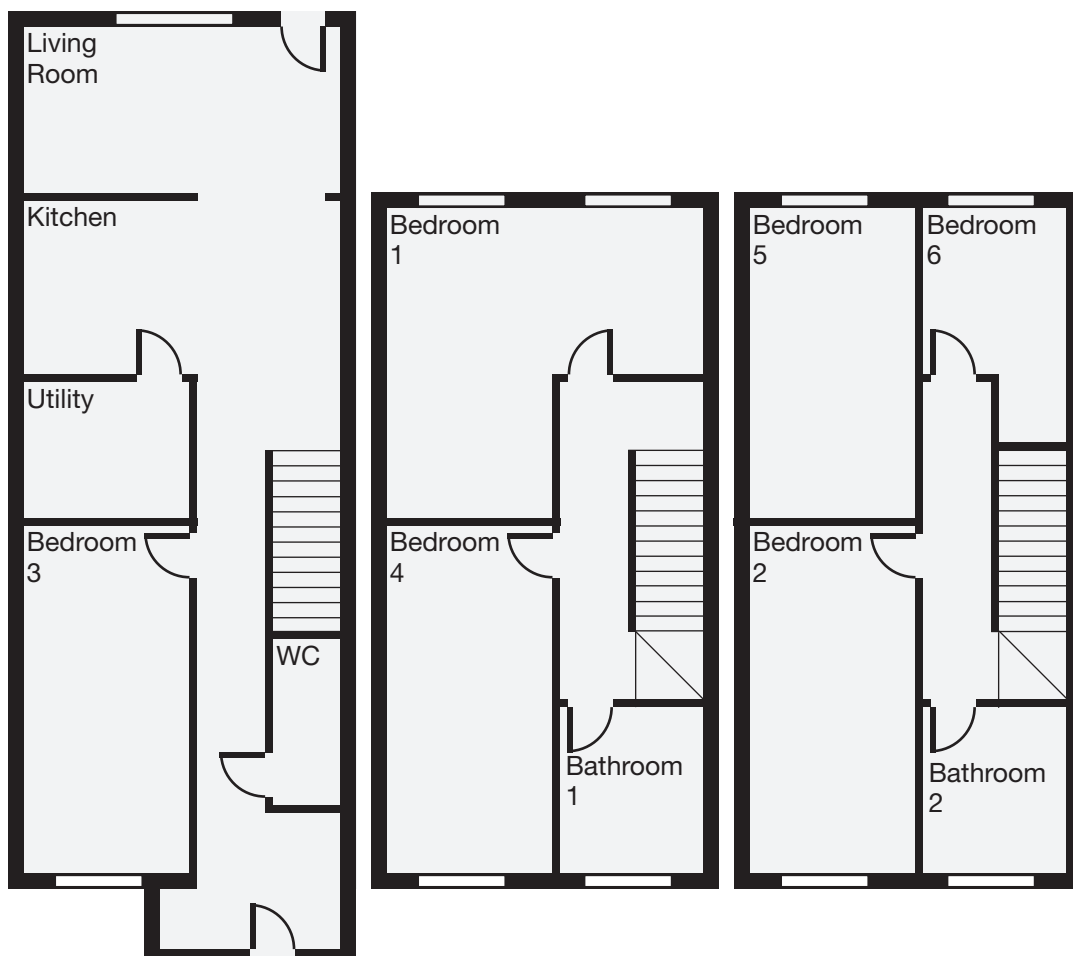
2  
Floorplan

The timber-panel front door is provided with a chain and thumb-turn 'Yale' type lock, which opens onto an internal porch with a separate handle timber door with no locks. The rear uPVC door incorporates a key-turn combination lock. The first-floor windows are escape windows. Walls and ceilings provide 30 minutes' fire resistance. Each tenant has a microwave in their bedroom as well as a TV and computer equipment. There is suitable directional fire safety signage.

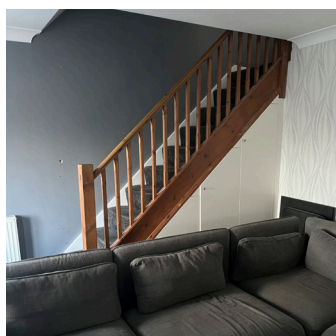
3  
Open plan stairs into living room

All internal doors are standard solid wood-panel doors without door closers. The bedroom doors have key-operated locks. The ground-floor stairs open onto the open-plan kitchen/living room, and the staircase is not enclosed. The battery-operated smoke alarms originally provided on each floor have all been removed or damaged at some stage, with no replacements provided. Three fire extinguishers (water) are provided, one to each floor. They do not appear to have been serviced in the last 5 years. No fire blanket has been provided in the kitchen.

If a fire were to occur, factors that would significantly increase the risk that occupants could suffer harm requiring medical intervention are the lack of any fire doors; the escape route being via the kitchen; and absence of a fire detection and alarm system.

Compliance with the baseline indicators would result in the installation of a mains-wired fire detection and alarm system (enabling early warning in the event of a fire and providing adequate time to escape), a protected fire escape route that avoids passing through a high-risk room, and keyless door locks. Improvement to the escape route would also be implemented by provision of external lighting to the rear yard (the secondary escape route), emergency lighting on the stairs and the installation of fire doors.

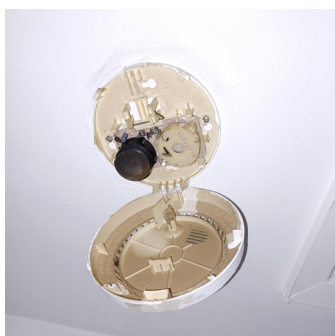
4  
Broken smoke detector

There are numerous deficiencies increasing the risk of injury. There is no functioning fire alarm system to alert occupants to an issue or hasten evacuation, and the open staircase results in a non-protected escape route and lacks any barrier to smoke travel from the open-plan communal living. Some mitigation exists by virtue of escape routes from the front and rear of the property and first-floor escape windows.
