## Housing Health and Safety Rating System (HHSRS)

## Case Studies

Hazard A4  
Fire and Explosions

Example A4.4  
1920–1945  
Detached House

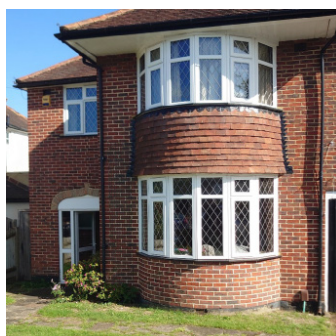
1

This was originally constructed as a three-bedroomed, two-storey detached house. It was built in the 1930s and is of brick (cavity) under a concrete tiled roof. A two-storey extension was added in the 1980s, housing a study on the ground floor and a fourth bedroom with ensuite on the first floor.

Front exterior

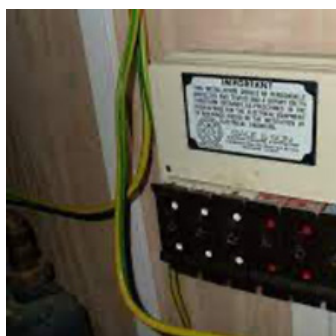
The property has what appears to be a 1960s/70s electrical installation with typical re-wirable fuses. Some additions have been installed at a later date, such as those for the 1980s extension.

2  
Rewireable fuse board

There is no gas safety certificate or electrical installation report. The property has what appears to be a 1960s/70s electrical installation with typical re-wirable fuses. The old and unmaintained electrical installation combined with insufficient sockets in the bedrooms increases the risk of fire from electrical overloading.

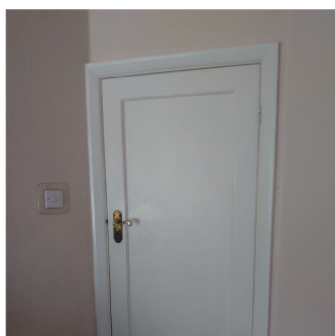
All internal doors – with the exception of the doors to the study, the ensuite and basement WC (each being a hollow composite door) – are well-fitting, original timber panelled doors. This includes the door down to the basement.

3  
Timber panel door

Provision of an escape window from the study would reduce the risk posed by this inner room, which is likely to be in regular use, and installation of fire doors throughout the dwelling would further protect the route of escape.

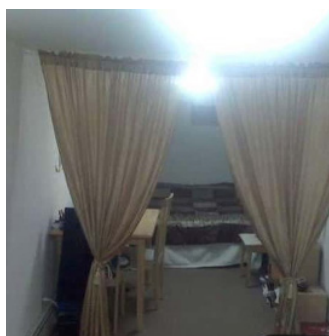
The heating system does not extend to the basement. Instead an LPG cylinder portable gas fire is present. In addition to the LPG cylinder in use, there are two empty and one full LPG cylinders stored in the basement. The basement has no windows or ventilation, natural or mechanical. In addition, the basement houses the gas and electrical meters and the fuse board.

4  
Basement bedroom

The heating system does not extend to the basement; instead, an LPG cylinder portable gas fire is present. The basement is unventilated, having no windows or any other form of ventilation. LPG cylinders – both empty and charged – are stored in the basement, which also houses the gas and electrical meters and the fuse board. The storage and use of LPG cylinders for heating in an unventilated basement increases the risk of fire and also explosion if LPG leaks into the unventilated space. The heater could be knocked over or come into direct contact with clothing or other furnishings, causing a fire.

Meeting the baseline indicators would see the removal of the portable LPG heater and spare cylinders from the basement and their replacement with an appropriate heating system, ideally extending the current gas-fired central heating system into this area. Compliance with the BIs would also address the lack of smoke detection via the installation of a dwelling-appropriate system, the absence of a thumb-turn lock to the front door and inadequate external lighting. A gas safety check and an electrical installation condition report would be arranged, with work being carried out to achieve a satisfactory rating. This would include the provision of at least two double electrical sockets in each habitable room and four double sockets in the kitchen. In combination, these measures should reduce risk considerably, but the issue of the inner room (study) and the basement having one means of access remains, with harm outcomes still slightly increased as a result.

The installation of a domestic sprinkler system could mitigate the risk of fire and explosions posed by use of the basement as a bedroom. This area, however, lacks any natural lighting or ventilation, therefore the dwelling would require assessment under other hazard areas, which would ultimately impact the decisions made regarding its use.
