Housing Health and Safety
Rating System (HHSRS)

Hazard A7
Structural Collapse
and Falling Elements

Example A7.3
Pre-1920
Flat

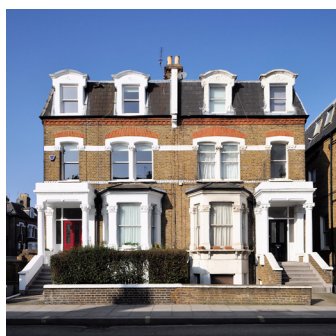
The front façade overlooking the street has been refurbished, including the front roof. The original tall chimneys and pots are in place.

1
Front exterior

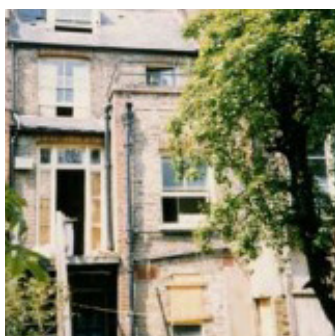
Solid brick walls and original windows are in sound condition, as is the small roof terrace and external stairs and balustrades at the rear.

2
Communal rear yard:
stairs to basement flat,
roof terrace garden

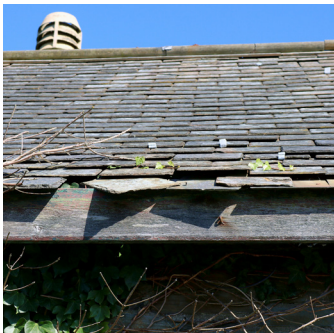
The rear roof is affected by 'nail sickness', with many slipped and some missing slates. The rear eaves gutter is loose. Chimney pots also appear unstable.

3
Roof with slipped and missing slates

Elements of the building at risk of collapsing or falling include loose slates from the rear roof slope, the pot from the chimney stack and loose eaves guttering, all presenting a risk of harm to occupants. In addition to the risks posed by using the communal areas, in respect of the first-floor flat occupants, there is also risk involved in the use of the private roof terrace at the rear.

If the baseline indicators were met, the rear roof covering would be repaired/replaced making it sound, safe and watertight, the guttering refixed, and the chimney pots secured. That would effectively deal with the defects, reverting the HHSRS scores to the national averages.

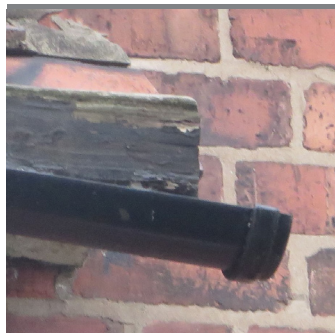
4
Loose rear eaves gutter

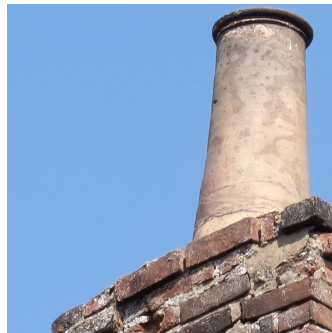
5
Disrepair to chimney
