## Housing Health and Safety Rating System (HHSRS)

Hazard A8  
Electrical Hazards

Example A8.4  
Pre-1920  
Detached  
House

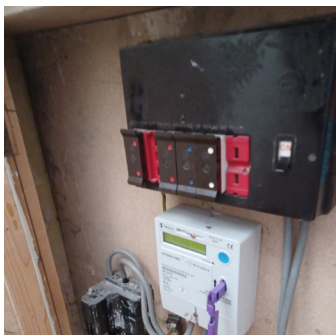
There is a mixture of wiring from the 1950s to the 1980s, with a wired fuse board in the understairs cupboard and cracked surface-mounted light switches in the hall, living room and kitchen.

2  
Consumer unit to  
understairs cupboard

The old consumer unit lacks RCD protection. The system incorporates rewirable fuses, meaning it is less likely to trip, thereby sustaining electricity to the defective sockets. This provides a lower standard of protection to an occupant exposed to an electrical hazard. The cracked and broken sockets indicate an electrical system in poor repair and not up to modern standards. Give the damaged state of a number of the sockets in the property along with cracked light switches, there is an increased likelihood that someone will come into contact with live wiring.

Baseline Indicator 14.4 addresses the disrepair to the installations, including the sockets and the switches. BI 19.4 requires an electrical report; this would also highlight the lack of RCD protection and earthing, ensuring steps are taken to comply with the current IEE Regulations. BI 18.1 addresses the mouse infestation, resulting in the severe harm outcomes returning to the national average, and the likelihood of an occurrence being reduced to a value closer to the national average.

A full rewiring to the property along with the installation of a modern consumer unit would improve the property to higher than the national average.

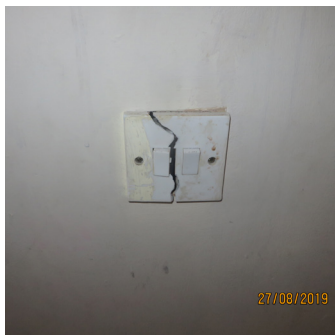
3  
Cracked light switch to  
kitchen

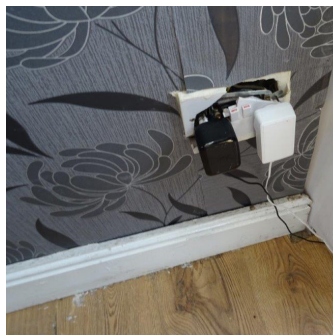
There are broken sockets on skirting boards in the living room and second bedroom. Two of the sockets above the worktops in the kitchen are broken.

4  
Broken socket to living  
room

Whilst the light switches and some of the sockets (such as those in the kitchen) may not be in easy reach of the vulnerable group, those broken sockets in the living room and second bedroom (the room that you would expect that the vulnerable group might occupy) are easily accessible, and the inquisitive nature of the vulnerable group significantly increases the risk of a harmful occurrence over the next 12 months. In addition, the likelihood of electrocution from contact with metal surfaces is increased due to the uncertain earthing of the installation.

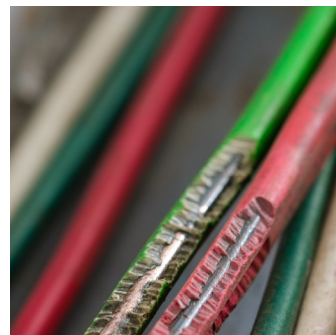
Wiring appears to be earthed to a nail that is hammered into one of the rafters in the roof. Some of the wiring in the roof space that is part of the lighting circuit for the bedroom and bathroom has been nibbled by mice, exposing the copper wiring.

5  
Nibbled wiring in loft  
room
