Housing Health and Safety Rating System (HHSRS)

Example C16.1
Pre-1920
Mid-terrace House
(Non-HMO)

Hazard C16
Domestic Hygiene

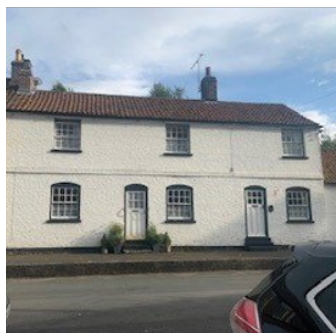
This is a pre-1920 house, occupied by a single household. The property is a three-bedroomed mid-terraced house constructed of solid brick walls and a pan-tiled roof. The property fronts directly onto the public pavement of the main village street.

1
Front elevation of the property, a mid-terrace two-storey house

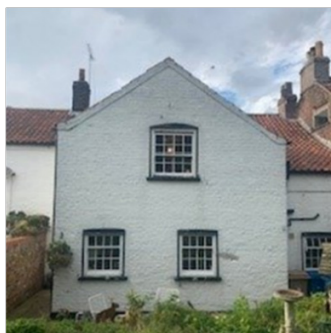
2
Rear elevation of the house, incorporating back addition with gable

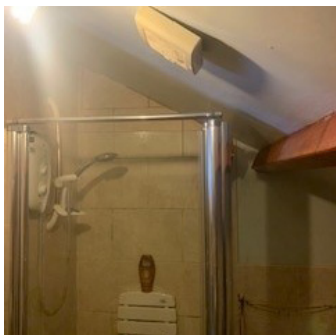
There is evidence of inadequate support to the wash-hand basin and shower waste pipes in the ground-floor shower room; both facilities clog up easily. The ground-floor electric shower does not maintain an appropriate temperature and the shower screen is broken. The extractor fans are defective (do not operate) in the ground-floor shower room and first-floor bathroom, where there are no windows. There is evidence of mould growth to the ceiling and walls as a result.

3
First-floor bathroom showing shower and extractor fan

0 1 2 3	4.8	Ventilation for the bathroom must be provided by mechanical extraction that is ducted to the outside of the building, in line with Baseline Indicator 16.1.

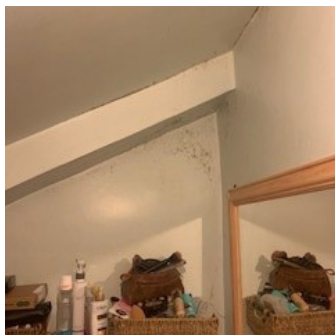
4
First-floor bathroom wall and sloping ceiling, with small patch of mould

Subject	Score	BI	Baseline Indicator
16 Ventilation	0 1 2 3	16.1	The air exhausted from a bathroom, WC room, kitchen, clothes dryer or basement must be provided by mechanical ventilation or by a correctly designed and installed natural ventilation system, as required by Part F of the Building Regulations. In addition, it shall not be vented into any other parts of the building's habitable space or an attic; such air shall discharge directly to the outdoors but not near any intake on the building exterior.
	0 1 2 3	16.4	All means of ventilation shall be maintained in good repair and working order.
17 Moisture and Contaminant Control	0 1 2 3	17.1	Every foundation, roof, roofing component, exterior wall, floor, door, skylight and window shall be watertight, weathertight, free of persistent dampness or moisture and in good condition.
	0 1 2 3	17.3	No single room in any of the property shall have an observable level of damp or mould growth or deterioration of internal finishes that exceeds 5% of the wall and/or ceiling surface.

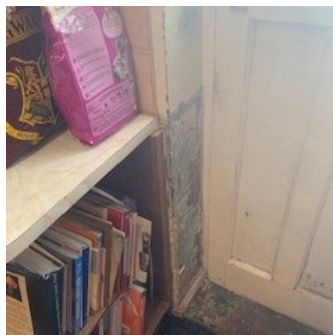
There are single-glazed wooden windows throughout and front and rear external doors, all of which are showing signs of rot.

5
Deterioration to front door

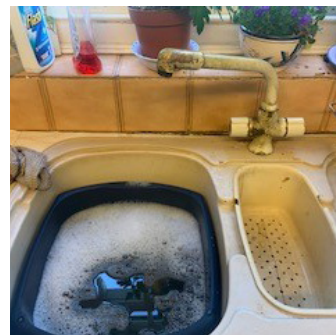
The mixer tap to the kitchen is in poor condition, is not capable of being kept clean and is not appropriately water-sealed to the sink top. The kitchen units are in a dilapidated state and there is evidence of damp and mould growth to the internal unit shelves. The kitchen worktops are damaged and not sealed to walls, so water can leak into the base cupboards. The cooker extraction unit is a recirculating cooker hood and therefore not ventilated to the outside. The floor surface to the kitchen is slippery when wet. There is evidence of pest activity in the form of slug trails. There are only three double sockets located in the kitchen.

6
Kitchen sink and taps

The condition of the kitchen work surfaces presents difficulties in preparing food safely as surfaces cannot be kept clean and will provide harbourage for pathogens and food-spoilage organisms, increasing risk of cross-contamination and infection. The tap disrepair will discourage good cleaning practices and handwashing, further compounding the issue.

Over the next 12 months, the disrepair to the kitchen tap, and consequent dampness to the associated base units, will worsen and this will impair the safe storage of food, providing an attractive environment for harbourage of pests. The cooker hood, whilst providing a grease trap, will not effectively reduce the relative humidity, exacerbating the damp issue.

Subject	Score	BI	Baseline Indicator
5 Sanitary Facilities: Kitchen	0 1 2 3	5.2	A kitchen sink in good working condition that is properly connected to heated and unheated water supplies and waste pipes, and has an area for draining wet cutlery and utensils which is connected to a waste outlet and sealed with flexible waterproof sealant. Any provided dishwasher and components of the sink, including disposal and water filtration devices, shall be in good working condition and properly connected. All feeds must have isolator valves to allow for maintenance.
	0 1 2 3	5.3	Sufficient work surface shall be provided for food preparation. Sufficient cabinets and/or shelves sufficient to store occupant or visitors' food that does not require refrigeration, and eating, drinking and food-preparation equipment. Cabinets shall have well-fitting doors and no gaps between any surfaces. The work surface, work-surface edges, cabinets and shelves shall be of sound construction and furnished with surfaces that are impervious to water, smooth and cleanable.
