## Housing Health and Safety Rating System (HHSRS)

Group C  
Protection Against  
Infection

Example C16.3  
1946–1979  
Semi-detached House  
(Non-HMO)

Hazard C16  
Domestic Hygiene

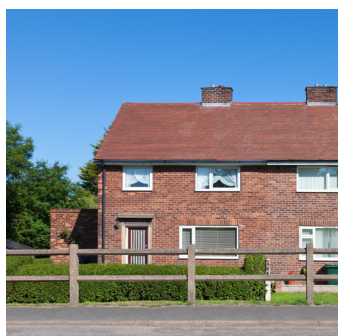
1  
Front elevation of the property

This is a two-storey semi-detached house built in the 60s, with cavity wall construction (no cavity fill insulation) under a tiled roof and with timber suspended floors.

The property comprises two reception rooms and a kitchen on the ground floor, and three bedrooms and a bathroom on the first floor. It is in a reasonably good state of repair and there is no evidence of disrepair to the foul- or surface-water drainage systems. Sub-floor ventilation is provided by airbricks: there are two in each of the front and rear elevations.

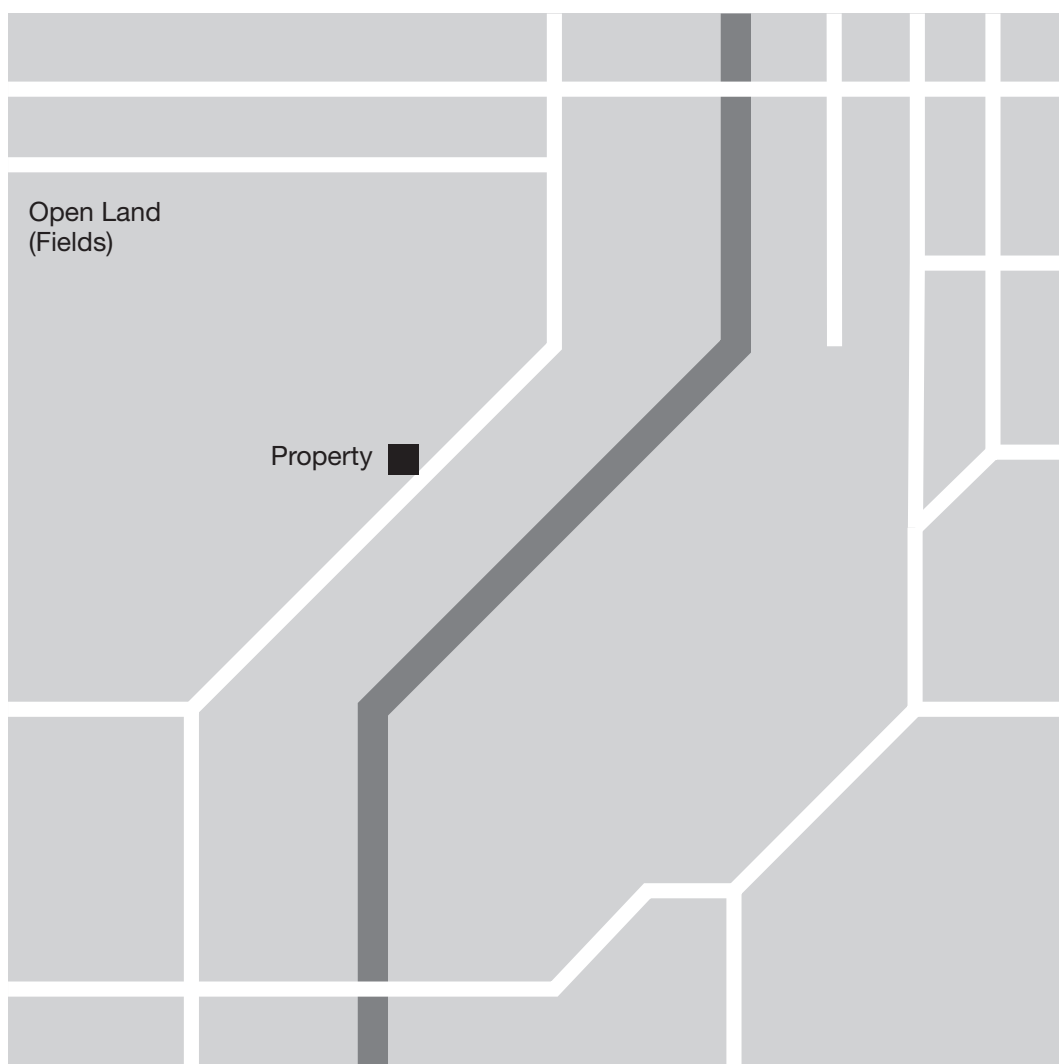
The house is in a residential area with a large open public field to the rear, laid to grass and used mainly by dog walkers and for informal recreation, as shown in the location plan above. Whilst this public area is well maintained, there is a history of rodent activity.

2  
Site plan showing open land to the northwest of the dwelling

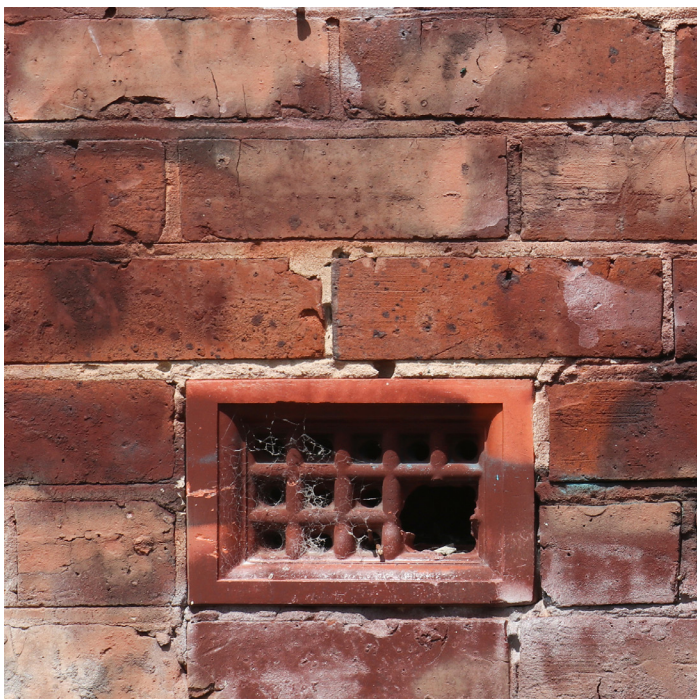
Both of the air bricks at the rear of the property are broken, allowing access to rodents.

3  
One of the broken  
airbricks at rear of the  
property

Compliance with the baseline indicators would see the replacement of the broken covers to the two air bricks to prevent rats and mice gaining access into the cavity walls, along with removal of the old rat droppings and carpet from the loft and disinfection of the area.

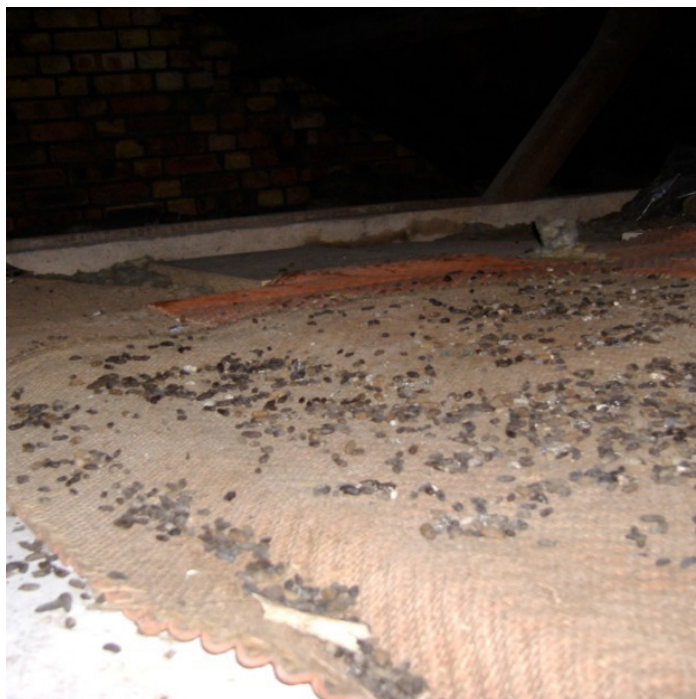
In the roof space, which is not used for storage, carpet has been laid over the existing loft insulation in some areas. There are lots of old rat droppings in the loft, indicating a significant infestation of rats, although there did not appear to be any current rodent activity at the time of inspection.

4  
Droppings in loft space

While there is no active rodent infestation in the property, the presence of two broken air bricks, a significant number of old rat droppings in the loft and a history of rodent activity in the local area all suggest an infestation is likely to recur in the next 12 months. The infestation was previously limited to the non-habitable loft space and there is no indication that rodents have accessed living areas. As the loft is not used for storage, the risk of an infestation causing harm through direct contact is no more than the national average.
