## Abbreviated Vibration Monitoring Reports

**Project:** Grenfell Tower

**Document Ref:** EEMC-VMR-201/110 – Grenfell Tower Rev 00

**Period:** 01 June 2026 to 28 June 2026

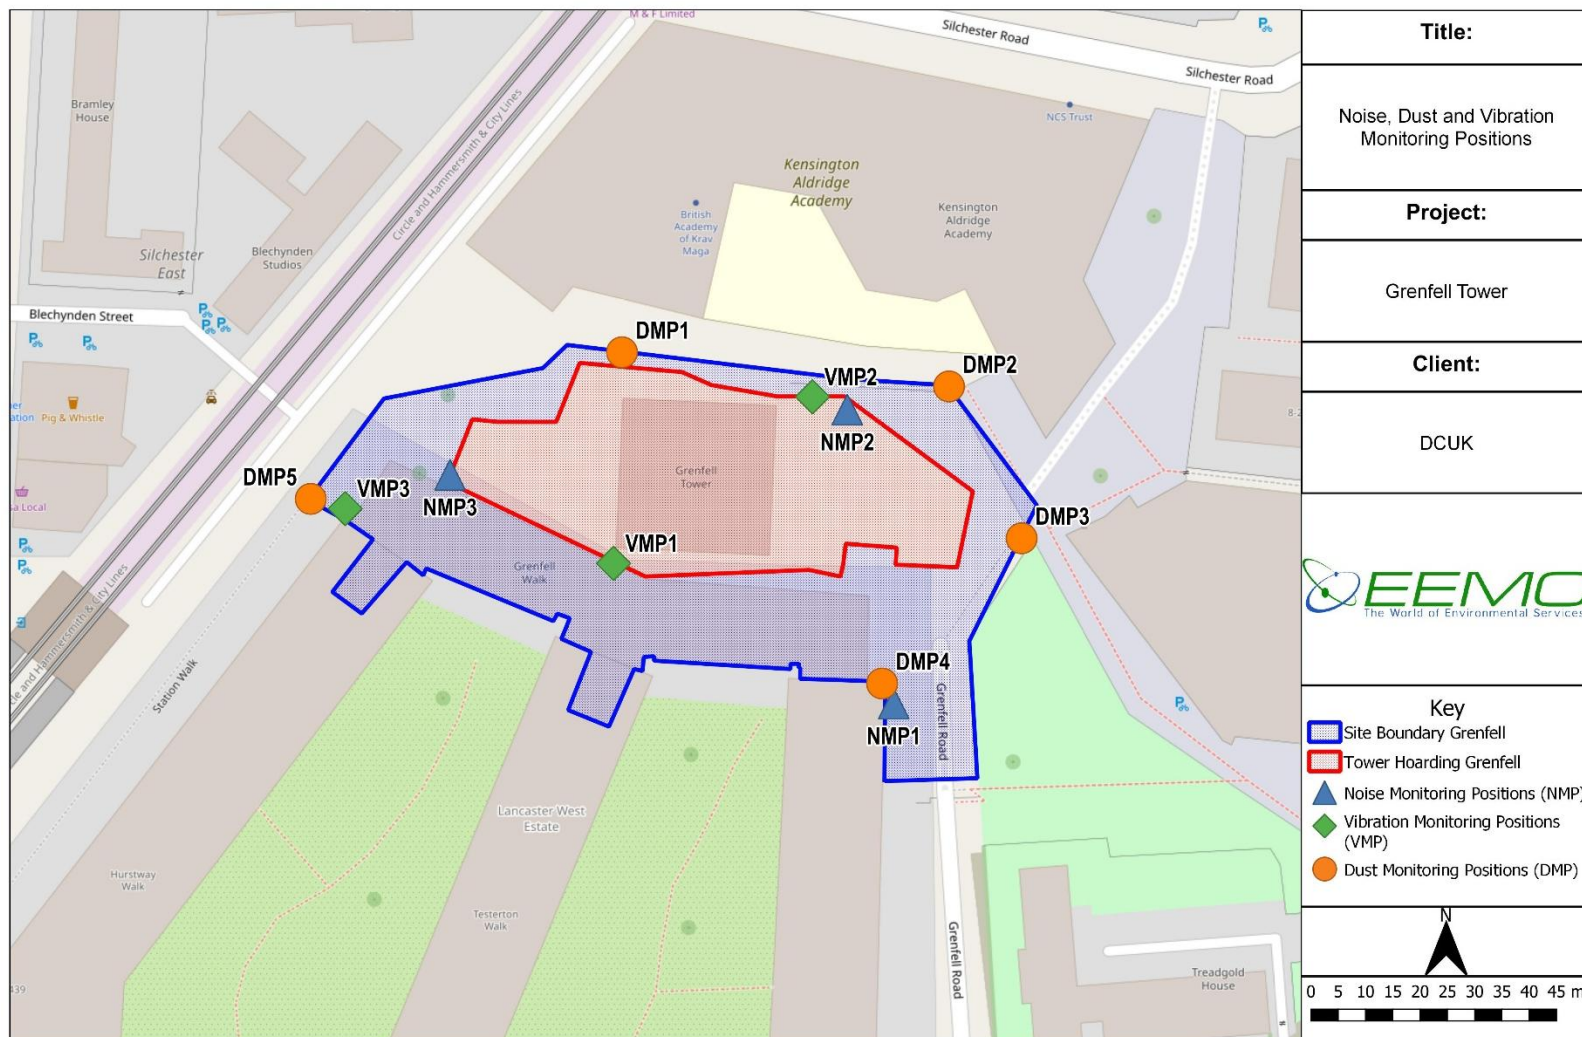
**Figure 1- Map of Vibration, Dust & Vibration Monitoring Locations**

The site boundary and hoarding line of this project is shown in Figure 1. The project is located at Grenfell Tower, Grenfell Road, W11 1TQ. The entire site is located within Royal Borough of Kensington & Chelsea (RBKC) and is bordered by residential blocks to the south, and a school and football pitches to the north and a leisure centre to the east. The London Underground viaduct is 70m to the west and Latimer Road Tube station is 200m from the project.

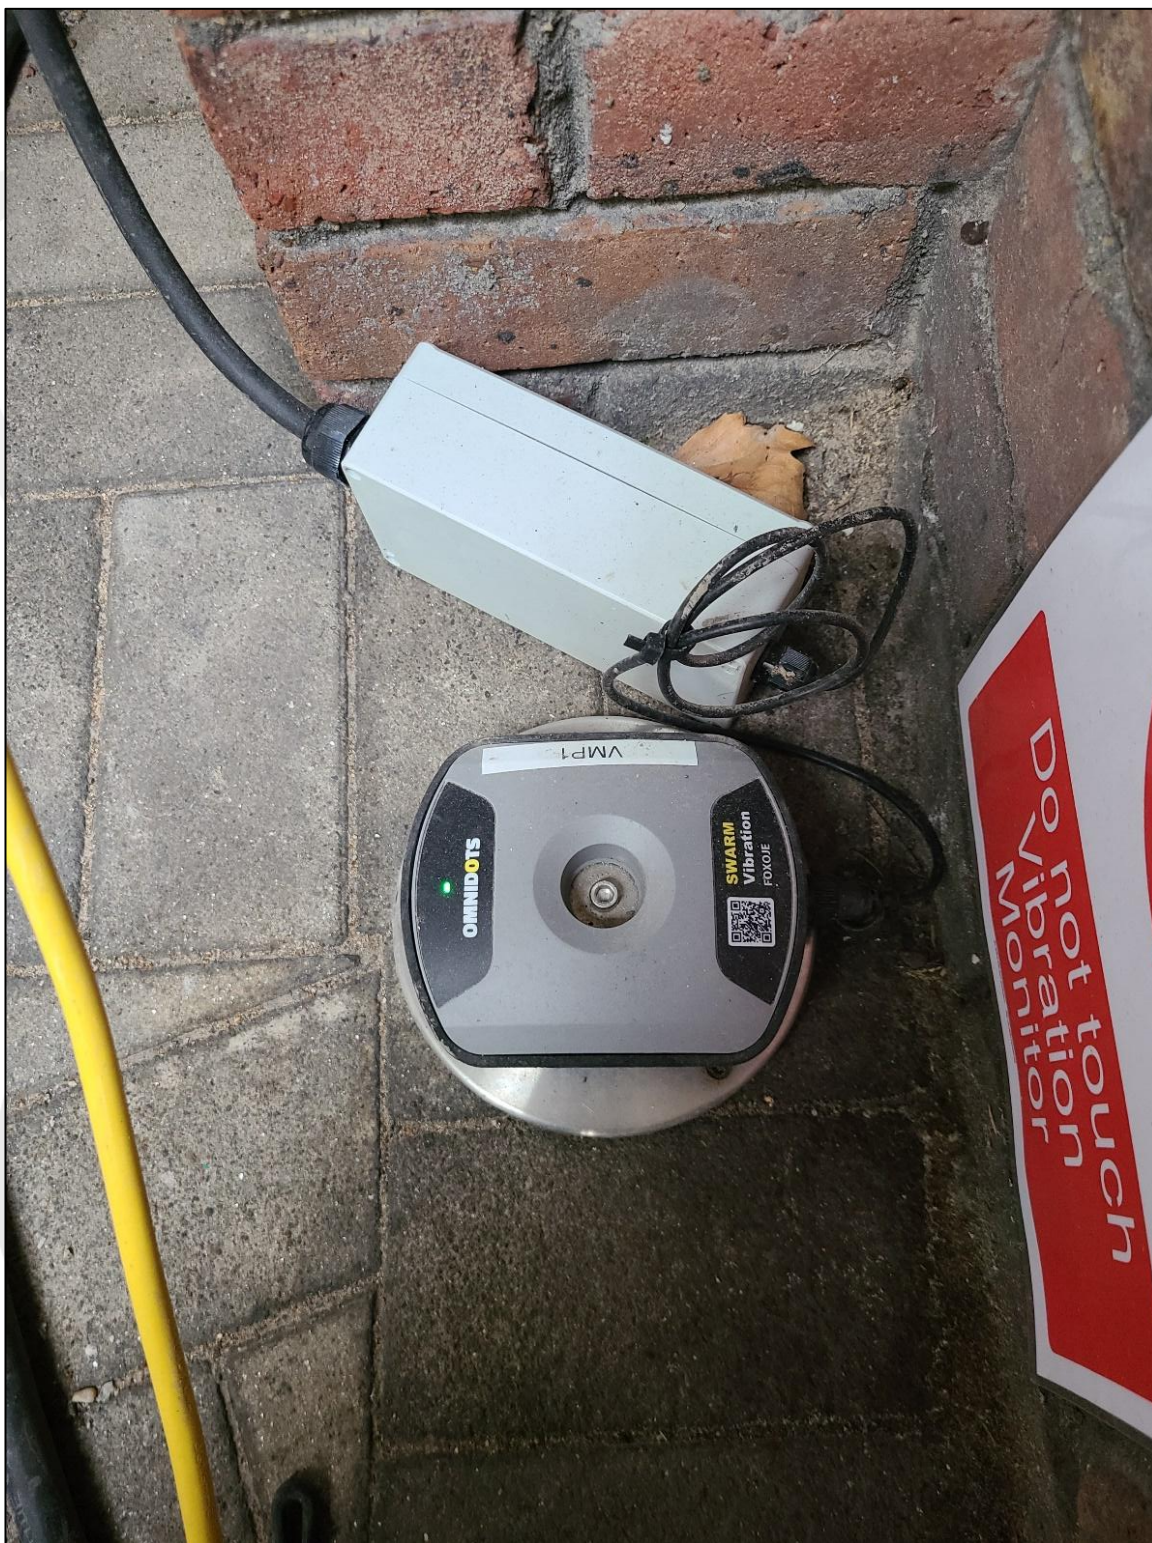
Image 2 – VMP1 Monitoring Location

| ID Reference | Location |
|---|---|
| VMP1 | Opposite Southeast corner of tower between two (2) concrete blocks |

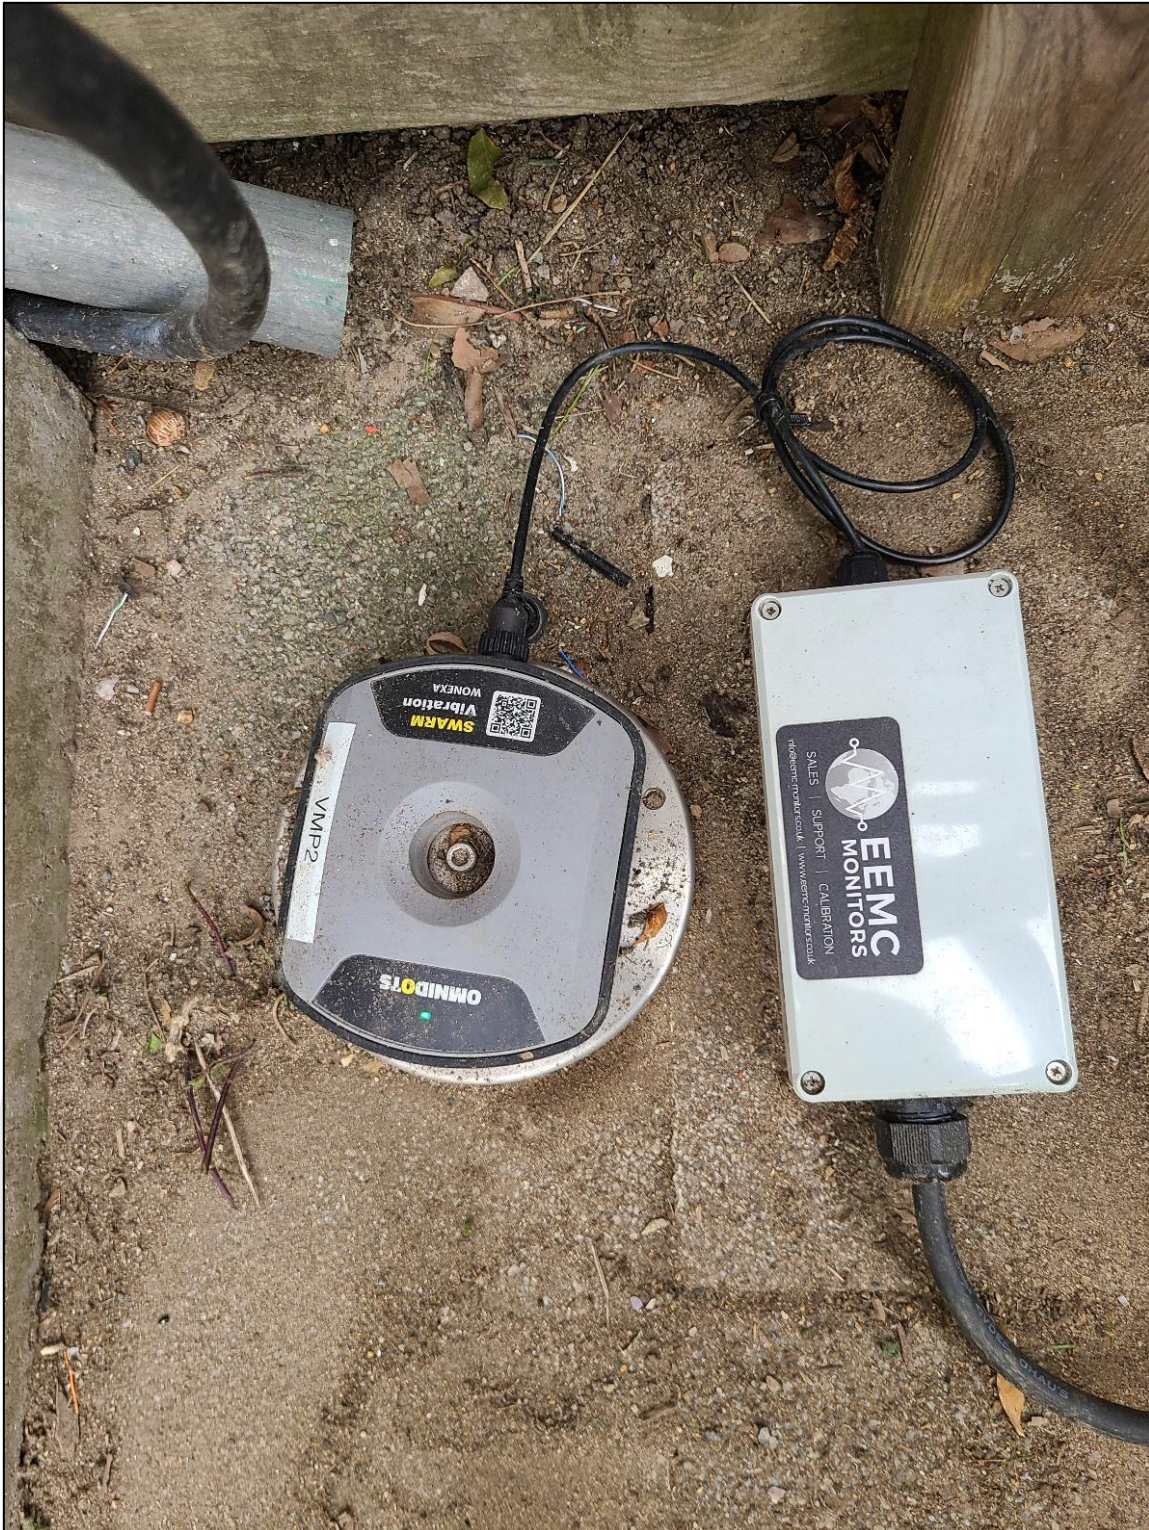
Image 3 –VMP2 Monitoring Location

| ID Reference | Location |
|---|---|
| VMP2 | Base of North hoarding co located with NMP2 |

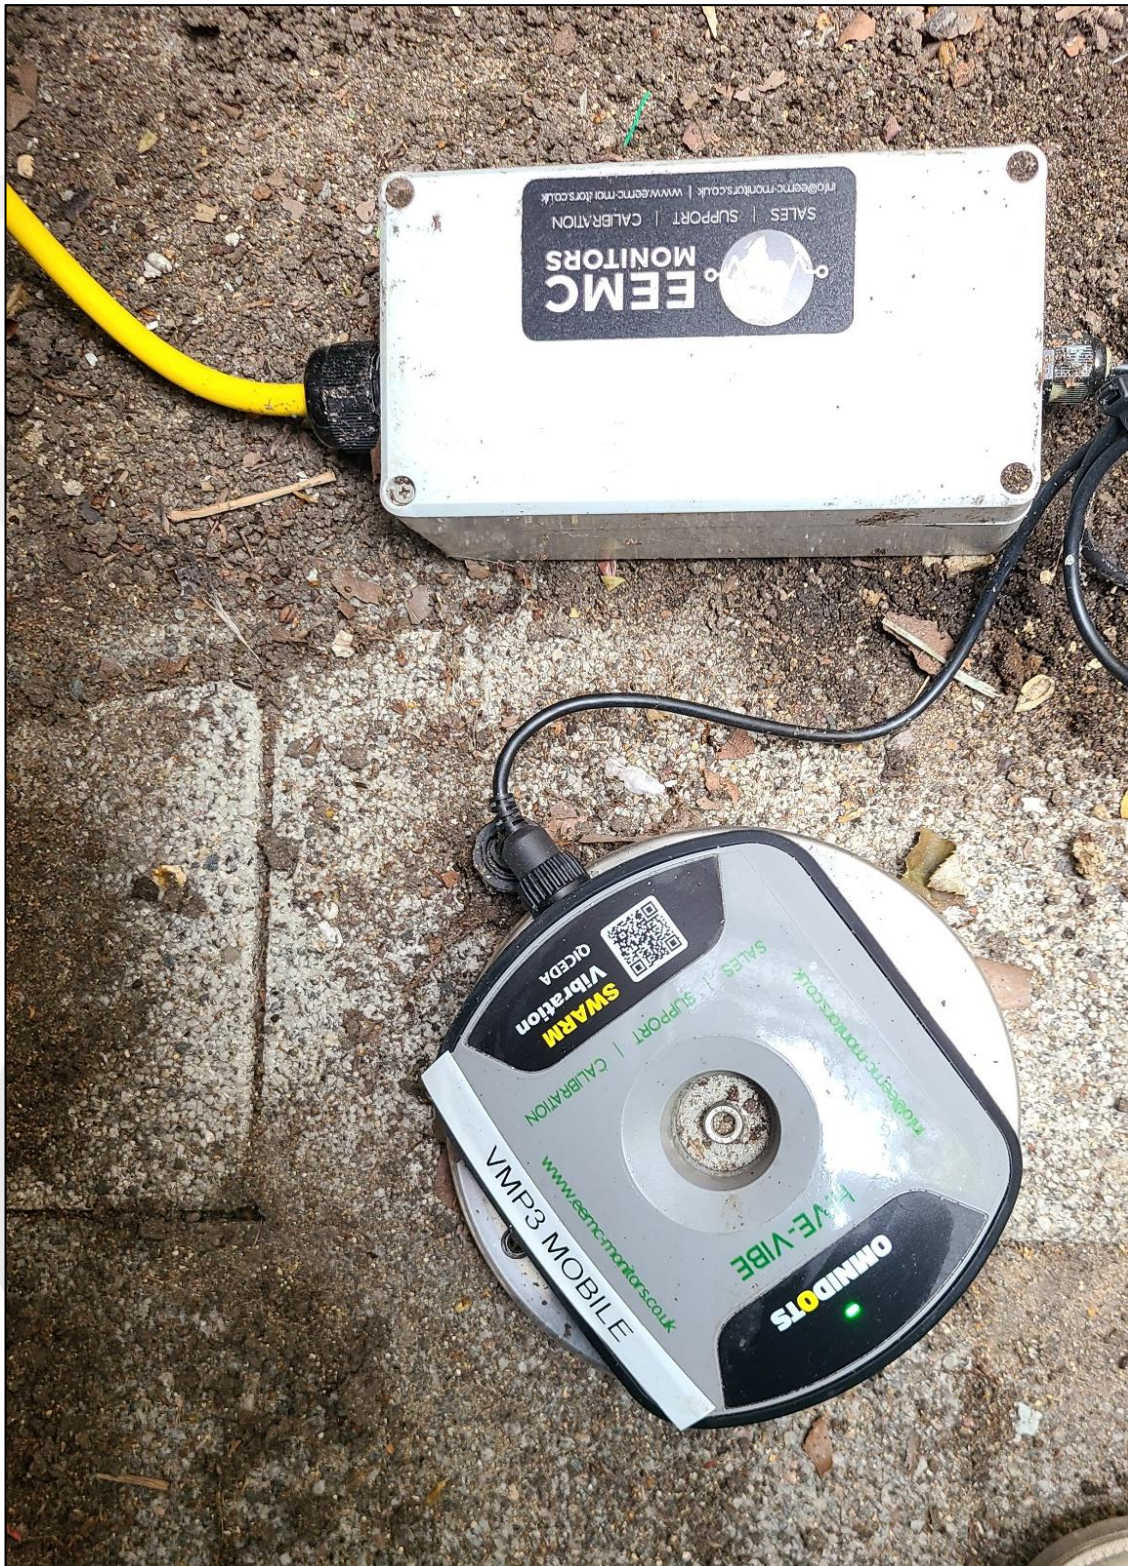
Image 4 – VMP3 Monitoring Location

| ID Reference | Location |
|---|---|
| VMP3 | Mobile unit- Located base of NW hoarding with DMP5 and NMP3 |

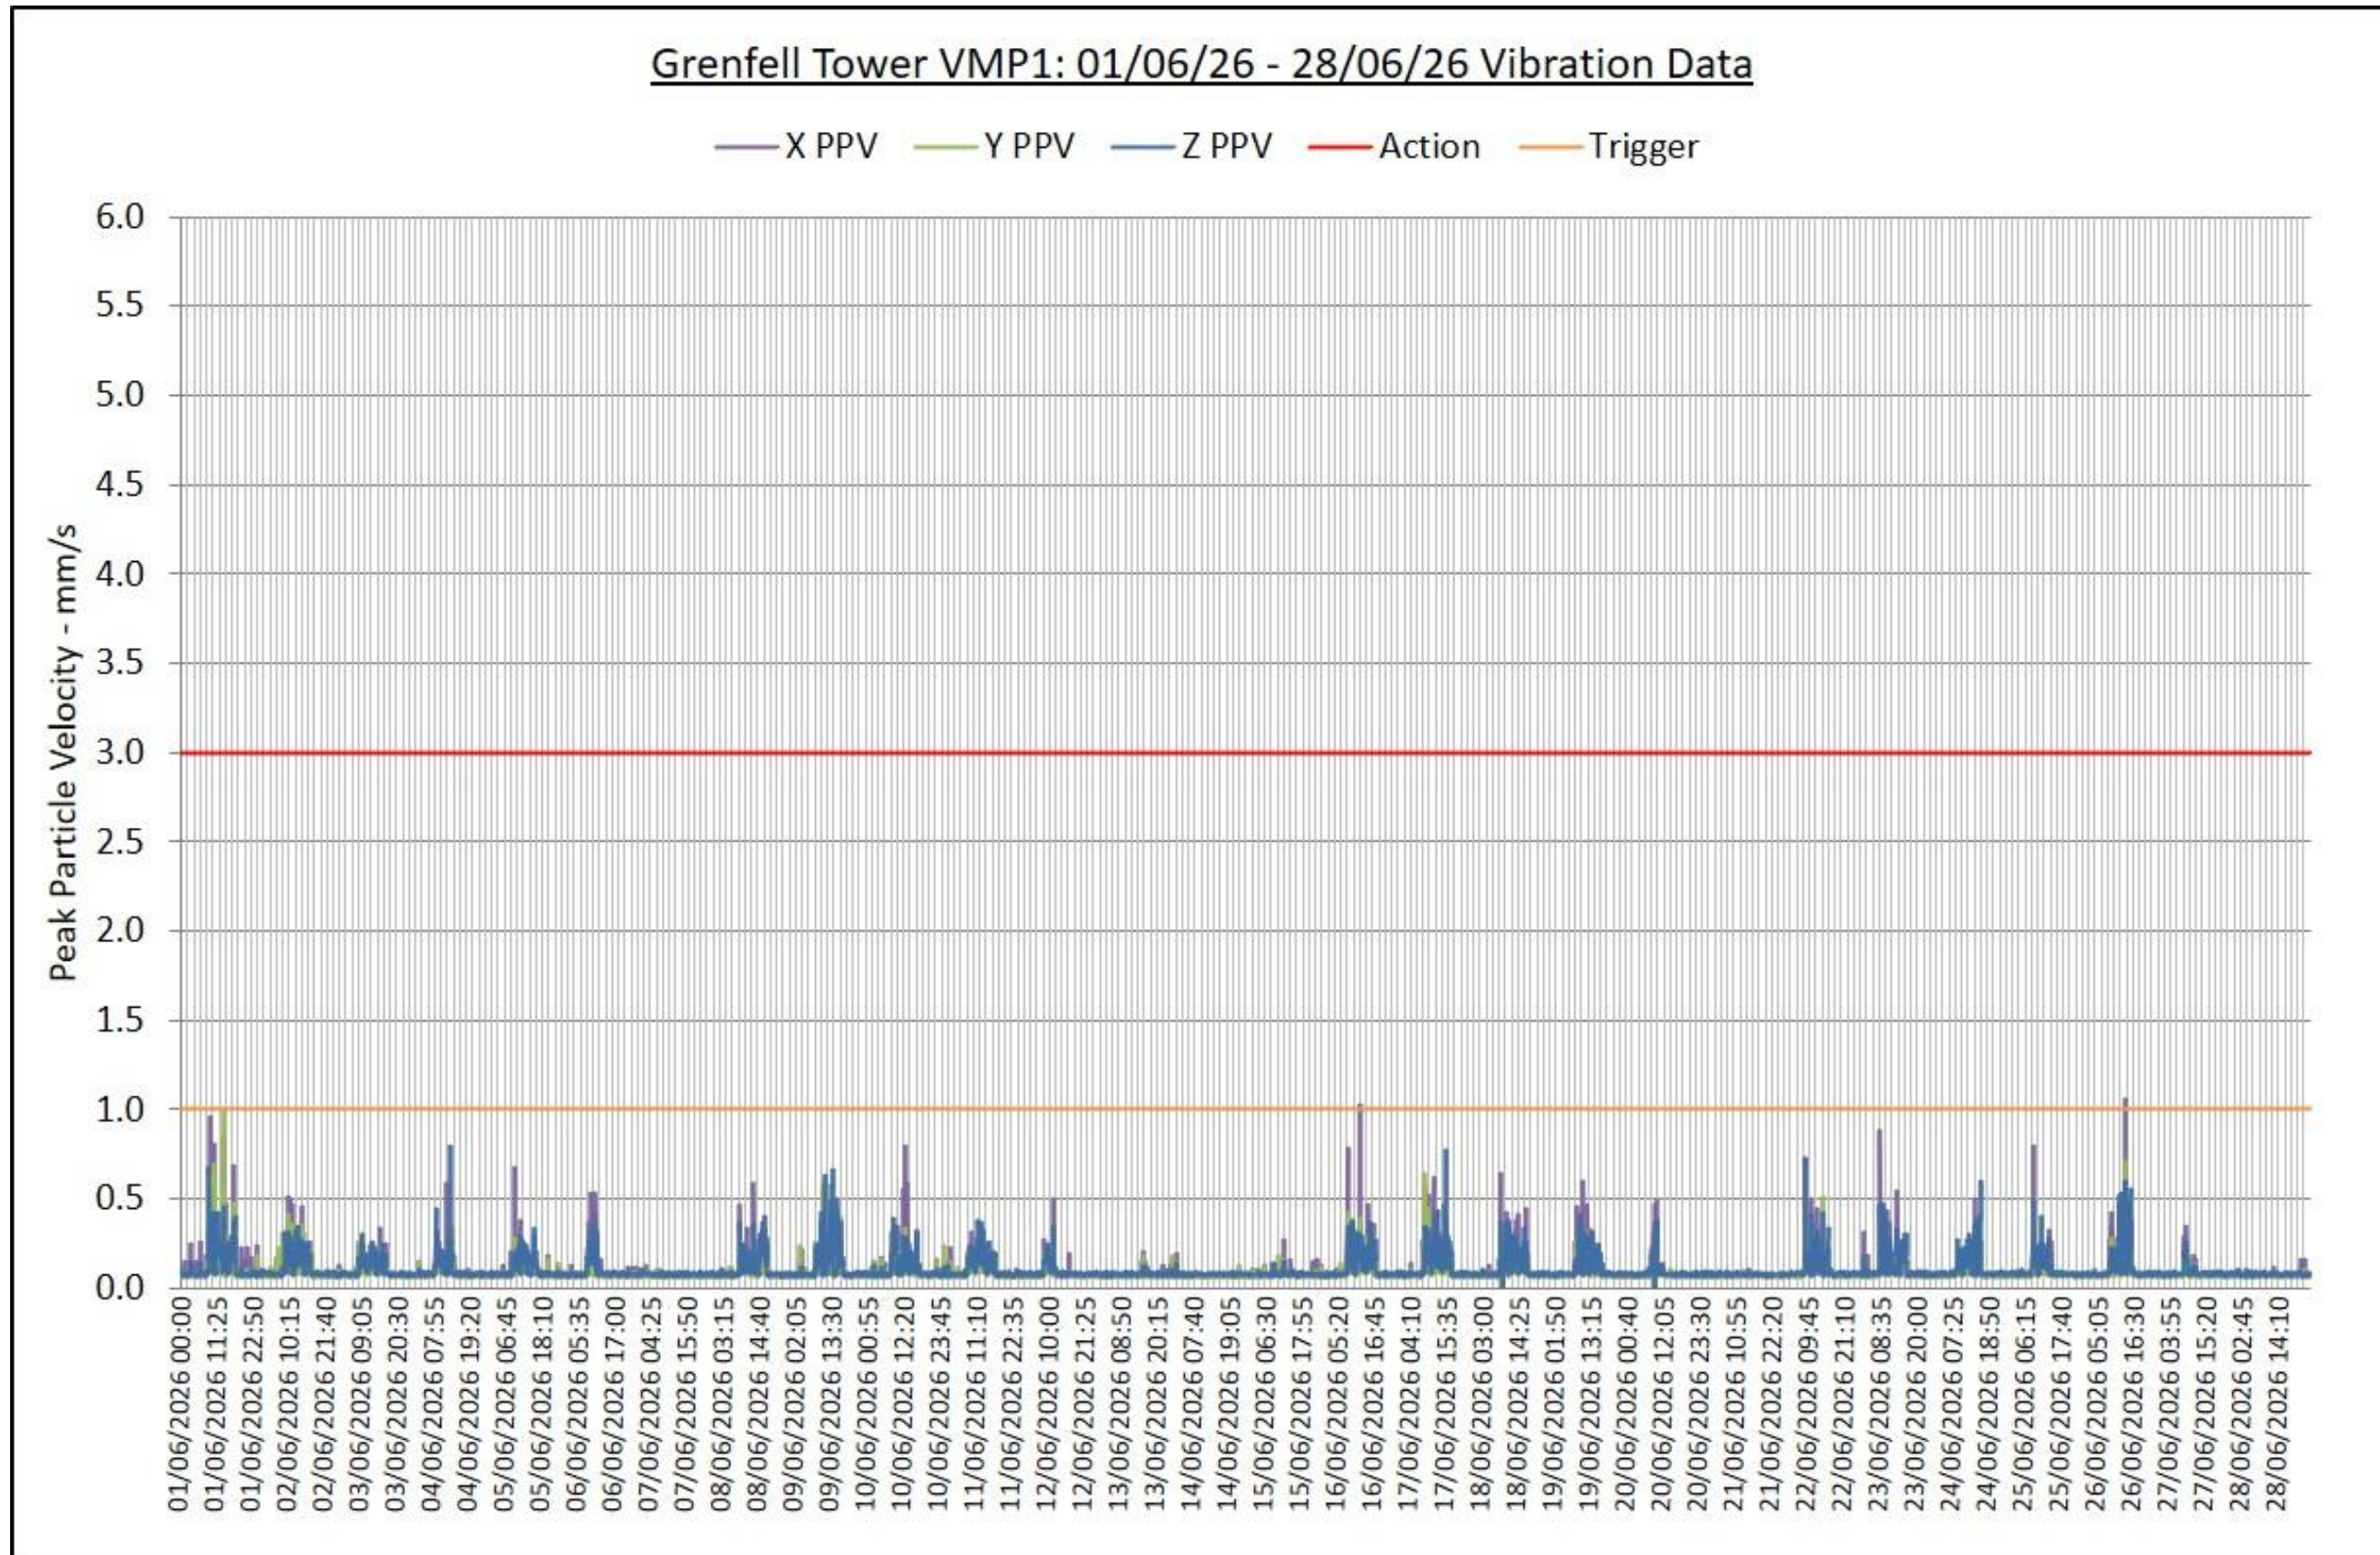
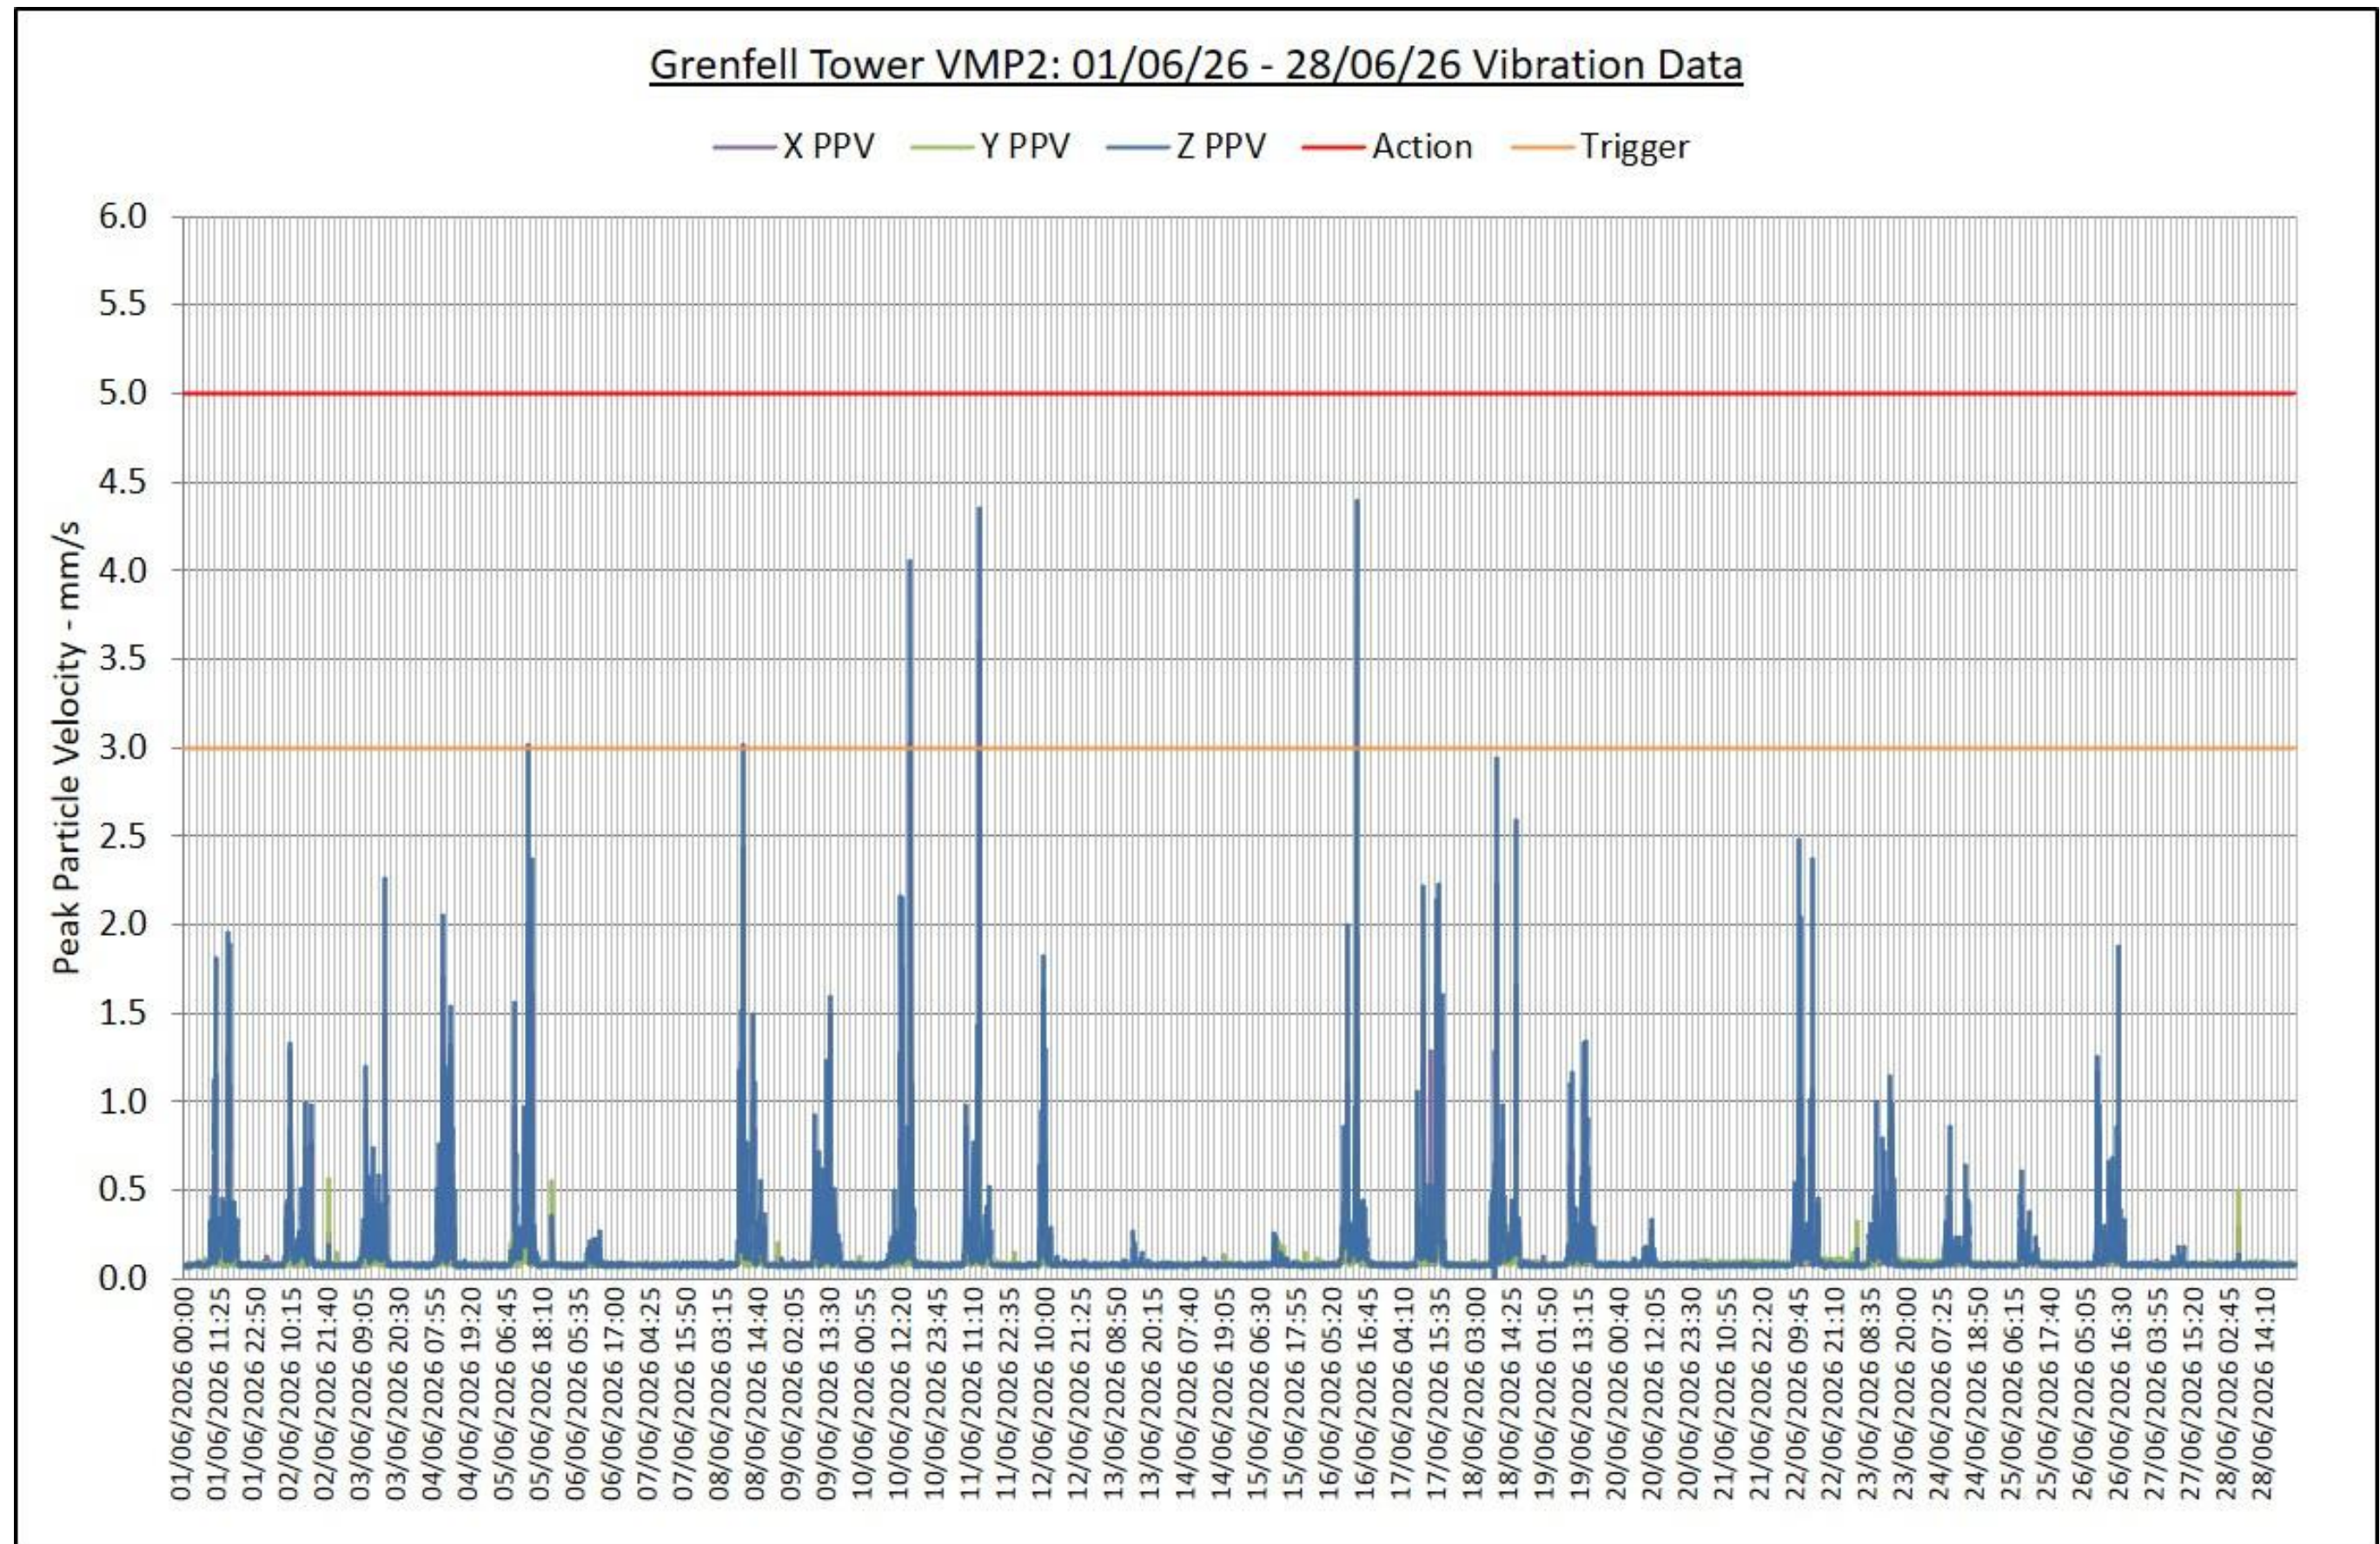
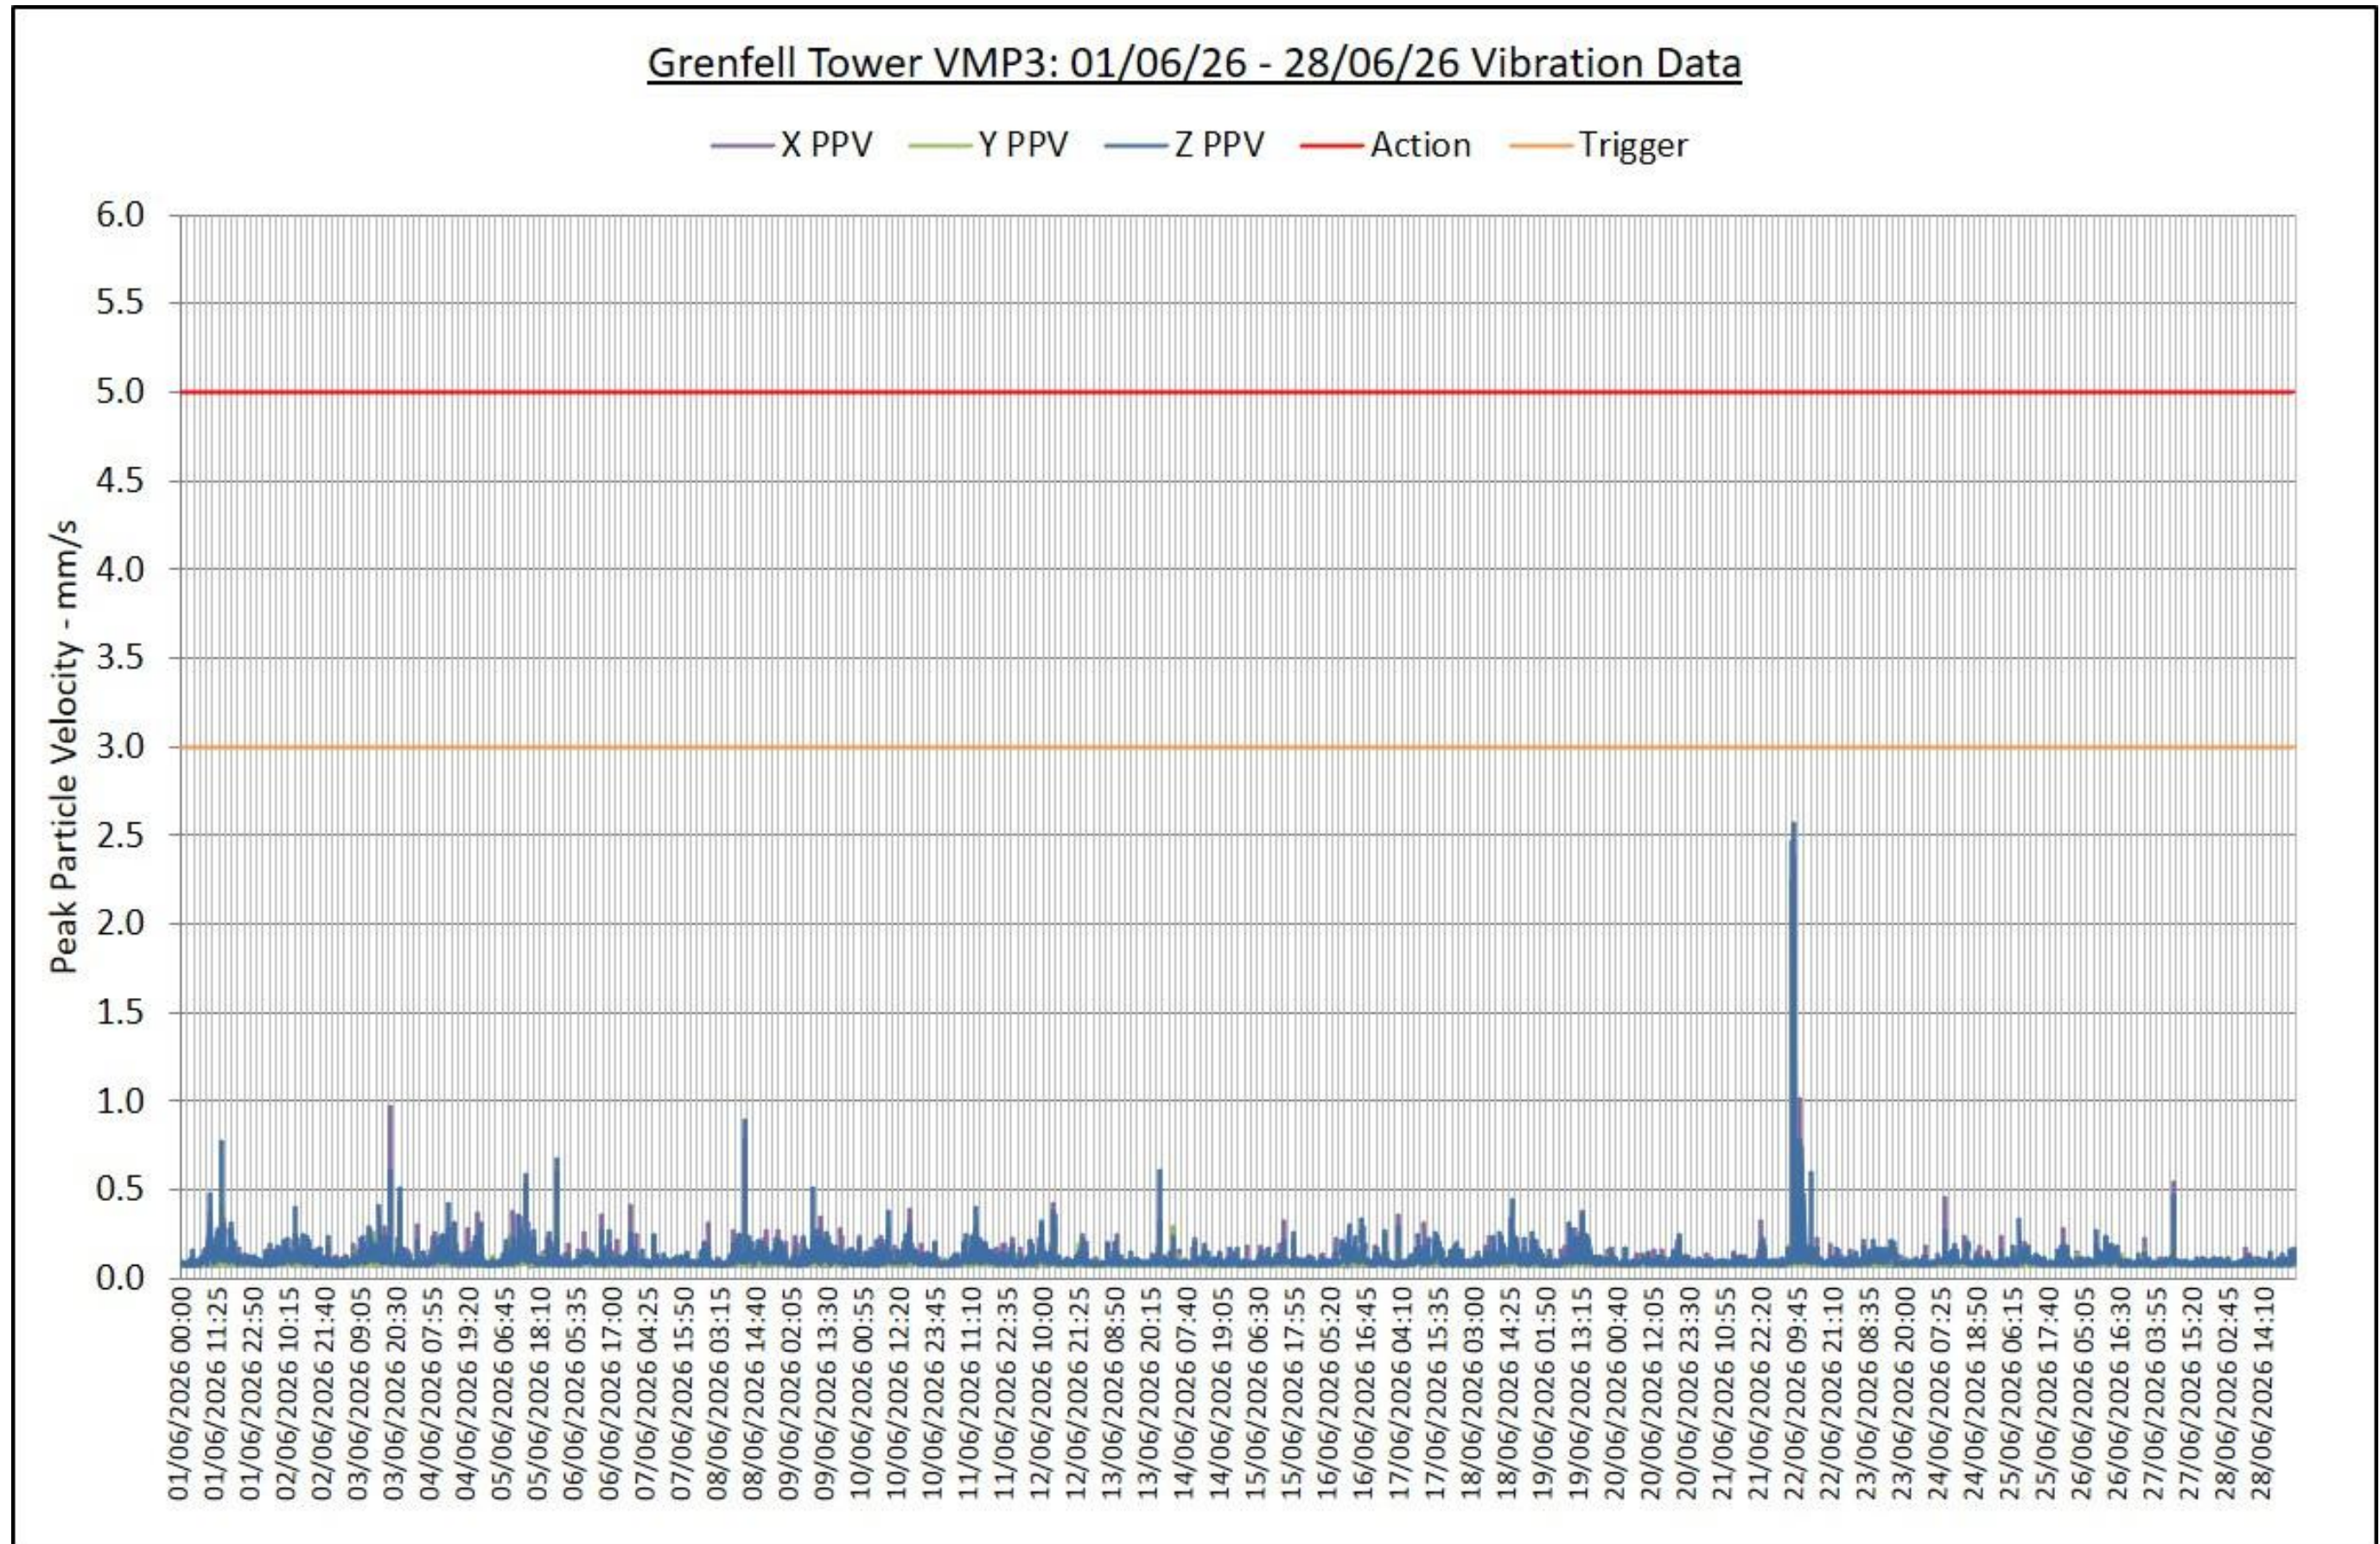
## 6. Vibration Monitoring Graphs

The Swarm monitors record Peak Particle Velocity (PPV) in orthogonal (x, y and z) directions in mm/s continuously over 1-minute periods. A map showing the locations of the monitors is in Figure 1. A photograph showing the monitoring location is shown in Image 1.

The results of the Vibration measurements in this period are presented graphically in Section 6 of this report.
