## Housing Health and Safety Rating System (HHSRS)

## Case Studies

Hazard A1  
Falls on the Level

Example A1.2  
Pre-1920  
Mid-terrace Bungalow  
(Non-HMO)

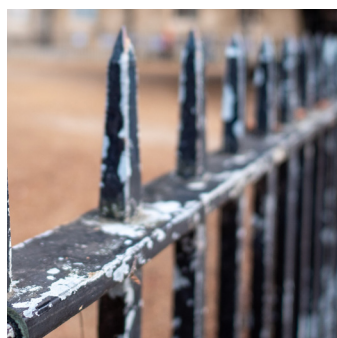
3  
Front yard  
metal railing fence

Access to the front door is via a gate and step, then across the common yard. This has no artificial lighting despite being located on a poorly lit service road. The yard surface comprises uneven stone slabs and brick paving. The spiked iron railings and spiked front gate are about 600mm high.

The risk of extreme, severe and serious harms occurring is increased due to number and location of hard and sharp objects on the property. There are several hard, uneven stone and concrete surfaces in the front and rear yards, with adjacent low-level spiked metal railings. The cooker (with a potentially hot surface) is located just inside the back, opposite a folding worktop.

The risk of harm occurring could be reduced to that of the national average by carrying out the following: removal of the metal spikes to the front; evening out surfaces to front and rear, together with provision of better lighting in both areas; lowering of the threshold to the rear entrance doorway; and improvement to the kitchen layout.

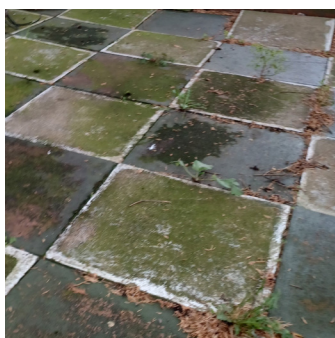
4  
Front yard  
uneven slabs

The risk of falls is increased due to the poorly lit approach to the main entrance across uneven stone slabs. The proximity to spiked metal railings and a spiked metal front gate exacerbates the likelihood of a fall requiring medical intervention. In the kitchen, there is greater risk of someone tripping over the step when coming in from the rear yard and then falling onto the cooker or folding worktop, with associated sharp edges and hot surfaces. Risk of falls in the rear yard is increased due to the cracked and uneven yard surface and restricted lighting. In winter, water pooling in and around the uncovered concrete drainage channel could freeze, leading to slips and falls.
