## Housing Health and Safety Rating System (HHSRS)

Hazard A8  
Electrical Hazards

Example A8.4  
Pre-1920  
Detached  
House

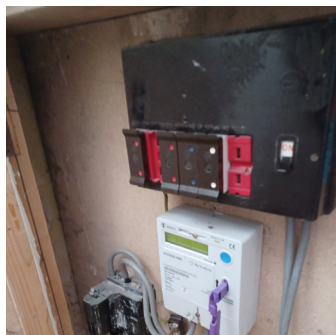
There is a mixture of wiring from the 1950s to the 1980s, with a wired fuse board in the understairs cupboard and cracked surface-mounted light switches in the hall, living room and kitchen.

2  
Consumer unit to  
understairs cupboard

The old consumer unit lacks RCD protection. The system incorporates rewirable fuses, meaning it is less likely to trip, thereby sustaining electricity to the defective sockets. This provides a lower standard of protection to an occupant exposed to an electrical hazard. The cracked and broken sockets indicate an electrical system in poor repair and not up to modern standards. Give the damaged state of a number of the sockets in the property along with cracked light switches, there is an increased likelihood that someone will come into contact with live wiring.

Baseline Indicator 14.4 addresses the disrepair to the installations, including the sockets and the switches. BI 19.4 requires an electrical report; this would also highlight the lack of RCD protection and earthing, ensuring steps are taken to comply with the current IEE Regulations. BI 18.1 addresses the mouse infestation, resulting in the severe harm outcomes returning to the national average, and the likelihood of an occurrence being reduced to a value closer to the national average.

A full rewiring to the property along with the installation of a modern consumer unit would improve the property to higher than the national average.
