# Abbreviated Dust Monitoring Report

Monitoring Period: 29 June 2026 to 26 July 2026

**Project:** Grenfell Tower

**Document Ref:** EEMC-DMR-201/111 – Grenfell Tower Rev 01

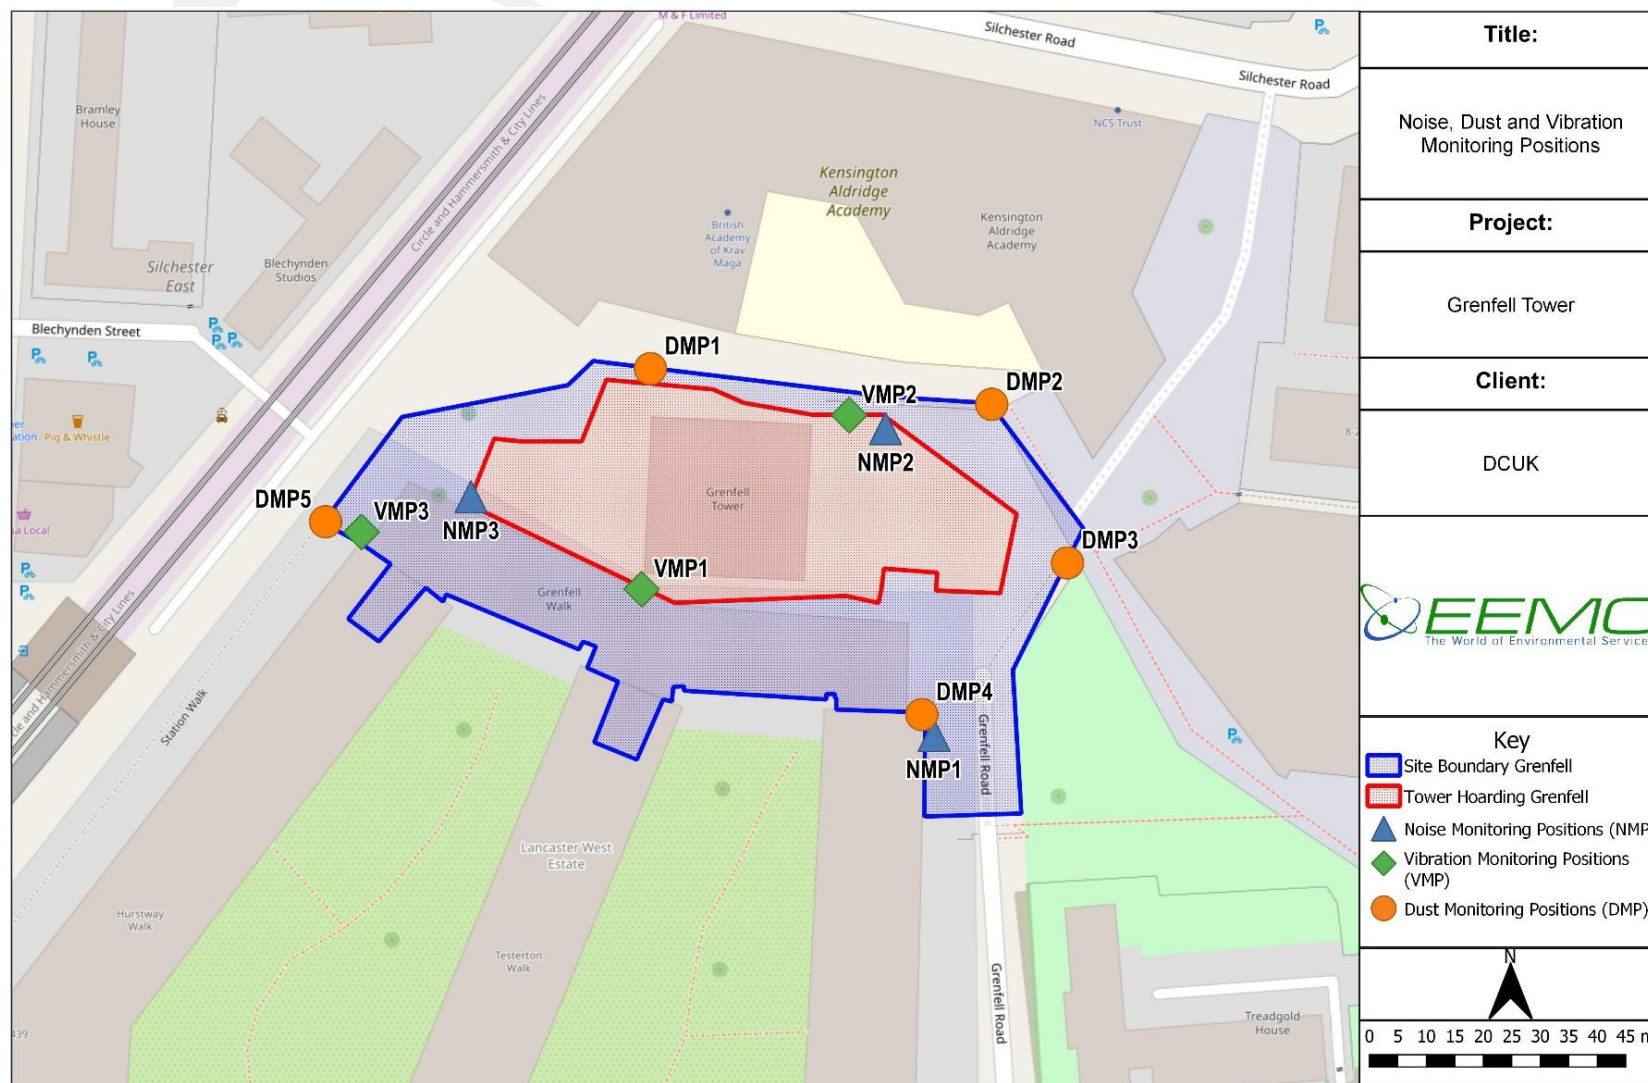
**Figure 1- Map of Noise, Dust & Vibration Monitoring Locations**

The site boundary and hoarding line of this project is shown in Figure 1. The project is located at Grenfell Tower, Grenfell Road, W11 1TQ. The entire site is located within Royal Borough of Kensington & Chelsea (RBKC) and is bordered by residential blocks to the south, and a school and football pitches to the north and a leisure centre to the east. The London Underground viaduct is 70m to the west and Latimer Road Tube station is 200m from the project.

Five (5) MCerts approved HIVE-AQ DUSTROID™ monitors are deployed to carry out the continuous monitoring on site. A map showing the monitoring locations is shown in Figure 1. Photographs showing the equipment installed at locations DMP1- DMP5 are shown in Images 1-5.

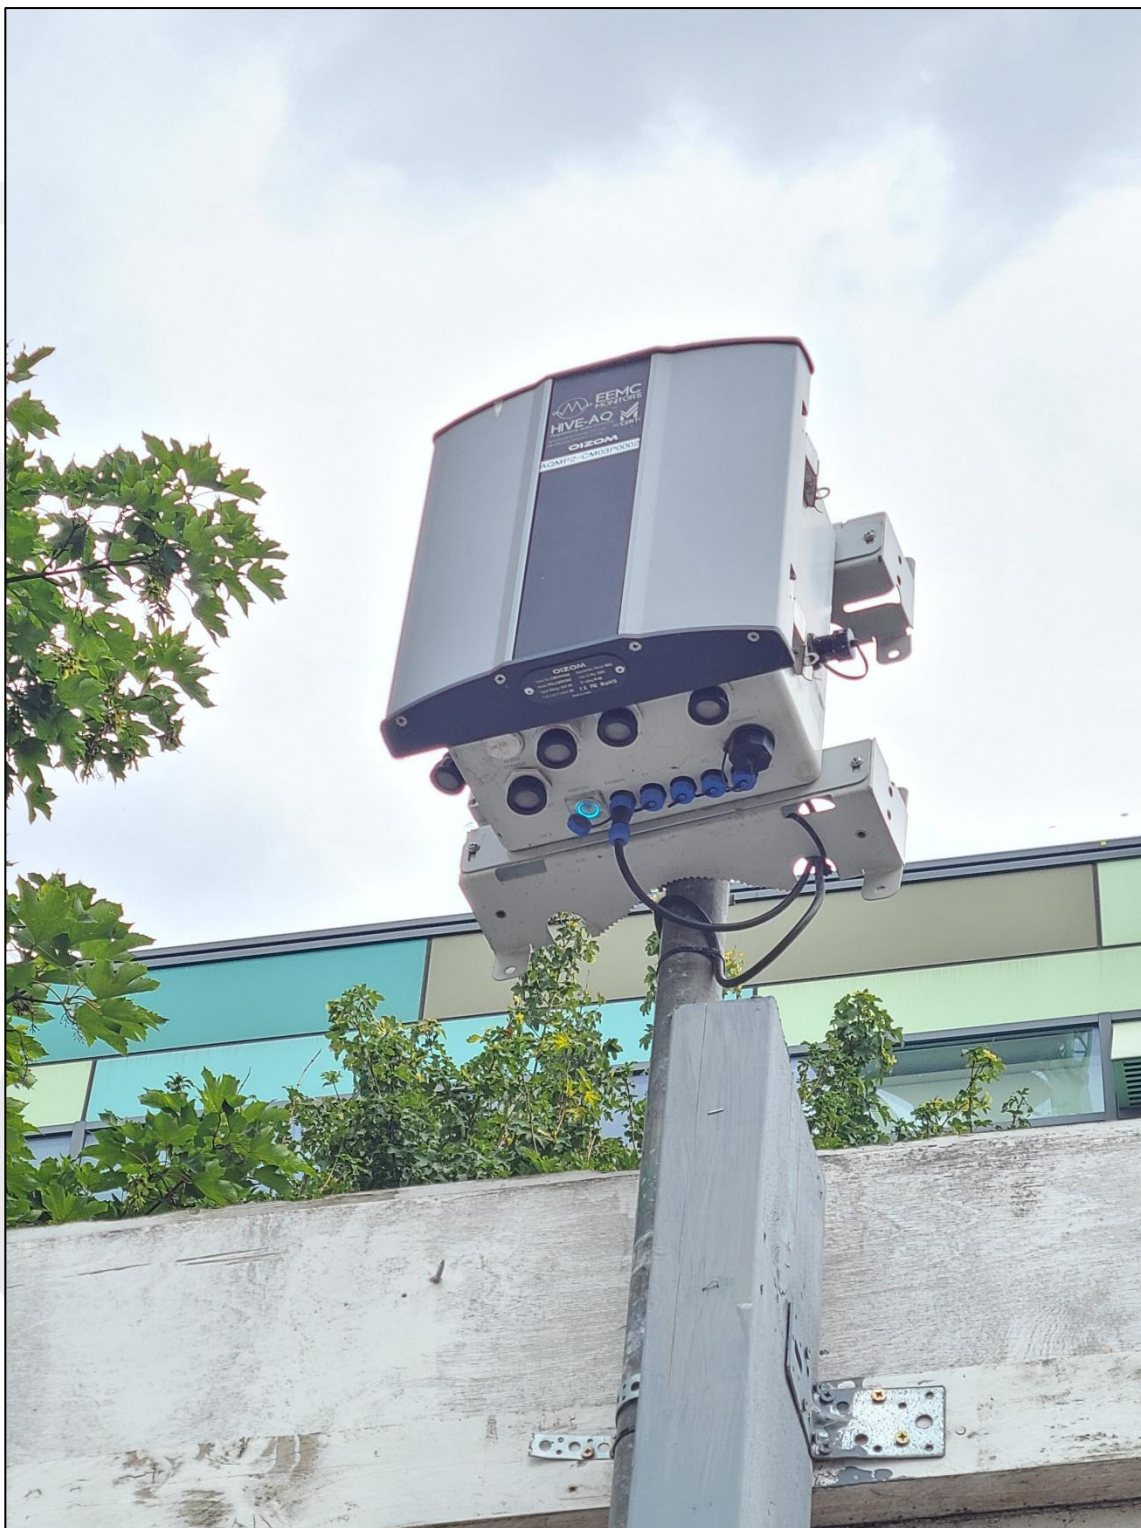
**Images 2 – DMP2 Monitoring Location** (photo taken on site on 24/07/2026).

There was a minor communication fault with DMP2, all data was back-filled however the monitor has been removed for further investigation and a replacement monitor installed on 24 July 2026. Due to this there is a small gap in measurement data when the replacement monitor was being installed.

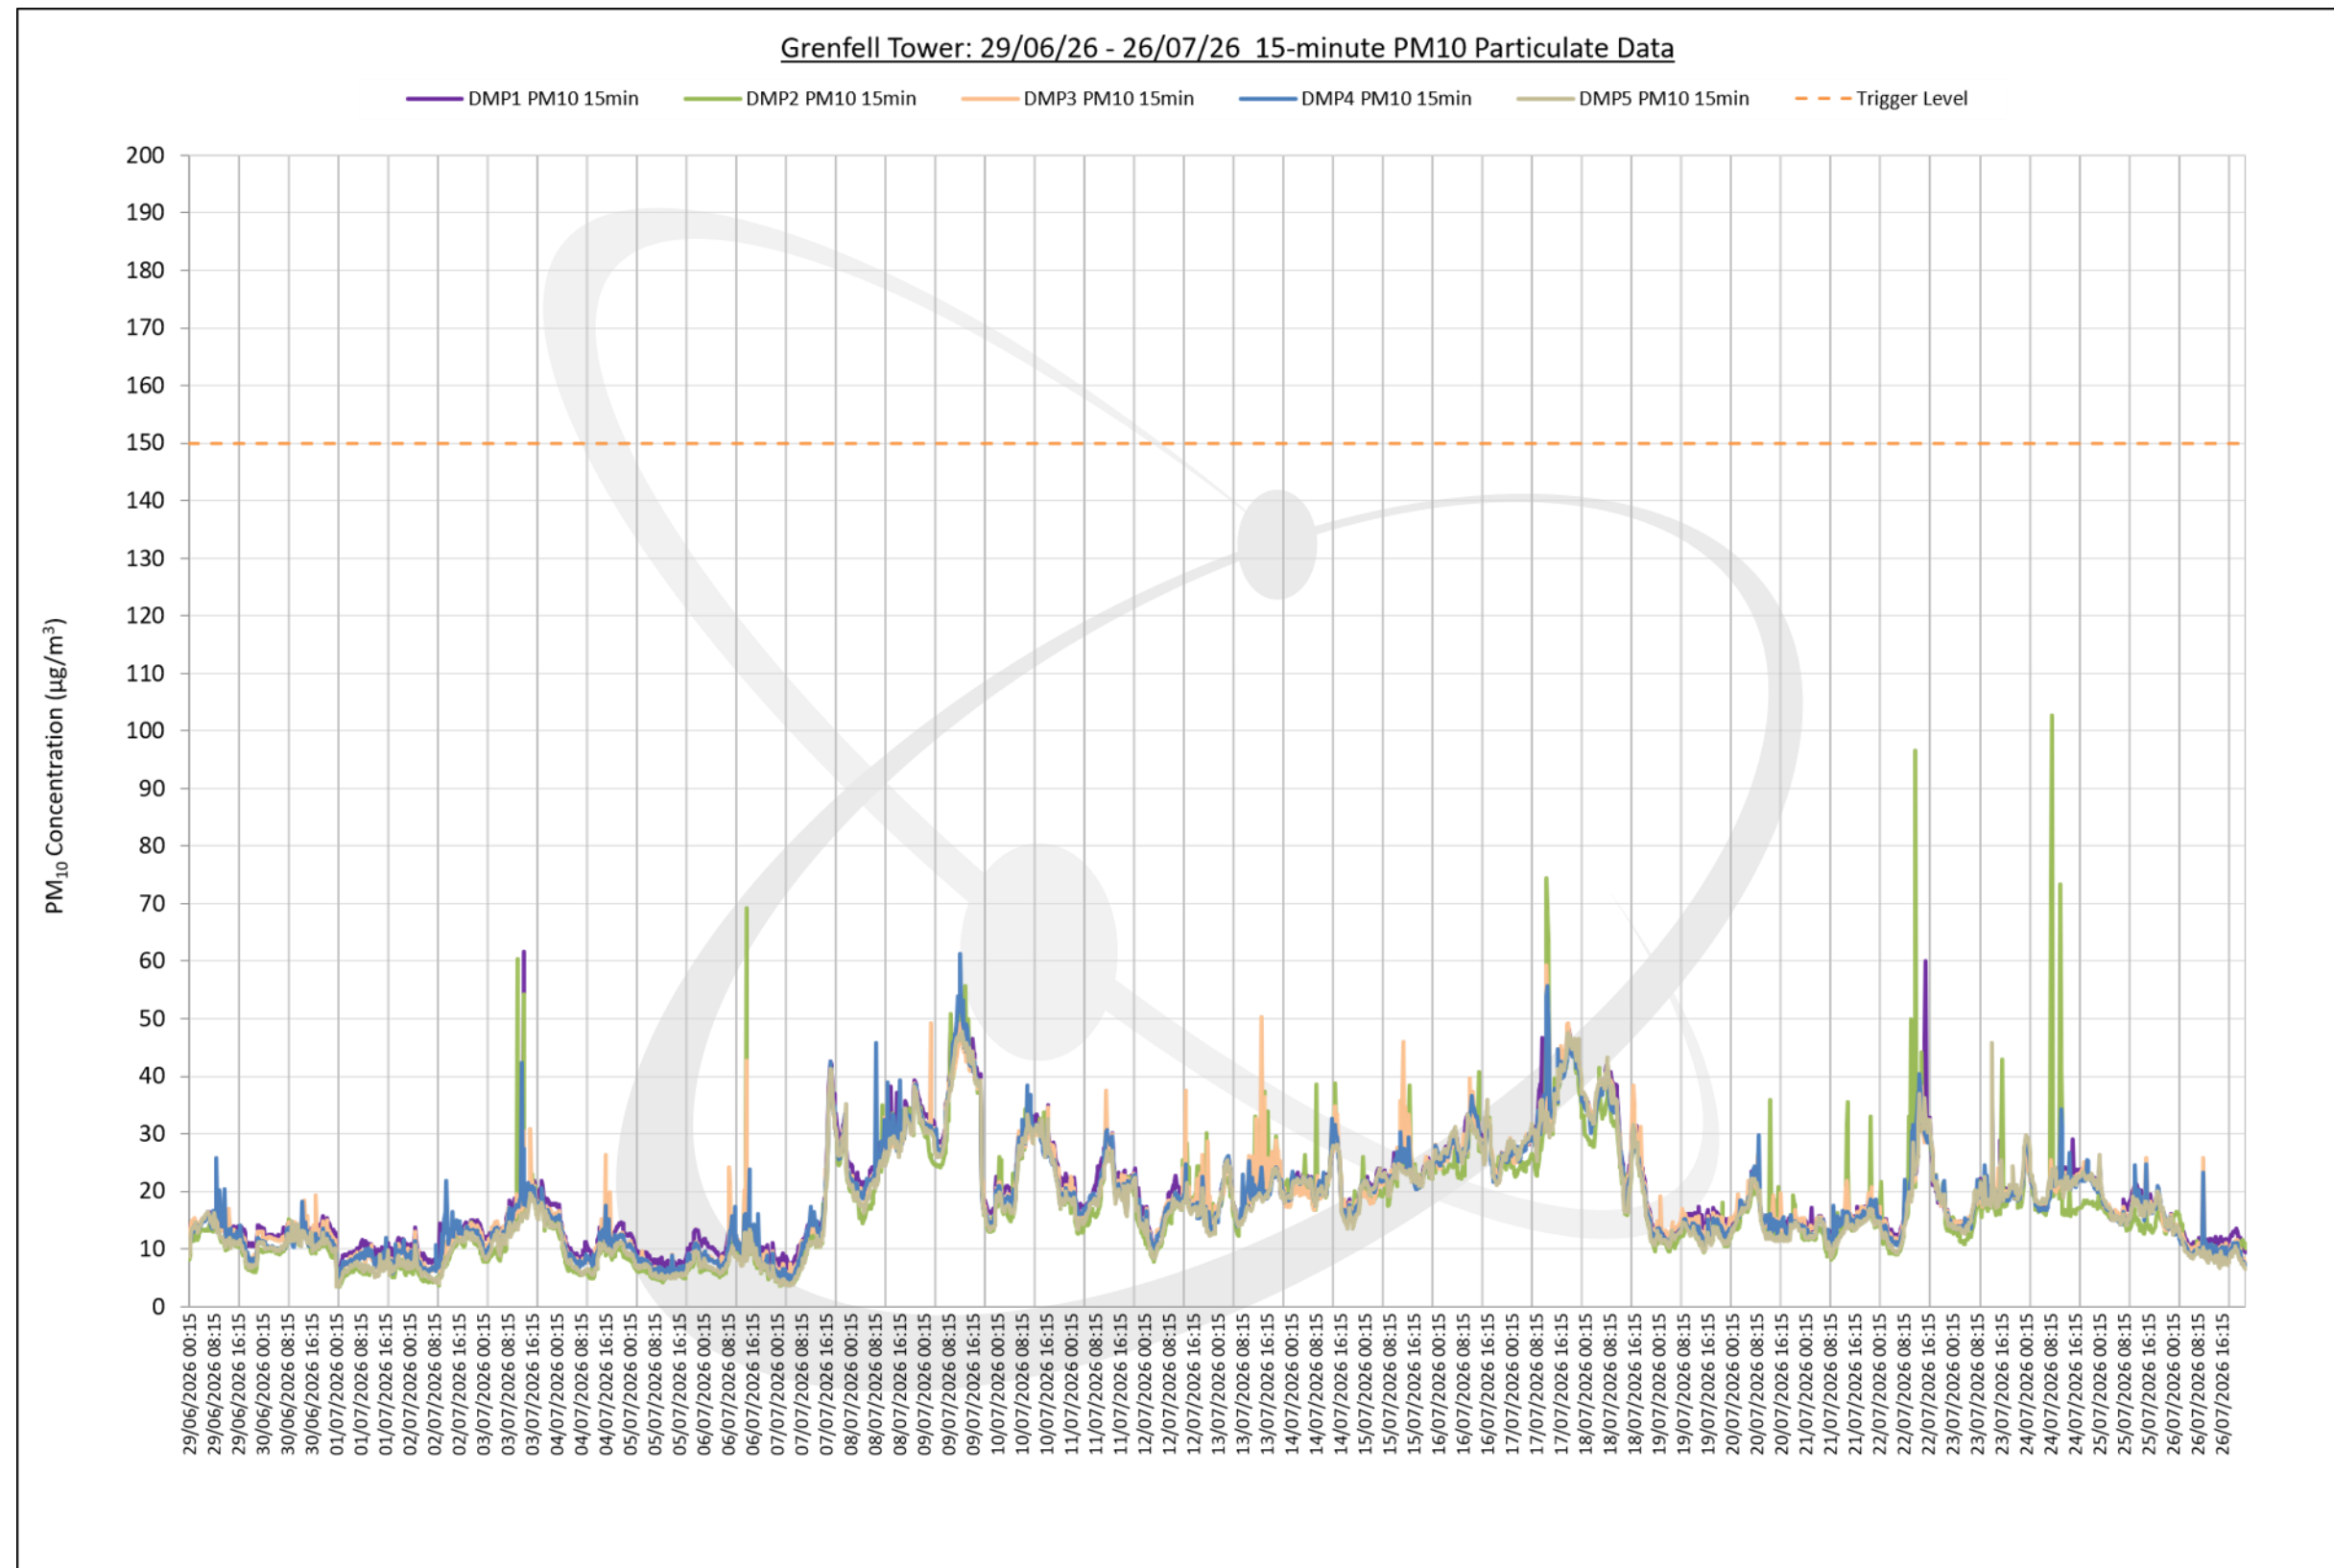
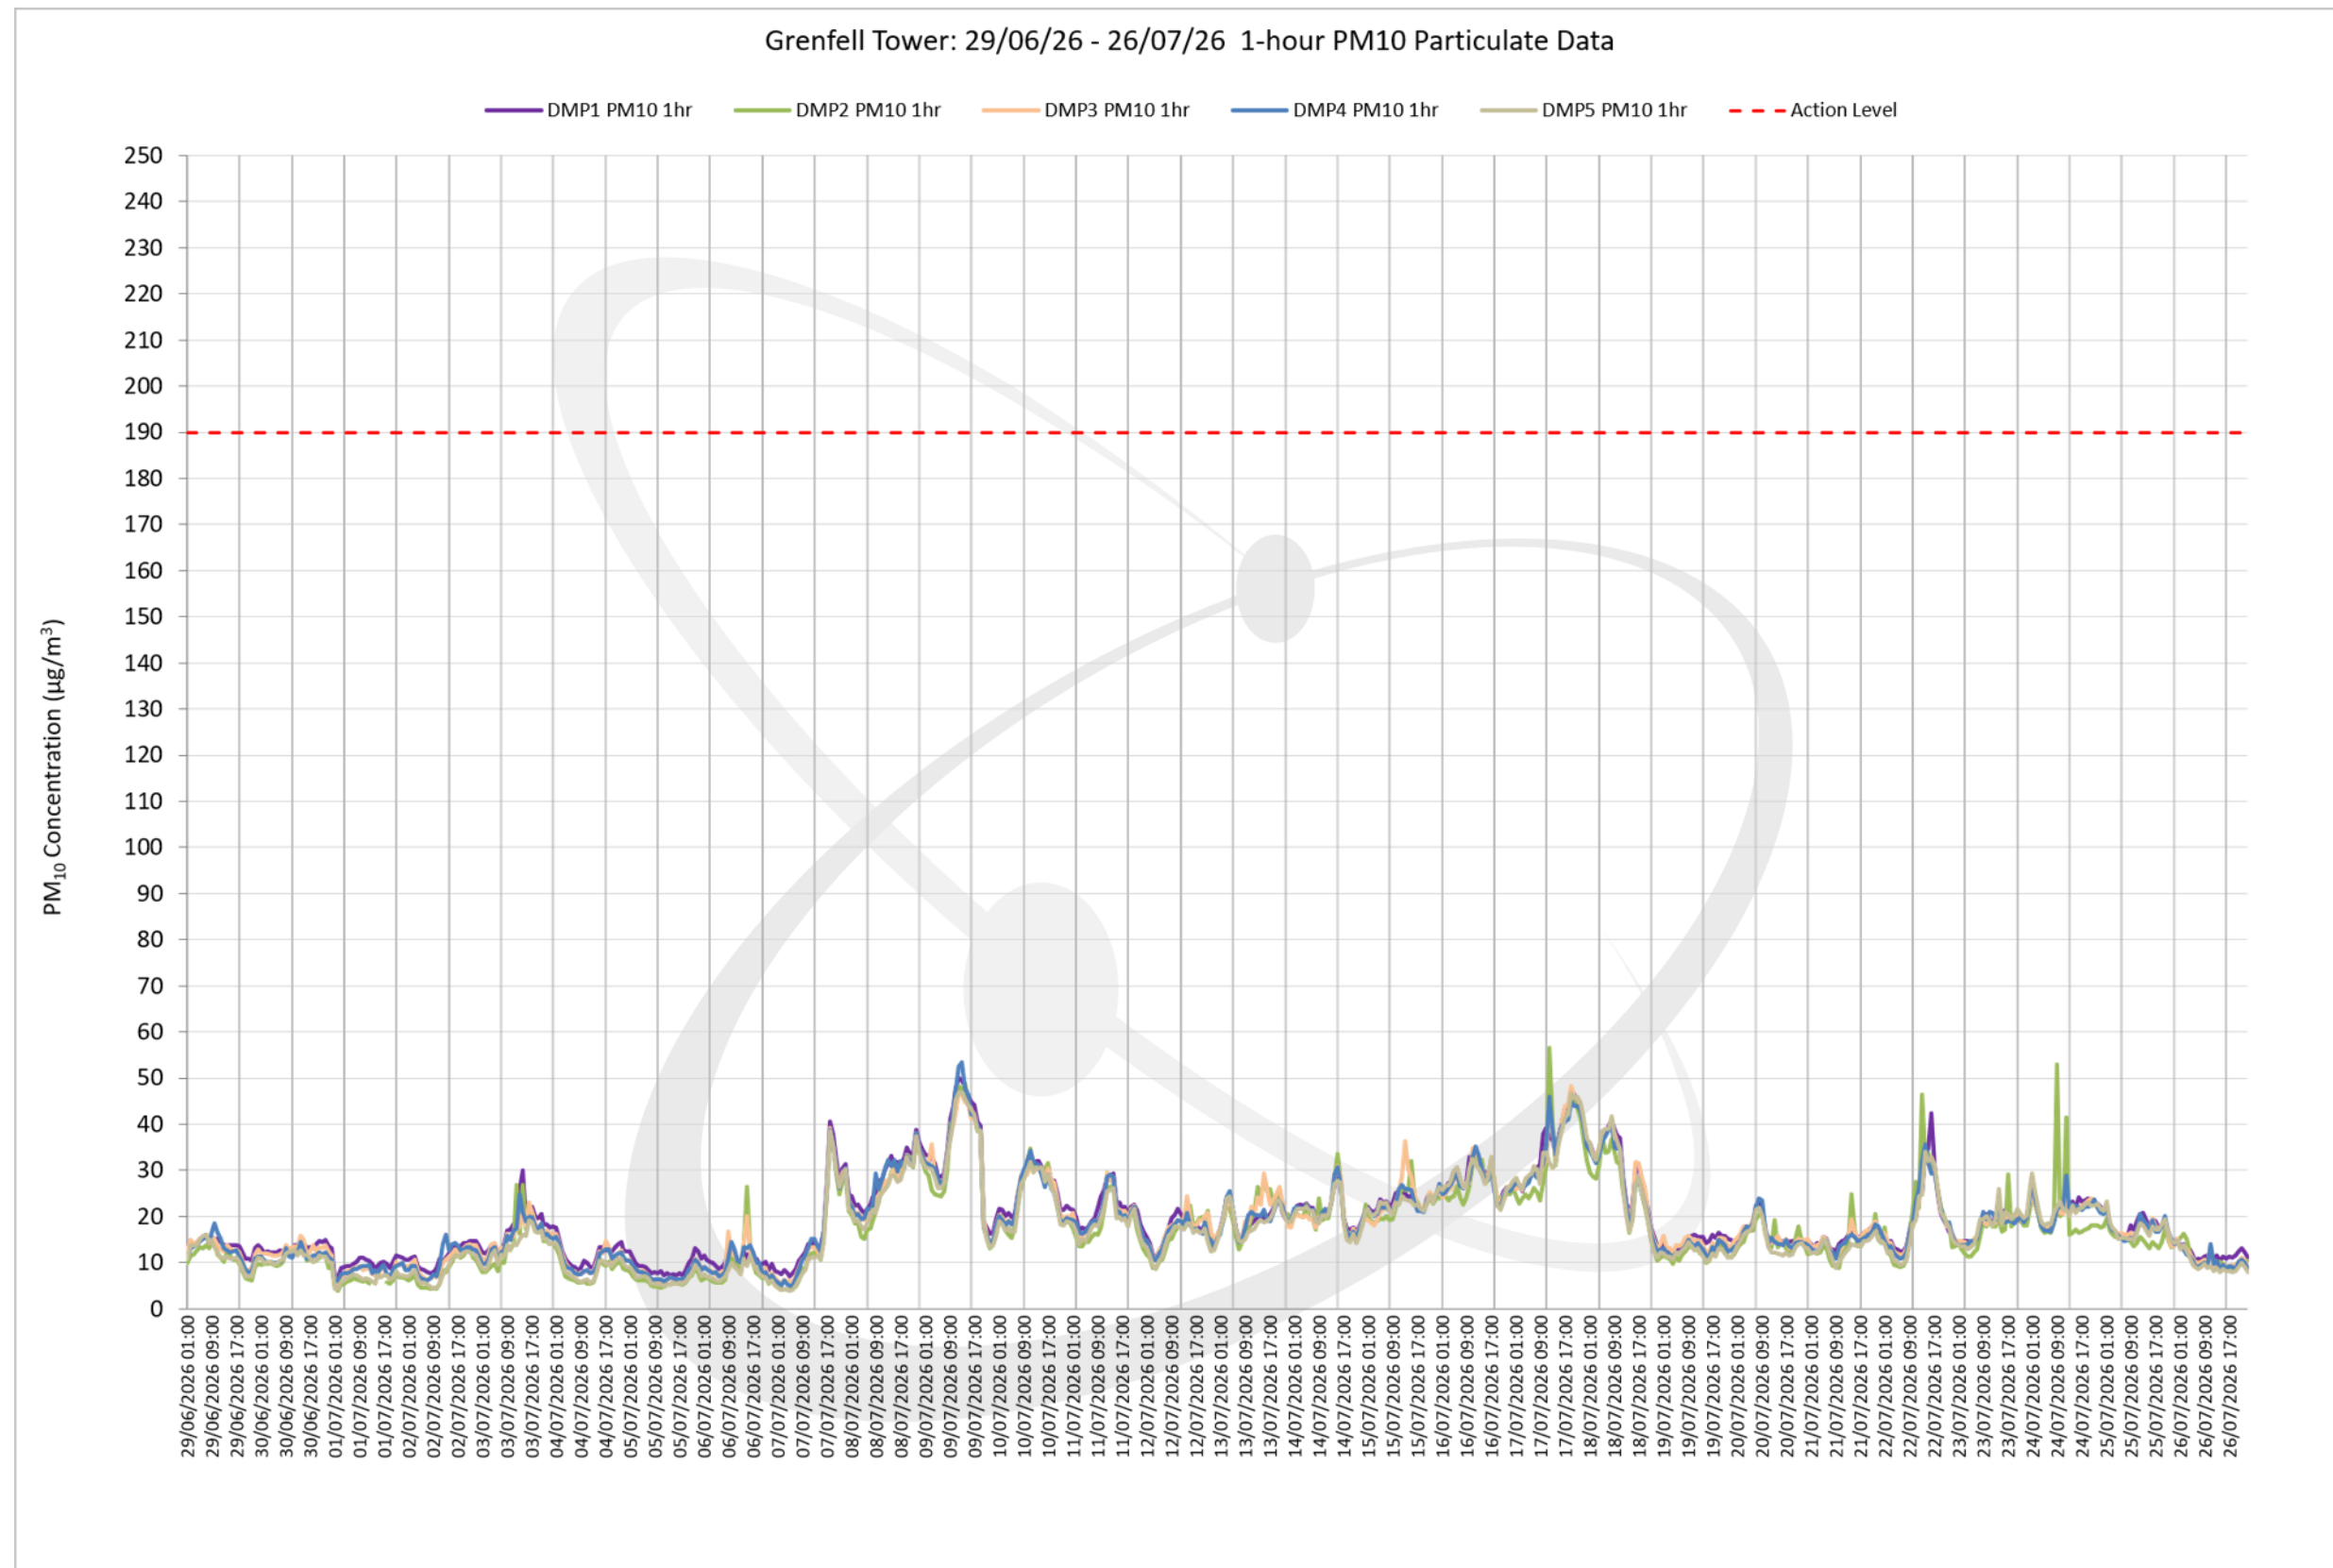
## 7. PM<sub>10</sub> Dust Monitoring Graphs

There were **no exceedances** of the 15-minute PM<sub>2.5</sub> 54 (µg/m<sup>3</sup>) and **no exceedances** of the 15-minute PM<sub>10</sub> 150 (µg/m<sup>3</sup>) **Amber Trigger levels** at DMP1-DMP5 in this reporting period.

There were **no exceedances** of the 1-hour PM<sub>10</sub> 190 (µg/m<sup>3</sup>) and **no exceedances** of the 1-hour PM<sub>2.5</sub> 70 (µg/m<sup>3</sup>) **Red Action Alert levels** at DMP1-DMP5 in this period.

The results of the dust measurements in this period are presented graphically for PM<sub>10</sub> and PM<sub>2.5</sub> in Sections 7 and 8 respectively of this report.
