## Abbreviated Noise Monitoring Reports

**Project:** Grenfell Tower

**Document Ref:** EEMC-NMR-201/111 – Grenfell Tower Rev 01

**Period:** 29 June 2026 to 26 July 2026

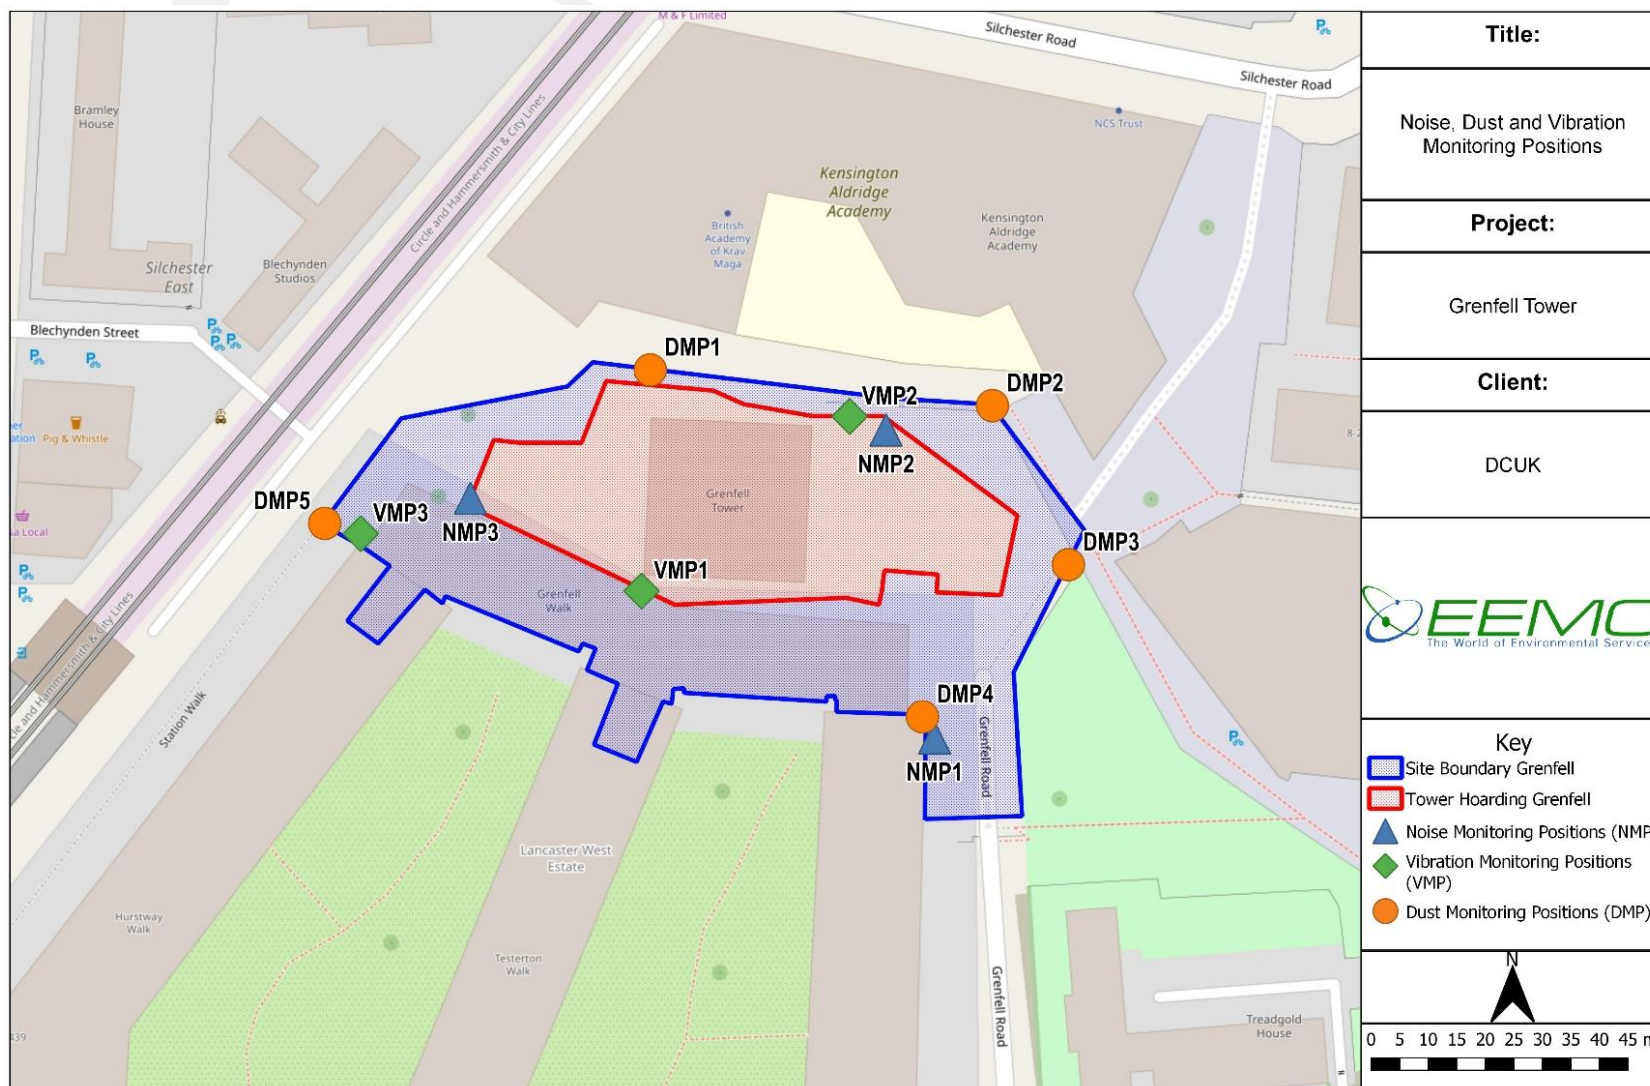
Figure 1- Map of Noise, Dust & Vibration Monitoring Locations

The site boundary and hoarding line of this project is shown in Figure 1. The project is located at Grenfell Tower, Grenfell Road, W11 1TQ. The entire site is located within Royal Borough of Kensington & Chelsea (RBKC) and is bordered by residential blocks to the south, and a school and football pitches to the north and a leisure centre to the east. The London Underground viaduct is 70m to the west and Latimer Road Tube station is 200m from the project

Three (3) Class 1 compliant noise monitors have been deployed to undertake noise monitoring on the site. A map indicating the location of the noise monitors is provided as Figure 1 and photographs of the installed noise monitors are provided as Image 1-3.

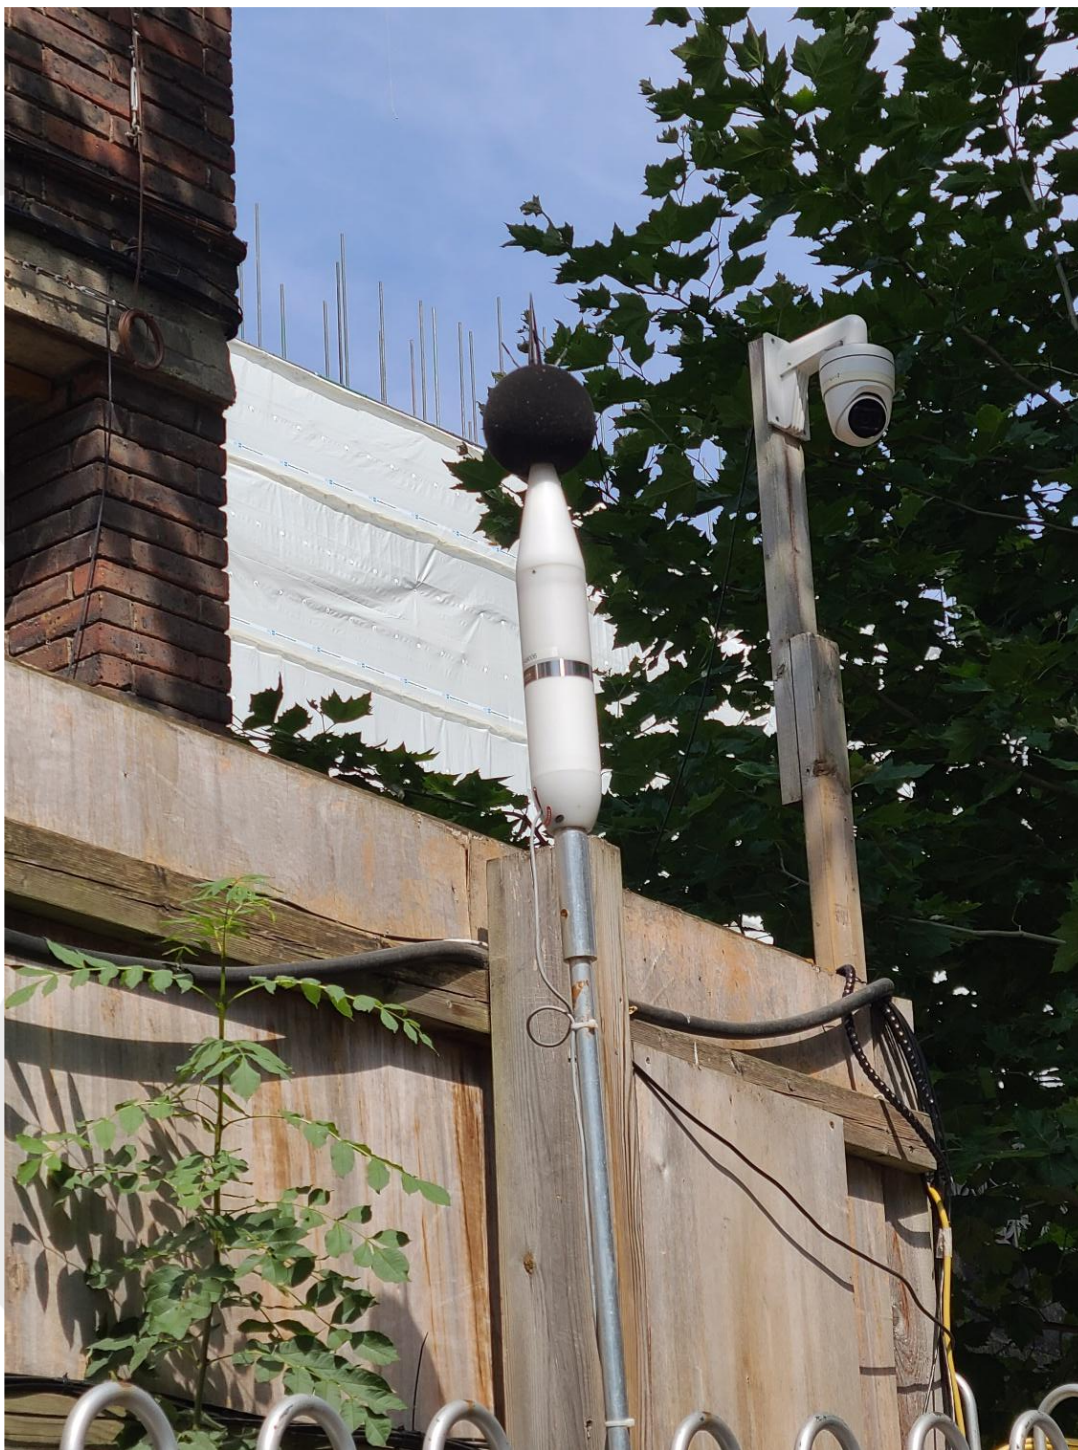
**Image 1 –NMP1 Monitoring Location** *(Image taken 22/07/2026)*

| ID Reference | Location |
|---|---|
| NMP1 | South-East of site on the hoarding |

The noise monitors are installed with an all-weather protective system fitted to the remote microphone, at elevations and locations previously agreed with RBKC. Each system is fitted with a modem to allow remote access to the measurement data via the internet. The modem also enables the provision of automatic email alerts.

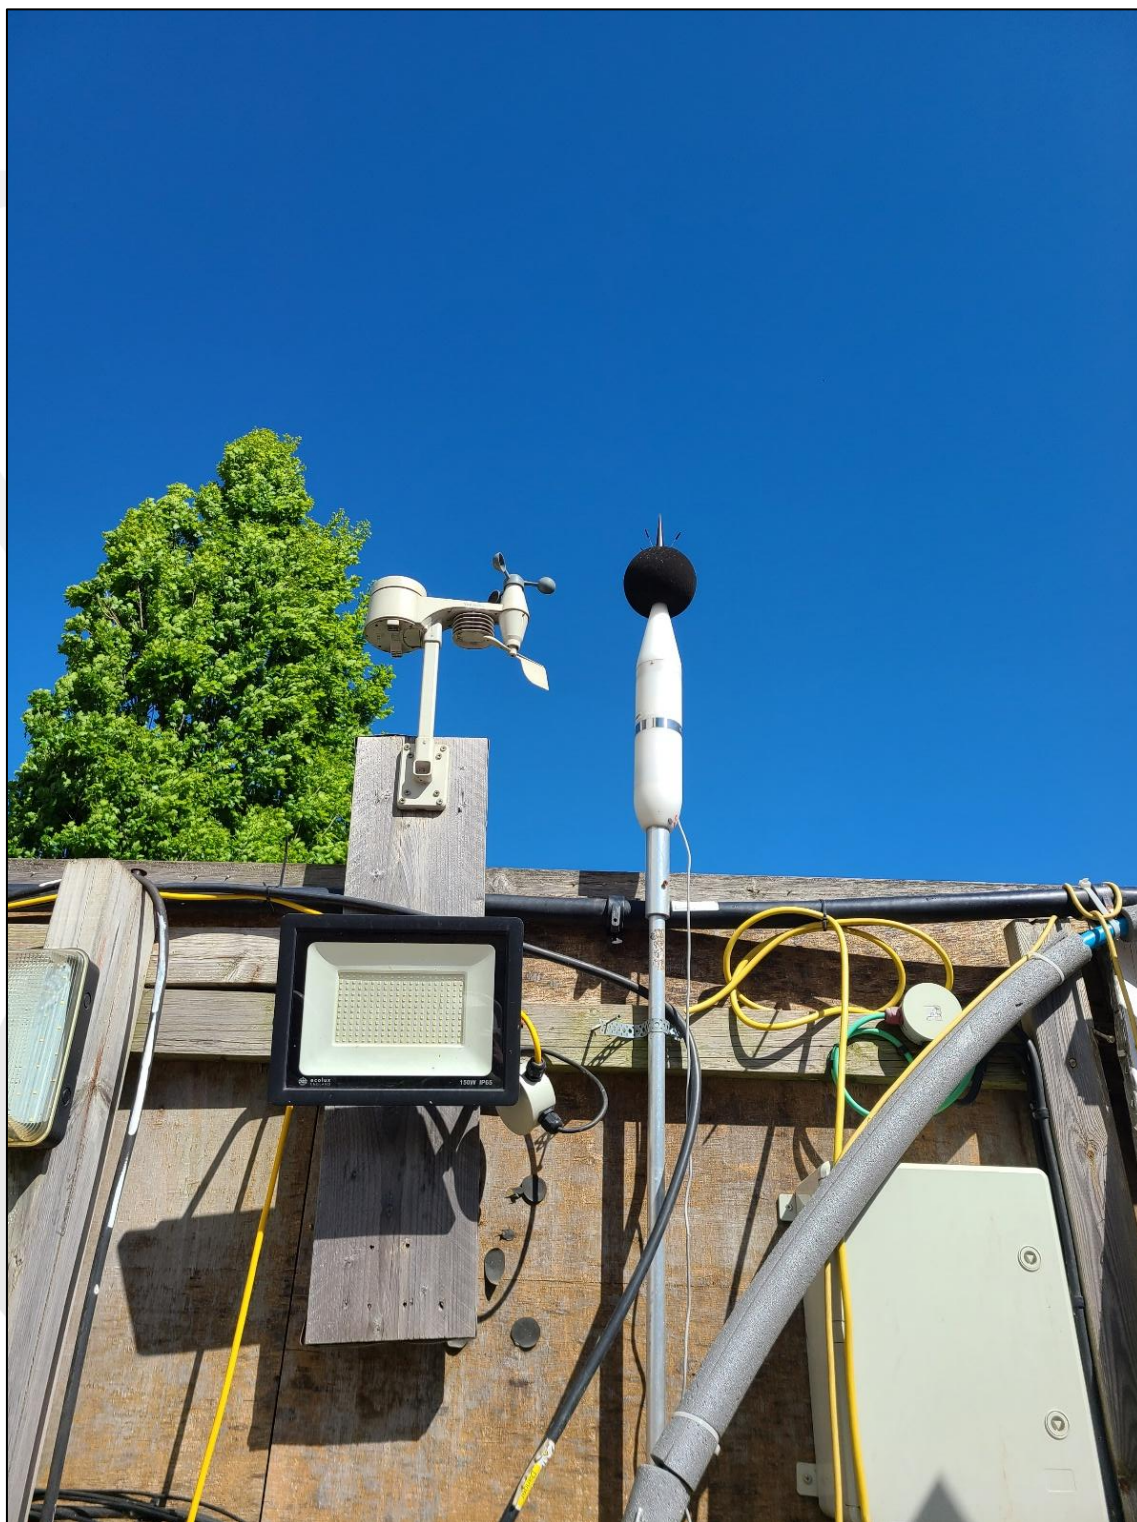
**Image 2 –NMP2 Monitoring Location** *(Image taken 22/07/2026)*

| ID Reference | Location |
|---|---|
| NMP2 | North-East of site on the hoarding |

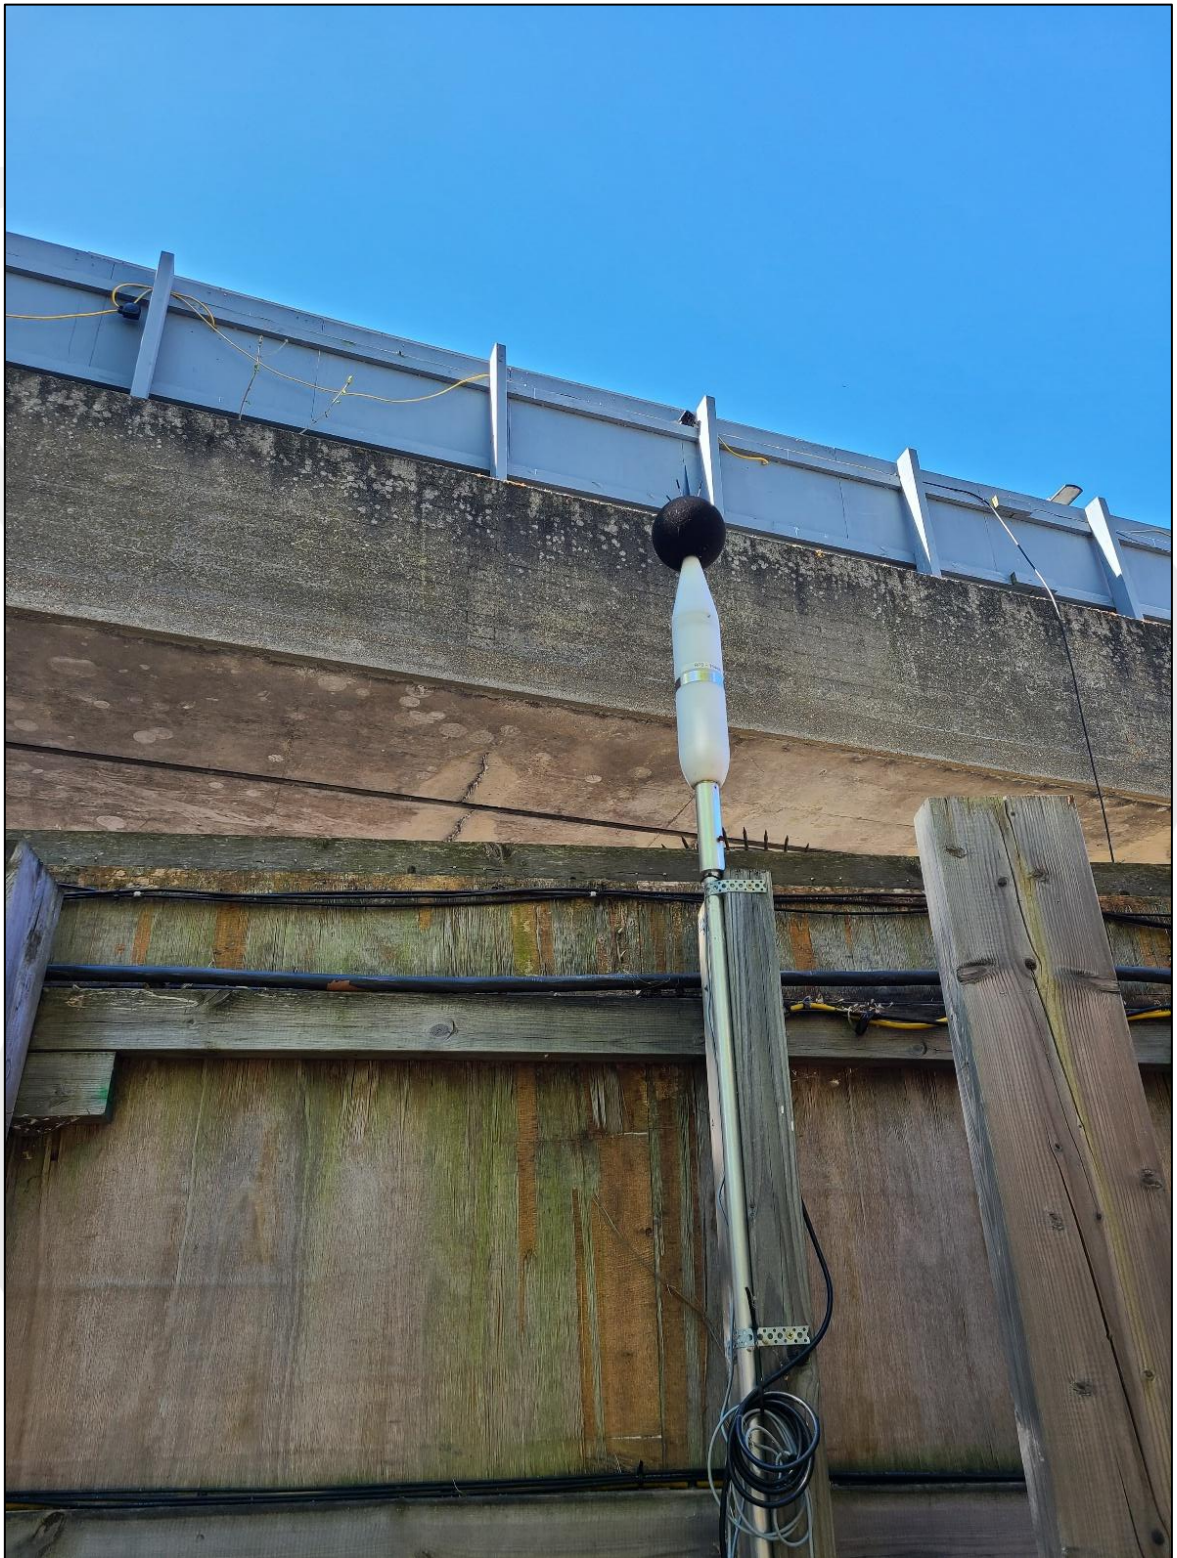
**Image 3 –NMP3 Monitoring Location** *(Image taken 22/07/2026)*

| ID Reference | Location |
|---|---|
| NMP3 | South-West of site on the hoarding |

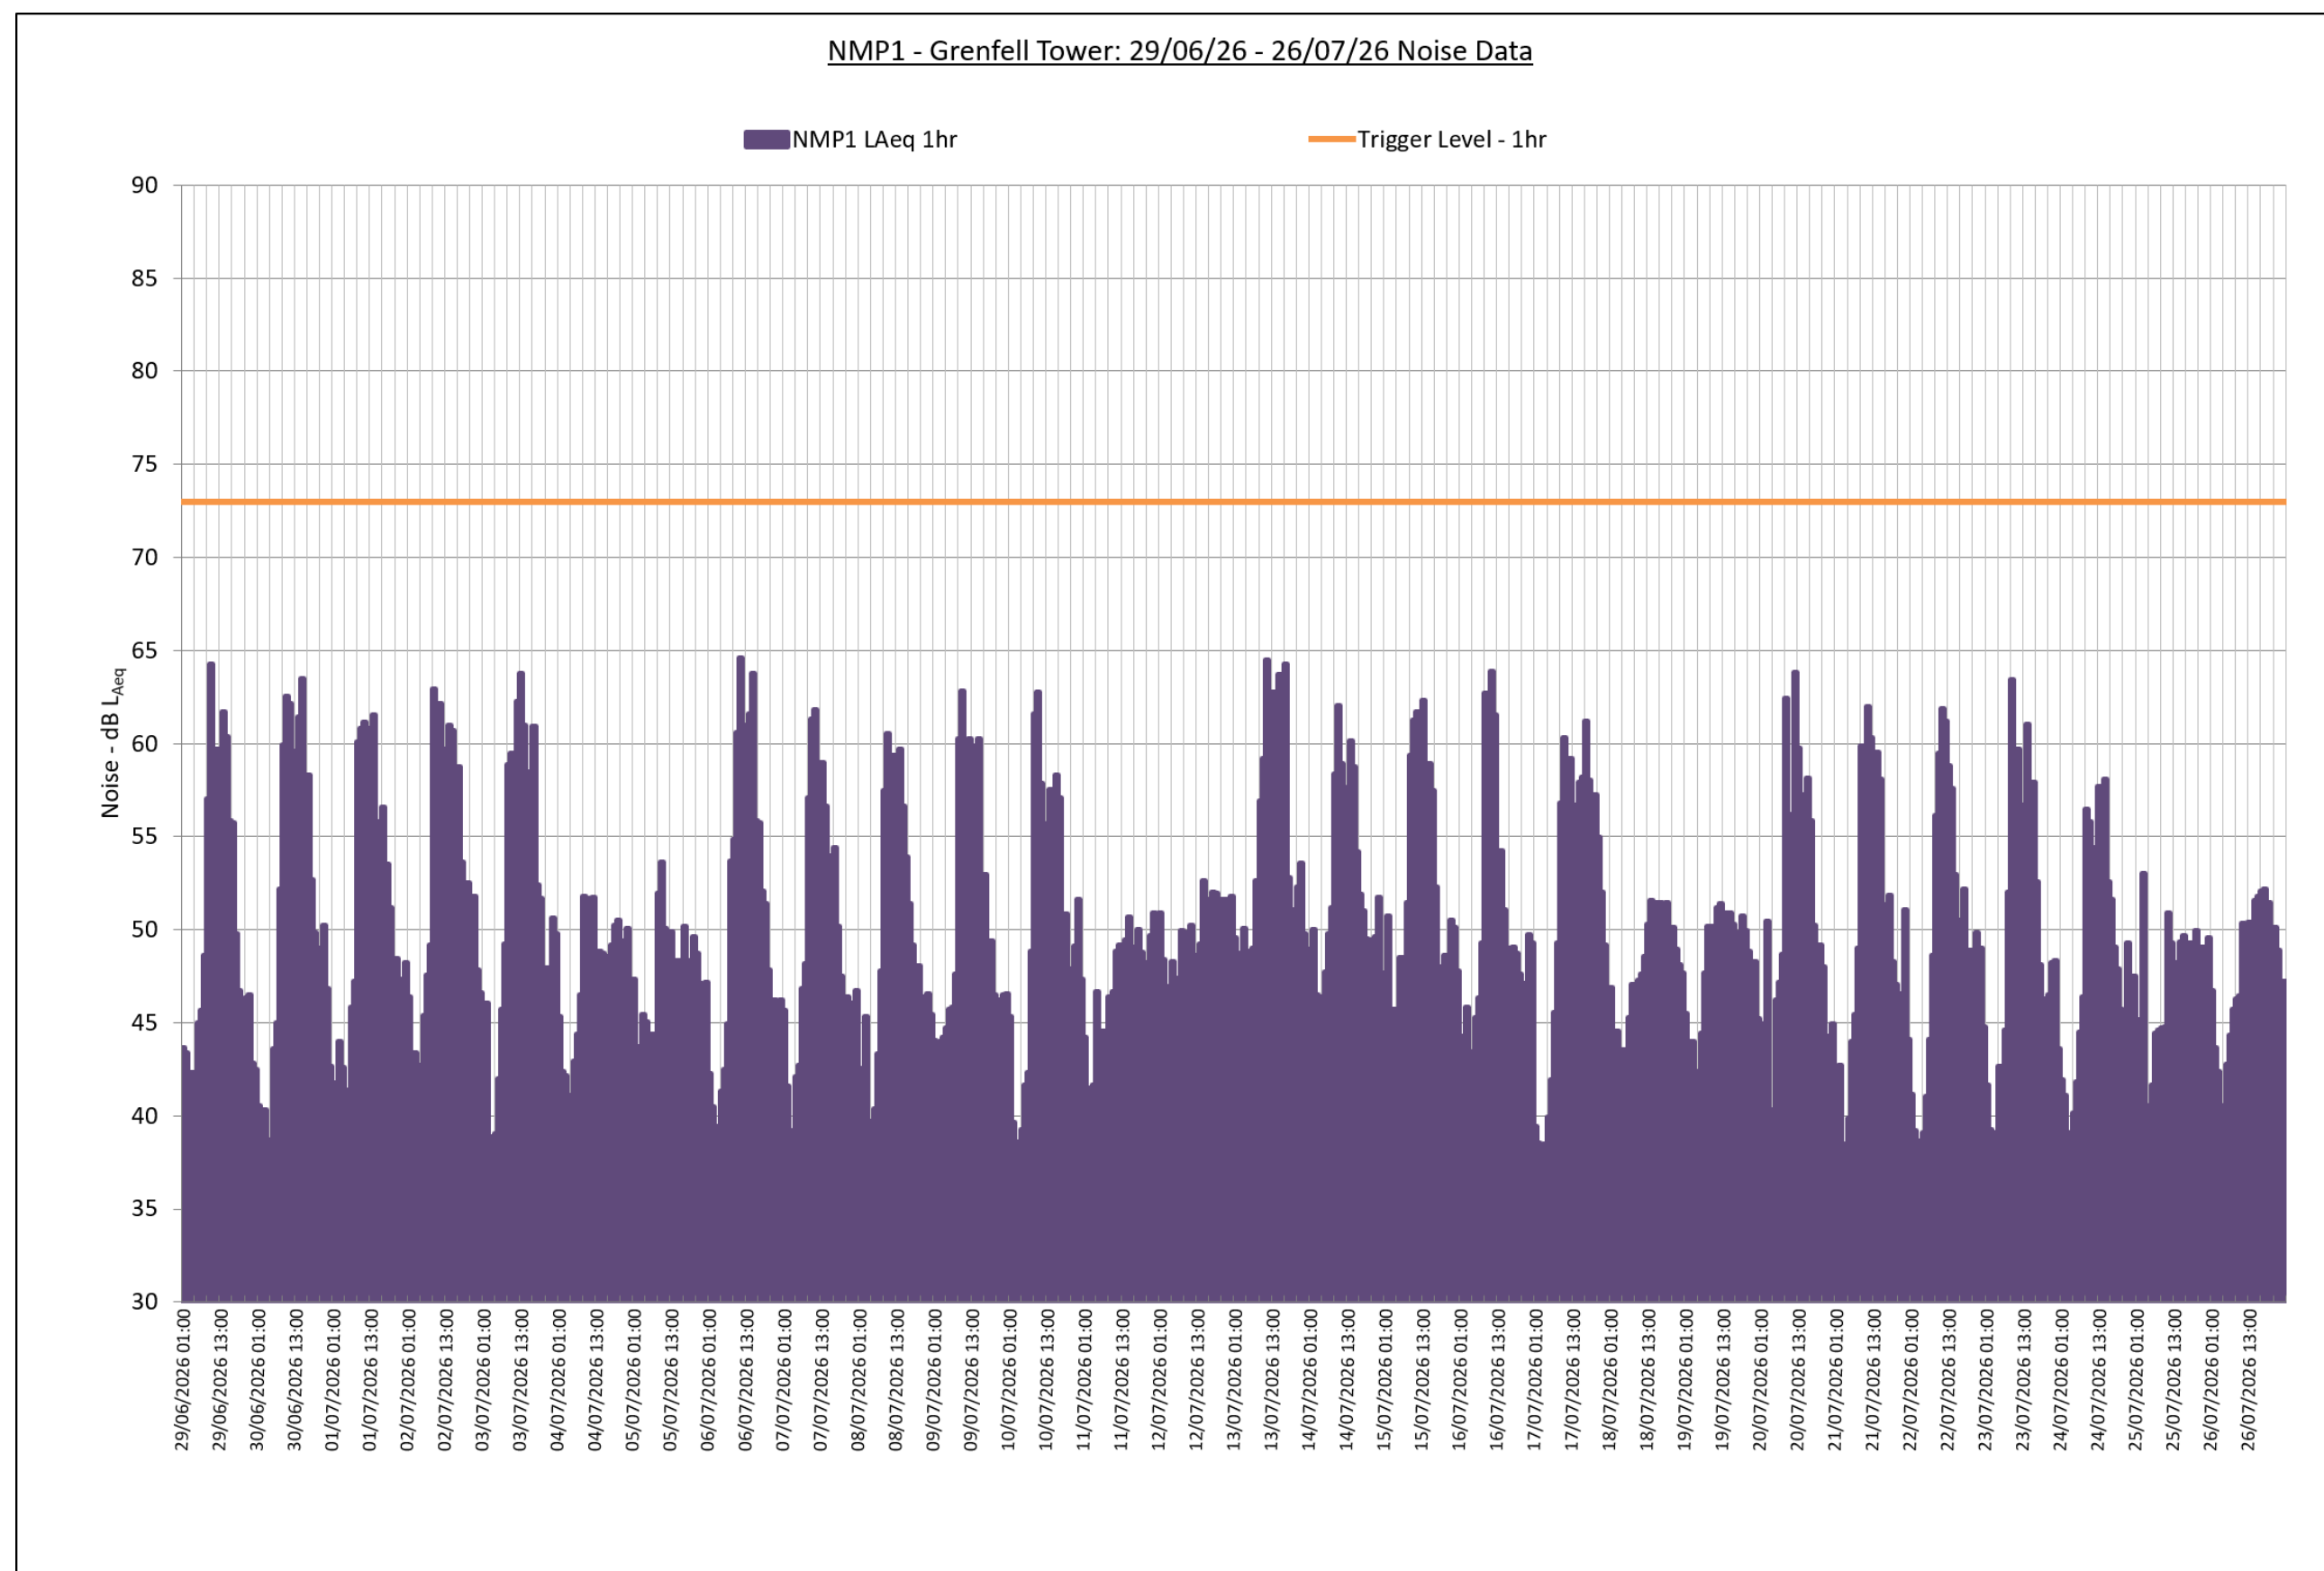
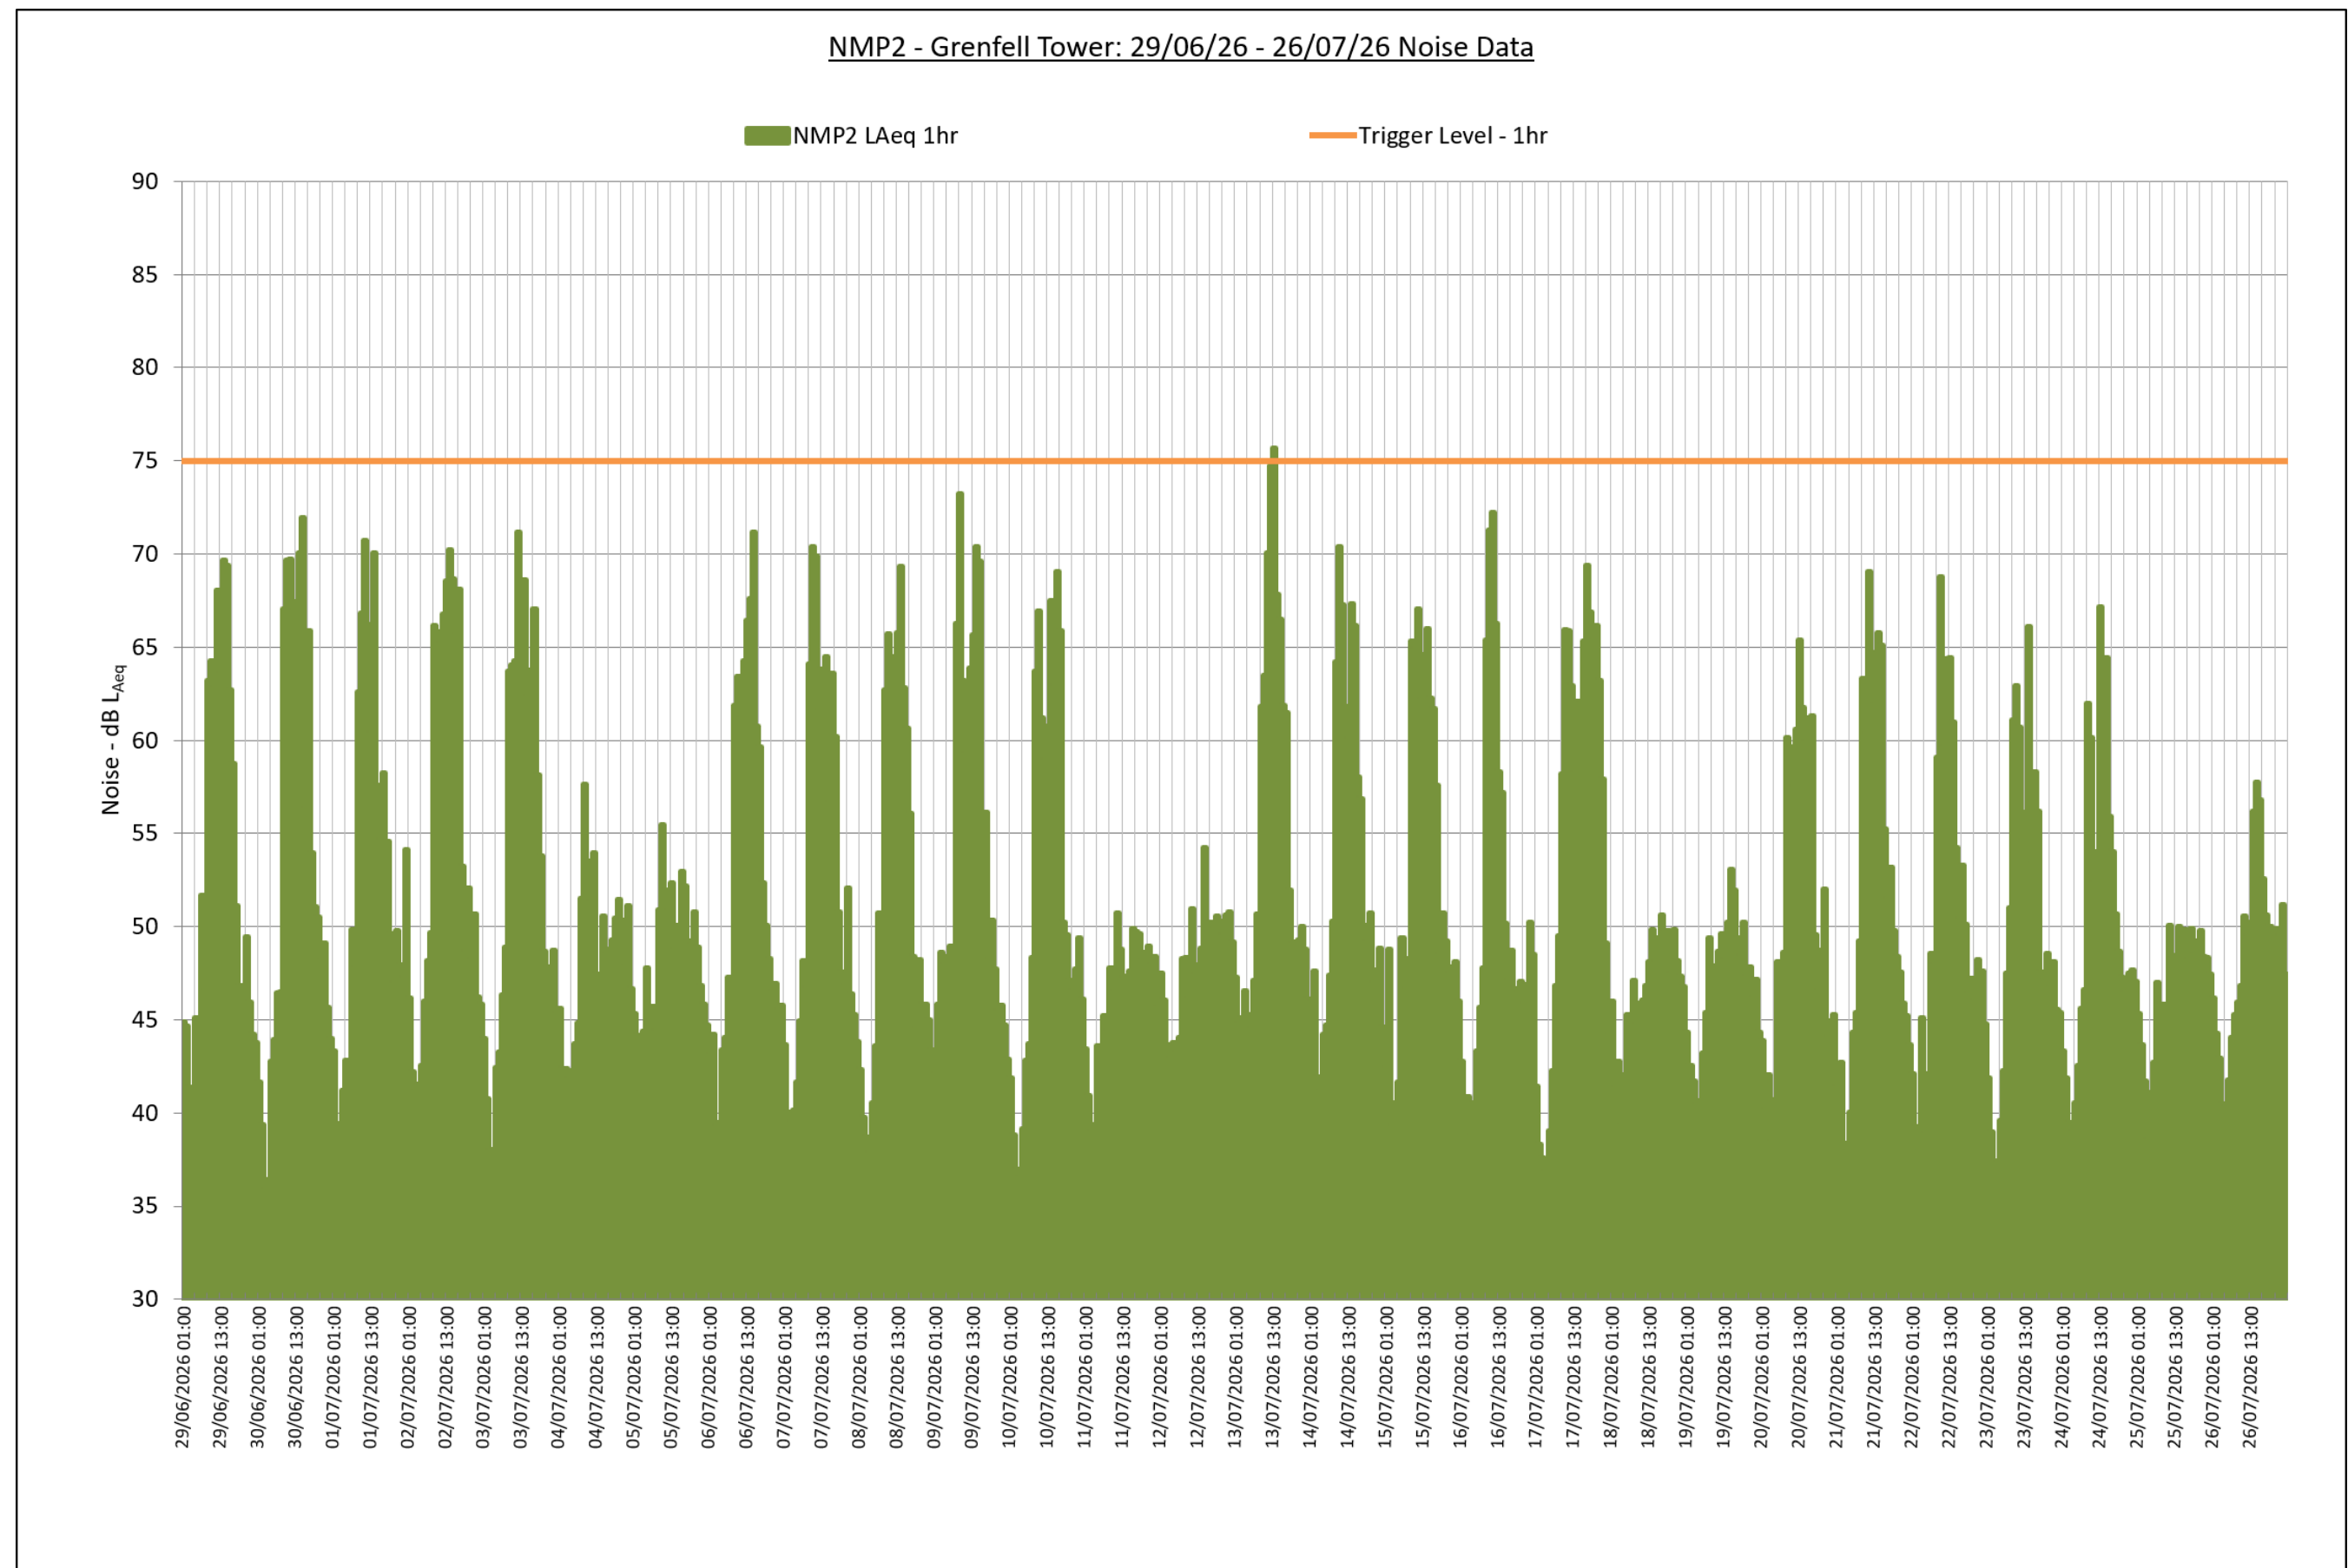
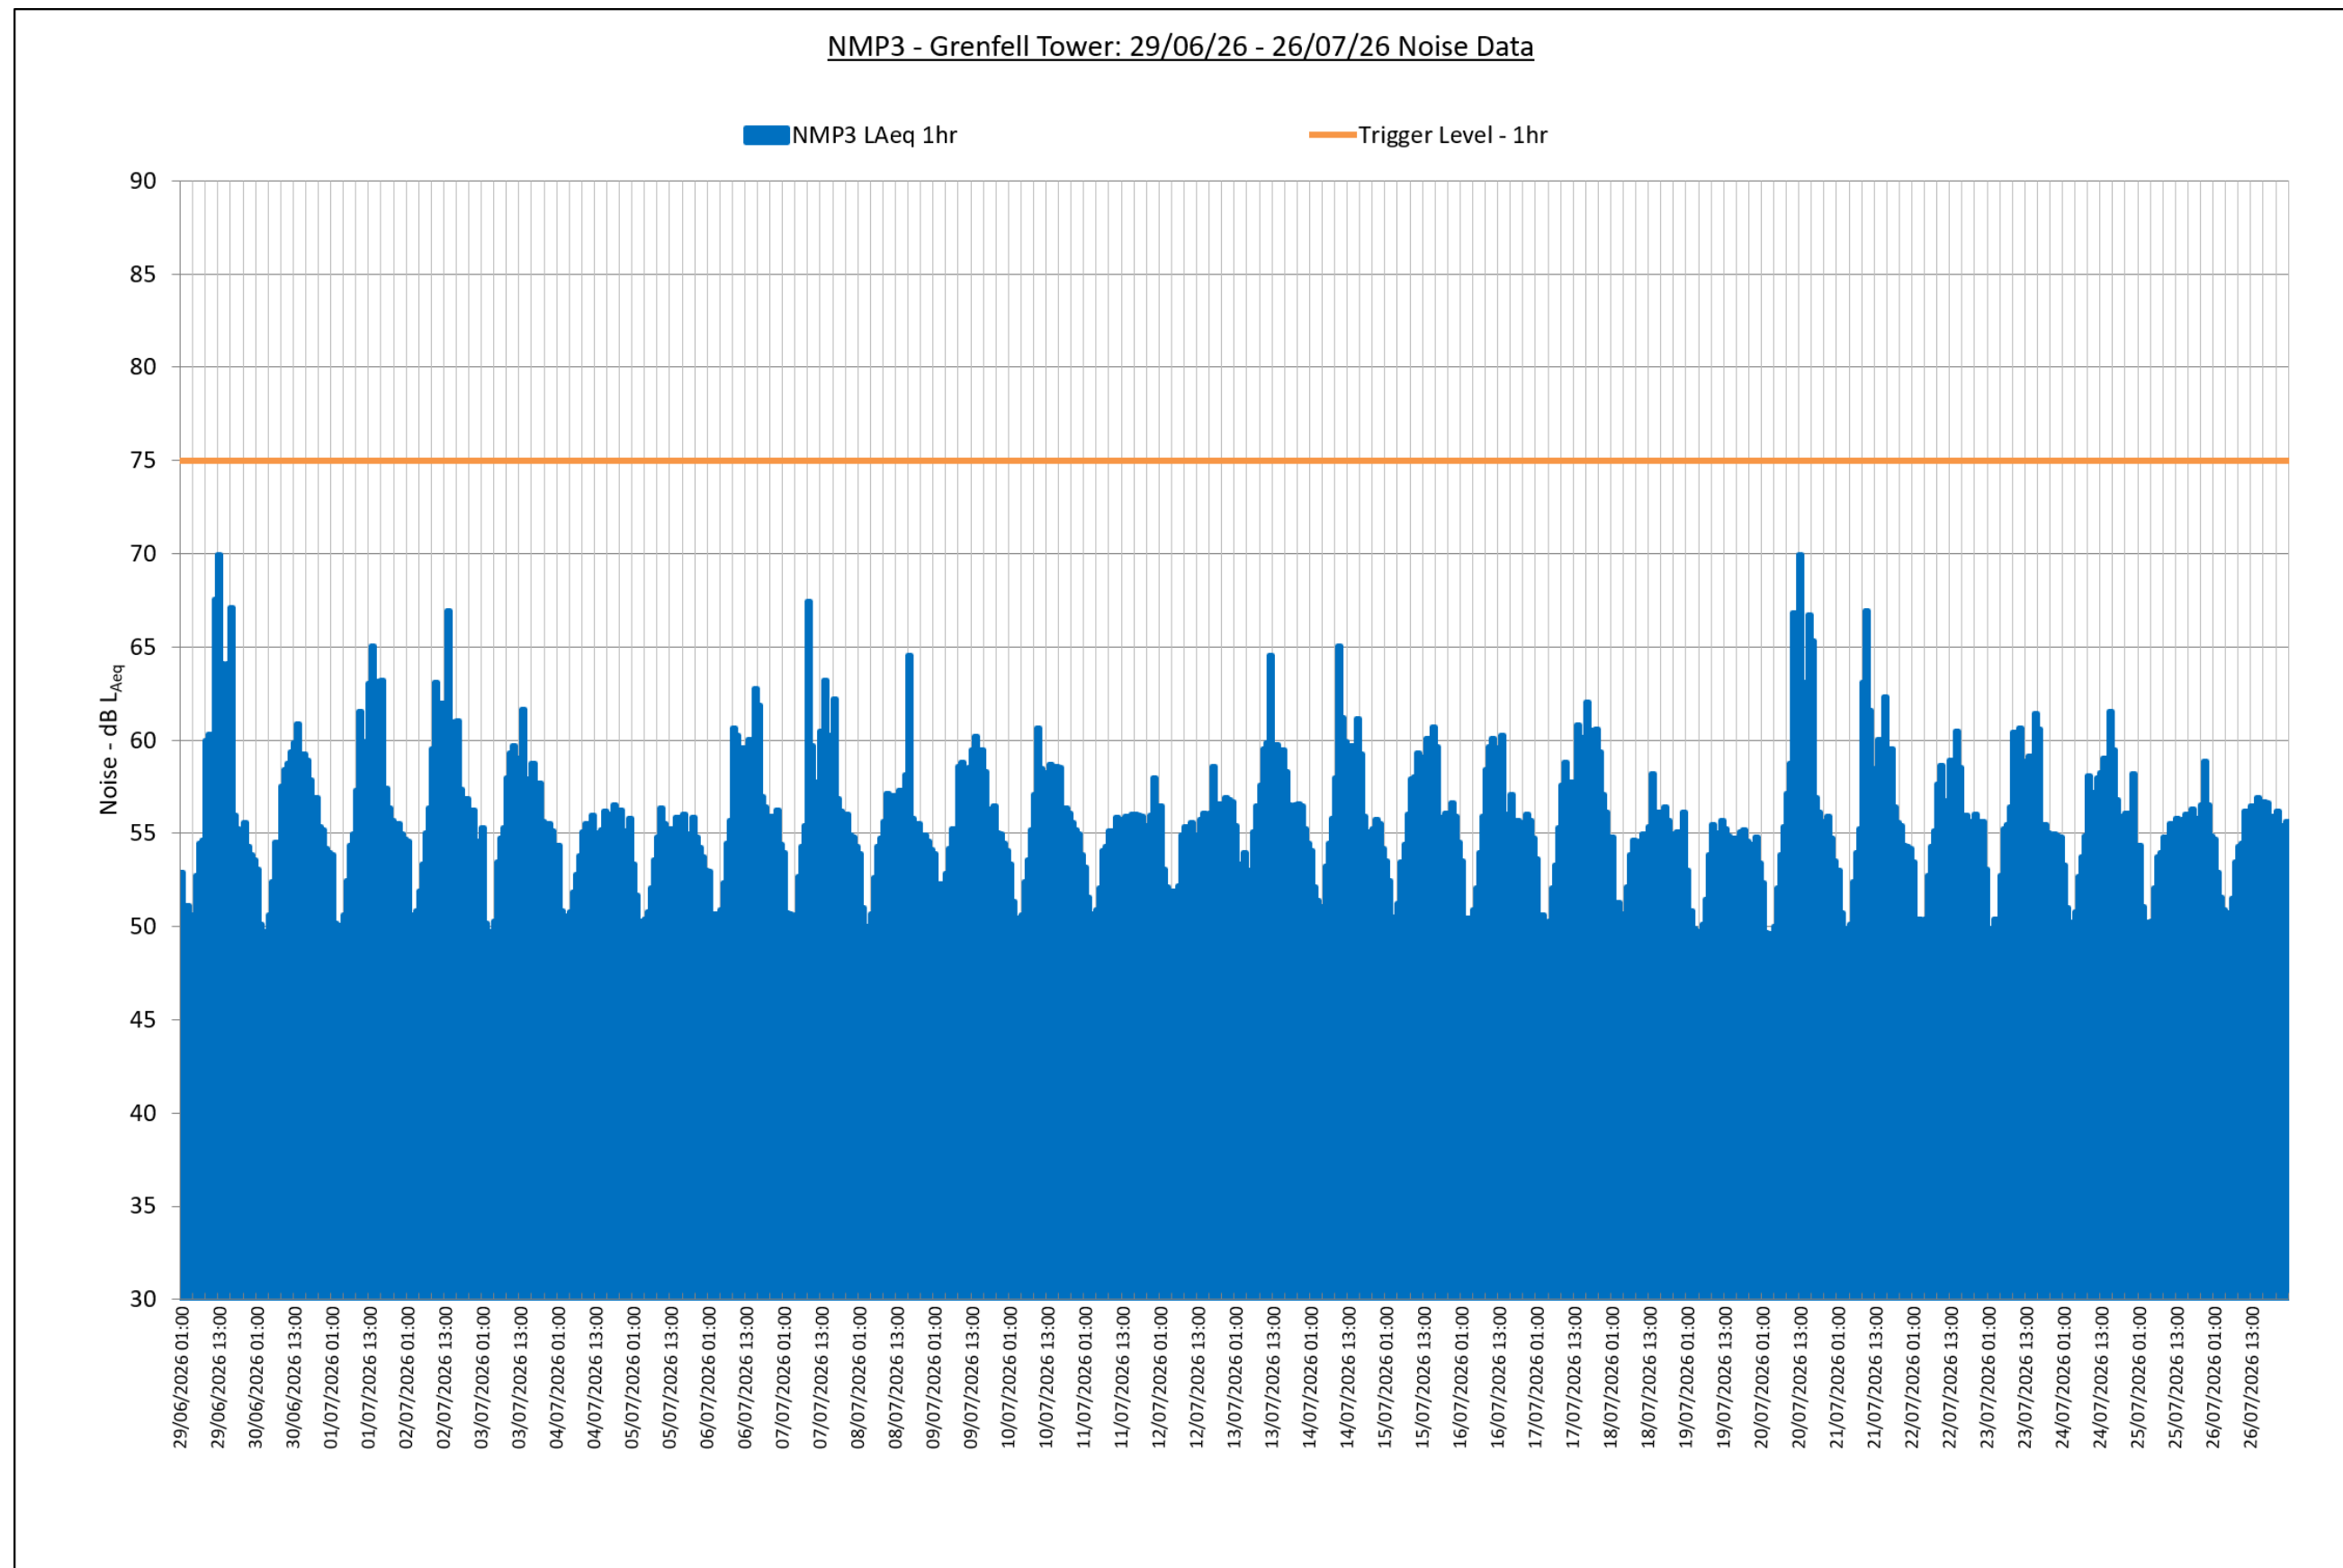
## 6. 1-hour Noise Monitoring Graphs

There were **no exceedances** of the Amber Alert level, and **no exceedances** of the Red Alert level during site working hours in this reporting period.

There was **one (1) exceedance** of the Amber Alert level, and **no exceedances** of the Red Alert level during site working hours in this reporting period.

There were **no exceedances** of the Amber Alert Level, and **no exceedances** of the Red Alert level during site working hours in this reporting period.

| Monitoring Location | Time and Date of Exceedance | Measured Level of Exceedance (dB $L_{Aeq,1hr}$ ) | Amber Trigger Alert Level (dB $L_{Aeq,1hr}$ ) | Cause of Exceedance |
|---|---|---|---|---|
| NMP2 | 13/07/2026 13:00 | 75.7 | 75 | Kensington Academy end of year celebration- Not site related. |

The results of the noise measurements in this period are presented graphically and tabulated in Sections 6 and 7 respectively of this report.
