## Abbreviated Vibration Monitoring Reports

Monitoring Period: 29 June 2026 to 26 July 2026

| <b>Project:</b> | Grenfell Tower |
| <b>Document Ref:</b> | EEMC-VMR-201/111 – Grenfell Tower Rev 01 |

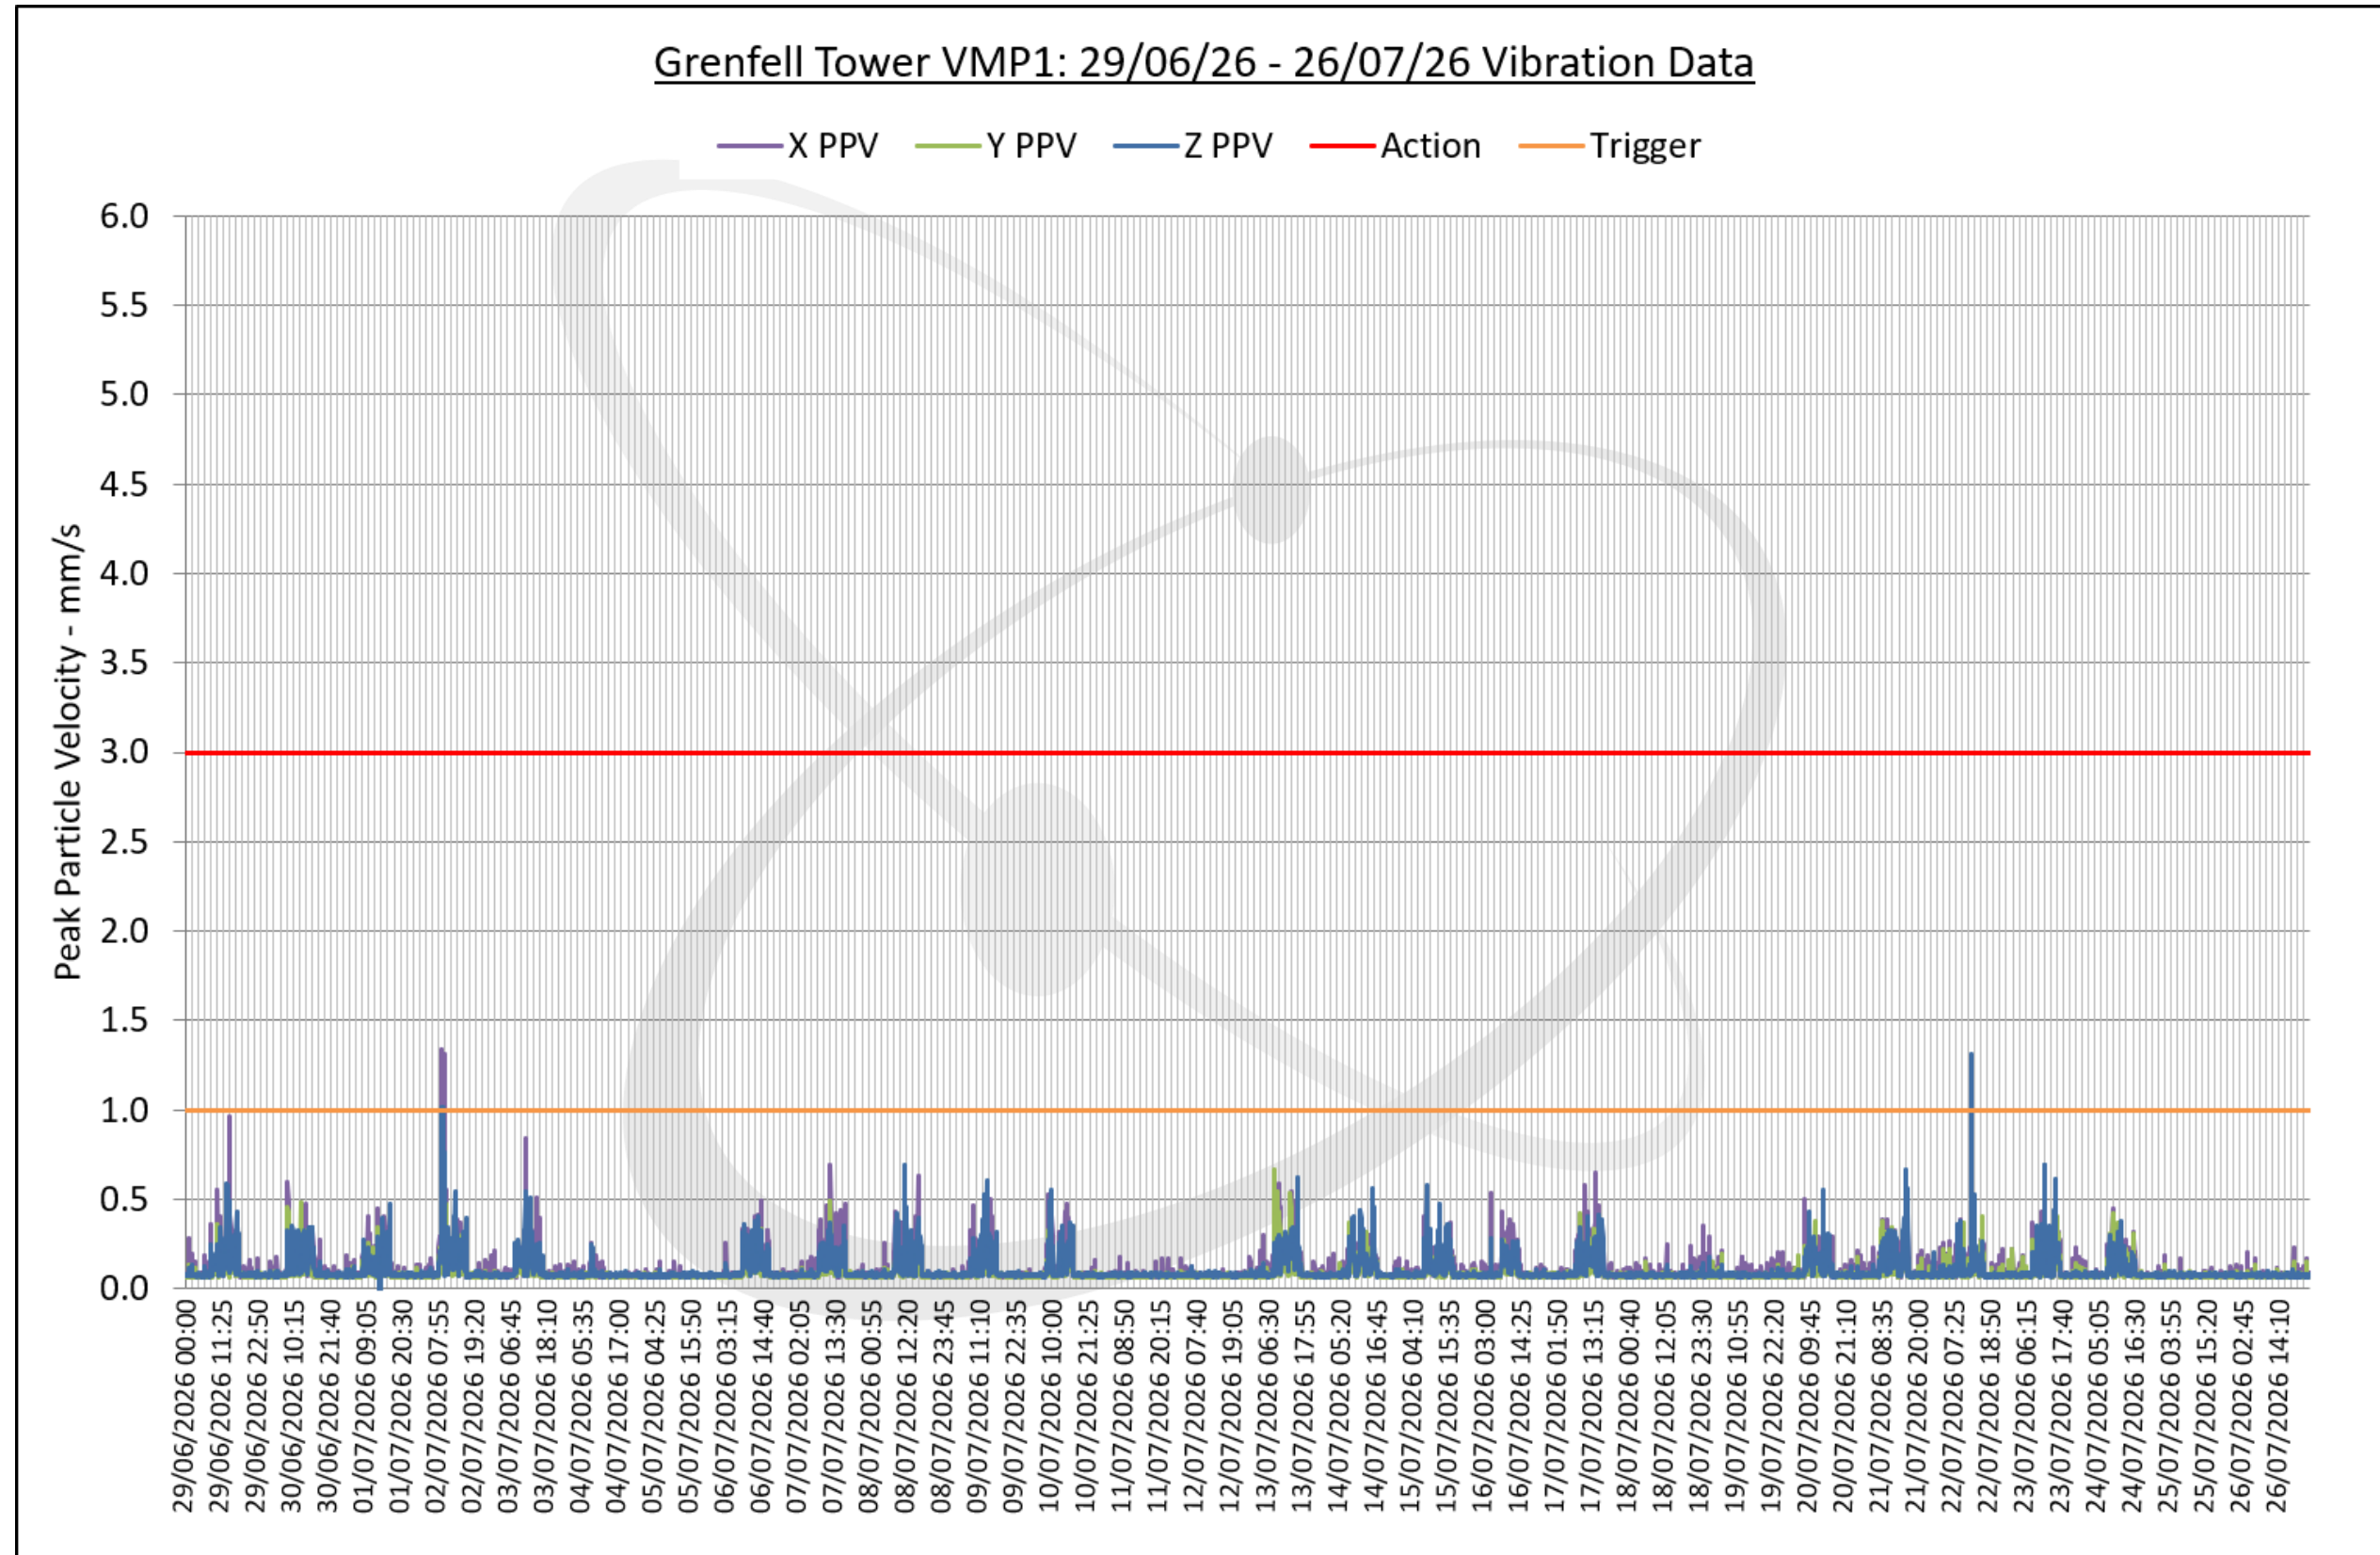
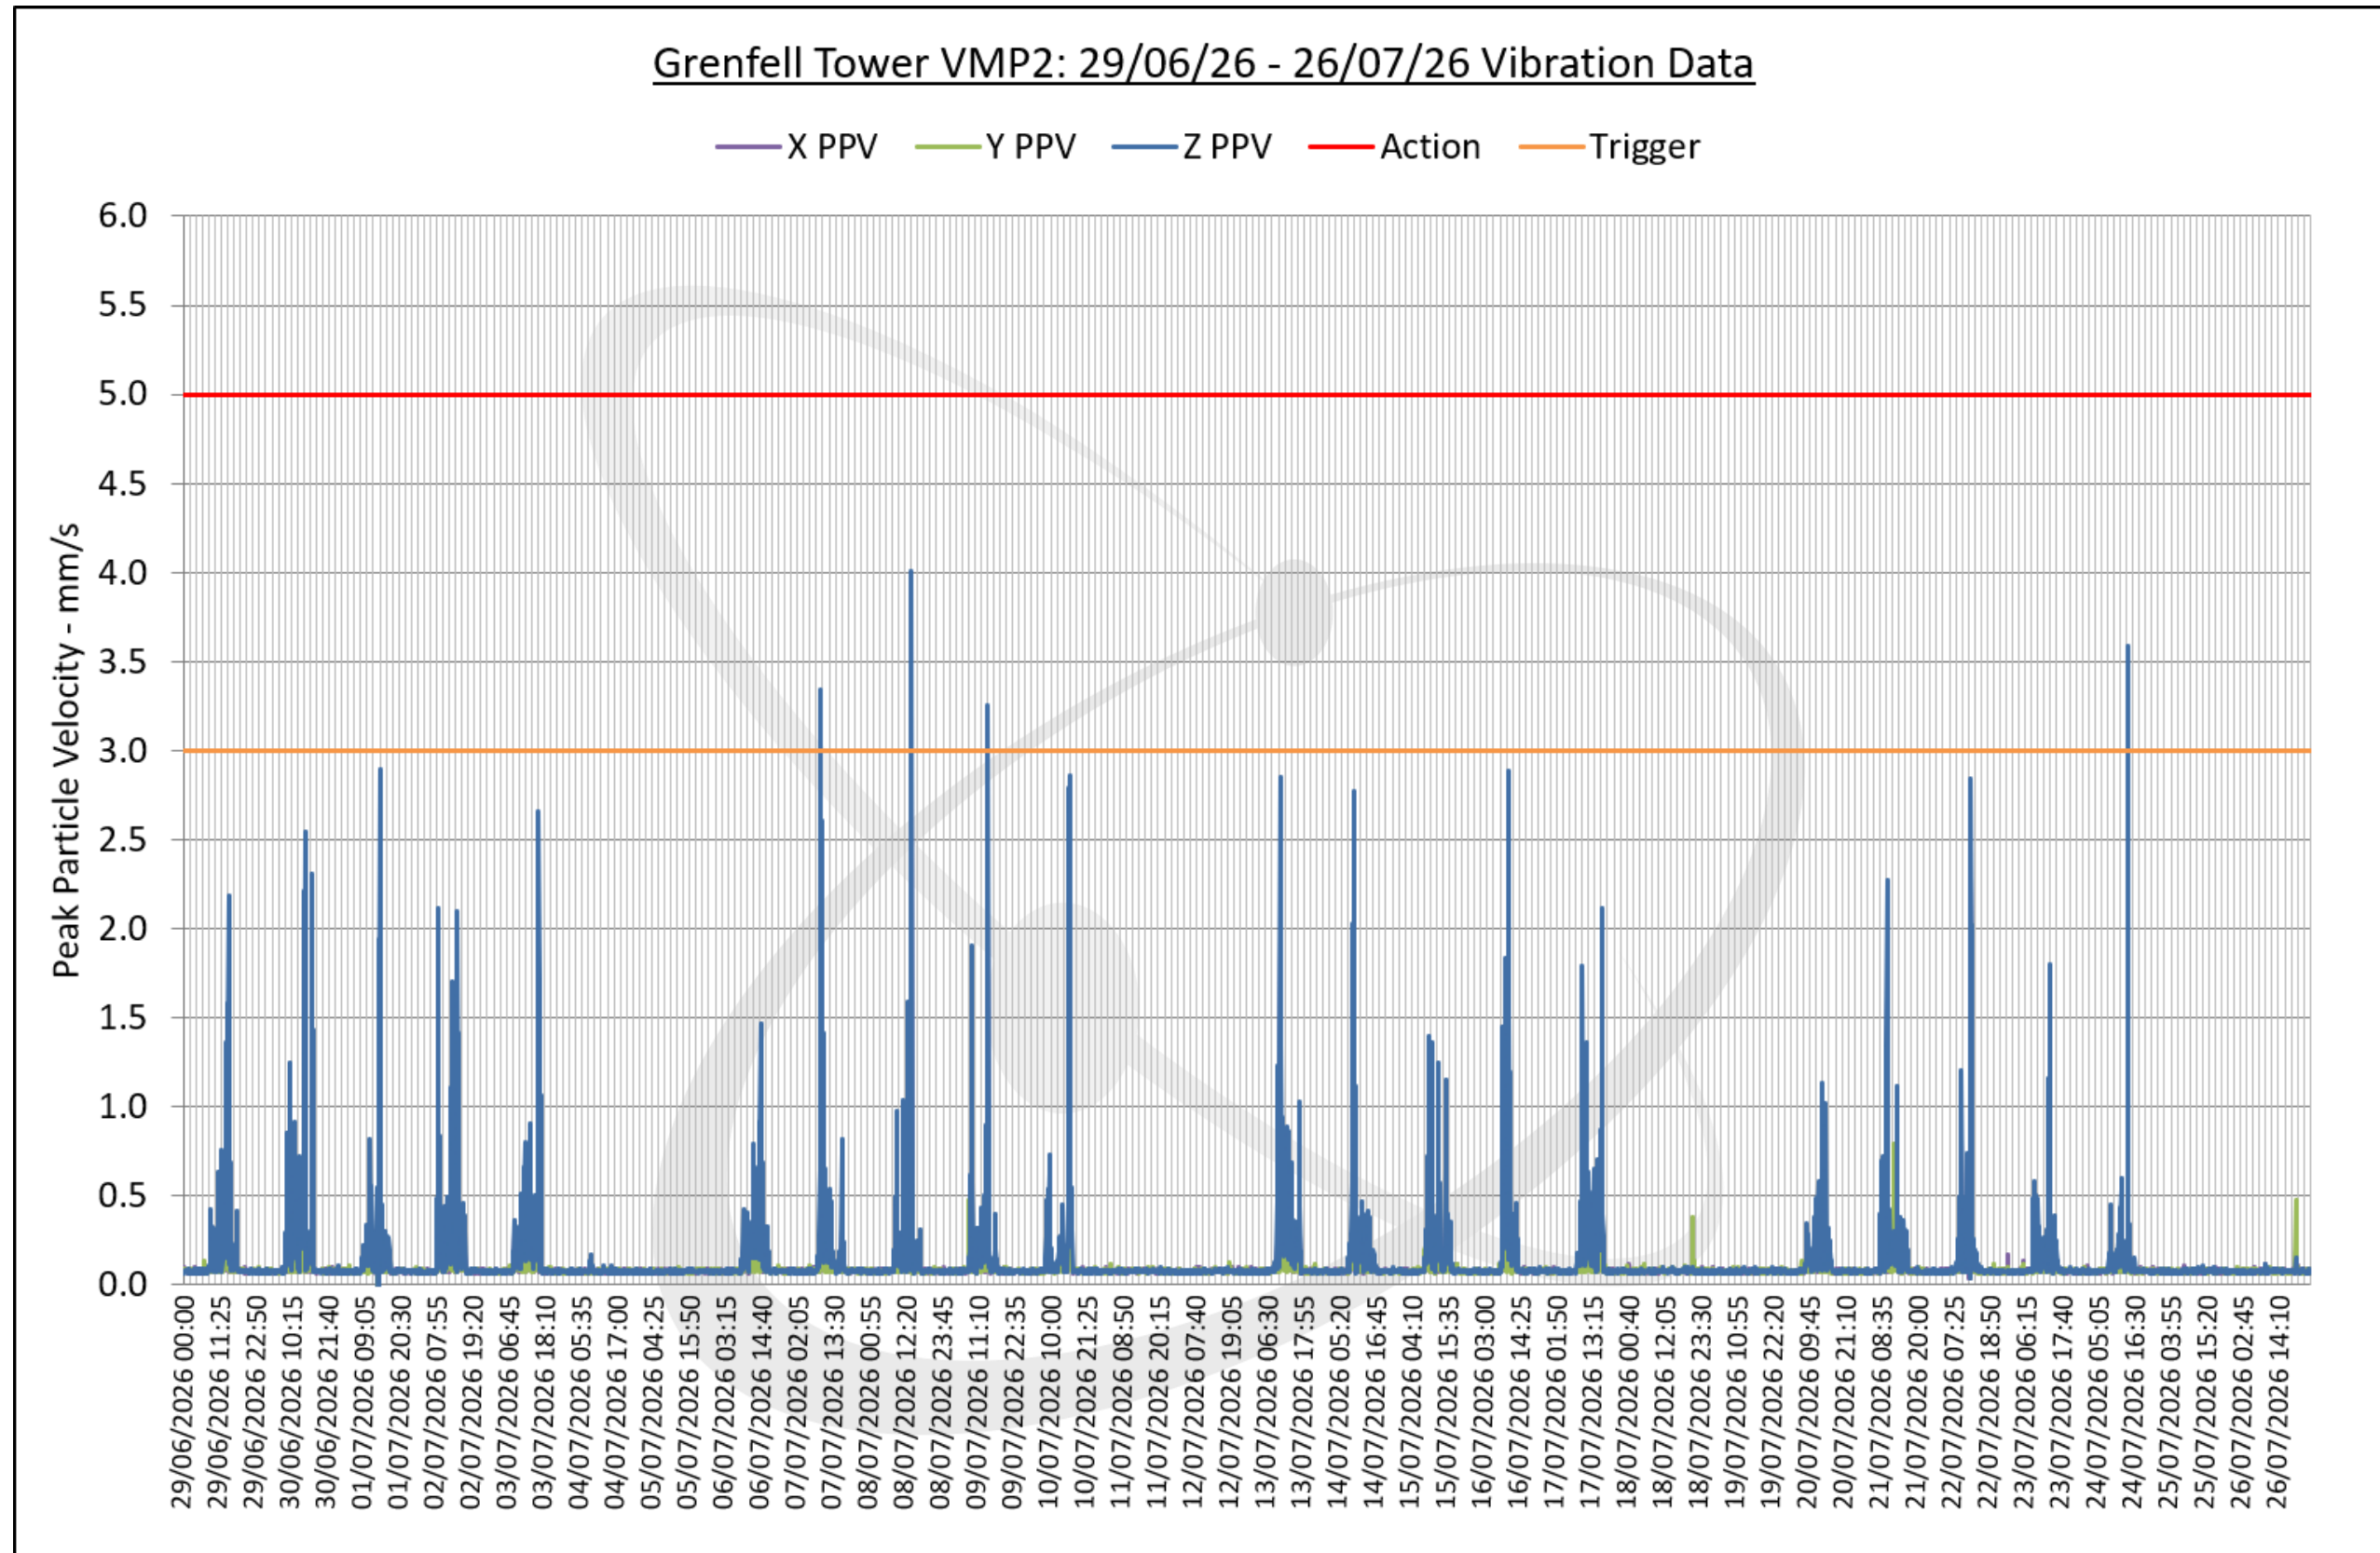
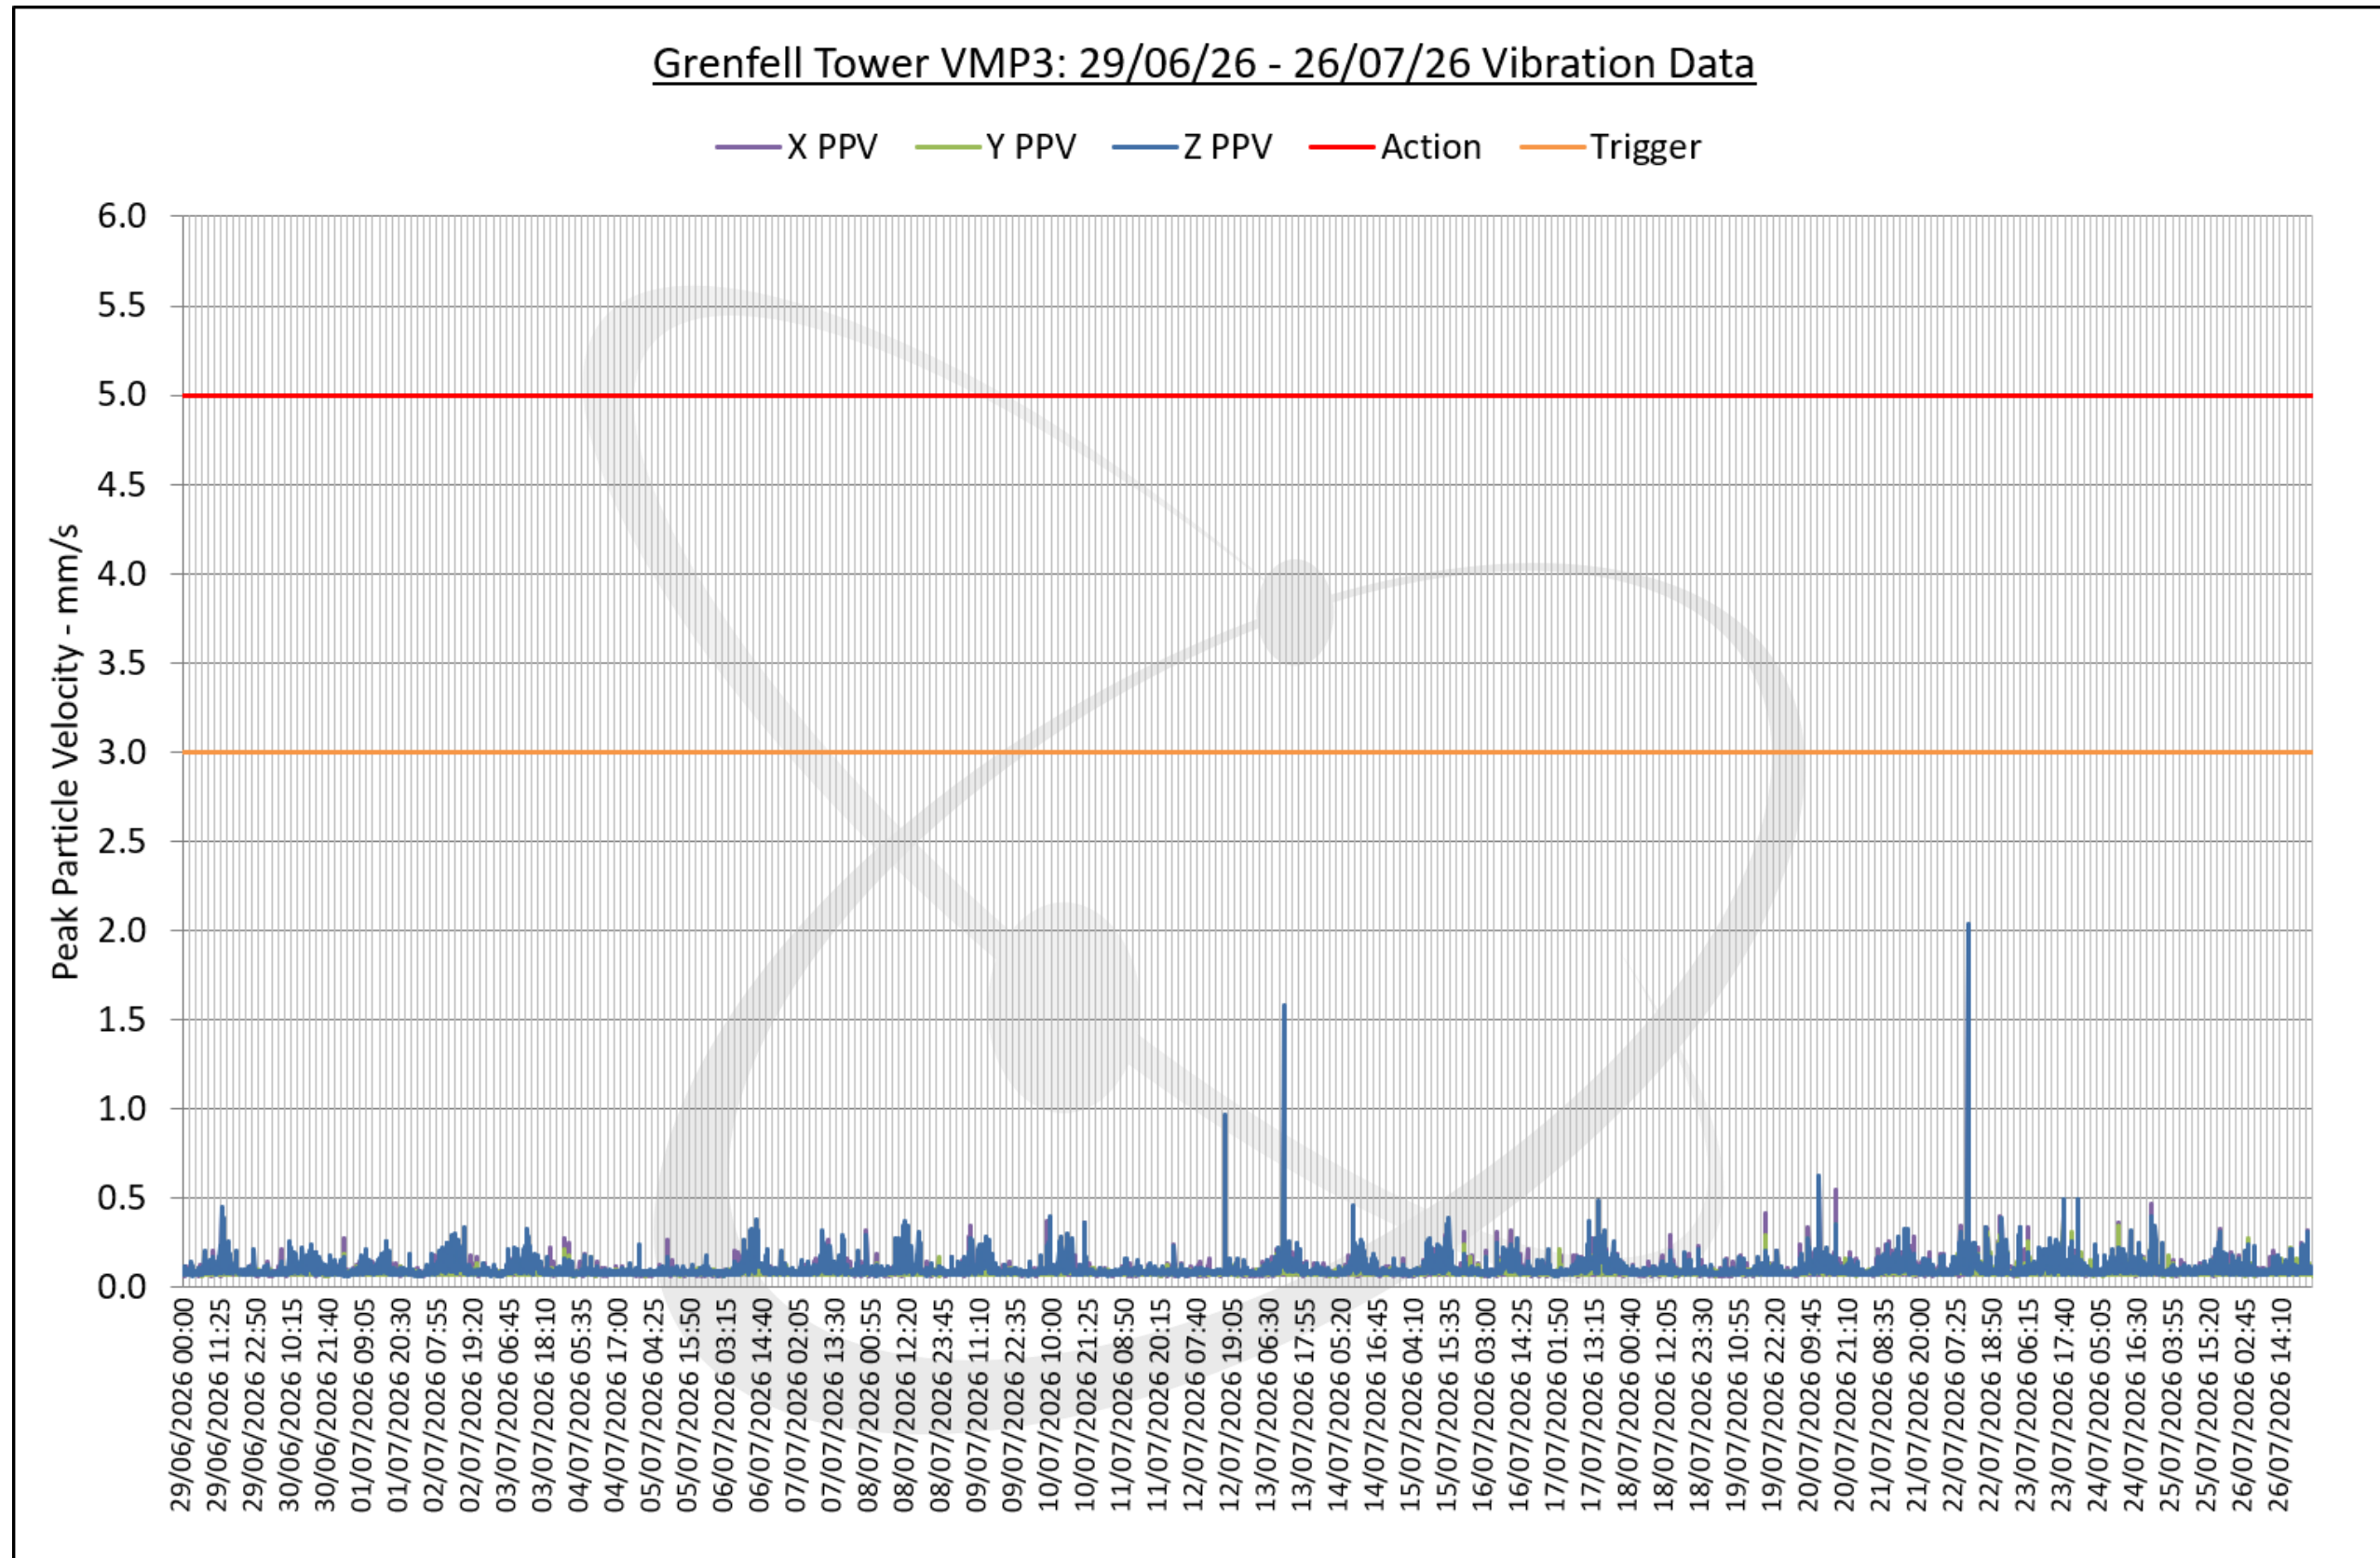
## 6. Vibration Monitoring Graphs

There were **no exceedances** of the 3.0mm/s Red Action level and **four (4) exceedances** of the 1.0mm/s Amber Trigger level during working hours in this reporting period.

There were **no exceedances** of the 5.0mm/s Red Action level and **four (4) exceedances** the 3.0mm/s Amber Trigger level during working hours in this reporting period.

There were **no exceedances** of the 5.0mm/s Red Action level, or the 3.0mm/s Amber Trigger level during working hours in this reporting period.

The results of the vibration measurements in this period are presented graphically in Section 6 of this report.
