## Abbreviated Vibration Monitoring Reports

Monitoring Period: 27 July 2026 to 30 August 2026

| <b>Project:</b> | Grenfell Tower |
| <b>Document Ref:</b> | EEMC-VMR-201/112 – Grenfell Tower Rev 01 |

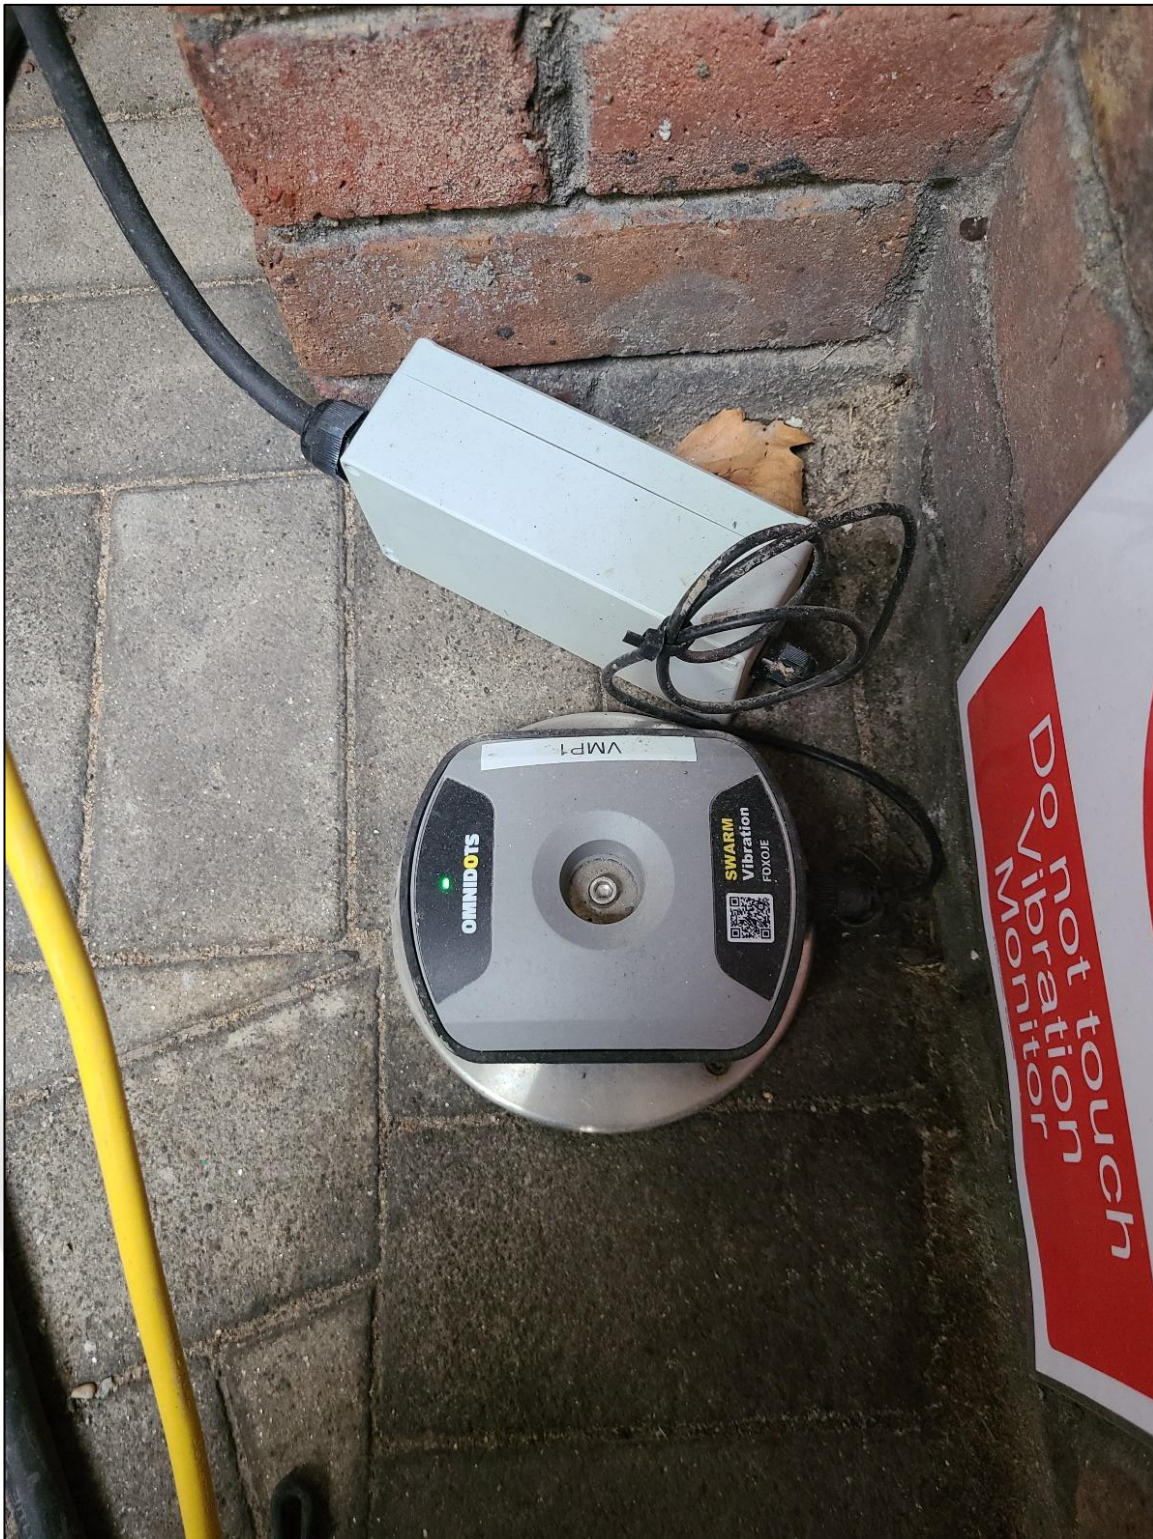
**Image 1 – VMP1 Monitoring Location**

| ID Reference | Location |
|---|---|
| VMP1 | Opposite the southeast corner of the tower between two (2) concrete blocks |

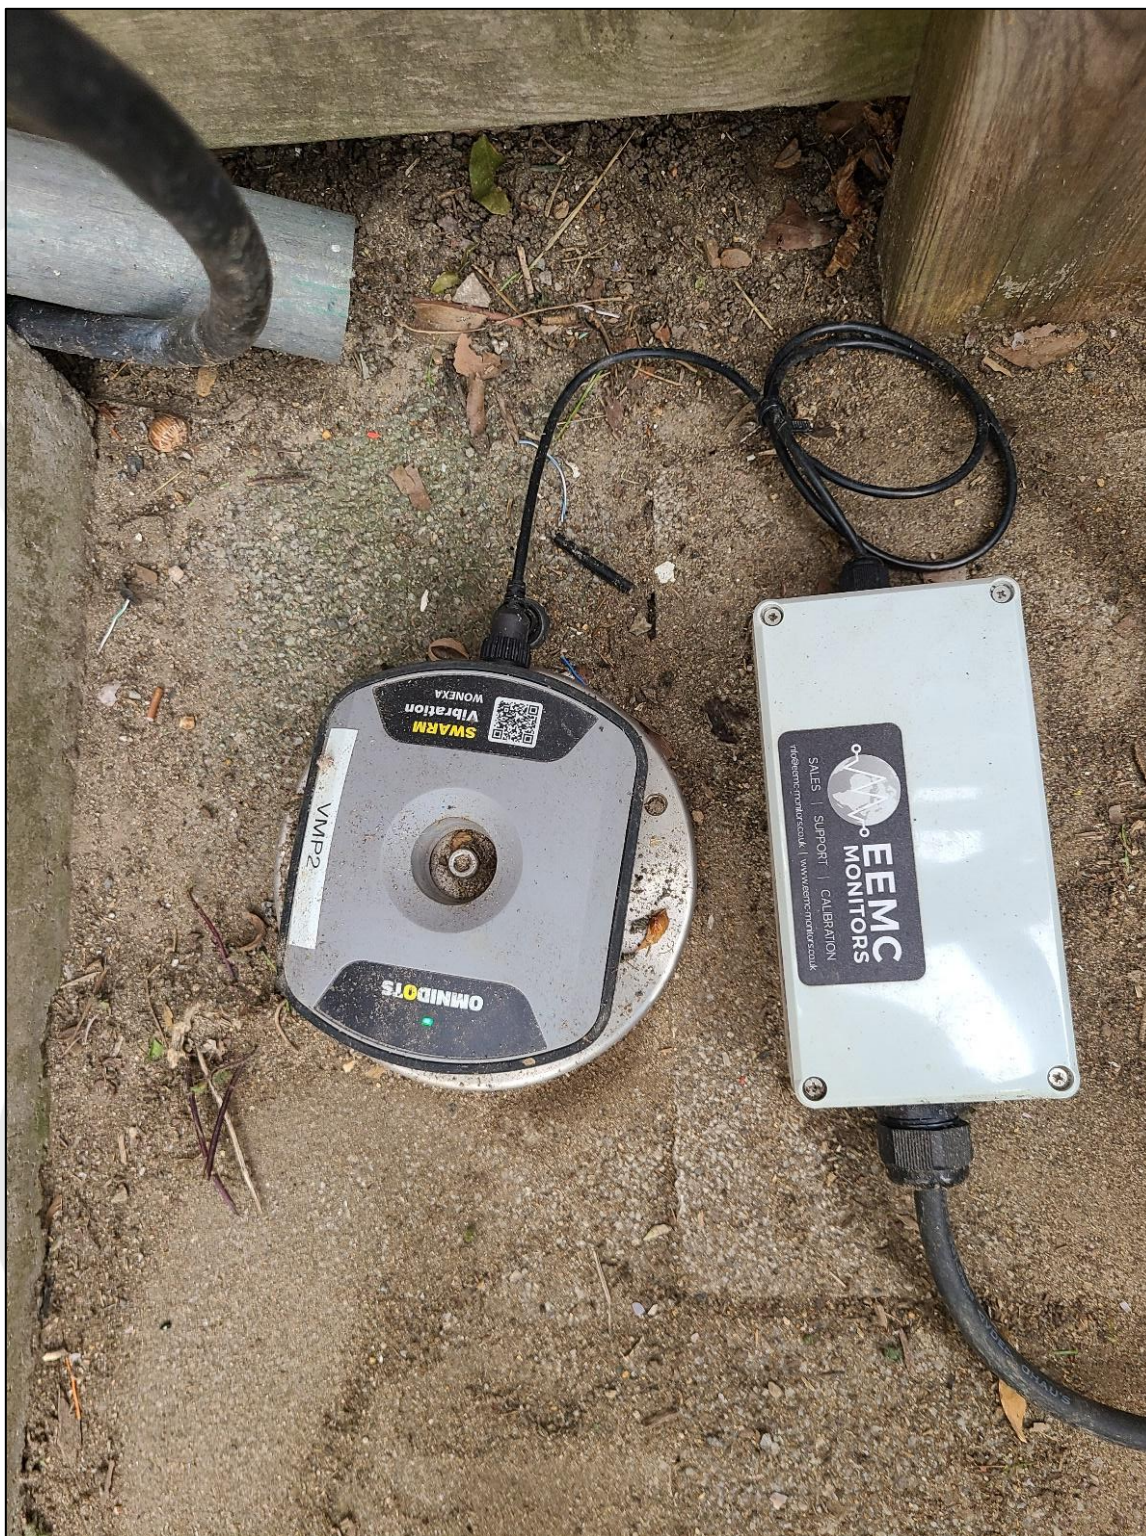
Image 2 –VMP2 Monitoring Location

| ID Reference | Location |
|---|---|
| VMP2 | Base of North hoarding co-located with NMP2. |

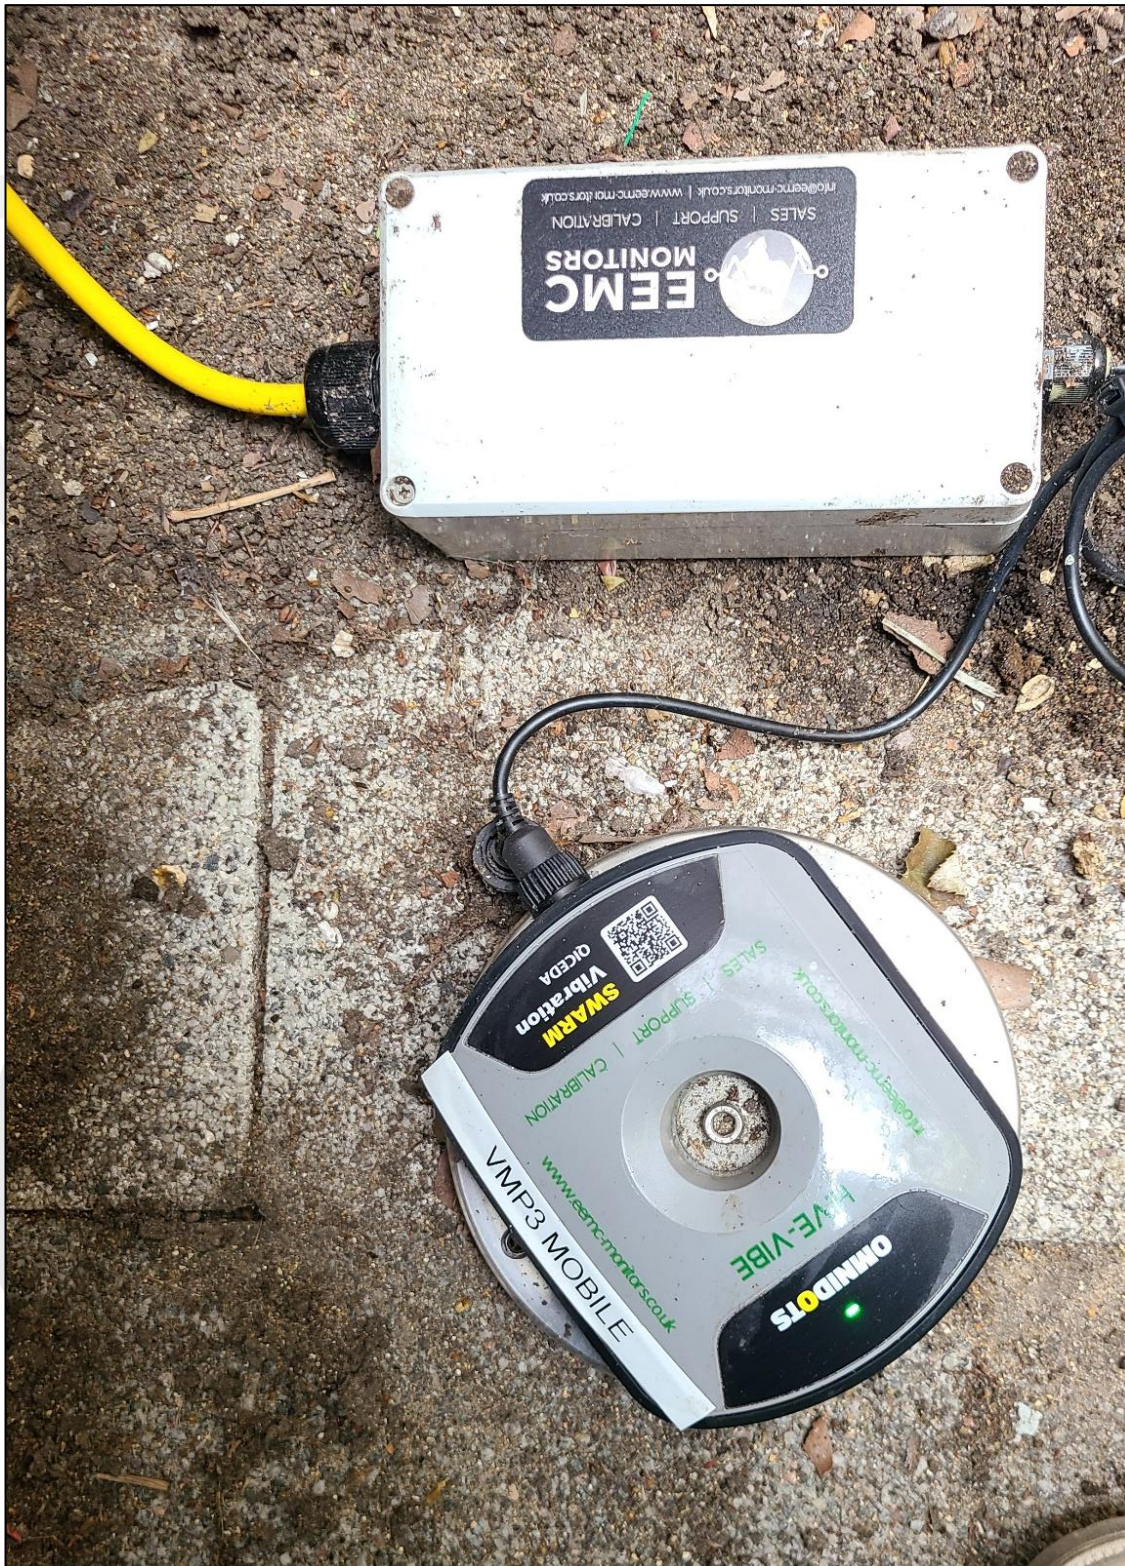
Image 3 – VMP3 Monitoring Location

| ID Reference | Location |
|---|---|
| VMP3 | Mobile unit- located at the base of NW hoarding with DMP5 and NMP3 |

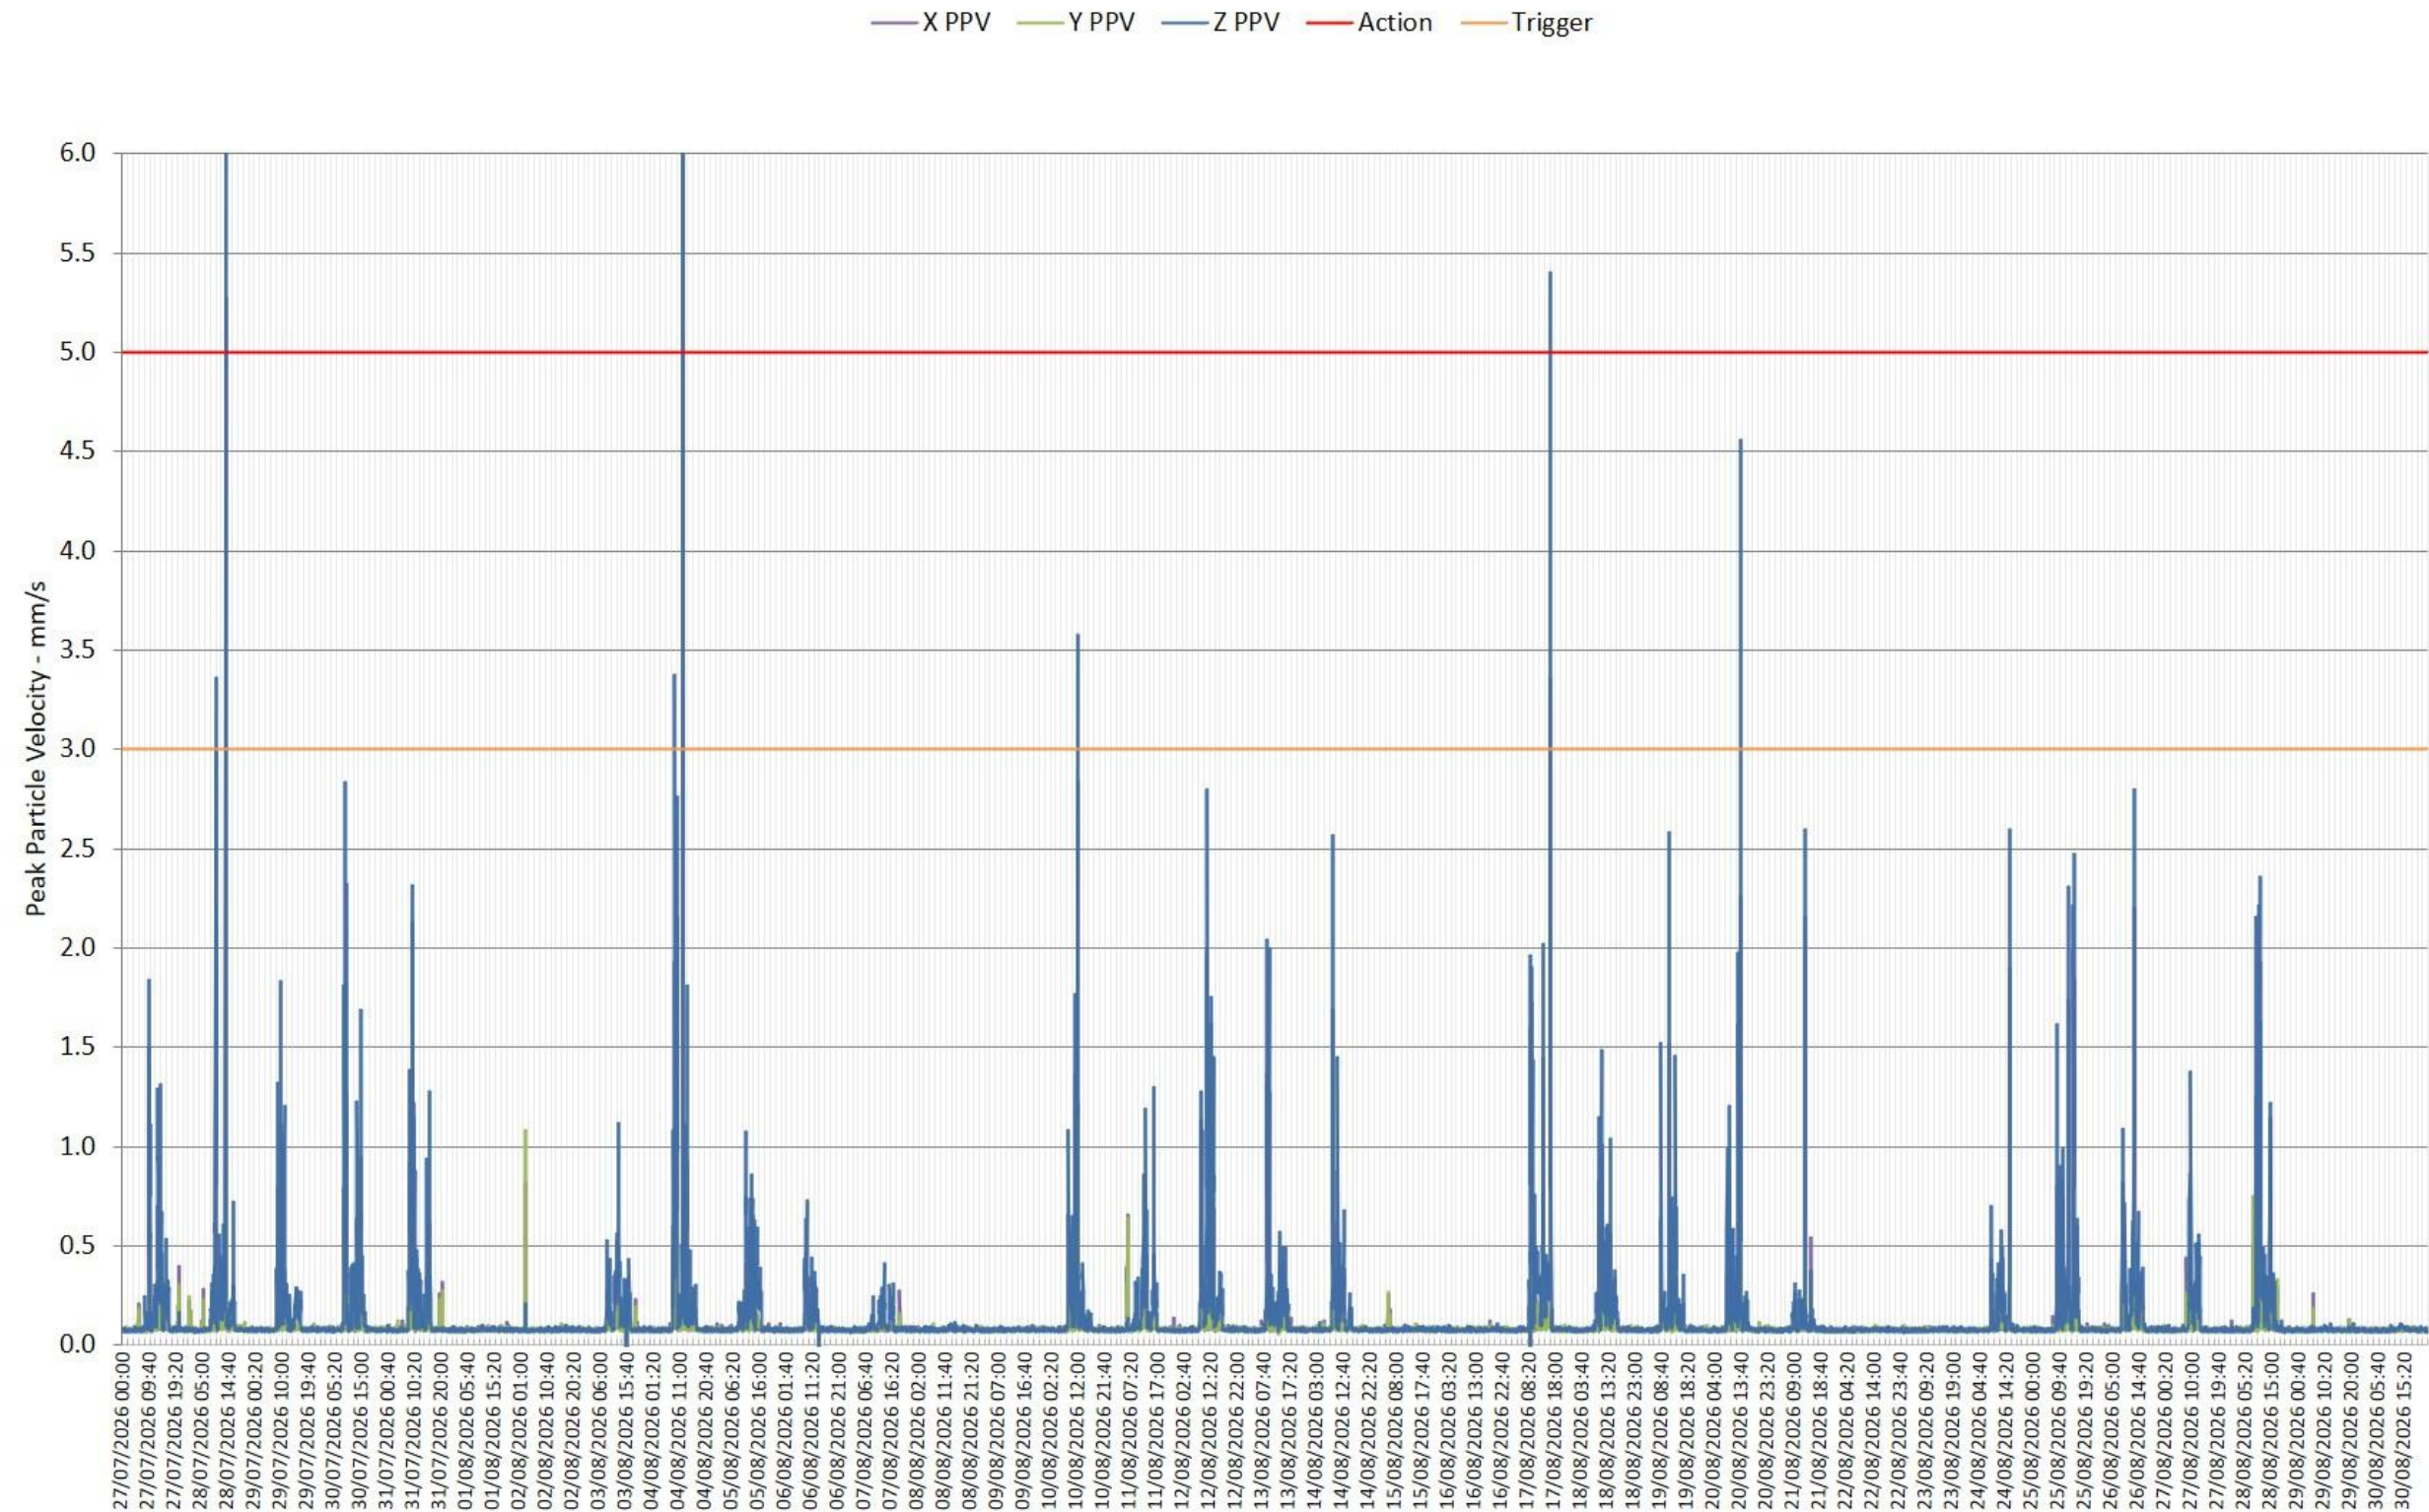
Grenfell Tower VMP2: 27/07/26 - 30/08/26 Vibration Data

There were **three (3) exceedances** of the 5.0mm/s Red Action level and **four (4) exceedances** of the 3.0mm/s Amber Trigger level during working hours in this reporting period.

| Monitoring Location | Date and Time of Exceedance | Measured Level of Exceedance (mm/s) | Red Action Level (mm/s) | Cause of Exceedance | Mitigation |
|---|---|---|---|---|---|
| VMP2 | 28/07/2026 13:40 | 7.78 | 5.0mm/s | 14T digger loading metal skip. | Methodology reviewed with operatives; works briefed to minimise direct impact adjacent to the monitor.<br>Reduced use of percussive tools within exclusion zone and increased supervision during proximity activities. |
| | 04/08/2026 12:25 | 9.37 | | Skip exchange. | |
| | 17/08/2026 16:25 | 5.41 | | Skip loading with props. | |

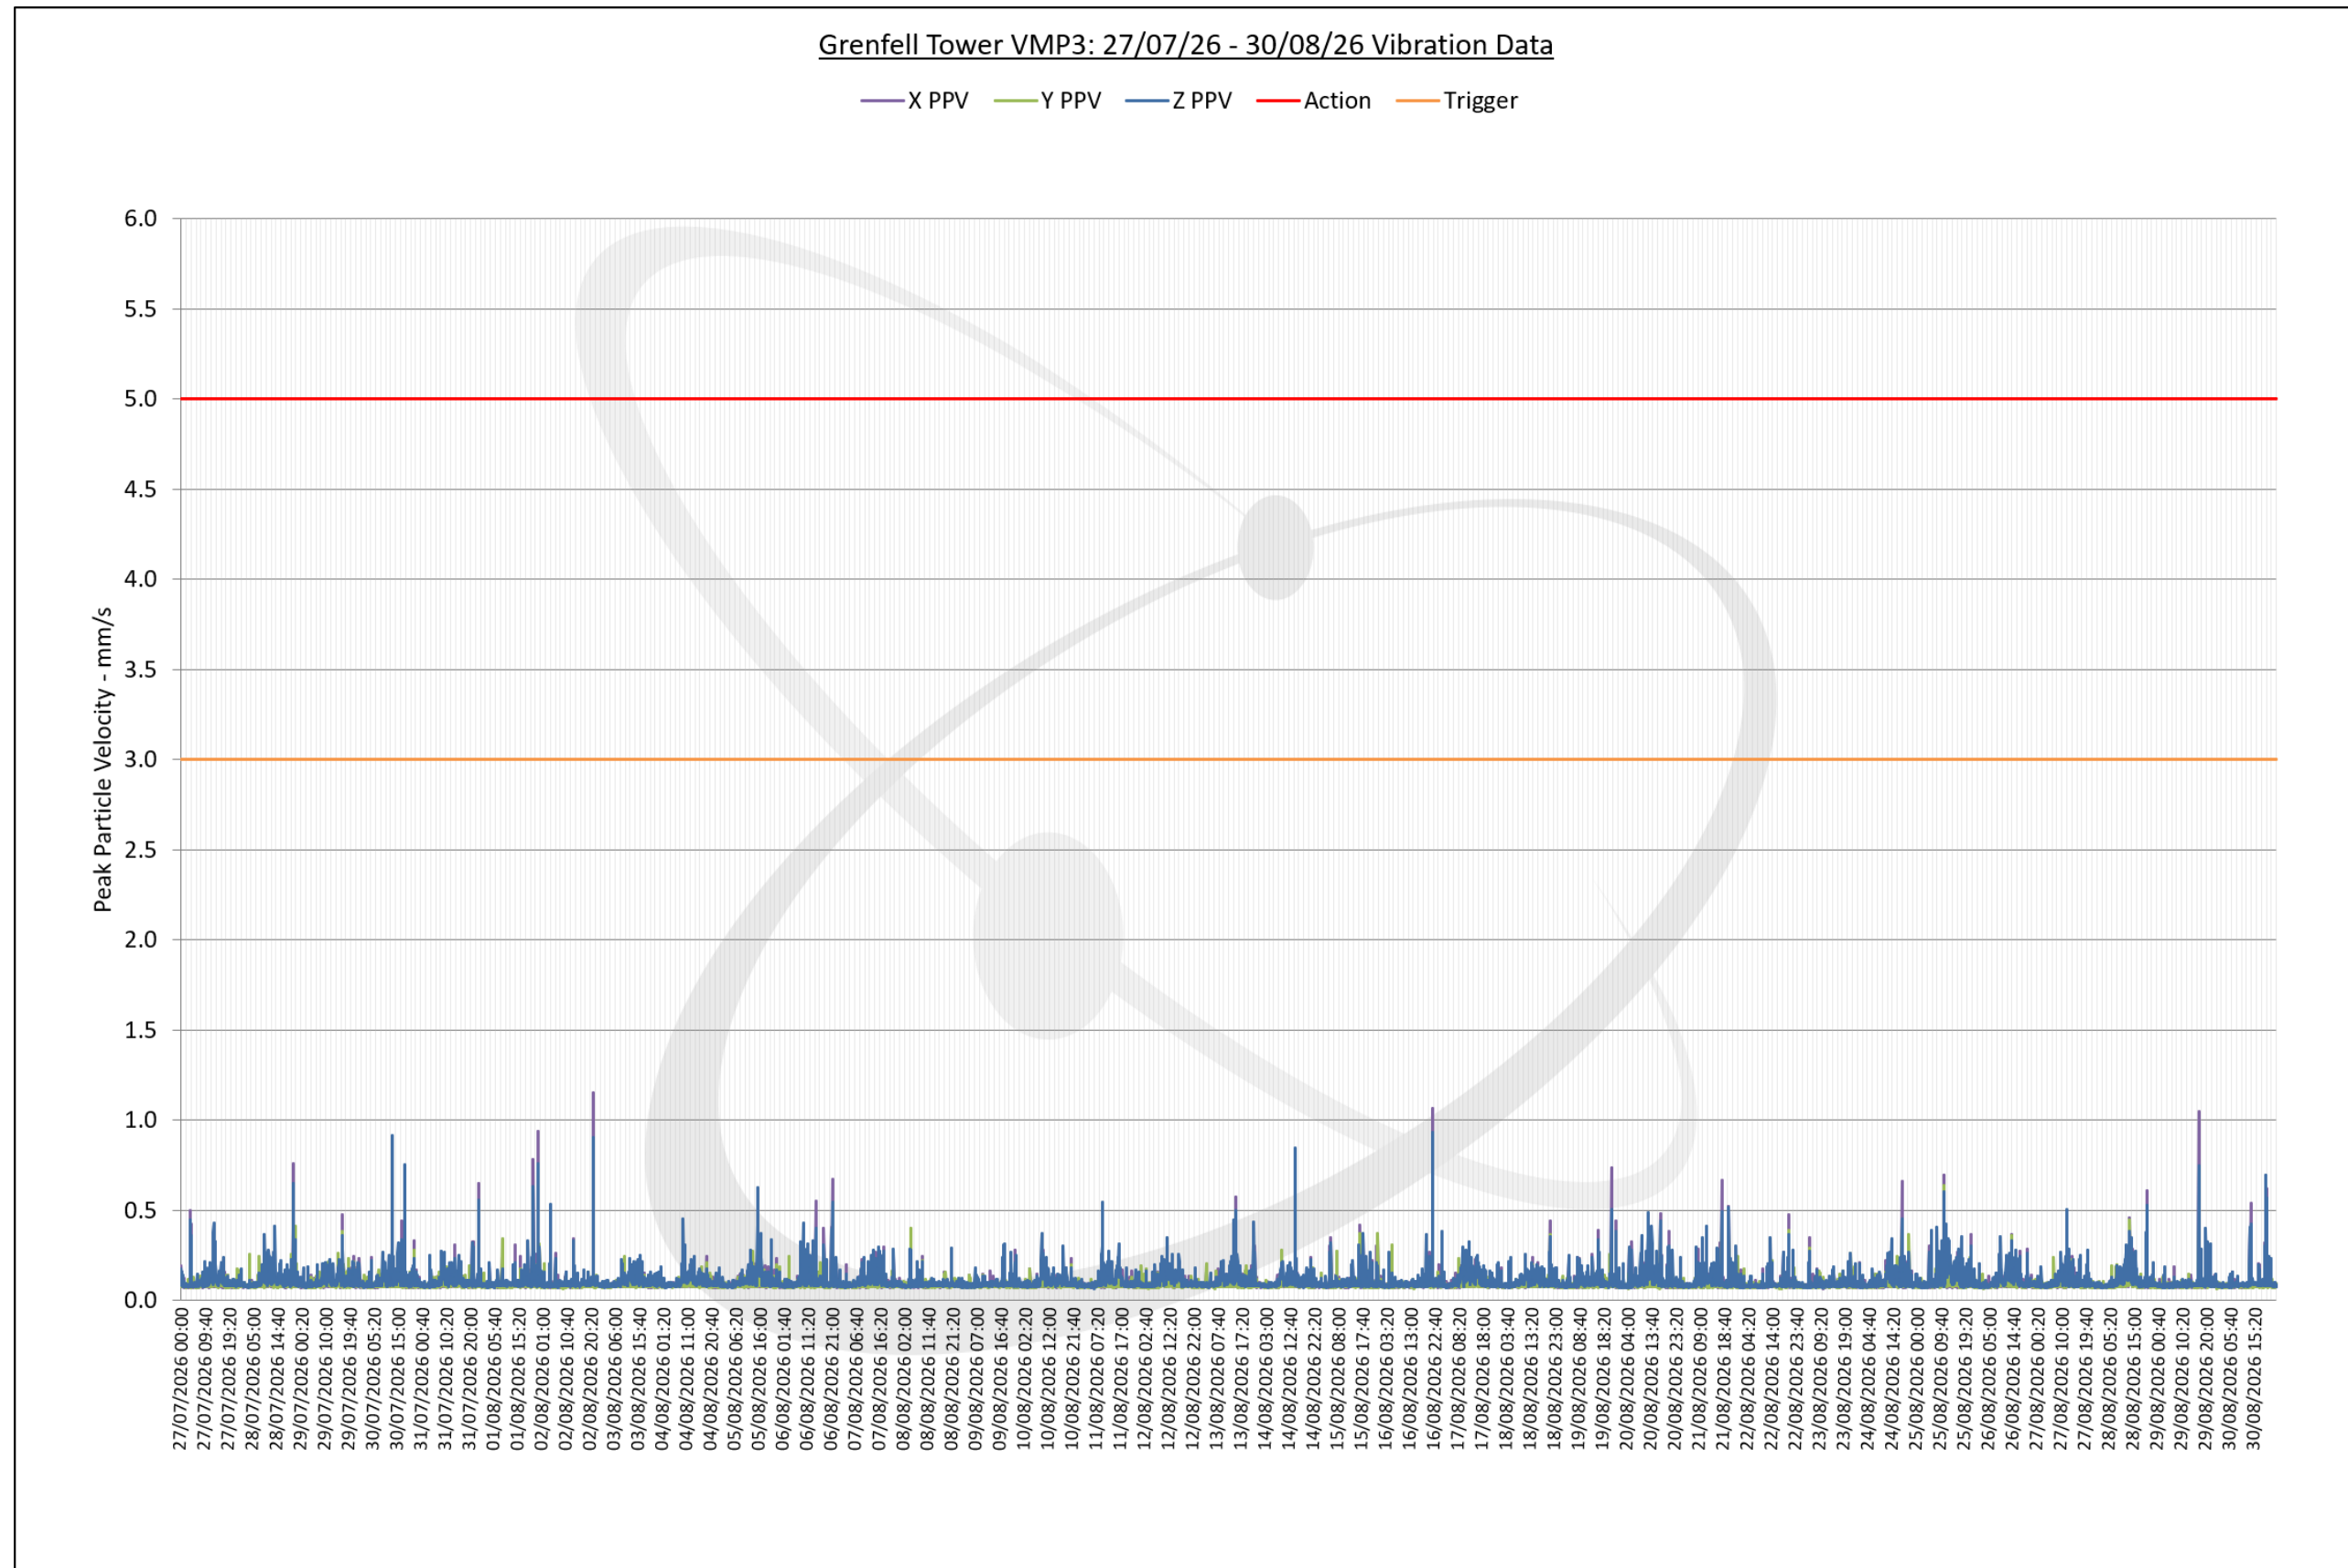
There were **no exceedances** of the 5.0mm/s Red Action level or the 3.0mm/s Amber Trigger level during working hours in this reporting period.
