# Victoria Field Decommissioning Close Out Report

**NEO Energy (SNS) Limited**

**VDCM-VIC-SU-RE-0006**

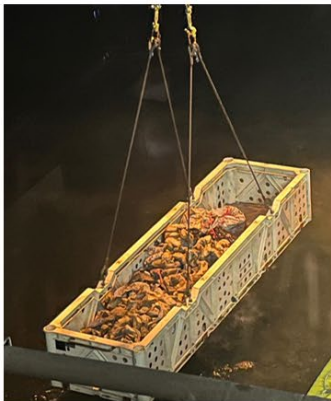
Figure 7 Grout Bag Recovery at Victoria

- Grout bags were recovered using a 20Te boulder grab and placed into debris baskets on the seabed
- ROV mounted sonar used to locate bags when visibility was poor
- Each grab was recorded on the nav screen

\*6t of grout bags was recorded on the DPRs from the original subsea infrastructure installation. However, during decommissioning several hundred tonnes of grout was discovered around the wellhead underneath the mattresses. The most likely explanation is that the grout was used as wellhead scour rectification before the commencement of the subsea installation scope. All of the grout bags were recovered and recycled.

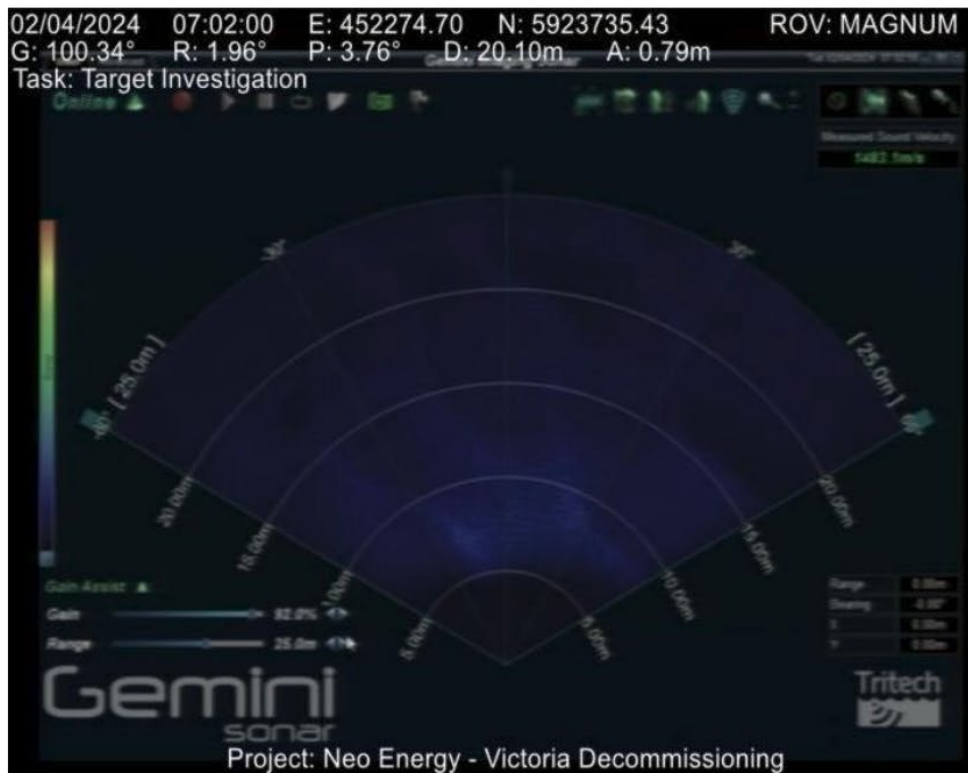
**Image 1:** Contact 1 – Clear Seabed

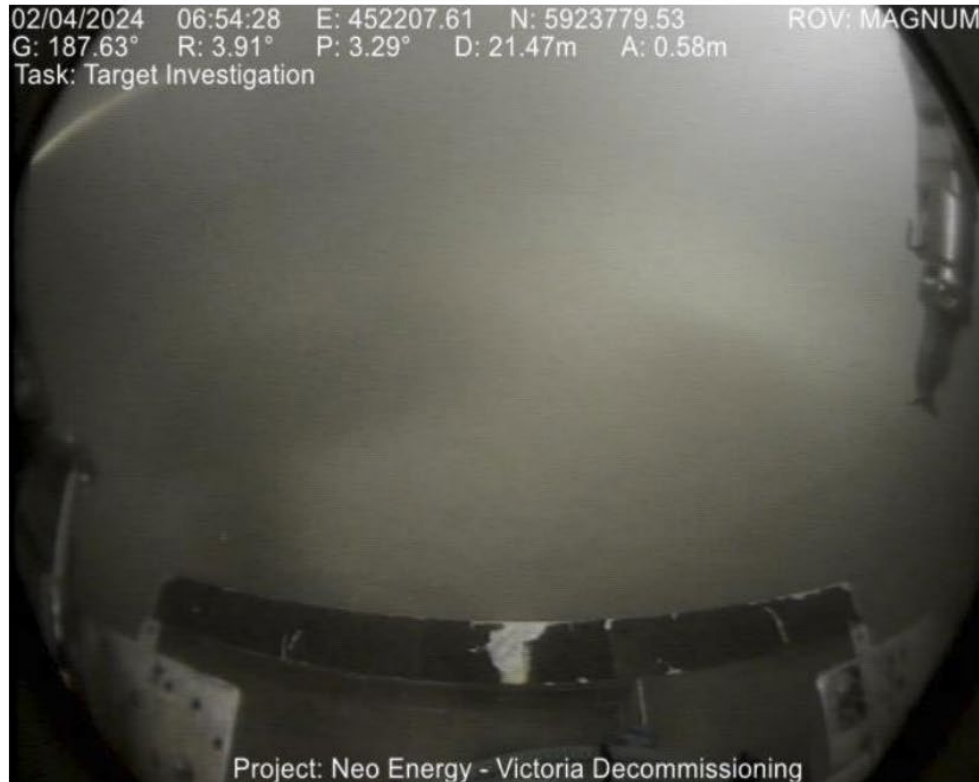
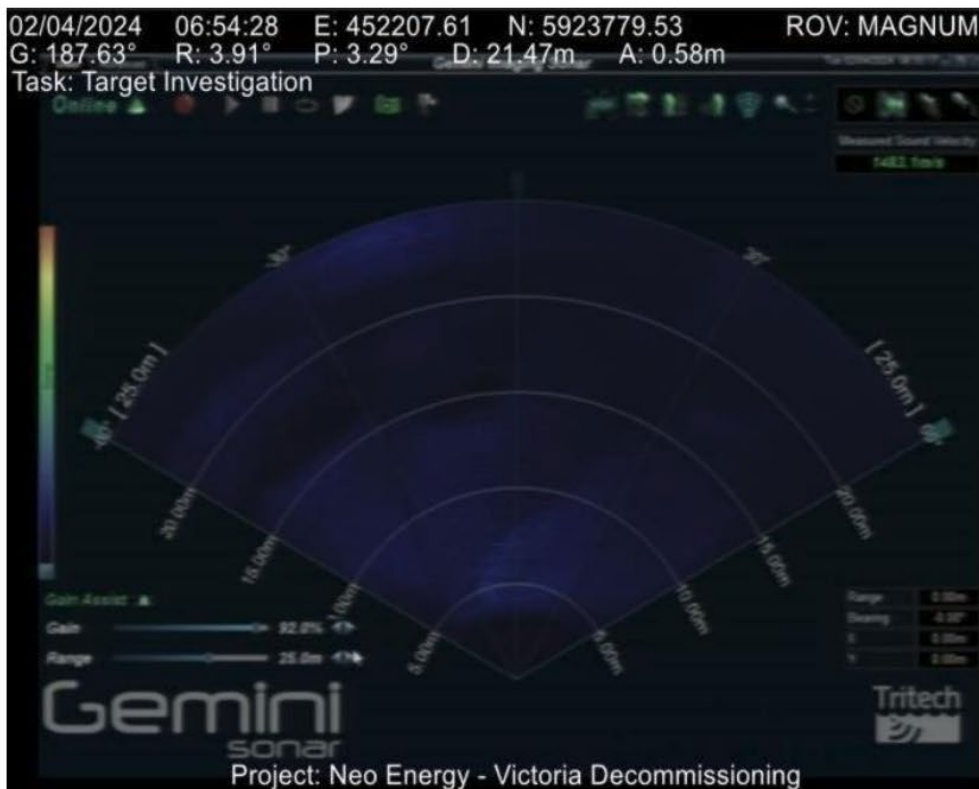
**Image 2: Contact 10 – Clear Seabed**

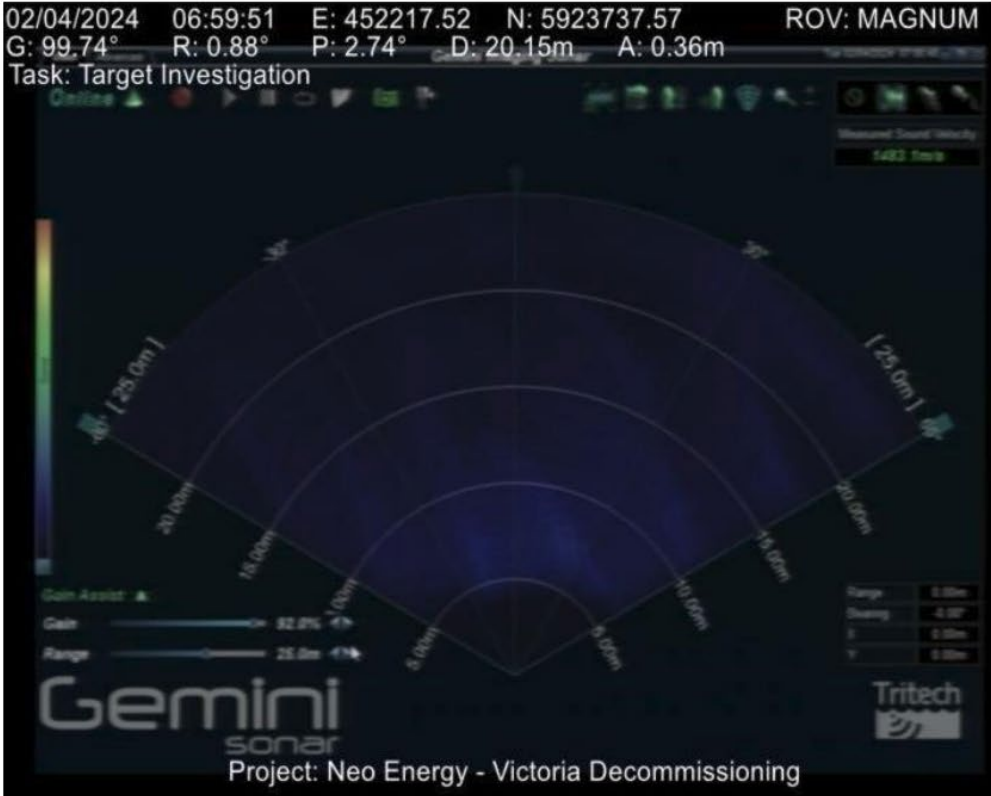
Image 3: Contact 11 – Clear Seabed

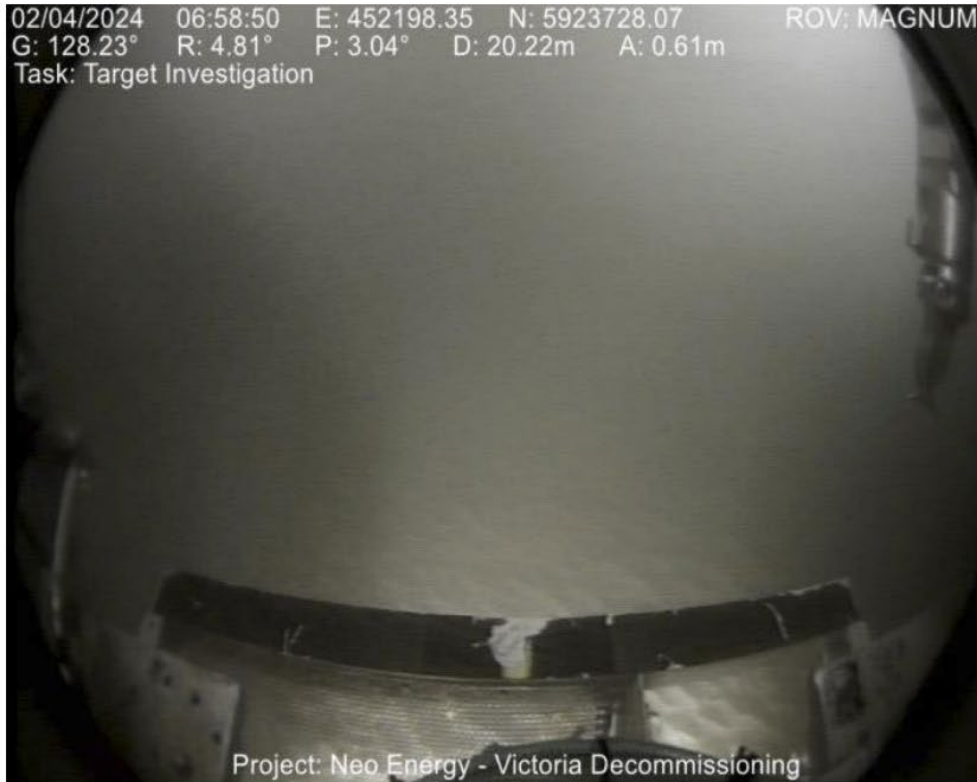
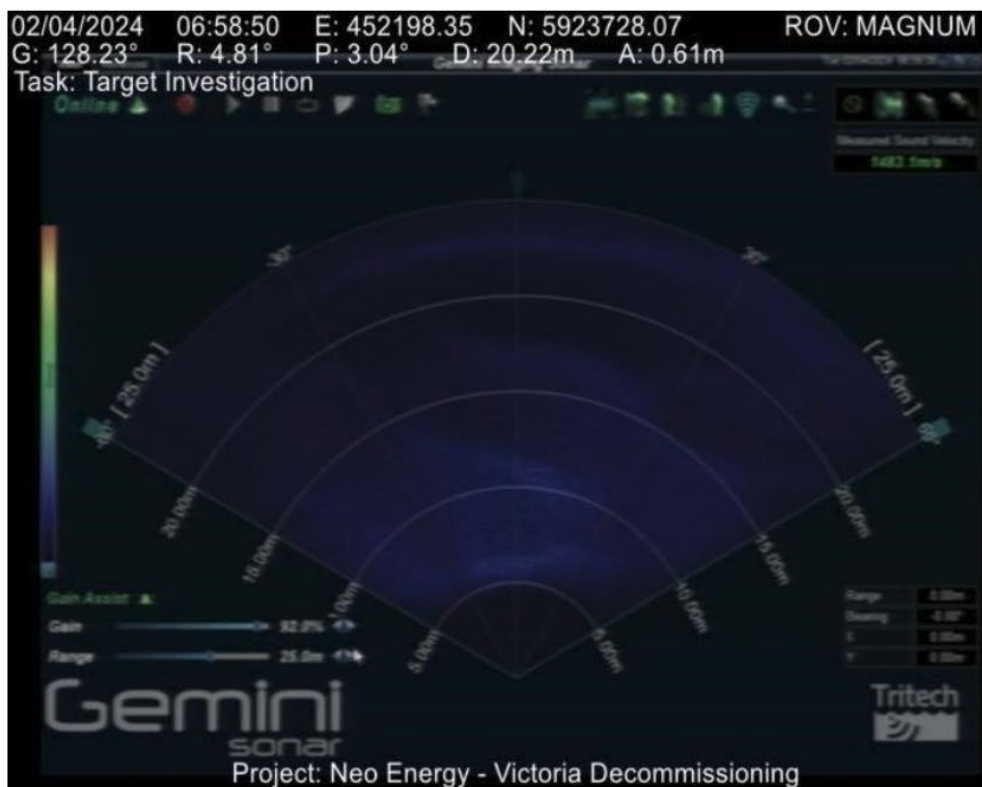
**Image 4:** Contact 16 – Clear Seabed

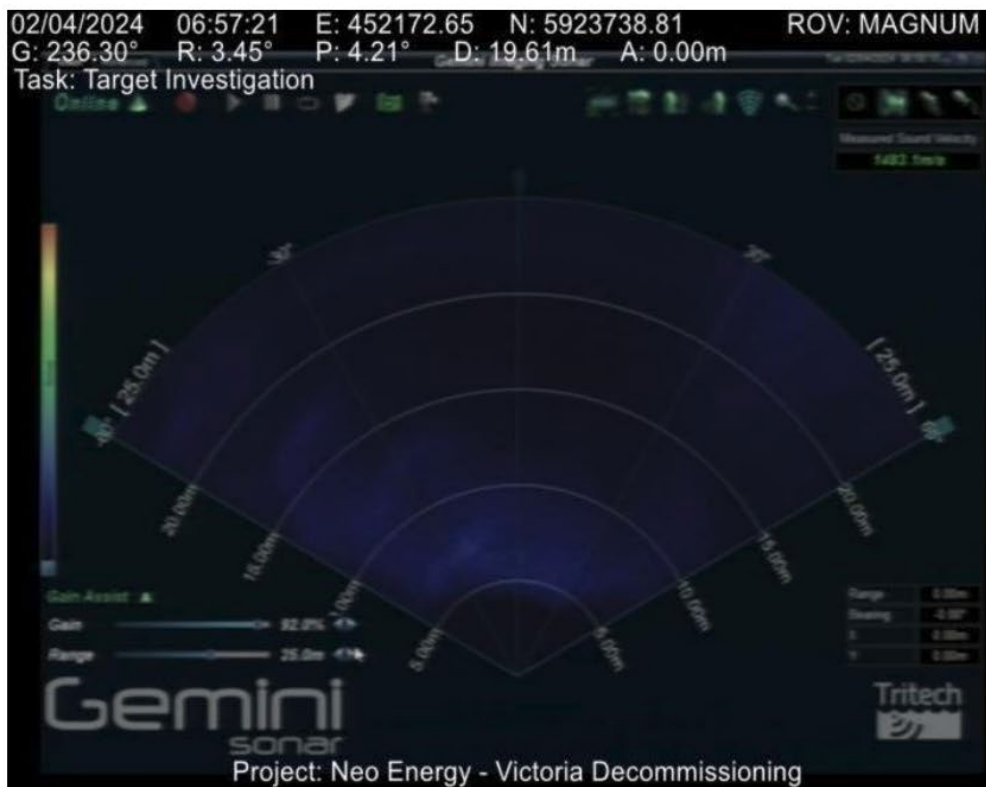
**Image 5:** Contact 17 – Clear Seabed

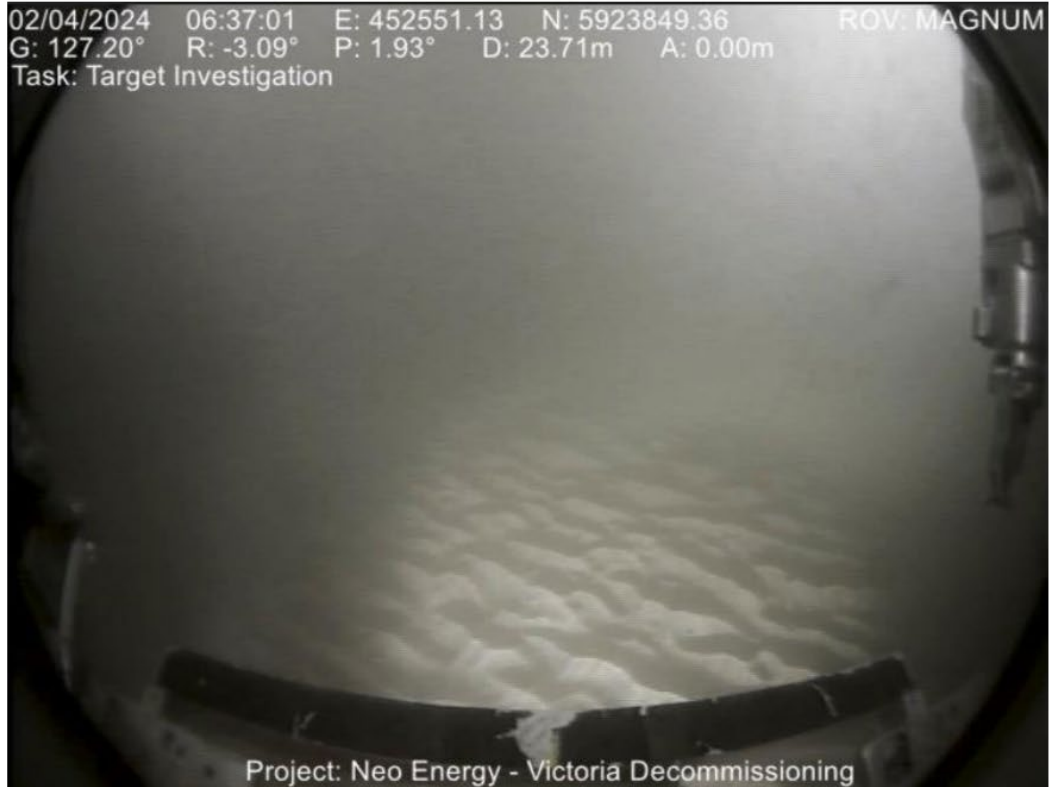
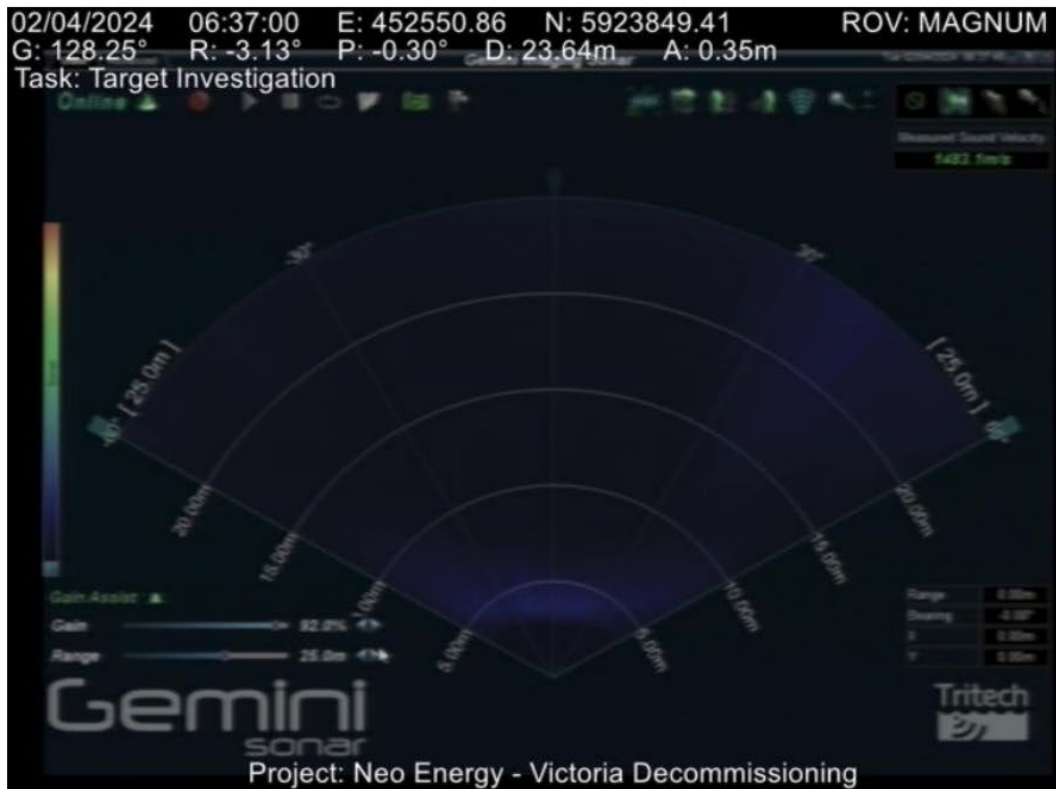
**Image 6:** Contact 22 – Clear Seabed

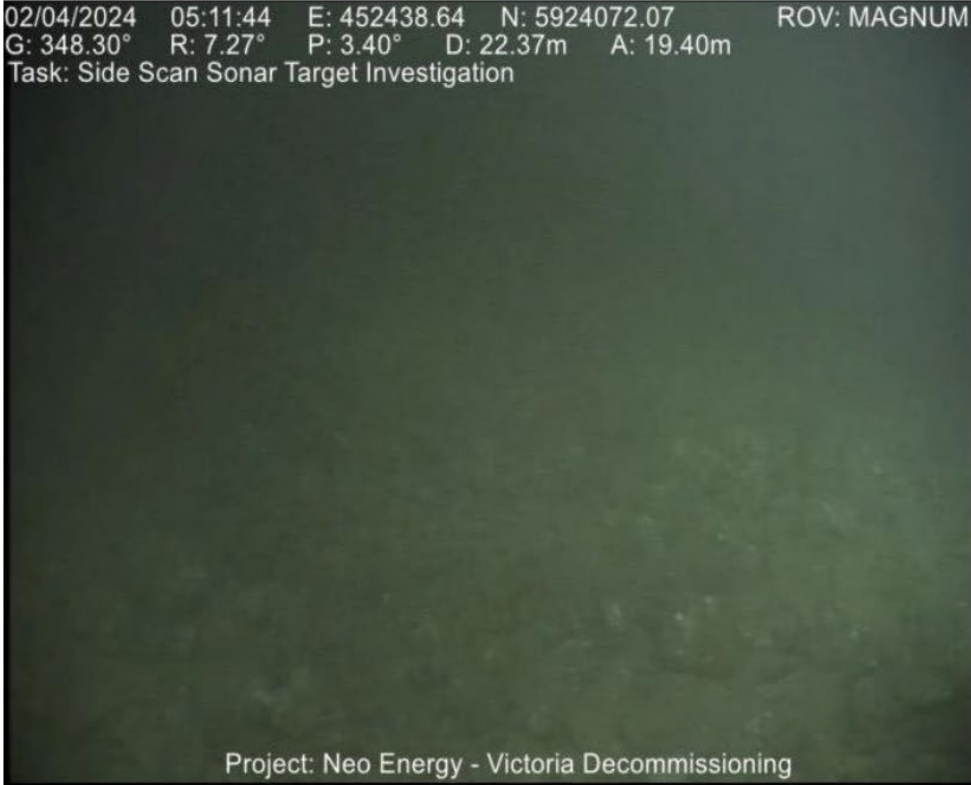
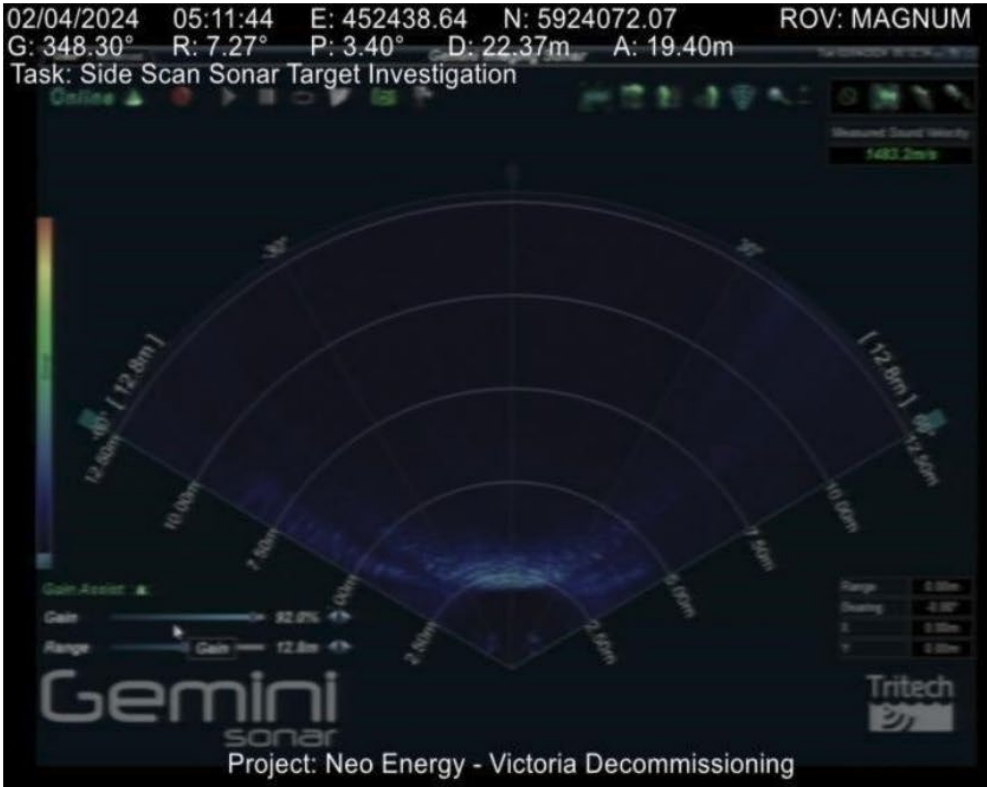
Image 7: Contact 2 – Scattered small / loose rocks

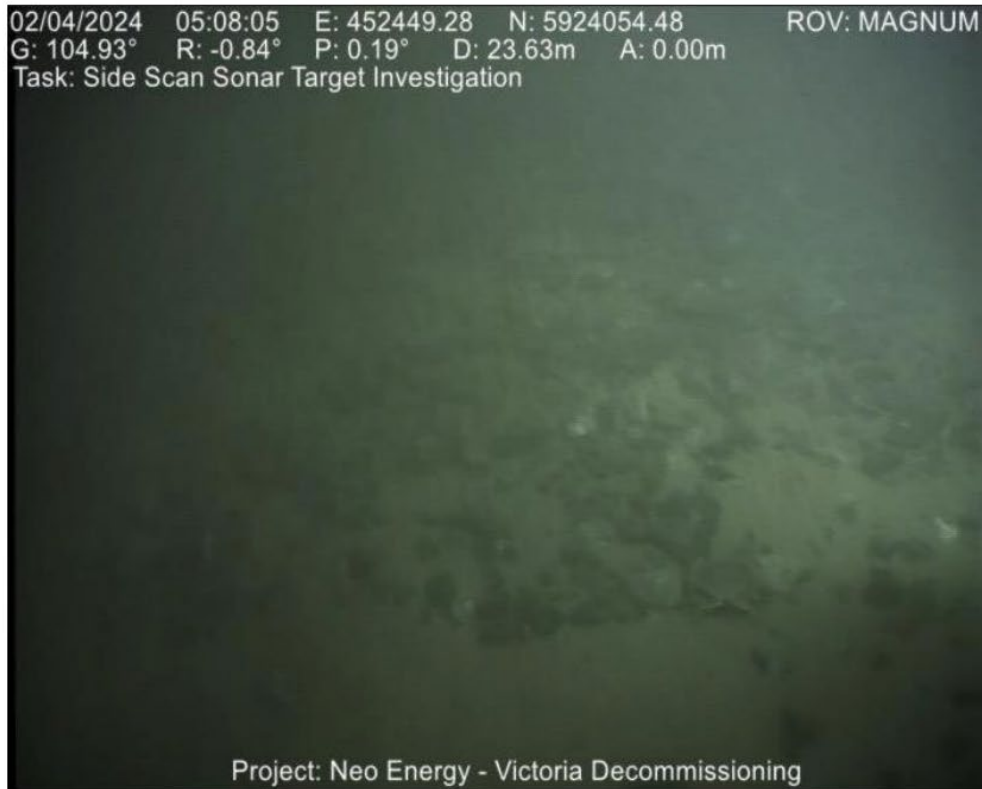
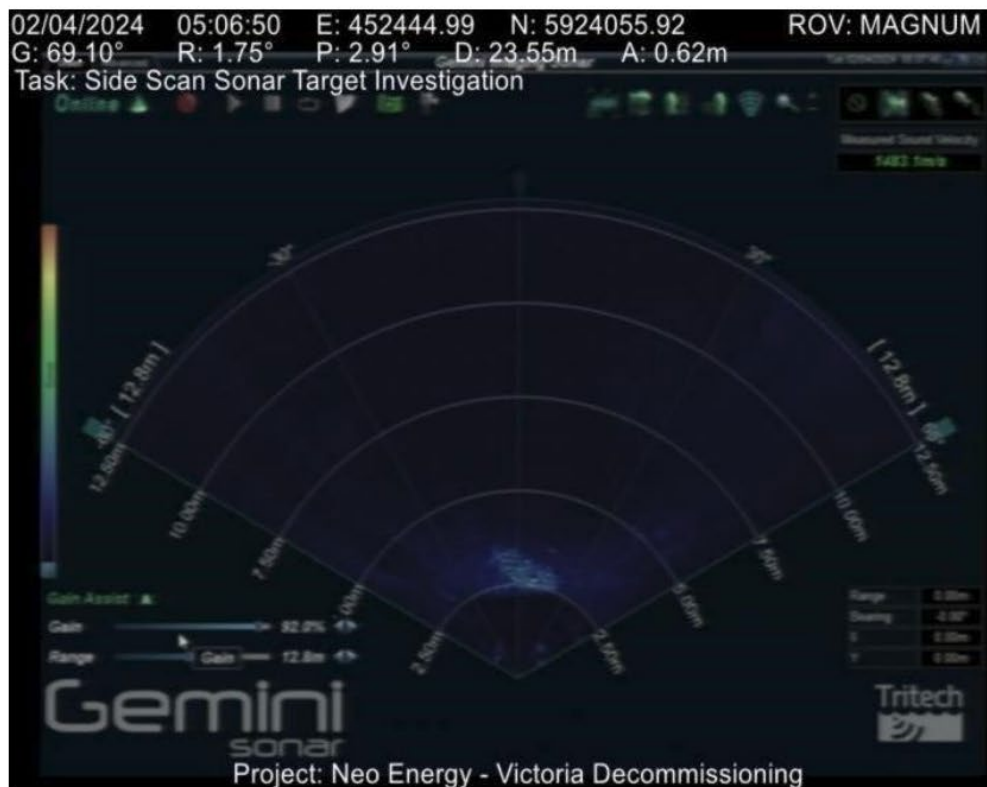
**Image 8:** Contact 3 – Scattered small / loose rocks

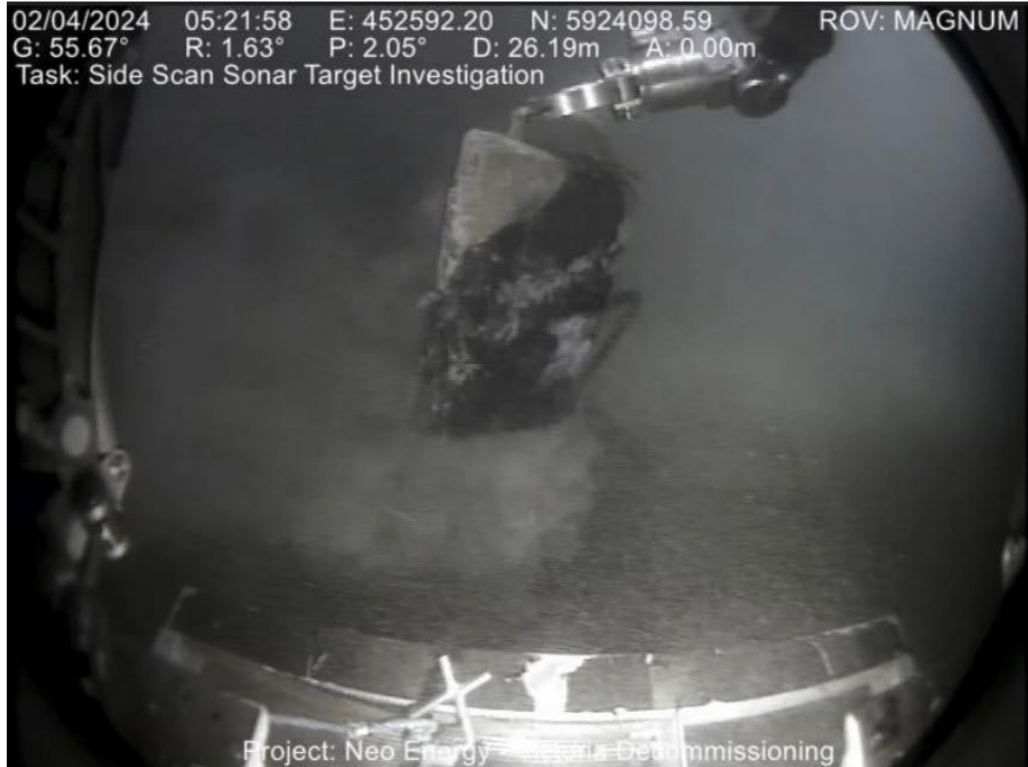
**Image 9:** Contact 25 – ROV removing concrete mattress block, recovered to deck
