# Detailed Unexploded Ordnance (UXO) Risk Assessment

| Project Name | Army Cadet Training Camp, Crowborough |
| Report Reference | DA23741a-01 |

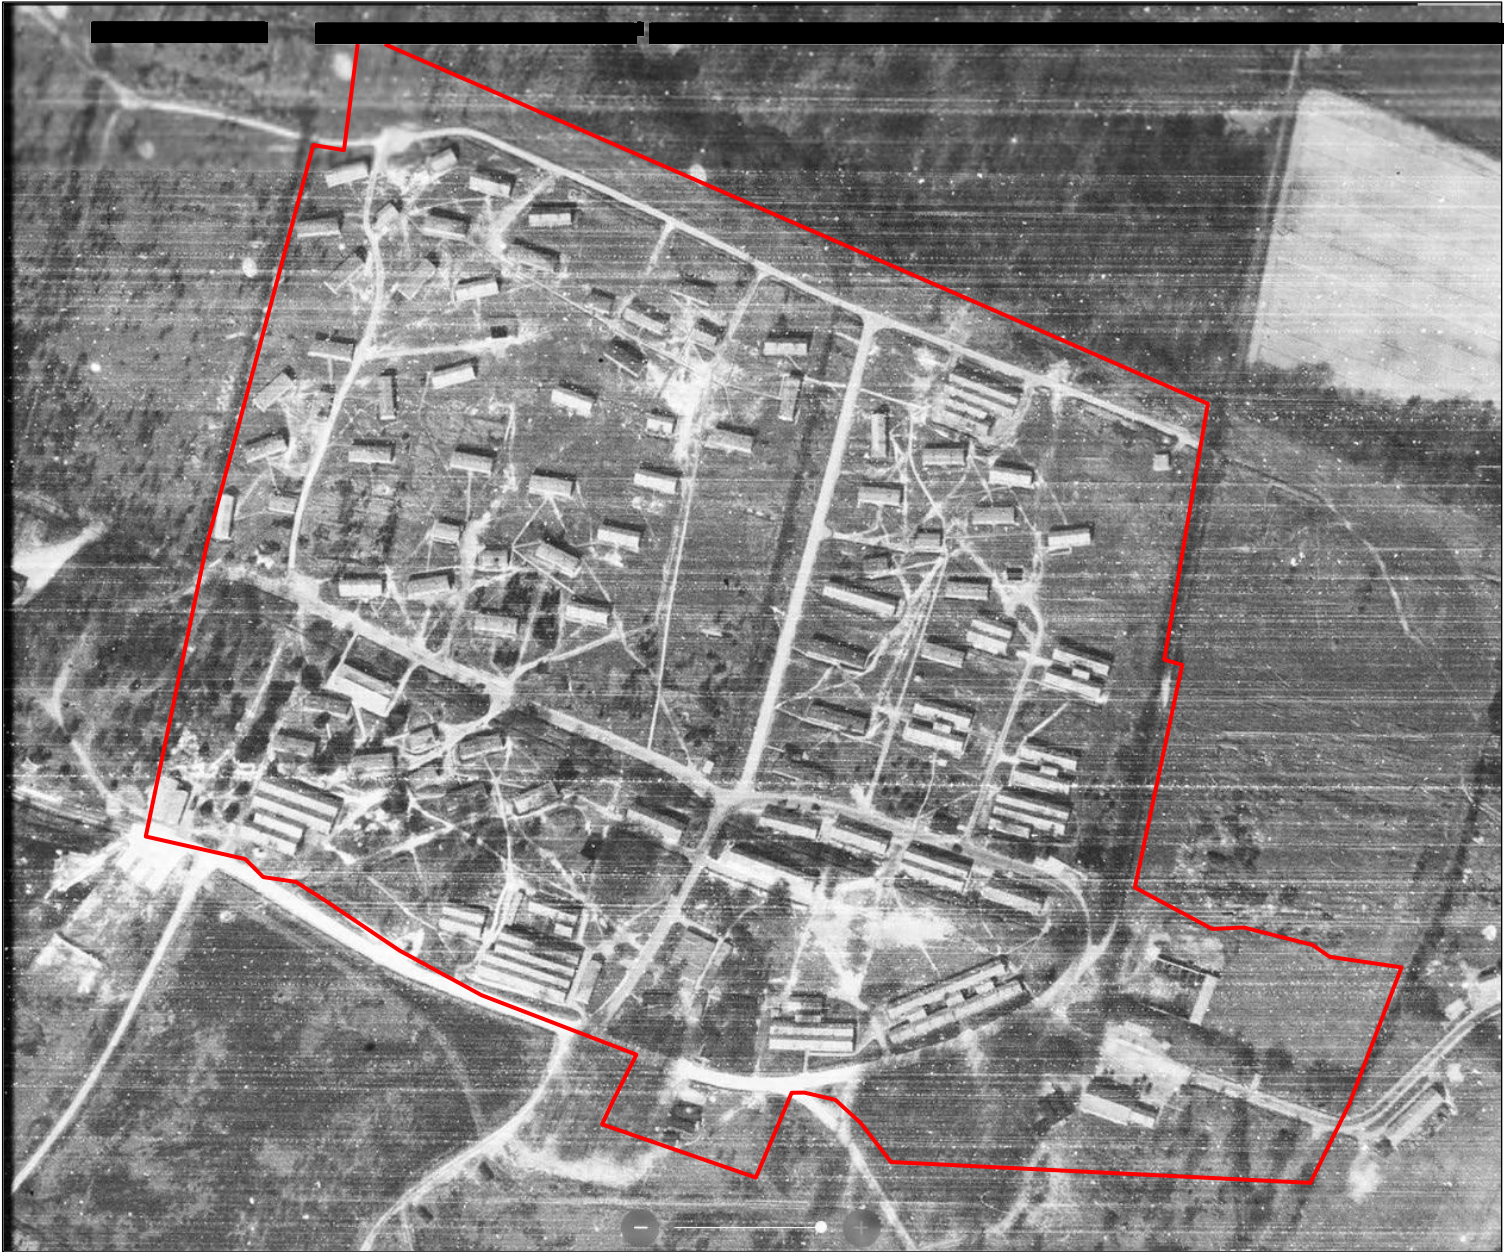
Top: J-curve Effect - Due to angle of entry, unexploded bombs would often end their trajectory at a lateral offset from point of entry, often ending up beneath adjacent extant structures/sites.

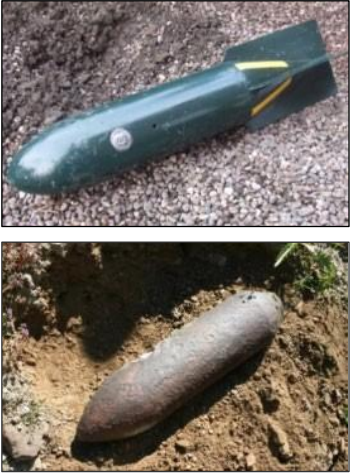
| SC 50kg High Explosive Bomb | | |
|---|---|---|
| Bomb Weight | 40-54kg (88-119lb) | <div></div> |
| Explosive Weight | 25kg (55lb) | |
| Fuze Type | Impact fuze/electro-mechanical time delay fuze | |

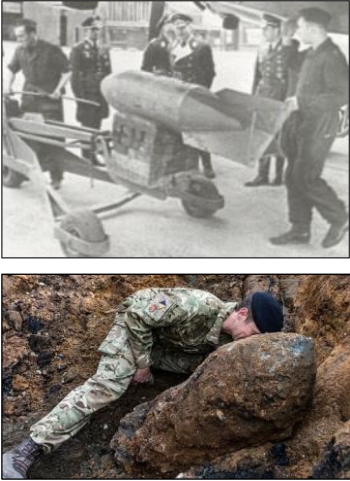
| SC 250kg High Explosive Bomb | | |
|---|---|---|
| Bomb Weight | 245-256kg (540-564lb) | <div></div> |
| Explosive Weight | 125-130kg (276-287lb) | |
| Fuze Type | Electrical impact/mechanical time delay fuze | |

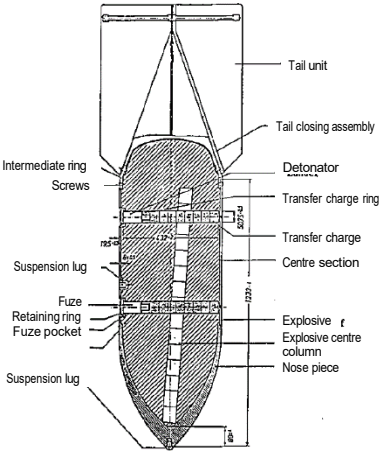
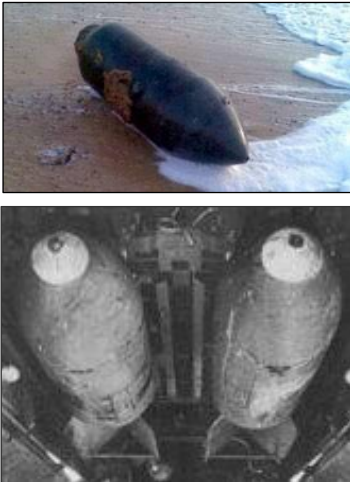
| SC 500kg High Explosive Bomb | | |
|---|---|---|
| Bomb Weight | 480-520kg (1,058-1,146lb) | <div></div> |
| Explosive Weight | 250-260kg (551-573lb) | |
| Fuze Type | Electrical impact/mechanical time delay fuze | |

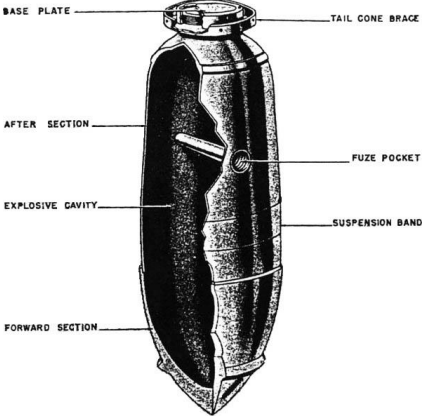
| SC 1000kg High Explosive Bomb | | |
|---|---|---|
| Bomb Weight | Approx. 993-1027kg (2,189-2,264lb) | |
| Explosive Weight | Approx. 530-620kg (1168-1367lb) | |
| Fuze Type | Electrical impact/mechanical time delay fuze. | |

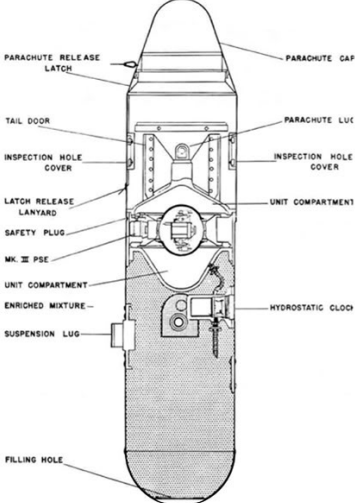
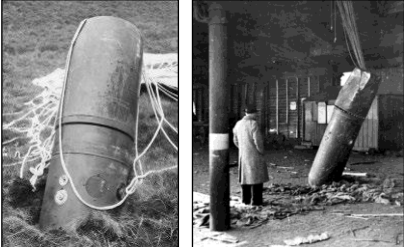
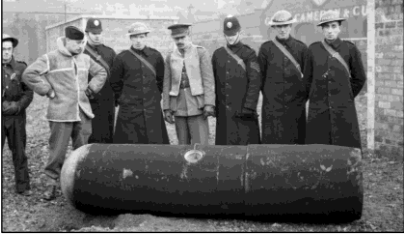
| Parachute Mine (Luftmine B / LMB) | | |
|---|---|---|
| Bomb Weight | Approx. 990kg (2176lb) | <div></div> <div></div> <div></div> |
| Explosive Weight | Approx. 705kg (1,554lb) | |
| Fuze Type | Impact/time delay/hydrostatic pressure fuze | |

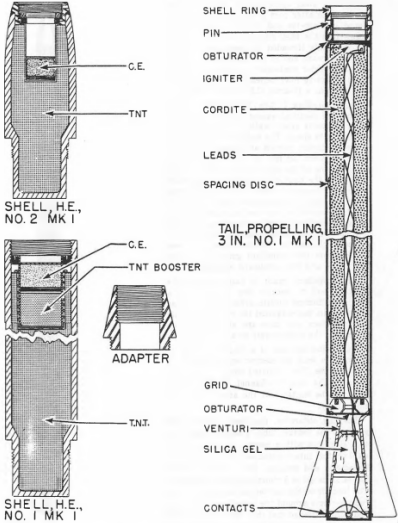
Figure 185—3-in. U.P. Antiaircraft Rocket Components

| Remarks | As a short range rocket-firing anti-aircraft weapon developed for the Royal Navy. It was used extensively by British ships during the early days of World War II. The UP was also used in ground-based single and 128-round launchers known as Z Batteries. Shell consists of a steel cylinder reduced in diameter at the base and threaded externally to screw into the shell ring of the rocket motor. |

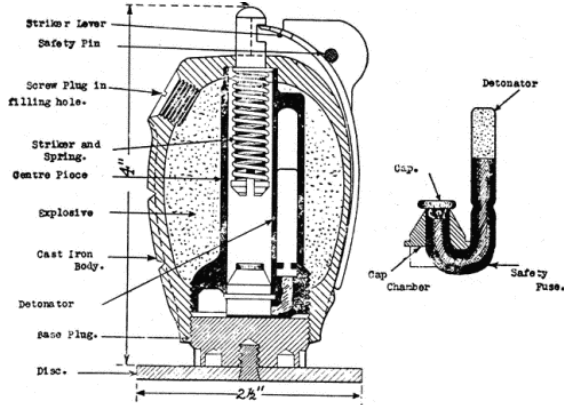
| No. 36 'Mills' Grenade | | |
|---|---|---|
| Weight | Approx. 765g filled (1lb 11.25oz) | <div></div> <div></div> |
| Explosive Weight | 71g (2oz) filling. | |
| Fuze Type | 4-7 second delay hand-throwing fuze. No. 6 Detonator | |

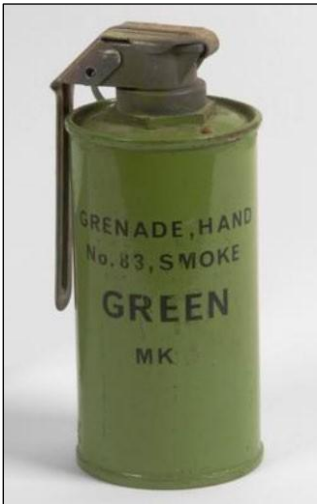
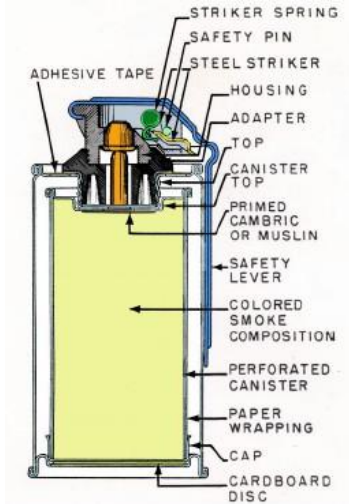
| No. 83 Smoke Grenade | | |
|---|---|---|
| Weight | Approx. 680g ( 1.5lb) | <div></div> <div></div> |
| Explosive Weight | Approx. 170-200g. (6-7 oz) | |
| Fuze Type | Originally used a friction system using a match head composition. Later developed to a striker lever ignition system. | |

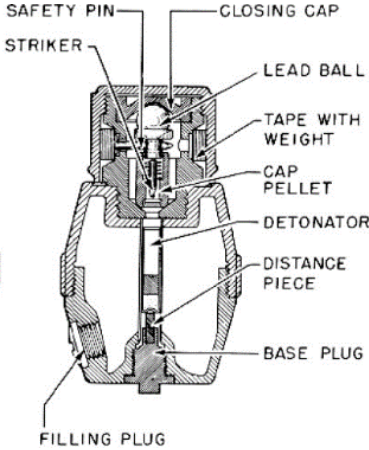
| No. 69 Grenade | | |
|---|---|---|
| Weight | Approx. 383g ( 13.5oz) | <div></div> <div></div> |
| Fill Weight | 93g (3.25 oz) of either Amatol, Baratol or Lyddite | |
| Fuze Type | 'All-ways' fuze. Comprised of a safety cap, a weighted streamer attached to a steel ball bearing and a safety bolt designed to detonate from any point of impact. | |

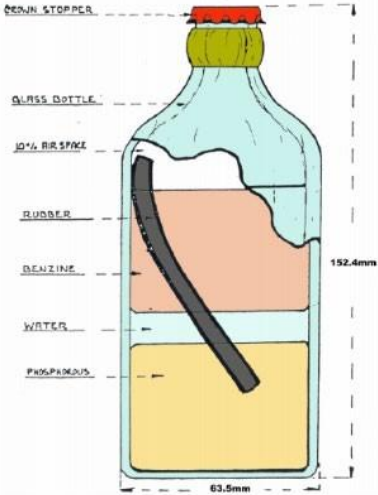
| No. 76 Self Igniting Phosphorous (SIP) Grenade | | | |
|---|---|---|---|
| Weight | Approx. 1lb 3oz | | |
| Filling | White Phosphorous and Benzene | | |
| Design | The filling was contained in a ½ pint sized glass bottle with water and a strip of rubber. Over time the rubber dissolved to create a sticky which would self ignite when the bottle broke. | | |

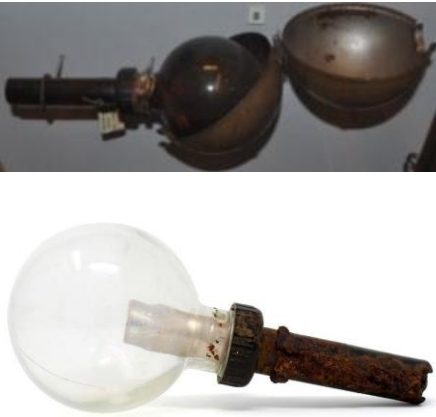
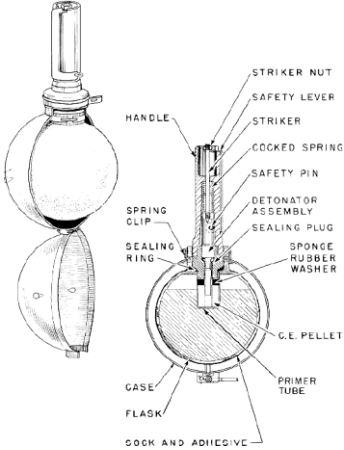
| No. 74 Grenade ("Sticky Bomb") Mk1 | | | |
|---|---|---|---|
| Weight | Approx. 1.1kg (2.25lb) | | |
| Filling | Approx. 600g Nobel's No.283 (Nitro-glycerine) (1.33lb) | | |
| Design | A glass ball on the end of a Bakelite (plastic) handle. The inside of the ball would contain the explosive filling and the outside a very sticky adhesive coating. | | |

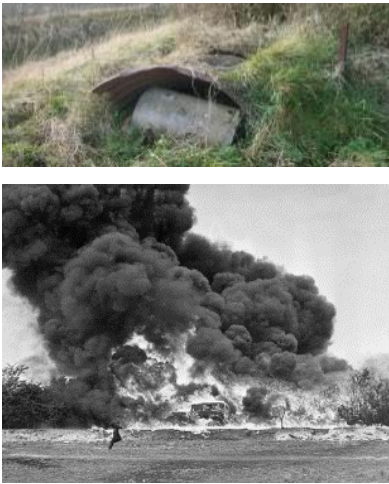
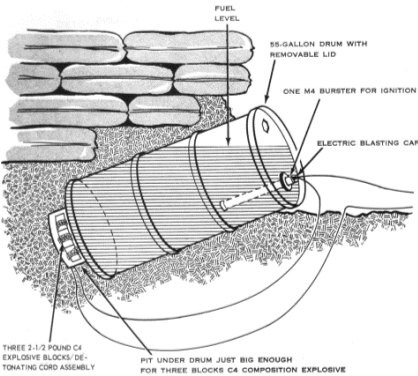
| Flame Fougasse Bomb | | | |
|---|---|---|---|
| Weight | Various | | |
| Filling | Initially a mixture of 40% petrol and 60% gas. Ammonal provided the propellant charge. | | |

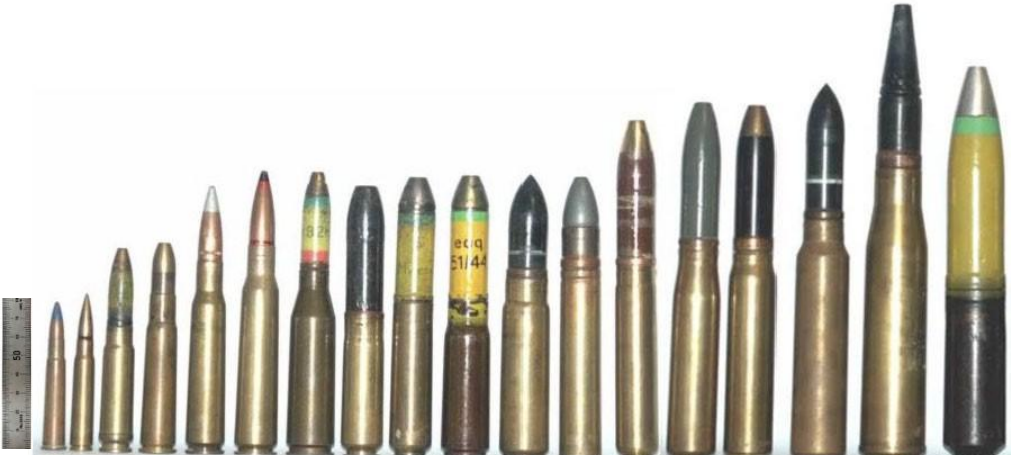
Common WWII-era Aircraft Mounted Gun Ammunition

7.7x58R 13x64B 12.7x81SR 12.7x99 12.7x108 15x96 20x72RB 20x80RB 20x82 20x94 20x99R 20x101RB 20x110 20x125 23x152B 30x90RB

7.7mm spitfire MKI Hurricane MKI others  
13mm MG 131 Bf109K FW190A8  
MG 7.92mm Bf109E,F Bf110C Ju87  
classic Browning P-40, P47, P51  
15mm MG 151 Bf109F  
MGFF cannon Bf109E Bf110C Ju87  
Mg 151 cannon 20mm FW190  
ShVAK 20mm Il2, yak3 others  
Ho-5 cannon 20mm jap.  
Hispano 20mm cannon spitfire mkIIb  
20x110RB  
20x125  
Ho-3 cannon 20mm Jap.  
VYa cannon yak il2  
MK 108 canr Bf109G6,Me. others  
MK FW1

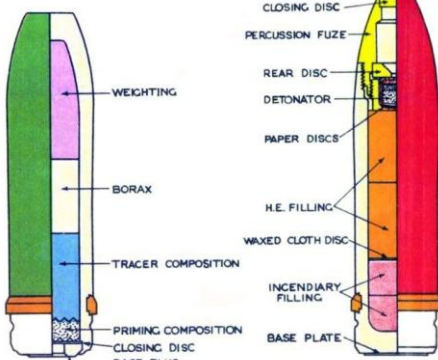
PROJECTILE TRACER

CLOSING DISC  
PERCUSSION FUZE  
REAR DISC  
DETONATOR  
PAPER DISCS  
H.E. FILLING  
WAXED CLOTH DISC  
INCENDIARY FILLING  
TRACER COMPOSITION  
PRIMING COMPOSITION  
CLOSING DISC  
BASE PLUG
