Public Health England

NHS Breast Screening Programme Equipment Report
Practical evaluation of Hologic® 3Dimensions™ Mammography System in digital breast tomosynthesis mode

July 2020

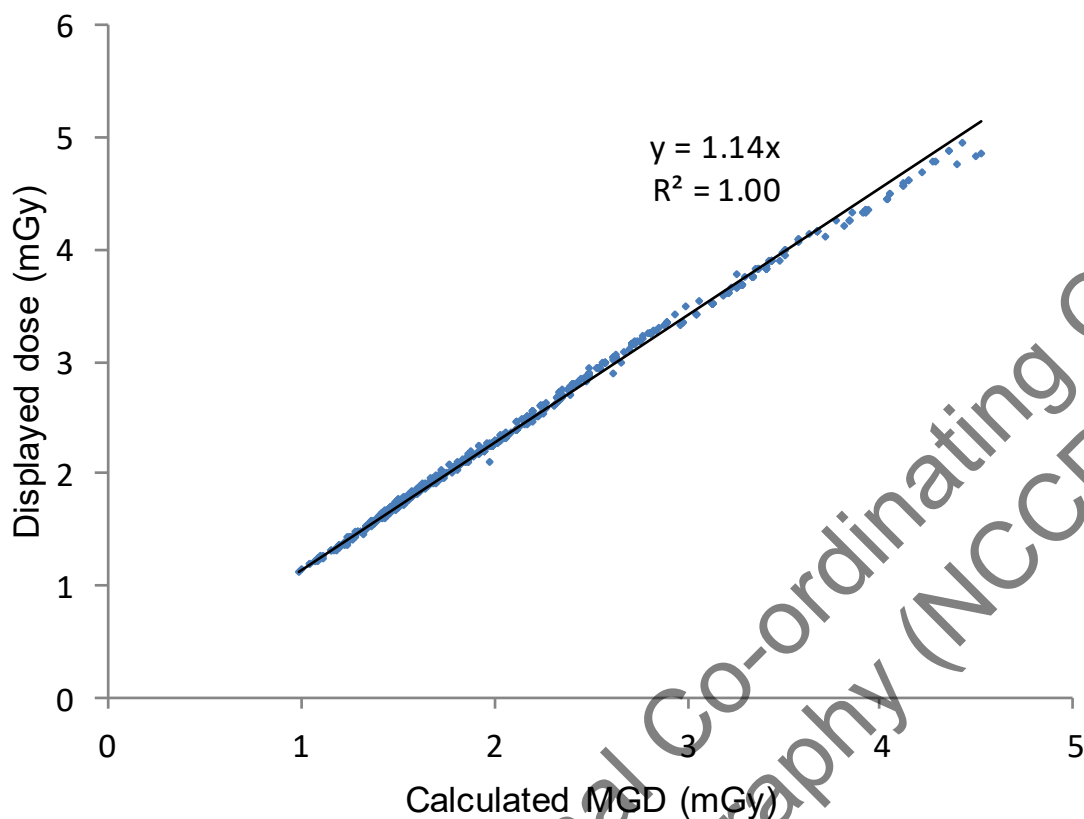
Figure 25. Displayed dose versus calculated dose (tomosynthesis)

The displayed dose is plotted against the calculated dose in Figure 25. The slope of the trendline is 14% higher than equality (slope = 1), and this reflects the differences in the output and HVL values used in the calculations.
