Archaeological Sites within Cramber Tor Training Area, Dartmoor National Park, Devon: A condition survey on behalf of Defence Infrastructure Organisation

February 2021

(SX 5884 6932)

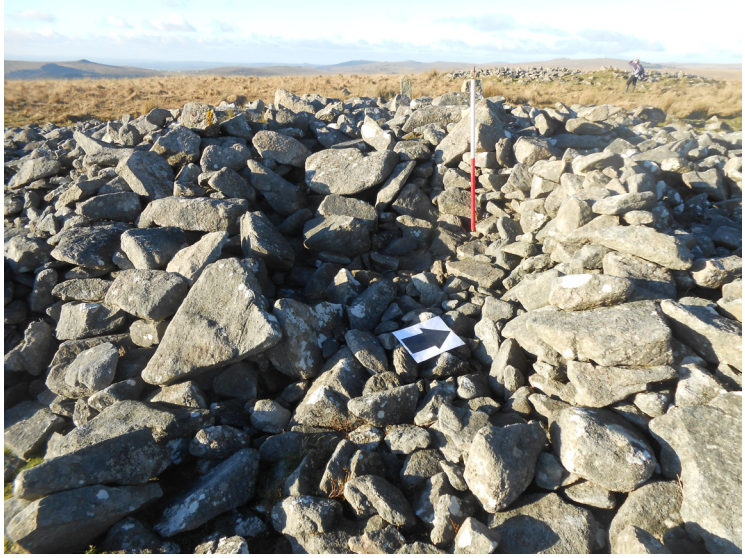
MoD DE-HMS ID: **438743**
SM No: **1010692**
HER No: **4014**
<u>Two large cairns on Eylesbarrow (Fig. 4)</u>
The perennial problem of stones being moved and used to build un-authorised structures within the stony fabric of these cairns continues at this site. However, only one current patch of interference is affecting the south cairn and appears to be the same structure identified and photographed in the 2017 report (Probert 2017). No fresh disturbance was noted and the level of significance of this problem currently requires no remedial action other than monitoring.

Fig.4 Unauthorised structure in Eylesbarrow cairn (438743).

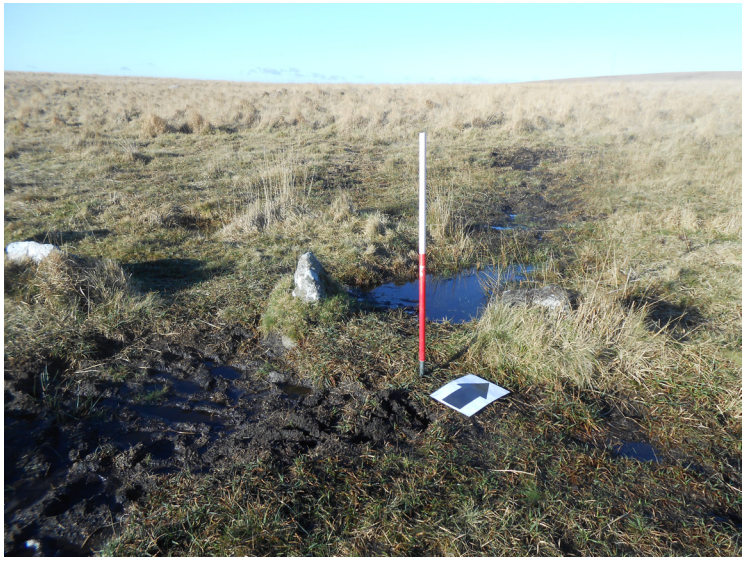
MoD DE-HMS ID: **438583**
SM No: **1009090**
HER No: **3502; 3439; 52428**
Stone alignment and encircled cairn on Hingston Hill (Fig. 5)
A combination of flowing storm water transecting the alignment, causing wet patches adjacent to the stones, increased human footfall caused by walkers following a course very close to the alignment, and livestock poaching, is causing small but significant patches of erosion around certain stones, which considering some may not be rooted that deeply threatens them becoming dislodged. This erosion was also noted in the 2017 report. No immediate action is required but the situation needs monitoring.

Fig. 5a (above) and b (below) Showing erosion around upright stones within the Hingston Hill alignment (438583).

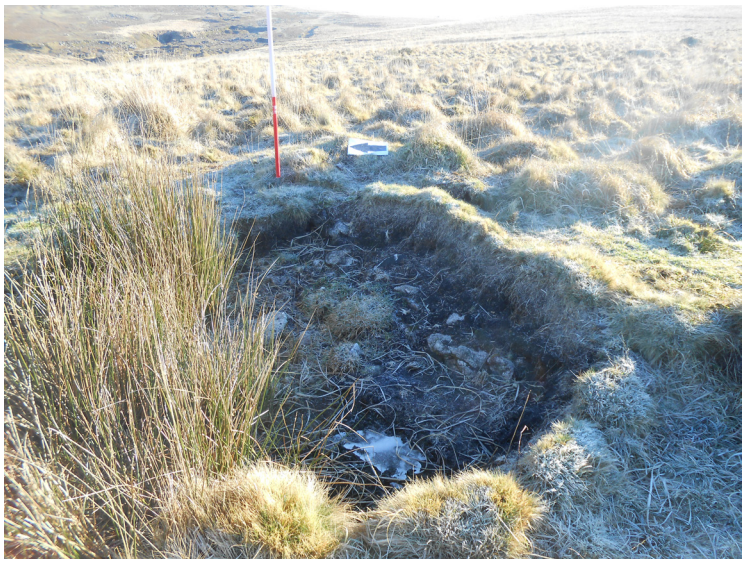
MoD DE-HMS ID: **1451287**
HER No: **25100**
A sub-circular enclosure with single hut circle which has been thoroughly robbed of larger stone, and survives mainly as an earthwork. (Fig. 8)
This small prehistoric enclosure, very unclear on the ground, may have been robbed of large stone in the past and what remains is protected by a shallow covering of turf. However, a small section of the enclosure wall has become disturbed in recent years, exposing a section of the stony bank. The exposure is approximately 2m long by 1m wide and could represent either, a deliberate intervention, animal poaching, or the former being exacerbated by the latter. Although this is a prehistoric site, it is not scheduled.

Fig. 8 Turf covering removed from prehistoric enclosure wall exposing stony bank (1451287).
