Report on the investigation of the capsized and sinking
of the cement carrier
Cemford
in the Pentland Firth, Scotland
with the loss of all eight crew
on 2 and 3 January 2015

Cemfjord

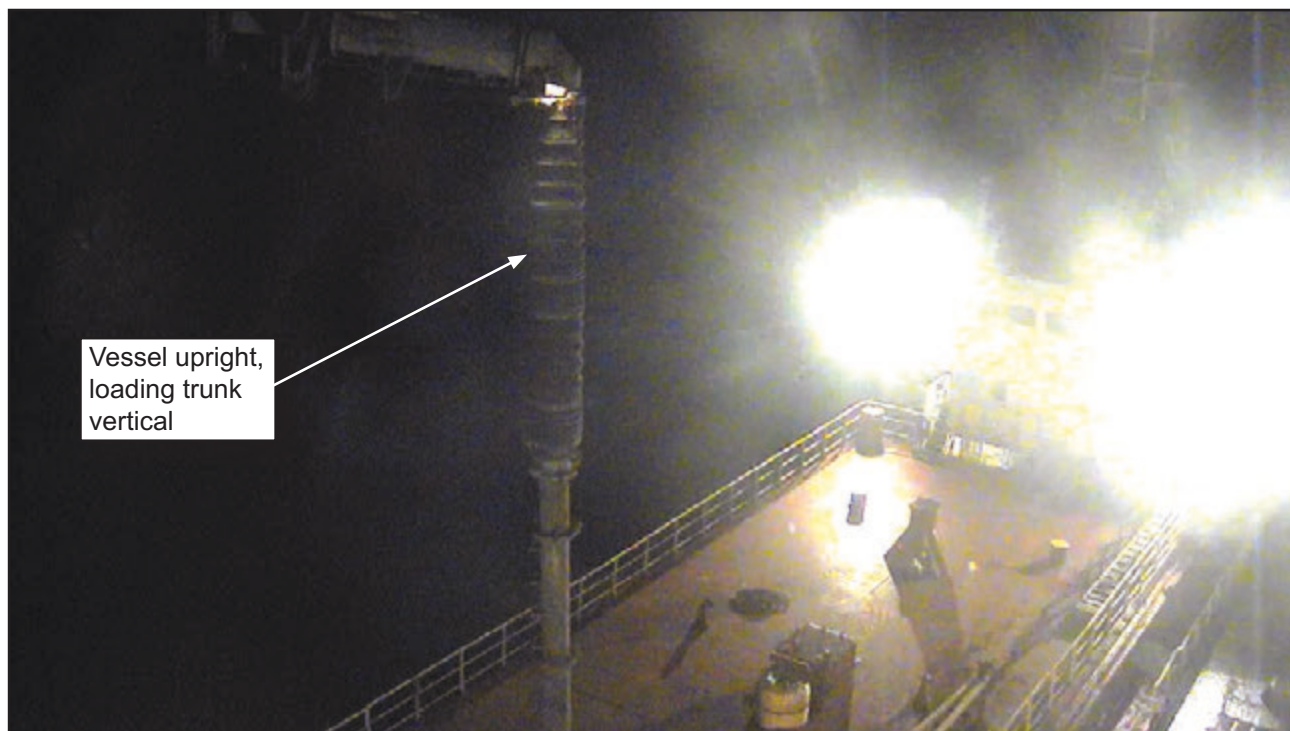
Figure 1a: CCTV image of *Cemfjord* alongside in Rordal at 0119, 30 December 2014. Vessel is upright, cement loading trunk is vertical

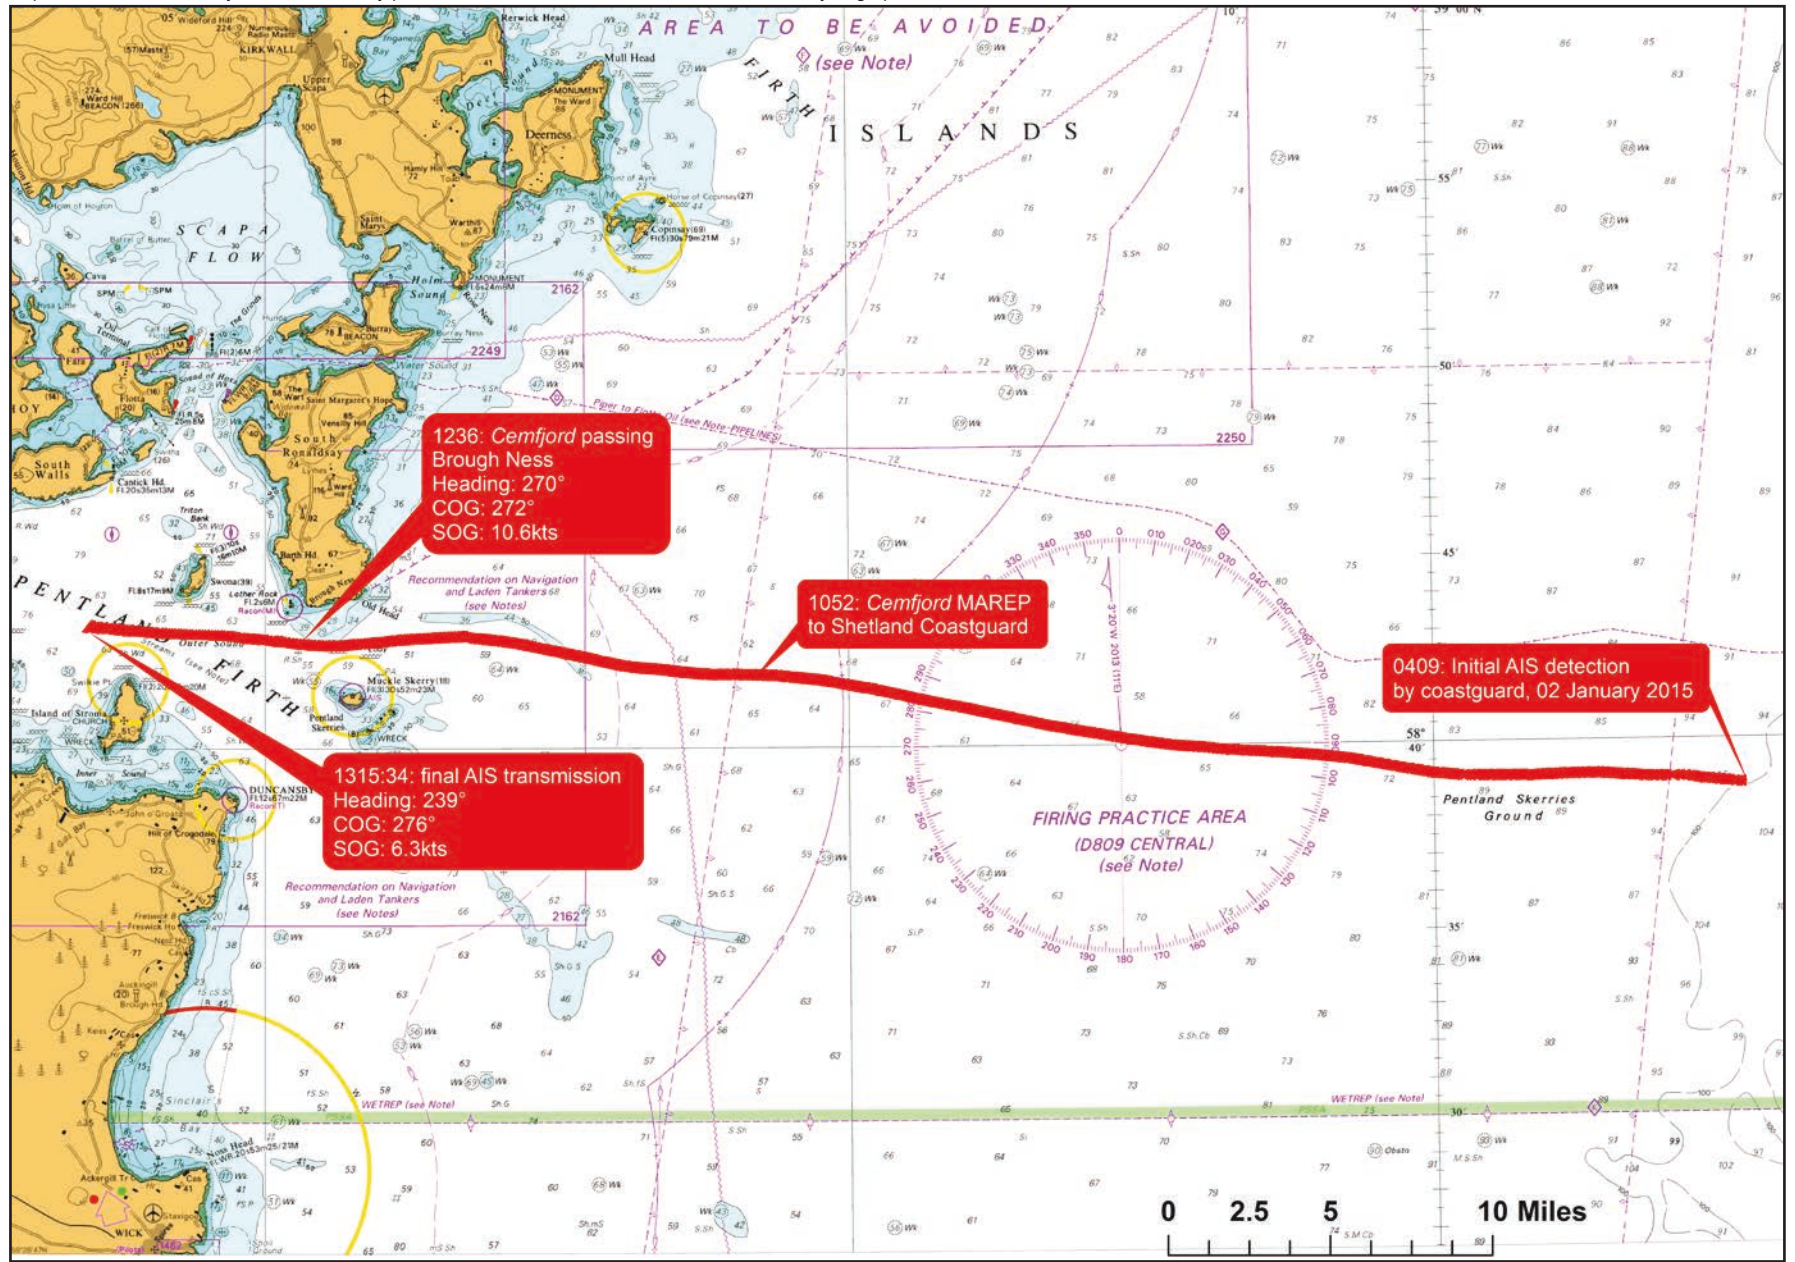
In the eastern approaches to the Pentland Firth, at 1052 (**Figure 4**), the master made voice contact with Shetland Coastguard on VHF radio in order to transmit a maritime report² (MAREP). Having established communications, the master advised

Figure 4: Cemfjord's AIS track from 0409 on 2 January 2015 including MAREP reporting position, AIS data passing Brough Ness and final AIS information

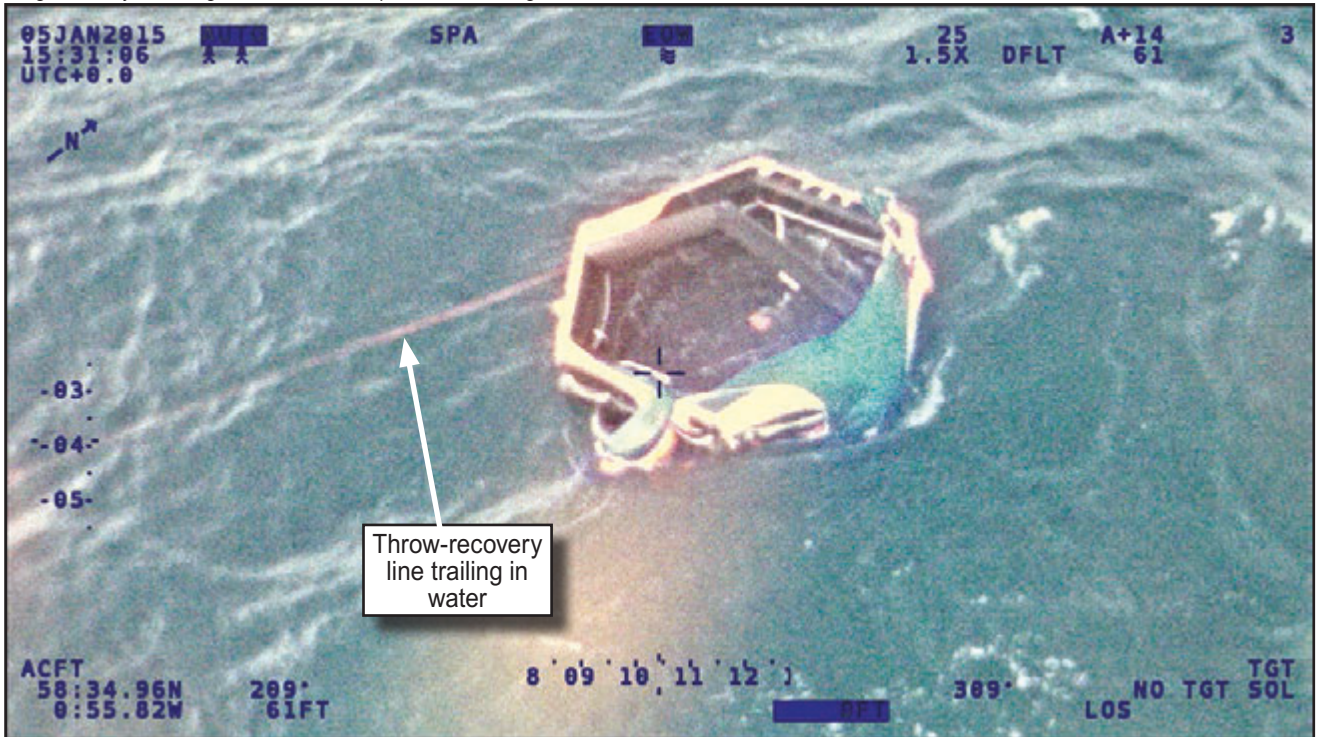
At 1455 on 5 January 2015, a liferaft was sighted in the North Sea by a passing ship, 70nm east of *Cemfjord's* last recorded AIS position (**Figure 6**). The sighting was reported to Shetland Coastguard and a SAR helicopter from Sumburgh was tasked to investigate (**Figure 11**). There was no-one on board the liferaft and, having recovered its maintenance records, the helicopter's winchman punctured the buoyancy chambers in order that it would sink. The maintenance records recovered from the liferaft positively identified that it had come from *Cemfjord*.

Figure 11: Cemfjord's liferaft in the North Sea as seen from the SAR helicopter

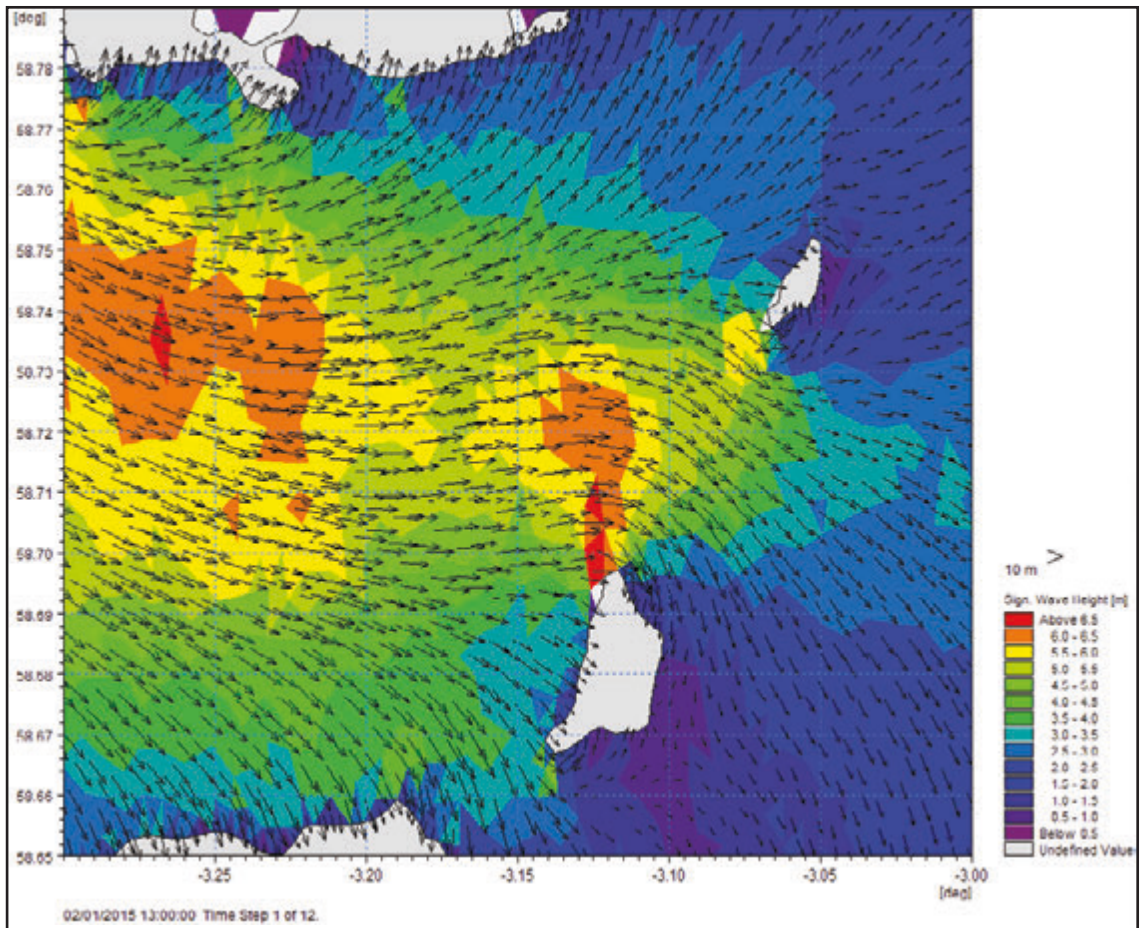
The MAIB also obtained hindcast modelling data after the accident from the European Marine Energy Centre (EMEC). This analysis was based on tidal energy fieldwork studies in the area, conducted for the renewable energy business sector. The tidal current data from this analysis for 1300 on 2 January 2015 (**Figure 13**) shows a 5.8 to 6.8kts⁵ north-westerly stream at the location where *Cemford's* AIS signal was lost. The EMEC data also included wave height analysis; this showed an assessed significant wave height in the area of lost AIS signal of 6-6.5m (**Figure 14**).

Figure 14: European Marine Energy Centre: significant wave height analysis for the Pentland Firth, Outer Sound at 1300 on 2 January 2015

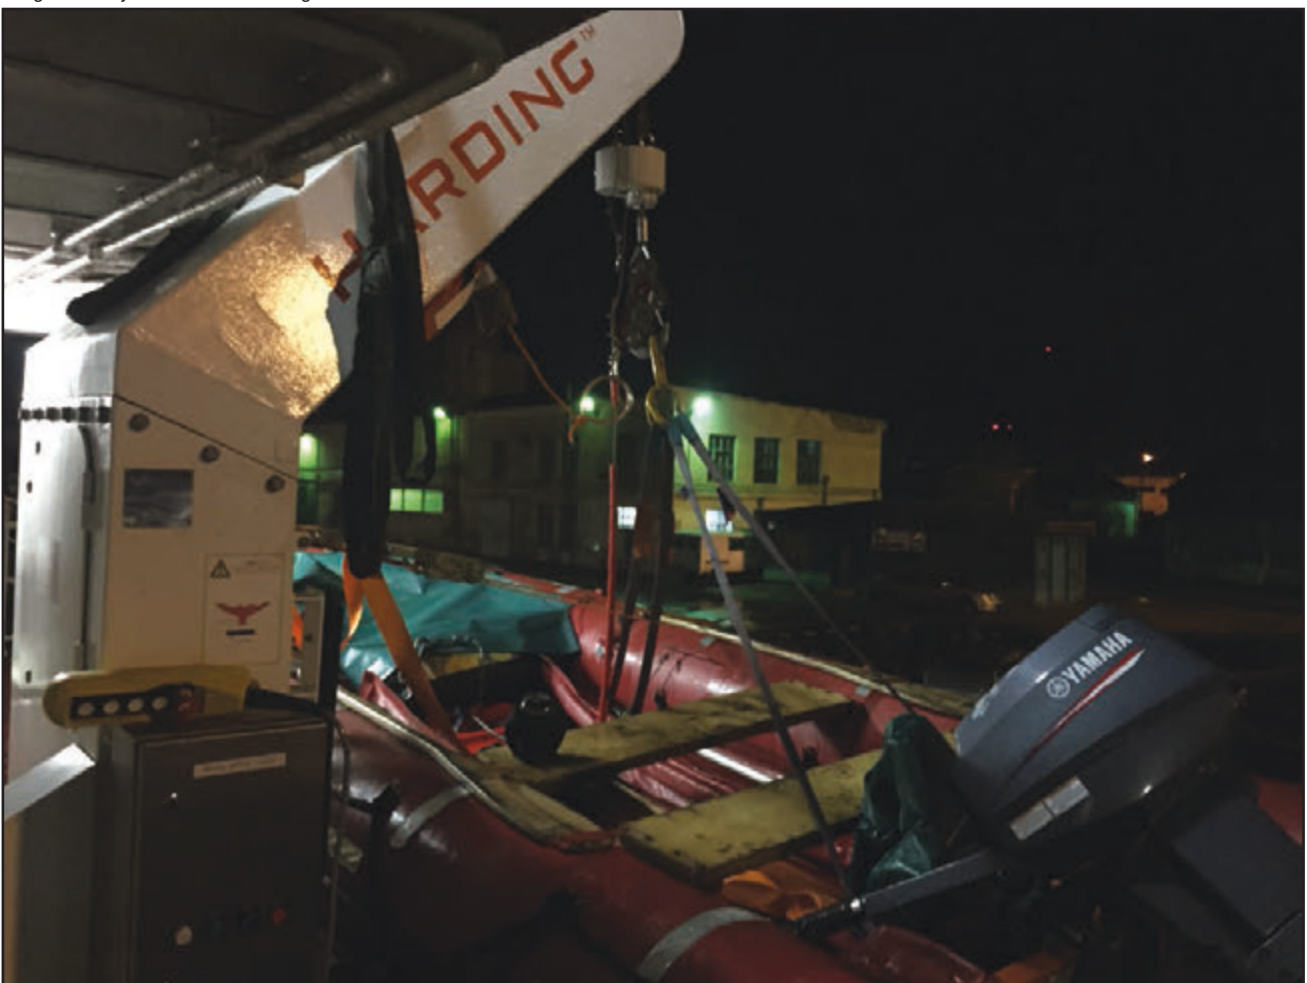
The rescue boat davit was manufactured and supplied by Harding Safety, and was fitted during *Cemfjord's* refit, approximately 1 month before the accident. It was a remotely operated hydraulic pivoting 'NOREQ NPDS 1300 H' davit and was fitted with a Harding type RRH15 off-load/on-load single fall release hook. The davit was designed to launch and recover rescue boats or lifeboats and could be operated from inside the boat or a remote position on deck. An extract of the davit's user manual is at **Figure 20**. A Harding rigid rescue boat Type 425 had been ordered at the same time as the replacement davit but it was not delivered during the refit and a temporary rescue boat was sourced and carried instead.

Figure 21: Zodiac temporary rescue boat in replacement Harding davit

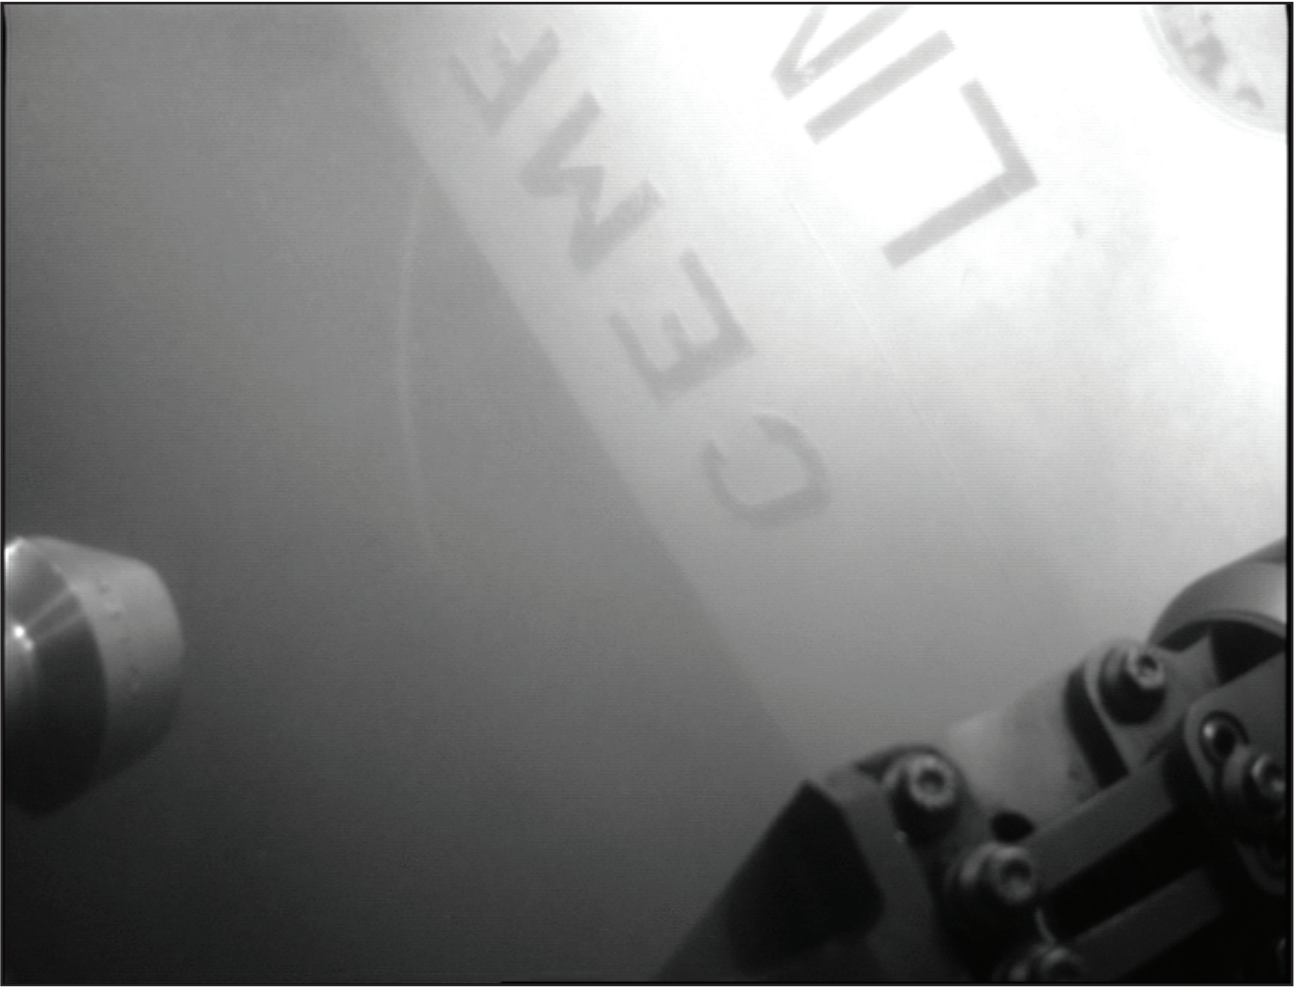
Figure 22: Wreck of *Cemfjord* - initial identification and angle of heel from Ministry of Defence remotely operated vehicle

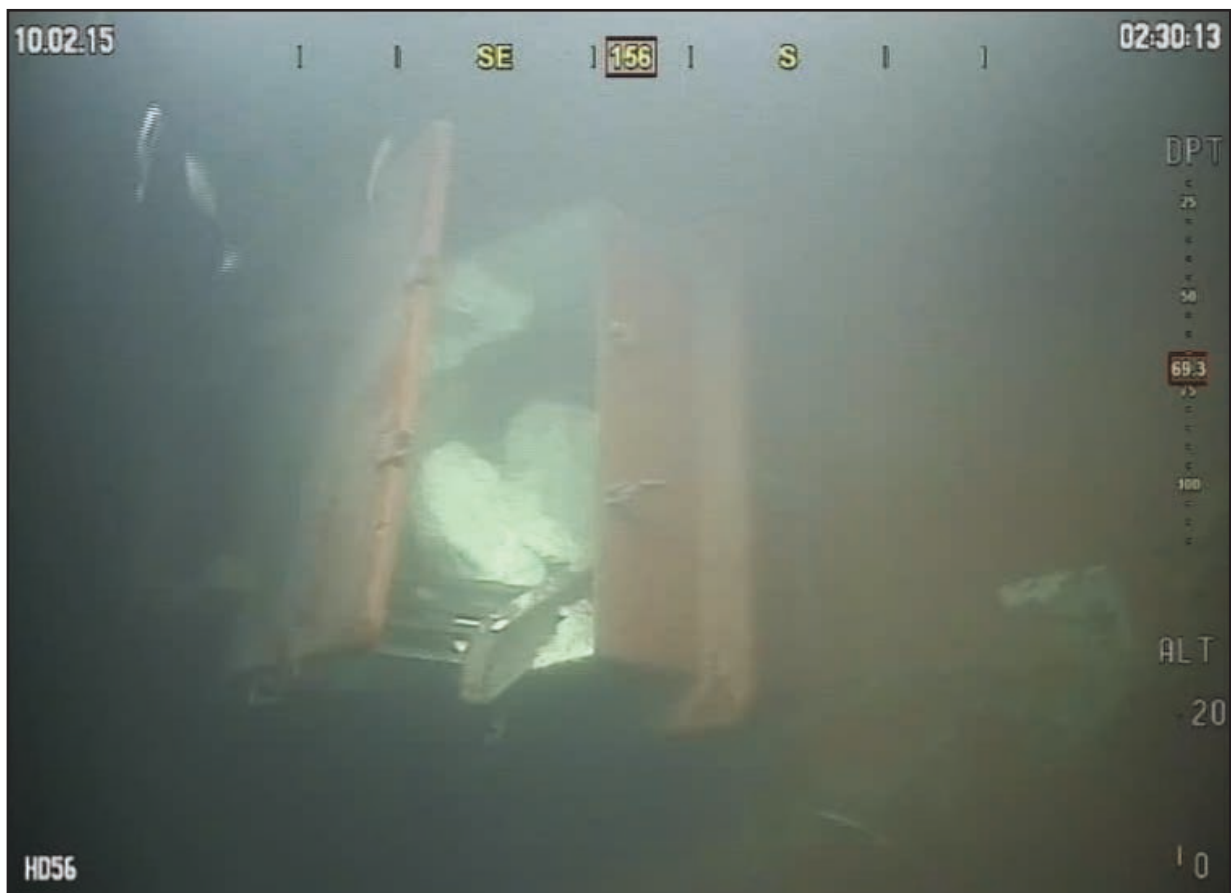
- The forward cargo hold loading hatch was slightly buckled and partially open (**Figure 33**).
- The rudder was set approximately 10° to port (**Figure 34**).

Figure 33: Wreck of *Cemfjord* - forward cargo loading hatch

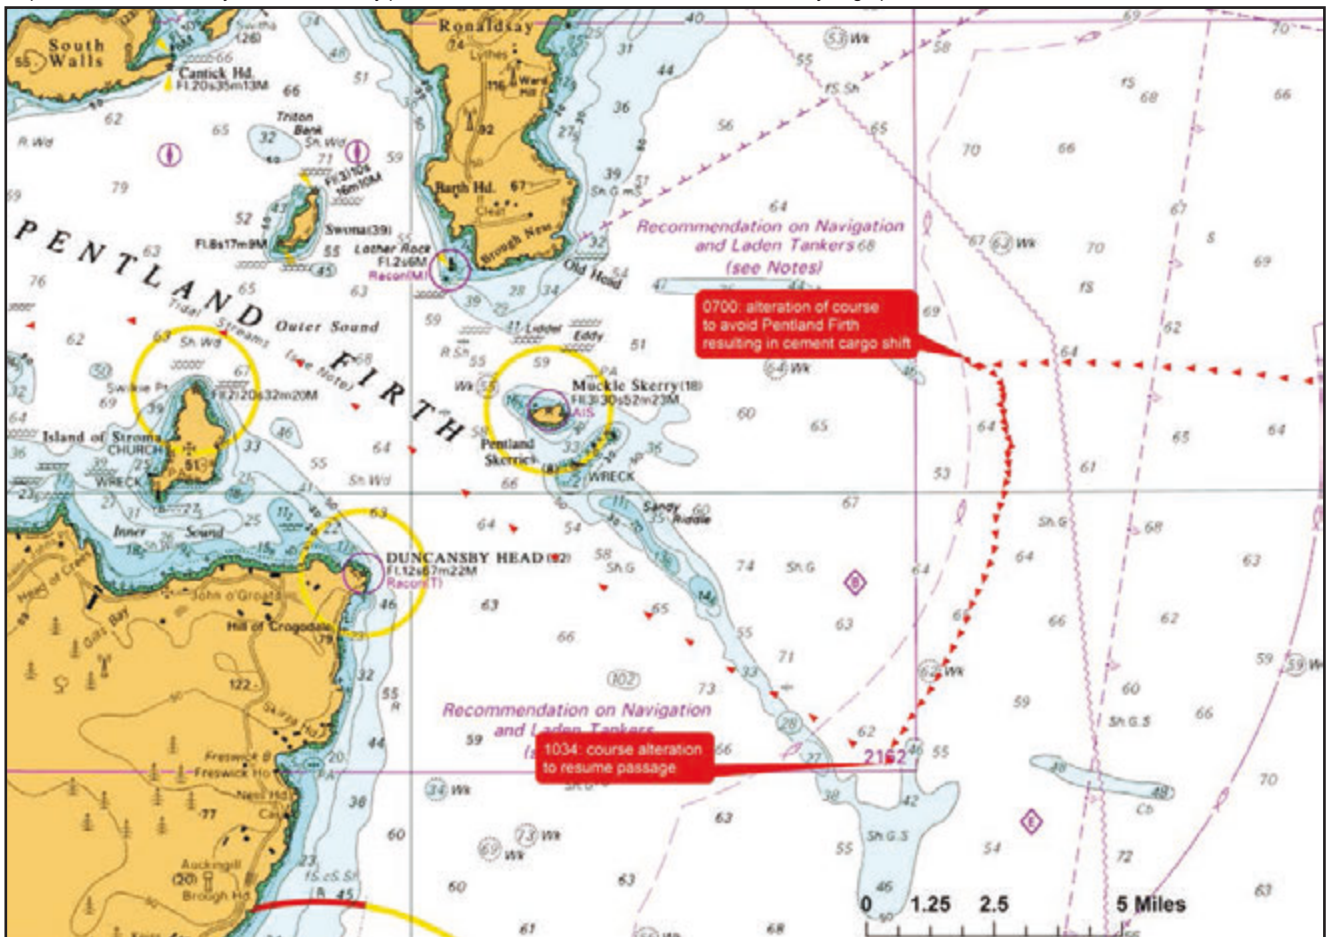
Figure 40: Cemfjord - AIS track on 7 October 2014

- At 0700 on 7 October 2014, the vessel altered course to avoid entering the Pentland Firth (**Figure 40**). This action resulted in a cement cargo shift [para 1.20.1].

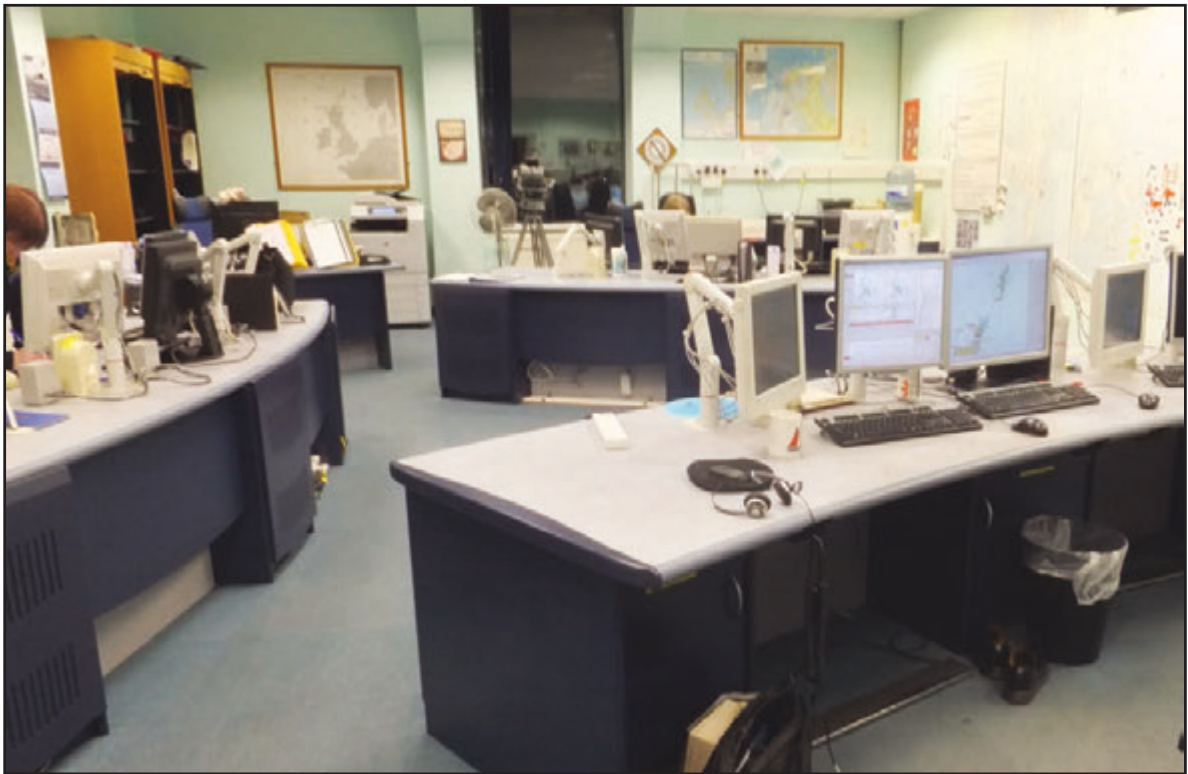
Figure 41: Shetland Coastguard operations room

Based in Lerwick, Shetland Coastguard's operations room (**Figure 41**) was continuously manned with a watch supervisor, watch officer and watch assistant. All the operations room staff had access to VHF radios and display screens, which were used for operations and planning management. Live AIS tracks were fed to the operators' display screens. At the time of the accident, the two display screens used by the watch supervisor were not showing AIS information due to a fault with the operations room data distribution system.

Coastguard staff did not routinely monitor vessels' progress through the voluntary reporting scheme. If AIS transmissions from a vessel in the scheme ceased, there was no alarm system to alert the watch officers and there was also no operator procedure to follow for such an event.

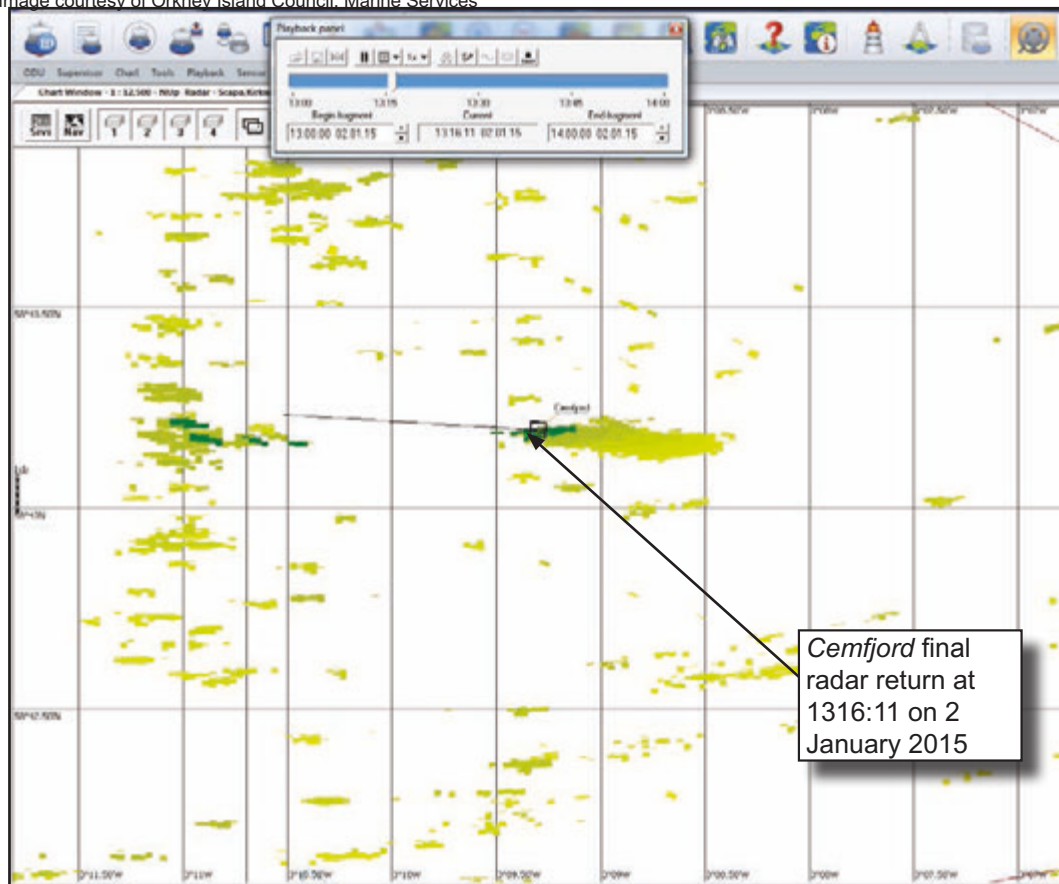
Orkney VTS radar and AIS contacts on *Cemfjord* were lost abruptly at 1316:12 on 2 January 2015 (**Figures 43 and 44**). A brief radar detection was subsequently made from 1317:58 until 1318:45; however, this was insufficient time for the radar system to form a track and no further radar detections were made of *Cemfjord* (**Figure 45**).

Figure 43: Orkney VTS final radar detection of *Cemfjord* at 1316:11

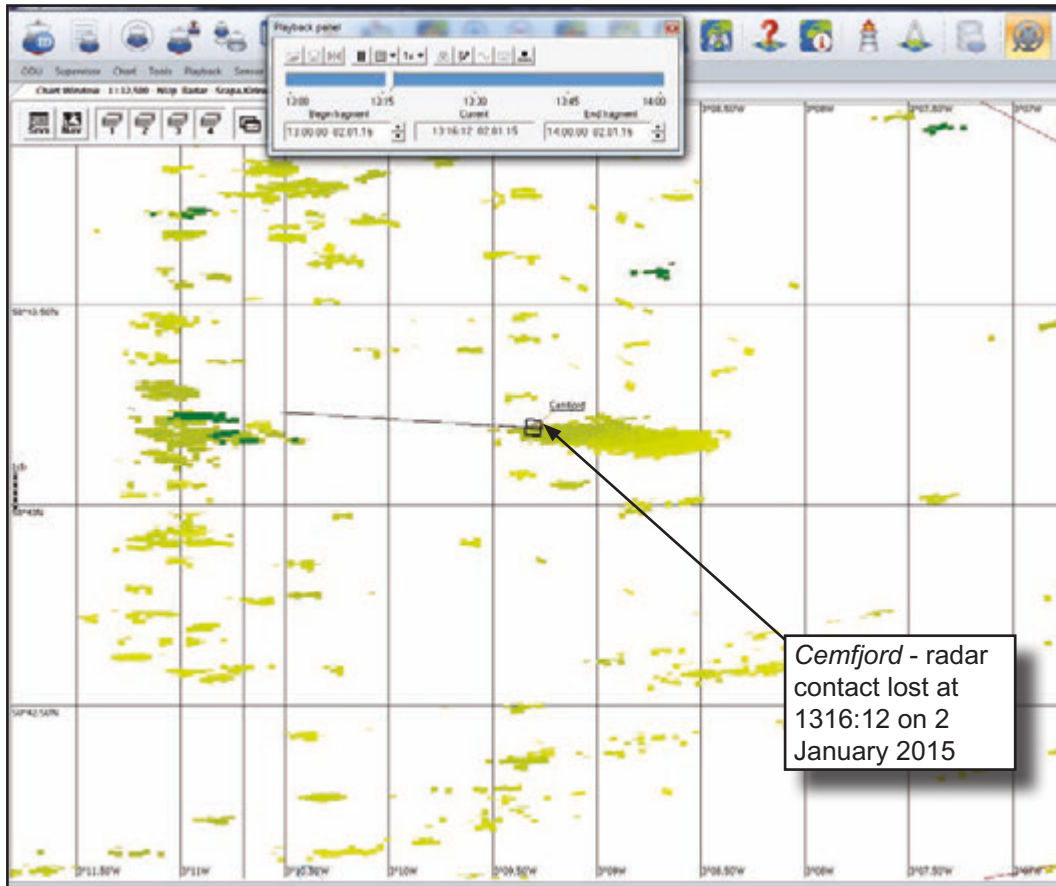
Figure 44 Orkney VTS picture at 1316:12 after loss of radar contact

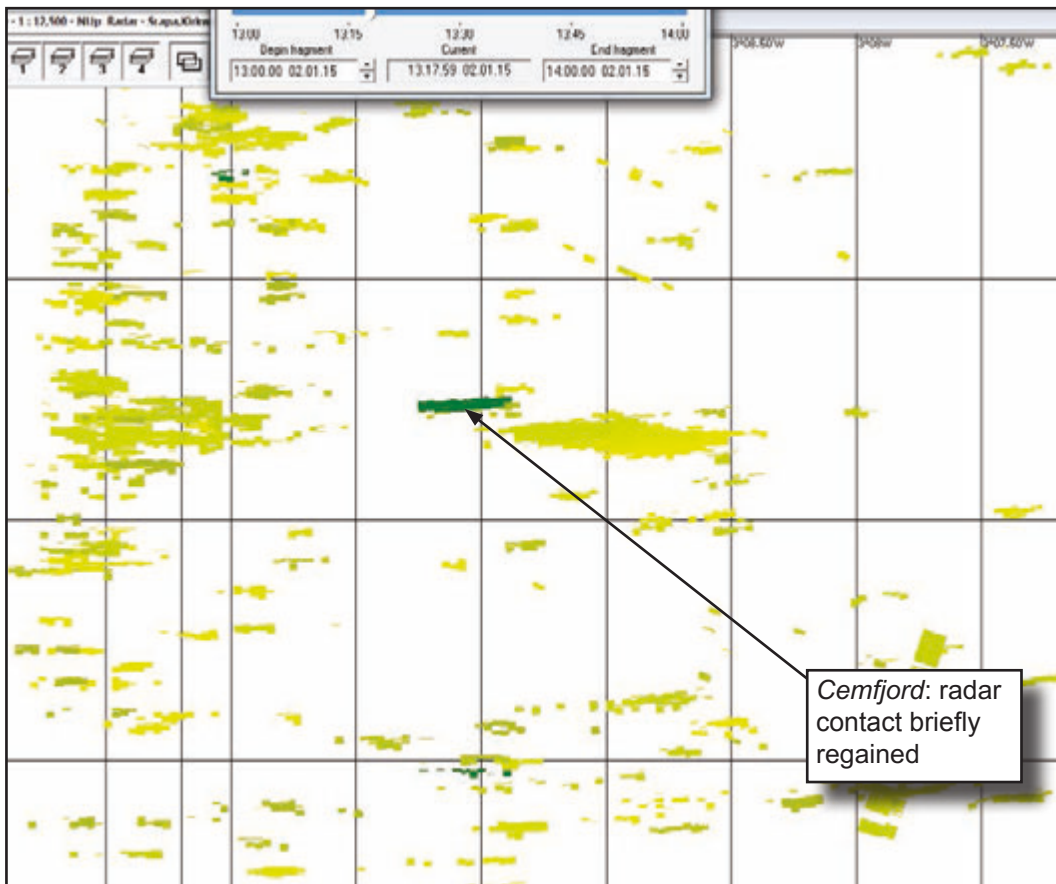
Figure 45: Orkney VTS picture showing brief regain of radar contact at 1317:58

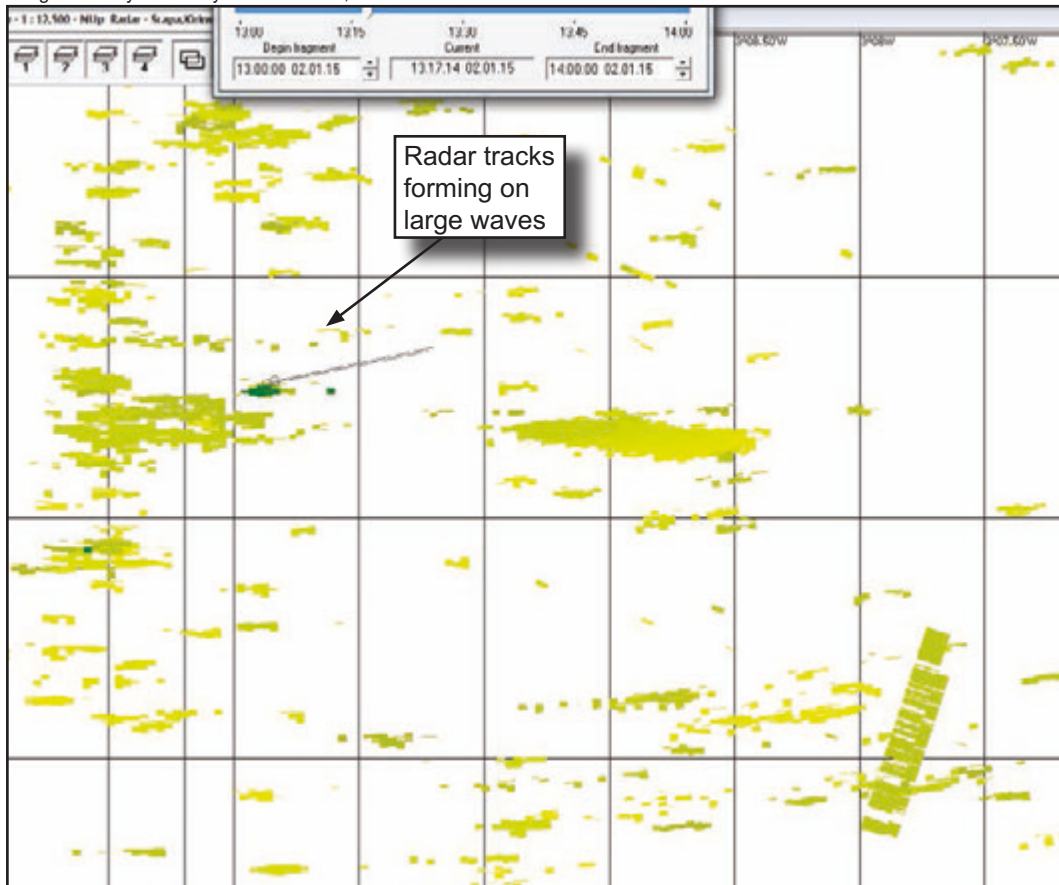
In addition to the radar detection of *Cemfjord*, clutter returns from large waves can also be observed; some of these waves were sufficiently large radar targets for the VTS system to form tracks (**Figure 46**).

Figure 46: Orkney VTS picture showing radar tracks forming on very large waves

the Outer Sound and Merry Men of Mey areas (**Figure 35**). The Orkney VTS radar imagery showed extreme wave conditions reaching across the Firth in *Cemfjord's* path at the time of the loss (**Figure 46**). Furthermore, the position where *Cemfjord's* radar and AIS contacts were lost was, critically, in the Outer Sound, west of the islands of Swona and Stroma where the Admiralty Sailing Directions specifically offer an unambiguous caution for westbound vessels, stating that, in the conditions that would have been present at that time, *passage through the firth should not be attempted*. It is also an area of peak wave heights, as shown by the EMEC analysis (**Figure 53**).

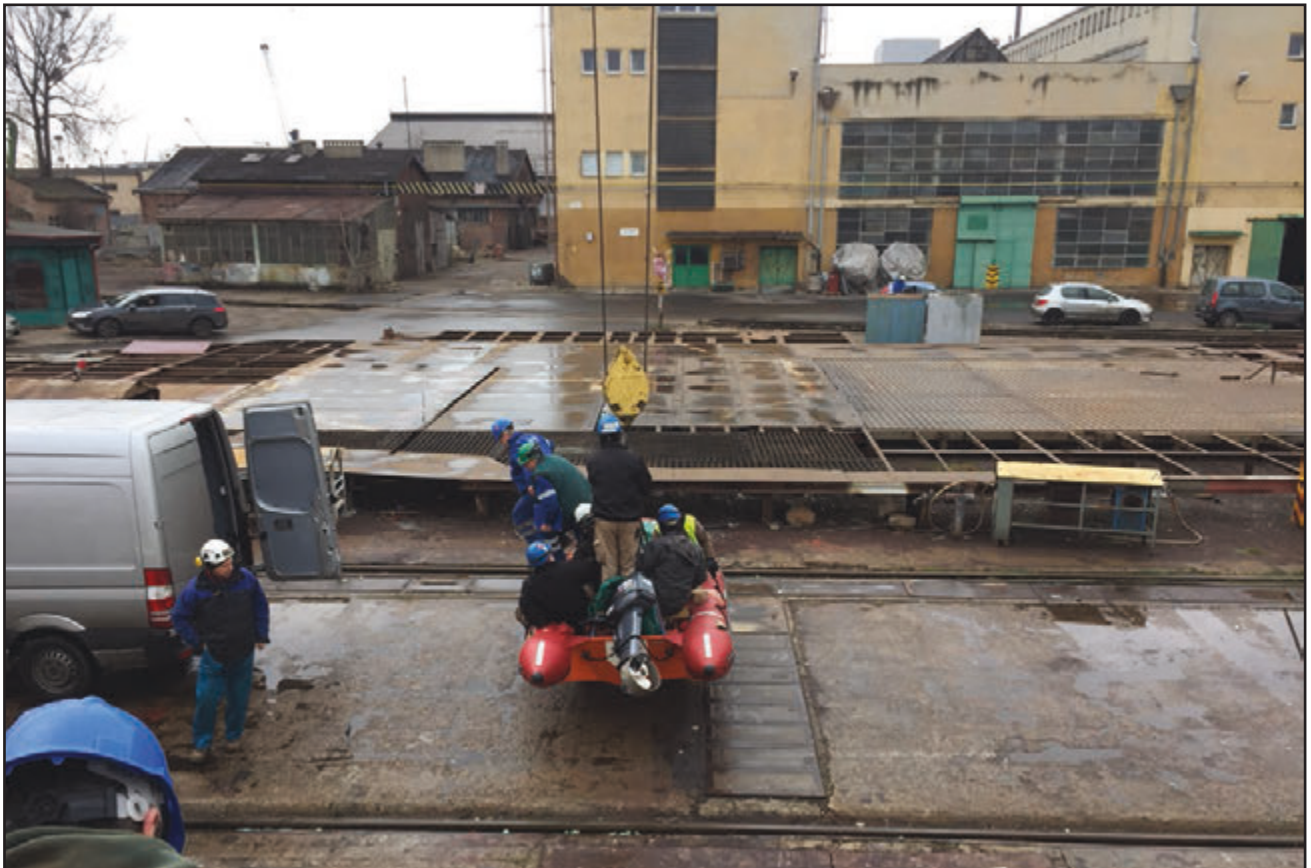
When the temporary rescue boat arrived in Poland, it was load tested on the quayside in the presence of the DNV-GL surveyor with seven persons embarked (**Figure 52**). When it was put in the davit it became apparent that it was not compatible as the rescue boat slings were too long. This prevented the crew from launching and recovering the boat using the hydraulic pivoting davit as designed.

Figure 52: Temporary rescue boat load test with seven persons embarked during refit period in Poland

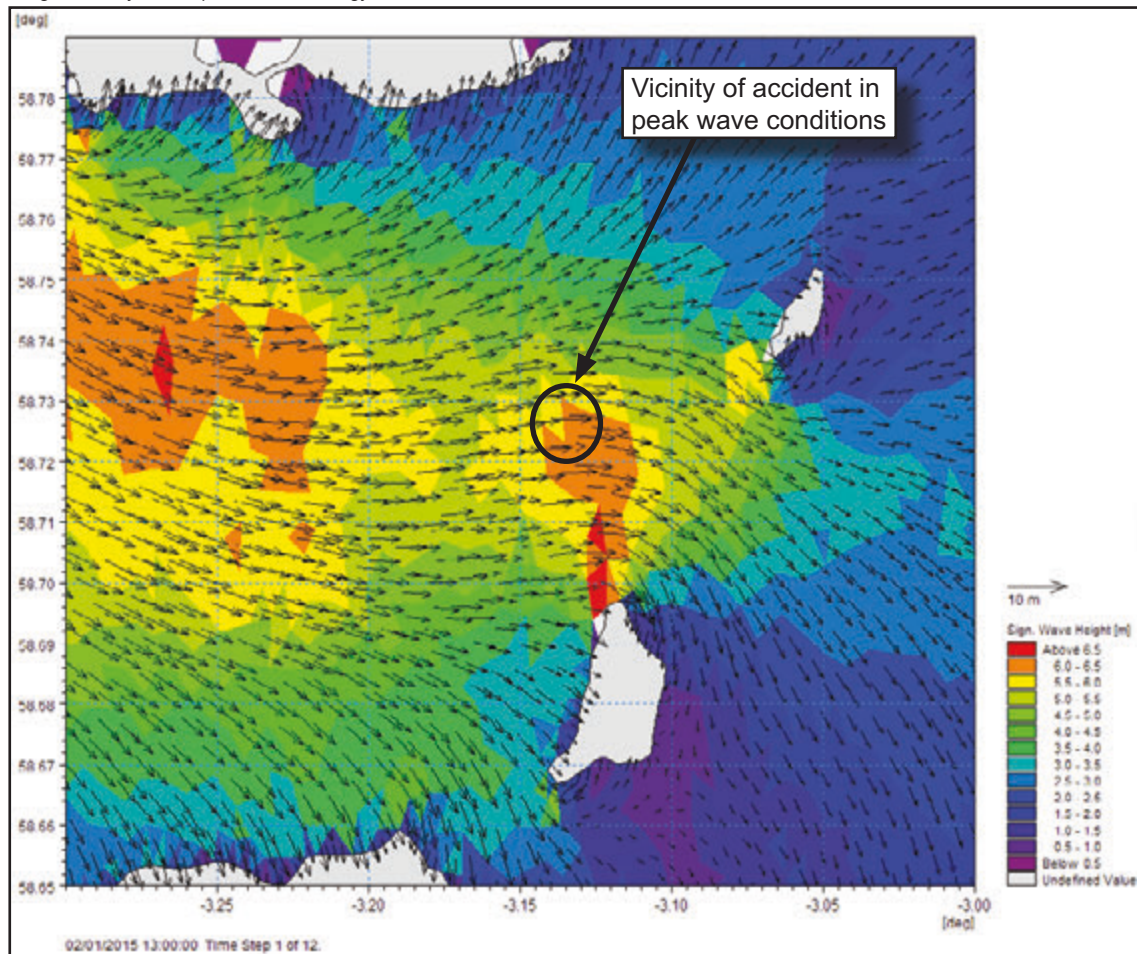
Figure 53: European Marine Energy Centre: significant wave height analysis for the Pentland Firth showing area of peak wave height in vicinity of the capsize

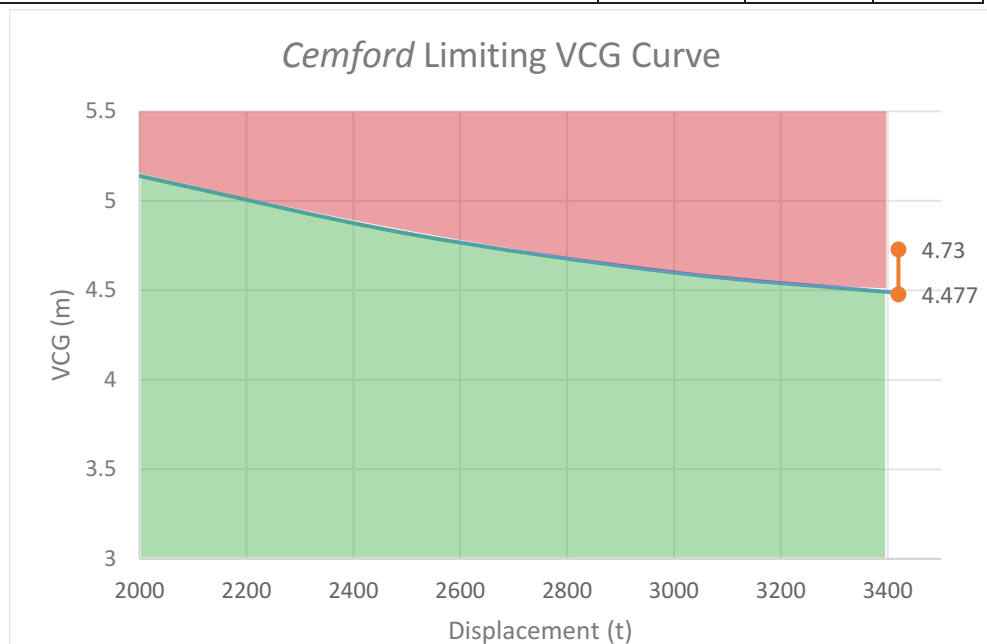
This effect can be illustrated by applying the manufacturer's bulk density figure of 1100kg/m³ to the limiting VCG curve for the loading manual's *Cement cargo settled +100% short voyage - departure* conditions. This calculation uses the same displacement value (3420t) but a modified VCG of 4.73m based on the lighter bulk density value that was applicable to *Cemfjord*'s cargo. When plotted next to the data from the loading manual (**Figure 58**), it is apparent that this calculation has the effect of increasing the VCG value above the VCG limiting line. In other words, the loading manual short voyage departure condition would only meet the IMO stability criteria if the cargo density value was 1350kg/m³, or higher.

Figure 58: Cemford's approved vertical centre of gravity limiting curve showing data points for 1350kg/m³ and 1100kg/m³
