**ACCIDENT**

<b>Aircraft Type and Registration:</b>	Embraer EMB-505 Phenom 300, HZ-IBN	
<b>No &amp; Type of Engines:</b>	2 Pratt & Whitney Canada PW535E turbofan engines	
<b>Year of Manufacture:</b>	2010 (Serial no: 50500040)	
<b>Date &amp; Time (UTC):</b>	31 July 2015 at 1408 hrs	
<b>Location:</b>	Blackbushe Airport, Surrey	
<b>Type of Flight:</b>	Private	
<b>Persons on Board:</b>	Crew - 1	Passengers - 3
<b>Injuries:</b>	Crew - 1 (Fatal)	Passengers - 3 (Fatal)
<b>Nature of Damage:</b>	Aircraft destroyed	
<b>Commander's Licence:</b>	Airline Transport Pilot's Licence	
<b>Commander's Age:</b>	57 years	
<b>Commander's Flying Experience:</b>	11,000 hours (of which 1,181 were on type) Last 90 days - 23 hours Last 28 days - 5 hours	
<b>Information Source:</b>	AAIB Field Investigation

**Synopsis**

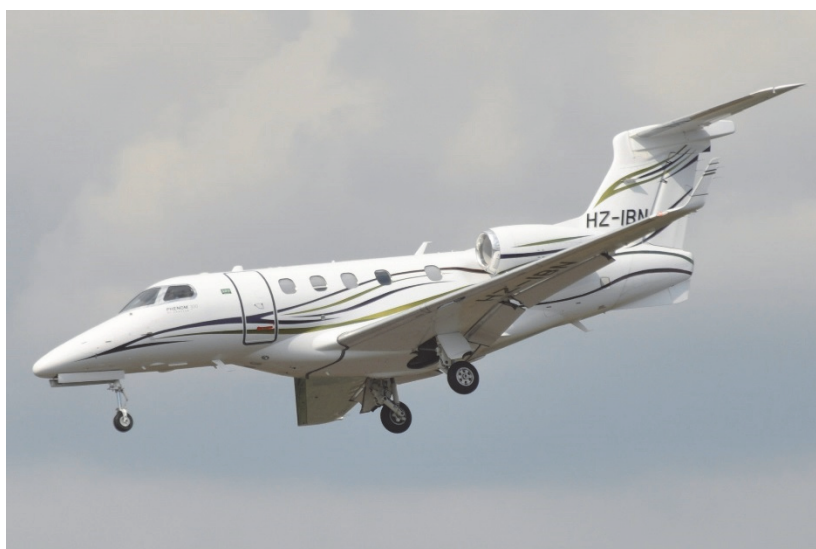
**Figure 1**

HZ-IBN on approach to Runway 25 shortly before the accident  
(photograph taken by Geoff Pierce)

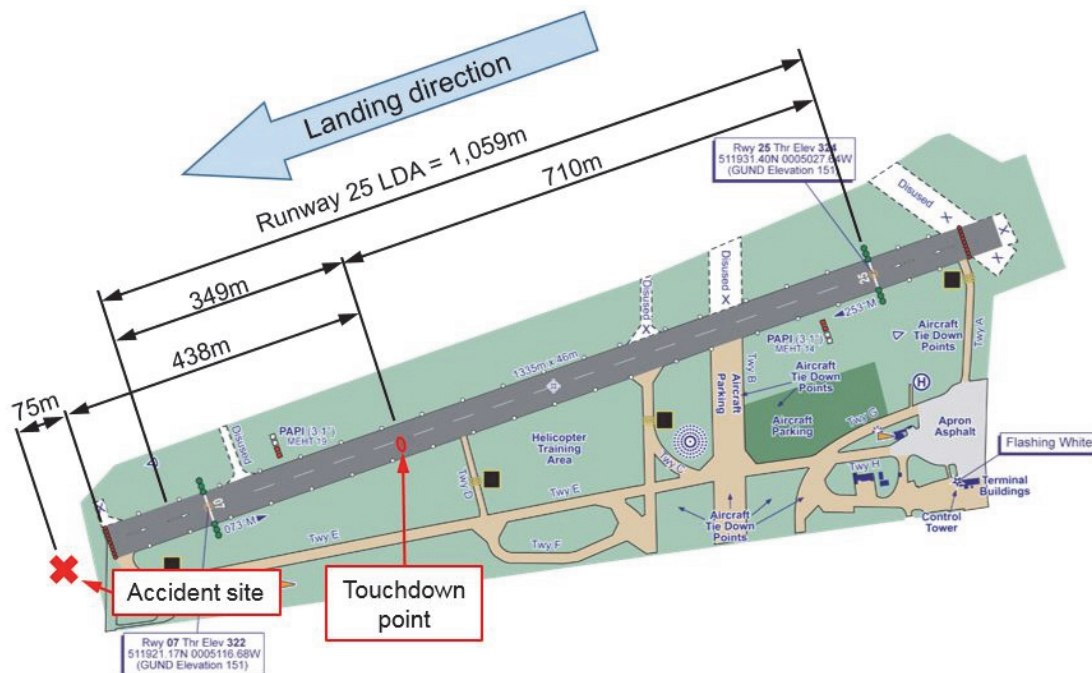
**Figure 3**

Blackbushe aerodrome chart, showing LDA and approximate touchdown point

Data from the aircraft's CVFDR indicated that the aircraft crossed the threshold of Runway 25 at approximately 50 ft agl at 151 KIAS, 43 kt above the target threshold speed. The aircraft touched down 710 m beyond the Runway 25 threshold with a groundspeed at touchdown of 135 kt, and an airspeed of 134 KIAS. The performance model predicted that at this speed, the landing ground roll required to stop the aircraft would be at least 616 m<sup>9</sup>. Runway 25 has a declared Landing Distance Available (LDA) of 1,059 m; therefore the aircraft touched down approximately 349 m before the end of the declared LDA, 438 m before the end of the paved runway surface (Figure 3).

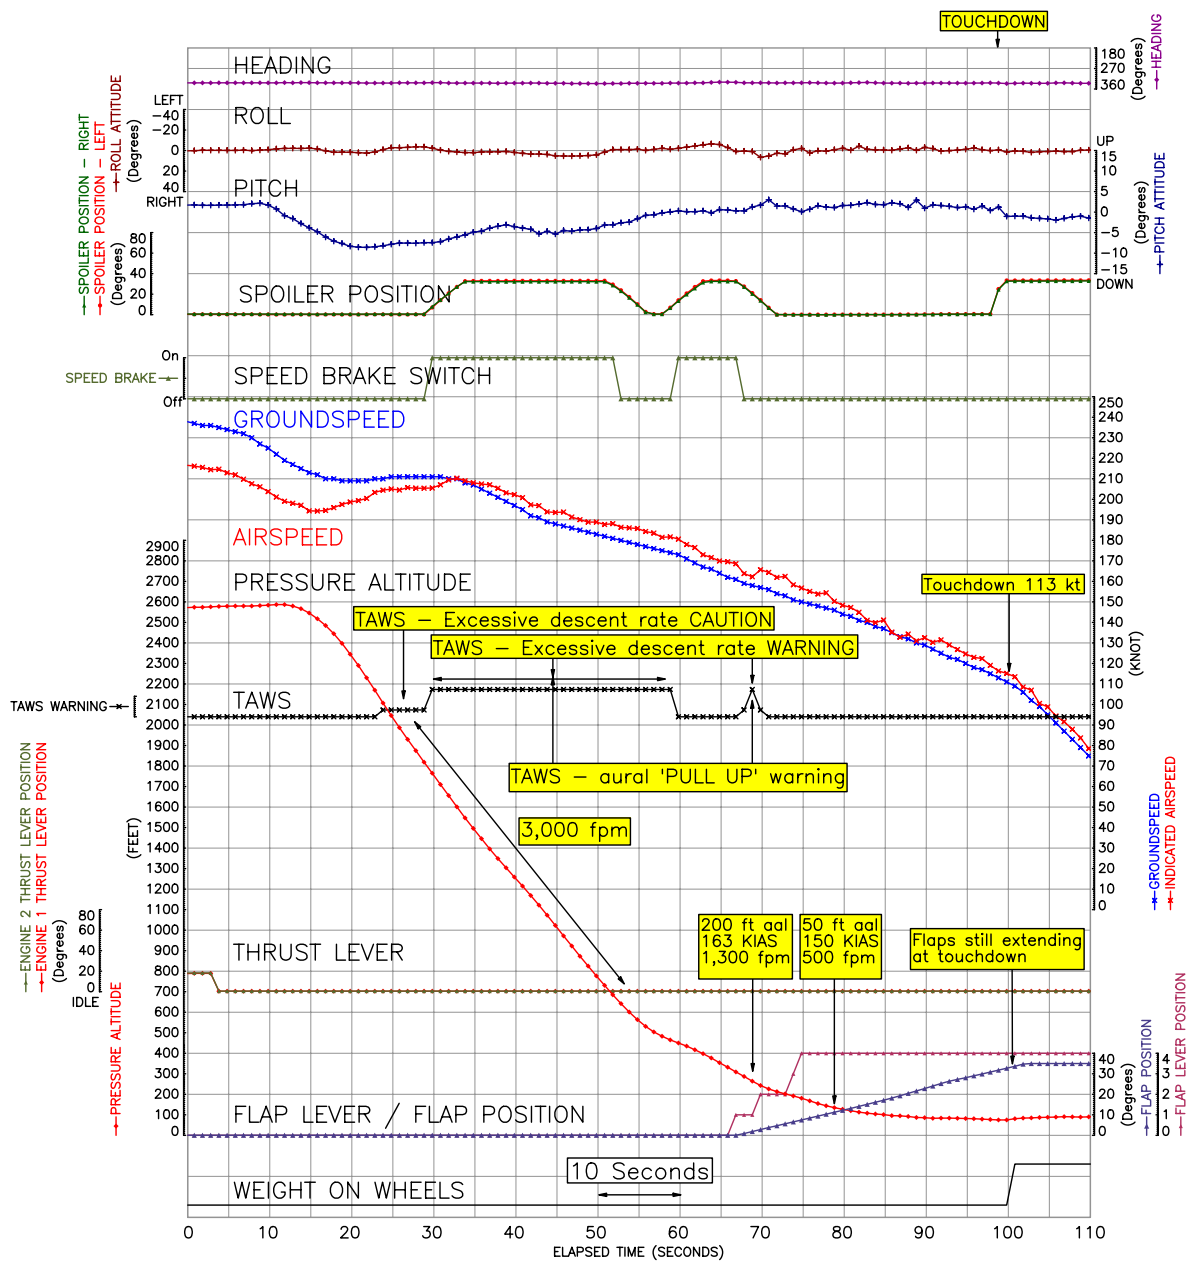
Twenty of the examined flights were flown by the pilot of the accident flight. On 18 April 2015 he had flown HZ-IBN from Riyadh to Jeddah King Abdulaziz International Airport, landing on Runway 34L which has a landing distance of 3,800 m available. Figure 8 presents the salient parameters for this landing. There were a number of similarities between this approach and that of the accident flight, with a high rate of descent, TAWS warnings and a speed of about 150 KIAS as the aircraft crossed the threshold at a height of about 30 ft. During this landing the flaps were still extending as the aircraft touched down. Another similar approach and landing was also identified; this had been flown by a different pilot landing at a different airport in Saudi Arabia. The operator stated that it was unaware of either of these events prior to the accident.

Pilot of HZ-IBN landing at Jeddah 18 April 2015

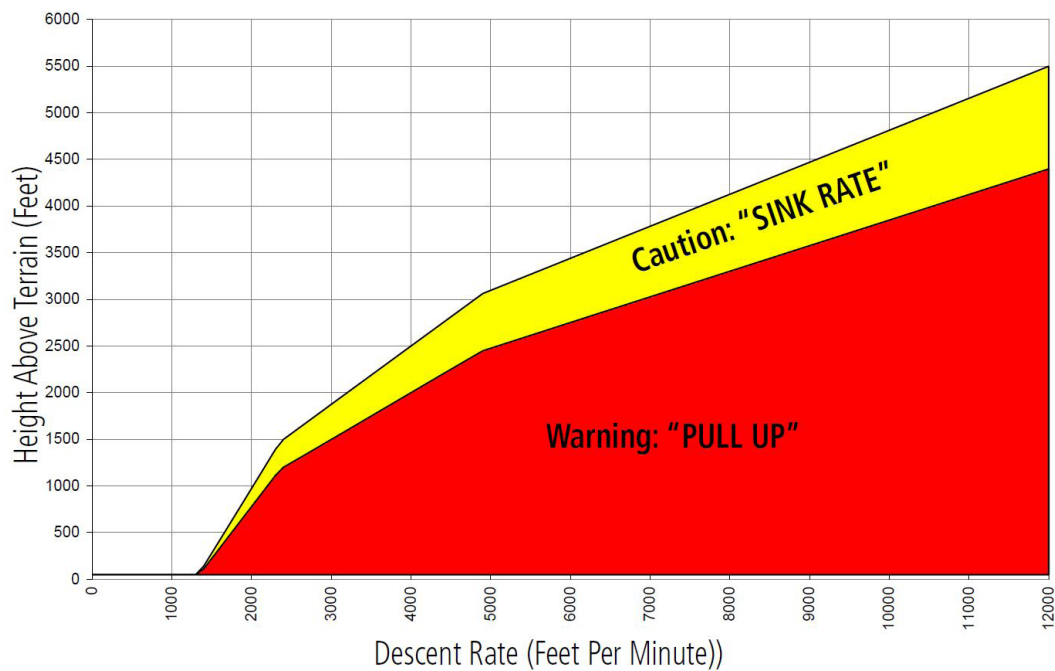
**Figure 10**

HZ-IBN was equipped with a TAWS. During the accident approach, the Excessive Descent Rate (EDR) warning was activated. This is intended to alert the pilot through both aural and visual means that the aircraft is descending towards terrain at an excessive rate<sup>7</sup>. Figure 10 provides the EDR caution and warning envelopes. If the caution envelope is entered, an aural alert of "SINK RATE" is provided in the cockpit and visual captions of TERRAIN and SINK RATE appear on the PFD's and MFD respectively. If the warning envelope is entered, an aural alert of "WHOOH WHOOP PULL UP" is provided in the cockpit with visual captions of PULL UP displayed on the PFD's and MFD. If the aircraft transitions quickly from no alert, through the caution and into the warning envelope, the warning alert is given priority and the caution alert is suppressed.

TAWS Excessive Descent Rate caution and warning envelopes

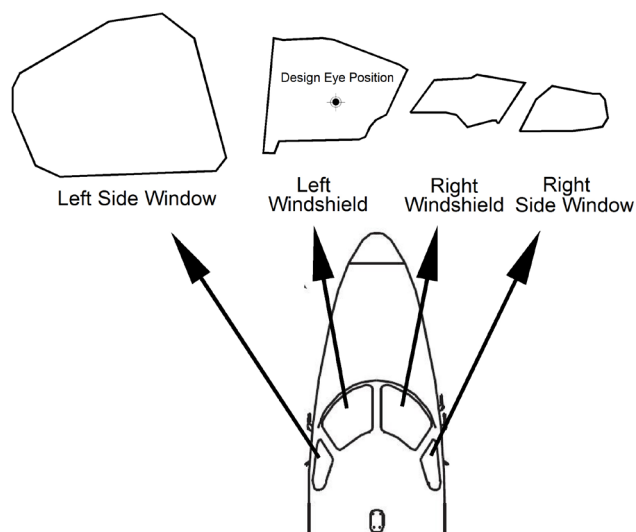
**Figure 17**

Figure 17 presents the perspective shape of the cockpit windows as observed from the left seat DERP. The following figures show the results of a perspective view analysis, taking account of the attitude of HZ-IBN and the positions of HZ-IBN, the microlight, and the light aircraft derived from radar. The angular size of the microlight and light aircraft is not represented in the figures; they are shown as points. Figure 18 provides the perspective view of the microlight as HZ-IBN approaches at 1406:54 hrs until just before it passes ahead at 1407:18 hrs; each position annotated is an average of 3 seconds apart with position 4 and 6 identifying when the TCAS TA and RA 'DESCEND' alert occurred. Figure 19 provides the perspective view of the light aircraft as HZ-IBN approached it between 1407:18 hrs and 1407:43 hrs; each position is 5 seconds apart with position 3 and 4 identifying when the RA 'ADJUST VERTICAL SPEED' occurred.

Perspective view of cockpit windows viewed from left seat design eye position
