Rail Accident Investigation Branch

Rail Accident Report

**Derailment and fire involving a tanker train at
Llangennech, Carmarthenshire
26 August 2020**

Report 01/2022
January 2022

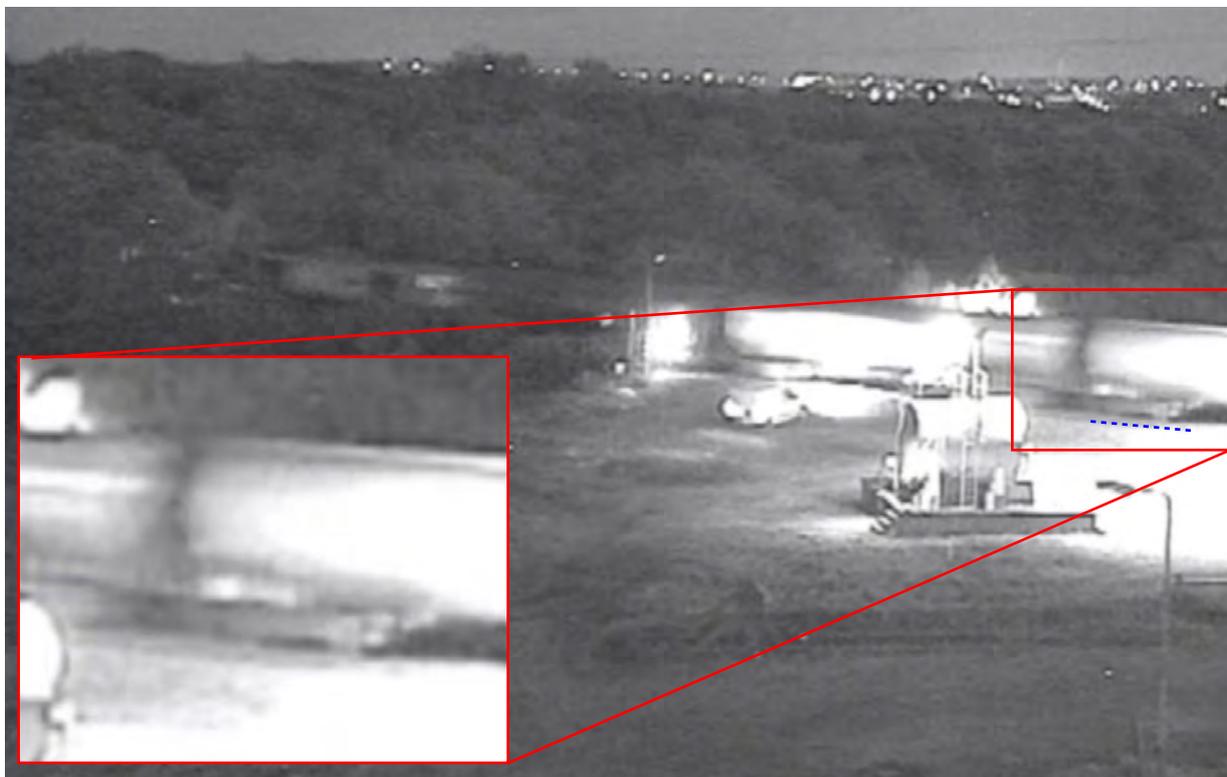
Figure 5: CCTV image of train 6A11 and (inset image) wagon GERS 89005 leaving Robeston depot

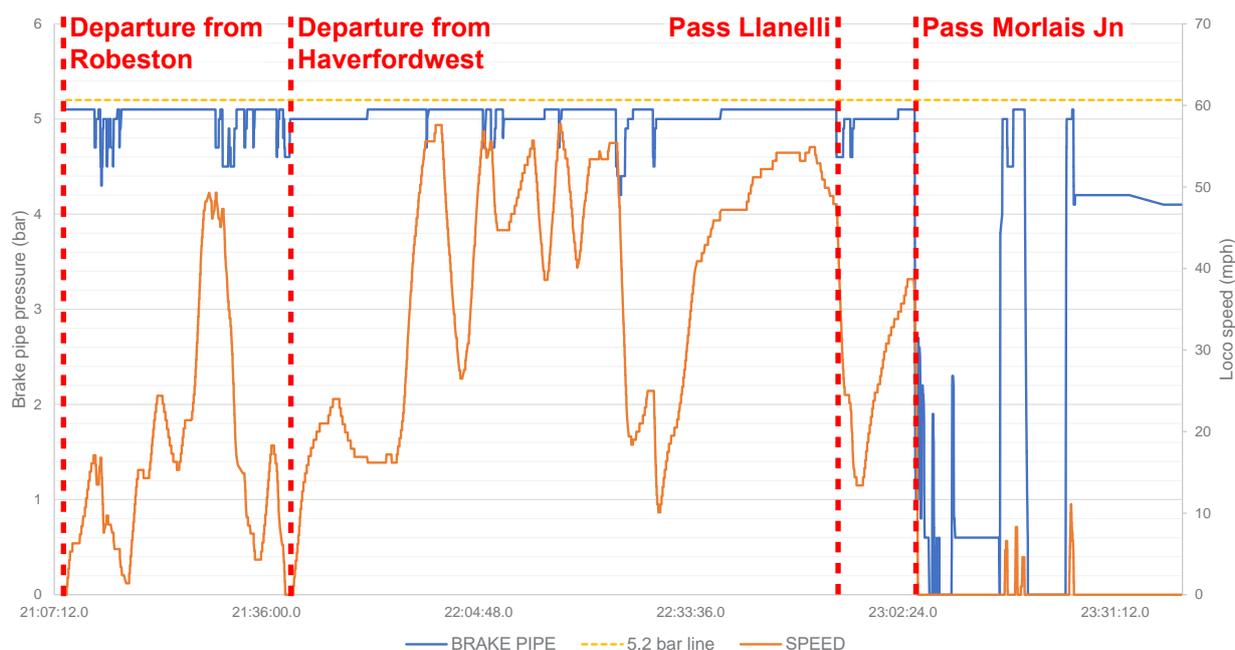
Figure 8: Data recorded by the on-train data recorder (OTDR) fitted to the locomotive of train 6A11 for the journey from Robeston to Morlais Junction, including the brake pipe pressure (blue solid line), 5.2 bar pressure line (yellow dotted line), speed (orange solid line) and locations en route

- 35 The train driver reported that he was unaware of any problem with his train until an un-commanded brake application occurred in the vicinity of Morlais Junction.

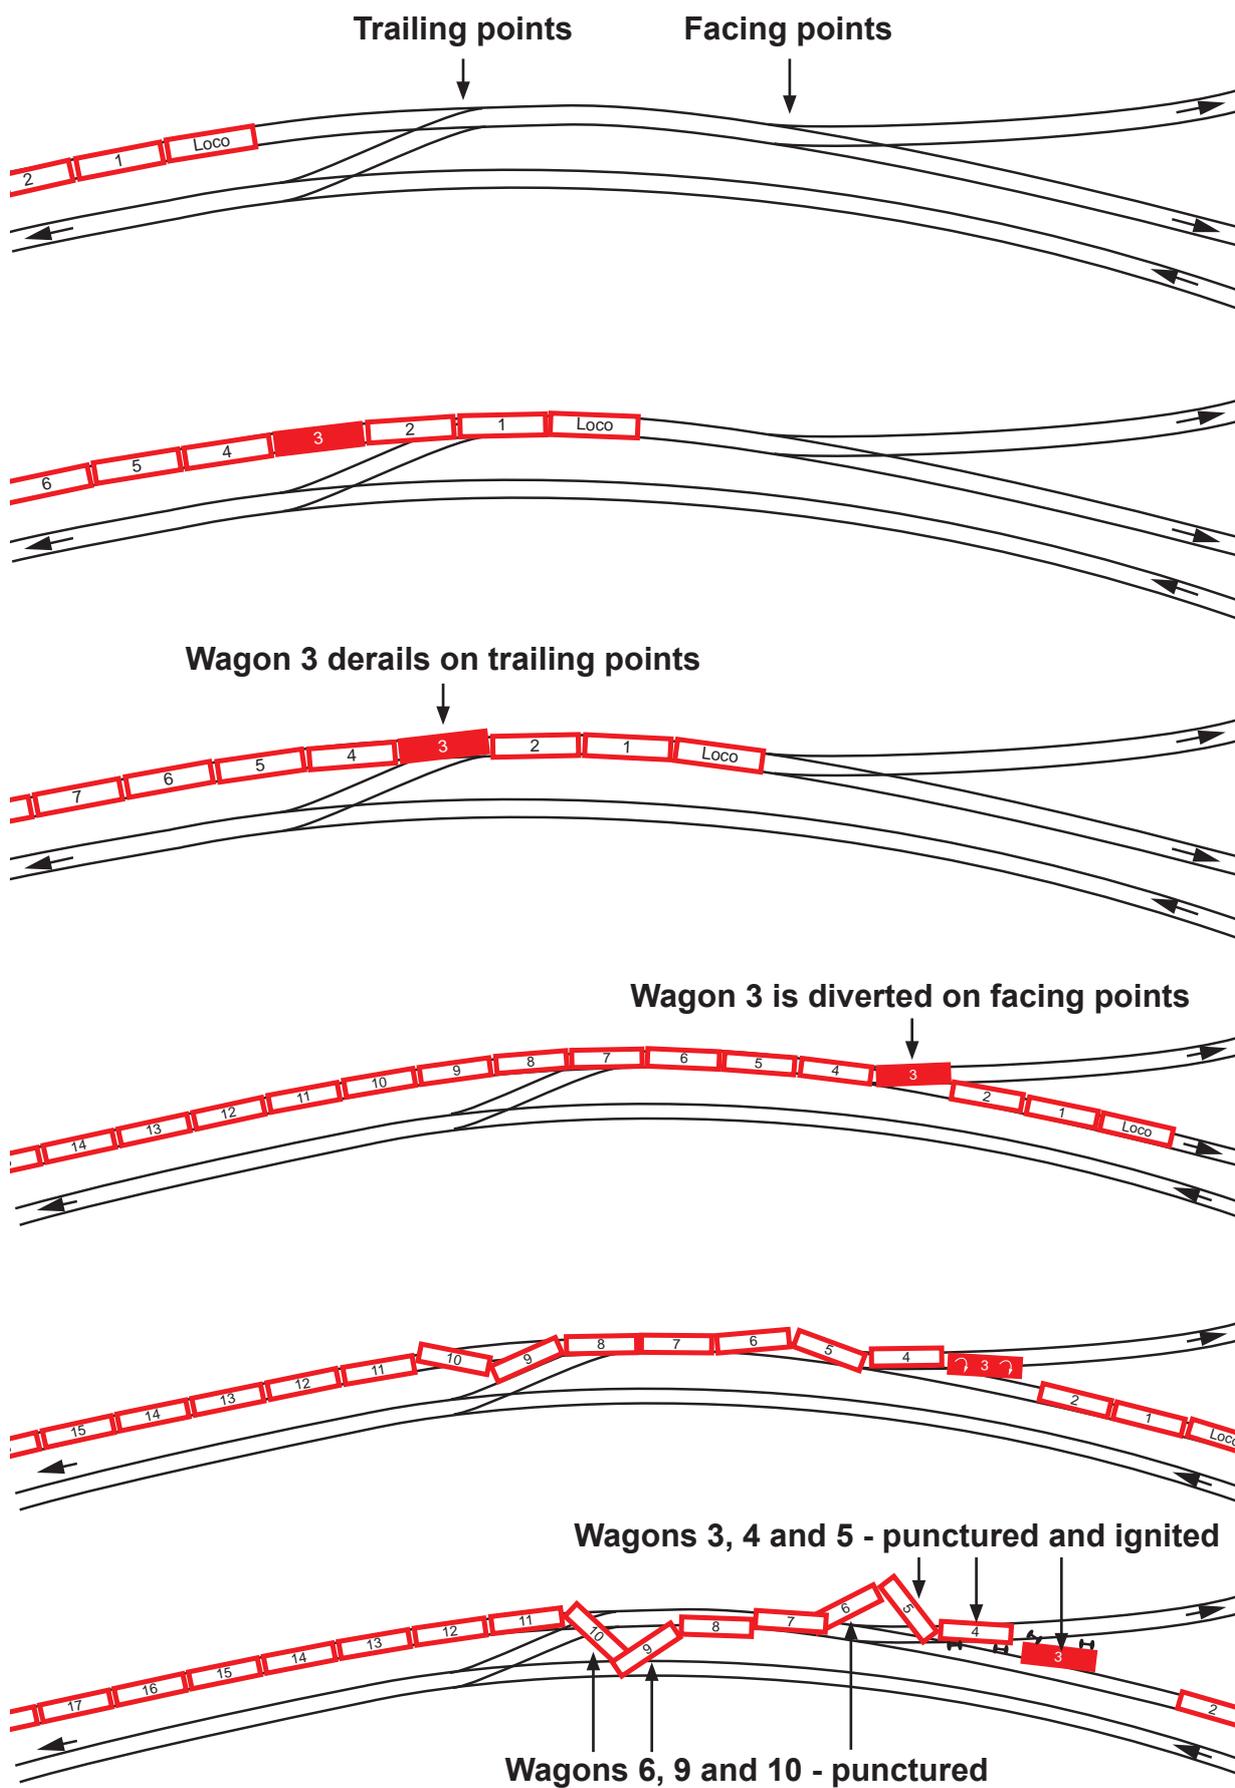
- 56 The point of derailment was identified from track marks and damage as being near the open end (the toe) of the switch rails of points 997A, which form part of a trailing crossover at Morlais Junction. As the third wagon traversed the trailing points, the false flange on the right-hand leading wheel rode along the inner face of the stock rail and caused the rail to rotate outwards towards the six-foot. The right-hand wheel then travelled along the web of the rail until it reached a fishplate, at which point the left-hand wheel climbed over the left-hand rail (figures 15 to 17).

Figure 15: Diagram (from top to bottom) showing the likely sequence of the train derailment

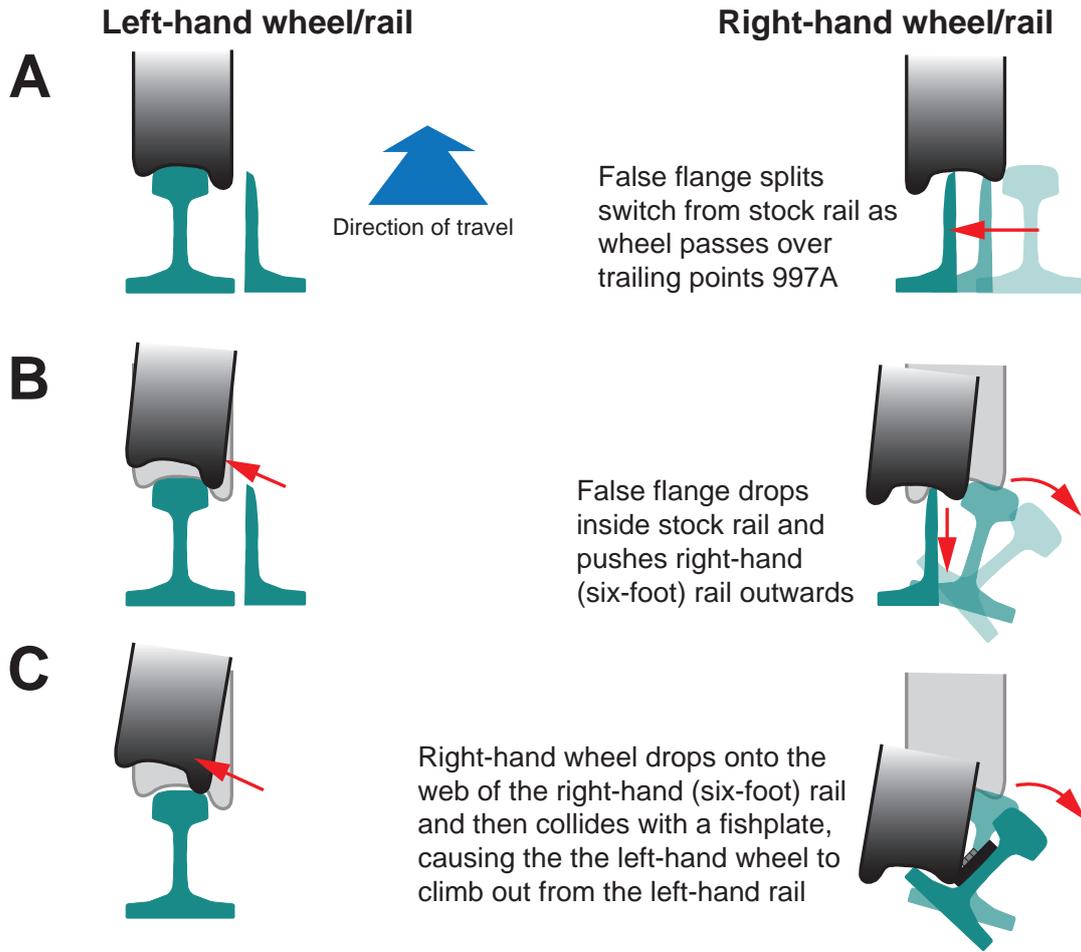
- 57 The wagon then ran with its leading wheelset derailed to the left for around 175 metres until it met the facing turnout, where it was guided to the left along the Central Wales line.

- 58 Marks on the track showed that the derailed wheelset travelled approximately 8 metres along the Central Wales line until the third wagon began to tip over, and the coupling between the second and third wagons broke. This caused the train brakes to apply, resulting in the train driver becoming aware of the derailment. Damage to the track caused by the derailed third wagon caused the derailment of the following wagons (figures 18 and 19).

Figure 16: Diagram showing the sequence of the derailment of wagon GERS 89005

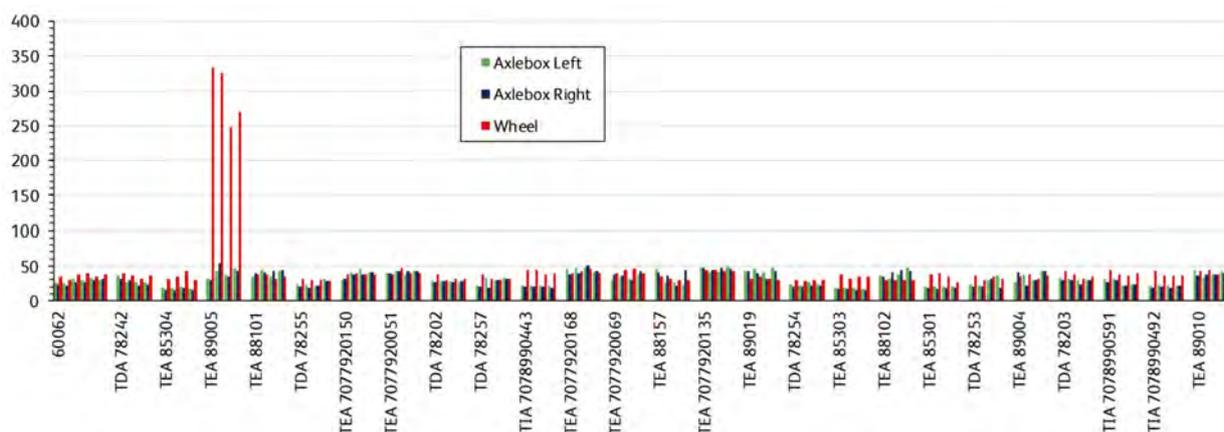
- 141 The data from the Pembrey HABD site shows temperatures that were measured as each wheel passed (figures 27 and 28). The contact point between the rail and leading wheelset recorded 334 °C, the second wheelset recorded 326 °C, and the wheelsets on the rear bogie recorded 248 °C and 270 °C. The data shows that, although all wheels registered a high temperature, there is a different temperature pattern for the leading wheel as compared to the other wheels on wagon GERS 89005 (figures 29 and 30).

Figure 28: HABD data for train 6A11 showing temperatures recorded for all wagons

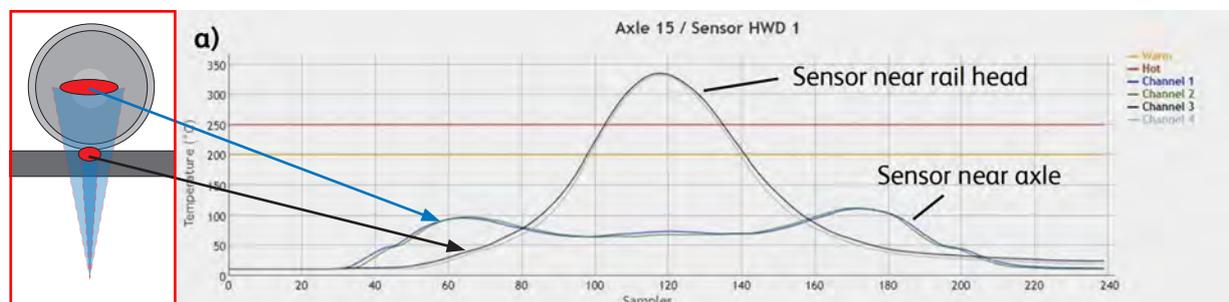
Figure 29: Diagram (left) showing the locations of the HABD sensors in relation to measurements taken from the axle box area of a wagon (shown as channels 1 and 2) and contact point between a wheel and the rail (channels 3 and 4). The graph (right) shows the temperature curves for the locked wheel of train 6A11 (Diagrams courtesy of Network Rail)
