# Rail Accident Investigation: Interim Report

**Collision between passenger trains at Salisbury  
Tunnel Junction  
31 October 2021**

Report IR1/2022  
February 2022

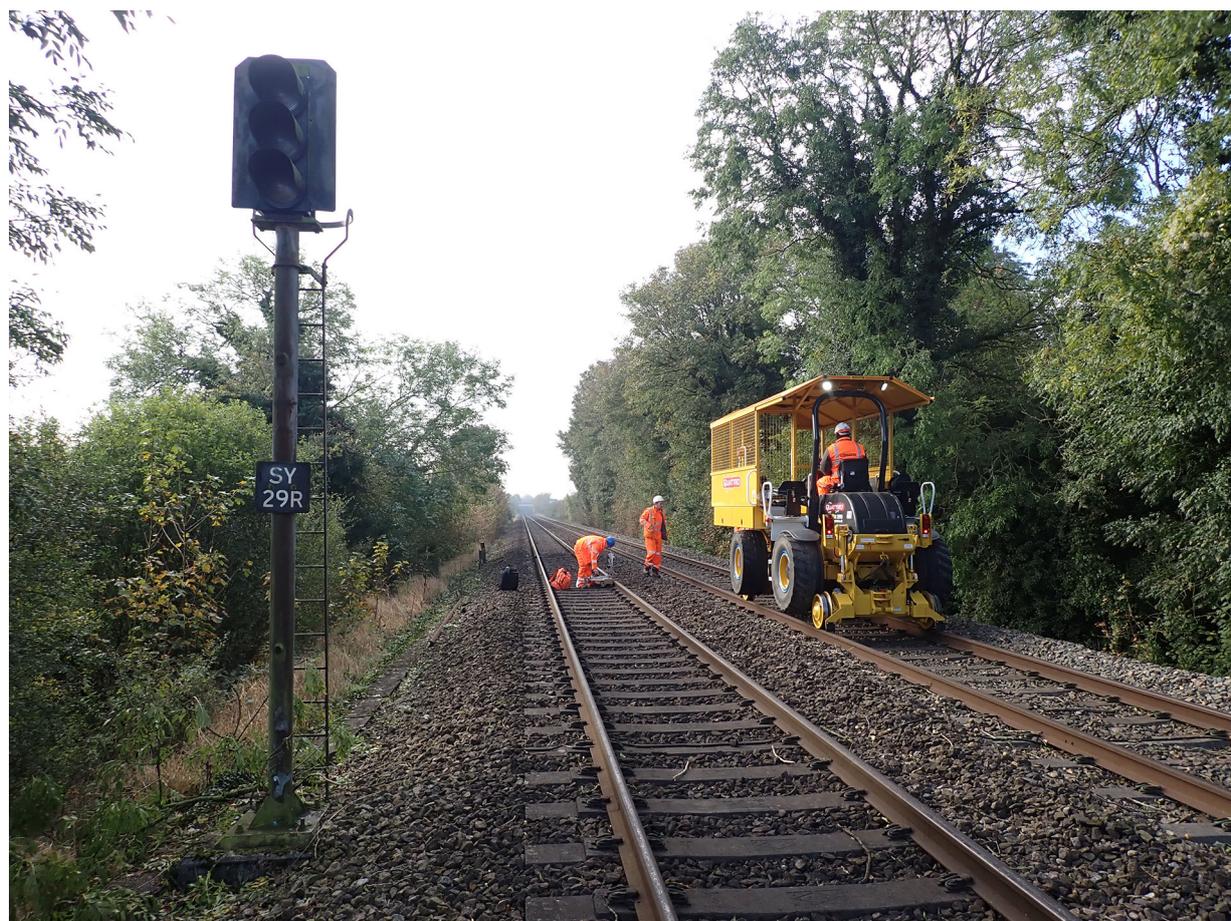
Figure 7: The railway at signal SY29R, looking towards Salisbury

- 36 The railhead was found to be contaminated throughout the areas surveyed with a black deposit. This deposit consisted of leaf material which had been crushed under the wheels of passing trains and which is often associated with low adhesion conditions. Analysis showed that many areas had a medium or heavy level of contamination, and that the thickness of the leaf deposit was relatively consistent through each of the areas surveyed. It is likely that the rails were wet at the time of the accident. Wet values of the coefficient of friction measured as part of the post-accident survey were found to be between 0.2 and 0.02, suggesting that there was low friction between the wheels and the railhead. The average rate of deceleration of train 1L53 suggests adhesion levels closer to the 0.02 value were prevalent at the time of the accident. Samples taken from the area around signal SY29 and between there and the junction showed that the deposits were smeared and flaky and typical of the sort of contamination layers which exist after train wheels have slid over them.
