Rail Accident Report

**Derailment of a passenger train at Carmont,
Aberdeenshire
12 August 2020**

Report 02/2022
v2 January 2024

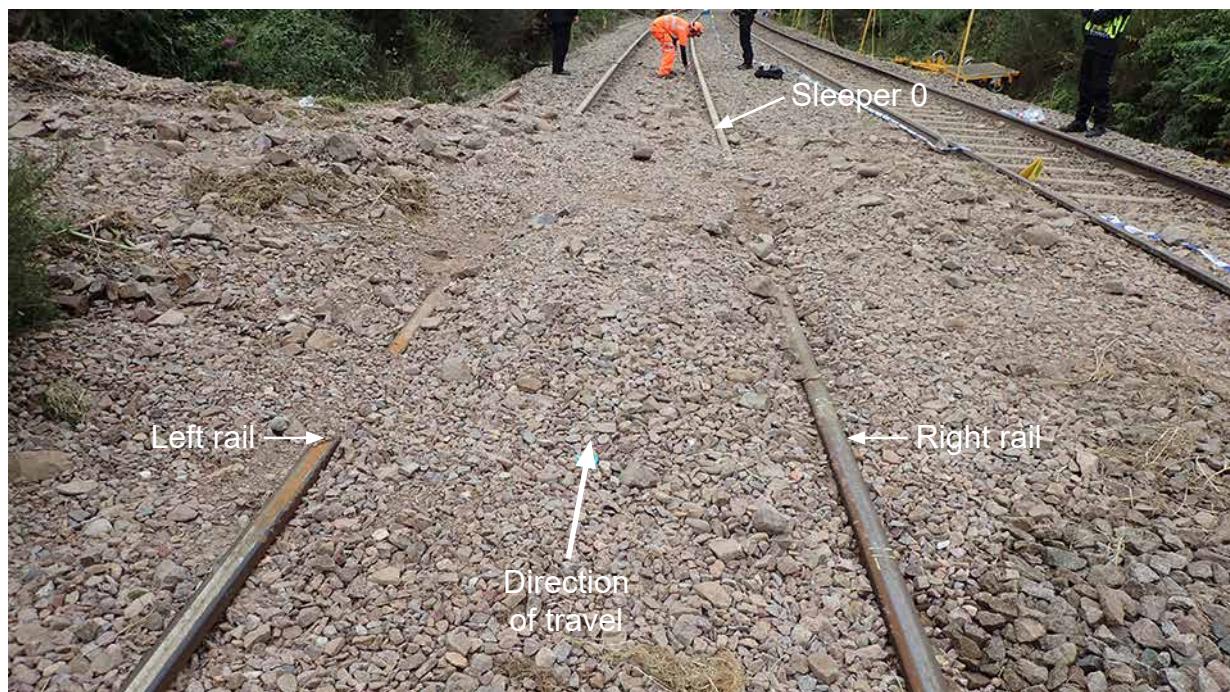
- S4 Train 1T08 derailed because it struck debris washed out from a 15 metre length of steeply sloping drainage trench. This is evidenced by CCTV images from the train, grooves cut through the debris, the absence of derailment marks on the track on the approach to the debris and marks indicating that the leading wheelset had derailed immediately after the debris field.
- S5 The debris mainly comprised gravel with some cobbles and covered the down line for a length of about 10 metres. Estimates made by RAIB after the derailment indicate the maximum depth of debris on the left and right railheads was probably around 170 mm and 135 mm respectively before the train ran through it.

Washout debris covering the track

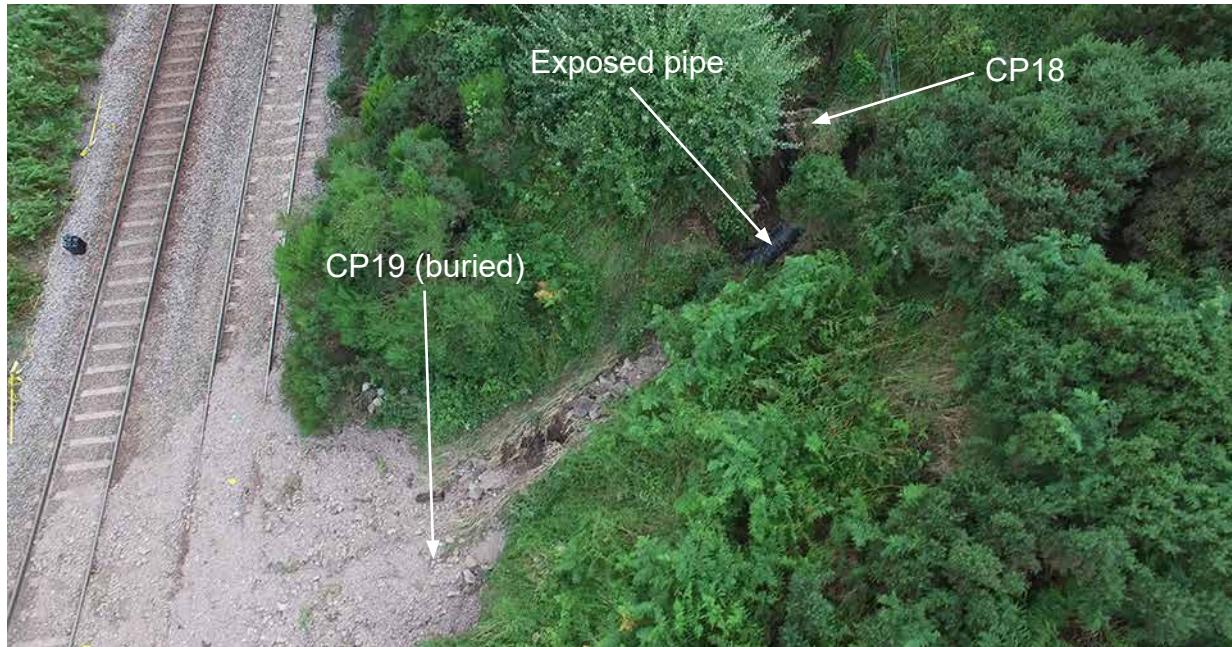
The washout (locations marked 'CP' are catchpits)

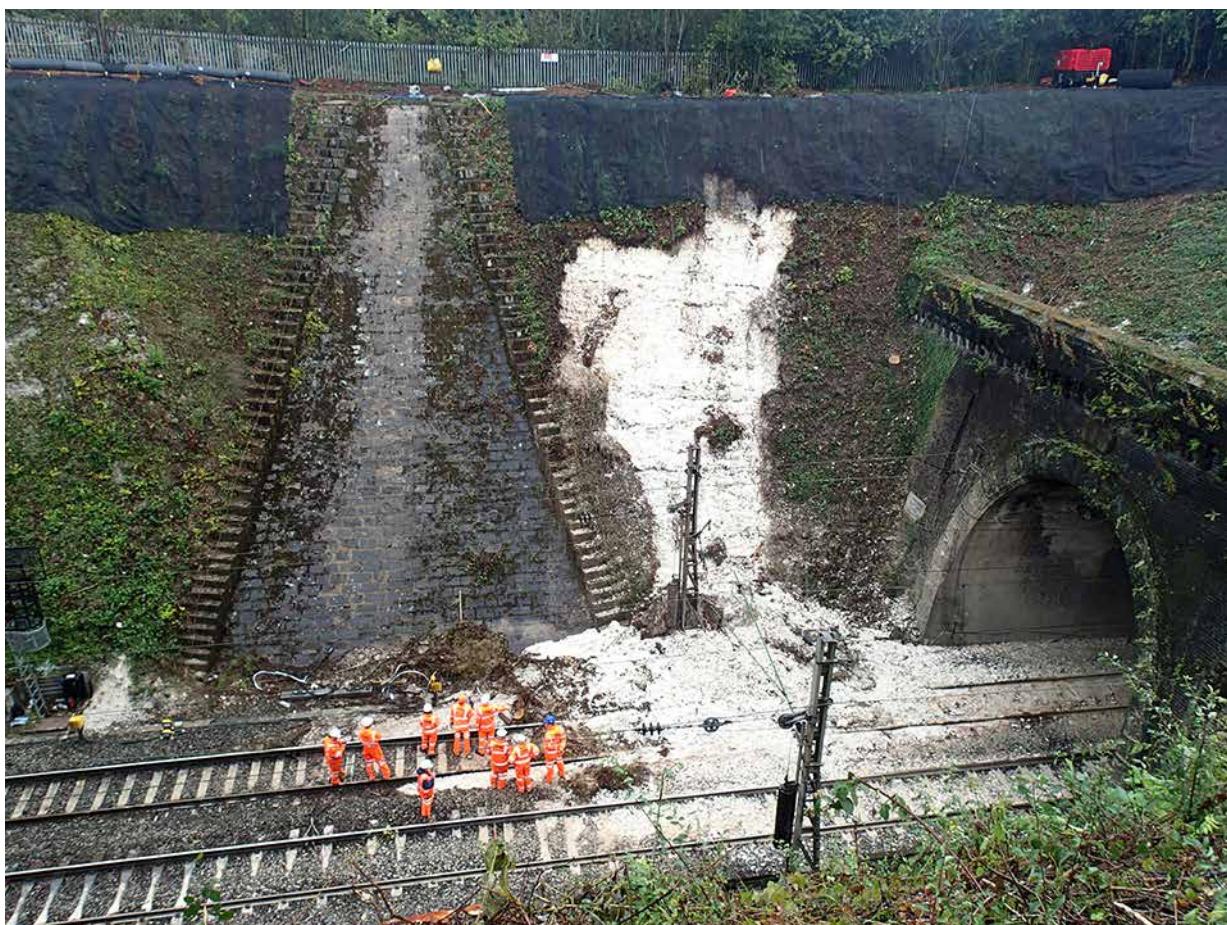
The landslip at Watford tunnel, September 2016

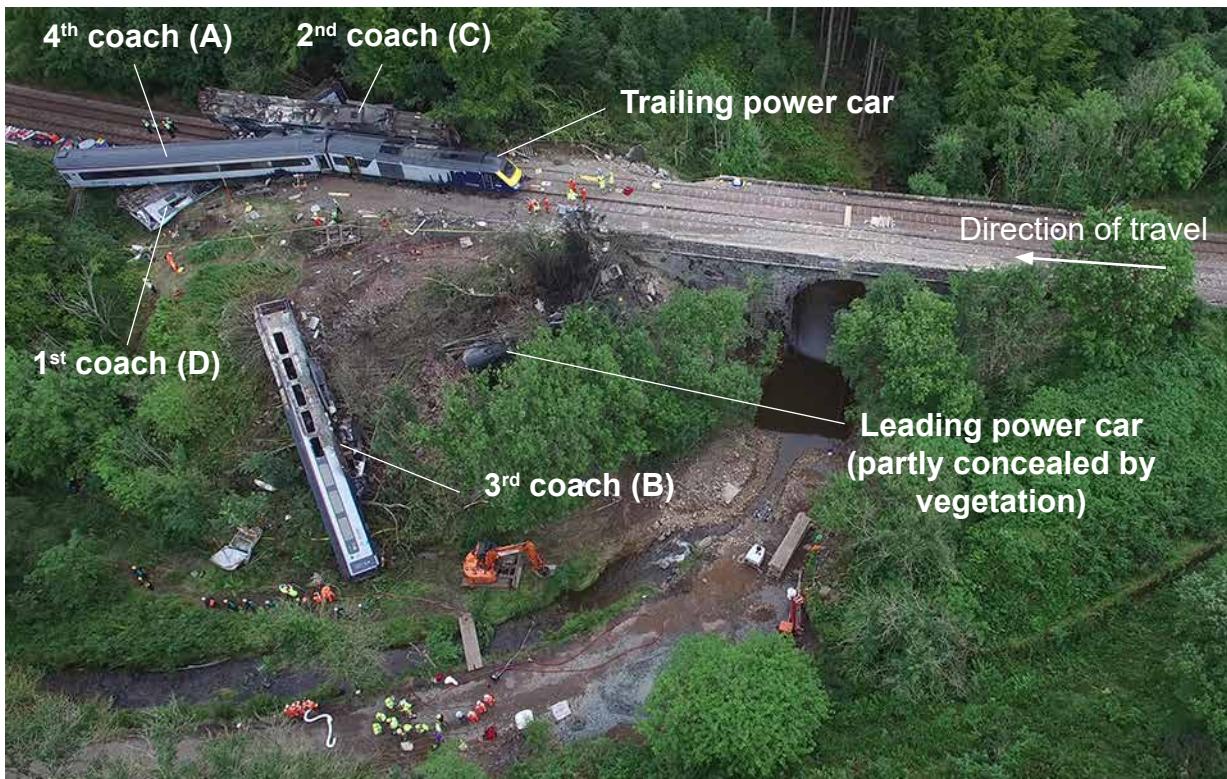
The derailed train

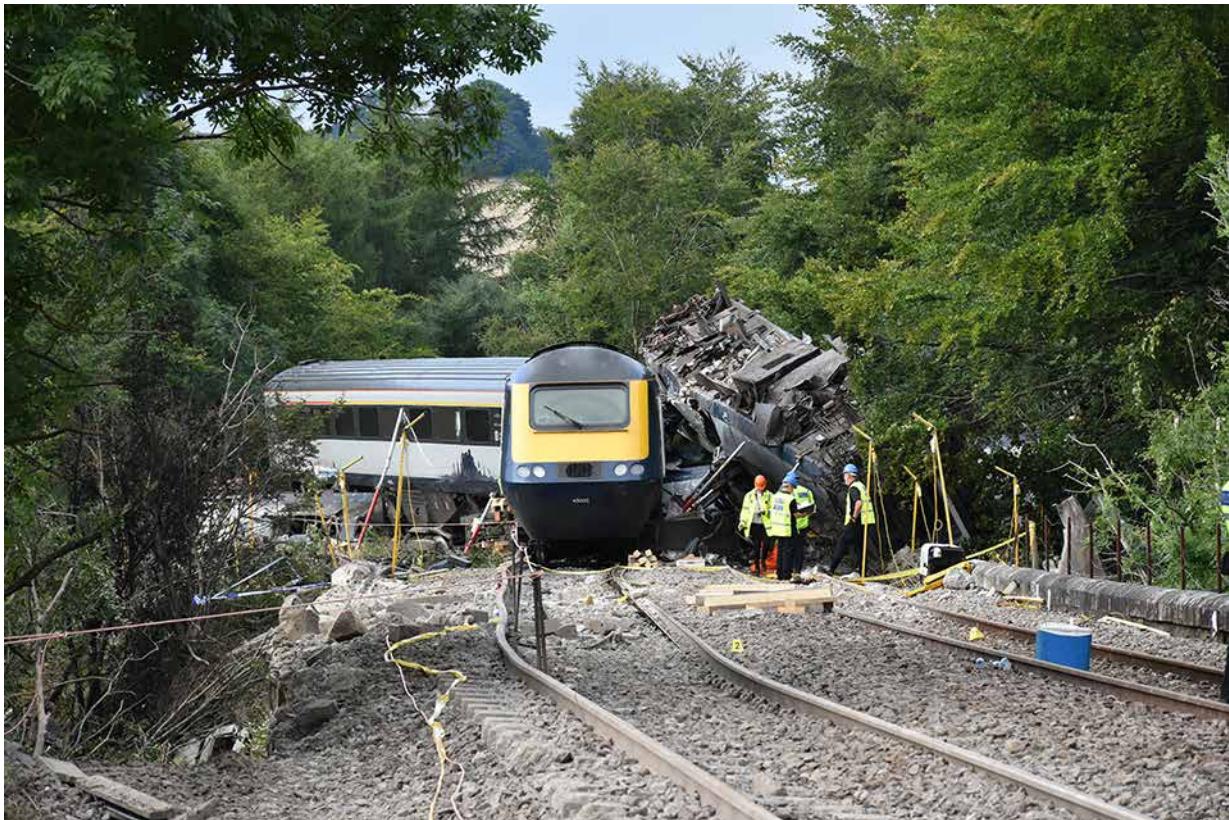
- 5 At around 09:37 hrs on Wednesday 12 August 2020, a passenger train collided with debris washed from a drain onto the track near Carmont, Aberdeenshire, following heavy rainfall (figure 1). The train (*train reporting number 1T08*) was the 06:38 hrs service from Aberdeen to Glasgow which was returning towards Aberdeen because the line to the south was blocked by a landslip.
- 6 The collision caused the train to derail and deviate to the left, before striking a bridge *parapet* which caused the vehicles to scatter. Three people died as a result of the accident: the driver, the *conductor* and a passenger. The other six people on the train were injured. There was catastrophic damage to the train, and significant damage to railway infrastructure (figure 2).

Figure 2: The aftermath of the accident (image taken on 13 August 2020)

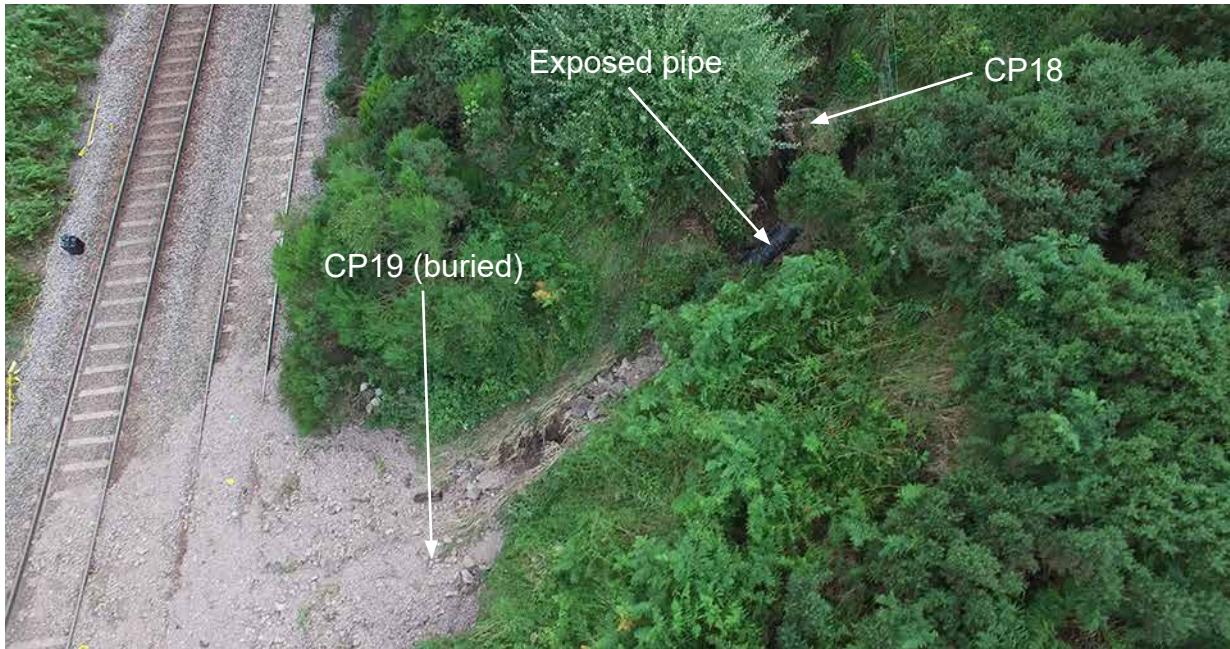
Figure 4: Washout debris on the track

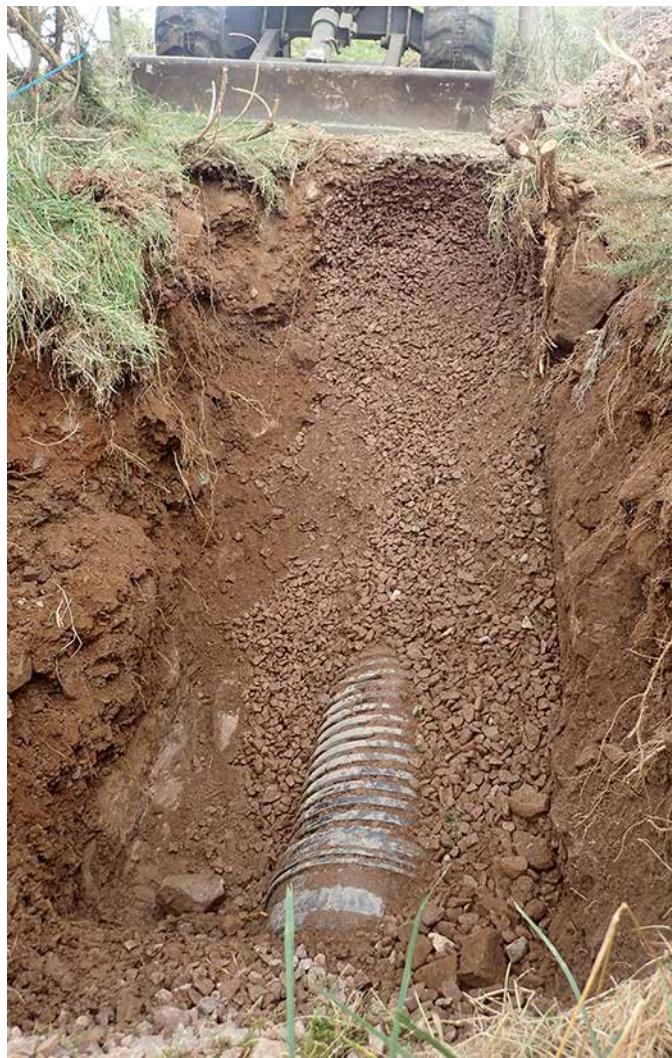
Figure 8: Gravel-filled drain close to washed out areas as exposed during post-accident excavations

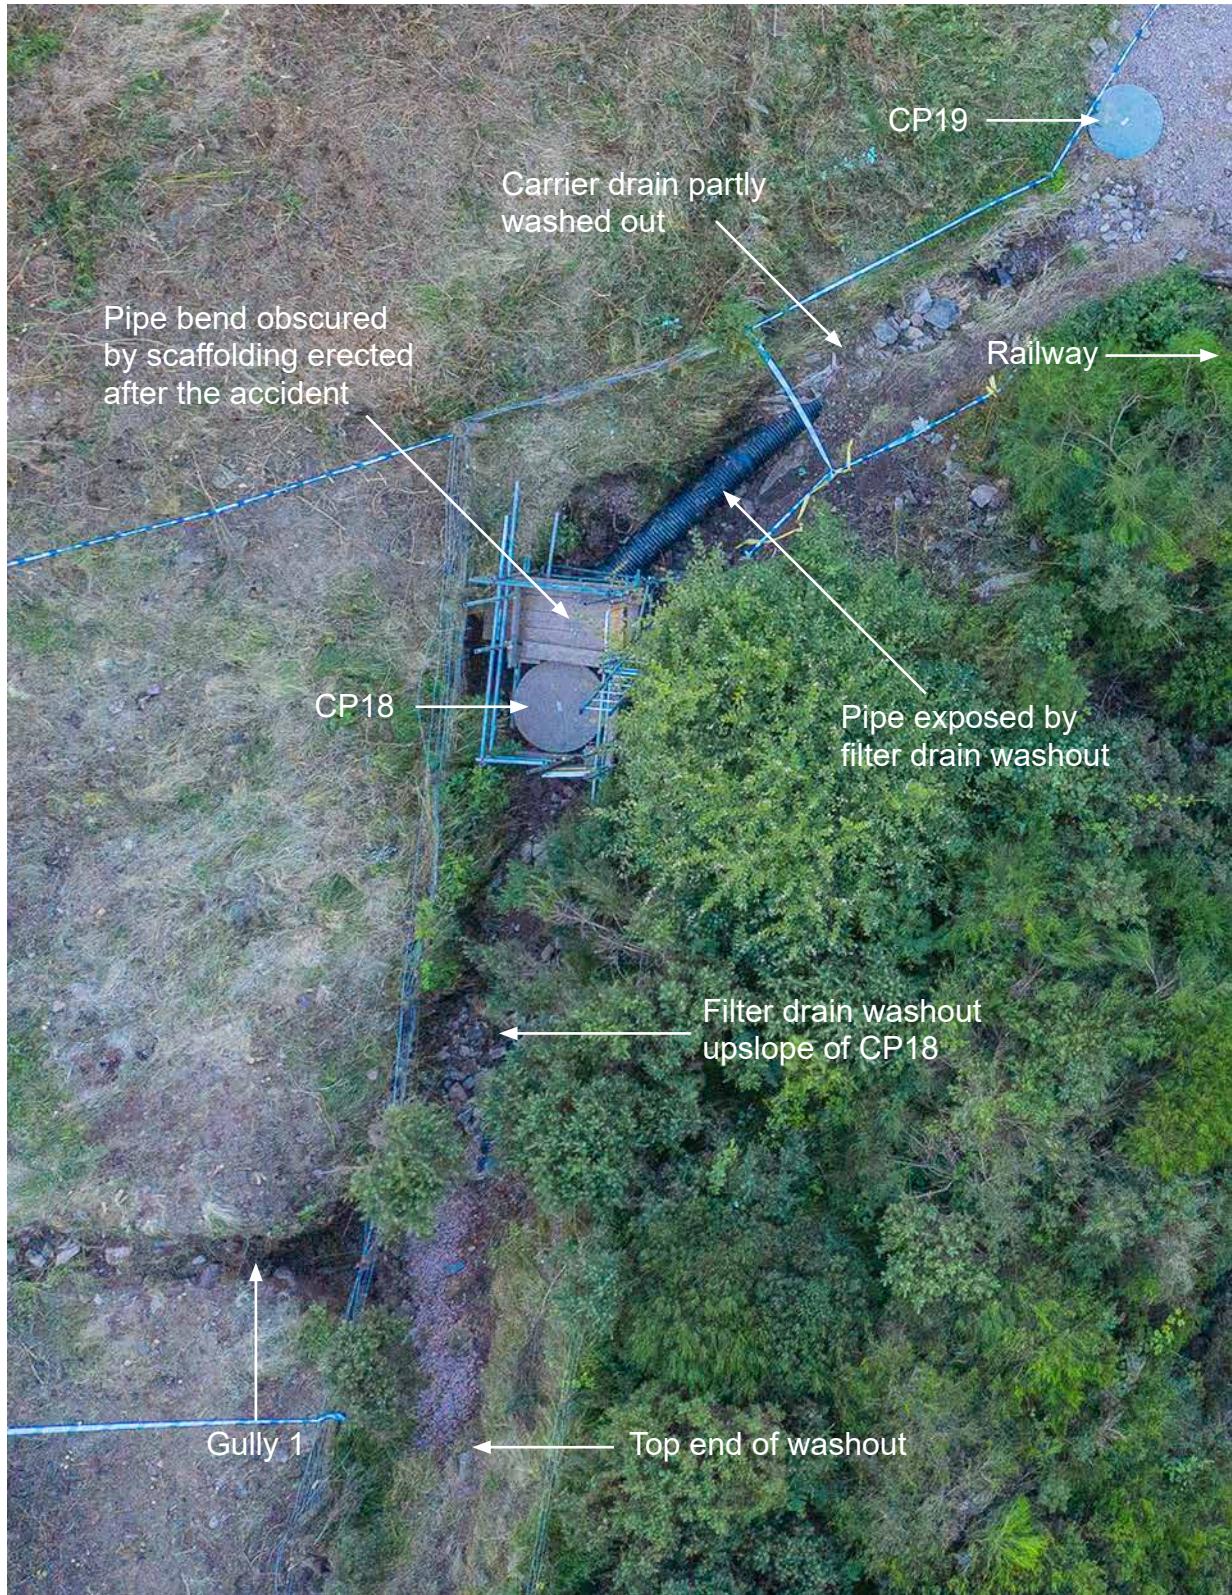
Figure 17: Aerial view of CP18 showing extent of washout (Scan Station/Network Rail)

- The gravel-filled 2011/12 drain had washed out for a distance of about 9 metres upslope of CP18 and for the full 6 metre length of gravel-filled drain downslope of this catchpit. Most of the material surrounding the carrier drain upslope of CP19 had remained in place. The drainage pipe in the bottom of the trench was partly exposed but was undamaged and continued to carry water (figures 17, 18 and 30).

- f) The top end of the washout of the 2011/12 drain was about 2 metres upstream of the point where gully 1 met this drain (figure 17), and there was no evidence of the drain being damaged by water flows above this point. Limited regression upstream of gully 1 would be expected as the gravel would not be stable with a vertical face, and eddying of inflowing water would cause some erosion just upstream of the point of entry into the drain.

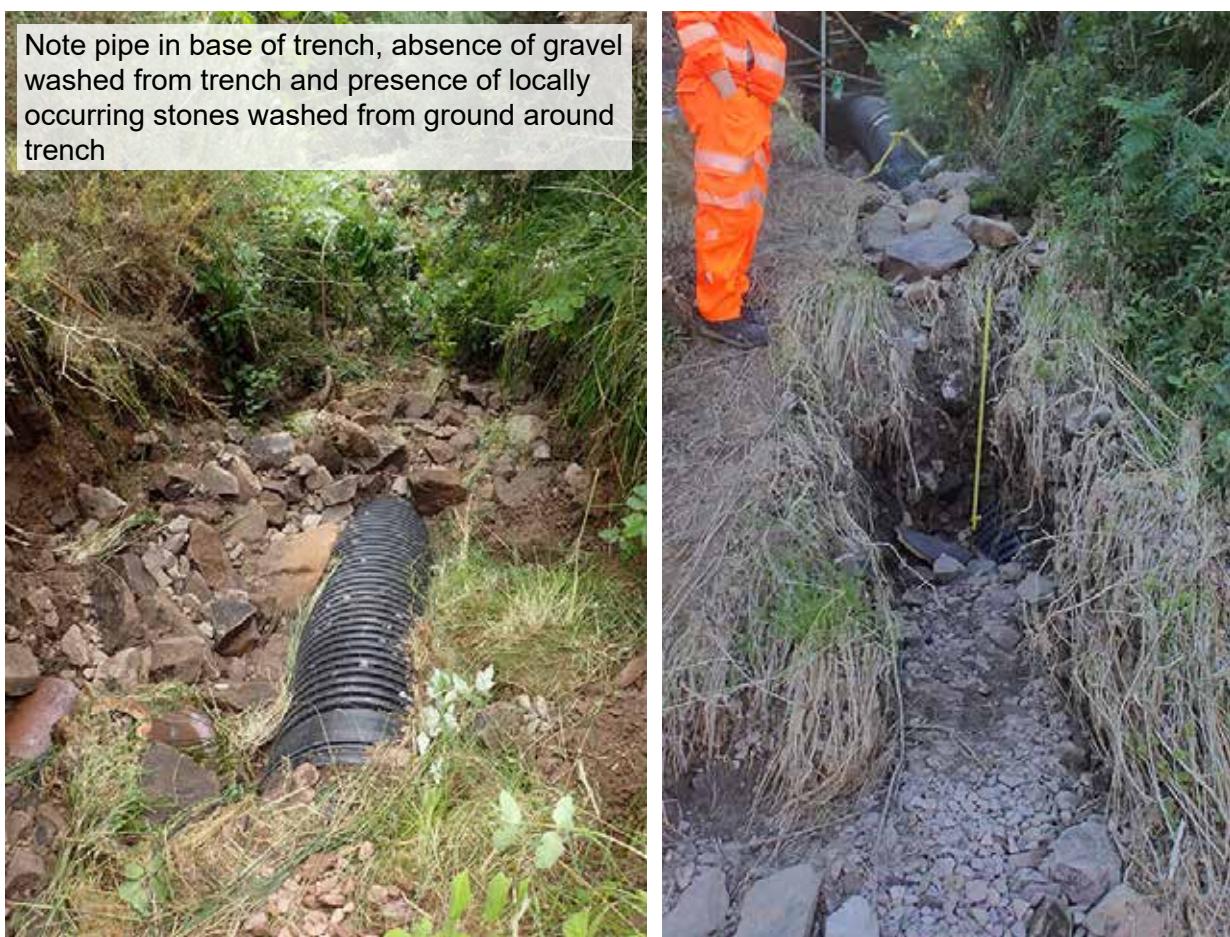
Figure 18: Washout upslope of CP18 (left image) and partial washout downslope of CP18, both images facing towards CP18

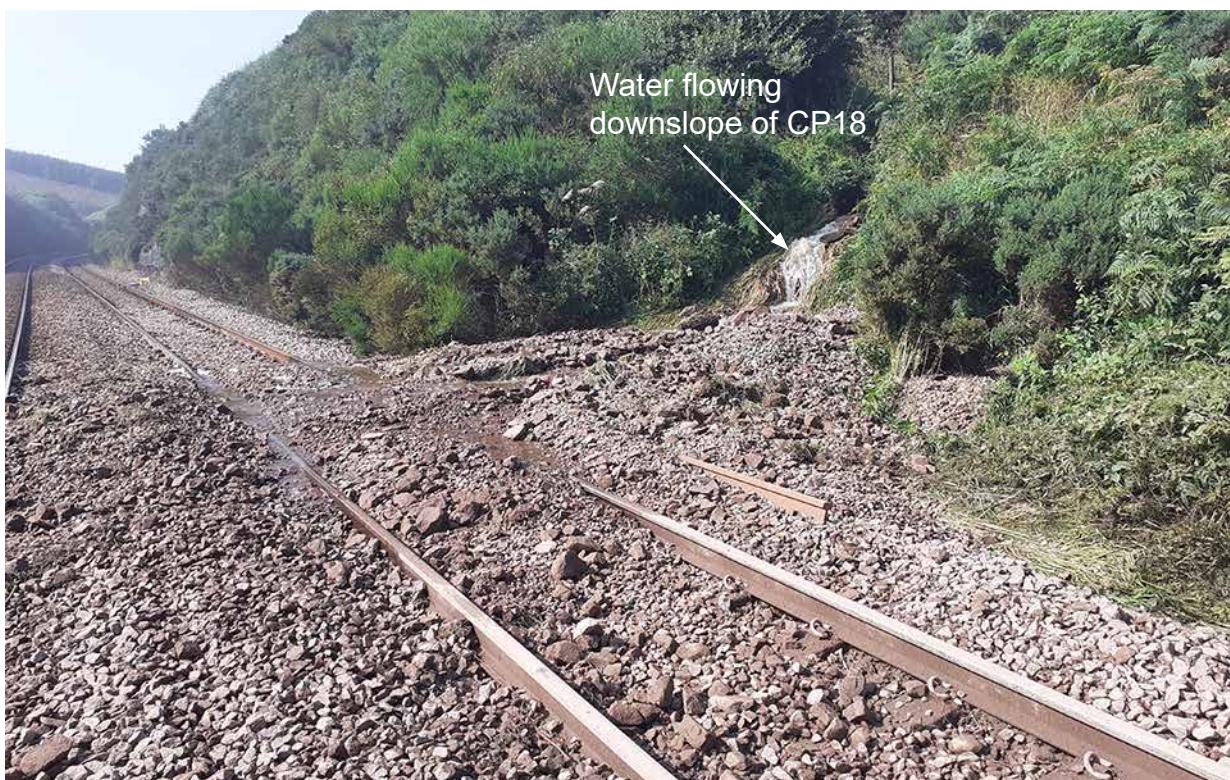
- 59 In the area of bridge 325, north of Carmont signal box, heavy rain between 05:50 hrs and 09:00 hrs on 12 August washed gravel from the 2011/12 drain (paragraph 25), together with stone and soil eroded from the ground on either side of the drain, onto the track. Most of the gravel was washed out from the drain trench for a distance of approximately 9 metres immediately upslope of CP18 and about 6 metres immediately downslope of this catchpit (figure 17 and figure 18). This, and stones from the surrounding ground, covered the down line between 220 miles 1610 yards and 220 miles 1621 yards (figure 19). The precise time at which this occurred is not known, but must have been between 07:07 hrs, when the last train before the accident passed this location (paragraph 50), and the arrival of train 1T08 at 09:37 hrs. Modelling indicates it was probably between 08:15 hrs and 09:00 hrs (appendix H).

Figure 19: Washout debris on the track approximately 55 minutes after the accident. A short length of scrap rail unrelated to the accident is also visible (Story Contracting)

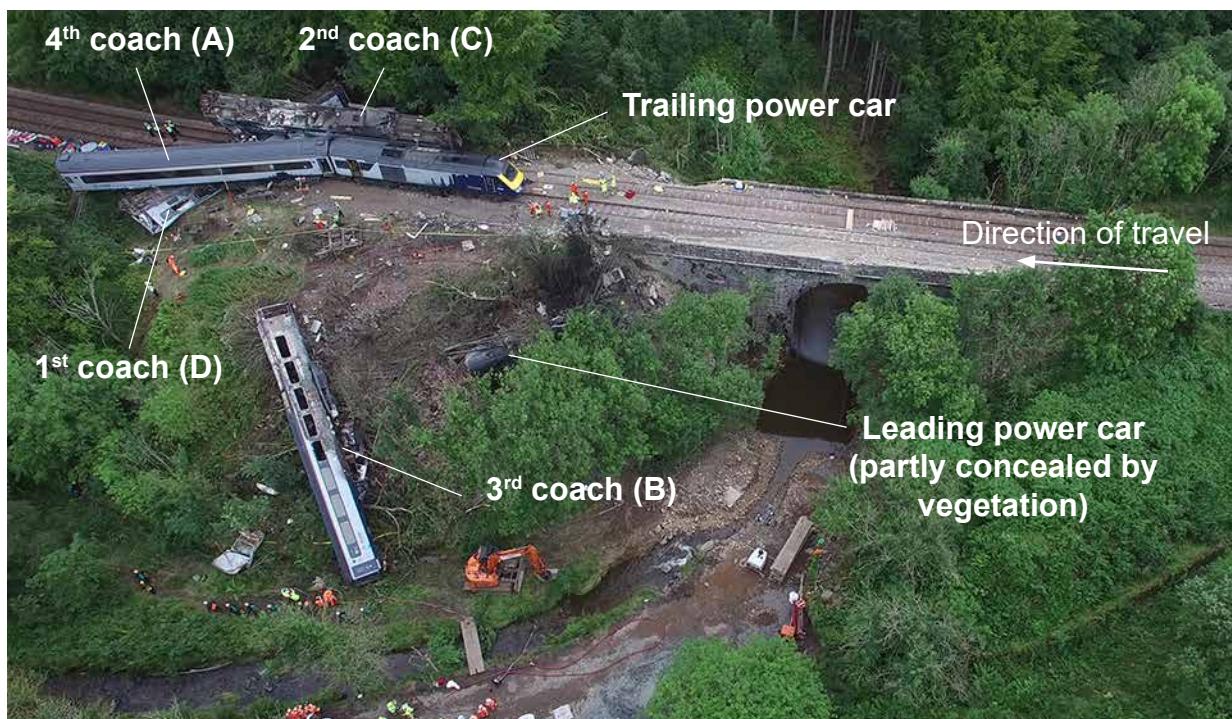
Figure 20: Derailed train

- 61 Three of the following five vehicles travelled in different directions beyond the bridge (figure 20). The first passenger coach (D) came to rest on its roof, almost at right angles to the track. The second passenger coach (C) came to rest overturned onto its roof with its trailing end on top of the first coach and facing the direction of travel. The third passenger coach (B) ran down the steep embankment to the left side of the railway, came to rest on its right-hand side and subsequently caught fire. The fourth passenger coach (A) remained upright and came to rest with its leading end on top of the first coach. The trailing power car remained upright on the down line, still coupled to the rear of the fourth coach. Its left-hand wheels were derailed and its right-hand wheels were resting on the right-hand rail which had rolled over to the right. The behaviour of the train in the derailment and the damage it sustained are described in more detail in paragraphs 453 to 469.

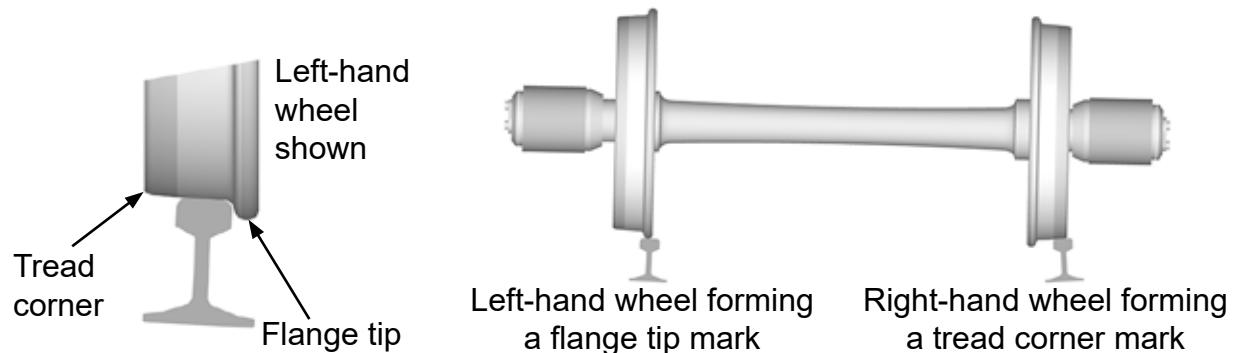
Figure 23: Wheel components and rail marks

- 75 The first indications of the point of derailment were faint flange tip marks on the head of the left-hand rail close to the northern limit of the debris (designated sleeper 0 during the post-accident examination of the track) and a *tread corner mark* on the right-hand rail at the same position. These marks and the subsequent anticlockwise yaw (rotated) attitude of the leading bogie (see paragraph 77) indicated that it was the leading wheelset that had derailed first. As the leading wheelset had run through the washout debris, its left-hand wheel had been lifted up by debris between the wheel and rail, and displaced to the left, such that its wheel flange was running on the railhead (figure 23).

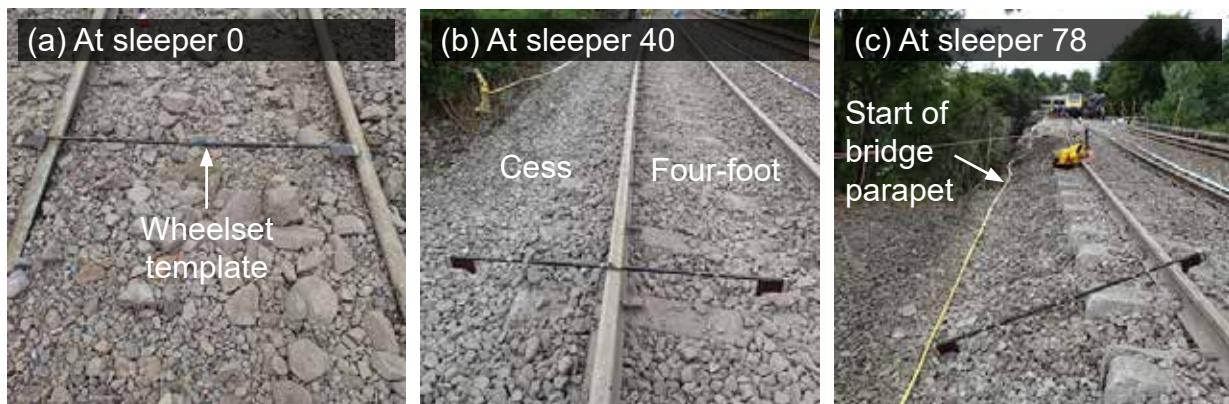
Figure 24: Position of leading wheelset (shown by wheelset template) from washout to bridge 325

- 76 The track was on a slight right-hand curve with a radius of about 1400 metres at the washout location, and the leading bogie should have been running almost straight. The displacement of the left-hand wheel was likely to have been caused by a combination of lateral forces on the wheel due to curving, the effects of running through deeper debris around the left-hand rail than the right-hand rail (tending to yaw the bogie left), and the small effect of rail curvature over the distance that the left-hand wheel flange traversed over the railhead. It is likely the right-hand wheel was also lifted as it ran through the debris. It then dropped into the *four-foot* just as the left-hand flange passed over the left-hand rail and dropped entirely off the rail and into the cess (figure 24a).

- 79 Observations of the derailed wheel paths in the ballast, showed the leading power car continued to drift further to the left as it approached the bridge, indicated by the position of the wheelset template (representing the leading wheelset) in figure 24b and 24c. From around sleeper 78 (approximately 55 metres beyond sleeper 0) and before the start of the bridge at sleeper 88 (approximately 61 metres beyond sleeper 0), the right-hand wheels of the leading bogie climbed over the left-hand rail and into the cess. The leading power car deviated even further to the left and subsequently came into collision with the end of the bridge parapet. Damage on the leading bogie indicates that the leading power car struck the bridge parapet slightly to the left of the vehicle centre line, which at that point had deviated between 2.0 and 2.4 metres from the centre line of the track.

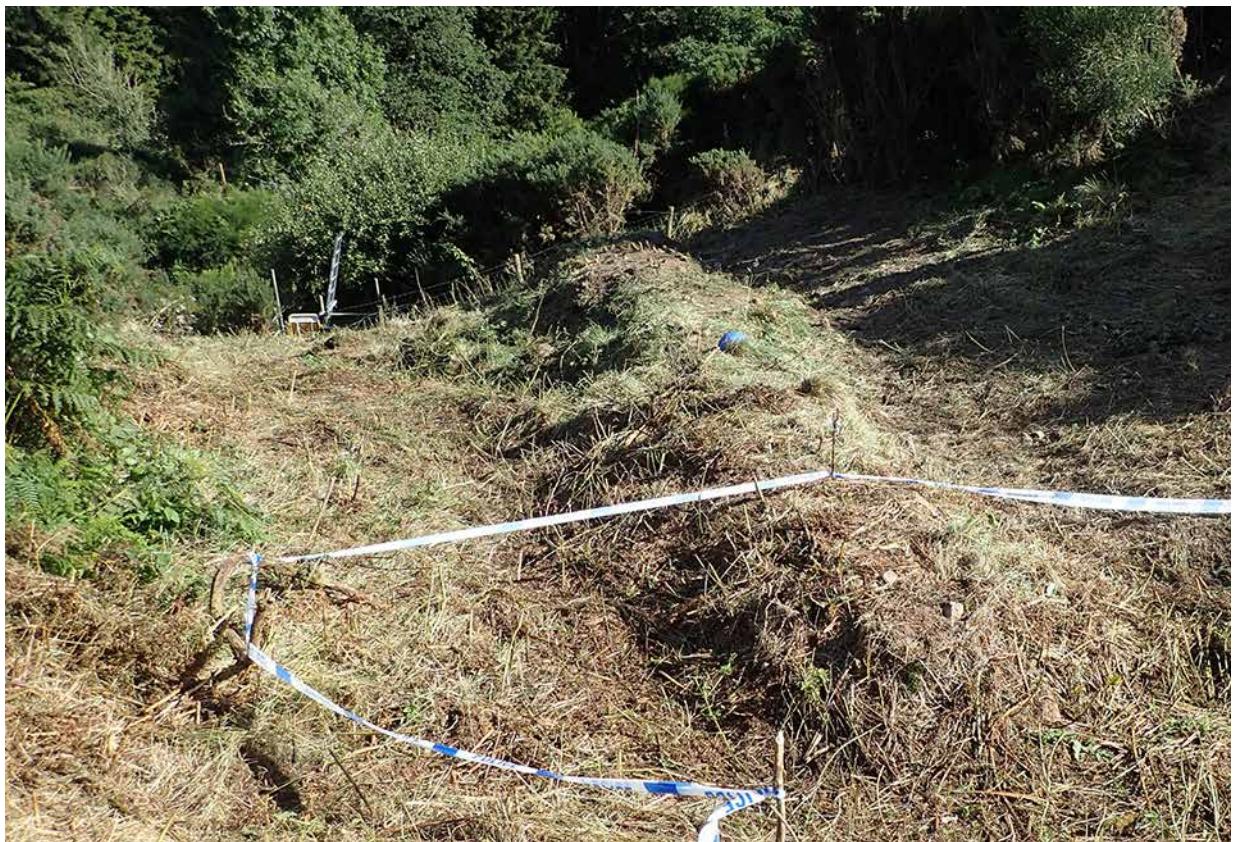
Figure 34: Bund viewed facing towards the 2011/12 drain post-accident after clearance of vegetation

- 98 A post-accident survey, conducted over several days as the gorse-cover was carefully removed from the funnel surface, located a bund (artificial ridge) which was almost certainly absent before the 2011/12 drain was constructed (figures 34, 35 and 36). This bund intercepted most water flowing into the funnel and guided it towards the 2011/12 drain at a point about 7 metres upslope of CP18. A gully, with a shape consistent with being caused by water erosion, had formed on the upslope side of this bund and is designated gully 1 in this report (figures 32 and 33). Another gully had developed in the lowest part of the funnel, on the line of the pre-2010 ditch and passing close to CP18 (gully 2). It intersected the 2011/12 drain immediately downslope of CP18. The effect of the bund was observed and recorded during wet weather on 25 August 2020 when water flowed along gully 1 without a corresponding flow in gully 2.

- 130 There is strong evidence that a bund, which diverted flows towards the 2011/12 drain and so initiated the washout 7 metres upslope of CP18, was a feature constructed at about the time that the drain was completed (figures 34, 35 and 36). Evidence that the feature is artificial is provided by its relatively uniform cross-section, its linear alignment over a length of about 20 metres, and by construction debris (wire and small pieces of geotextile) found embedded in the bund.

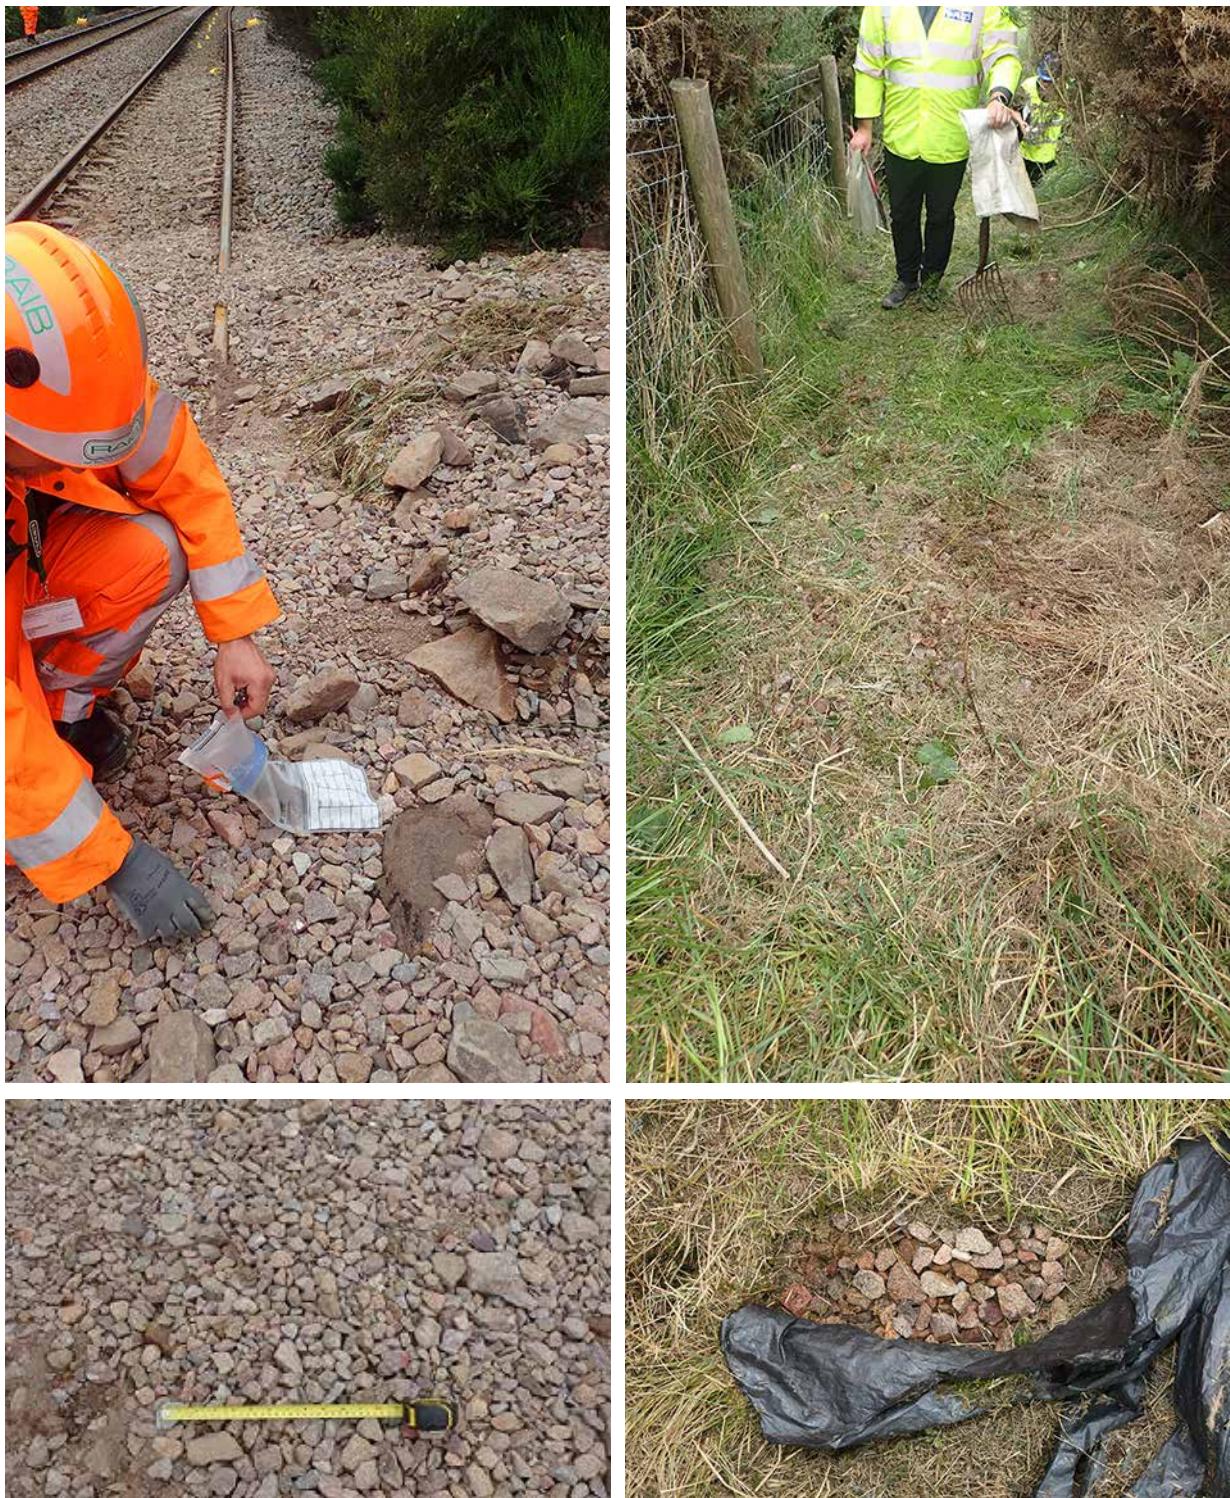
Figure 37: Landslip debris (left-hand images) and undamaged area of 2011/12 drain between washout and CP16. Surface of drain, probably protected by discarded plastic sheet since around the time it was constructed, shown in lower right image (Police Scotland)

- 99 Site inspection by RAIB in the period immediately after the accident found that:
- The debris on the track comprised a pinkish-grey granite gravel with some gravel and cobbles of grey stone (figures 20 and 37).

- The pinkish-grey granite gravel on the track was similar to that found in the drain immediately upslope of the washout (figure 37), indicating that this gravel had reached the track from the drain.

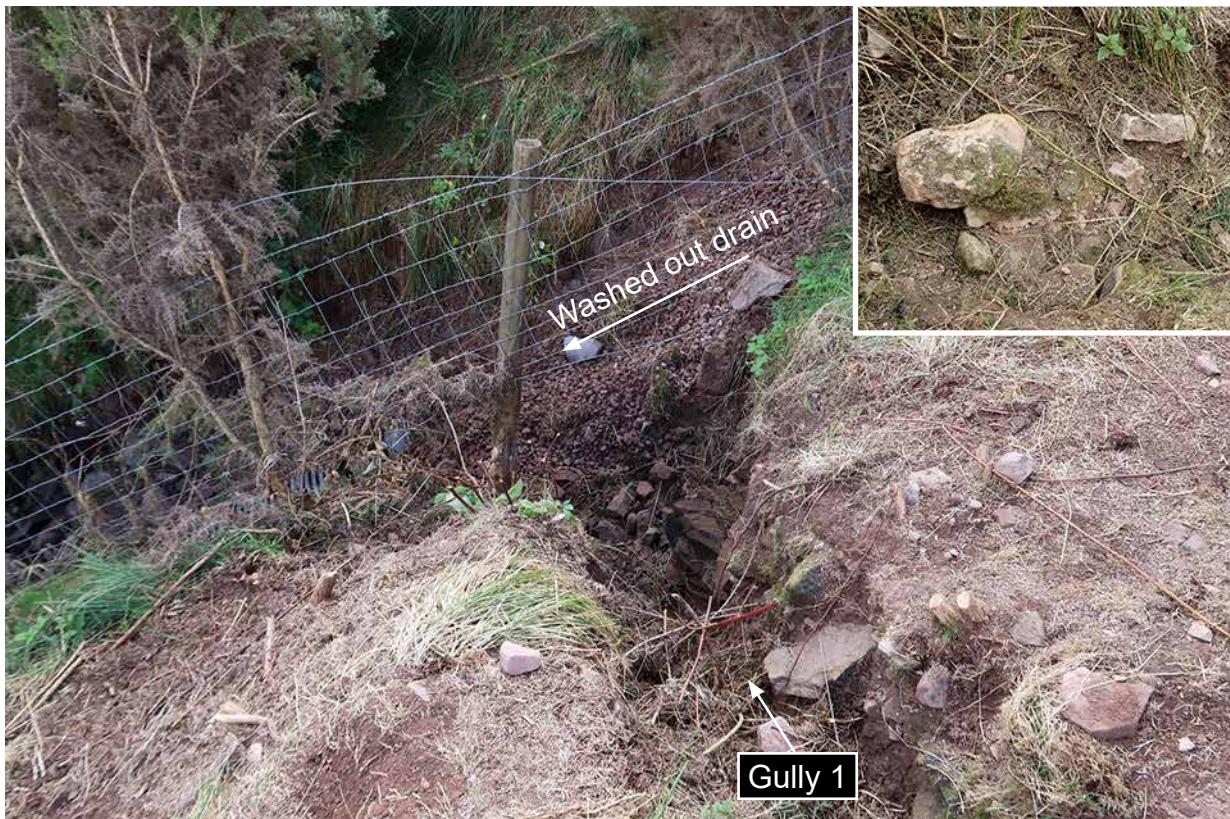
Figure 38: Gully 1 erosion at junction with 2011/12 drain (ORR/Coffey). Inset shows organic growth in base of gully 1 just outside main picture

- e) Very close to the 2011/12 drain, gully 1 was deeply eroded to a depth more than halfway down the drain, something which could only occur after washout of significant amounts of drain gravel (figure 38).

- j) The base of gully 1 contained large stones with some of those further from the 2011/12 drain having local patches of green organic growth indicative of intermittent water flows for a considerable period of time (figure 38).

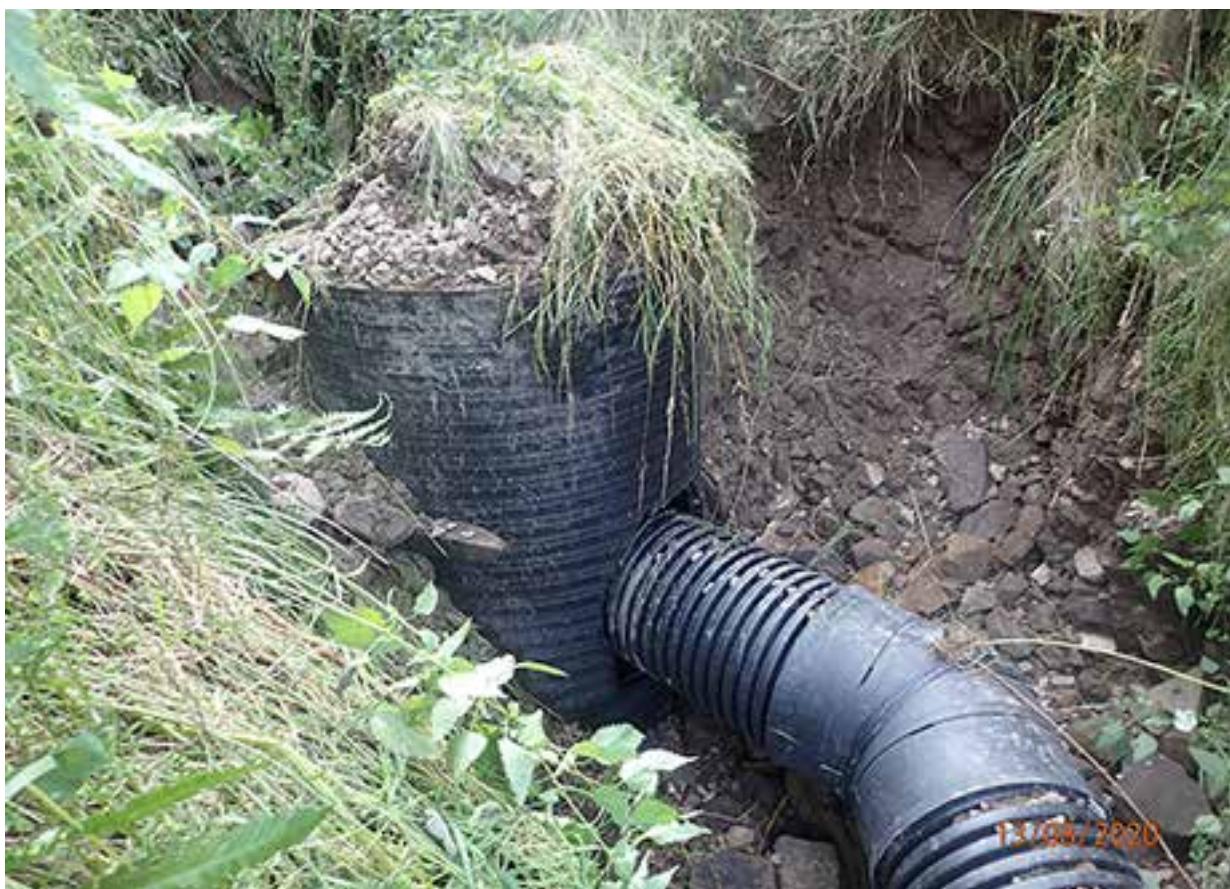
Figure 39: CP18 viewed from downslope on 13 August 2020 with the end of gully 2 visible at the upper right of the image

- g) Gravel from the drain was found on top of CP18 (figure 39), demonstrating that flows from gully 1 were sufficient to wash out gravel from the drain and that washout upslope of CP18 was not a regression of a washout initiated downslope of this catchpit.

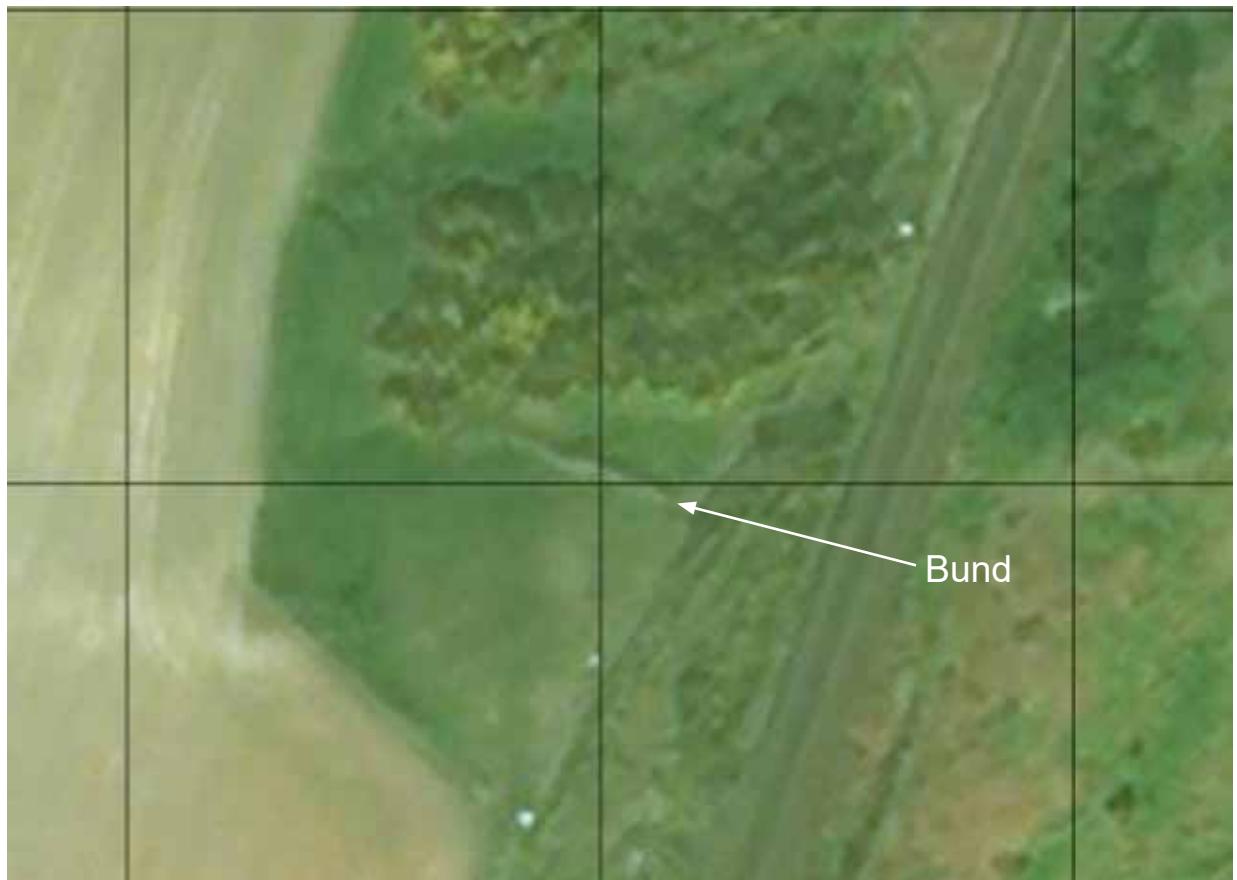
Figure 47: Satellite image April 2014 (Network Rail/ESRI Wayback imagery)

- 132 The bund is visible in a satellite photograph of the same area in April 2014 (figure 47). The larger, thus likely to be the older, gorse growing from the bund was found to contain ‘tree’ rings indicating approximately seven years’ growth (that is, growing since around 2013). There is no evidence of any construction work in the area of the bund after completion of Carillion’s drainage work.

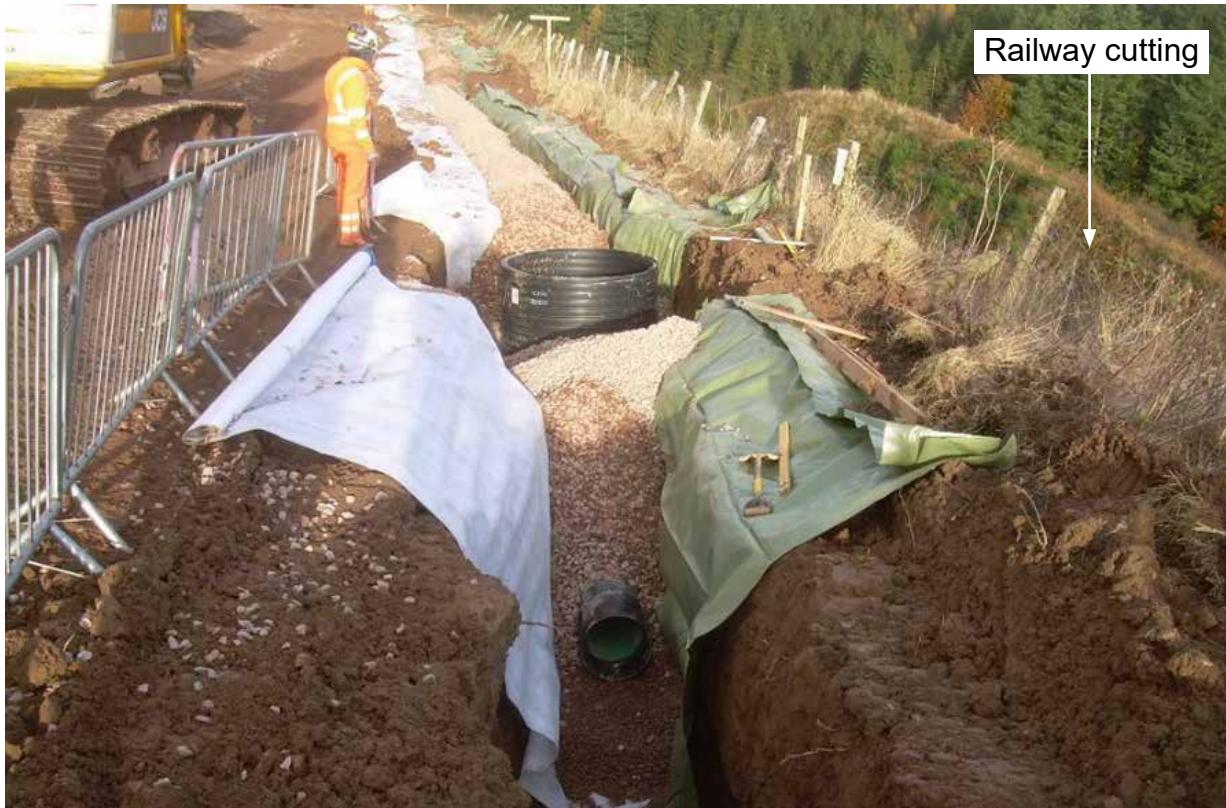
Figure 50: Drain under construction in late 2012 showing section between CP11 and CP16 looking north (Network Rail)

- 145 Arup's design for the 2011/12 drain required a geotextile to be placed on the upslope (field) side and near the top of the gravel. This is a sheet with very small holes which allows water, but not fine soil particles, to pass through it. This was intended to prevent fine particles in surface runoff water from being washed into the spaces between the gravel where they would impede water flow to the pipe. An impermeable membrane was specified on the downslope (railway) side and lower part of the trench, to prevent water seeping out of the drain and into the adjacent cutting slope where it could cause instability. The geotextile and the impermeable membrane are shown on Arup drawing 002/002 issue 04 'Drains and Pits' and in a photograph taken during construction at a location between the south end of the 2011/12 drain and CP16 (figures 49 and 50).
