Rail Accident Report

**Derailment of a passenger train at Carmont,
Aberdeenshire
12 August 2020**

Report 02/2022
v2 January 2024

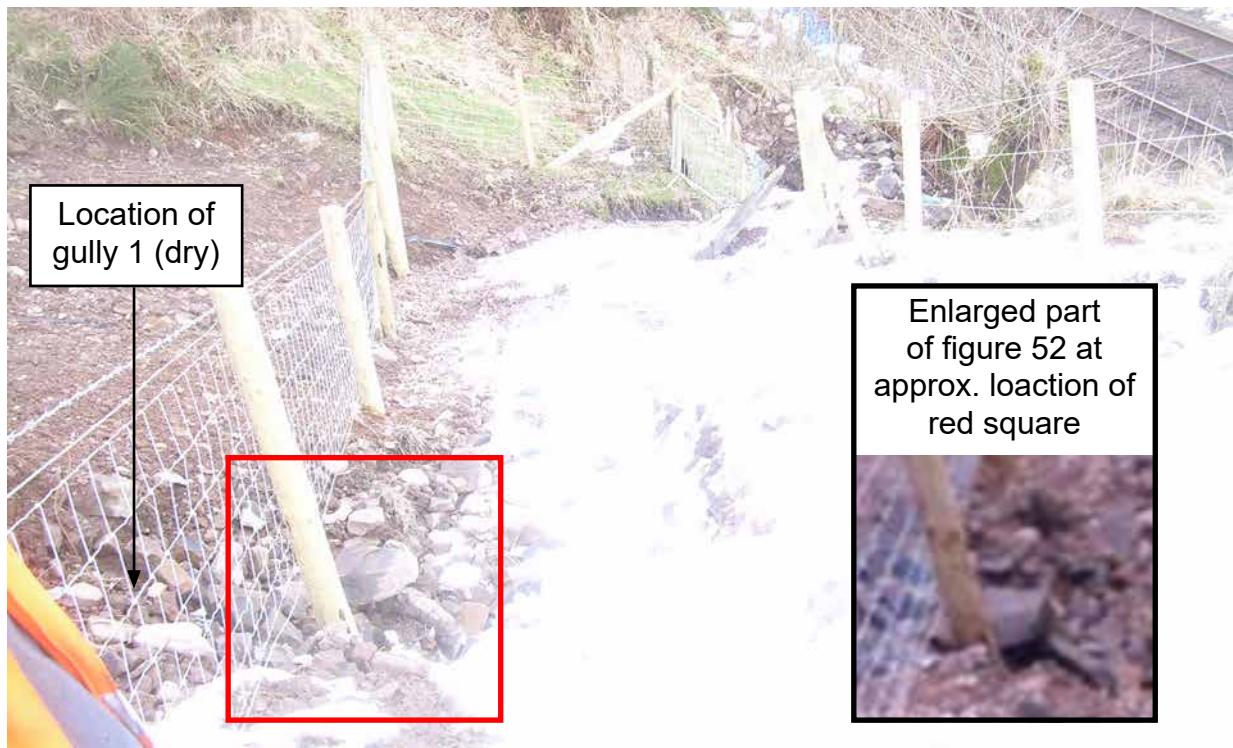
Figure 53: Surface of drain in light snow looking towards CP18 and railway in March 2013 during an inspection of the completed works (Network Rail). The original image is over-exposed

- 187 A photograph of this area was taken during an inspection of the completed works by Carillion and Network Rail in March 2013. Although the photograph is of poor quality, it indicates that the flow of surface water into the drain was established by the time of this visit (figure 53). Snow cover means the photograph cannot be used to definitively determine whether erosion on the surface of the 2011/12 drain was also still present. However, the limited areas visible on this photograph suggest remedial work had not taken place; there is no evidence of the ground surface disturbance likely to have accompanied any remedial work undertaken in response to the December 2012 photograph.

- 188 It is very unlikely that the slight erosion of the gravel surface would have been immediately recognised as a precursor to a sudden washout affecting railway safety. However, it is clear evidence of a problem requiring action such as repair, monitoring, investigating the source of the water and/or reference to the drain designer (Arup). It is possible that actions such as these would have resulted in provision of safe and effective drainage so avoiding the washout in August 2020.

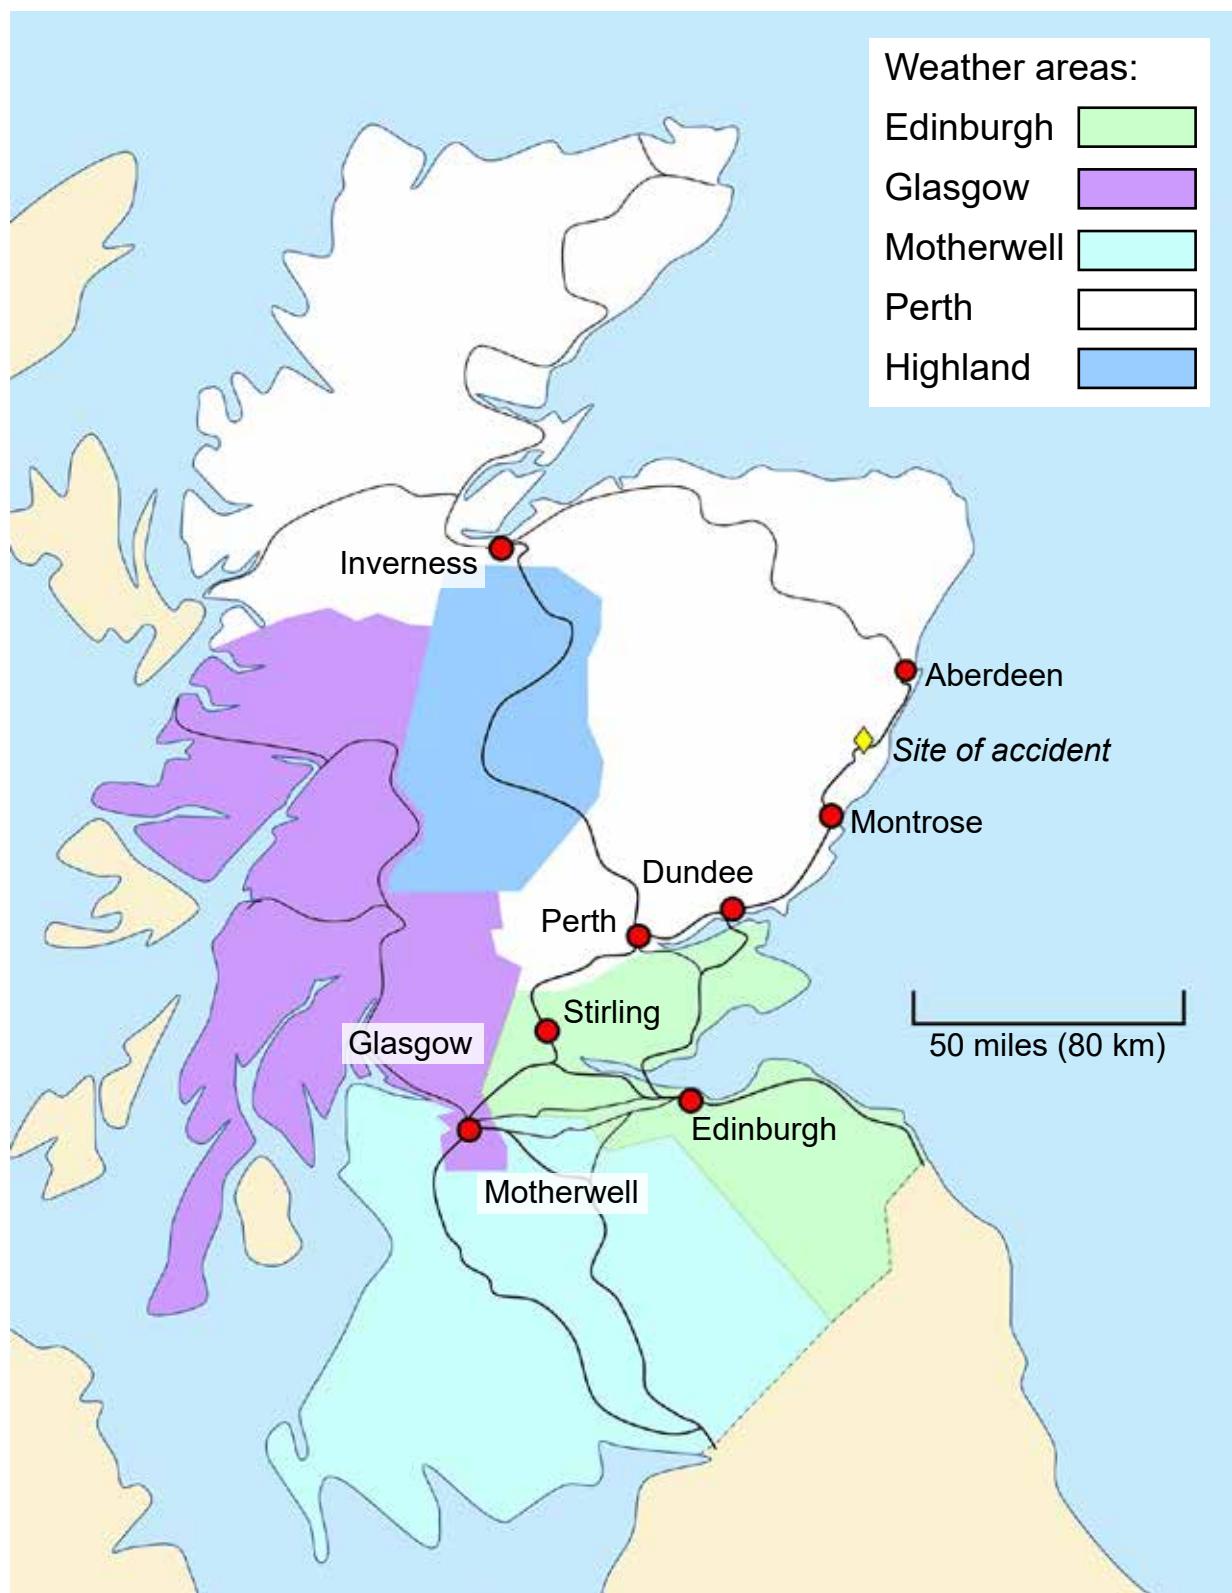
Figure 56: Forecast areas in Scotland (based on Network Rail drawing)

- 308 Witnesses stated that in Scotland a 'majority of areas' approach was taken so a 'red day' would be declared by the RCM if extreme weather was forecast in three or more of the five forecast areas for Scotland (figure 56). However, events in the lead-up to the accident demonstrates that this approach was not consistently applied (for example, the forecast for 11 August contained extreme weather forecast in three of the five areas and yet no 'red day' was declared).

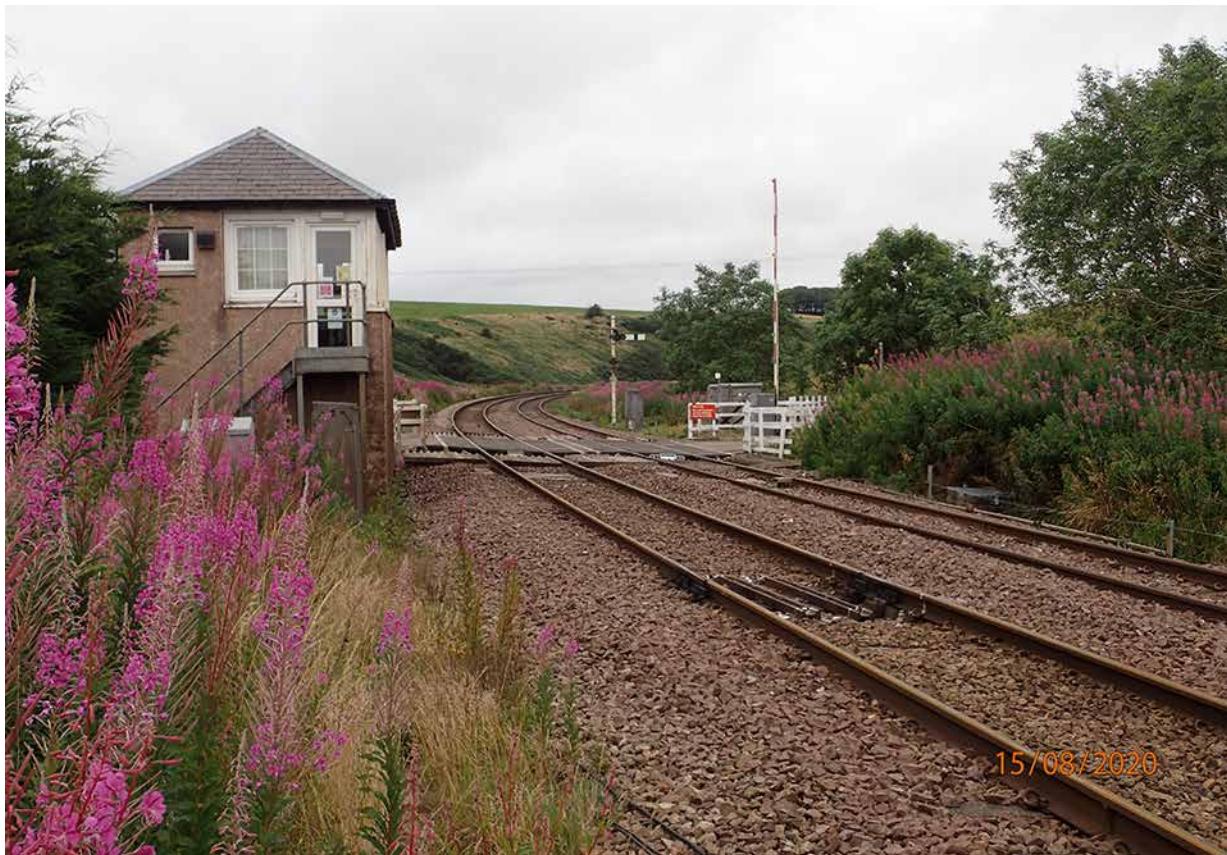
Figure 57: Carmont signal box looking north

- 253 The Carmont signaller had no indication that the line was obstructed between his location and Stonehaven when authorising the movement of train 1T08 to Stonehaven. After passing his signal box, train 2B13 had passed the location of the washout at 07:07 hrs and reached Stonehaven station at 07:13 hrs, with its driver subsequently confirming that he had seen no indication of a problem (paragraph 50). The Carmont signaller was told that this train had reached Stonehaven during a phone call with the Stonehaven signaller at 07:19 hrs, during which they concluded there was no known obstruction of the up line, so this could be used for the northbound movement of train 1T08 if necessary (the movement was actually made on the down line). Neither signaller had received any indication of an obstruction at the washout location when, at and after 09:08 hrs, they exchanged the messages needed to authorise the northward movement of train 1T08 to Stonehaven.

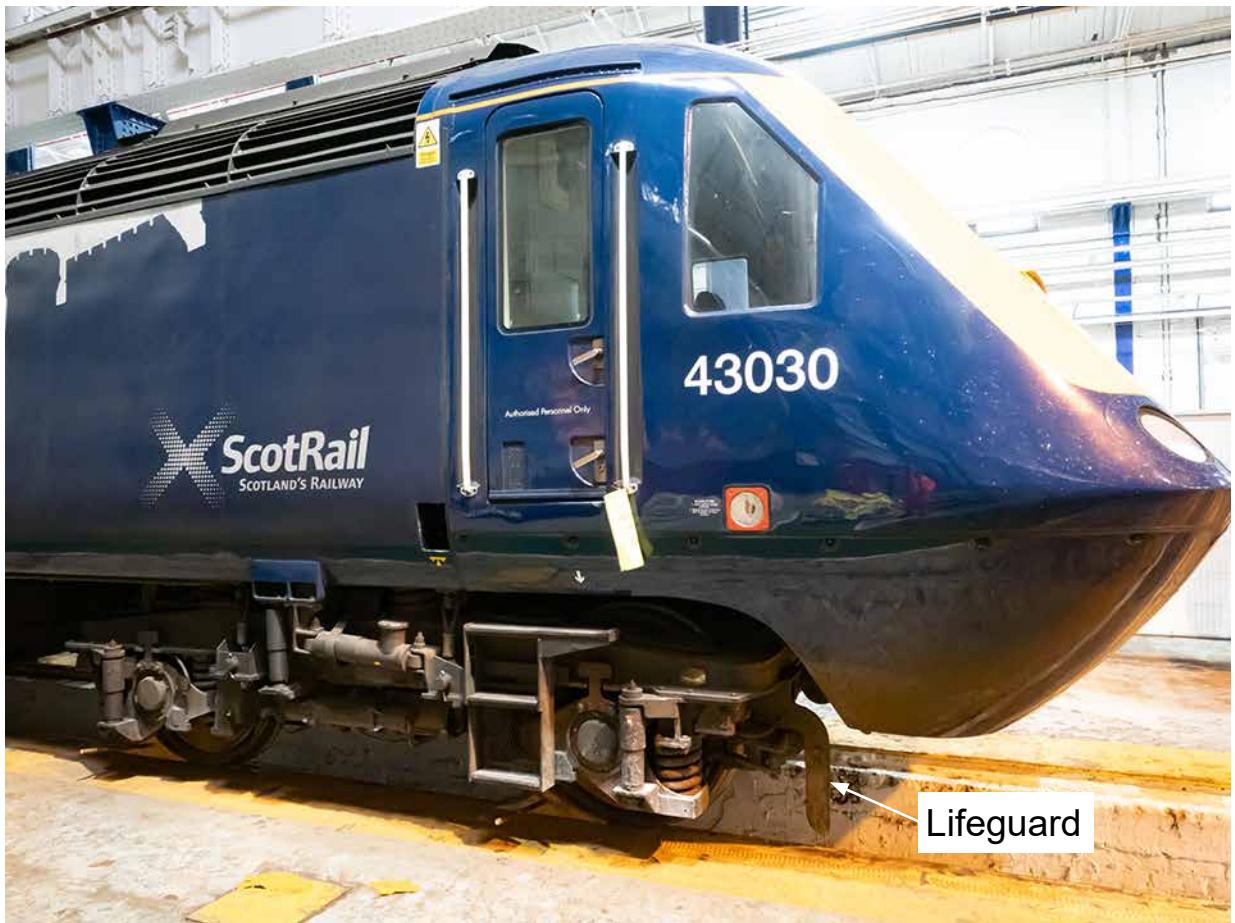
268 Lifeguards on rail vehicles are heavy metal brackets fitted immediately in front of the leading wheels of a train. Their purpose is to prevent small³⁰ obstacles getting under the leading wheels and causing derailment. Figure 58 shows one of the lifeguards fitted to the trailing power car.

Figure 58: HST lifeguard (trailing power car)

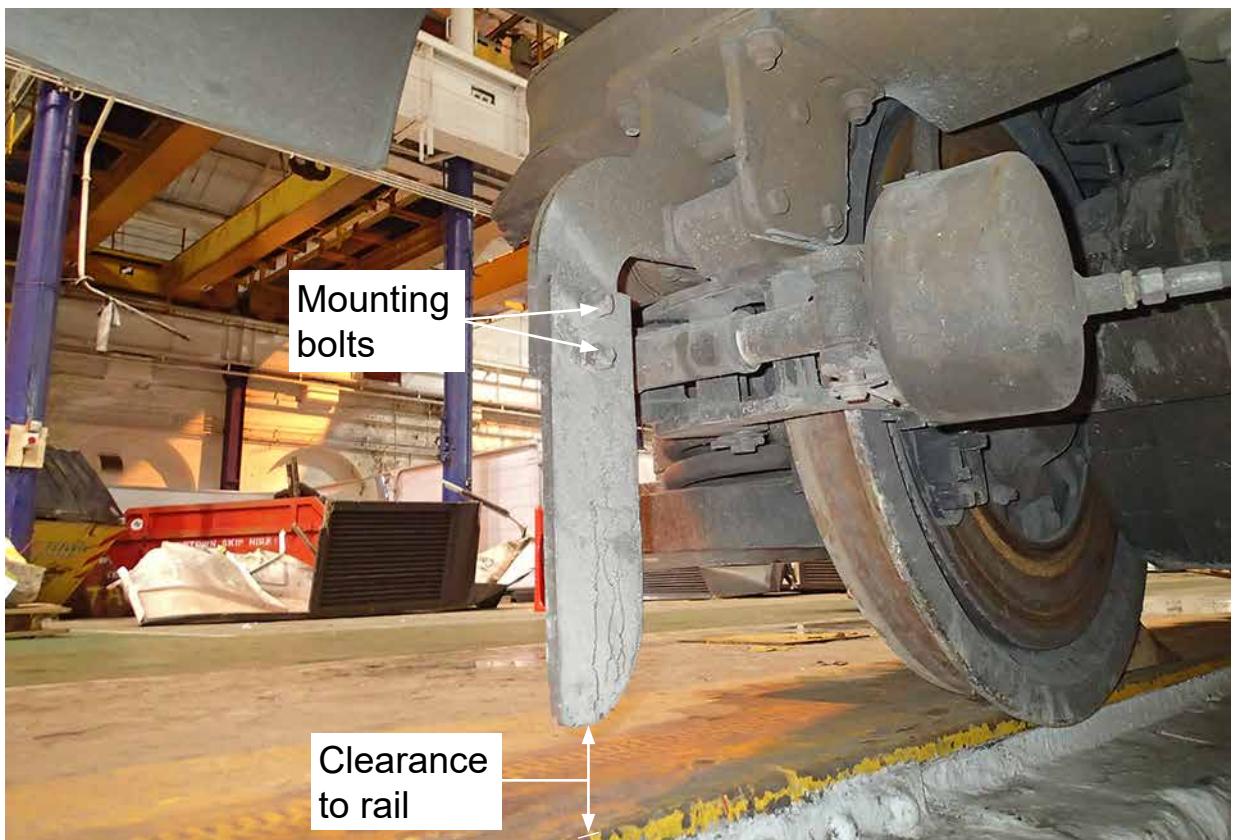
269 To allow for suspension movements and wheel wear, lifeguards are mounted with a clearance between the bottom of the lifeguard and railhead (figure 59) to ensure the lifeguard never contacts the railhead during normal operations. The amount of clearance varies between train types and until 2011 there was no specified value in British railway standards. From 2011 the LOC&PAS TSI³¹ (now superseded by the LOC&PAS NTSN³² which imposes the same requirement) applied to new rolling stock and introduced a height range above the railhead of between 30 mm and 130 mm in all conditions. There is a parallel requirement in British domestic standards, introduced from 2011, for a lifeguard to be positioned as close as reasonably practicable to the railhead taking into account wheel wear, suspension movements, suspension wear and assembly tolerances. The clearance of the lifeguards above rail level on the leading power car could not be measured due to the damage they sustained in the accident. The clearance on the trailing power car was measured by RAIB as 58 mm for both lifeguards. The normal operational range for HST power cars is 48 to 85 mm.

Figure 59: Lifeguard mounting bolts and clearance between bottom of lifeguard and railhead

- 271 The HST lifeguard was designed before the introduction of GM/RT2100. The lifeguard comprises a vertical blade made from mild steel which is bolted to a bogie-frame mounted bracket by means of two bolts (figure 59). Using design drawings, RAIB has calculated that the ultimate strength of the HST lifeguard is around 15 kN. This is less than half the minimum ultimate strength of lifeguards compliant with current standards. The weakest point of the HST lifeguard is the lower of the two attachment bolts, which shears when the lifeguard is overloaded, allowing the lifeguard to rotate backwards, so preventing it from carrying any significant load and performing a clearing function. At Carmont both lifeguards failed at the bolted joint and rotated backwards. This mode of failure is similar to that seen in a previous accident, but in that case the train struck heavy debris from a fallen bridge parapet, which would have been likely to have damaged a modern lifeguard.³⁴

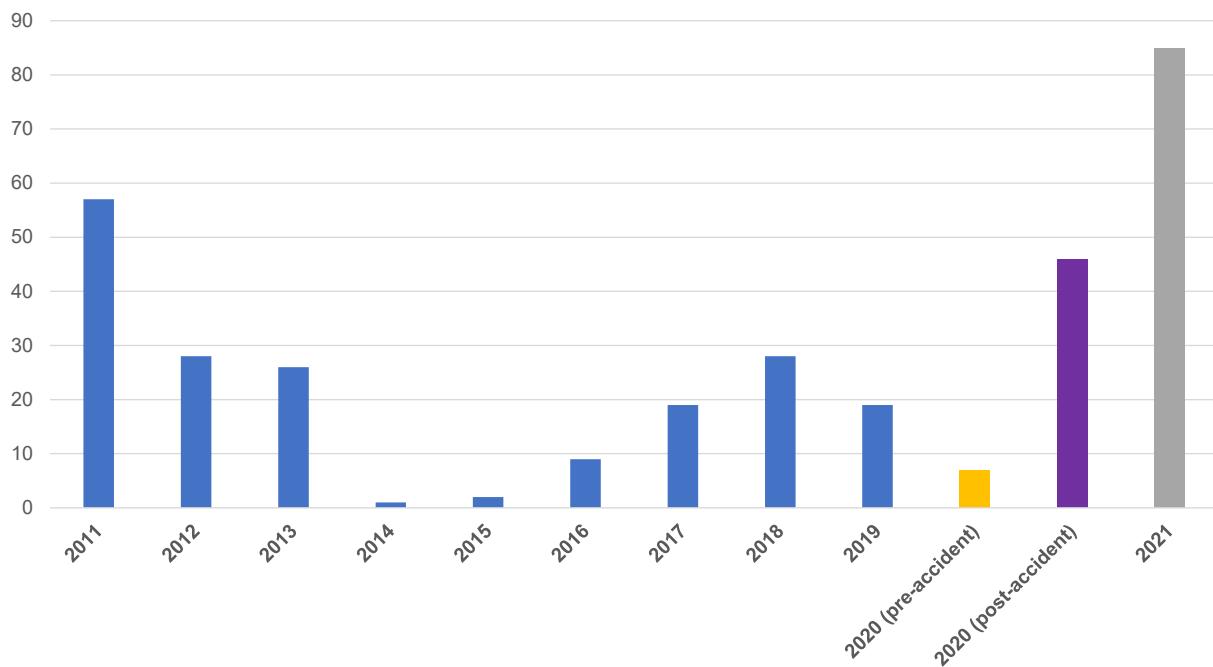
- 310 There is evidence that the number of EWATs convened by Scotland's route control in the years before the accident at Carmont was fewer than would have been expected had the national operations standard governing the response to extreme weather events (NR/L2/OPS/021) been implemented in the way intended by Network Rail (for example, RAIB found almost no records of EWATs having been convened in 2014 and 2015) (figure 61). This is surprising given the frequent occurrence of major weather events in Great Britain and the severity of weather in Scotland relative to other parts of the country.

Figure 61: Number of EWATs convened in Scotland 2011 to 2021 (based on records provided by Network Rail and ScotRail)

311 The reason for the relatively low number of EWATs is thought to relate to the publication of a report commissioned by Network Rail Scotland in 2012 following widespread disruption to the network on 3 January 2012 due to a severe storm and high winds. This report identified a number of weaknesses in the management of the incident, including poor management co-ordination and control. It included a recommendation that:

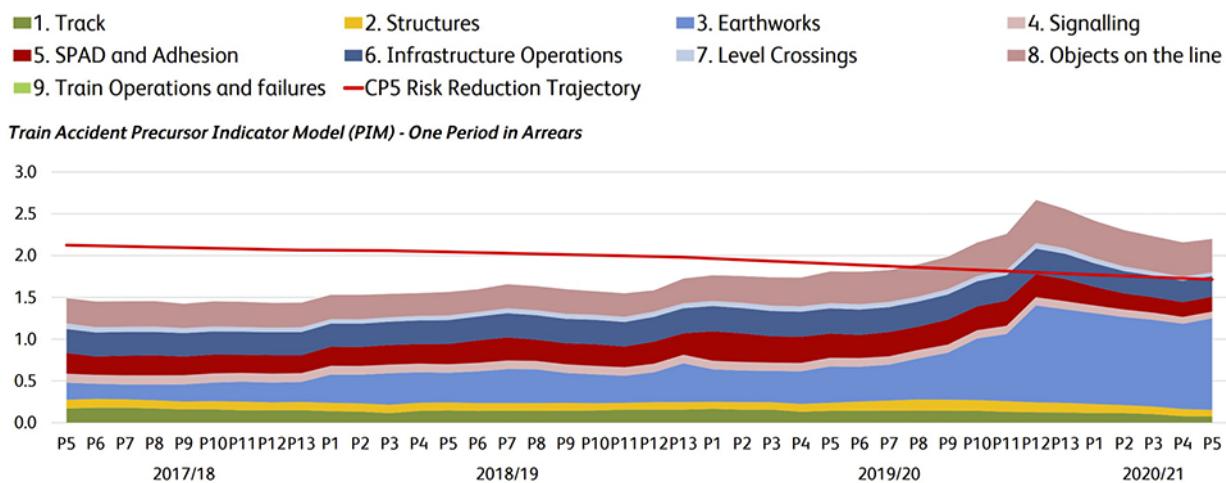
332 The SHEP report showed that from early 2018 the risk³⁸ associated with earthwork failure was rising significantly (figure 63 and see paragraph 385). Consequently, the risk of earthwork failure was seen to be accounting for a greater proportion of the overall train accident risk.

Figure 63: Outputs of the train accident precursor indicator model showing the rise in risk associated with earthwork failure, relative to other precursors. (Extract from Network Rail's Safety, Health and Environment Performance report for period 6 of 2020/21).

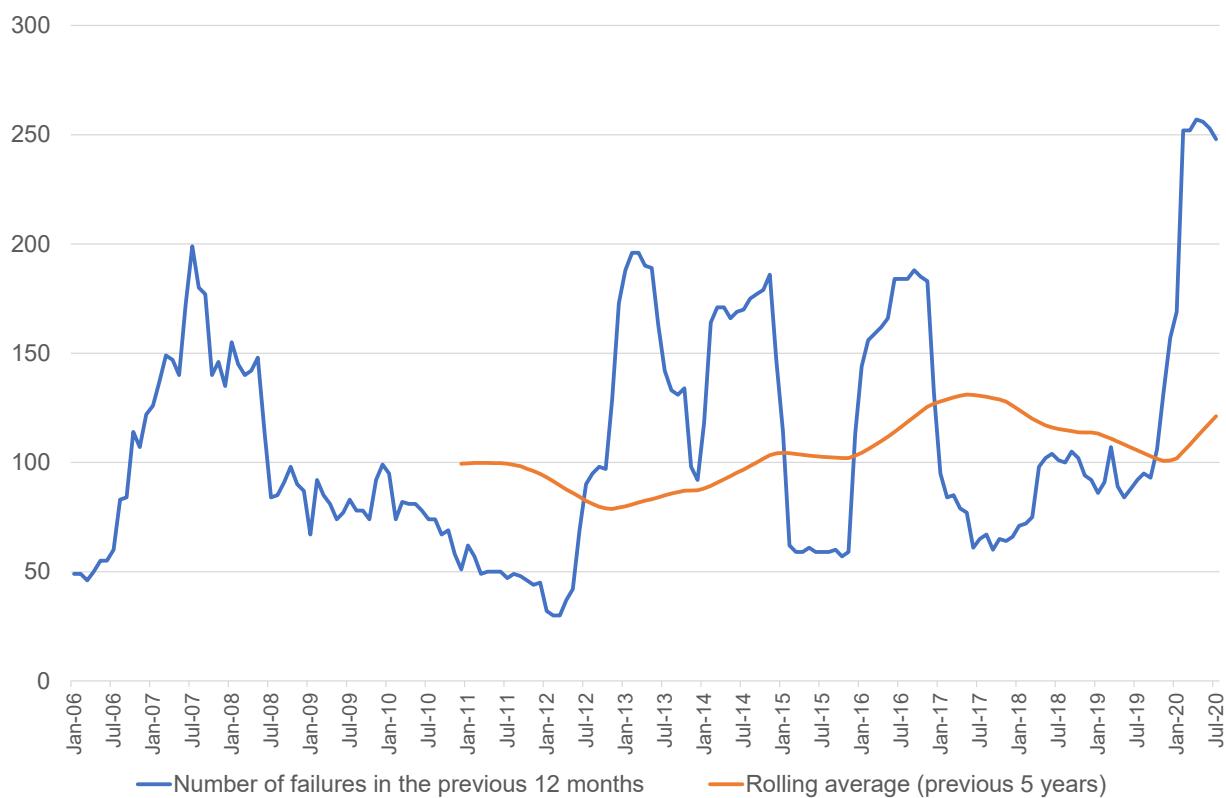
- 377 The starting place for any risk assessment of earthwork failures is data on the number of earthwork failures. Figure 64 plots the number of failures recorded by Network Rail between January 2006 and August 2020. The blue line plots, for each month, the number of failures in the previous 12 months (for instance, the value shown for July 2007 is the total number of recorded failures from August 2006 to July 2007) and the orange line the rolling mean annual average over the previous five-year period. This figure shows that the frequency of earthwork failures varies considerably year-by-year, as does the weather. However, when viewed over a longer time frame, for instance five years, it can be seen that the average number of failures had risen from about 79 to 131 per year between November 2012 and May 2017. It then fell back to about 100 per year in November 2019 before starting to rise again in the seven months before the accident at Carmont.

Figure 64: Recorded earthwork failures on Network Rail infrastructure July 2005 to August 2020 (as defined in accordance with Network Rail's standard NR/L3/CIV/185⁴⁵)

379 The variability of the underlying data means that it is inappropriate to conclude that the statistical fall between June 2017 and November 2019 was evidence that the underlying long-term risk was actually falling. Consideration of a time frame longer than five years indicates a gradual increase in the number of earthwork failures over the last decade. This is likely to be a more representative picture of earthwork risk but the variability of failure data, and the relatively short time frame for which it is available, means it is not possible to draw a definitive conclusion based only on this data: it is also possible that part of the increase is due to improved reporting of earthwork failures. These shortcomings can be largely overcome by recognising the correlation between earthwork failures and rainfall, for which large amounts of historical data and long term forecasts are available (see paragraph 387).

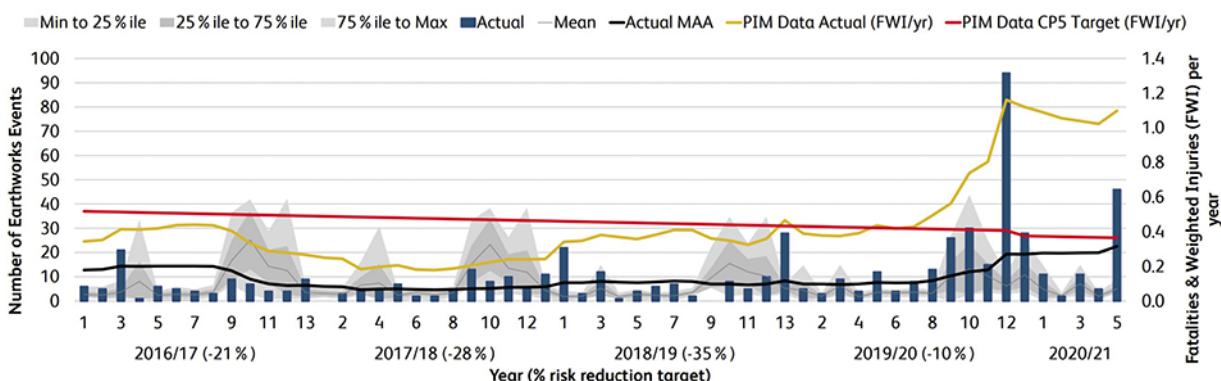
- 385 According to the PIM data provided by RSSB, the FWI/year associated with failures of earthworks in 2016/17 was 0.30 (table 4, and figures 65 and 66). In 2018/19, the estimate of FWI/year had risen to 0.53. In 2019/20 the estimated FWI/year had risen to 1.28, driven by the number and severity of storms during 2019/20 that resulted in earthwork failures (figure 67). This meant that earthwork failure now accounted for 27% of all train accident risk and about 60% of the train accident risk associated with asset integrity.

Figure 65: Earthworks PIM 2016/17 to 2020/21 (Extract from Network Rail's Safety, Health and Environment Performance report for period 6 of 2021/22)

387 At first sight, the presentation of the PIM data in figures 65 and 66 might suggest that the risk from earthwork failures only started to rise in April 2018. However, since this risk is closely linked to the variability of the weather, it is important that risk management decisions are based on a longer view of changes in risk. The earthwork failure data at figure 64 shows that the five-year rolling mean average number of earthwork failures has been gradually rising over the last decade. Furthermore, rainfall data collected over the last 160 years suggests an increase in the UK's average annual rainfall since the 1980s (figure 68). Since rainfall is closely linked to the risk of earthwork failure, it is likely that the underlying risk of earthwork failure has been rising for some considerable time.

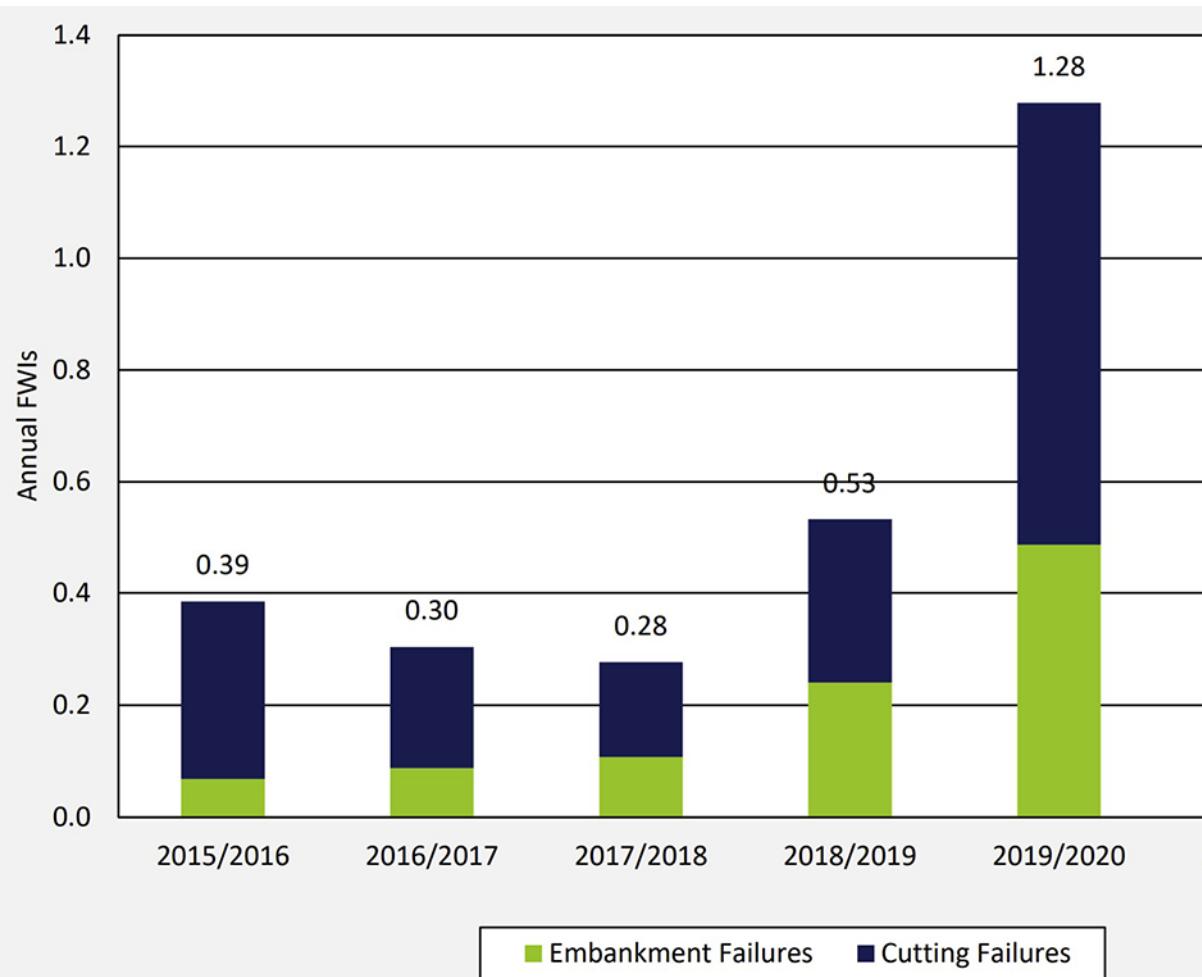
Figure 66: Train accident risk from earthwork failures 2016 to 2020 (RSSB)

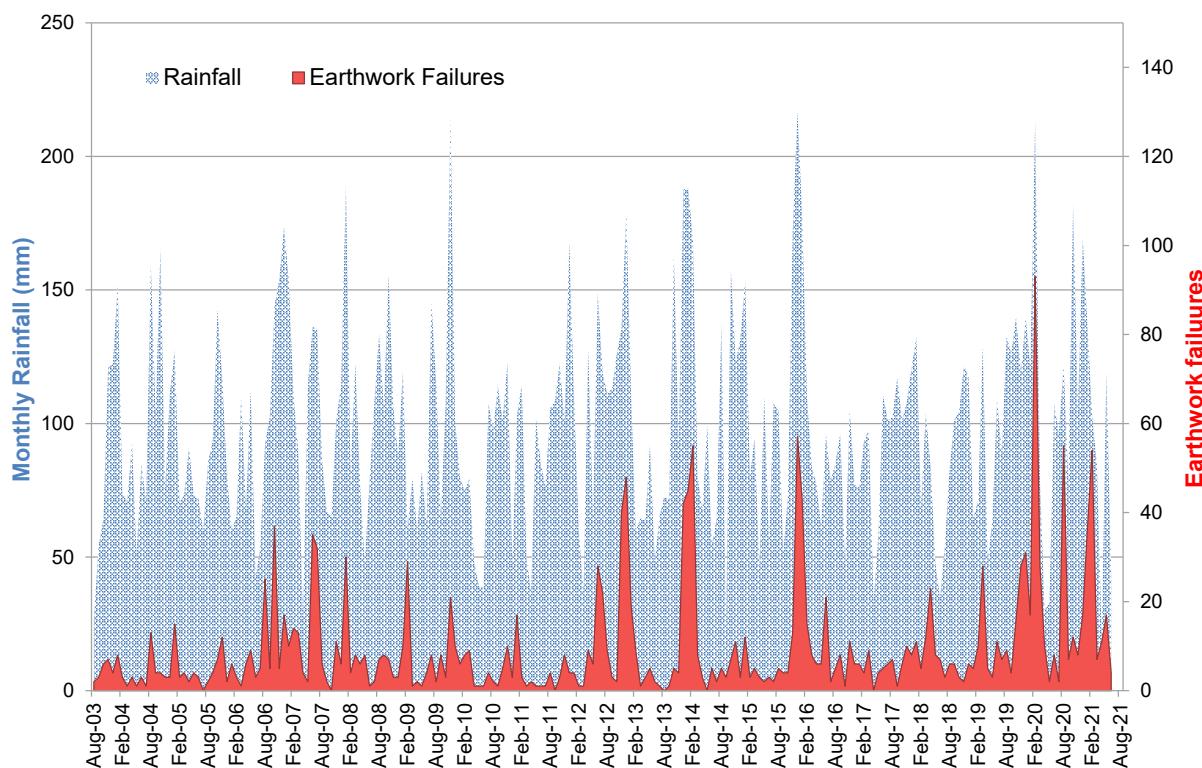
401 Earthwork failures (including those involving drainage) are usually related to periods of heavy rainfall. The correlation is apparent in figures 70 and 71 but is stronger than these plots suggest as the rainfall data is a nationwide monthly average, and so does not fully reflect a few days of very heavy rain and/or heavy rain limited to only part of Great Britain. The need for mitigation at earthwork locations is not dependent on recognising the precise mechanism for endangering the railway. As at Carmont, this is often impractical, so safe railway operation depends on recognising that extreme weather can result in unpredictable events at locations not previously considered to present a high risk.

Figure 70: Timeline of earthworks failures and rainfall 2015 to 2020 (Network Rail NR/L3/CIV/185 failures and Met Office national average rainfall data (<https://www.metoffice.gov.uk/pub/data/weather/uk/climate/datasets/Rainfall/date/UK.txt>))

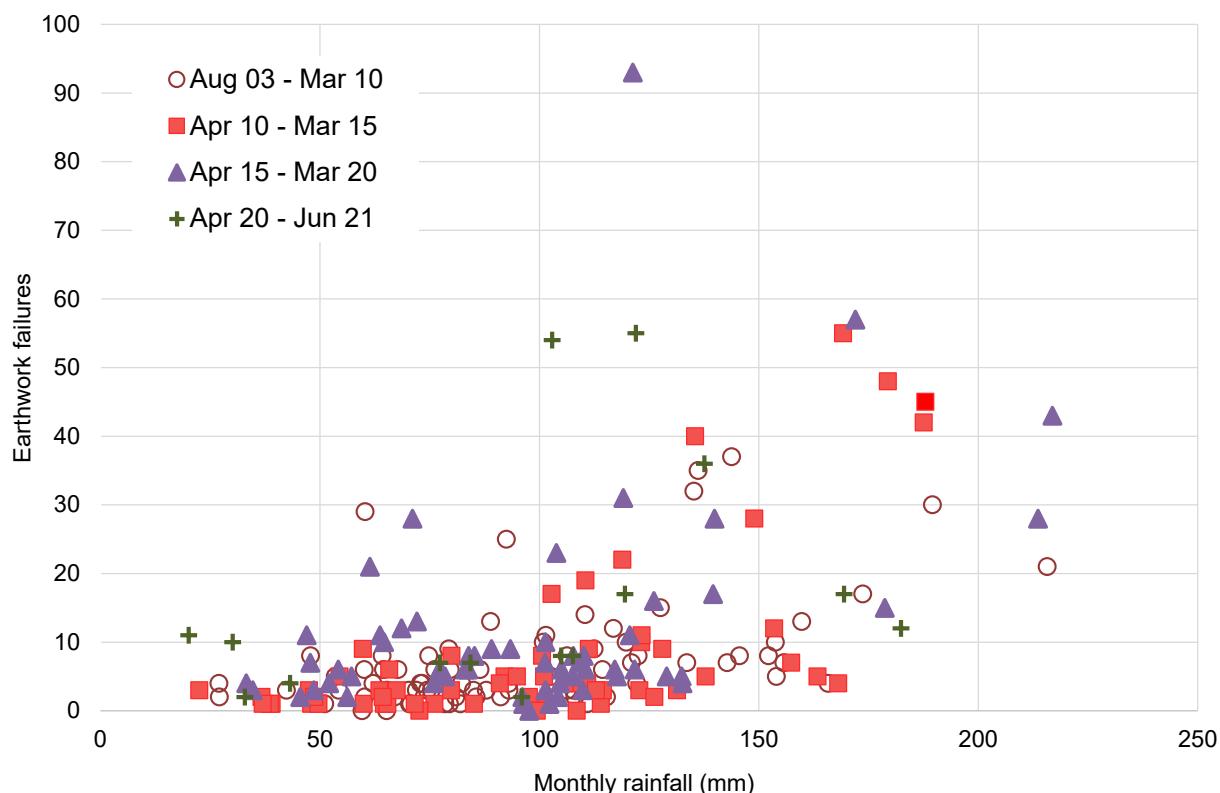
Figure 71: Relationship between earthwork failures and rainfall, 2015 to 2020 (data sources as figure 70)

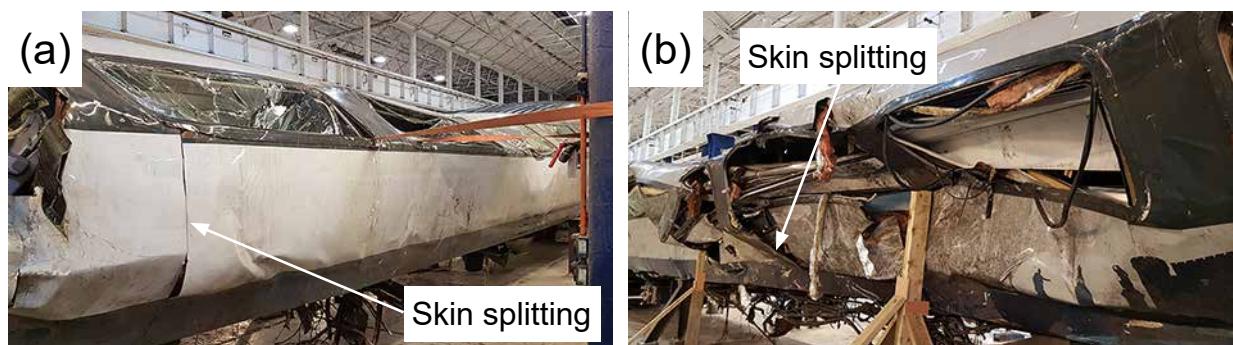
- 501 Vertical splitting of the bodyside skin panels was observed on all the coaches but particularly on coaches C and D. Examples of the bodyside splits on the left and right-hand sides of coach D are shown in figure 82. On examination, these were found to be due to failure of the welds that were laid to join the panels together during the original build, caused by inadequate depth of weld fusion. Because the mark 3 coach is designed as a monocoque structure the observed splitting of the skin panels is also likely to have aggravated the deformation of coach D.

Figure 82: Bodyside skin splitting on coach D, left side (a) and right side (b)

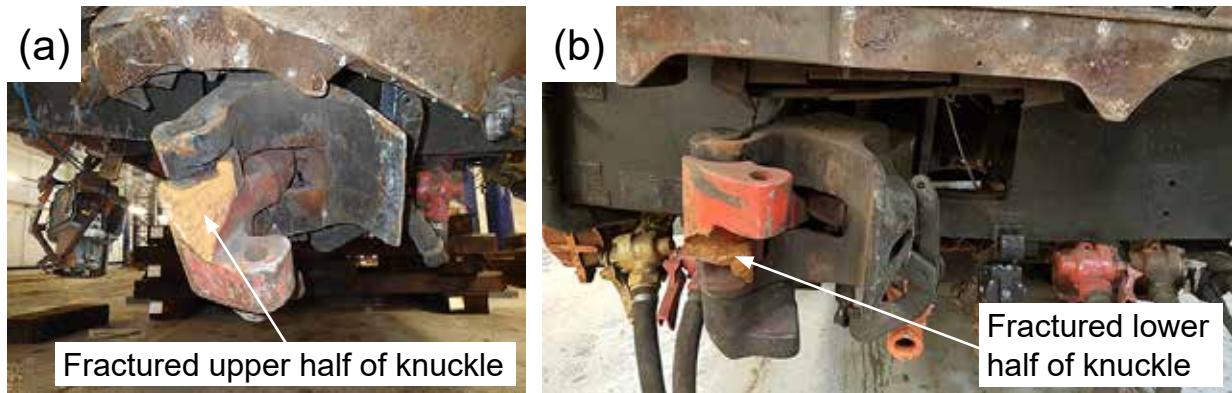
503 The typical failure mode of the coupler was fracture of either the upper or lower half of the knuckles of the coupler (figure 83). The same failure mode of the Alliance coupler was also noted in the investigation following the derailment at Ufton Nervet.⁵⁶

Figure 83: Fractured knuckles on the couplers of coach D leading end (a) and trailing end (b)

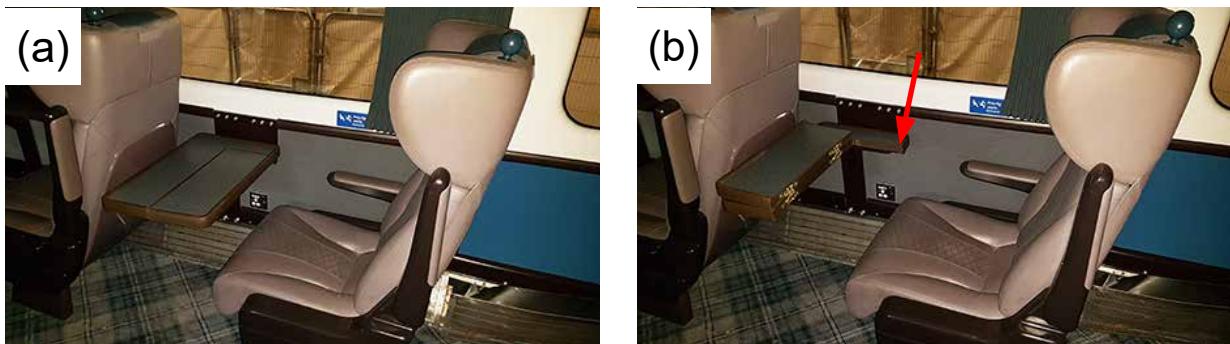
- 510 The folding tables used with the single 'priority' seats at four locations in the first class coach A were observed to have a particularly sharp corner when in the folded position (figure 84b). This corner could cause injury to a seated forward-facing passenger in the event of a train collision in which they were thrown forwards into the table. The same folding table design is also used in coach B at two locations adjacent to wheelchair positions. In the coach B positions, it poses less of a risk to a passenger sitting in a wheelchair because the side of the wheelchair frame would impact the sharp corner. When in the flat (down) position, no sharp edge is presented (figure 84a). No occupants were seated next to these folding tables or injured by them during the derailment at Carmont.

Figure 84: First class folding table from coach A in flat position (a) and folded position (b). Sharp corner indicated by red arrow. The same table design is also used at two positions in coach B

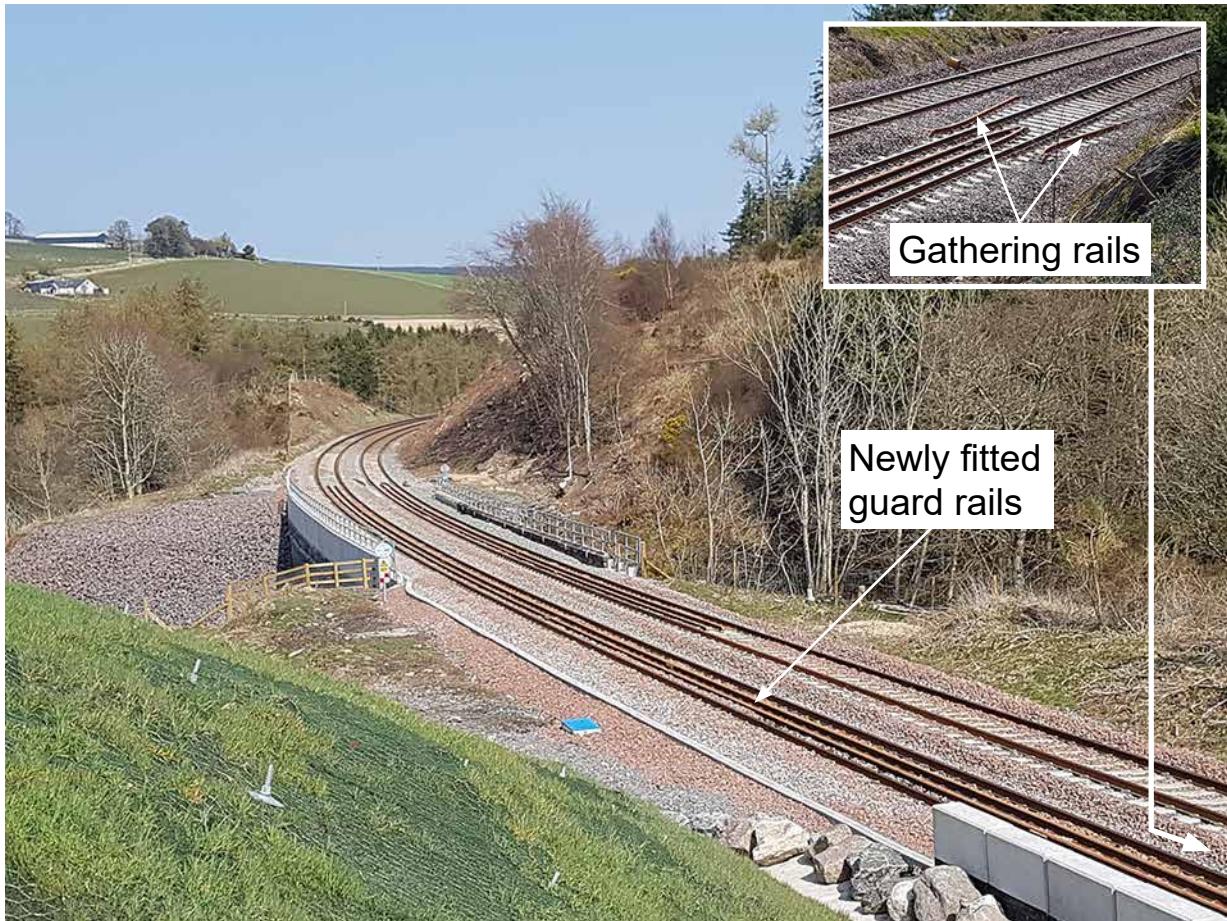
- 537 At the time of the derailment, no guard rails were installed on the approach to and over the bridge at Carmont. The purpose of guard rails is to contain any derailed wheels so that they remain close to the track and do not allow the train to deviate into collision with the infrastructure (for example, tunnel portals, bridge parapets) or trains on adjacent lines. Guard rails usually comprise a pair of parallel steel rails fitted to the sleepers in the four-foot. The ends of the rails are usually tapered so that they converge to a point at the centre of the track and are able to gather any derailed wheels. Gathering rails can also be fitted outside the running rails. To be effective in guiding a derailed train approaching a high-risk area, guard rails need to extend for a sufficient distance on the approach to the tunnel, bridge or other feature that poses the potential risk to the derailed train. Guard rails have since been installed at the Carmont accident site as part of the track reinstatement works (figure 86).

Figure 86: Guard rails fitted post-accident at bridge 325. The gathering rails are positioned at the start of the guard rails to the right of the main picture

621 Guard rails were fitted on both up and down lines on the approach to bridge 325 when the track was relaid after the accident (figure 86). The protection includes gathering rails (paragraph 537) and, on the down line, extends beyond the site of the washout.

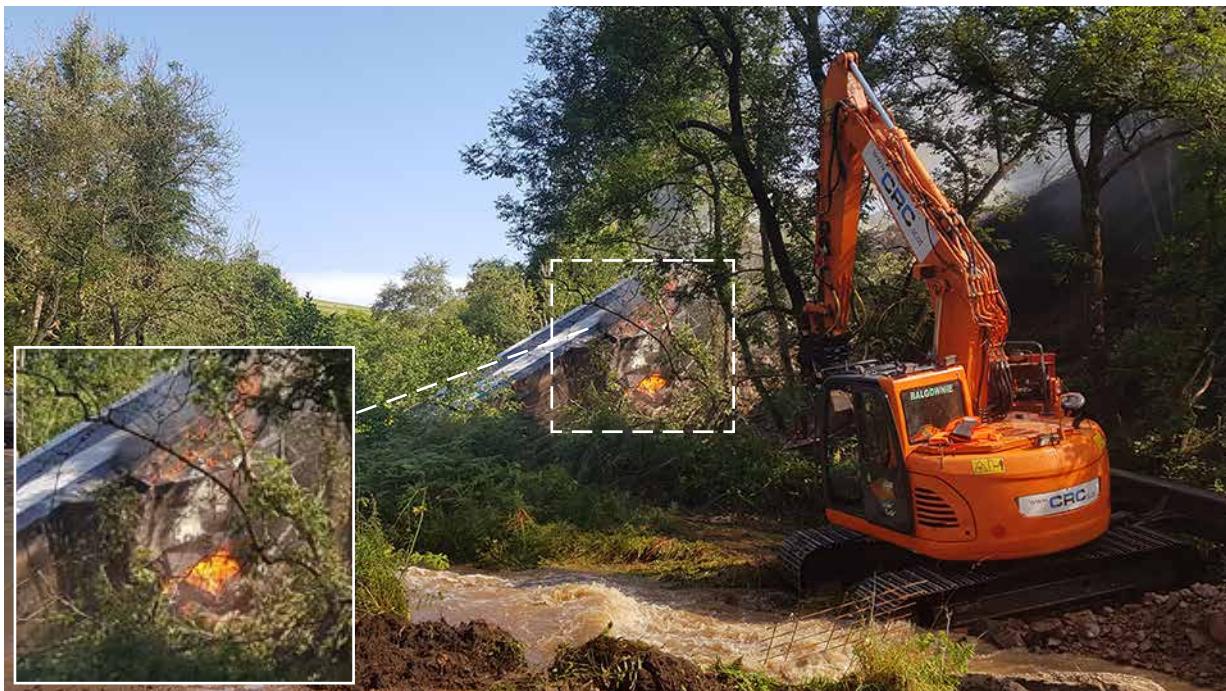
549 Coach B caught fire after coming to rest on the embankment flank with its right-hand side on the ground and sloping so its leading end was lower than its trailing end. The fire was not apparent to witnesses until around 11:00 hrs (approximately 90 minutes after the accident). Photographs indicate that no fire was apparent before 10:22 hrs, but by 11:09 hrs a significant fire had developed around the battery box (figure 88). The following paragraphs describe the evidence showing that this was the source of the fire which then entered the coach through a floor opening, required for the ventilation system, before spreading up towards the rear of the coach.

Figure 88: Coach B on fire at 11:09 hrs (Mark Davidson)

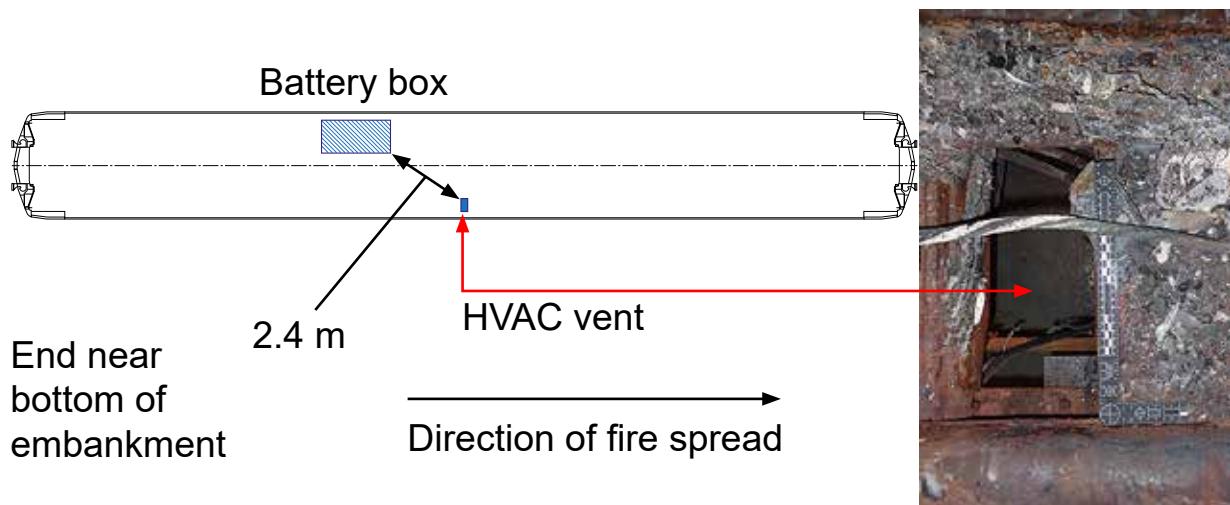
557 The subsequent spread of the fire was a result of the coach coming to rest on its right-hand side on the slope, with its trailing end uppermost. This orientation meant that the fire naturally extended across the underframe and grew towards the trailing end of the coach. The rectangular hole on the left-hand side, designed to allow air from the HVAC system into the passenger compartment, was likely to have been the route of the fire into the coach's interior. This hole, measuring approximately 280 mm by 160 mm, is 2.4 metres away from the battery box, diagonally across the underframe.⁶⁷ It was exposed during the accident because the lightweight sheet metal ducting previously connected to it was stripped away from the underframe during the accident. The hole with evidence of surrounding fire damage is shown in figure 90.

Figure 90: Opening for ventilation system in coach B floor

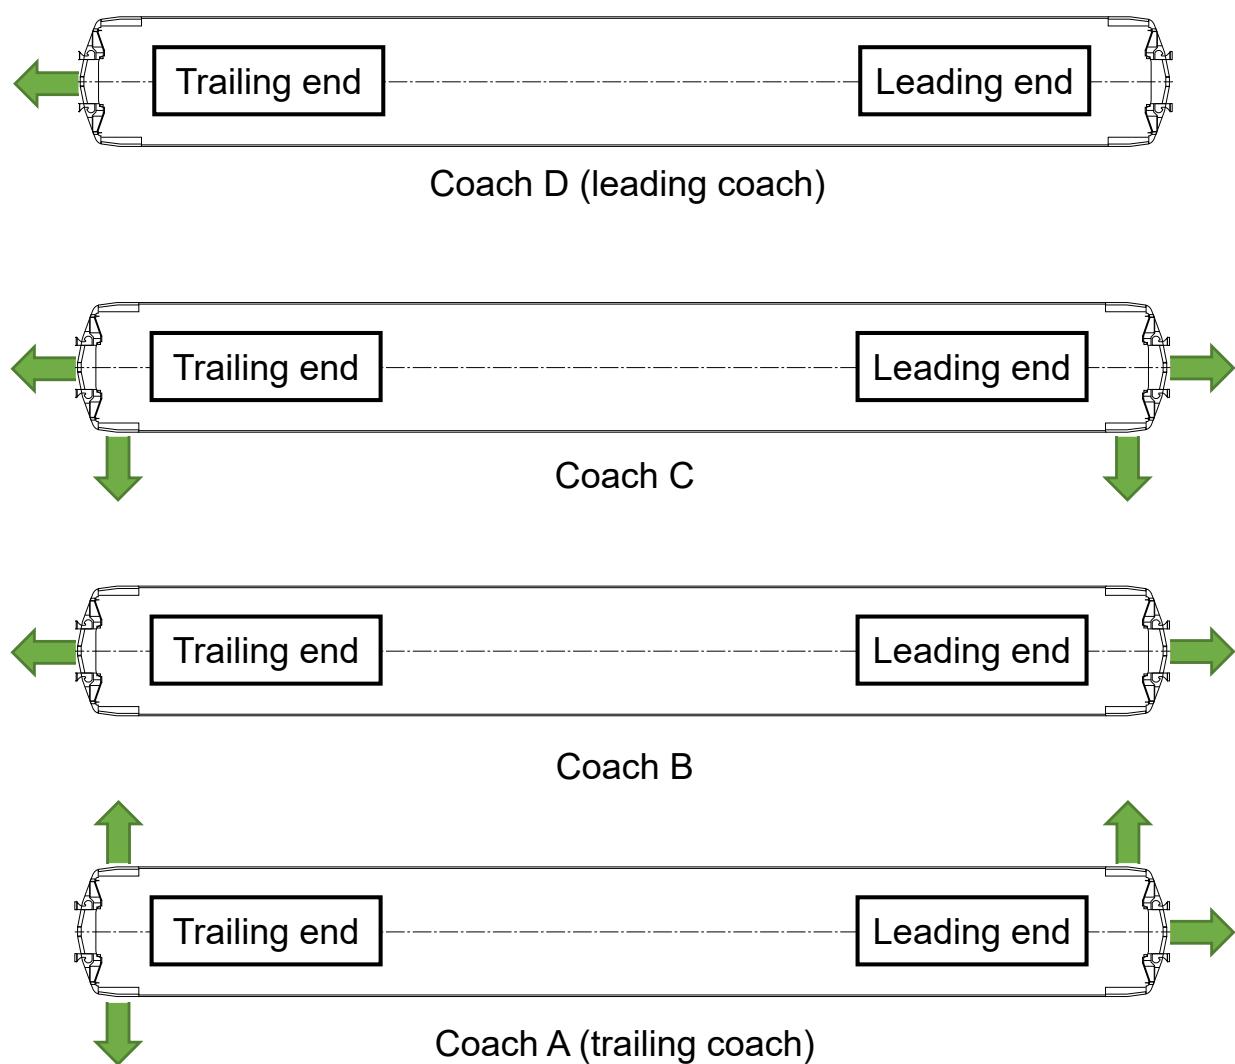
Figure 93: Egress routes available to survivors from each vehicle

565 Coach D only had only one egress route available (discounting broken windows). All the other coaches had a minimum of two routes available. Coach B, which had rolled onto its side, only had two routes because the doors on the low side were blocked and those on the high side would have been difficult to open due to their position above anyone in the coach. There were no egress issues resulting from the power door modifications to the mark 3 coaches.
