Rail Accident Report

**Derailment of a passenger train at Carmont,
Aberdeenshire
12 August 2020**

Report 02/2022
v2 January 2024

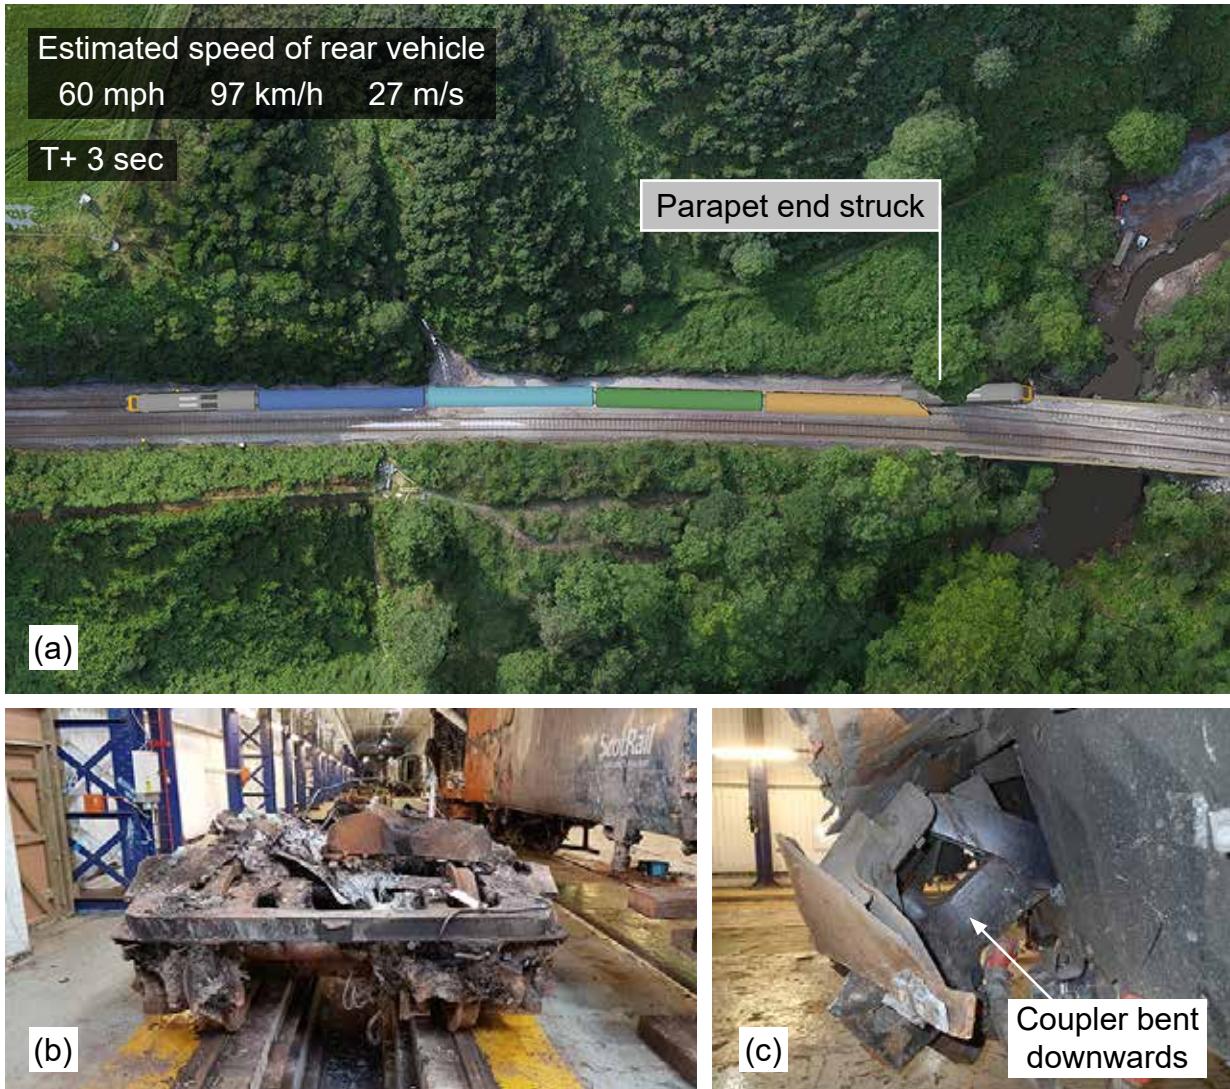
Figure E.4 (T+3 seconds):

- Leading power car strikes and demolishes left-hand bridge parapet, image (a).
- Sudden compressive force at the first interface and height difference between coach D (high) and power car (low) causes coach D to override the trailing right-hand side of the power car.
- Damage to leading bogie from impact with parapet, image (b).
- Damage to leading coupler of coach D - coupler bent downwards, image (c).

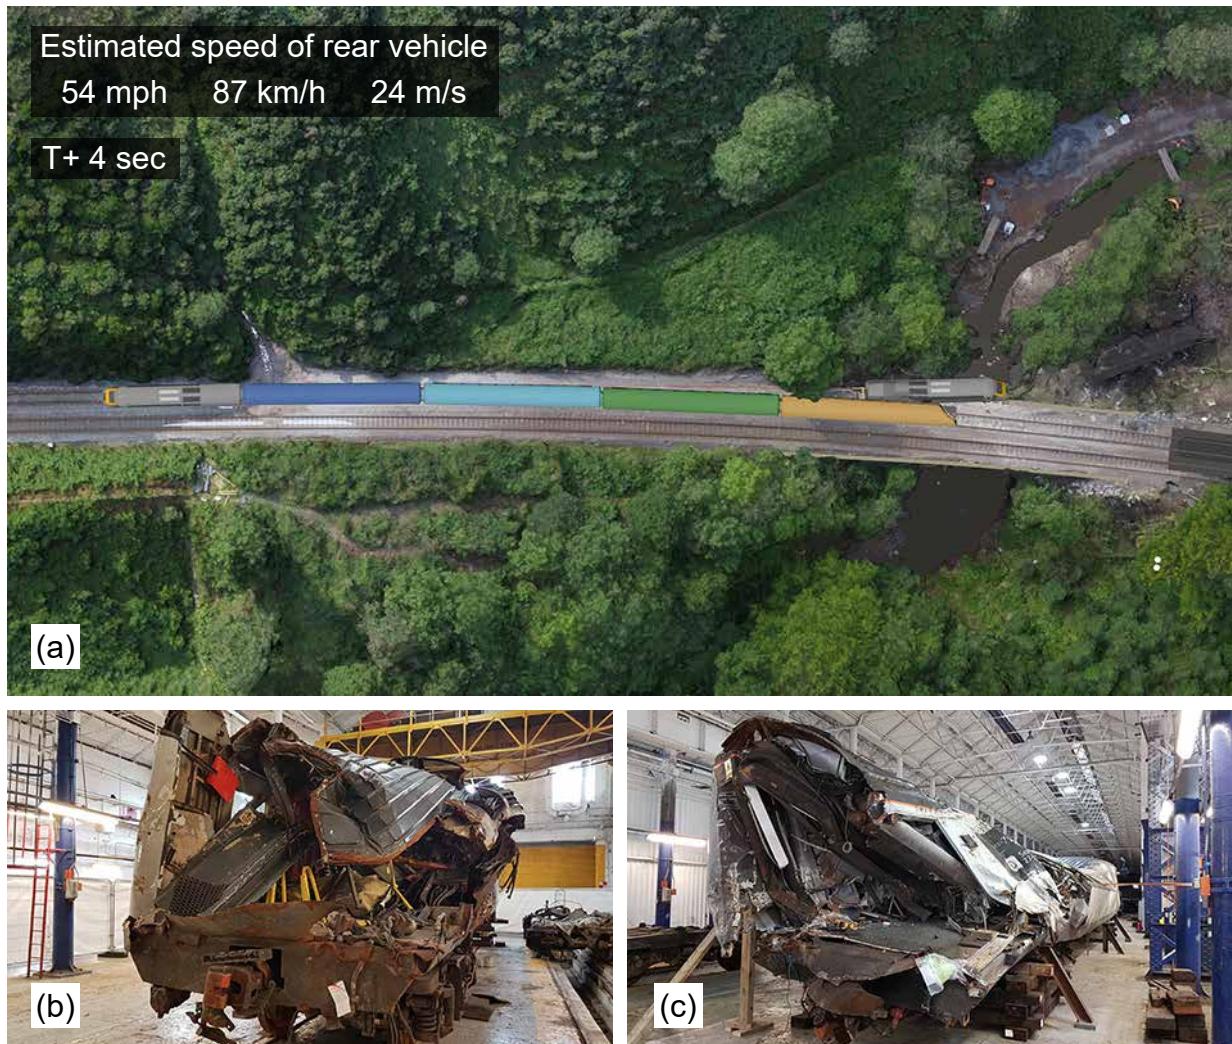
Figure E.5 (T+4 seconds):

- Overriding continues between leading power car and coach D, image (a).
- Rear of power car no longer restrained by coach D, image (b).
- Coach D lifts off from its leading bogie during overriding, which allows further interpenetration between the vehicles, image (c).
- Power car veers off the bridge.

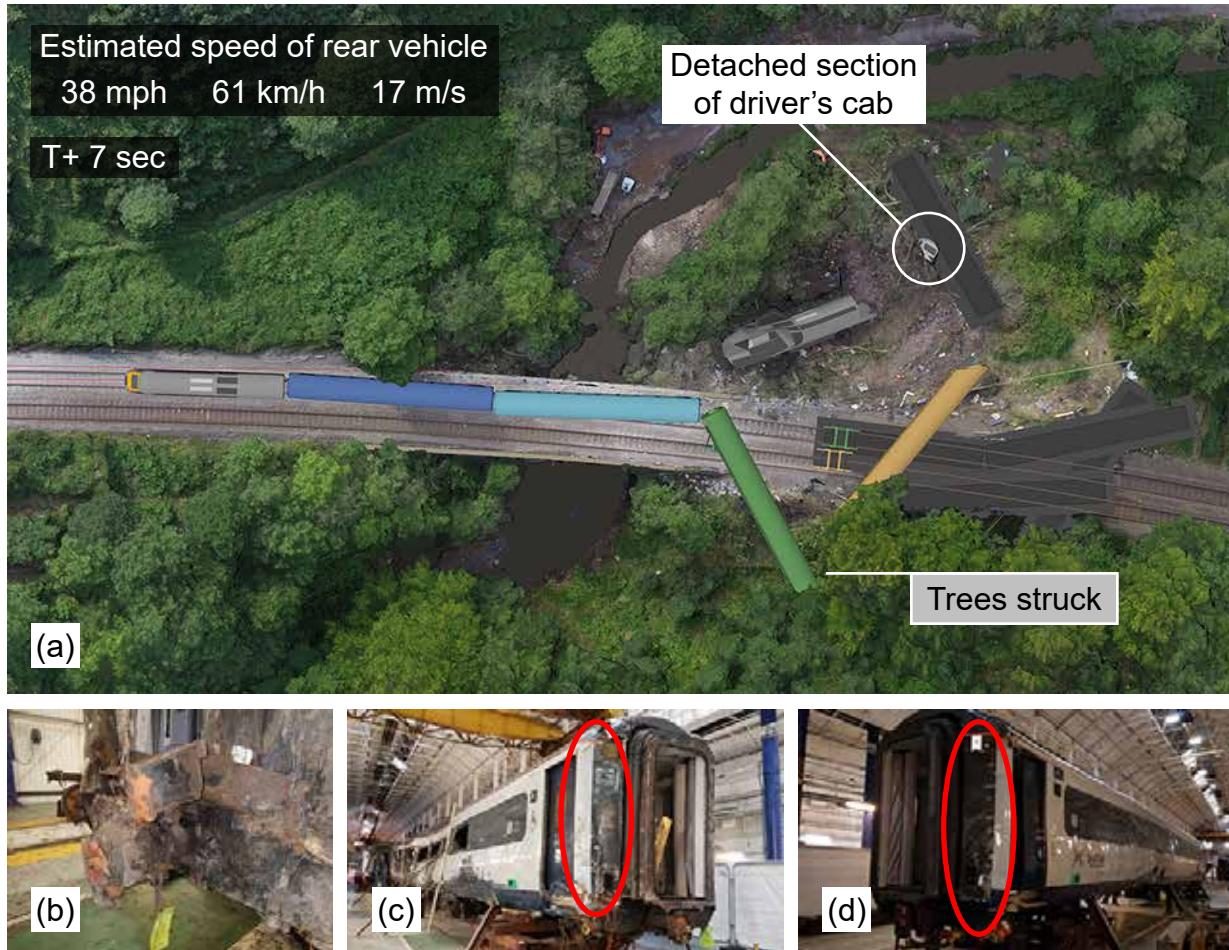
Figure E.8 (T+7 seconds):

- Driver's cab detaches and moves down the embankment slope, image (a).
- Coach C runs through trees while pitching down and impacts the earth bank on the up cess. Wood from trees in the up cess was found in the leading coupler of coach C, image (b), confirming its path.
- One passenger is ejected through the leading gangway of coach C.
- Jack-knifing occurs between coach C and coach B resulting in corner contact damage to coach B, image (c) and coach C, image (d).
- Coach D slides forward on its underframe, maintaining its rotated position.

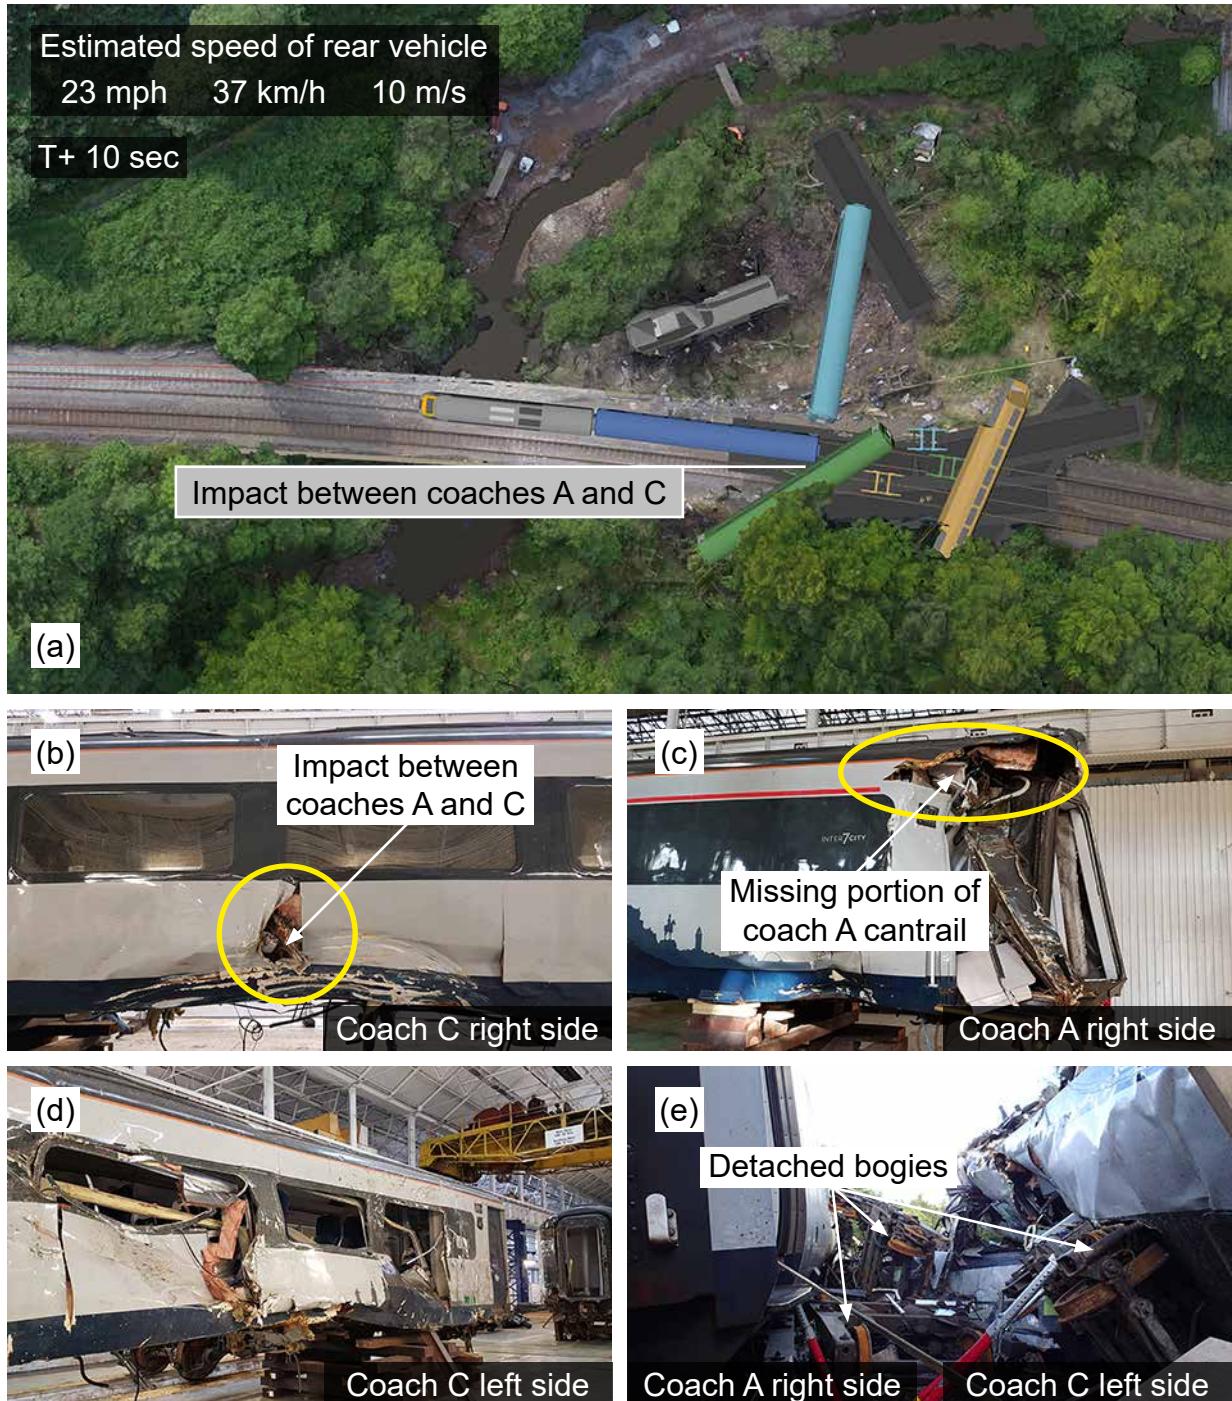
Figure E.11 (T+10 seconds):

- Coach A collides with coach C, penetrating coach C's bodyside, images (a) and (b) with a portion of its right-hand cantrail, image (c).
- Coach C is driven round clockwise by the impact with coach A and strikes detached bogies in its path, image (e). The trailing left-hand side suffers penetration damage, image (d).
- Meanwhile coach B continues to move towards its final rest position.
- Coach D is at a temporary rest position on its right side.

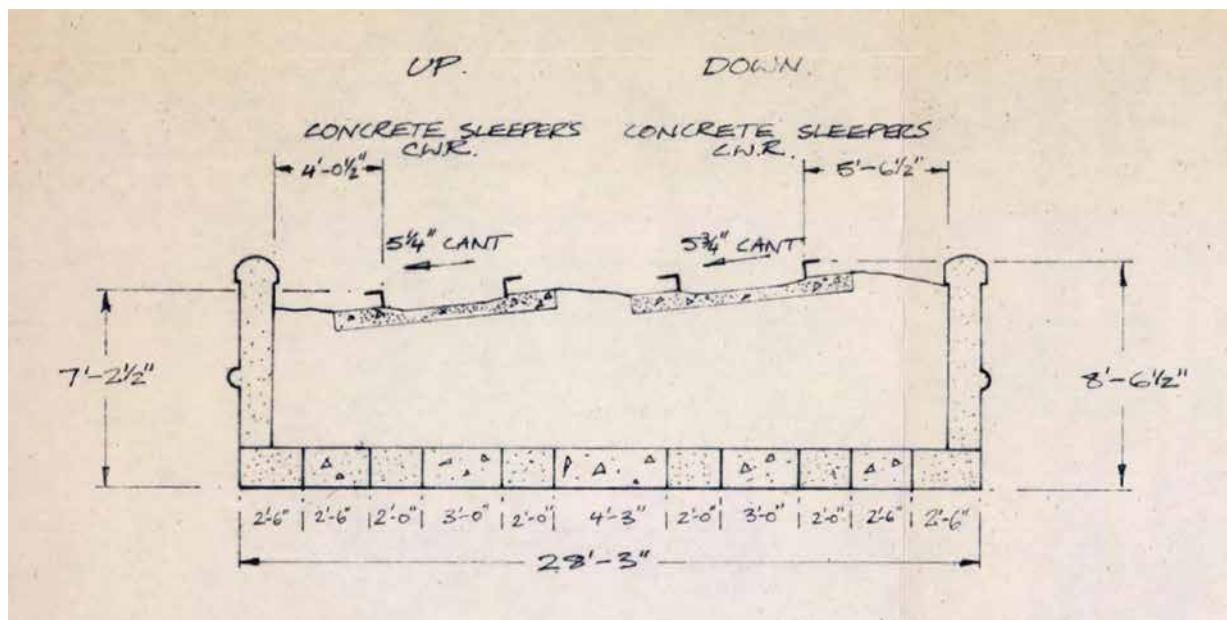
- F20 British Rail issued a structural assessment report for bridge 325 in December 1980. Photographs included in this report show that the reduced height sections of parapet had, by then, been infilled with concrete blocks to make each parapet a uniform height. Infilling the gaps allowed the ballast depth to be increased and a cross-section drawing within the report shows the top of the ballast at the same level as the underside of the coping (uppermost) stones on the down-side parapet (figure F.3). The ballast remained at about this level until the accident. A post and wire fence was installed as parapet edge protection for staff working on the railway.

Figure F.3: Drawing showing level of the tracks relative to the parapets (British Rail)

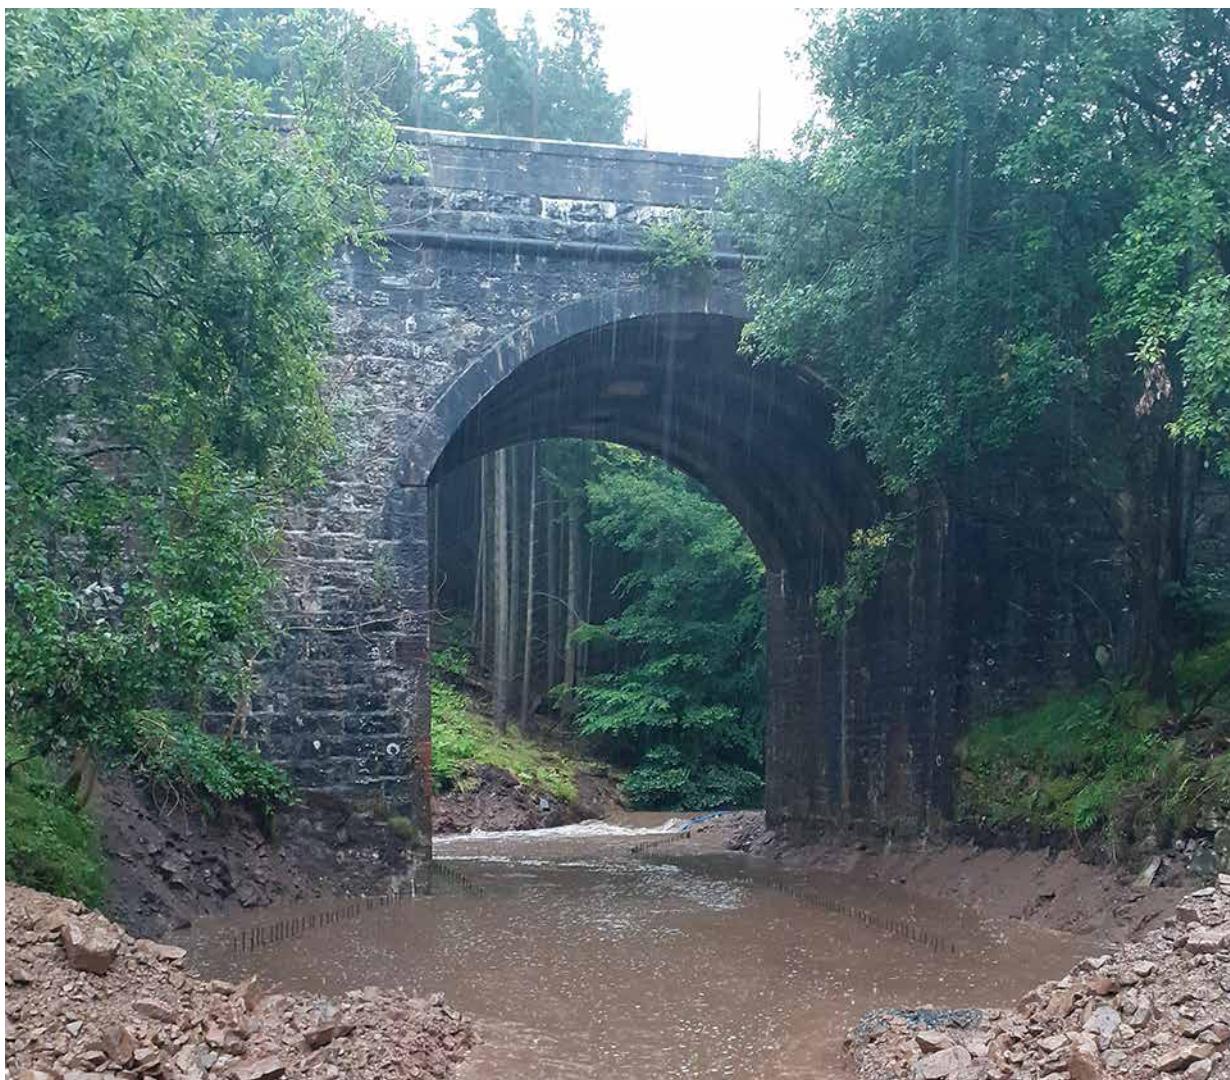
- F23 The most recent detailed examination of bridge 325 was undertaken in November 2014. The examination report recorded a parapet height of 100 mm from top of ballast level adjacent to the down line and 300 mm adjacent to the up line. The report identified some deterioration to the masonry and noted that the low mileage abutment had 'wet and damp patches throughout'. It recorded that the down-side parapet was in fair condition. Longitudinal fractures were identified on both sides of the arch where it met the spandrel walls. The examination report indicated that there were no previously unreported defects.

- F24 The depth of the ballast present before the accident meant that it applied an outward force on almost the full height of the down-side parapet wall and for a large proportion of the up-side parapet wall. It is possible this force contributed to the formation of longitudinal fractures between the arch and the spandrel walls (figure F.4). There is no evidence that these fractures influenced the behaviour of the parapets during the accident.

Figure F.4: Down-side elevation of bridge 325 at 08:19 hrs on 12 August 2020, shortly before the accident (Story Contracting)

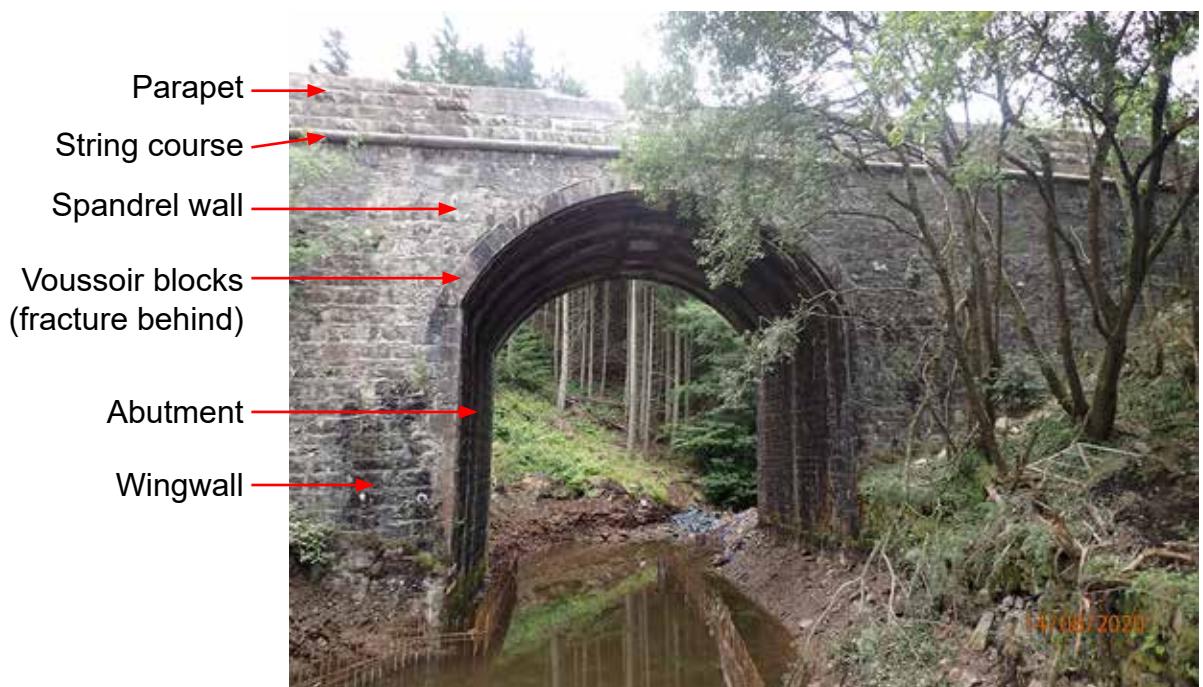
- The section of parapet over the low mileage (south end) wingwall had three areas of deep mechanical spalling to the exposed top two courses up to 220 mm deep. The adjacent stonework remained stable. (RAIB site measurements indicate that parapet damage at the south end of the down-side parapet extended for about 6 metres, figure F.5).
- The parapet had its coping stones pushed off for the full length with the exception of five coping stones over the high mileage wingwall (north end). These had been displaced by up to 100 mm but remained stable (figure F.6).
- There was a large damaged (spalled) section of masonry directly above the crown (centre) of the arch (figure F.7).
- Otherwise the down-side parapet stonework remained intact and stable.

Figure F.7: Down-side elevation of bridge 325 on 14 August 2020

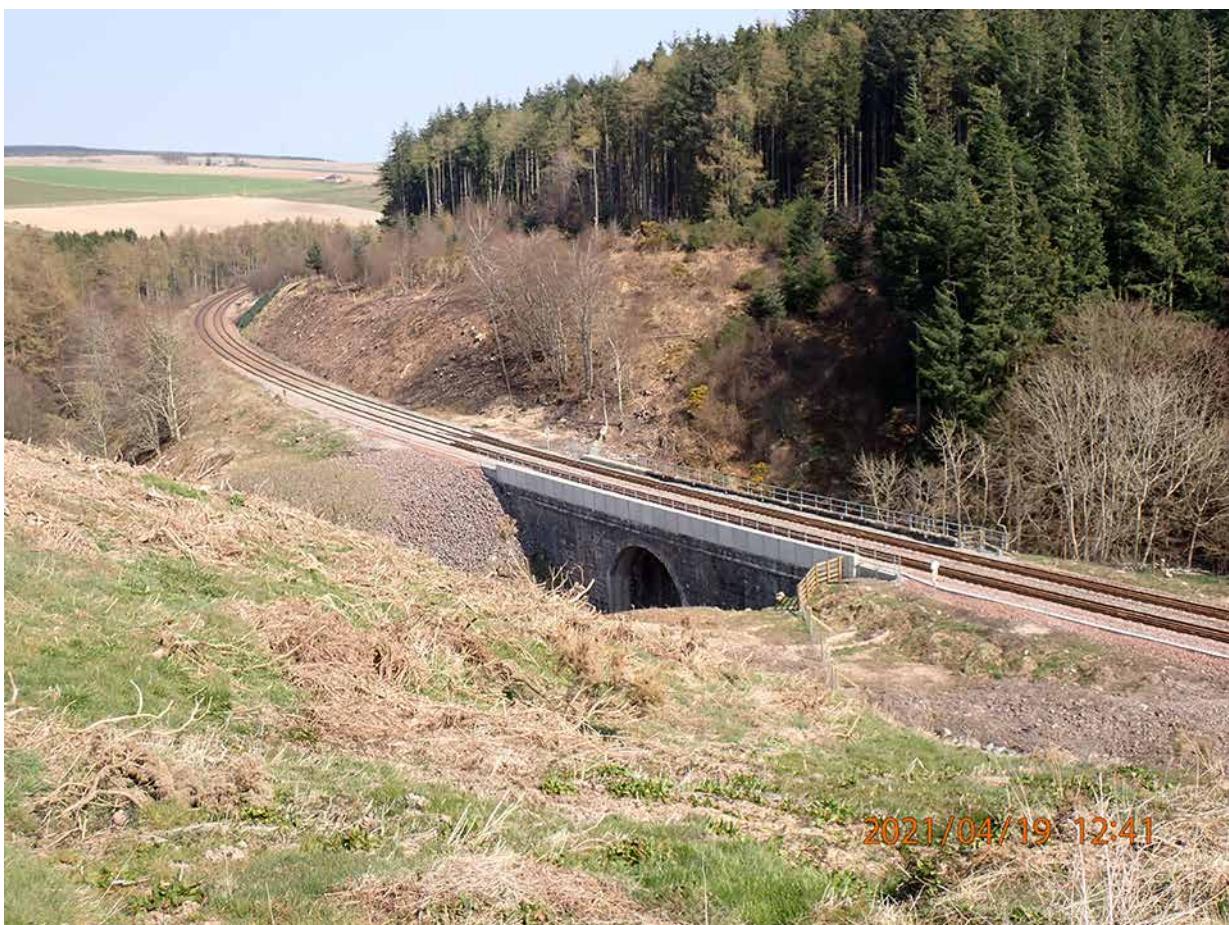
Figure F.9: Bridge 325 in April 2021 following the replacement of the down-side parapet and track

- The damaged section of the up-side parapet at the high mileage end of the structure, over approximately 6 m length, was taken down to sound material and rebuilt like-for-like in new masonry. This required a new handrail which was continued for the full length of the up-side parapet.

- Grouted stitching bars were installed to each stone (voussoir) in the arch ring embedded 2 metres into the arch barrel on both the up-side and down-side. Network Rail has confirmed that these works addressed existing defects within the structure (longitudinal separation fracture between spandrel (voussoir) and barrel), and were considered integral to reinstating the full integrity of the structure due to the potential impact damage suffered during the accident.

- Grouting of a vertical hairline fracture to the high mileage (north) abutment.

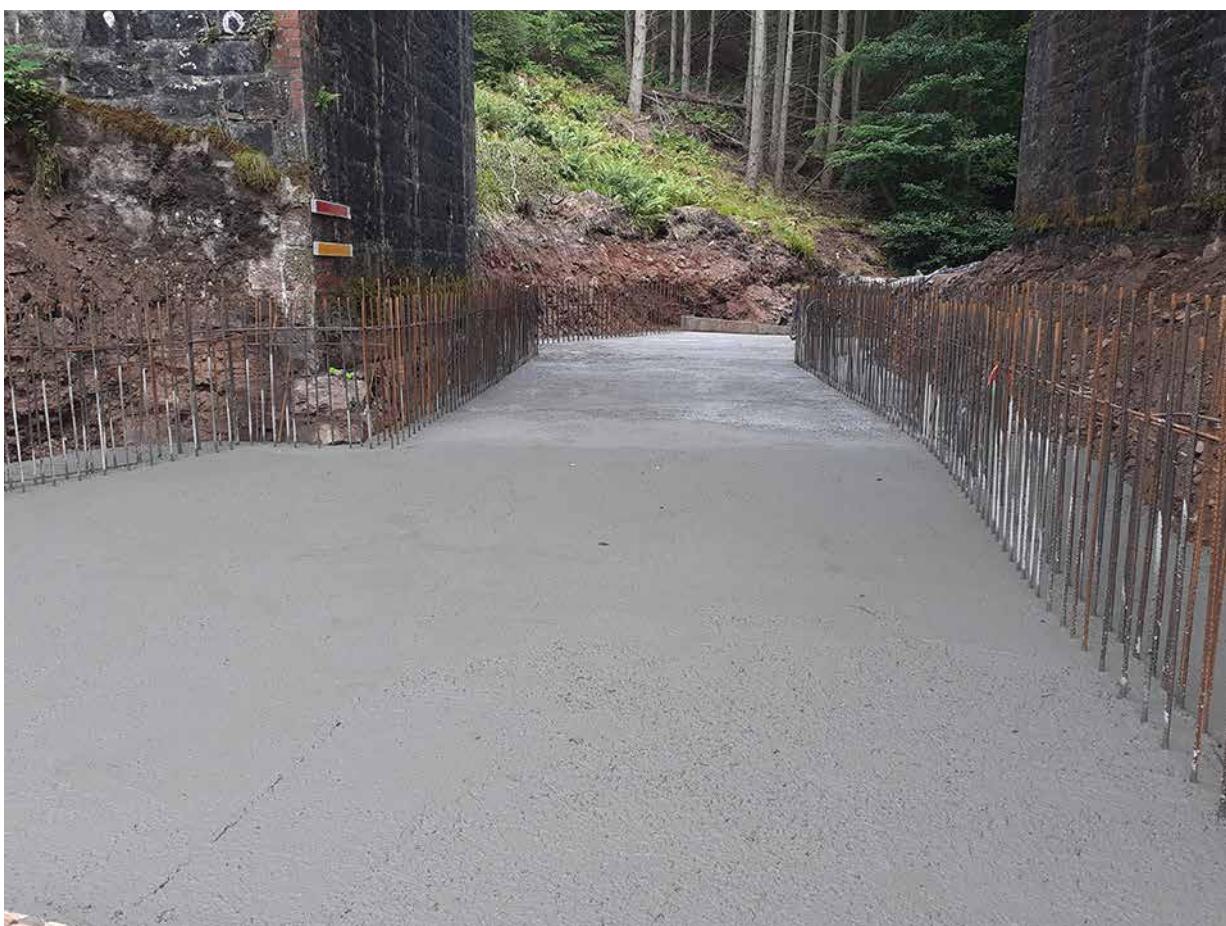
F29 At the base of bridge 325, scour protection works were in progress at the time of the accident to prevent the river eroding away the bridge foundations. The northern abutment had been identified as vulnerable during a scour assessment undertaken on behalf of Network Rail in September 2016. Scour risk meant that the structure was monitored when river levels were high, but this was not the situation on the morning of 12 August 2020.

- F30 In its planning application to Aberdeenshire Council submitted in June 2019, Network Rail described the works as ‘to construct a reinforced concrete invert within the channel near the bridge to provide a high level of scour protection with minimal excavation, mitigating the risk of undermining the bridge’s shallow abutment.’ Story Contracting was awarded the contract to install scour protection to both bridge 325 and bridge 328 located approximately 1.8 km (1.1 miles) further north.
- F31 Work at bridge 325 commenced on 20 July 2020, and the concrete forming the main base slab across the river bed was poured on 11 August 2020 (figure F.10). During these works, the river flow was controlled by a temporary dam and diverted through a pipe. There is no evidence suggesting that scour or the works being undertaken to address scour risk were factors in the accident.

Figure F.10: Scour protection works at bridge 325 on 11 August 2020 (Story Contracting)

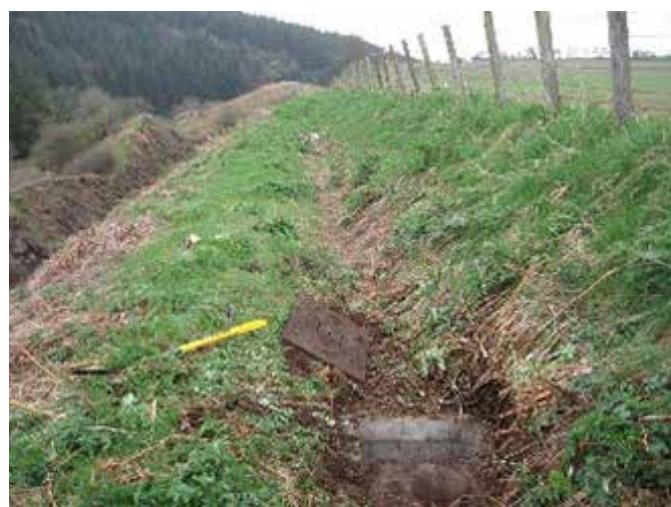
Figure G.1: Pre-2010 crest drain catchpit between CP10 and CP16 showing drain close to the cutting crest in 2010 (Carillion)

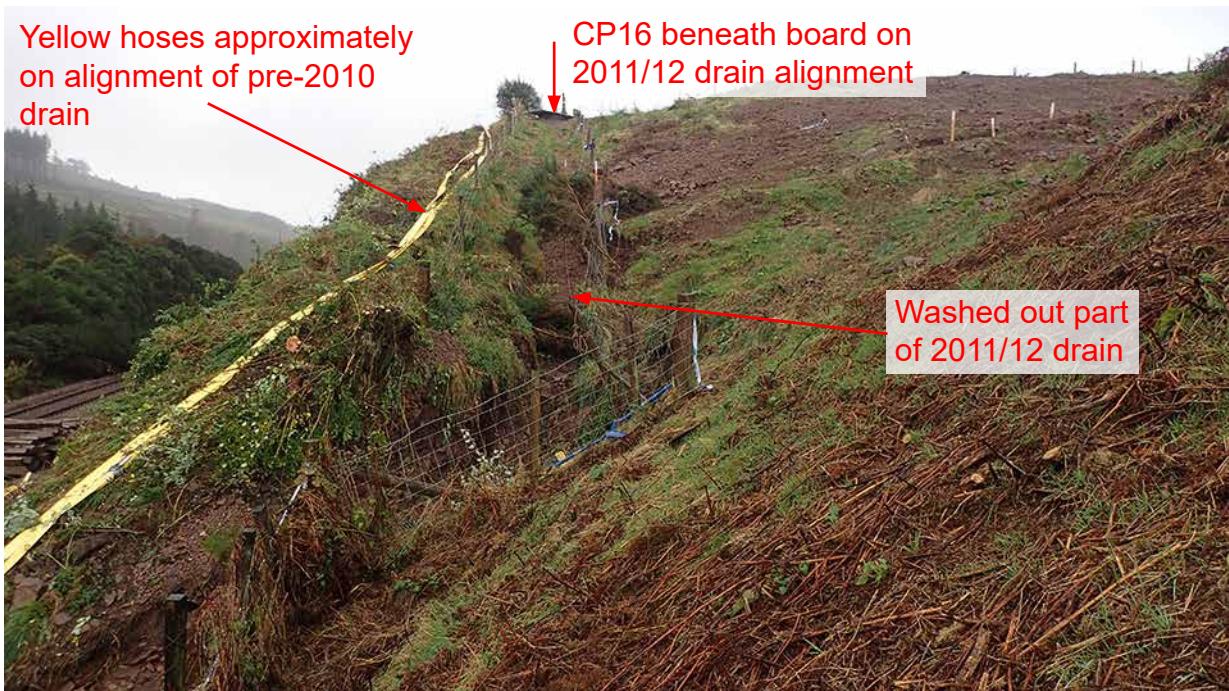
Figure G.2: View from near CP18 towards CP16 showing alignment of the pre-2010 crest drain and the 2011/12 drain after post-accident vegetation clearance

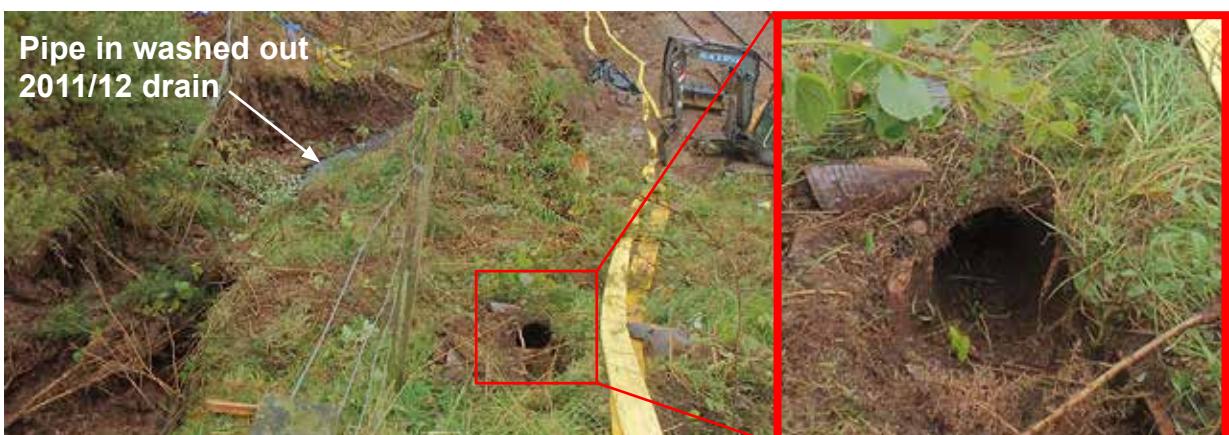
- G4 Observations after the accident showed that the old drain still collected and discharged water, although the way it did this would have been influenced by post-accident investigations, such as those which exposed the lower end of the pipe. There is no evidence that the old drain discharged water in a manner which influenced the accident. A broken section of pipe was found on the ridge separating the funnel feature and the new drain from the railway. Although the break was positioned near the top of the area from which gravel was washed from the 2011/12 drain, and was likely to have been present before the accident, there were no witness marks (such as soil erosion) indicating a significant outflow of water from the pipe at this location (figure G.3).

Figure G.3: Break in pre-2010 crest drain near top of washed out section of 2011/12 drain looking downslope with railway visible in top right-hand corner of image

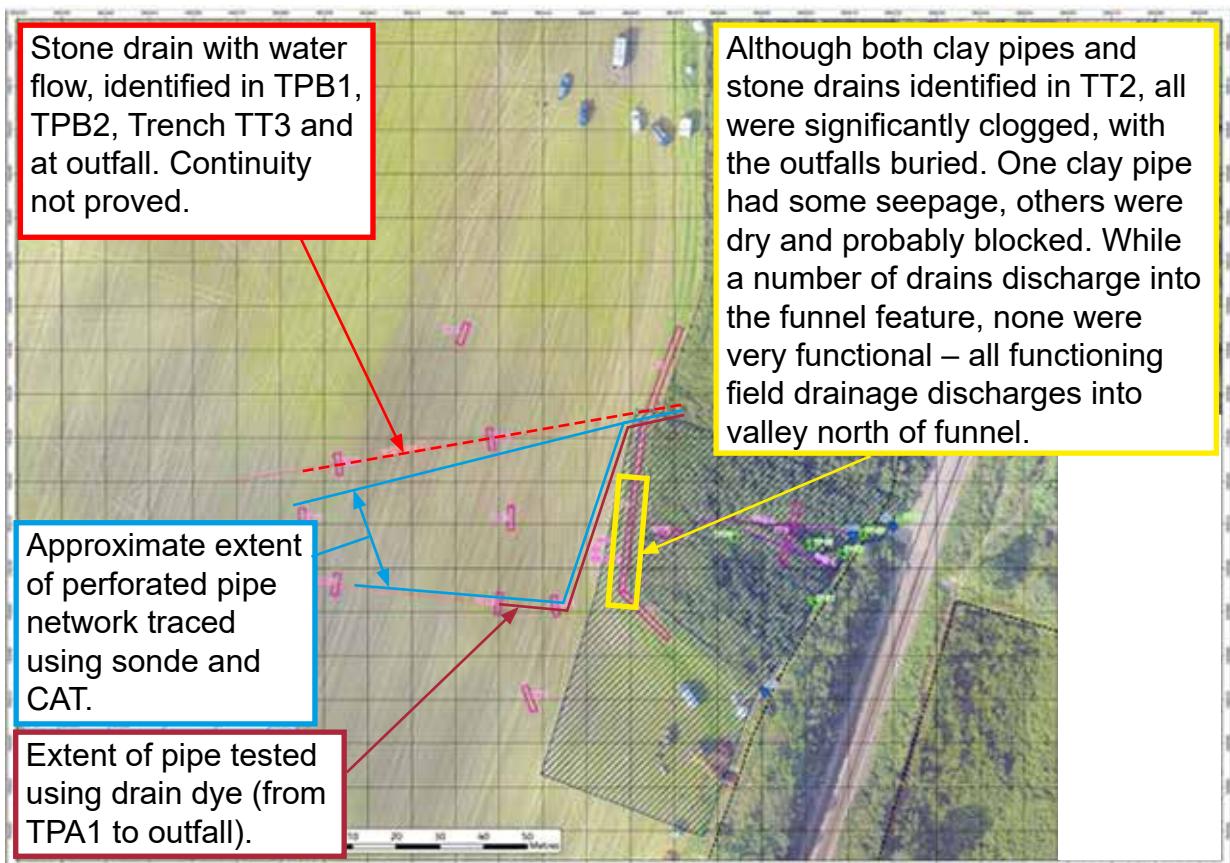
- G9 Post-accident investigations undertaken by Network Rail in the field adjacent to the funnel feature revealed a network of field drains laid a short distance below the ground surface (figure G.4). Some comprised large stones placed in a trench and then covered with soil (probably the oldest drains), some consisted of clay pipes and some were constructed with plastic pipes (probably the newest). Sediment in the older drains suggested these no longer carried large flows but some of the newer drains appeared to convey water. Testing showed that some of the newest pipes conveyed water to an outfall in an area to the north of the funnel feature where a natural valley carried water down to the ditch, which also collected water from the drain outfalls described in paragraph G6.

- G10 The investigations were sufficient to establish that the field drains would have a relatively small effect on surface flows during heavy rainfall, due to the time taken for water to percolate through the soil to reach them (although they would reduce long-term waterlogging of the soil). The full extent of field drains was not established. The extent of pipes exposed during investigations is shown on figure G.5. Variations in vegetation colour visible on aerial photographs indicated that the field drain network probably extended most of the way to the side spilling ditch shown on figure 29.

Figure G.5: Field drain survey findings (edited version of Network Rail drawing)

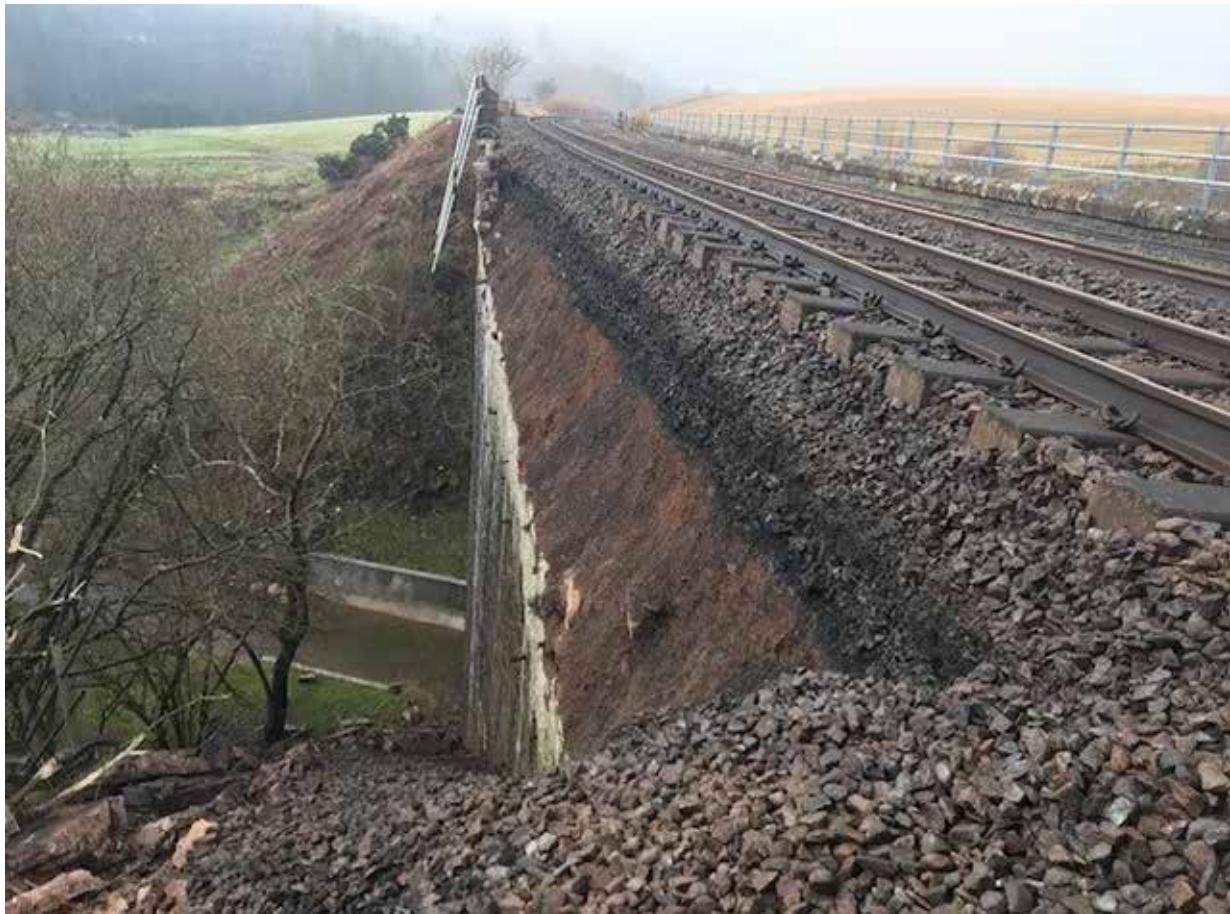
Figure M.2: Up line on bridge 328 looking south on 15 January 2021 (Network Rail)

- M5 An investigation undertaken by Network Rail found that the parapet had become pushed outwards by deep ballast on the bridge. Additional ballast had been placed as part of a track upgrade undertaken between 1980 and 1993. During this project, jointed rail was changed to continuous welded rail. The depth of the ballast was increased to support the stresses and forces generated by the rail being welded together and stressed and to allow train speeds to be increased. There was no evidence that the parapet wall had been designed to carry forces from the ballast and its failure was exacerbated by the presence of existing defects in the parapet and wingwall.

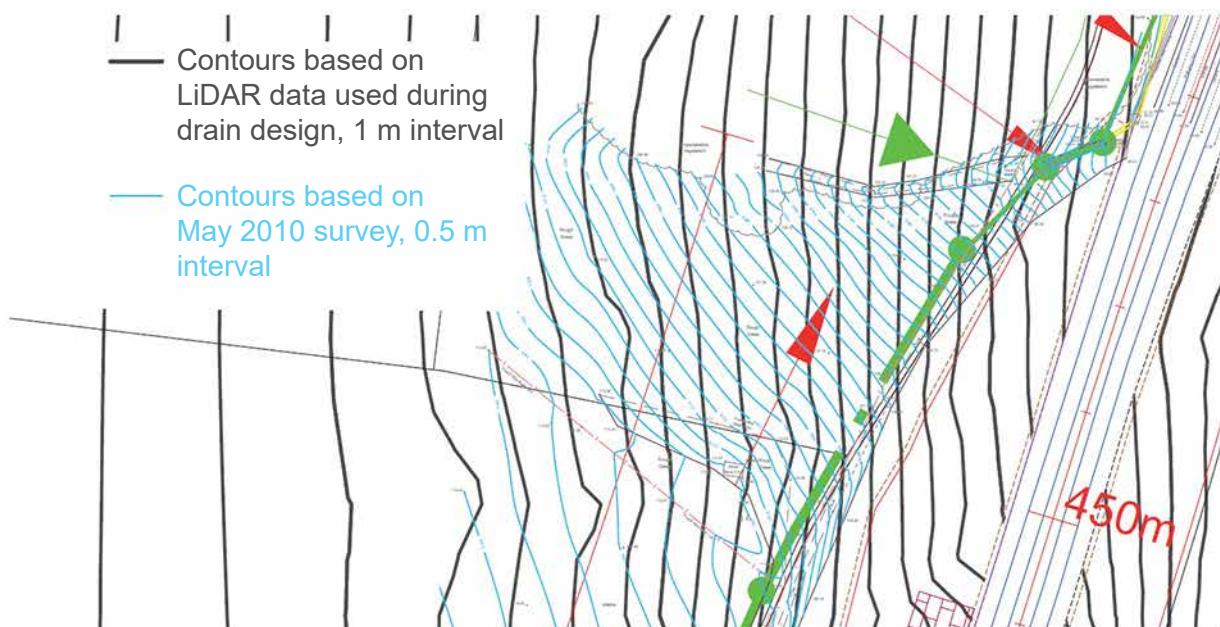
- N3 The LiDAR data used by Arup lacked the accuracy needed to show the funnel feature, but this was shown on additional survey data which was provided to Arup in May 2010 (paragraph 95 and figure 33). The two sets of data are compared on figure N.1.

Figure N.1: Funnel area contours compared

- N4 Some unwanted material excavated during construction of the 2011/12 drain was placed on the southern face of the funnel feature, so it is shown on the post-accident LiDAR survey, but not on the May 2010 survey. There is no evidence suggesting that the placement of this material affected the accident.
- N5 Network Rail standards applicable in 2010 did not specify the method to be used to calculate the amount of water reaching each part of the 2011/12 drain. Arup used the Institute of Hydrology Report 124 (IH124) method. AECOM confirmed that the Arup calculations were in accordance with this.
