AAIB Bulletin

5/2022

Aircraft Type and Registration:	Silent 2 Electro, G-CIRK	
No & Type of Engines:	1 FES electric motor	
Year of Manufacture:	2013 (Serial no: 2054)	
Date & Time (UTC):	23 April 2021 at 1305 hrs	
Location:	Wormingford Airfield, Colchester, Essex	
Type of Flight:	Private	
Persons on Board:	Crew - 1	Passengers - None
Injuries:	Crew - 1 (Serious)	Passengers - N/A
Nature of Damage:	Aircraft destroyed	
Commander's Licence:	Light Aircraft Pilot's Licence (Sailplanes)	
Commander's Age:	71 years	
Commander's Flying Experience:	295 hours (of which 55 were on type) Last 90 days - 13 hours Last 28 days - 13 hours	
Information Source:	AAIB Field Investigation

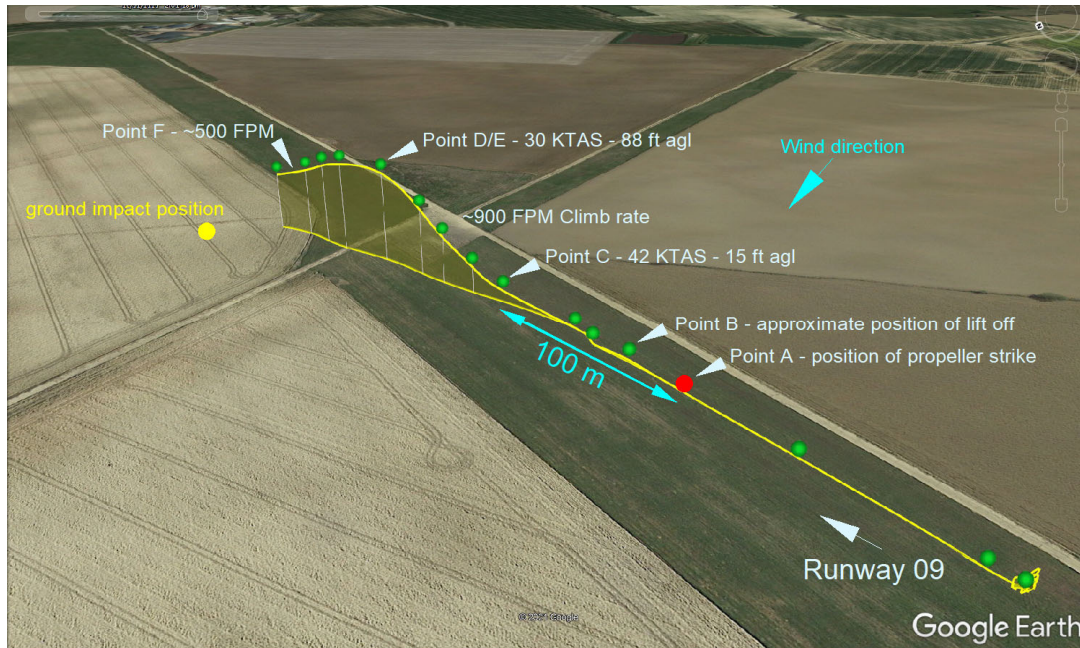
Figure 4
GPS derived data for accident takeoff

A series of 11 propeller slash marks were found on the runway surface near the liftoff point (Figure 4) with an initial spacing of about 10 cm.

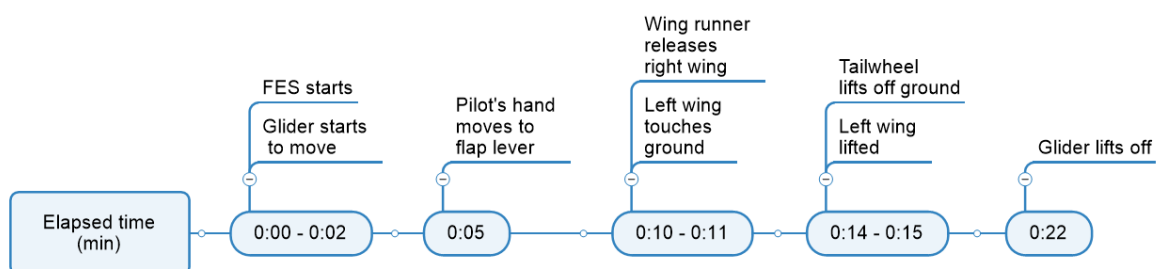
Figure 5
Timeline of the pilot’s previous self-launch takeoff

The video of the pilot’s previous takeoff showed that approximately three seconds after the glider started to move, the pilot transferred his left hand from the instrument panel mounted FES control unit onto the flap lever (Figure 5). The flap lever appeared to be in the flap +1 position but the angle from which the footage was taken meant that this could not be positively confirmed. After a further five seconds, the wing tip runner released the right wing and the glider immediately started rolling left over a period of one second, until the left wing touched the ground. G-CIRK’s tail wheel lifted off the ground three seconds later, just before the glider rolled right into a wings level attitude. During the following six seconds, some minor oscillations were noted in all axes but the pilot appeared to correct these. The glider then lifted off and climbed in a nose up attitude to a height of about 30 ft agl, before the nose was lowered slightly, to what appeared to be an almost level pitch attitude, and a shallower climb was established. The video ended when the glider was at a height of about 45 ft agl.

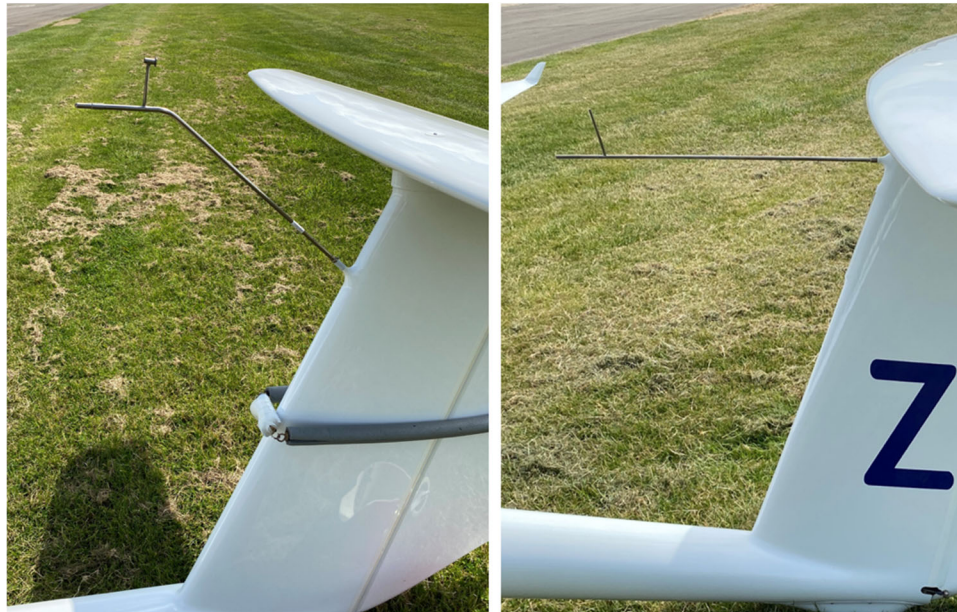
Figure 8

A pitot tube is used for measuring airspeed and G-CIRK was fitted with an angled version attached to the leading edge of the vertical tail (Figure 8, left). This same type of pitot tube was fitted to the Silent 2 Electro that was used for a flight evaluation as discussed later in the report. Later model Silent 2 Electro's have a straight pitot tube (Figure 8, right). It was reportedly changed to reduce aerodynamic drag.

Angled pitot tube fitted to G-CIRK and the flight evaluation aircraft (left) and straight pitot tube fitted to later model Silent 2 Electro's (right)

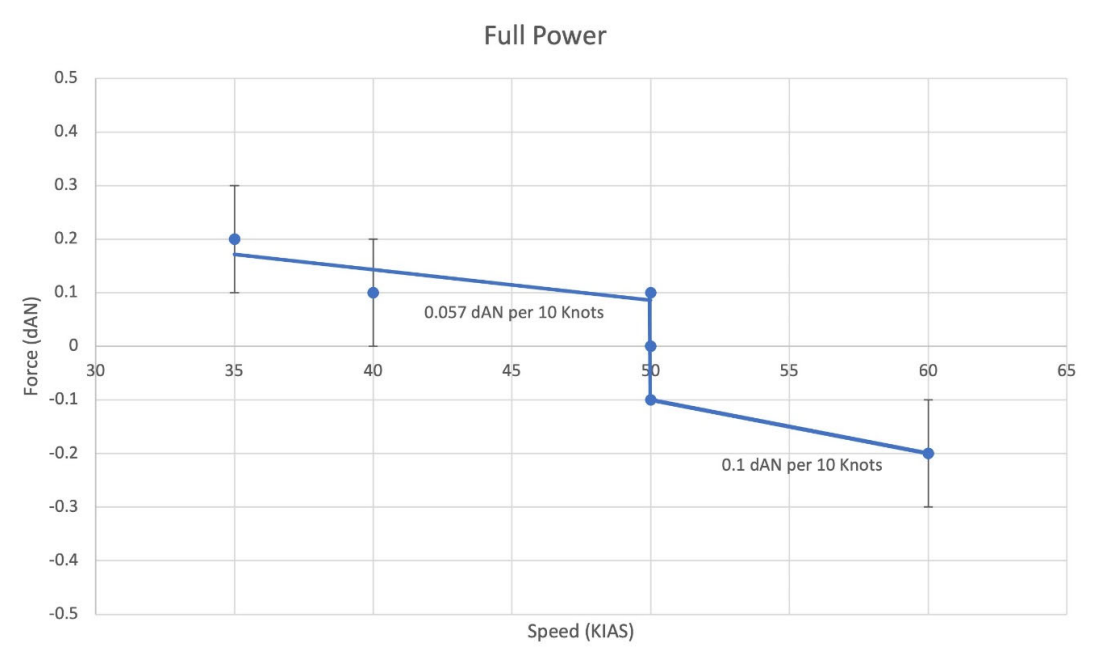
Figure 13

The stick force versus airspeed relationship was measured at low airspeed and full power (the takeoff scenario) and is shown in Figure 13. The slope was very flat at 0.1 dAN per

The test pilot reported that the flat stick force gradient and high break-out friction has two effects: it means that the pilot receives minimal feedback through the stick about how the aircraft is manoeuvring or its attitude, and it is difficult for the pilot to feel where the stick needs to be positioned to adopt a specific aircraft attitude or fly the aircraft smoothly and predictably.

The glider had weak positive longitudinal static stability at a CG that was 40 mm forward of the aft CG limit, so the stability would have been even less at the aft limit.

Stick force versus airspeed measurements

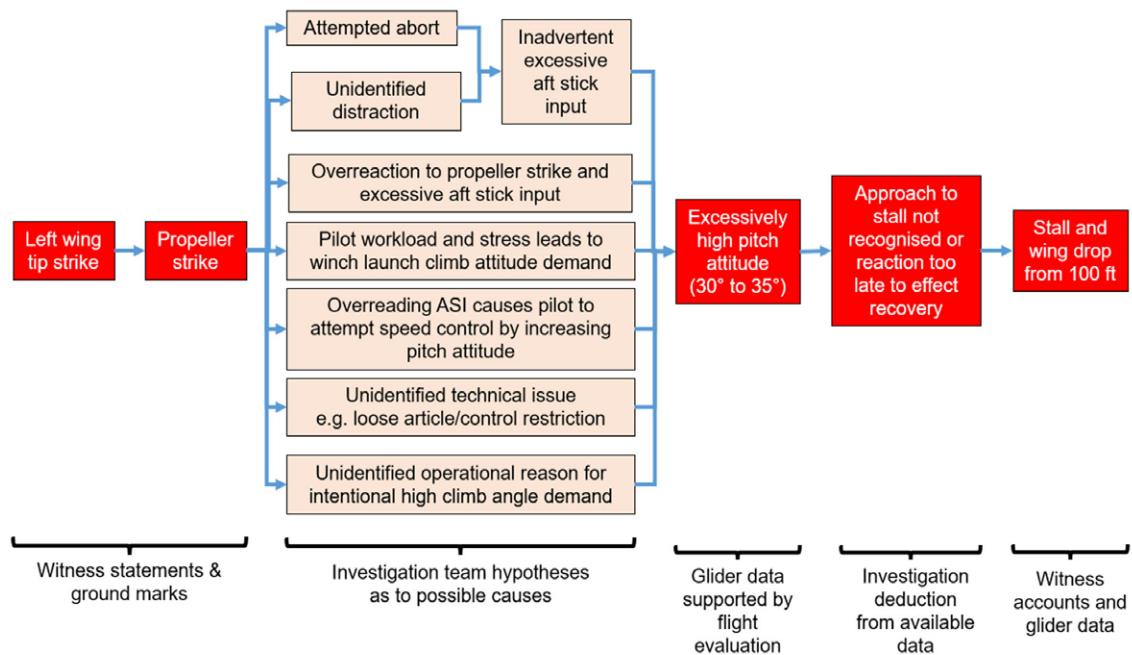
While the investigation could not determine the reason for the steep climb it considered that it most likely resulted from a single or combination of factors outlined in Figure 16 and explained below.

Sequence of events: actual (in red boxes) and possible (in pink boxes)

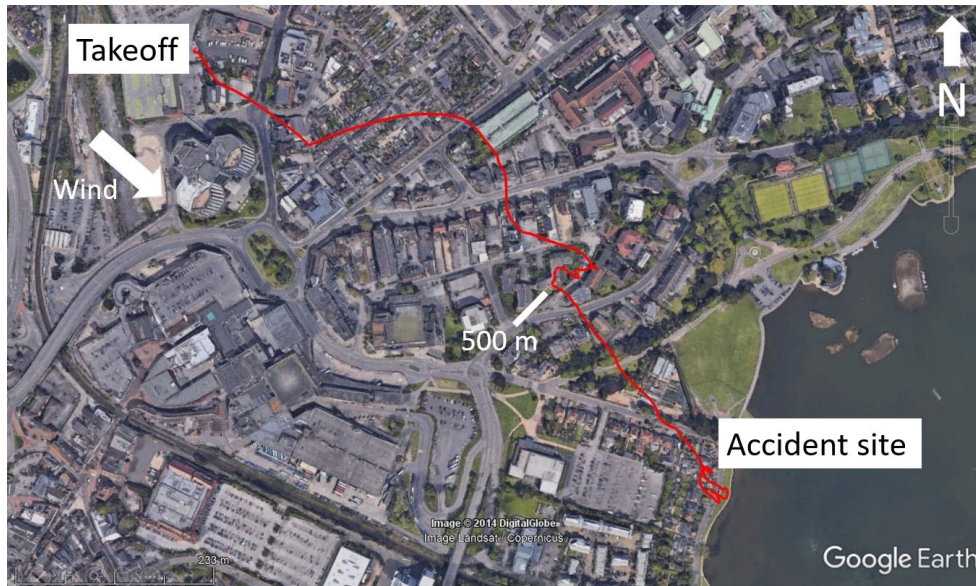
**Figure 1**

The pilot was now very concerned and activated the '*Return to home (RTH)*' feature on the controller, but it did not appear to engage despite being operated multiple times. RTH then appeared to activate but the aircraft did not move any closer. The pilot then switched to '*Sport Mode*' as per their emergency procedure which he expected would give him a top speed of 51 mph, allowing a greater ability to overcome the headwind. This cancelled the RTH feature so he pressed RTH again, but it would not re-engage. The remote pilot asked the observer to try engaging it using his slave controller, but this did not work either. At this stage neither the pilot nor the observer could see the aircraft, but they could see it on the moving map heading slowly towards Poole Park boating lake in a south-easterly direction (Figure 1). Both controllers then lost communication with the aircraft.

Accident flight ground track
Underlying image © Google Earth™

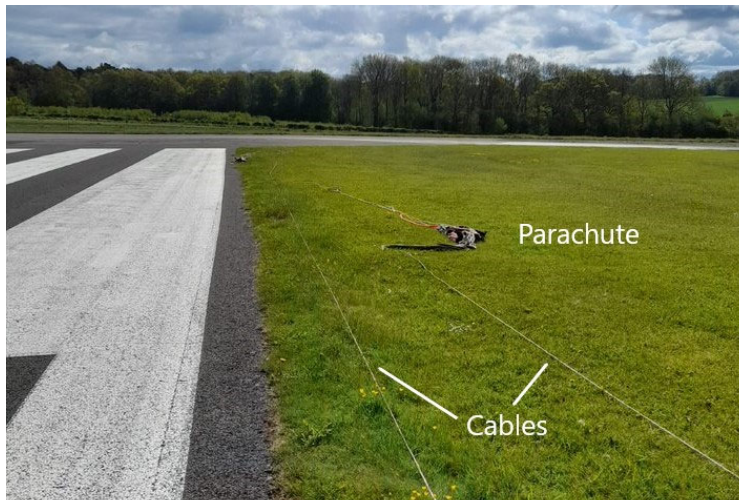
Figure 1

The investigation by the MRO found there was an absence of coordination between airfield users. This resulted in information not being shared between the flying operation and other sections of the gliding club. Consequently, the winch team was unaware that the arrival time of G-EZAJ was earlier than originally advised, while the flying staff were unaware of the planned winch cable maintenance.

Winch cables with parachutes laid on grass along southern edge of Runway 27 abeam the landing threshold

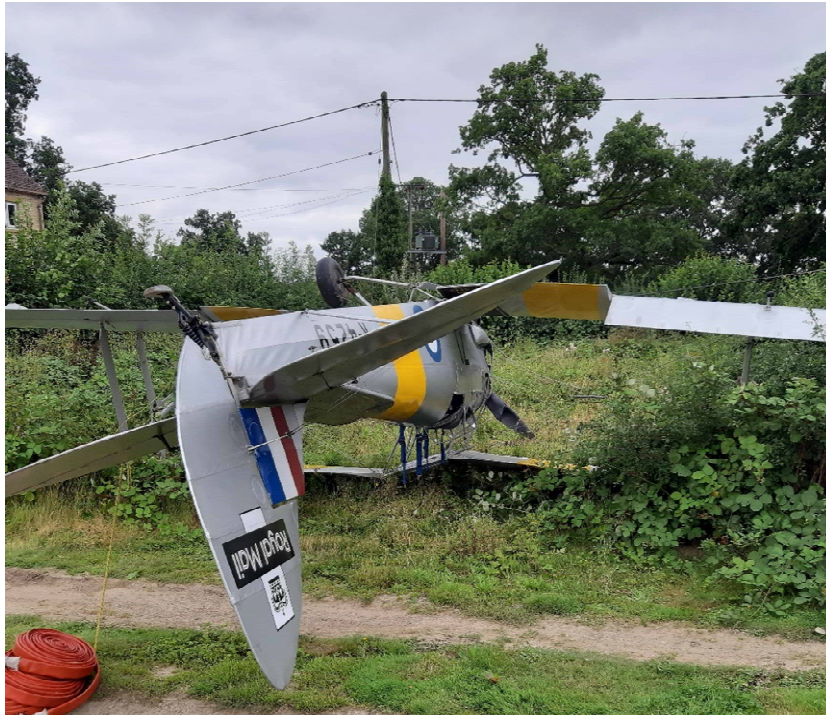
Figure 2

For the second approach the instructor again told the PF they were too high so the PF sideslipped the aircraft slightly to the right to lose some height. The PF, feeling the aircraft was getting low checked the altitude on his instruments, and noted they were descending through 300 ft aal at 50 kt. He then turned his attention to the touchdown point. By the time the aircraft neared the trees, the airspeed had decayed to near stalling speed. The PF felt the aircraft sinking and applied full power. In the meantime, the instructor hadn’t noticed that the aircraft was again low but also slow over the trees. The aircraft then started to buffet, which is an indication of an approaching stall, so the instructor took control just as the left wingtip hit a tree and the tailskid caught the power line. The aircraft pitched down and hit the ground, with very little forward speed, on the undercarriage and the nose, and finally onto its back (Figure 2).

The aircraft with the trees and power line on the approach to Runway 03

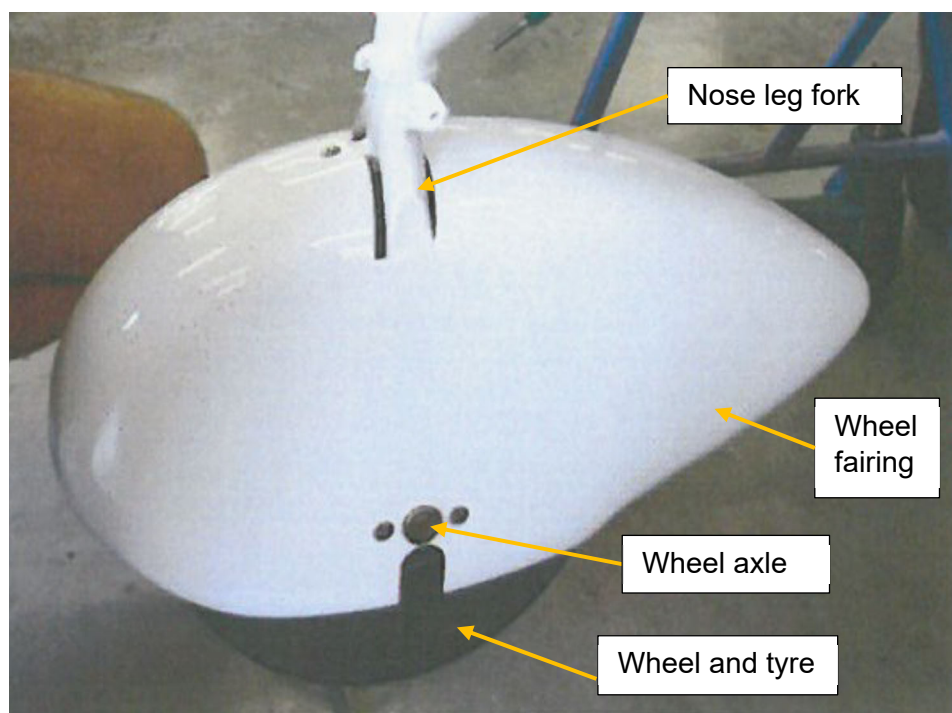
The potential to incorrectly fit the nosewheel to the leg fork was recreated during a visit to the manufacturer's UK facility. Figure 3 shows a correctly assembled nosewheel and Figure 4 is a view from underneath the fairing with the axle in place, but the wheel removed.

Example of an assembled nosewheel

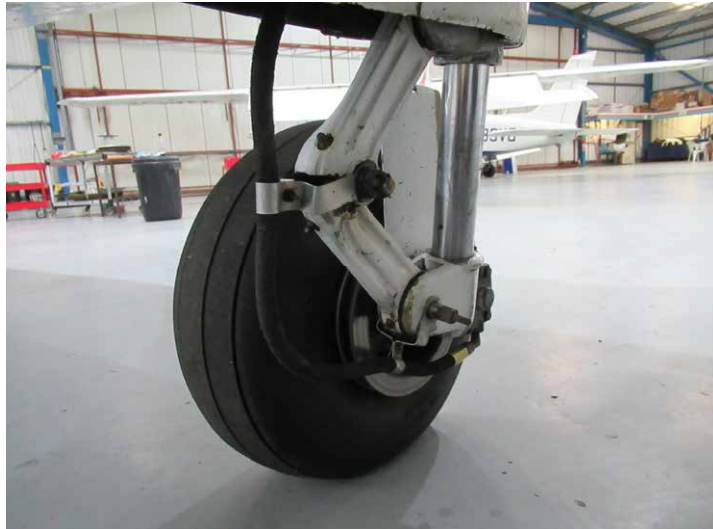
The Piper PA-28 has a fixed tricycle landing gear. Each main landing gear consists of an oleo with a single wheel and brake calliper. The lower part of the oleo is retained within the upper part by a torque link and flexible brake pipe. The torque link also maintains the alignment of the main landing gear wheels. Figure 4 shows the normal assembly (the photograph is of the left land gear of G-BRBA).

The original cast cylinders have a history of fatigue cracks developing in the torque link attachment lugs of the upper cylinder. Following previous failures of the lugs, the CAA issued an Airworthiness Directive (AD) requiring the inspection of the landing gear castings for cracks (AD 002-06-99).

PA-28 left main landing gear
