Rail Accident Investigation Branch

Rail Accident Report

**Track worker struck by a train near Surbiton station, south-west London
9 February 2021**

Report 05/2022
May 2022

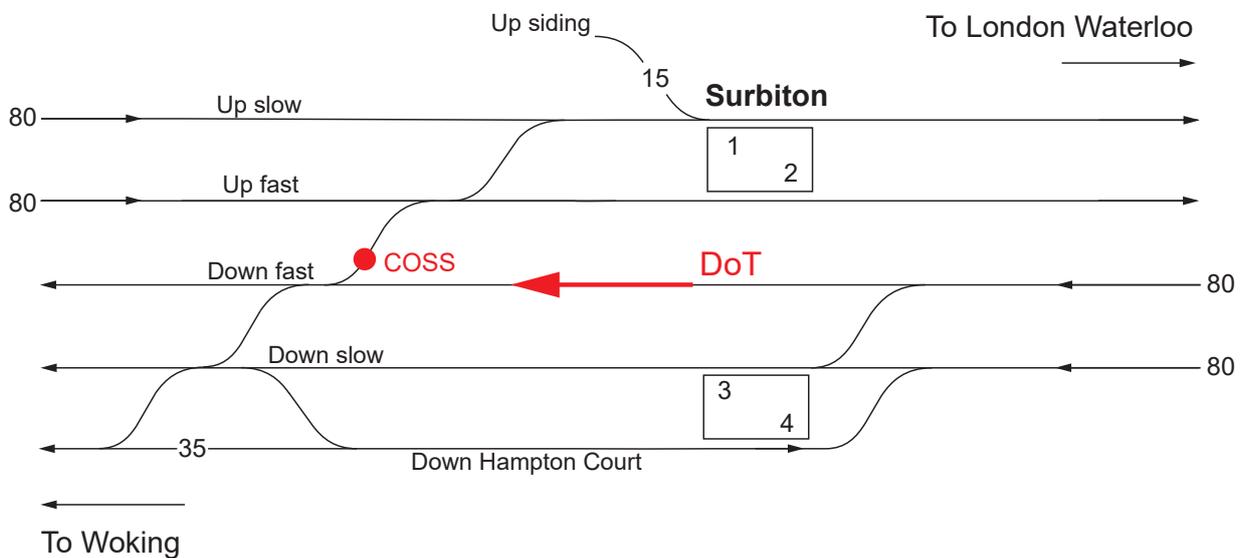
Figure 2: Track layout (not to scale and not all features shown)

- 7 Starting around 250 metres on the country side of Surbiton station, all five railway lines are interconnected by crossovers (figure 3). Crossovers connect lines together so that trains can move between them. They consist of a set of switches (moveable rails) at each end and a crossing (an assembly of track components used to support and guide train wheels where two running rails cross each other), together known as switches and crossings (S&C) (figures 3 and 4), which are connected by a section of plain line. The crossovers that are relevant to the accident are those that connect the up slow line to the up fast line, and the up fast line to the down fast line (figure 2).

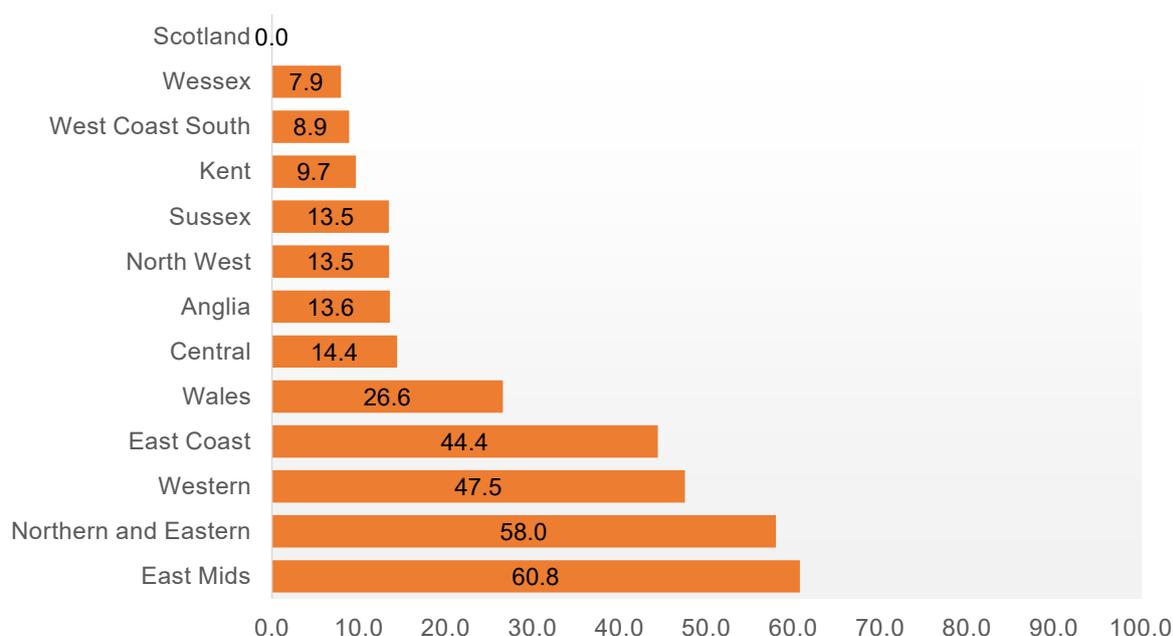
Figure 7: Data showing % reduction in baseline ULW hours to September 2020 (baseline is 1 April 2019)

118 During 2020, Network Rail’s Safety Task Force (paragraph 45) had raised concerns about the slow rate of reduction of ULW within a number of routes within Southern region, North West and Central region and Anglia route (figure 7).¹⁸ It engaged with senior management within these routes in an attempt to drive the TWS programme forward and reduce levels of unassisted lookout working.
