AAIB Bulletin

8/2022

Aircraft Type and Registration:	DA 40 NG, G-CTSB
No & Type of Engines:	1 Austro E4-A piston engine
Year of Manufacture:	2015 (Serial no: 40.N283)
Date & Time (UTC):	12 December 2020 at 0926 hrs
Location:	Cranfield Airport, Bedfordshire
Type of Flight:	Aerial Work
Persons on Board:	Crew - 1 Passengers - None
Injuries:	Crew - 1 (Serious) Passengers - N/A
Nature of Damage:	Aircraft destroyed
Commander's Licence:	Commercial Pilot's Licence
Commander's Age:	23 years
Commander's Flying Experience:	1,229 hours (of which 779 were on type) Last 90 days - 70 hours Last 28 days - 33 hours
Information Source:	AAIB Field Investigation

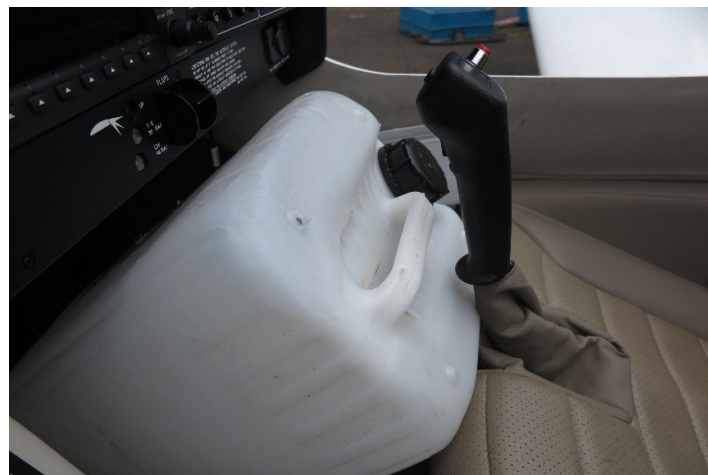
**Figure 8**

This demonstrated that with the container in the upright position the control stick could not be moved forward of the control neutral point, and only slightly forward of the neutral point with the container lying at an angle with its base as far forward as possible (Figure 8).

De-icing fluid container positioned at an angle with its base in contact with the rudder pedal adjustment rail

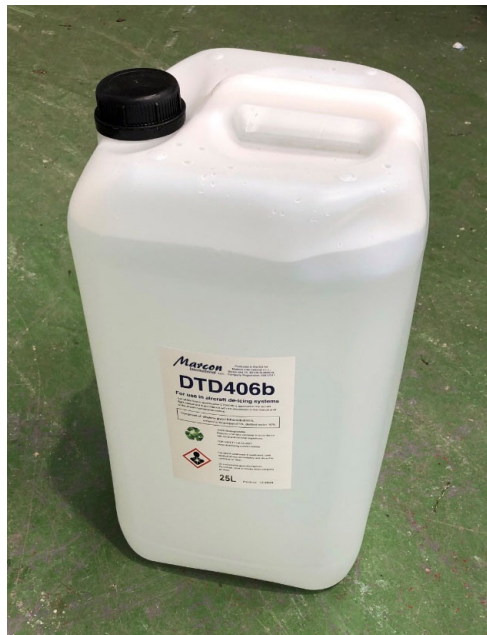
Figure 13

25 litre container as carried in G-CTSB

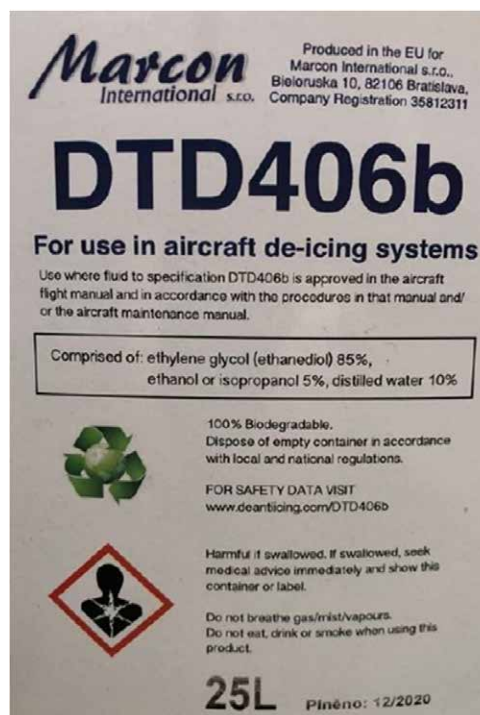
Figure 14

Each container (Figure 13) had a label affixed (Figure 14). The label stated the contents as DTD406b de-icing fluid consisting of 85% ethylene glycol (ethanediol), 5% ethanol or isopropanol, and 10% distilled water. It did not carry a UN number, but did carry markings and wording identifying that gas, mist and vapours should not be inhaled, nor the fluid ingested. It also provided a web address for safety data which, when tried, did not exist.

Label affixed to each container of de-icing fluid

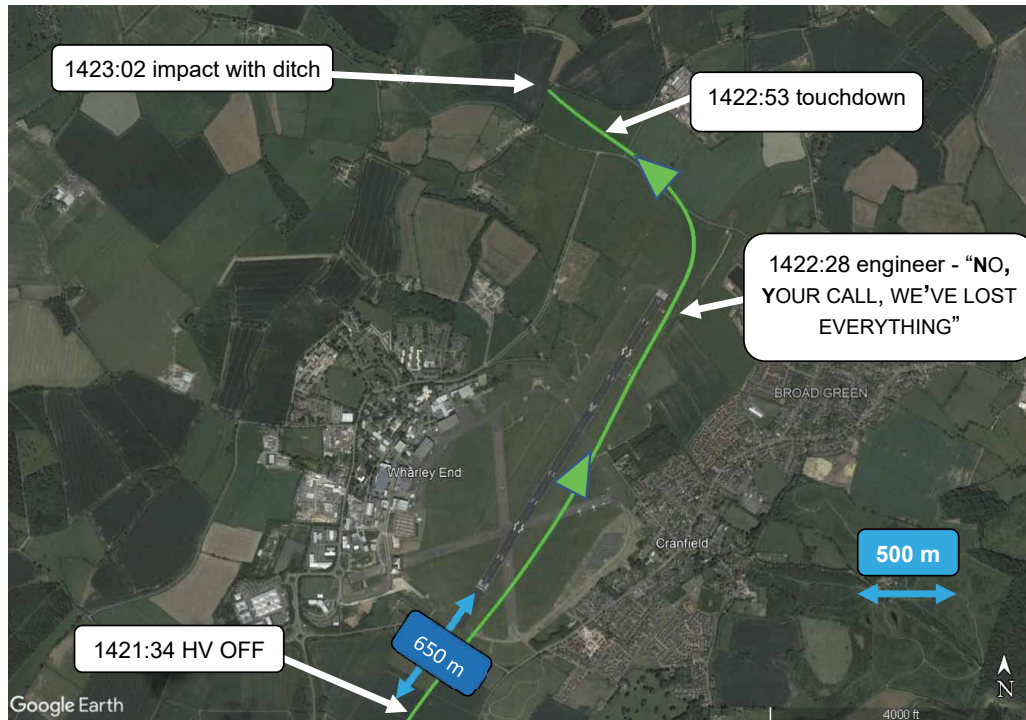
At 1421:34 hrs, the pilot selected the HV battery OFF using a switch in the overhead panel. The aircraft was located 650 m (Figure 9) from the displaced threshold of Runway 03 at 1,300 ft amsl (942 ft aal).

Figure 9
G-HYZA track

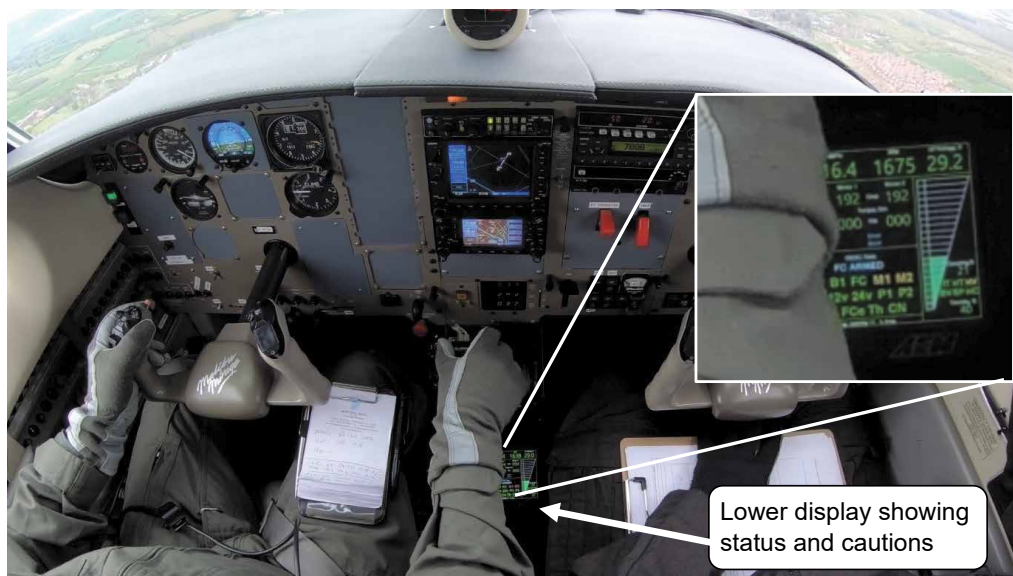
The recorded power lever position was 41% and the motor rpm was 2,310 rpm. The pilot returned his hand to the power lever which then obscured his view of the lower display (Figure 10).

Figure 10
G-HYZA cockpit camera view, just after HV selected OFF,
showing zoom of lower display

The on-board camera showed that immediately after the HV battery was selected OFF, the displays showed M1 and M2 initially in red, then amber, representing motor fault conditions. Four seconds later, the pilot noted the loss of power. Five seconds after this, the observer stated, "YOU'VE LOST THE INVERTER, PUSH THE BUTTON".

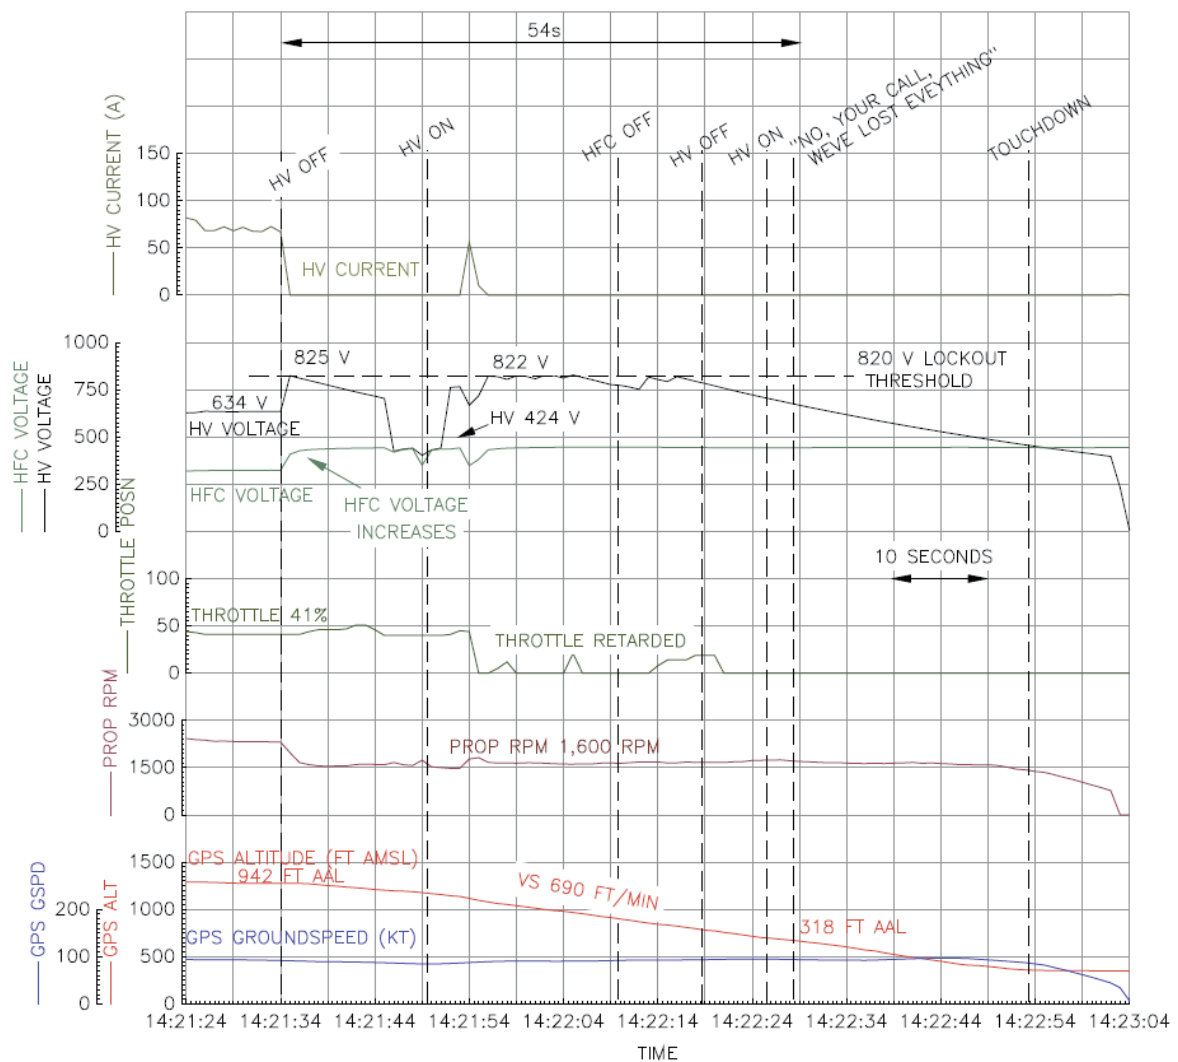
The observer instructed the pilot to select HV battery ON which was successful. However, due to the combination of an increased HFC voltage and continued windmilling action of the propeller, the inverters detected further overvoltage conditions which led to further lockouts. After HV battery was selected ON, further attempts were made to restore power over the next 38 seconds with the observer acknowledging that "THE VOLTAGE IS TOO HIGH". This included resetting the HFC and HV battery supplies with the fault clear button selection at various power lever positions, with no visual reference to checklists. The troubleshooting required the pilot to look down to the power lever and display and then look up to the HFC and HV battery switches in the overhead panel. Despite these attempts, power could not be restored to the motors. Figure 11 shows these data parameters throughout the event.

Figure 11
G-HYZA flight data parameters

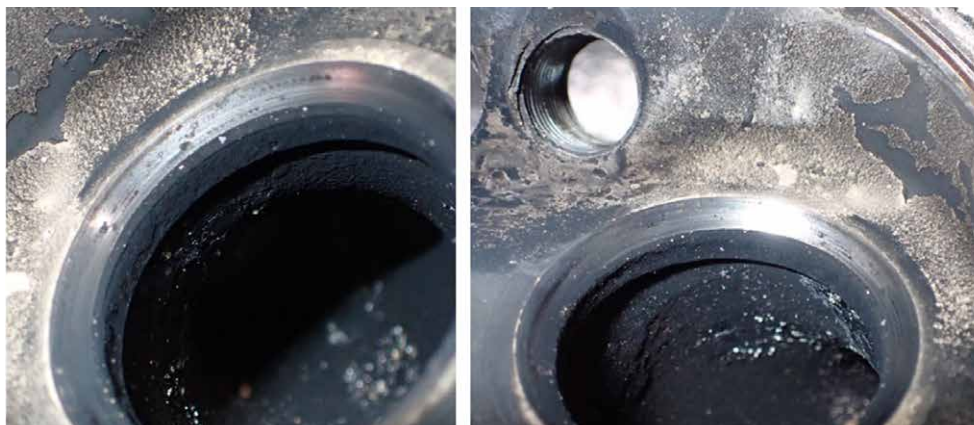
Figure 12

The cylinder heads were removed, and engine oil was found in all cylinders but there was no readily visible evidence to explain the leak test results. The inlet valve from cylinder 2 and the exhaust valve from cylinder 3 were removed and examined in detail. The valves and valve seats were examined using an optical microscope at magnifications up to x120. Multiple surface defects were found on both valves and their corresponding seats (Figures 9 to 12).

Cylinder 3 exhaust valve seat surface defects

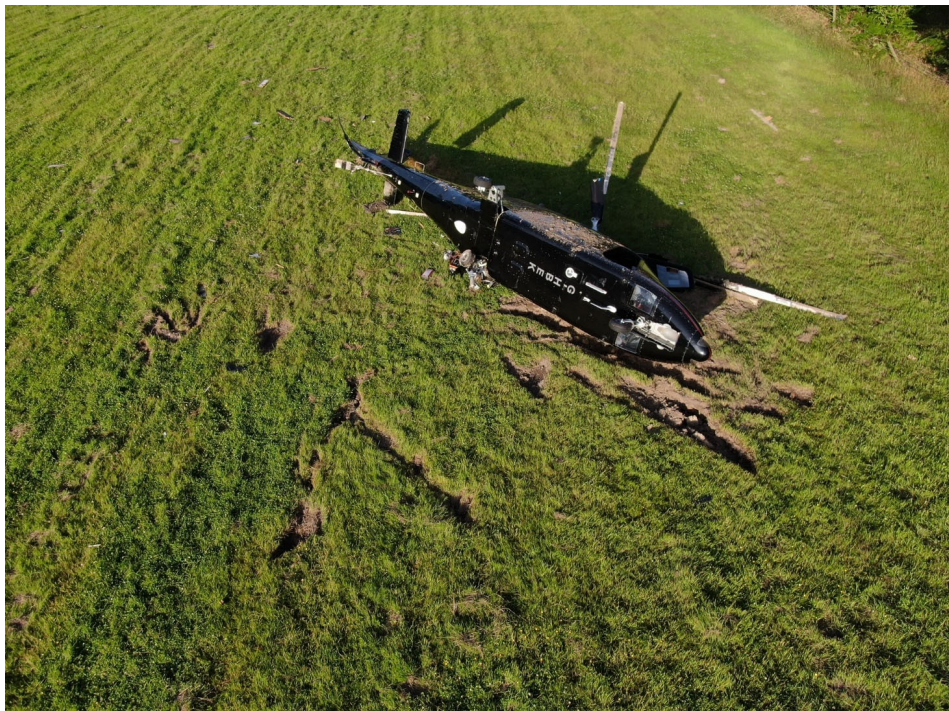
The aircraft was examined by the AAIB and representatives from the aircraft manufacturer. The tail rotor blades were damaged but the tail rotor gearbox shaft rotated freely. There was sufficient oil in the tail rotor gearbox and no evidence of overheating. All tail rotor control linkages were secure and applying full left and right pedal in the cockpit produced corresponding tail rotor actuator and blade pitch changes. The tail rotor driveshaft was in good condition along the length of the tail boom. The tail rotor driveshaft had separated from the main rotor gearbox at a spline fitting. There was no damage to the splines, which indicated that the failure probably occurred as a result of the ground impact. The aircraft manufacturer's representative stated that they had only seen this type of spline separation once before and that it was the result of impact forces.

Figure 2
G-HBEK at the accident site

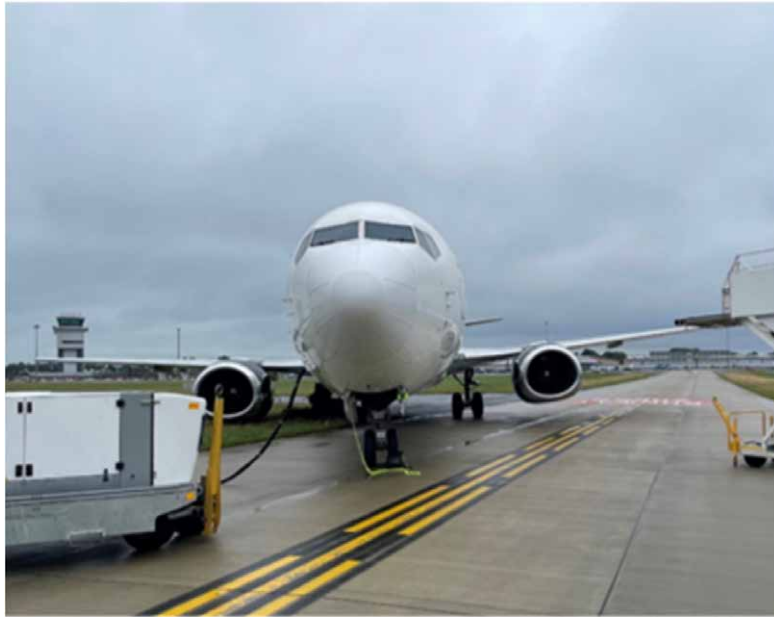
While the aircraft was in the right turn onto Taxiway B, ATC cleared it to enter and backtrack Runway 05 to vacate at D. The co-pilot then commented on the aircraft's proximity to the grass at which point the commander believes it had already left the taxiway. The commander stated that the aircraft was still moving slowly and his natural reaction was to increase power in order to return to the taxiway. Simultaneously, ATC asked whether assistance was required but received the response "*I think we can power out*". The commander reported increasing the power but, by the time the engines had spooled up, the aircraft had lost momentum and subsequently came to a stop. ATC instructed the aircraft to hold position and wait for assistance. The crew complied, shut down the engines and secured the aircraft. Figure 1 shows where the aircraft came to rest, with its nosewheel approximately 2 m right of the yellow taxi line.

The fire brigade, aircraft engineers and handlers attended the aircraft in its location between Taxiways B and Z. The cargo was offloaded in situ and the crew were collected by an operations vehicle. Following guidance from the manufacturer, the aircraft was subsequently towed to a hangar and underwent a maintenance inspection. There was no damage found and the aircraft was released to service two days later. The lower portion of two taxiway edge lights - the stalks, frangible couplings and synthetic tripods - were damaged beyond repair, however the light fittings remained serviceable. Some cable ducting along the taxiway edge was damaged and a portion of the taxi edge was reinstated.

Stopped position of the aircraft

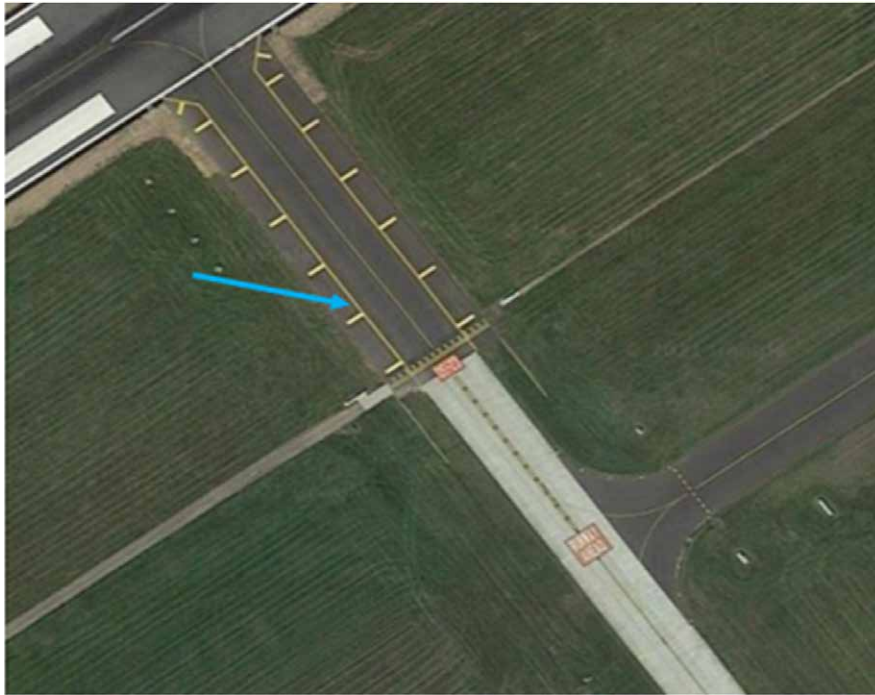
Figure 3

Aerial view of Taxiways B and Z and the representation of approved taxiway width north of B1 (Image from Google Maps)

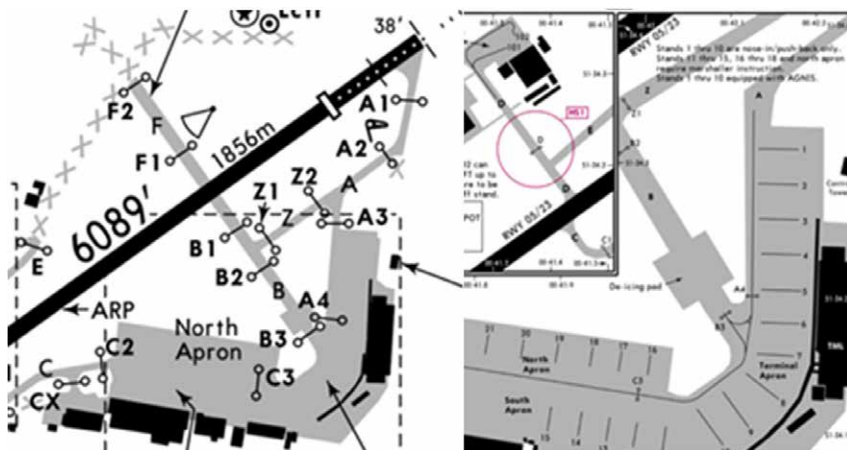
Figure 4a

Taxiway B is depicted as wider than Taxiway Z and of a constant width on both ground charts which were available to the crew (Figures 4a and 4b). However, Taxiway Z has a declared width of 15 m, which is the same as Taxiway B.

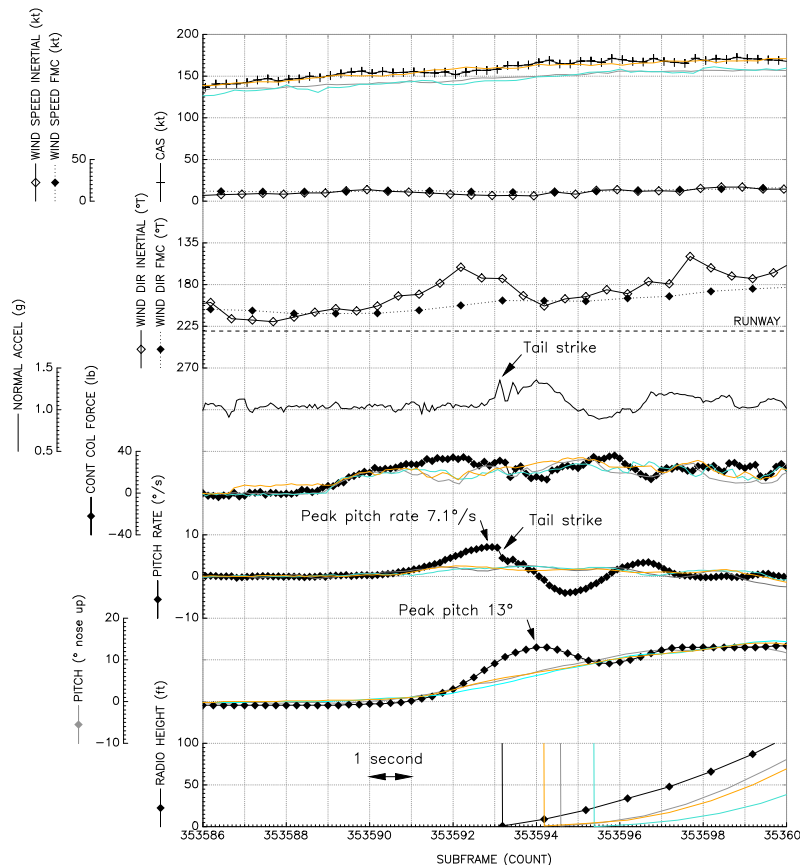
Figure 1

Takeoff plot for the incident flight (black)
and the aircraft's three previous flights (grey, orange, and blue)
(vertical lines on the radio height scale indicate the lift-off point)

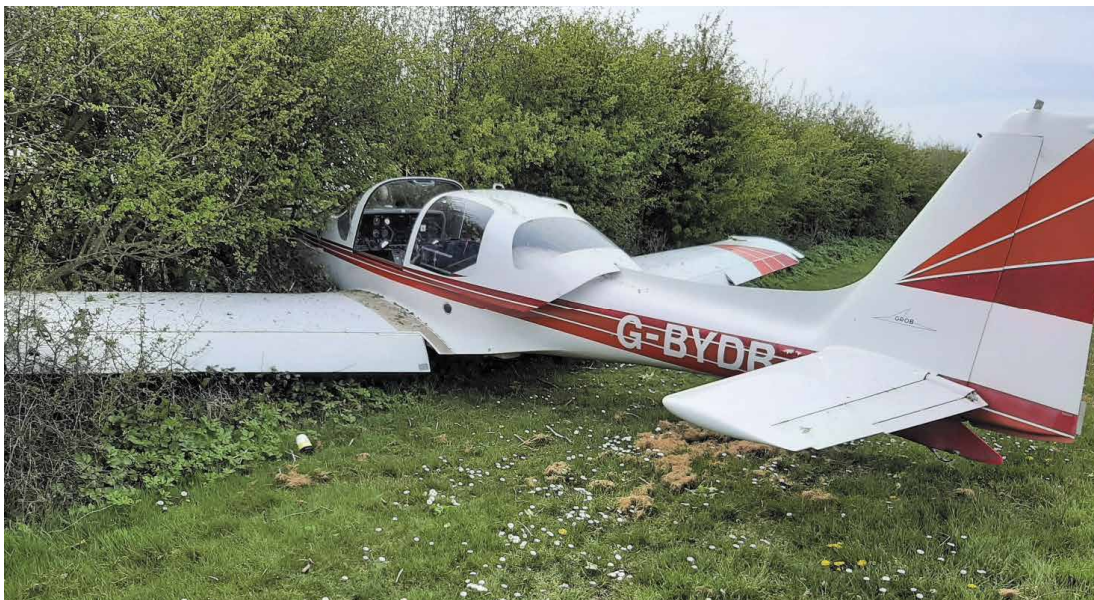
Figure 2

unable to stop the aircraft in the remaining distance. G-BYDB overran the runway before coming to an abrupt halt in the airfield's boundary hedge (Figure 2). Uninjured, the pilot unfastened his harness and exited the aircraft without external assistance.

The aircraft suffered damage to the wing leading edge and shock loading of the engine. During a pre-takeoff test at Fowlmere Airfield G-BYDB's brakes had worked normally, and a post-incident technical investigation found the brakes to be "fully functioning".

G-BYDB in the boundary hedge after the runway overrun
