Rail Accident Investigation Branch

Rail Accident Report

Collision between a tram and a cyclist, near Audenshaw tram stop, Manchester 1 September 2021

Report 08/2022
August 2022

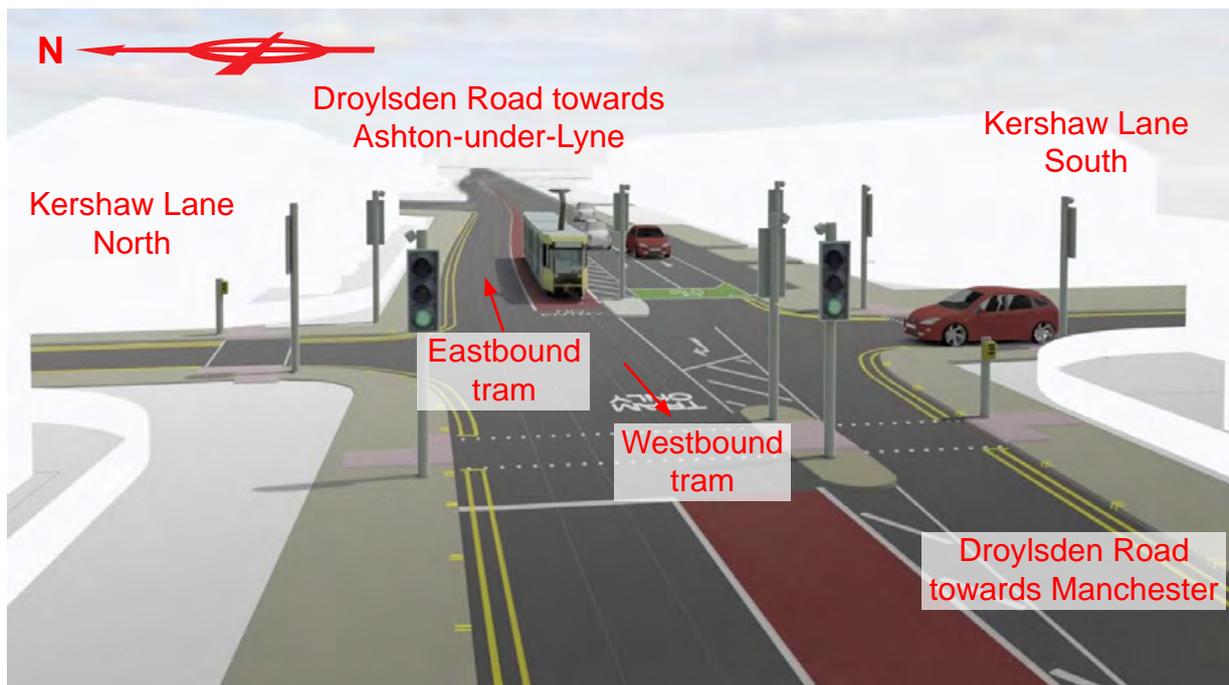
Figure 3: graphical representation of the junction layout, looking east (courtesy of TfGM)

- 8 In the area between Audenshaw and Droylsden tram stops, trams travelling eastbound (from Manchester city centre towards Ashton-under-Lyne) share the carriageway with all other road users travelling in the same direction. Westbound trams use a section of the carriageway from which other vehicles are prohibited; this prohibition is indicated by signage and by the tram section of the carriageway being painted red. Westbound road vehicles use the remaining section of the carriageway (figure 3). From north to south, the areas of the road are:

- 10 The crossing at the western arm of the junction with Kershaw Lane is provided with a mid-carriageway pedestrian refuge. The refuge, protected by high containment kerbs, is located between the road for westbound vehicles and the track for westbound trams (figures 3 and 4). The refuge also provides a location for traffic signals.

- 85 The positioning of the refuge at the Kershaw Lane crossing does not follow this pattern. Eastbound trams and eastbound road vehicles travelling on Droylsden Road share a single lane. However, westbound road vehicles are separated from westbound trams (such as that involved in the accident) and westbound trams use a separate area of the road from which other road vehicles are prohibited (figure 3).

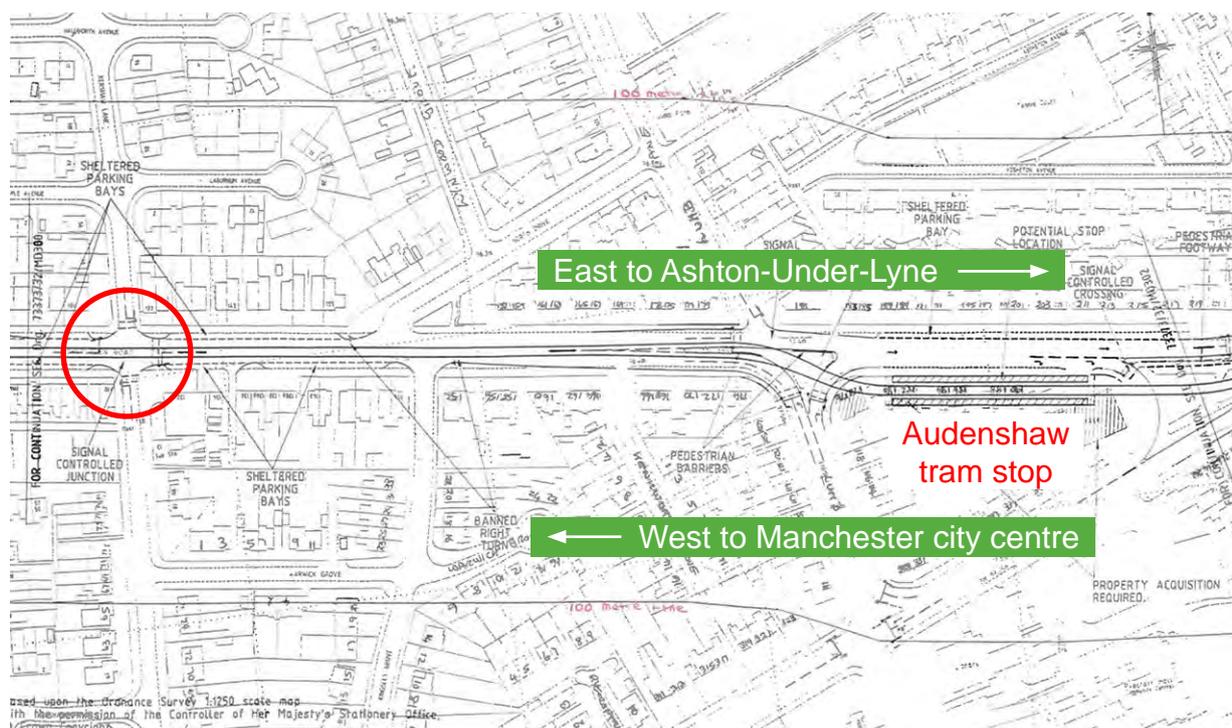
Figure 7: 1994 concept drawing (courtesy of TfGM)

- 50 In 1994, GMPTE carried out a public consultation exercise to seek views on the East Manchester Line project from local stakeholders (such as Tameside MBC and residents). A concept drawing created for the purposes of that consultation (figure 7) shows the tramway laid within the existing carriageway of Droylsden Road. However, at that point, no details regarding track alignment (beyond incorporation of the track within the existing highway) or pedestrian crossings had been considered.

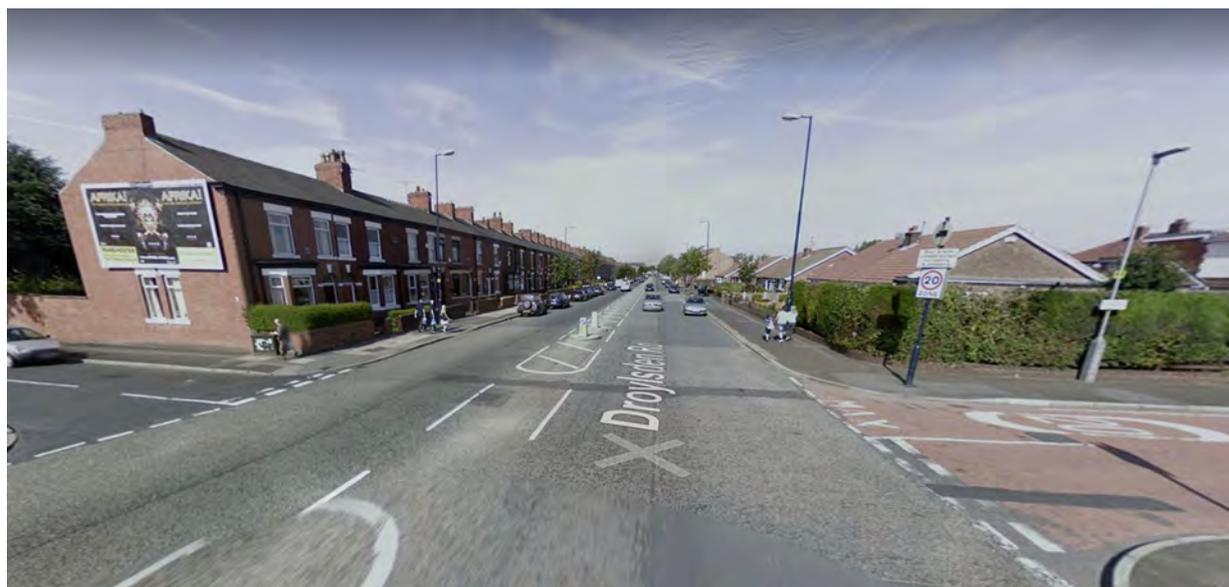
Figure 8: Image taken in 2008 of the junction looking west, before the start of East Manchester Line works (courtesy Google Streetview)

- 51 Before the construction of the East Manchester Line, the Droylsden Road/ Kershaw Lane junction did not have traffic signals. There were no controlled pedestrian crossings, and traffic movements such as right turns were permitted. A set of bollards and a small refuge was provided in the centre of the carriageway at the western side of the junction (figure 8), as part of an uncontrolled crossing route.

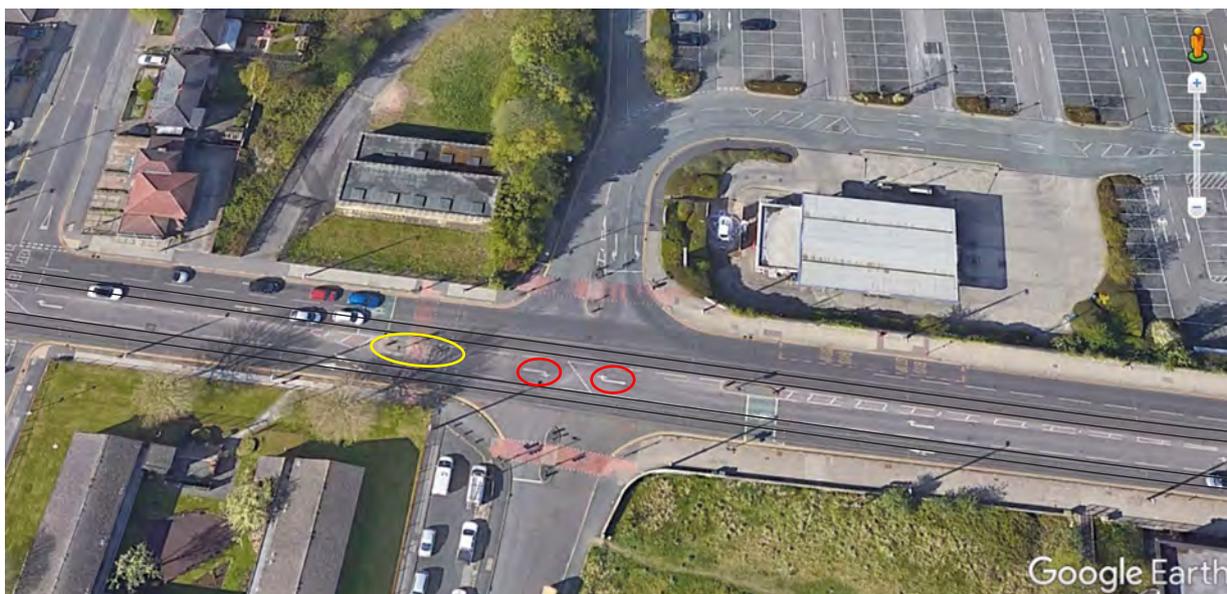
- 58 Despite the problems caused by right-turning road traffic (paragraph 56), design solutions are available. For example, at a location approximately 0.5 mile (0.8 km) to the west of the accident location, the two tramway tracks are integrated with the road traffic in each direction, with right turn lanes being placed between the tramway tracks in the centre of the road (figure 9).
- 59 However, such a layout is incompatible with the Trambahn concept. Placing the right turn lane between the tramway tracks would have meant the loss of a considerable length of the Trambahn, and therefore the loss of many of the benefits of the concept.

Figure 9: Right turn lanes (highlighted red) positioned between tramway tracks, with pedestrian refuge (highlighted yellow) positioned in the centre of the carriageway

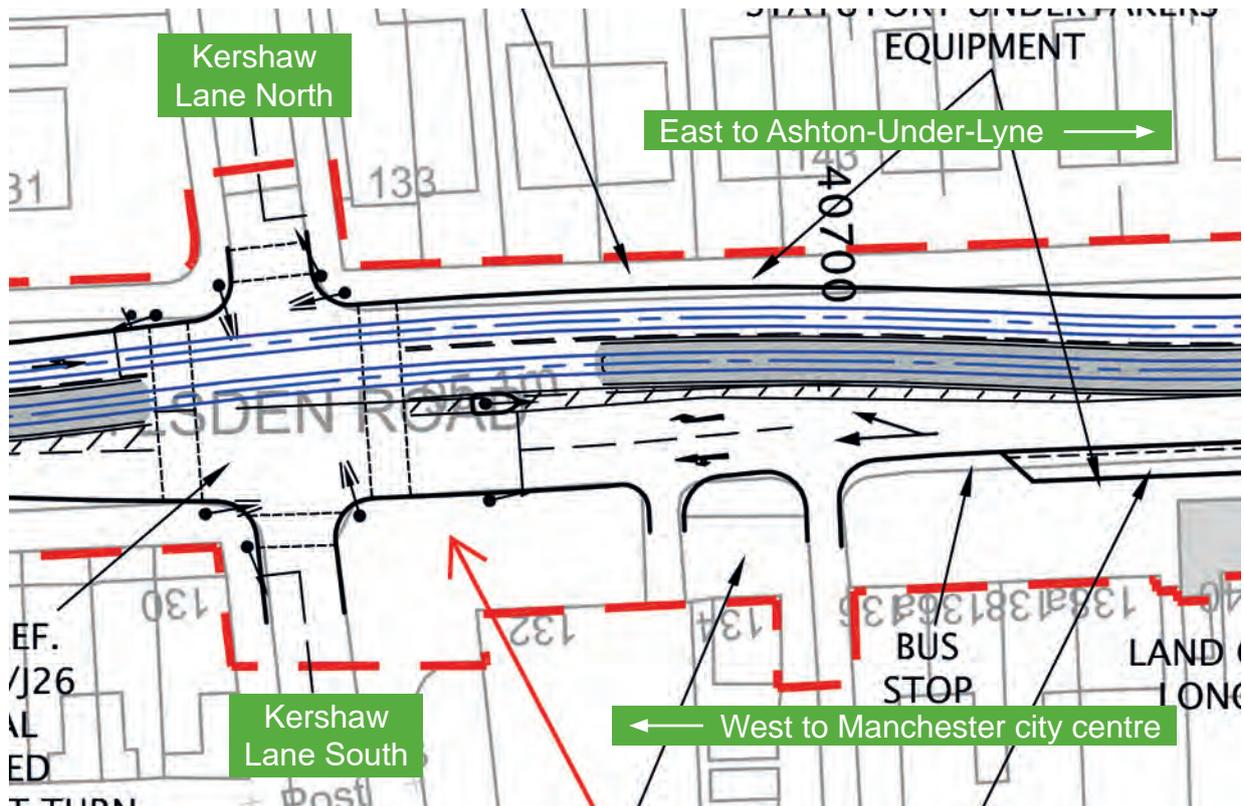
- 62 As such, the outline design (figure 10) included the following features:
- Trambahn for the westbound trams
 - tracks slewed to the north across the junction

- right turn lane for westbound road vehicles wishing to access Kershaw Lane north
 - controlled crossings of all four legs of the junction - Kershaw Lane north, Kershaw Lane south and Droylsden Road to both the east and the west of the junction.

- 63 The design produced on behalf of GMPTE was an outline design. It did not include details such as the provision (or otherwise) of a pedestrian refuge at the crossings of Droylsden Road (or details of any similar refuges). The design also omitted considerations such as parking bays and junction stop lines.

Figure 10: GMPTE-developed outline design, dated January 2010 (Trambahn indicated by areas of tram track shaded grey) (courtesy of TfGM)

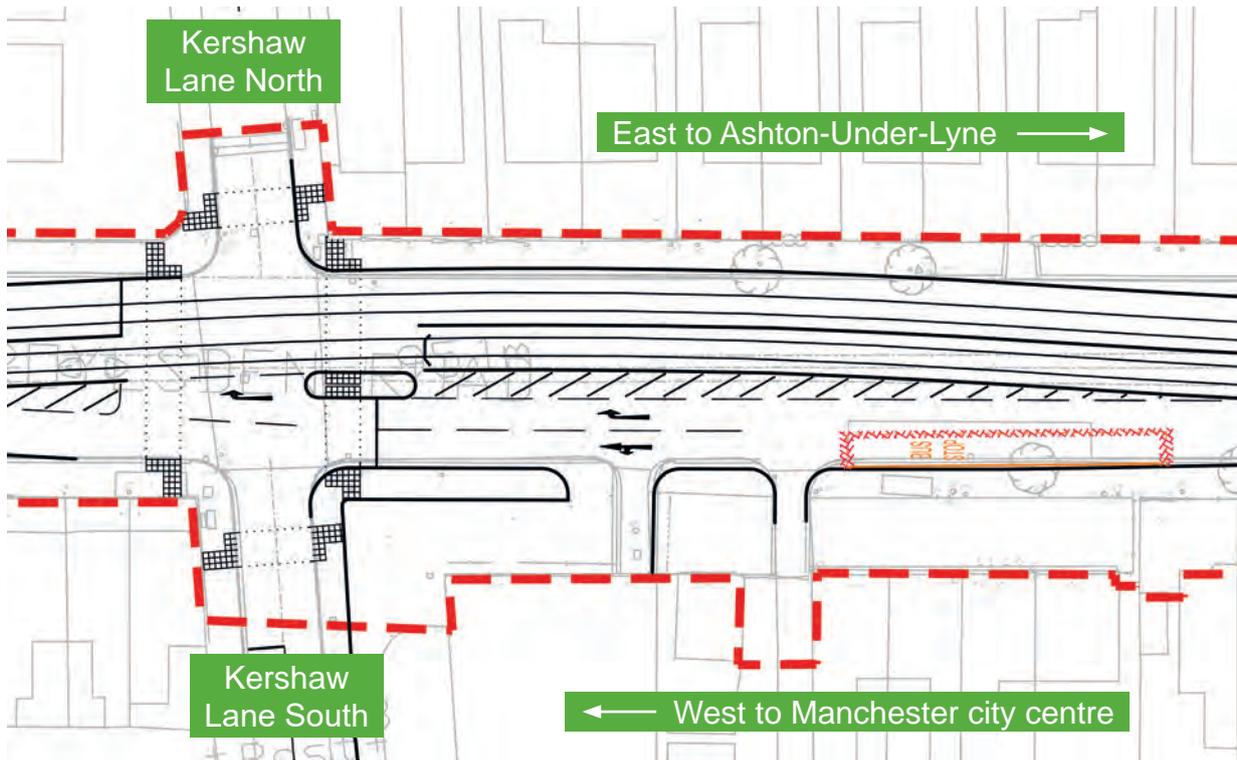
Figure 11: April 2010 initial design (courtesy of TfGM/MPT)

- 65 In April 2010, an initial design (figure 11) for the layout at Kershaw Lane had been prepared which included a pedestrian refuge at the eastern side of the junction, this refuge being positioned to the south of the tram tracks. In this design, the western side of the junction (the location of the accident) was shown as a controlled crossing with no pedestrian refuge.

- 66 This initial design had the advantage of placing a controlled crossing at the location of the likely 'desire line' for pedestrians crossing to and from the convenience store and other businesses at the eastern side of the junction (paragraph 61). However, problems associated with the needs of property owners in the vicinity were encountered with the layout. For these reasons, this initial design was rejected. Design work then progressed with the intent of providing a controlled crossing (on Droylsden Road) solely across the western leg of the junction. By June 2010, MPT's detailed design had progressed to a point where it included the pedestrian refuge in its final position, to the south of both tram tracks. It was this configuration which was ultimately constructed, and which existed at the time of the accident (figure 12).

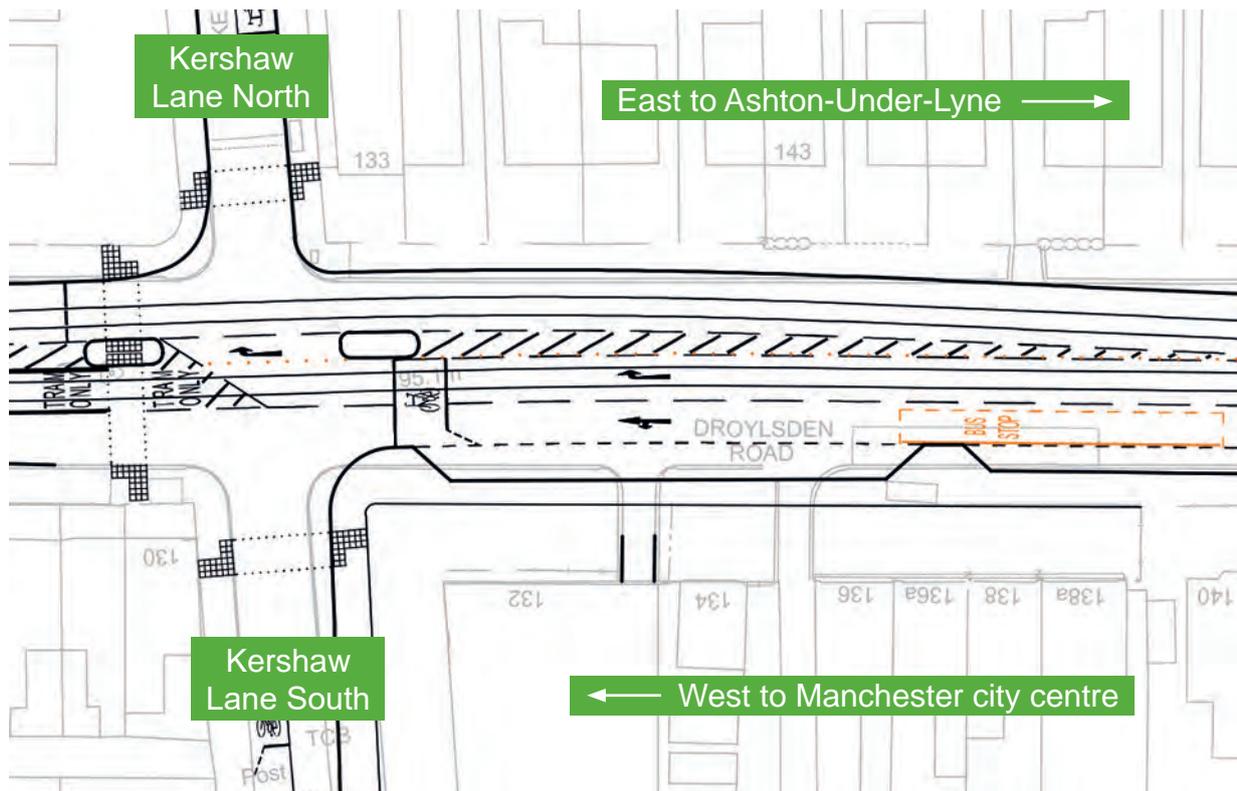
Figure 13: September 2011 concept design (courtesy of TfGM/MPT)

68 Local stakeholders, including Tameside MBC, raised concerns about the layout of the tramway in the area and the Trambahn concept in general. These concerns included issues with residents accessing driveways and anticipated problems with unloading delivery vehicles at the convenience store and other businesses. In September 2011, TfGM requested MPT to prepare an alternative layout. In response, MPT prepared a concept design (figure 13) which showed a layout with westbound trams sharing the right turn lane. This layout placed the pedestrian refuge between the tram tracks. However, this layout was later rejected. The reasons for the rejection are discussed at paragraph 107.
