AAIB Bulletin

1/2023

Published 12 January 2023

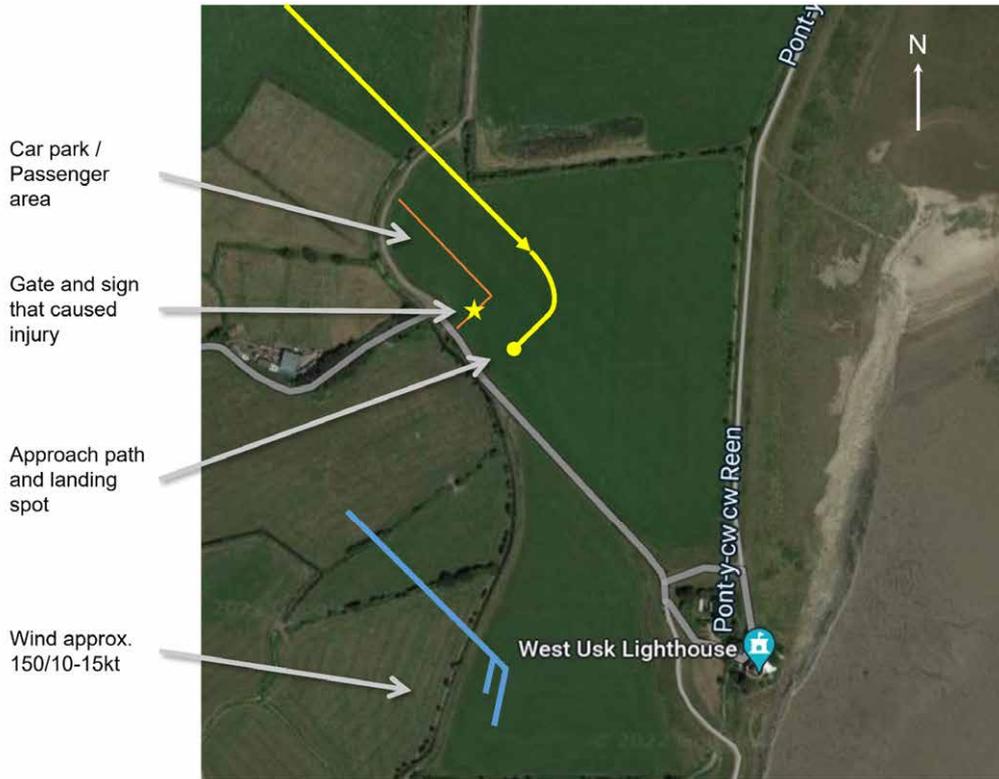
Figure 1

On 4 September 2022, the operator's staff set up a temporary site in a field at West Usk Lighthouse for the operation of helicopter sightseeing flights (Figure 1). This consisted of a passenger parking, waiting and briefing area delineated by a rope cordon with a gate to 'airside'. A sign was displayed next to the gate and was used as part of passenger briefings before they were escorted to board the helicopter.

During the site set-up cows escaped on to the site from an adjacent field and needed to be removed and secured. The site set-up was then running late, and passengers were arriving and parking in incorrect locations. The sign was secured with two plastic cable ties on the top corners when normally it would be secured with plastic cable ties on all four corners. The sign measured 800 mm x 575 mm x 10 mm and weighed 2 kg (Figure 2).

Site layout at West Usk Lighthouse (reproduced from pilot's sketch, not to scale and showing approximate approach path and landing position) © 2022 Google

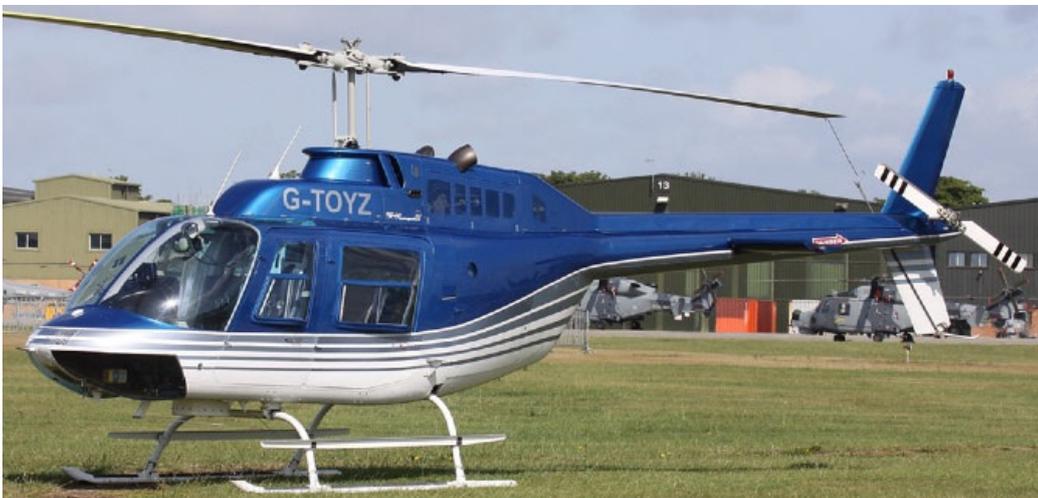
Figure 3

The next day, on 5 September 2022, G-TOYZ (Figure 3) commenced flying with no check of the security of the sign. The TAFs for nearby Cardiff and Bristol Airports predicted winds of 150° at 9 kt and 160° at 10 kt respectively, and both predicted a 40% chance of occasional stronger wind of 15 kt from 1300 hrs. The pilot conducted eight uneventful flights in G-TOYZ. All landings were in the same place. The pilot reported that the wind speed had then increased to about 10 - 15 kt and, while landing on the ninth flight at approximately 1110 hrs, the cable ties broke and the sign became detached. The sign struck a passenger who was waiting to board, causing a cut to their lower leg that required stitches. No one had noticed the sign was not secured well or any movement in the sign before the accident.

G-TOYZ (Image used with permission)

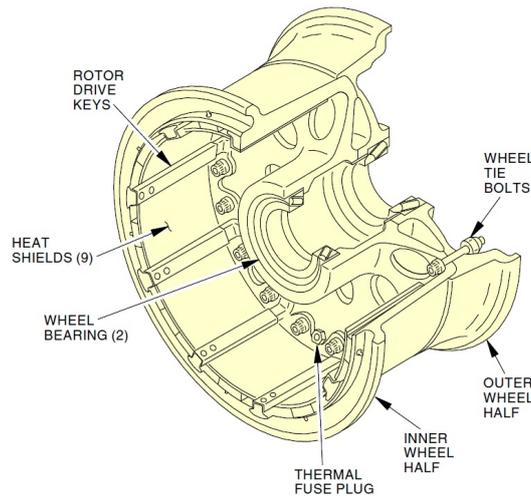
Figure 2

The Boeing 737-8AS is a single aisle commercial airline with a tricycle landing gear. Each main landing gear has two wheel assemblies attached to the landing gear axle. The wheels are made up of an inner and outer wheel half. Conical roller bearings located in the wheel half hubs carry the load from the wheel to the axle. Tie bolts hold the two halves together (Figure 2). The wheel brake pack is positioned within the inner wheel half.

Boeing 737-800 wheel assembly (reproduced with permission)

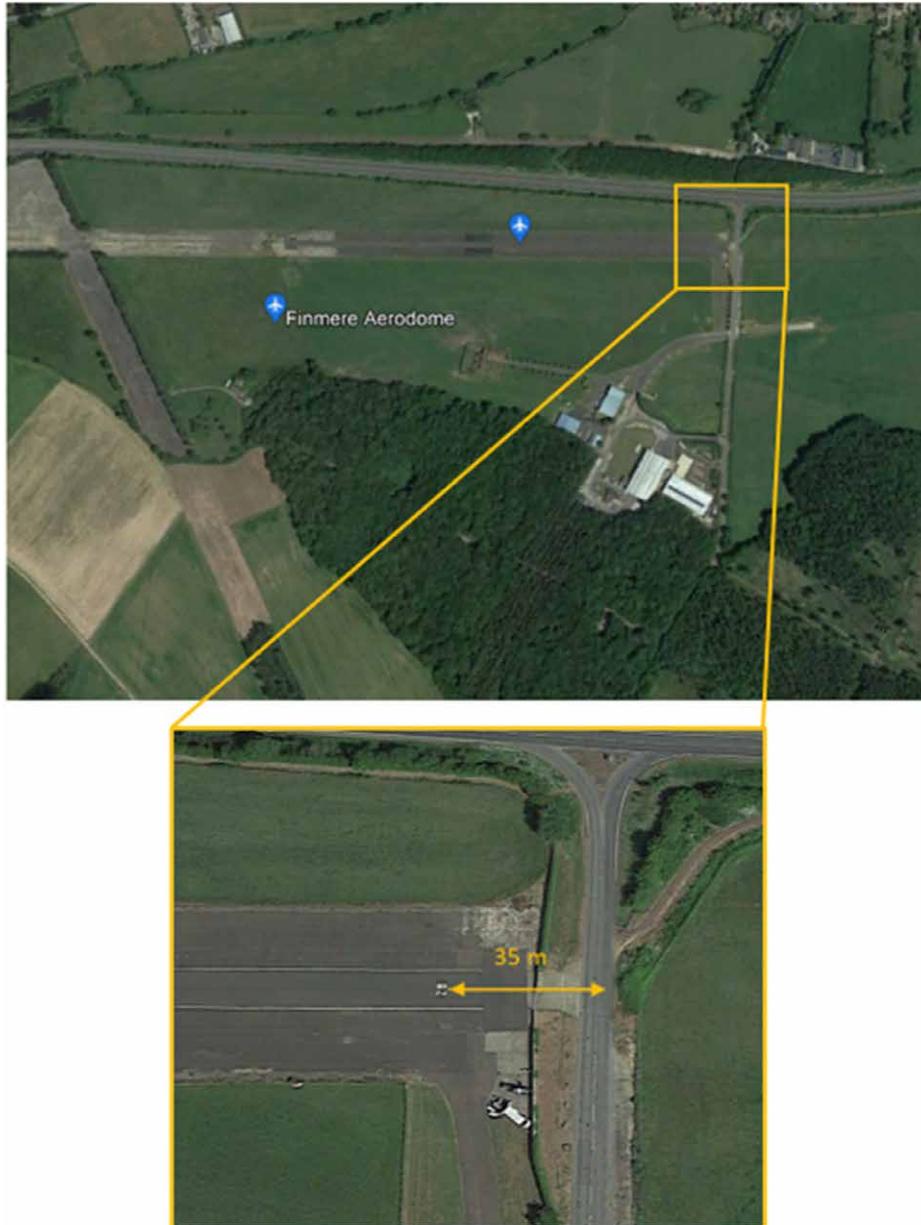
Figure 1

Distance from Runway 28 markings to public road

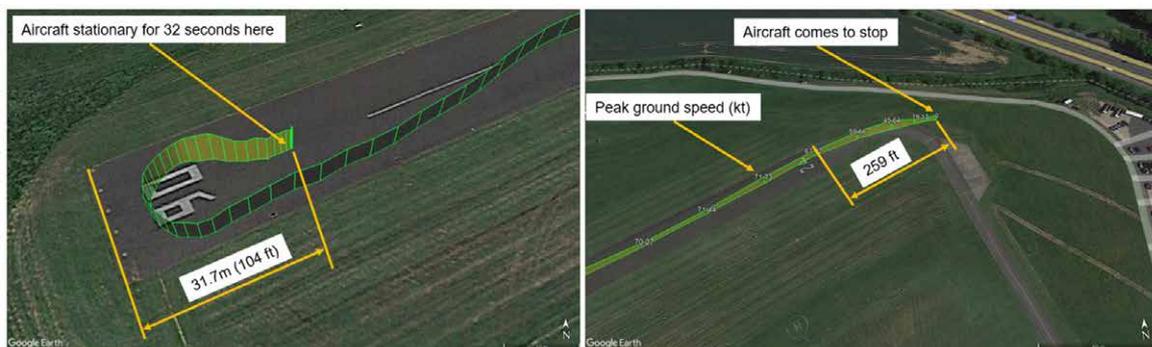
Figure 3

Using the positional data from IFD, it was possible to determine that after the 180° turn, the aircraft lined up to take off 31.7 m (104 ft) from the end of Runway 06 (Figure 3). It reached a peak ground speed of 71 kt (and KIAS of 71kt) after 30 seconds and had used 2,272 ft of the available runway. The positional track data overlaid with the skid marks seen with good correlation and the aircraft came to rest 259 feet from the end of the runway.

Take off roll start (left), Peak ground speed and stop point (right)

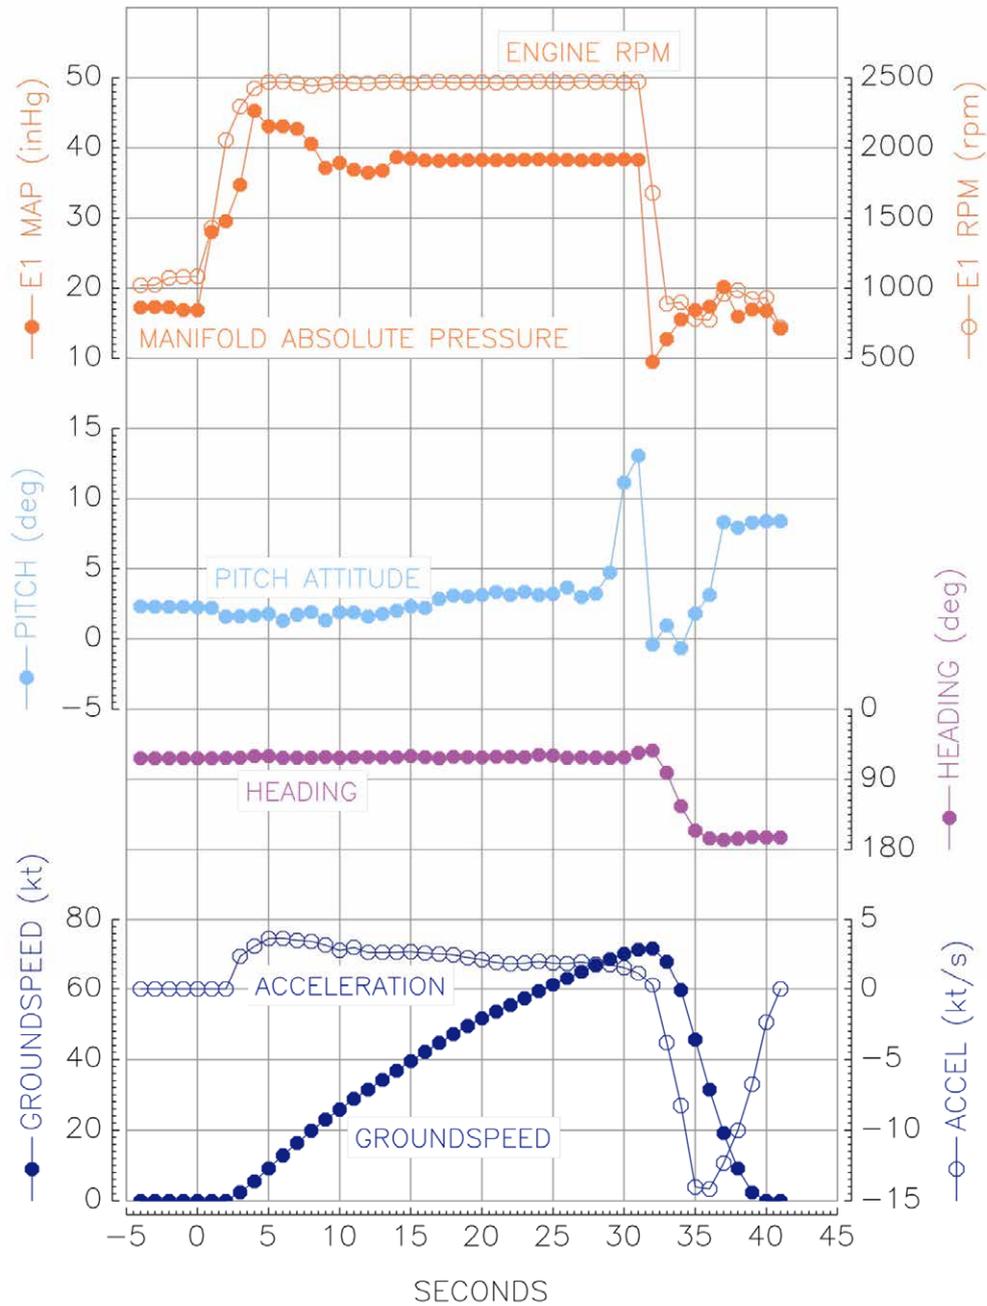
Figure 4
Garmin G1000 IFD data

The ground speed, aircraft pitch, aircraft heading, MAP and engine rpm from the IFD was plotted against time in Figure 4 along with the calculated acceleration. At T=1 second the engine rpm starts to increase with a corresponding increase in MAP. The aircraft is moving at 2.4 kt at T=3 seconds when the MAP is 34.75 inches Hg, and the engine speed is 2,294 rpm. The MAP peaks 3 seconds later at 45.3 inches Hg and remains above the 42 inches Hg threshold for the CAS red warning for 4 seconds. It is then reduced and stabilised at 38 inches Hg for the remainder of the takeoff with the engine speed at 2,450 +/- 25 rpm.

The ground speed increases under constant acceleration between T=11 to T=29 seconds with a corresponding increase in IAS until the aircraft pitch increases to 13° nose up at T=31 seconds where the acceleration decreases. 1 second later the ground speed and IAS peak at 71 kt after which the throttle is closed, and the aircraft deaccelerates rapidly. As the aircraft pitched up, the heading veered slightly to the left, then swung 100° to the right after the brakes were applied and it came to a stop in 7 seconds.

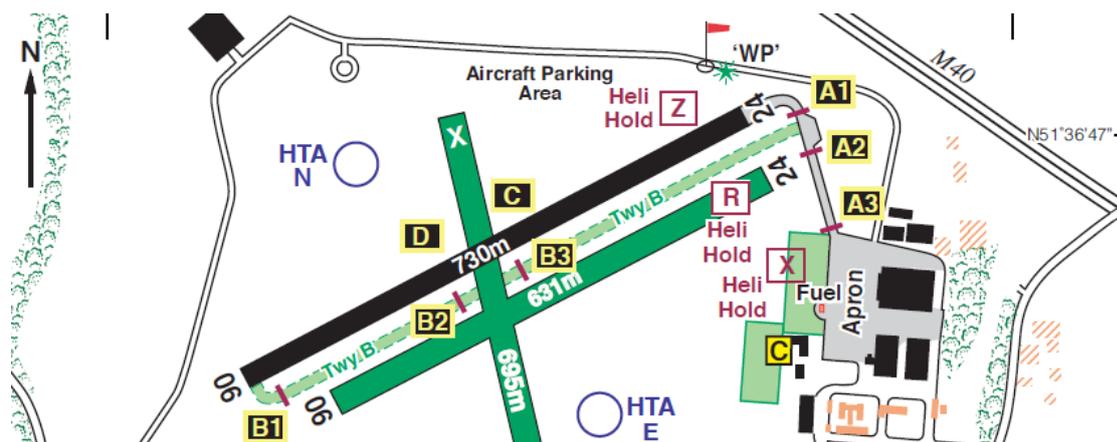
Figure 7

Wycombe Air Park has five runways; two asphalt 06/24 and three grass 06/24 & 35 (Figure 7). Runway 06 has a TORA of 730 m (2,395 ft) with a tall stand of trees (visible in Figure 2 left) 2,800 ft from the threshold and the M40 motorway beyond. Entry to Runway 06 is via the Alpha taxiway which joins to the Runway 24 threshold thereby necessitating a backtrack along Runway 24 or taxiing along the grass Taxiway Bravo which runs parallel.

Wycombe Air Park runways and taxiways

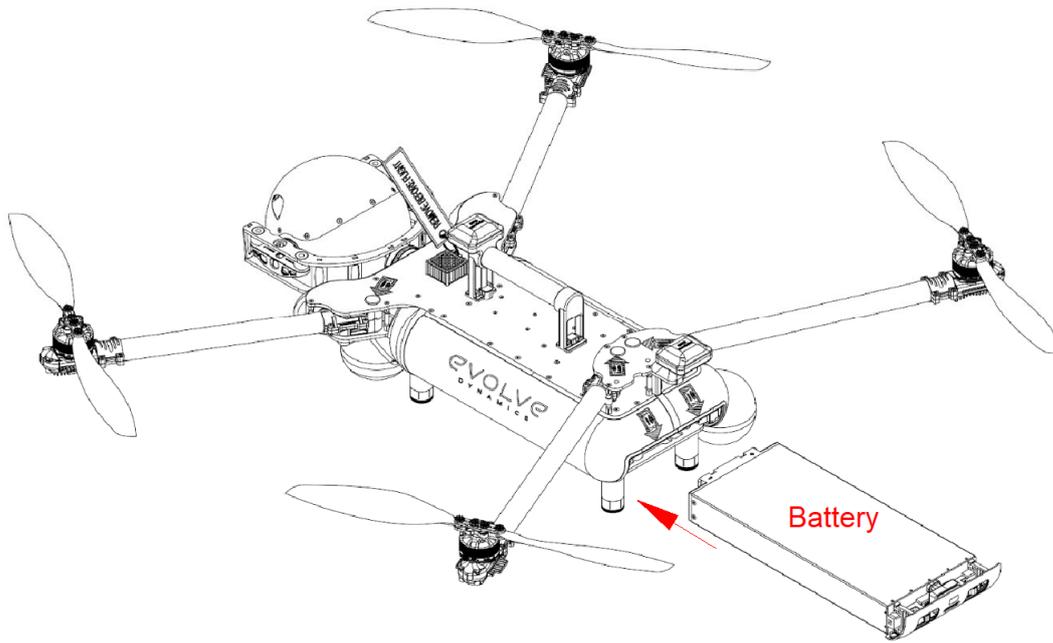
Figure 2
Sky Mantis battery insertion

Aircraft electrical power is provided by a 34Ah Lithium-ion battery (Figure 2). This is fitted into the rear of the aircraft and secured in place using a locking mechanism, which provides a visual indication when it is correctly latched. The battery charge level is displayed using four LED's that are fitted adjacent to the latches on the rear of the battery (Figure 3).

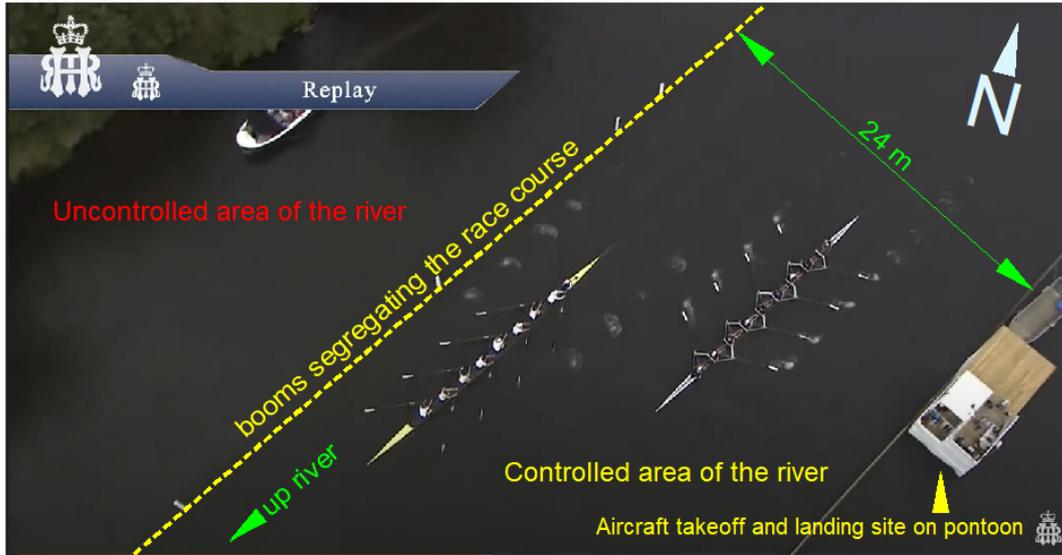
Figure 1

Image taken from the aircraft's camera showing the takeoff and landing pontoon and the adjacent controlled/uncontrolled sides of the river

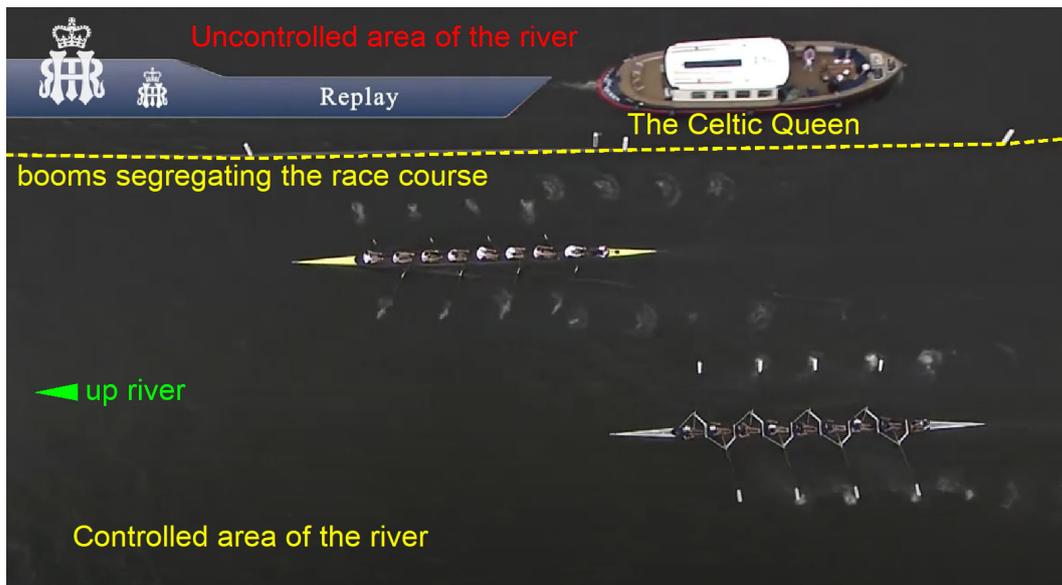
Figure 2

Image from the aircraft, with The Celtic Queen travelling down-river.

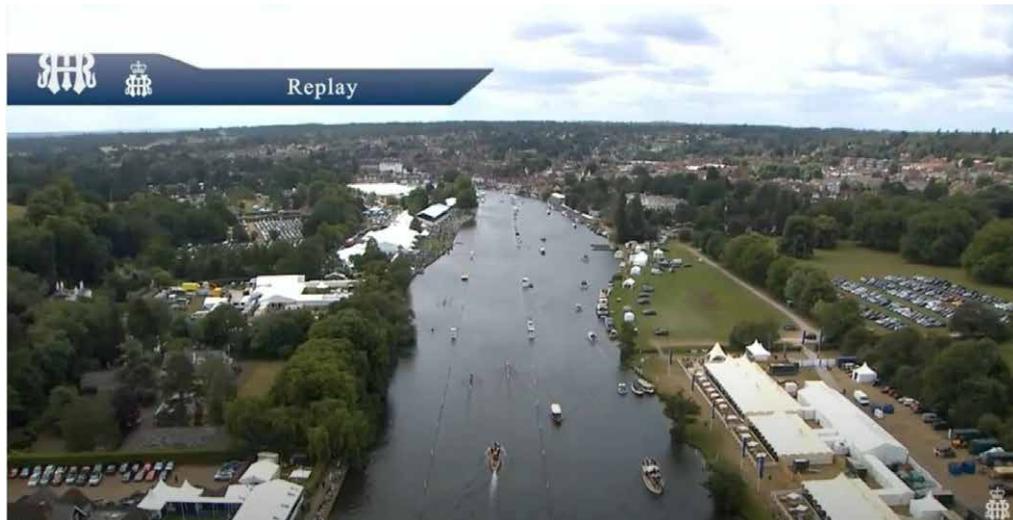
Figure 3

When the aircraft was about 250 m up-river from the pontoon, the aircraft's low voltage battery warning activated. The pilot responded by flying the aircraft back towards the pontoon to expedite its landing. However, when the aircraft was almost overhead the pontoon at a height of about 50 m, it stopped responding to the pilot's commands and started to rotate whilst also descending rapidly. The aircraft struck The Celtic Queen, which was now almost abeam the pontoon, before falling into the river. No persons were injured. One of the aircraft's batteries came to rest between the two passengers seated near the bow, which was about 2 m away from where the aircraft had struck the boat. The aircraft was not recovered from the river.

Image from the aircraft taken shortly before its loss of control

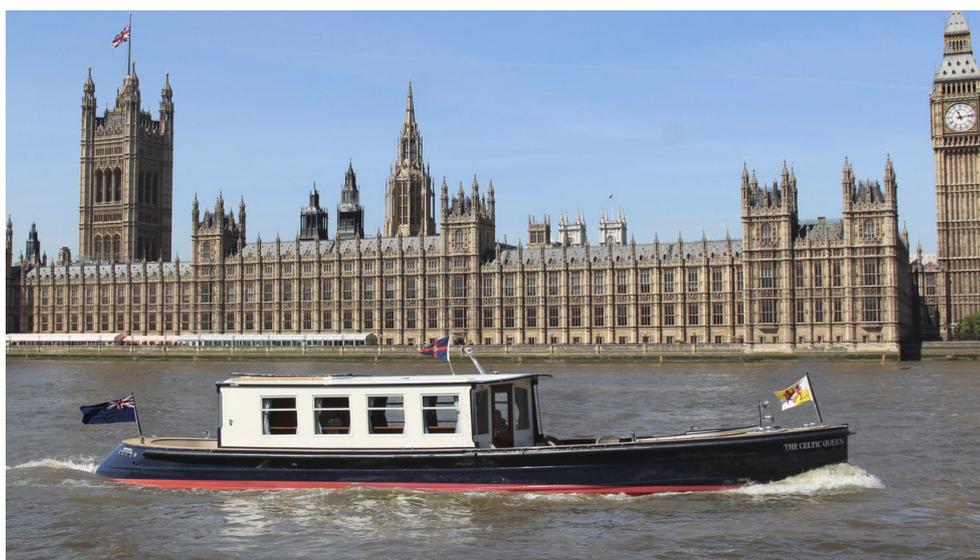
Figure 4

The Celtic Queen is a boat of approximately 20 m in length and 3 m wide (Figure 4), with a cabin of metal construction. At the bow and stern are seating areas for passengers.

The Celtic Queen (Photograph used with permission)

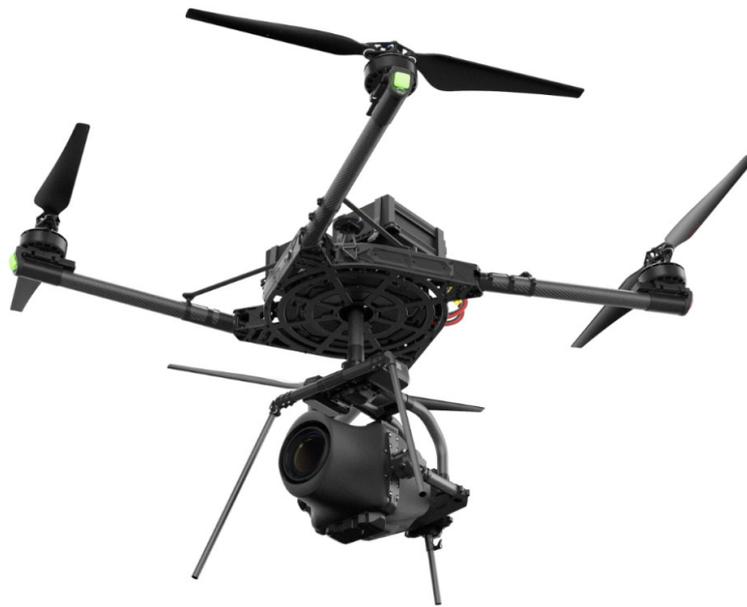
Figure 8

The Alta X (Figure 8) is an unmanned, electrically powered quadcopter with a maximum takeoff weight of 34.9 kg². This type of aircraft relies upon its propulsion system for lift. The aircraft's rotors are 84 cm in length and, when the motor arms are extended for flight, the aircraft measures 2.28 m from rotor tip to rotor tip. During the accident flight the aircraft's takeoff weight was 28 kg, which included an underslung camera mounted on a gimbal.

Alta X (not the accident aircraft)
