AAIB Bulletin

2/2023

Aircraft Type and Registration:	Piper PA-23-250, G-BJNZ	
No & Type of Engines:	2 Lycoming IO-540-C4B5 piston engines	
Year of Manufacture:	1979 (Serial no: 27-7954099)	
Date & Time (UTC):	2 April 2022 at 1535 hrs	
Location:	Enfield, Greater London	
Type of Flight:	Private	
Persons on Board:	Crew - 1	Passengers - 3
Injuries:	Crew - None	Passengers - None
Nature of Damage:	Damage to the engines, propellers, landing gear, left flap and underside of the fuselage	
Commander's Licence:	Private Pilot's Licence	
Commander's Age:	67 years	
Commander's Flying Experience:	1,859 hours (of which 1,090 were on type) Last 90 days - 33 hours Last 28 days - 21 hours	
Information Source:	AAIB Field investigation

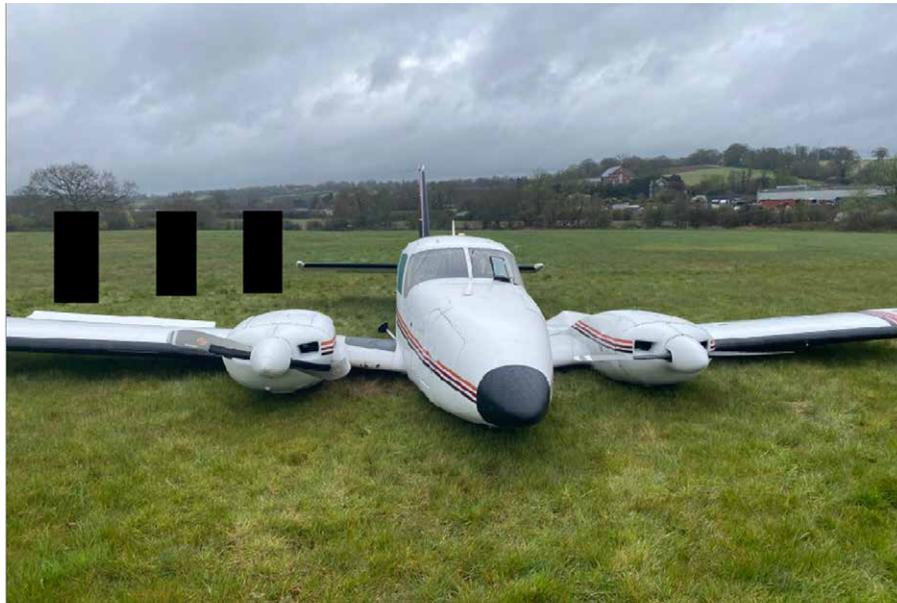
Figure 5

The aircraft landed in a grass field near Enfield, Greater London, approximately 7.8 nm from Elstree Aerodrome (Figure 5). Ground marks made by the aircraft showed that the landing gear had been extended at touchdown, before it had then rapidly collapsed. The right main

and nose landing gear legs were pushed upwards into their landing gear wells and the left main leg had detached. The left flap was partially detached from the wing.

G-BJNZ following the forced landing

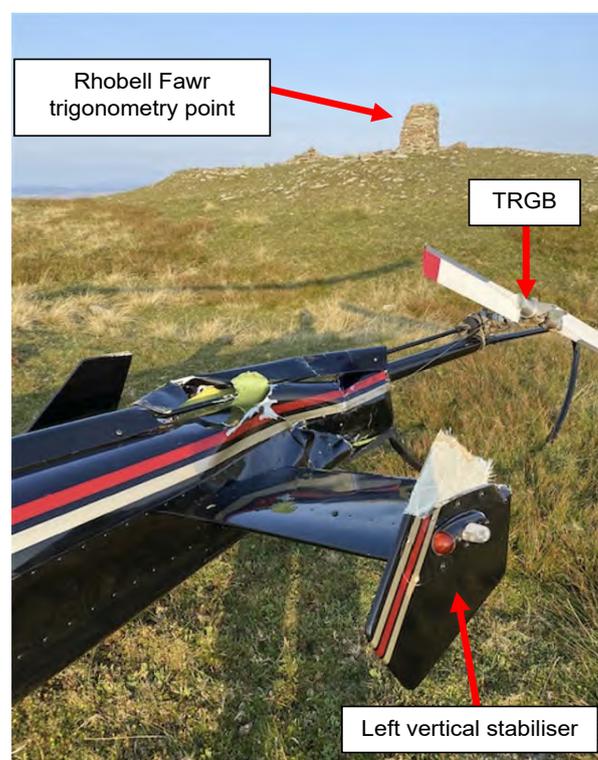
Figure 3

Damage to tail boom and left vertical stabiliser

The helicopter was recovered from the mountain approximately four weeks after the accident, and then transported to its owner's private site. The damage to the helicopter indicated that the main rotors had struck the rear of the tail boom, the tail rotor drive shaft and left rear stabiliser. This had deformed the fuselage, caused the coupling between the main gearbox and tail rotor drive shaft to fail, and severed the upper section of the left vertical stabiliser (Figure 7). The tail rotor blades were intact and their tips undamaged, although one blade had two small indentations adjacent to its leading edge. This was likely to have been caused by the blade striking the severed tip of the left stabiliser.

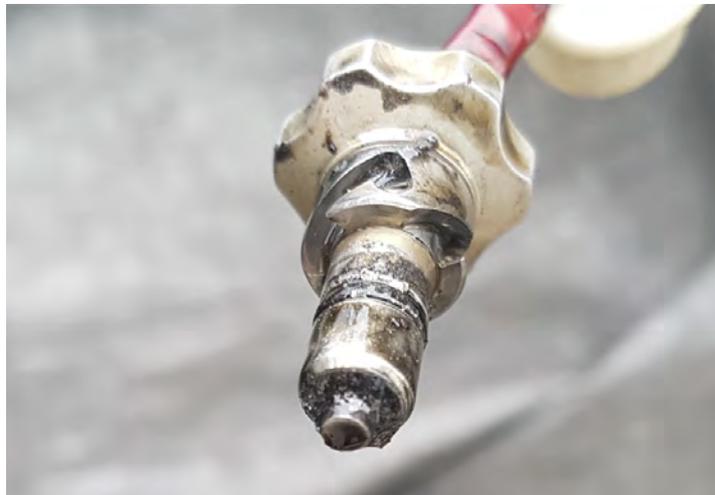
Figure 8

While the input shaft of the TRGB remained stationary, the output shaft and tail rotor could be turned by hand. The TRGB magnetic plug was subsequently removed and found to be covered in metal particles (Figure 8). The engineer reported that when the plug was initially removed, a few drops of oil dripped from the oil drain plug. The plug was then refitted and the TRGB and tail rotor were sent to the AAIB for detailed examination. Subsequent checks on the helicopter showed that the TRGB CHIP indicator in the cockpit operated correctly when the TRGB magnetic plug connector was electrically shorted to the airframe.

TRGB magnetic plug

The metallic fragments in the TRGB oil would have been created when ferrous bearing material was liberated as a result of spalling during the bearing failure sequence. From the photograph of the magnetic plug taken shortly after the helicopter was recovered (Figure 6)

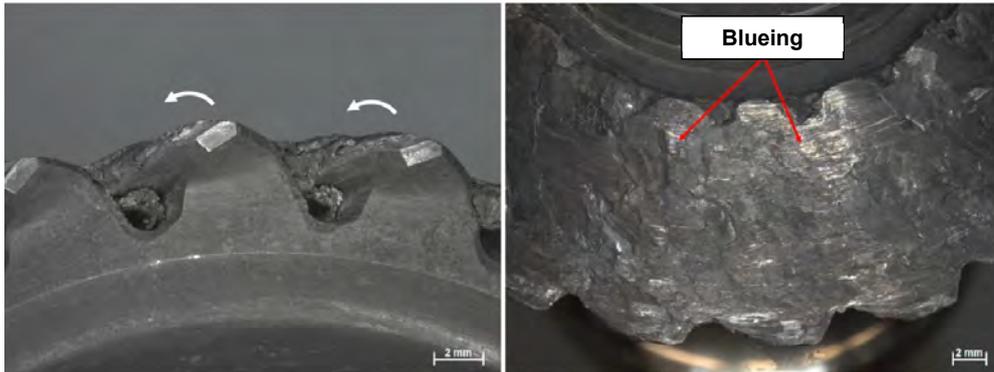
Figure 10

On the input shaft bevel gear, the apexes of the teeth had folded over into the roots and the surface of the gear showed evidence of high temperature oxidation (blueing) in places (Figure 10). The damage to the output shaft bevel gear appeared similar.

G-OJBB input shaft bevel gear

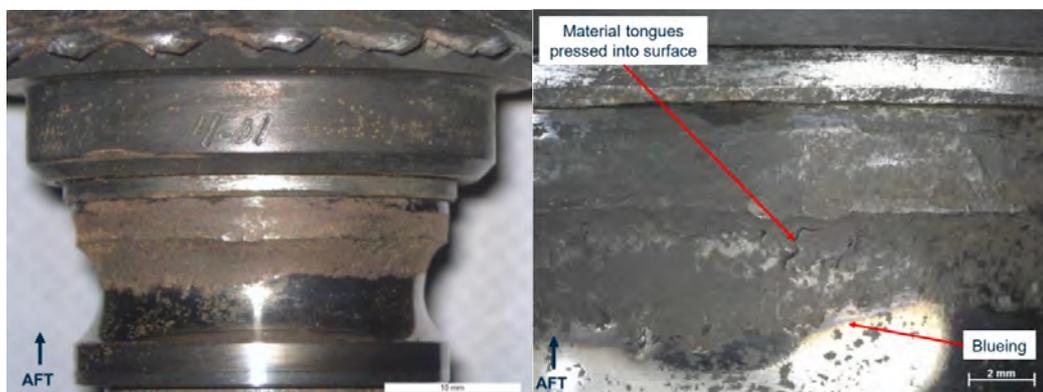
Figure 12

The inner race was damaged around its full circumference, across the rear half of its raceway and rear shoulder. In contrast to the damage observed on the outer race, the inner race damage was heavily oxidised and showed evidence of blueing in places, as well as material tongues rolled into the surface (Figure 12). Material removal in the form of pits was evident in the raceway. The damage on the shoulder was consistent with balls having run along it.

Inner race of input shaft, inner bearing

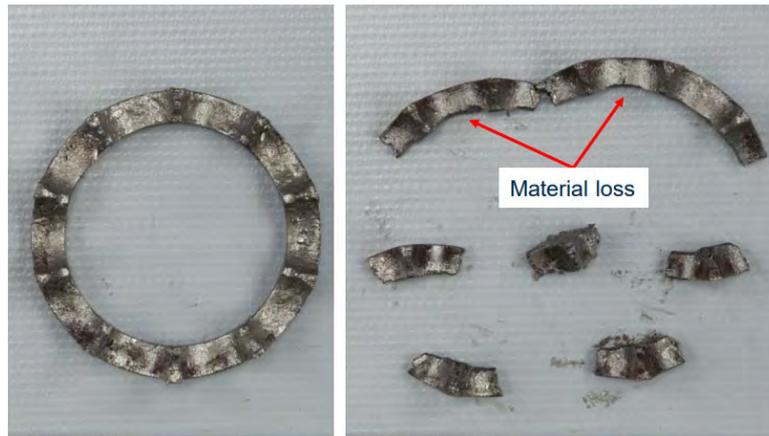
Figure 14

The bearing cage is a single-piece cotton-fibre reinforced phenolic resin cage, formed from two faces joined by axial posts. The cage had broken into eight pieces; one piece made up the whole of one face and the remaining seven pieces made up the other face (Figure 14). Material loss was evident on the inner circumference of the face that had broken into seven pieces, but not on the inner circumference of the intact face. SEM examination of one of the fractured axial posts showed cotton fibres present with very little phenolic resin visible. Resin was also missing from the sidewall adjacent to the fracture.

Cage from input shaft, inner bearing

Once the bearing cage had failed, the balls within the bearing would no longer be separated or equally spaced. This would allow contact between adjacent balls (with an associated increase in friction and temperature), unequal loading, and damage to both the raceways and balls. Damage observed on the shoulders of both raceways provided evidence that the balls had moved out of the raceway. Either this, or grouping together of all the balls, is likely to have caused the input shaft to move out of axial alignment. Loss of alignment would alter the normal engagement of the input and output bevel gears so that they could move apart. This in turn would result in increased contact between the tips of the teeth, leading to skipping and deformation. When the deformation progressed to the extent that the gears were effectively 'toothless' (Figure 7), there would have been no effective connection between the TRGB input and output shafts. At this point, the anti-torque thrust from the tail rotor would have been lost, resulting in the rapid rotation of the helicopter and subsequent loss of control.

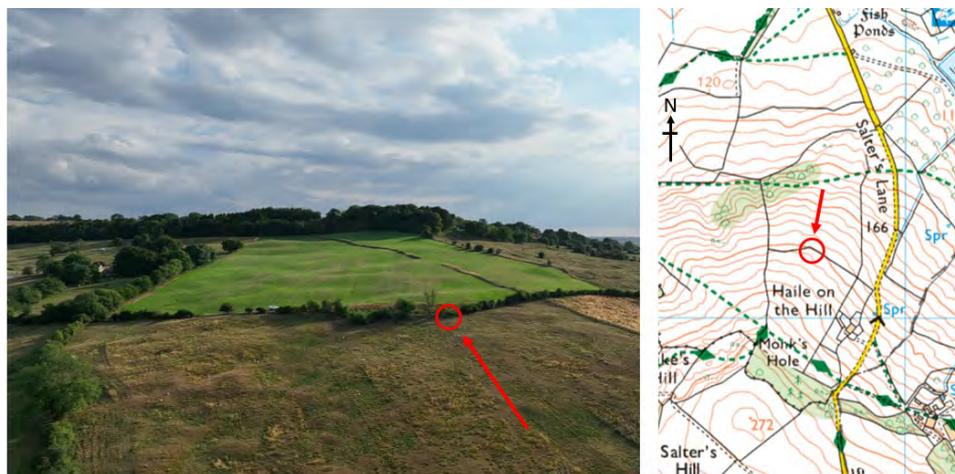
Figure 2

The glider came to rest in a hedge at the uphill end of a grass field at Haile on the Hill, approximately 6 nm northeast of Cheltenham, Gloucestershire (Figure 2). The hedge contained a wire stock fence which the nose of the glider penetrated, breaking the canopy transparency and trapping the canopy frame in the closed position.

Accident site looking south (left image) and accident location (right image), with approach direction into field indicated with a red arrow. © 2022 Ordnance Survey

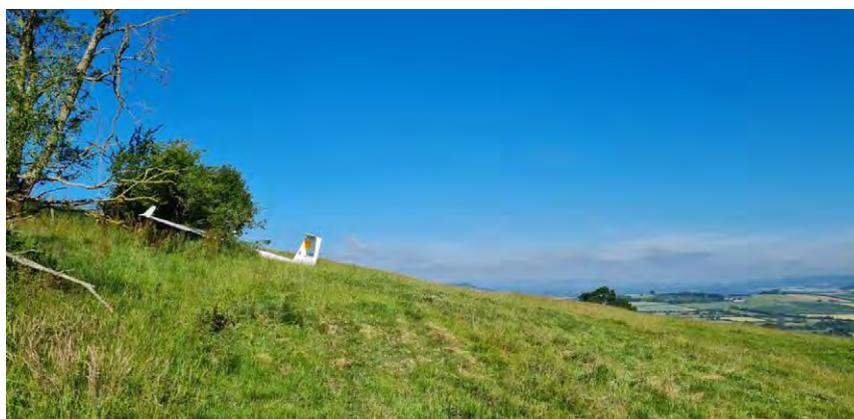
Figure 3

The surface of the field was undulating grass pasture, with a steep upslope of approximately 20% (Figure 3).

Accident site, looking north-west

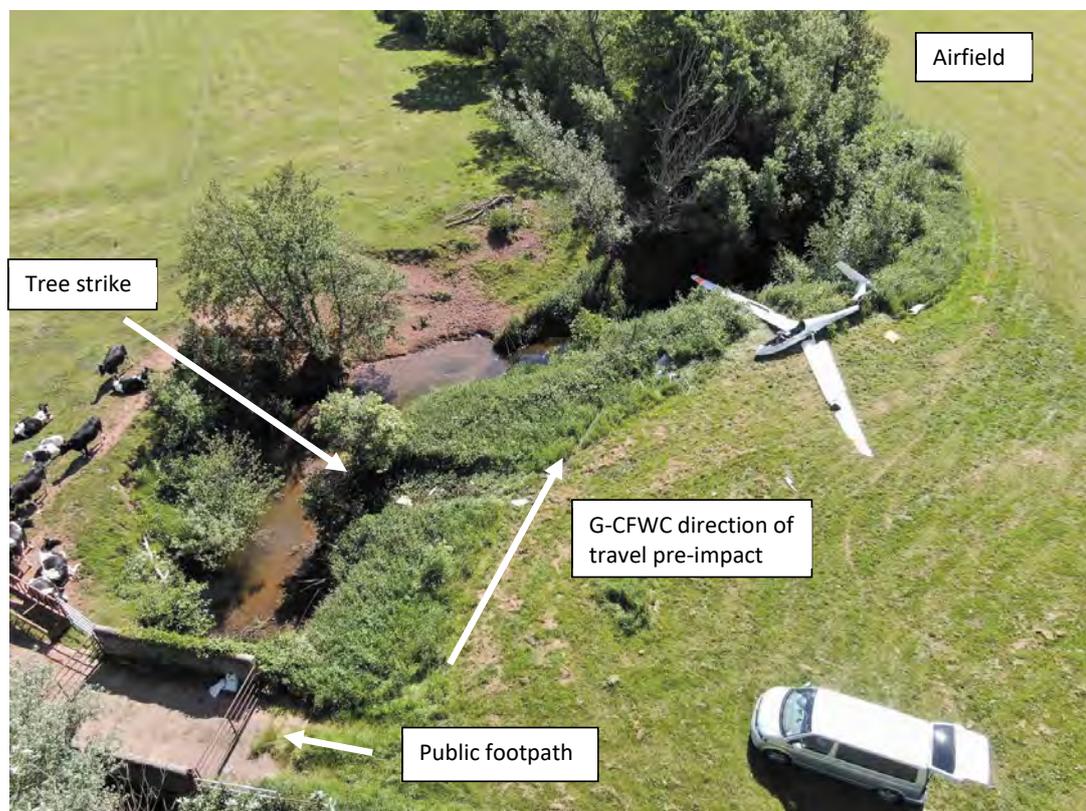
Figure 2
Accident site

A flattened area of vegetation on the stream bank corresponded to the shape of the left wing and debris in the vicinity of the tree was matched to the left wing leading edge. Corresponding strike marks on the tree indicated that the glider was approximately at ground level when it struck the tree. The impact caused the glider to pivot sharply around the tree before coming to rest in its final position.

The left wing had separated from the fuselage such that it remained attached only by the aileron and airbrake control rods. The right wing was intact, with the exception of damage to the trailing edge where the wing had struck a fence post as it came to rest.

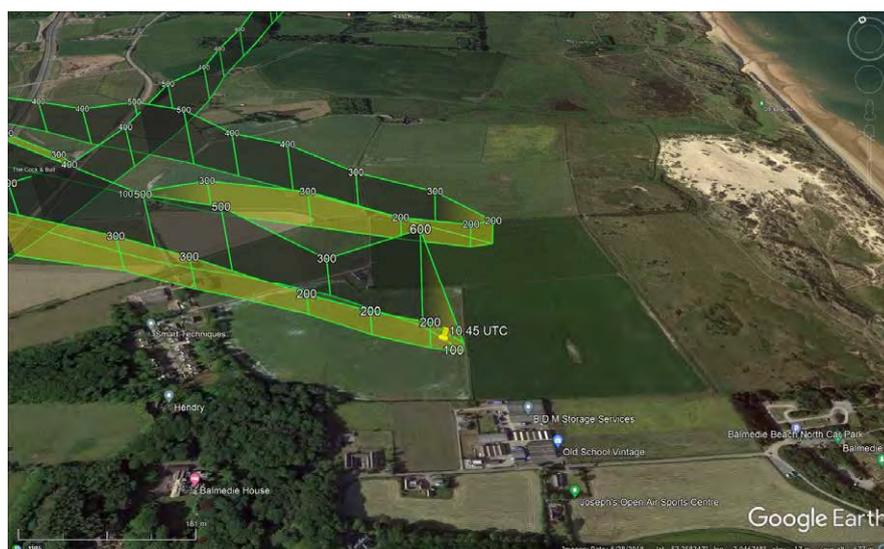
Figure 2

At 1045 hrs the pilot was manoeuvring the helicopter from one planned survey track to the next. To ensure he stayed clear of buildings he had reduced speed to minimise the turning radius. As the speed reduced, the power required to maintain level flight would have increased as translational lift reduced. During the manoeuvre the helicopter lost height and the underslung antenna array struck a 8 m (26 ft) tall electricity supply pylon north of Balmedie (Figures 1 and 2). The collision severed the power cables and interrupted the power supply to 1,682 properties. An expanded view of the incident area is at Figure 2. The pilot stated that he was unaware that the antenna had struck the pylon, so continued the sortie as planned, and was only made aware of the event after landing at the operating field location.

Flight path, with incident at 1045 hrs, showing barometric altitudes

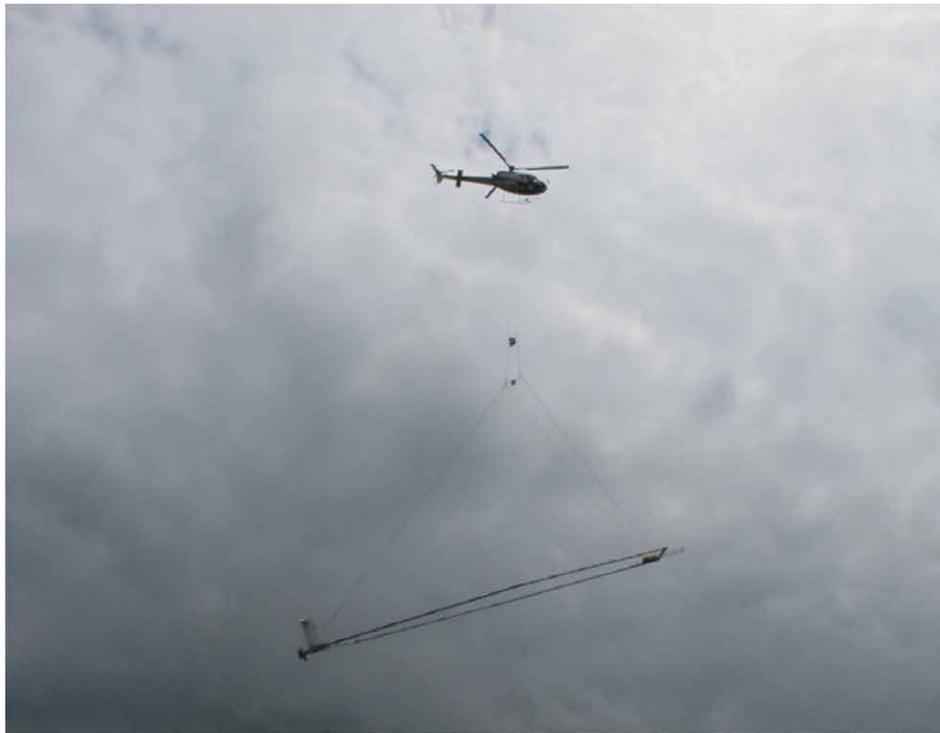
Figure 3

To conduct the geophysical survey the helicopter carried an underslung antenna array (Figure 3). The whole system including its internal generator weighs 780 kg. To avoid the structure of the helicopter affecting the measurements taken by the system the antenna is carried 50 m below the aircraft. The antenna frame is 28 m long, 16.5 m wide, and covers an area of 340 m². The operator had no specific flight test data related to the load but stated that the Rotorcraft Flight Manual limited the speed to 80 kt for underslung loads but gave no limit for angle of bank.

Antenna suspended from an AS350

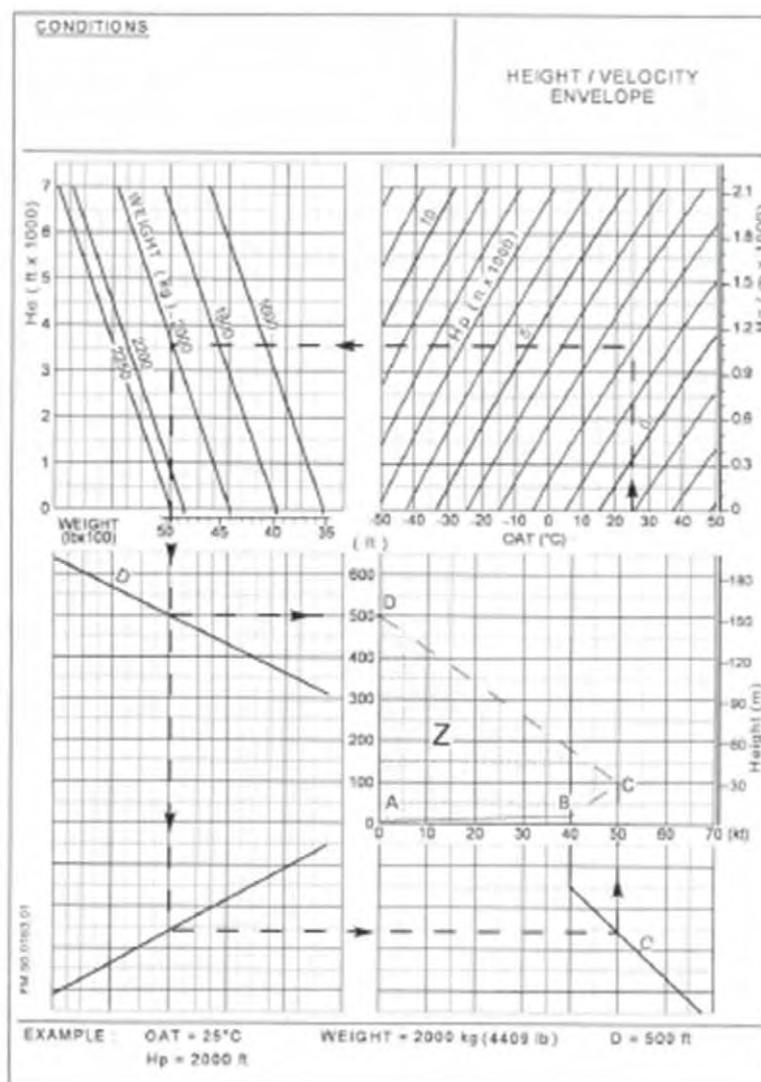
Figure 4

AS350 Height/Velocity diagram

At low speed and height the helicopter was operating within the unsafe area of the Height/Velocity diagram. As a result, if the aircraft suffered an engine failure, then a safe landing would be unlikely. As the aircraft would lack the performance to achieve a safe landing the training and experience of the pilot, suggested by the operator as a mitigation would

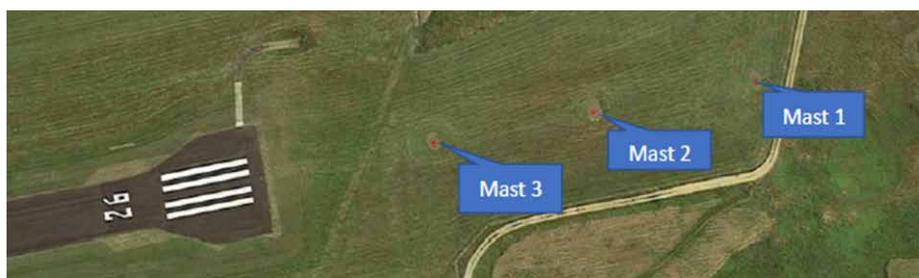
Figure 3
 Approach light positions

The light masts are shown in Figure 3 in sequence with 1 being the first mast struck.

Mast 1 was severed approximately half way up and so the aircraft was already below the level of the runway at that point. Mast 2 appeared to have been struck low down and ground marks suggested it was likely the aircraft touched the ground at this point. It is probable

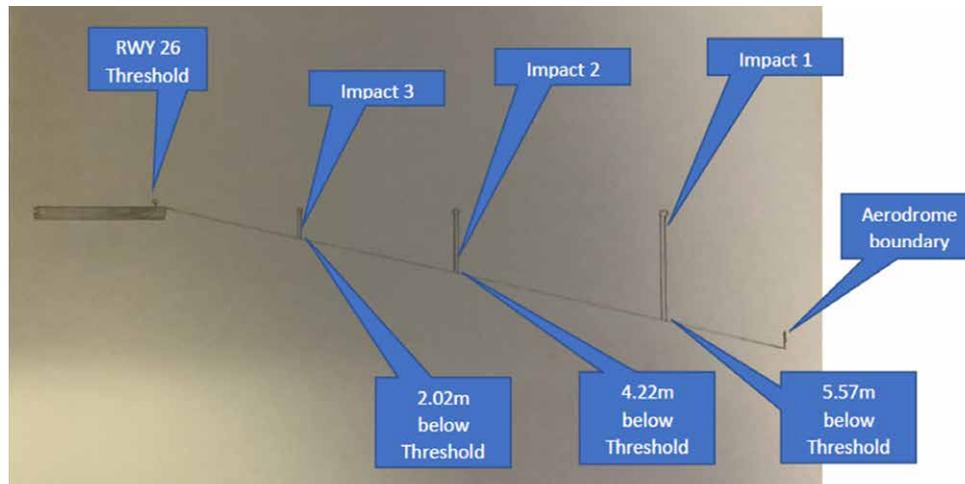
Figure 4

A cross section view of the approach lights is shown in Figure 4. The lights were mounted on masts to give the correct perspective to pilots.

that the most serious damage to the right wing occurred at Mast 2, still approximately 117 m from the runway threshold. The fuel spill trail began at Mast 2 and continued until the aircraft was 90 m along the runway surface.

Cross section of the approach showing mast position

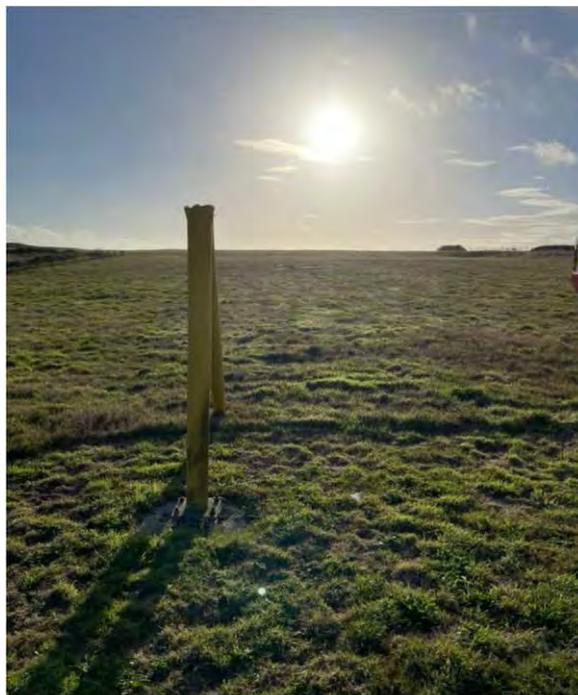
Figure 5 shows an image, taken by the RFFS, of a view from the approach lights looking toward the Runway 26 threshold.

View towards Runway 26 threshold

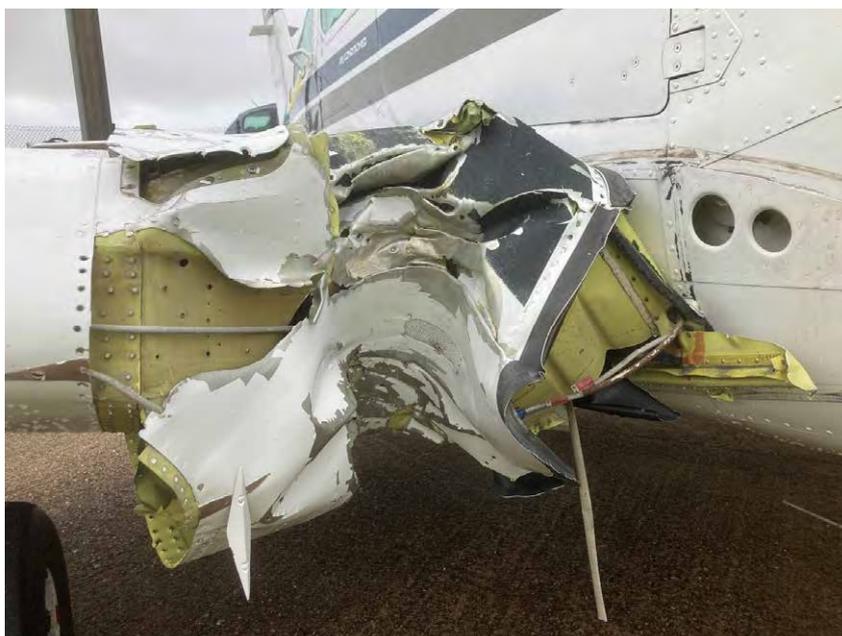
Figure 7

The most serious damage was likely sustained on the right wing when the aircraft struck Mast 2 and this is shown at Figure 7.

Right wing root damage

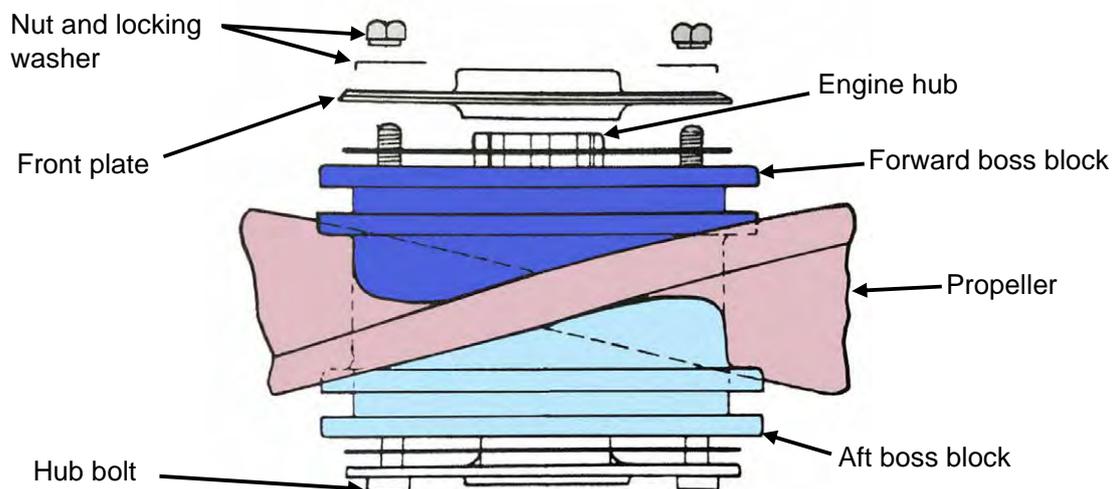
Figure 1

The propeller is paired with forward and aft boss blocks made from cast aluminium (Figure 1).

Propeller assembly arrangement

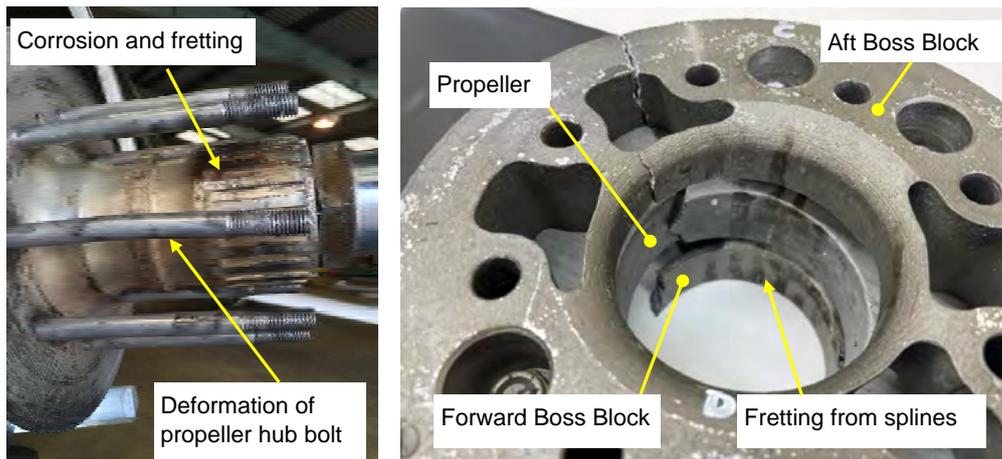
Figure 4

Engine hub corrosion and fretting, and fretting of inner surfaces of blocks and propeller

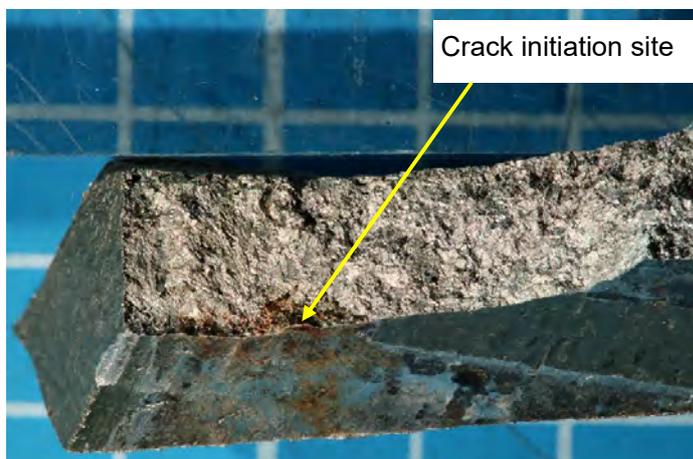
Figure 5

Of the four cracks in the forward boss block, one was assessed as the primary fatigue fracture and the remaining three were assessed as secondary overload failures. The primary fracture originated from a worn area on the inner diameter, caused by fretting from the splines of the removable propeller hub. Thumbnail shaped deposits of oxide and rust at the edge of the fracture surface (Figure 5) indicated that the crack initially grew slowly and then accelerated when it was a few millimetres deep. The crack had grown to approximately 20 mm in length when final failure occurred.

Primary fracture surface of forward boss block

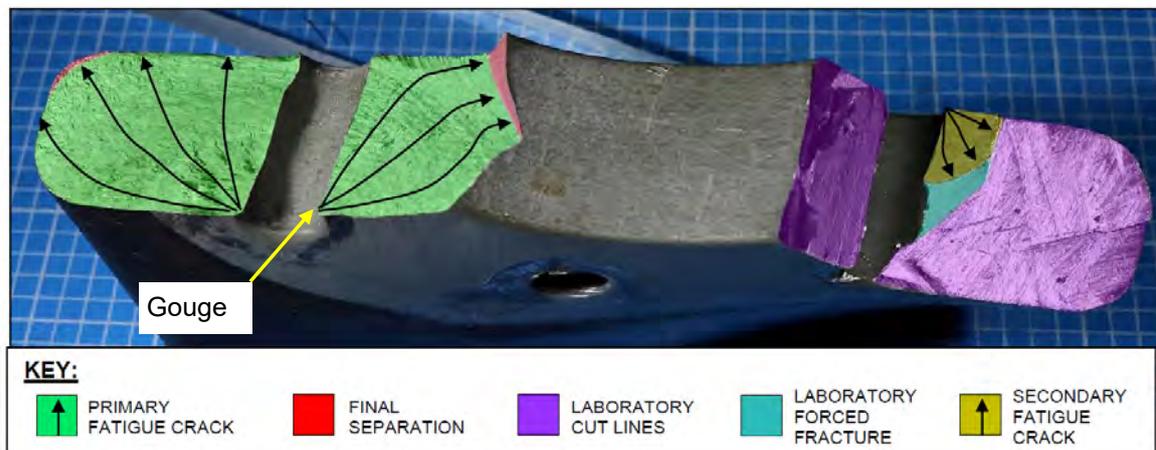
Figure 6

The primary fatigue crack of the propeller initiated on opposite sides of a propeller hub bolt hole (Figure 6). There is no evidence of damage associated with crack initiation on one side of the hole. On the other side of the hole, the crack initiated from a small gouge; however, this damage was not considered to be large enough to have initiated the fatigue failure.

The secondary fatigue crack in the propeller also initiated from the radius of a bolt hole; there was no evidence of pre-existing damage around this hole.

The surface finish of the radii on the bolt holes and the propeller face were not in accordance with the manufacturer's specification. However, this was not considered to be the primary origin of the fatigue failures in these areas.

Propeller fracture surfaces
