Leadon Field Decommissioning Programme Close Out Report

CR5318-LEA-000-PM-RE-5002

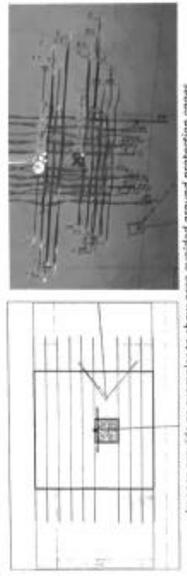
NOTE 1: Due to concerns regarding 6x protection cages installed along the bundle, two of which are located outside the 500 metre safety zones, trawl sweep operations avoided the positions below by 100 metres. Fishermen are therefore advised to keep at least 100 metres clear of these positions:
 # 1 Cage: 59° 34.7669'N, 001° 39.2357'E
 # 2 Cage: 59° 34.2547'N, 001° 39.2514'E
 # 3 Cage: 59° 33.1236'N, 001° 39.3489'E
 # 4 Cage: 59° 34.2585'N, 001° 39.2631'E
 # 5 Cage: 59° 32.5532'N, 001° 39.3937'E
 # 6 Cage: 59° 33.1279'N, 001° 39.3478'E

Images provide as examples to show area avoided around protection cages

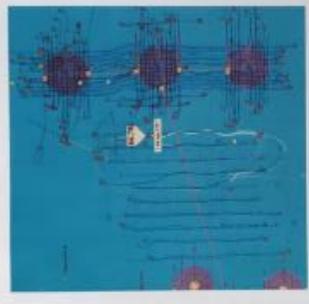
2. PL1895 Route

Various North and South crossings outside 500m safety zones completed (shown in the image below), to confirm there are no concerns over seabed disturbance in relation to the removal of the pipeline.
